Job Title
Highland School RAAC Survey –
Nairn Academy

Prepared for
Highland Council and Watts Property
Service

Report Type
RAAC Survey Final Report

Date
21 August 2023

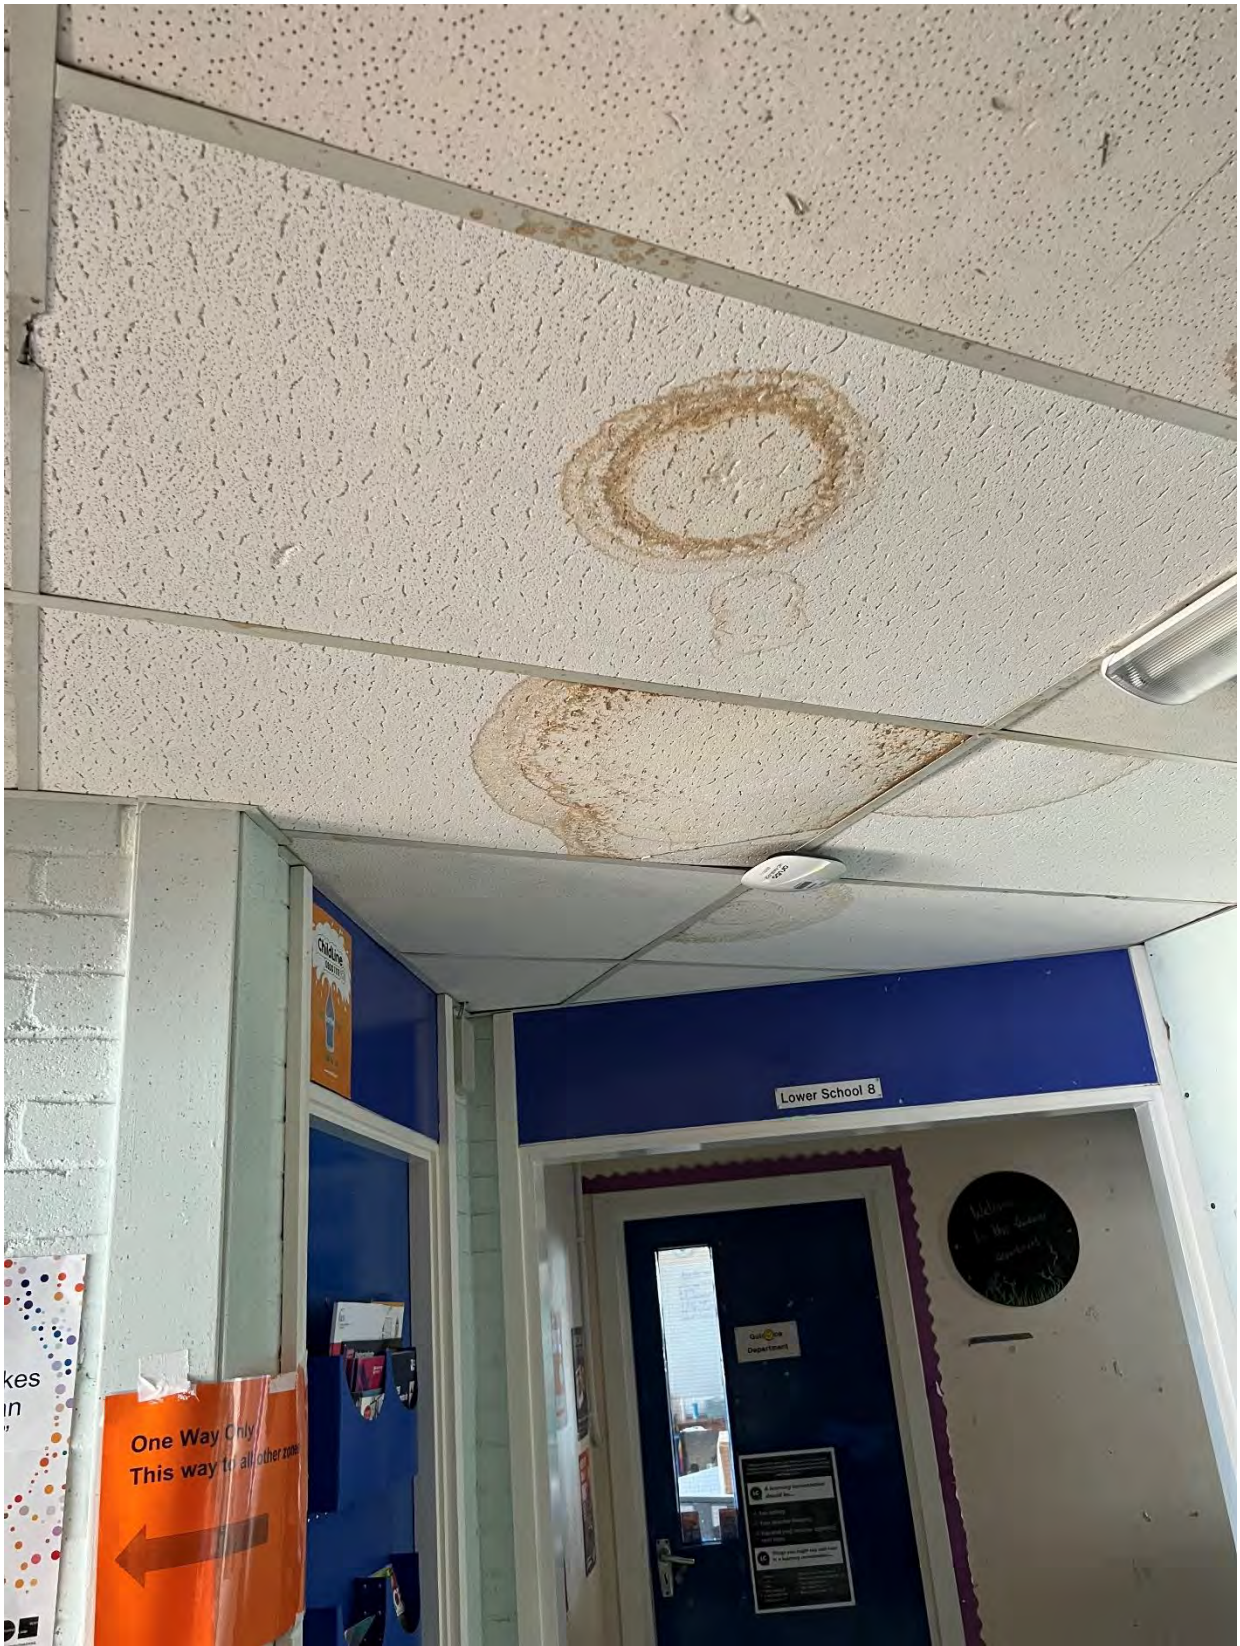
Defect Ref.	Description	Assessed Risk	Recommendation
N.1	Photo N.1 water staining to ceiling tiles in corridor. See photo N.1	Critical Risk	Ceiling tiles to be removed and panel condition assessed. Requires remedial action urgently – remedial detail to be developed at next inspection (w/c 17.07.23)
N.2	Castellated beams supporting Siporex panels – flange appears to be 165mm. See photo N.2	Medium Risk	Requires inspection regularly – say annually unless condition changes
N.3	Soffit of Siporex panels has been damaged during removal of asbestos coating. See photo N.3	High Risk	Requires remedial action asap – remedial detail to be developed at next inspection (w/c 17.07.23)

Photo N.1 water staining to ceiling tiles in corridor

2. Suspended ceilings tiles showing water staining to be popped throughout – It can be just one in each the area for now until we agree a remedial detail.

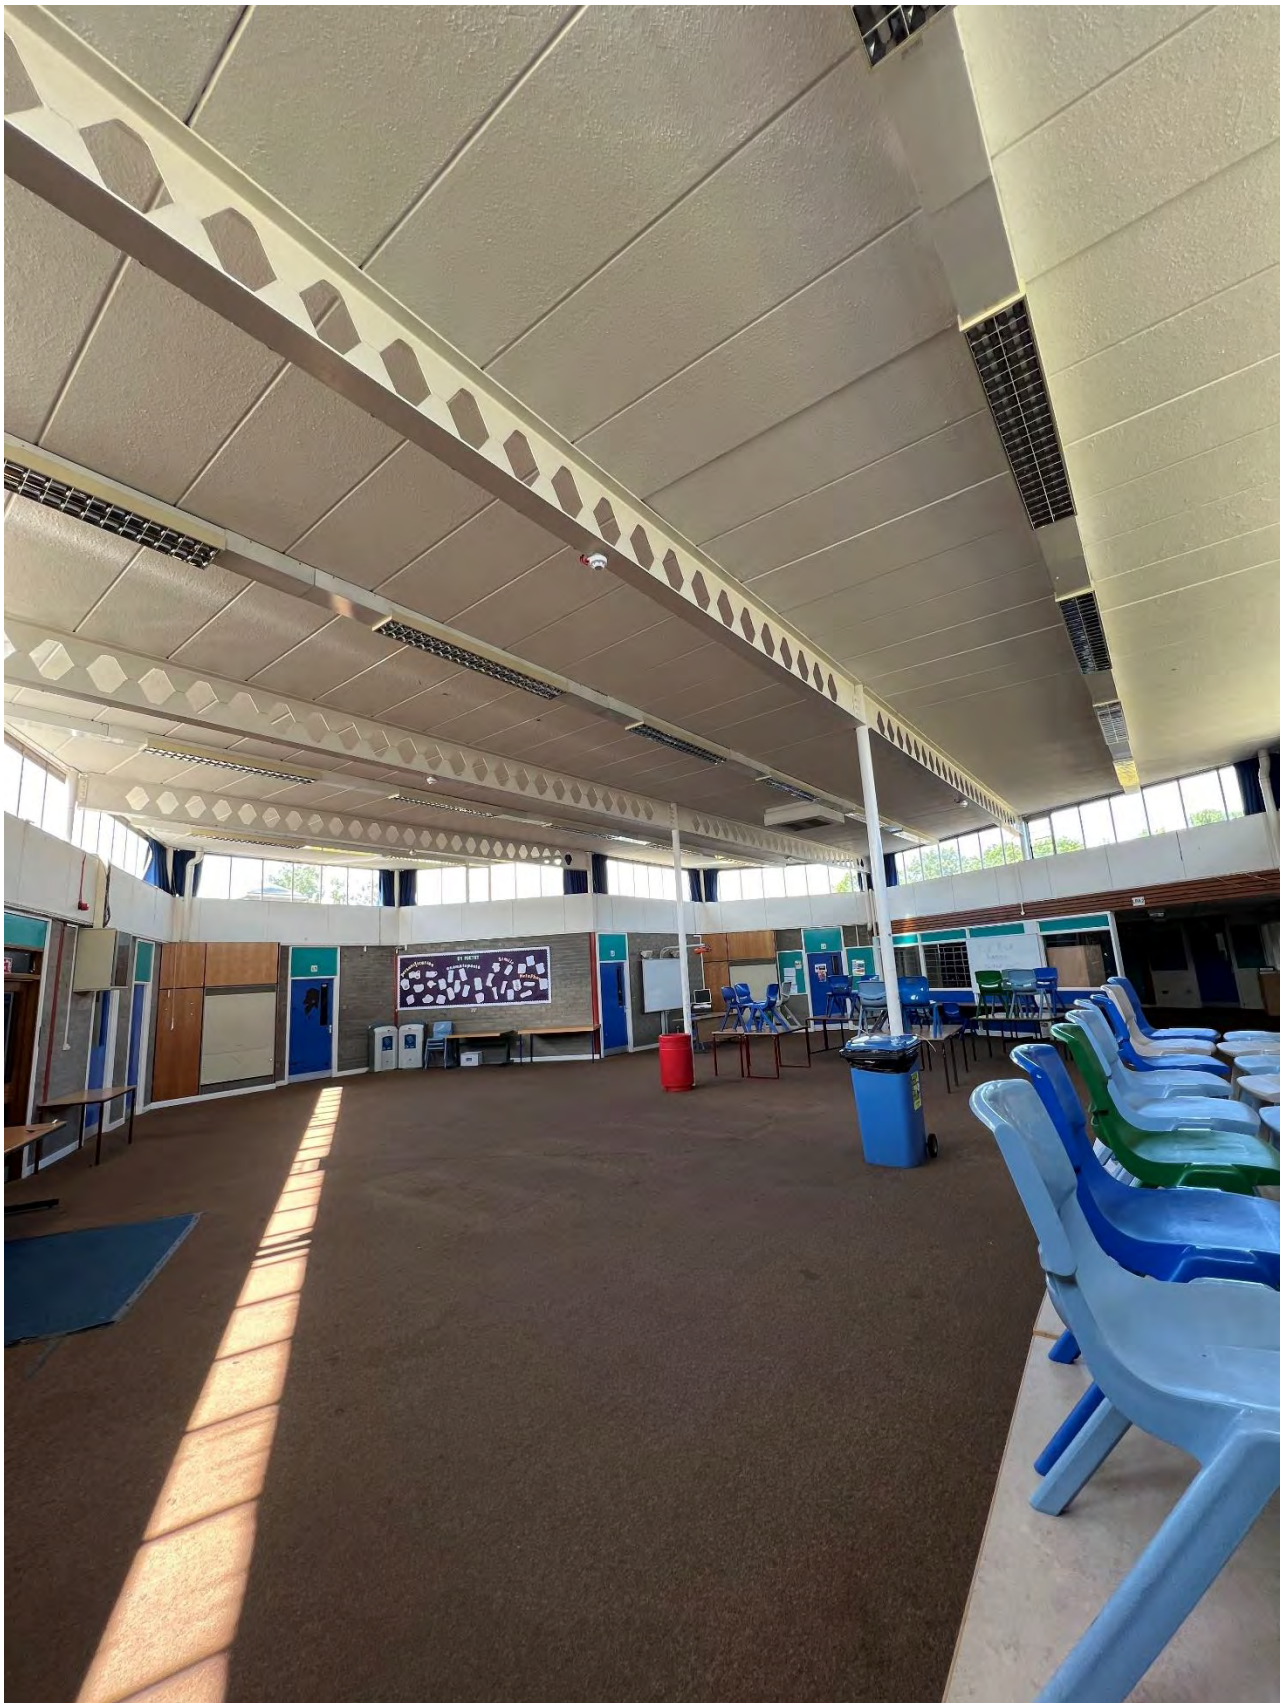
Photo N.2 Castellated beams supporting Siporex panels – flange appears to be 165mm

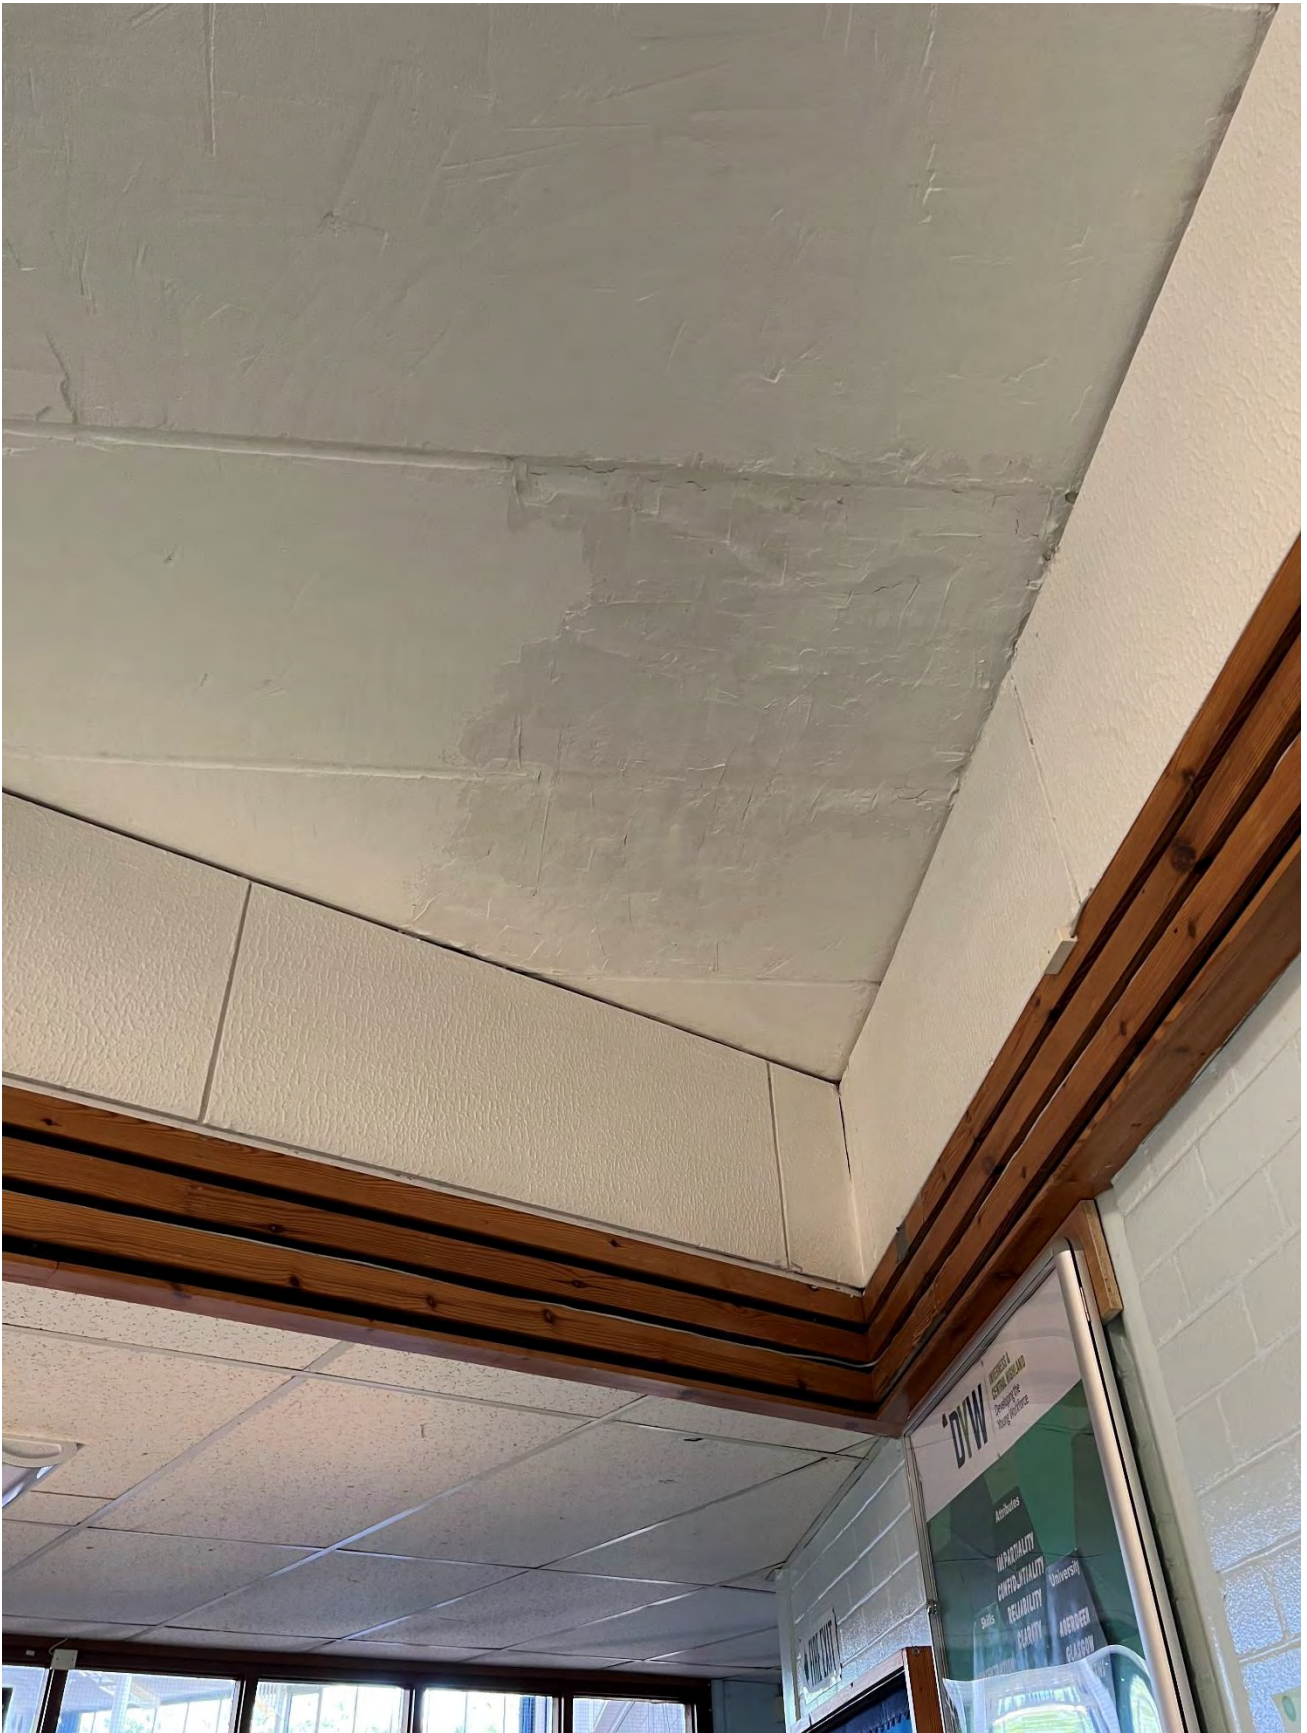
Photo N.3 Soffit of Siporex panels has been damaged during removal of asbestos coating

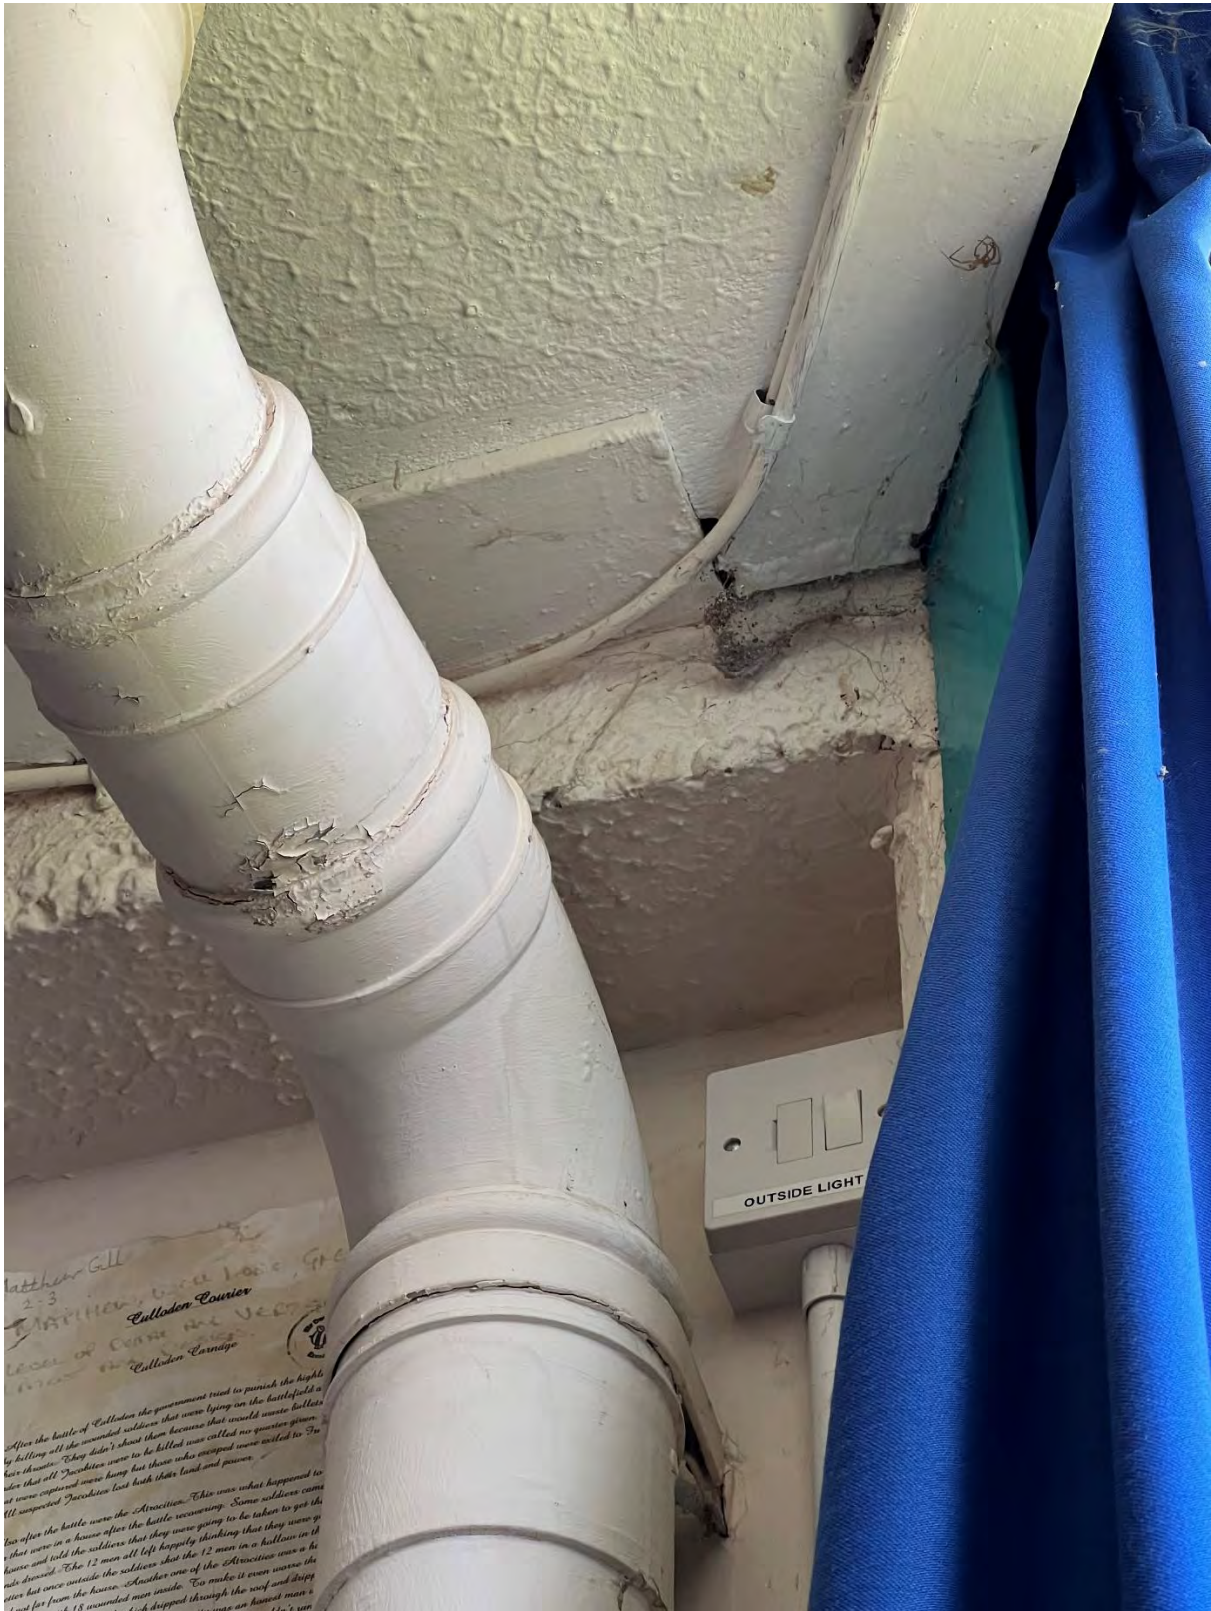
N.4	Bearing of panels appears to be less than 75mm. See photo N.4	High Risk	Requires remedial action asap – remedial detail to be developed at next inspection (w/c 17.07.23)
N.5	Pipework through panel is supported with correct bridle detail but bearing is less than 75mm. See photo N.5	High Risk	Requires remedial action asap – remedial detail to be developed at next inspection (w/c 17.07.23)
N.6	Geometry of rooms mean the panels are not parallel to supporting beam – unclear on whether bearing length is more than 75mm across whole length See photo N.6	Medium Risk	Requires inspection regularly – say annually unless condition changes
N.7	Wall panels internally show no water ingress. See photo N.7	Medium Risk	Requires inspection regularly – say annually unless condition changes
N.8	Flat roofs externally have moss and vegetation throughout which will trap moisture and makes it difficult to inspect the integrity of the roof sheeting below. See photo N.8	High Risk	Requires remedial action asap – remedial detail to be developed at next inspection (w/c 17.07.23)

Photo N.4 Bearing of panels appears to be less than 75mm

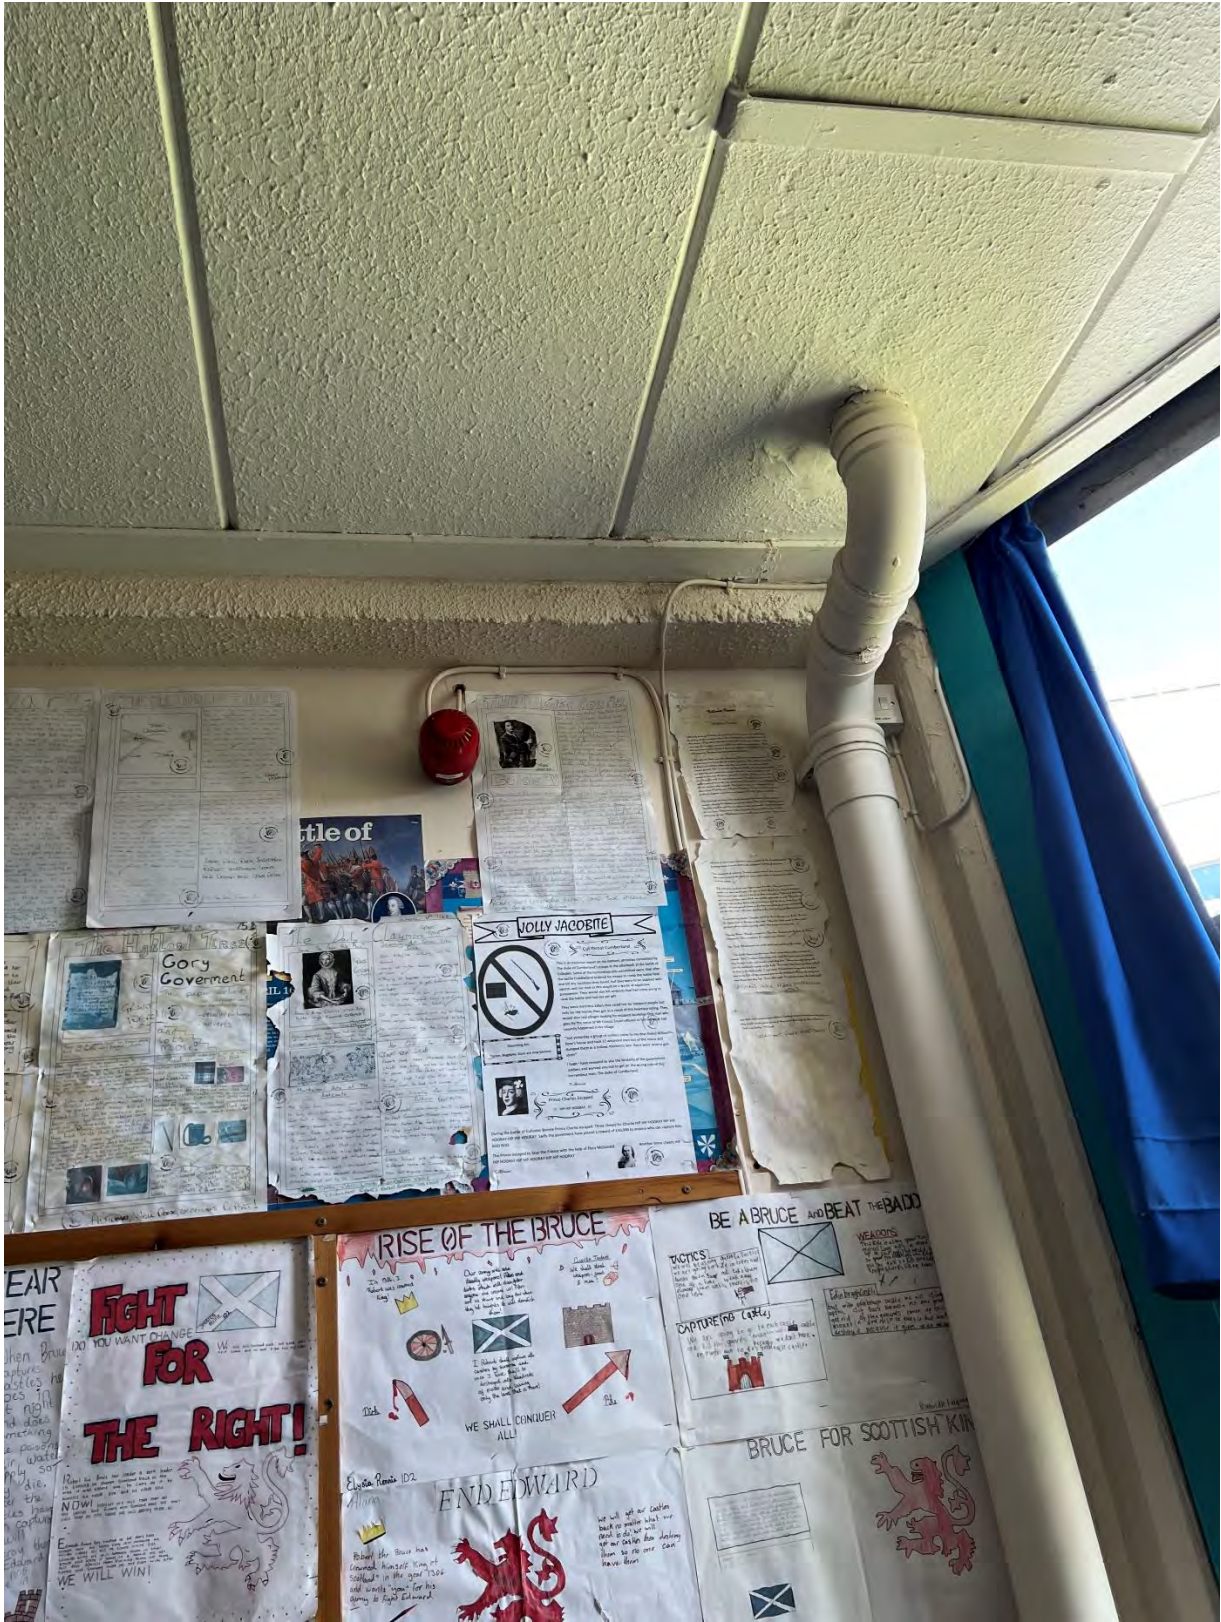
Photo N.5 pipework through panel is supported with correct bridle detail

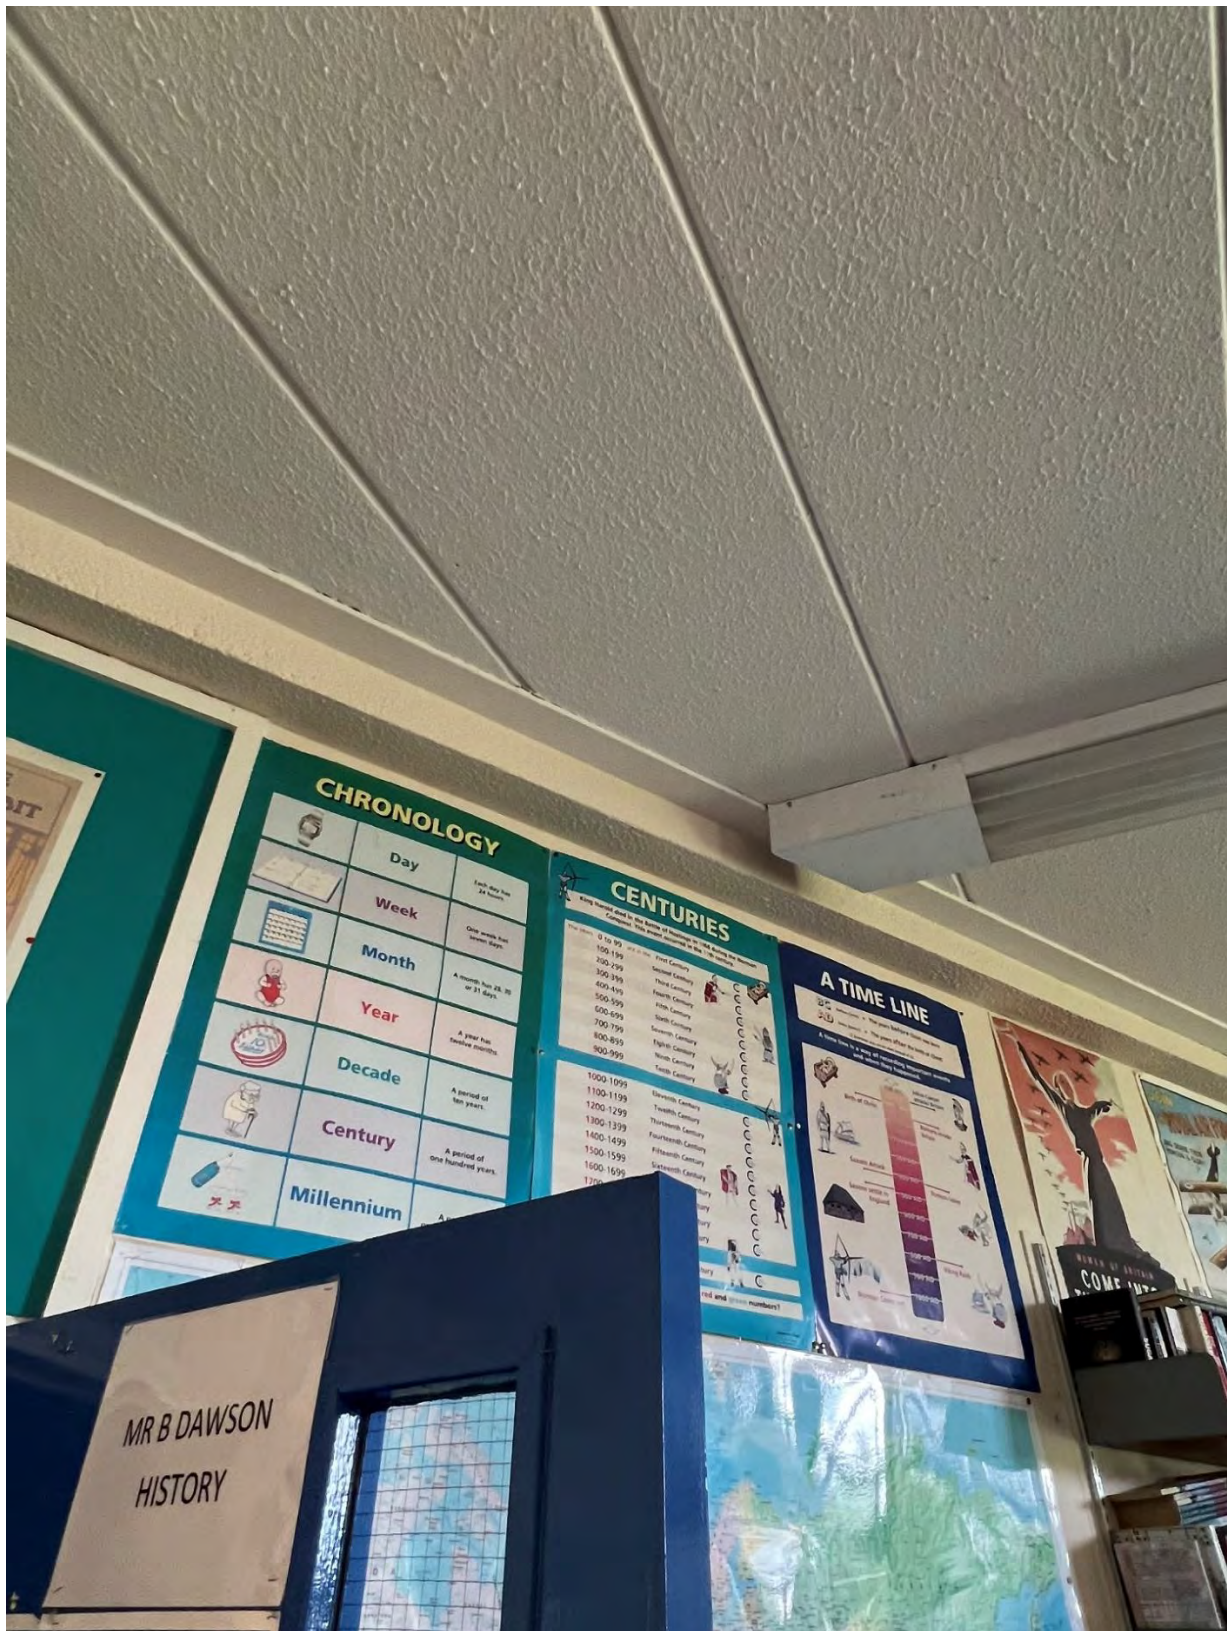
Photo N.6 Geometry of rooms mean the panels are not parallel to supporting beam – unclear on whether bearing length is more than 75mm across whole length

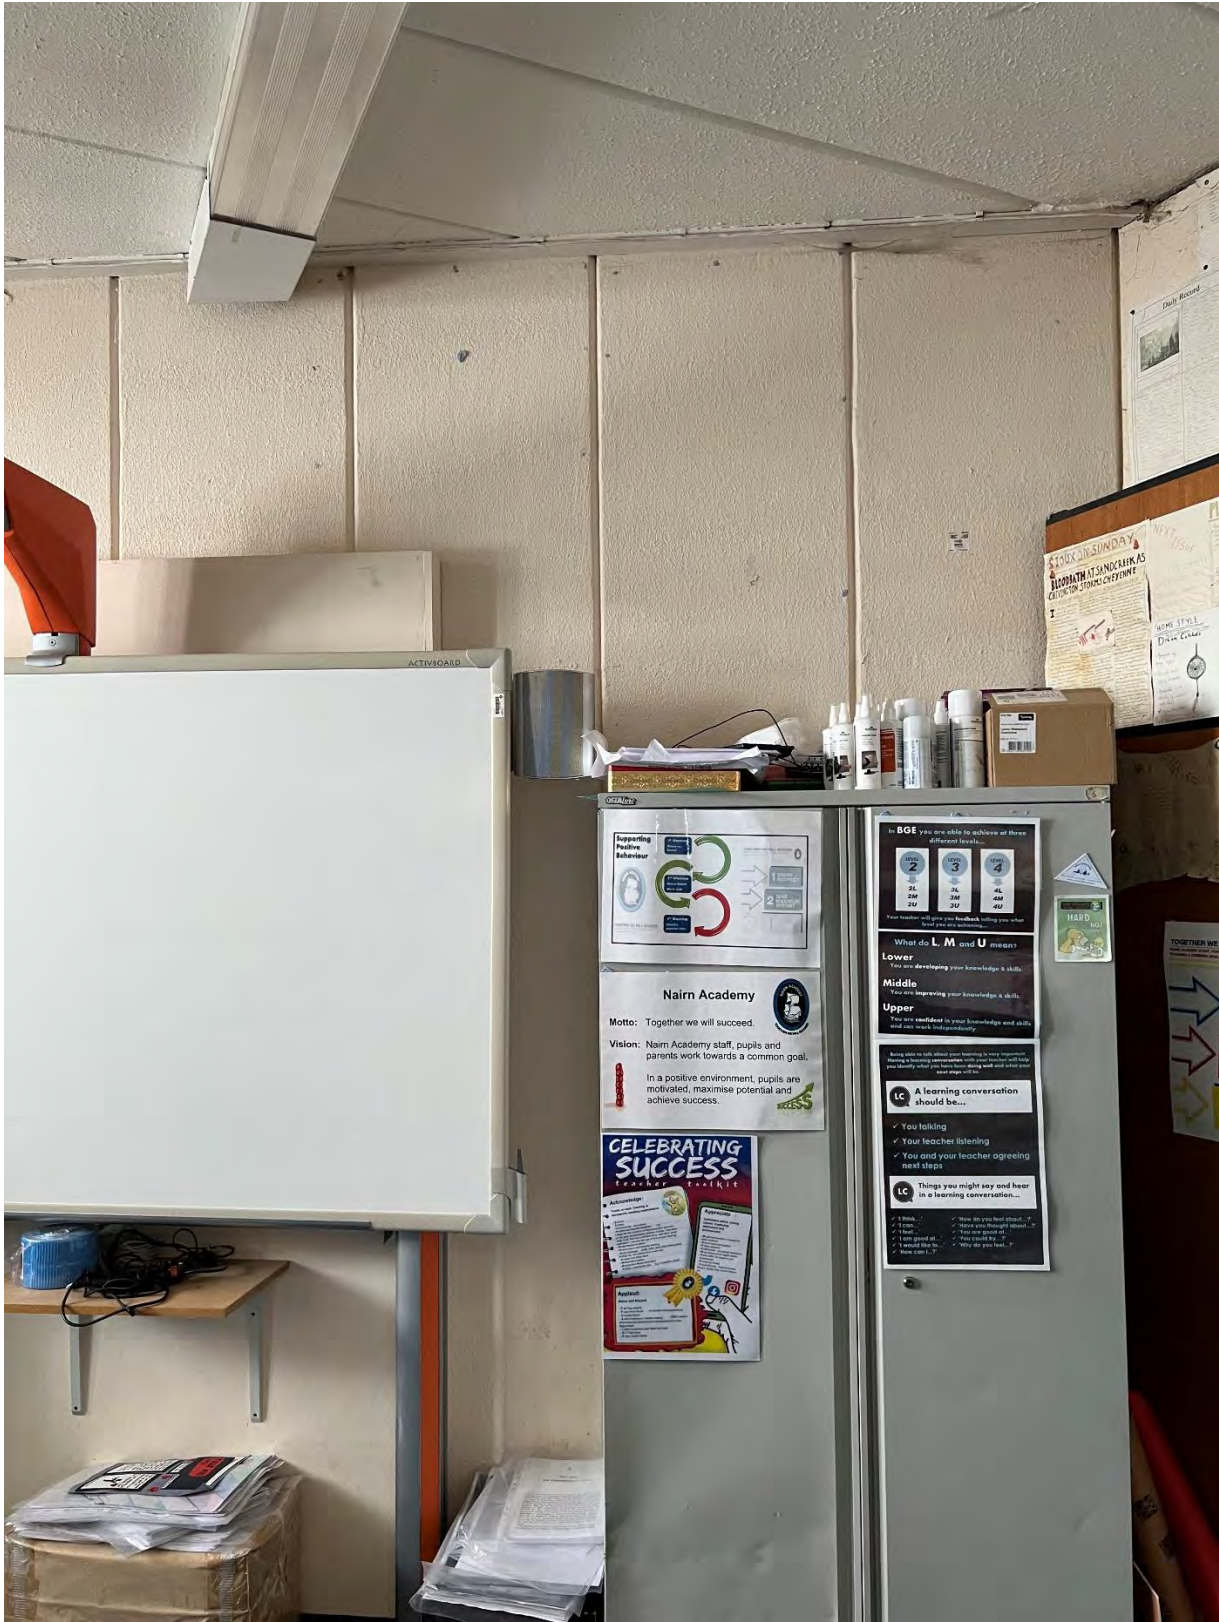
Photo N.7 Wall panels internally show no water ingress

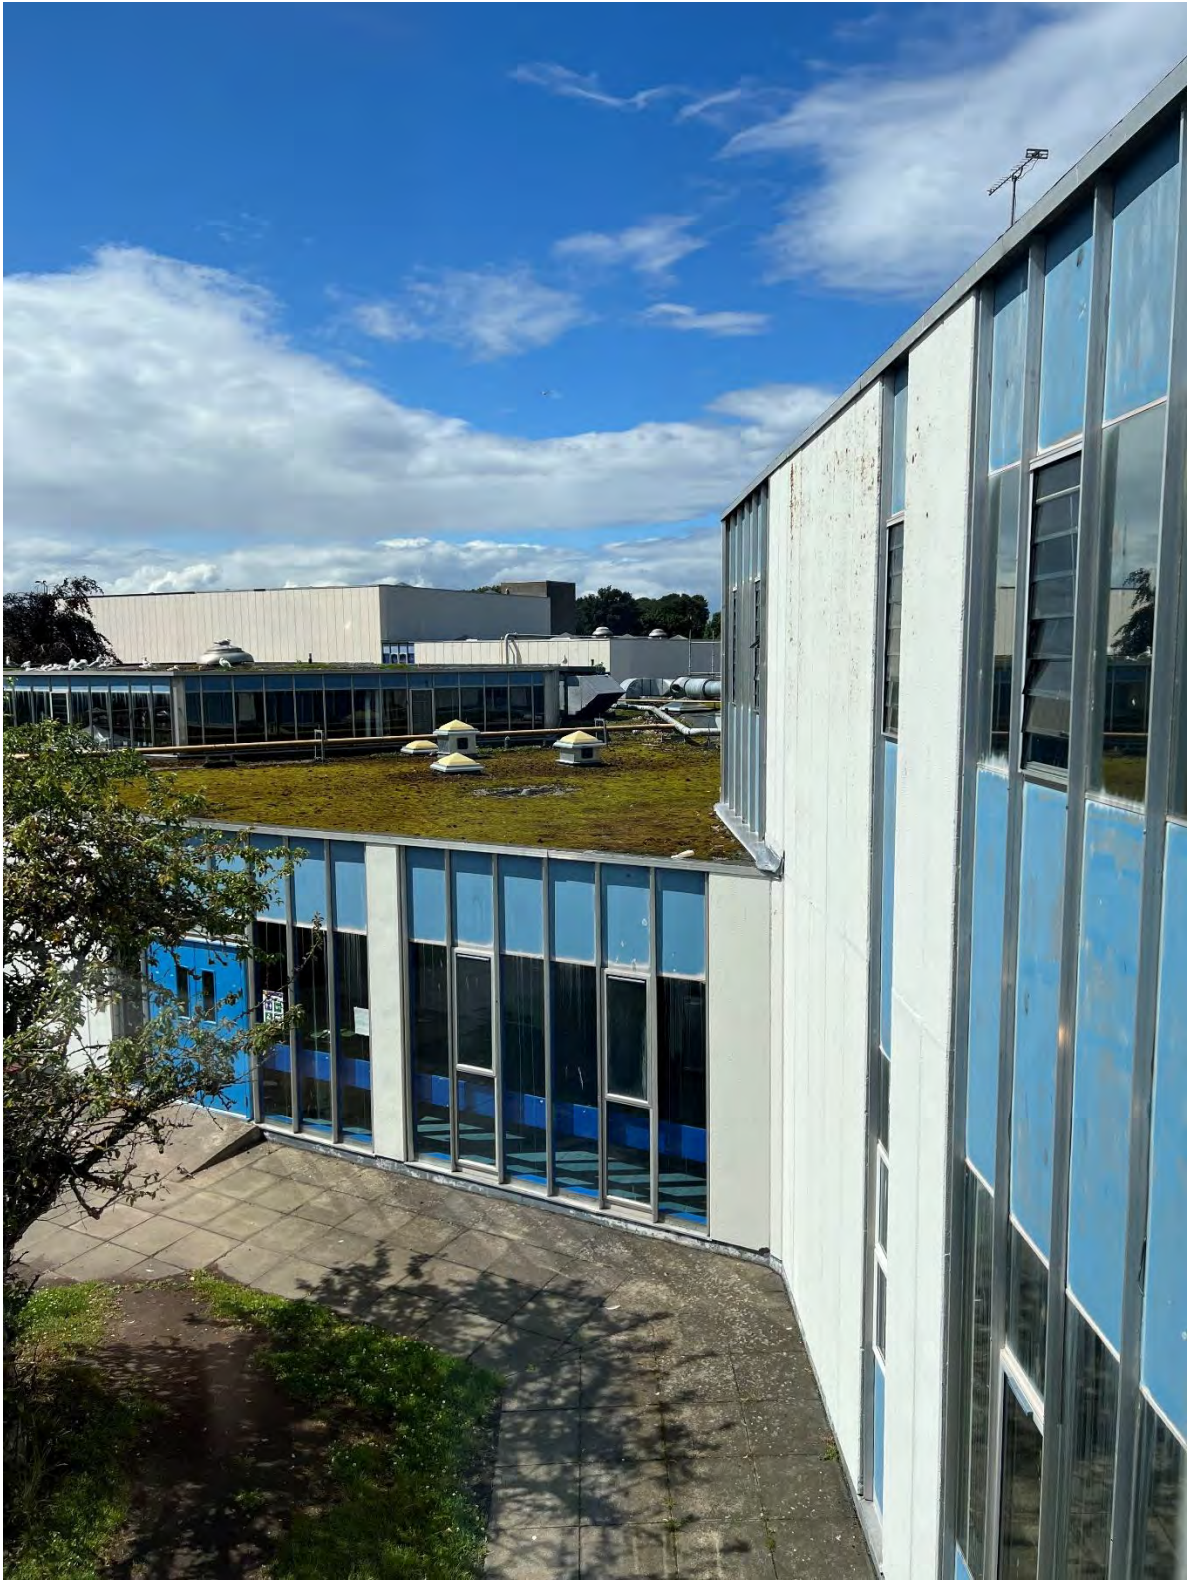
Photo N.8 Flat roofs externally have moss and vegetation throughout which will trap moisture

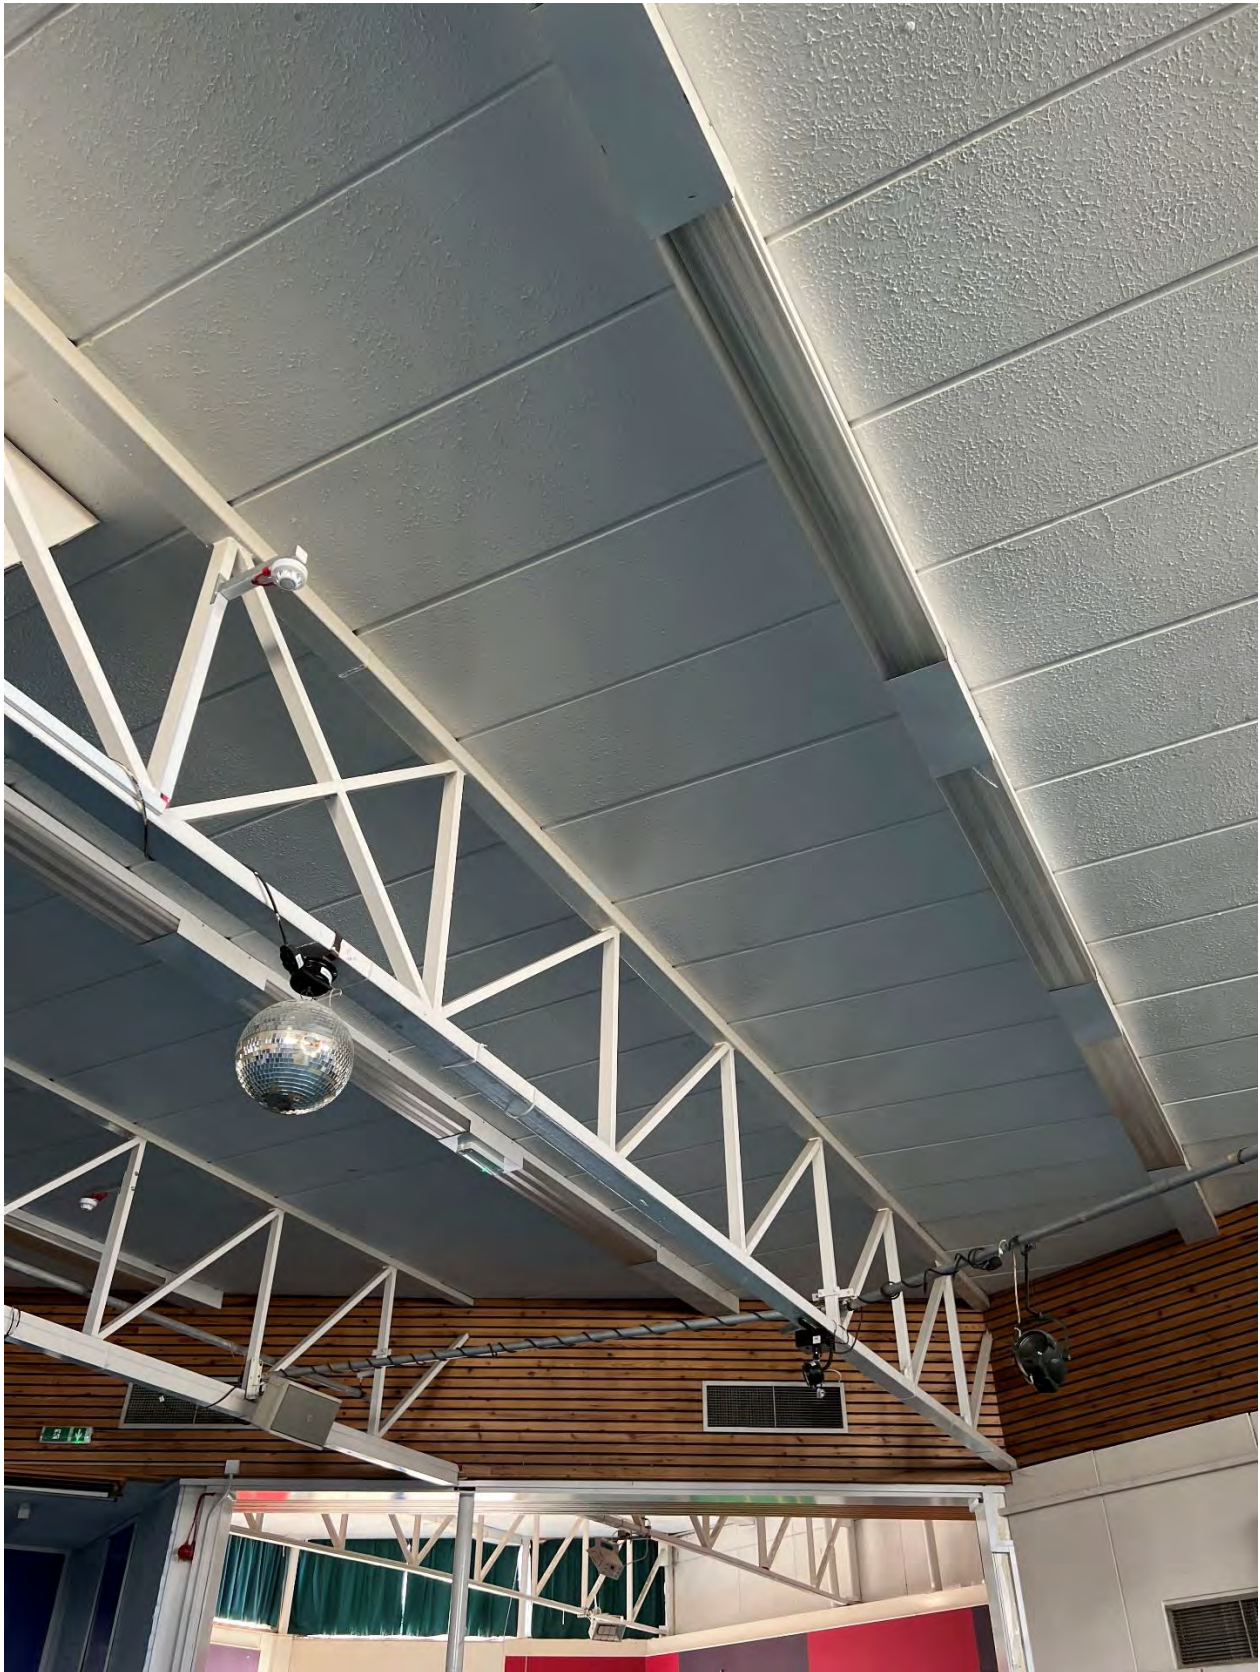
N.9	Siporex roof panels supported on top chord of truss in canteen area – bearing appears less than 75mm. No water ingress visible See photo N.9	High Risk	Requires remedial action asap – remedial detail to be developed at next inspection (w/c 17.07.23)
N.10	Castellated beams supporting Siporex panels – flange appears to be 165mm. No water ingress visible See photo N.10	High Risk	Requires remedial action asap – remedial detail to be developed at next inspection (w/c 17.07.23)
N.11	Siporex roof panels supported on top chord of truss in gym area – bearing appears less than 75mm. No water ingress visible See photo N.11	High Risk	Requires remedial action asap – remedial detail to be developed at next inspection (w/c 17.07.23)

Photo N.9 Siporex roof panels supported on top chord of truss in canteen area – bearing appears less than 75mm

3. High level access in the canteen and gym halls to inspect the trusses and finalise a detail for increasing the bearing length, which looks to be less than 75mm – it would be worthwhile having a fabricator on site to agree how this can be safely done.

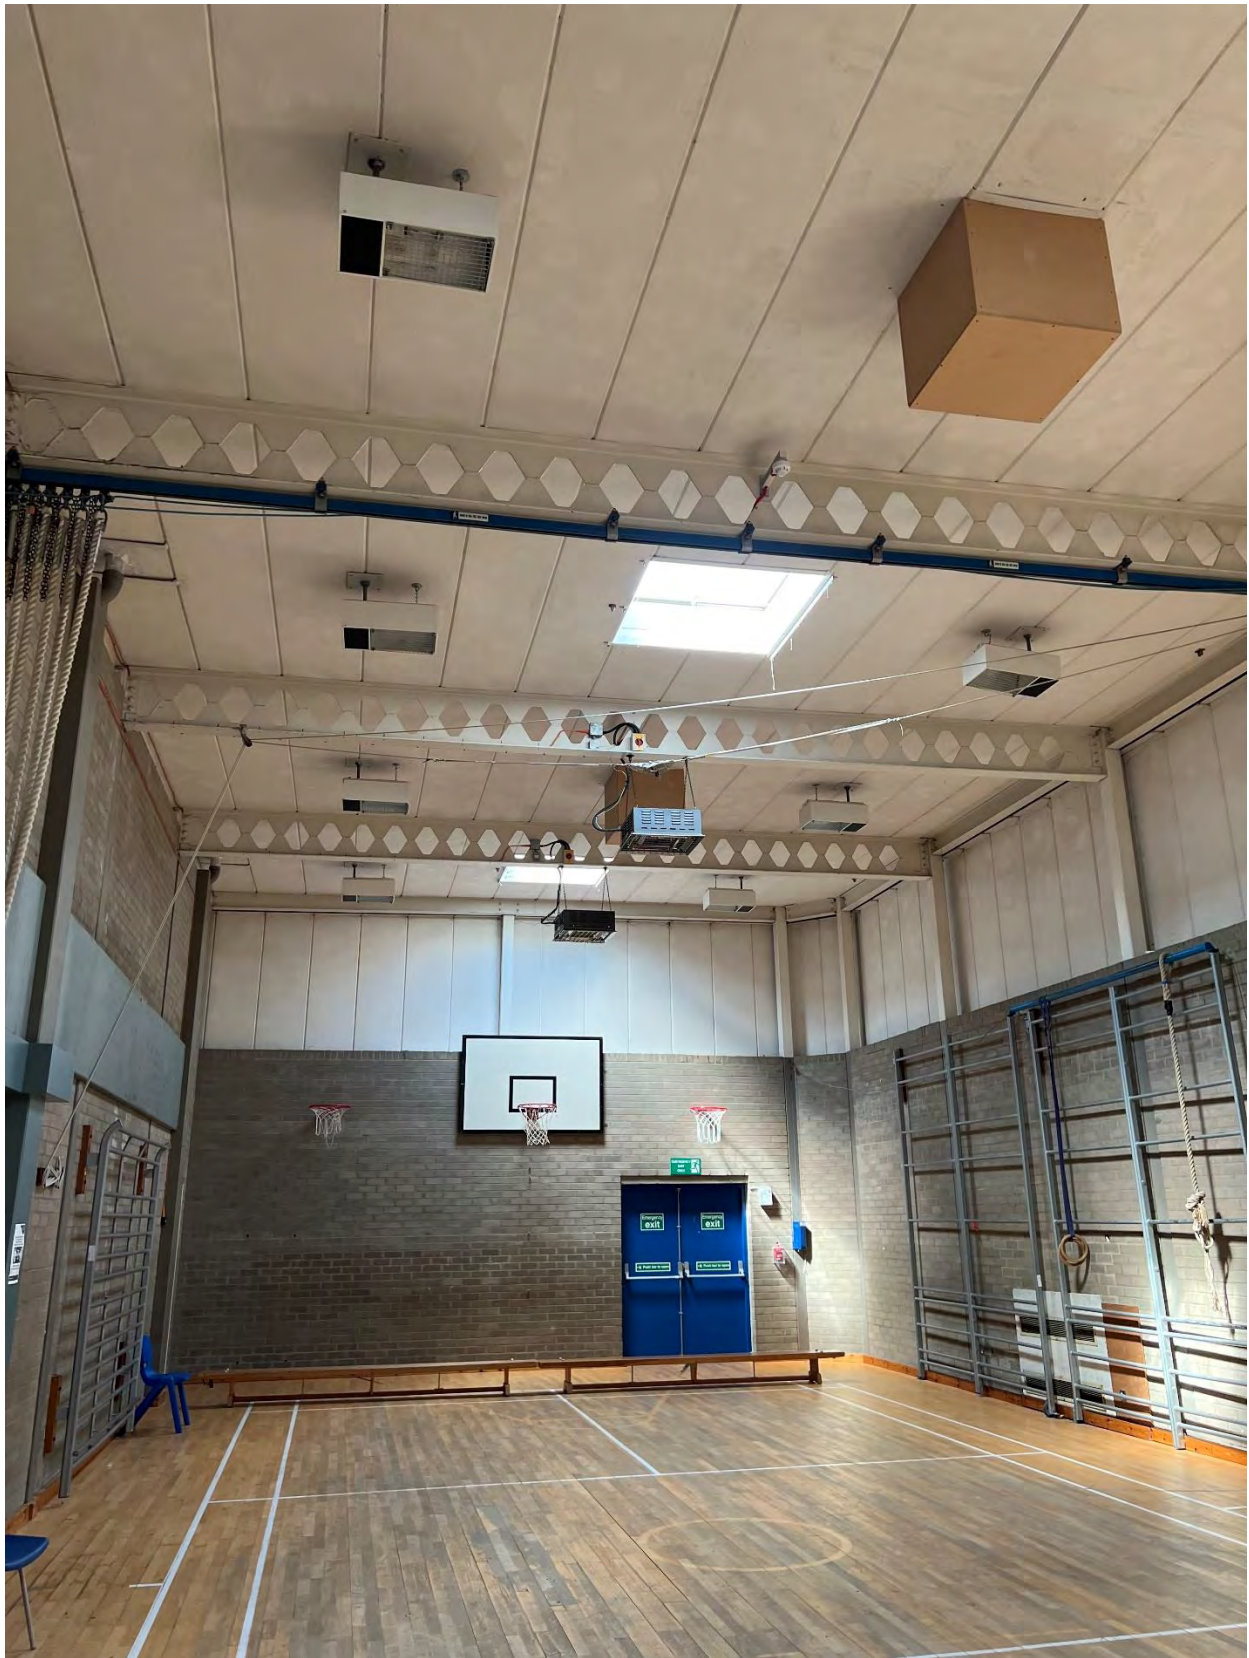
Photo N.10 Castellated beams supporting Siporex panels in gym – flange appears to be 165mm
