Job Title
Highland School RAAC Survey –
Nairn Academy

Prepared for
Highland Council and Watts Property
Service

Report Type
RAAC Survey Final Report

Date
21 August 2023

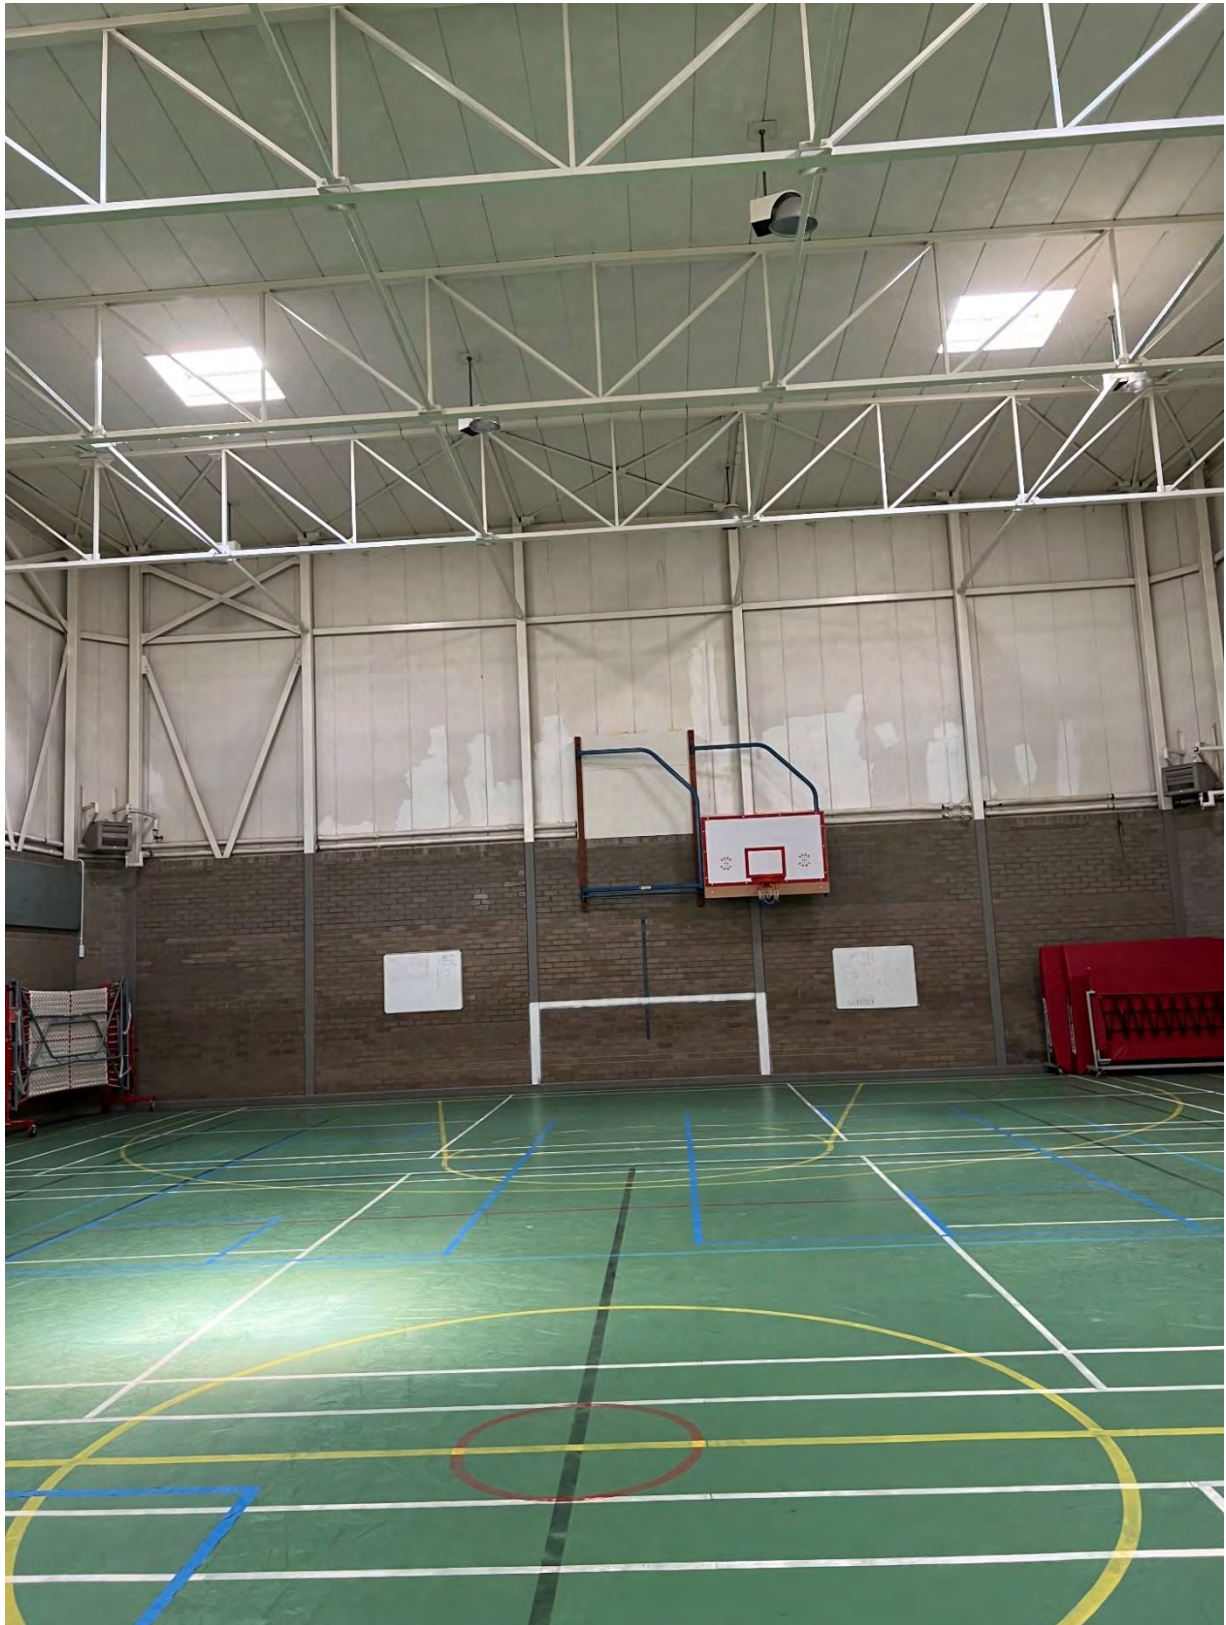
Photo N.11 Siporex roof panels supported on top chord of truss in gym area – bearing appears less than 75mm

3. High level access in the canteen and gym halls to inspect the trusses and finalise a detail for increasing the bearing length, which looks to be less than 75mm – it would be worthwhile having a fabricator on site to agree how this can be safely done.

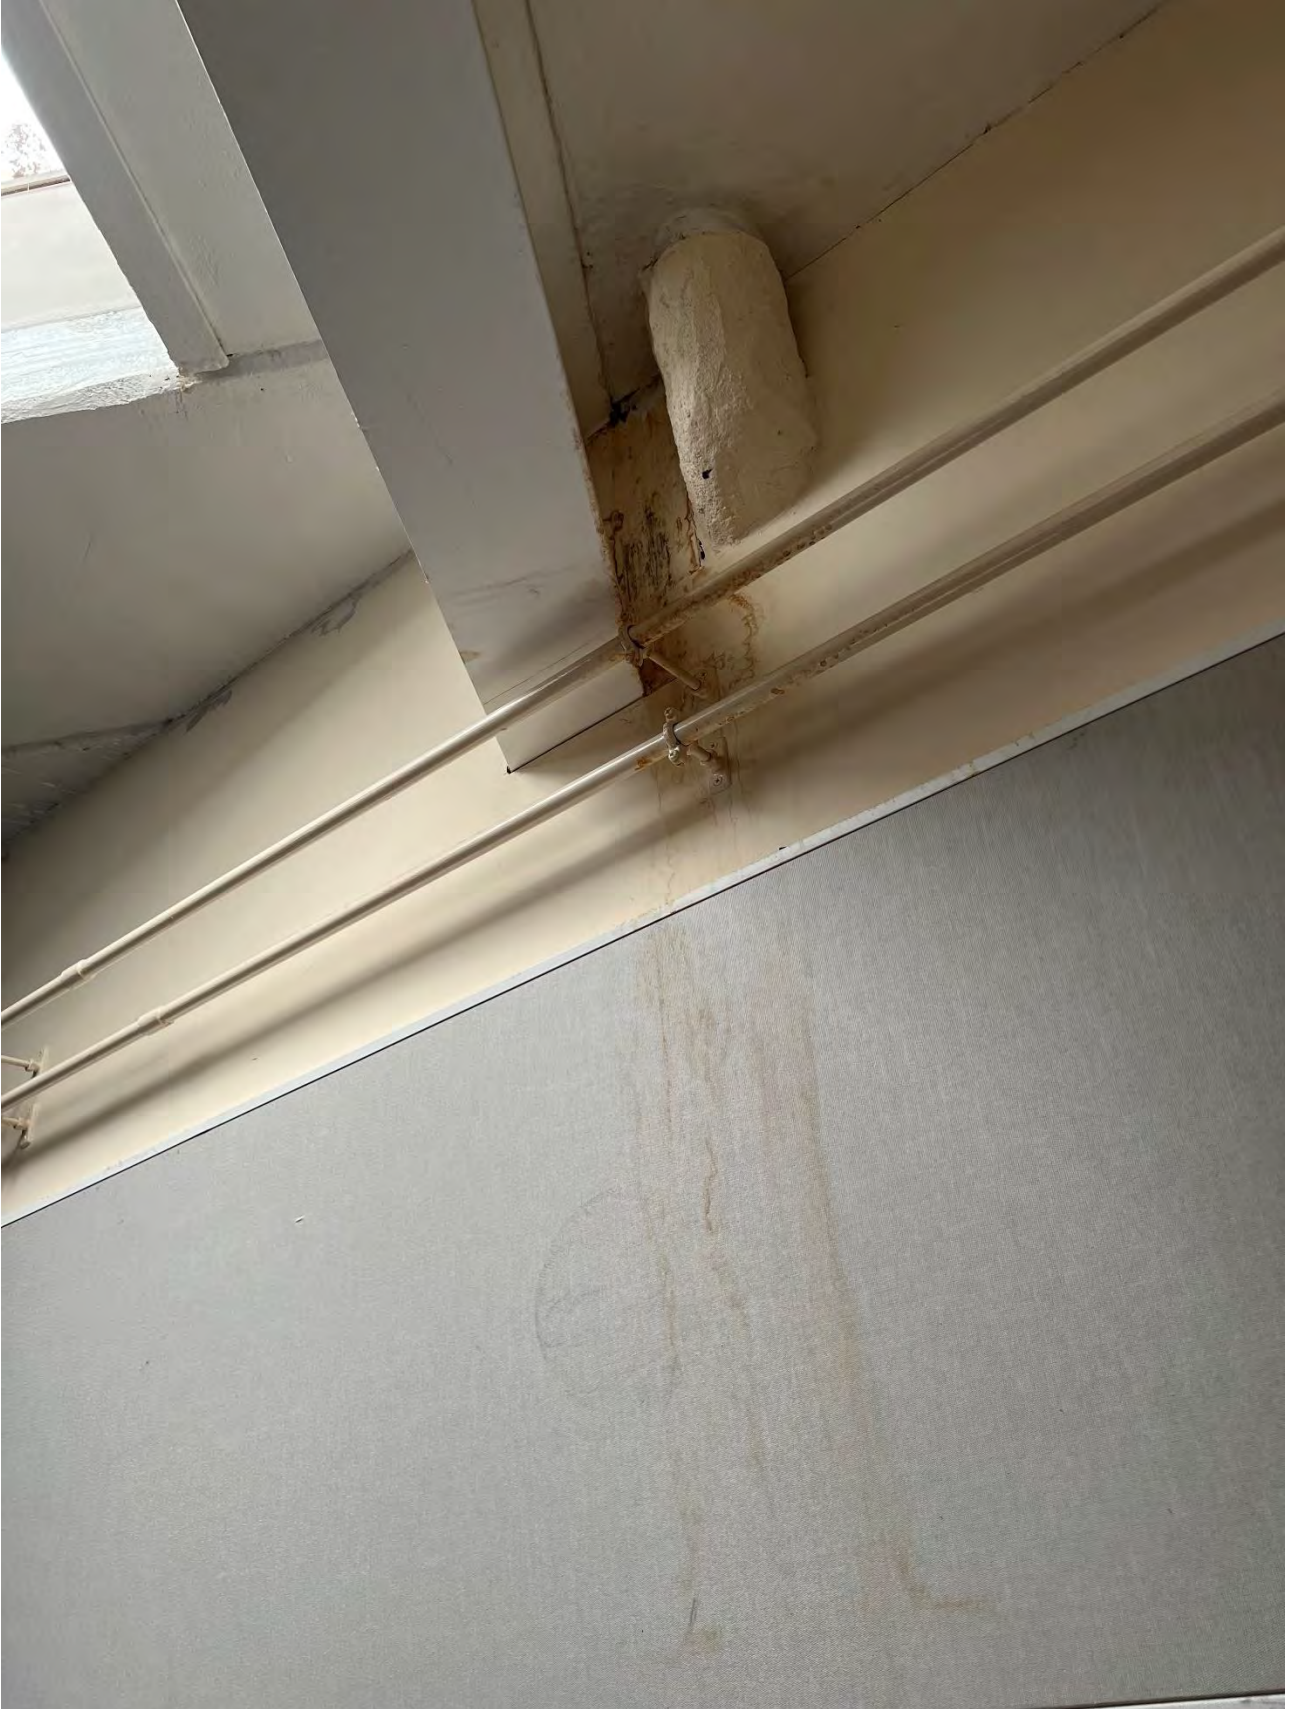
N.12	Water ingress at service pipe location no bridle to support slab penetration. See photo N.12	Critical Risk	Requires remedial action urgently – remedial detail to be developed at next inspection (w/c 17.07.23)
N.13	Castellated beams supporting Siporex panels in Tech workshop – flange appears to be 165mm. No water ingress visible See photo N.13	Medium Risk	Requires inspection regularly – say annually unless condition changes
N.14	External Siporex wall panels no visible water ingress typically See photo N.14	Medium Risk	Requires inspection regularly – say annually unless condition changes

Photo N.12 water ingress at service pipe location no bridle to support slab penetration

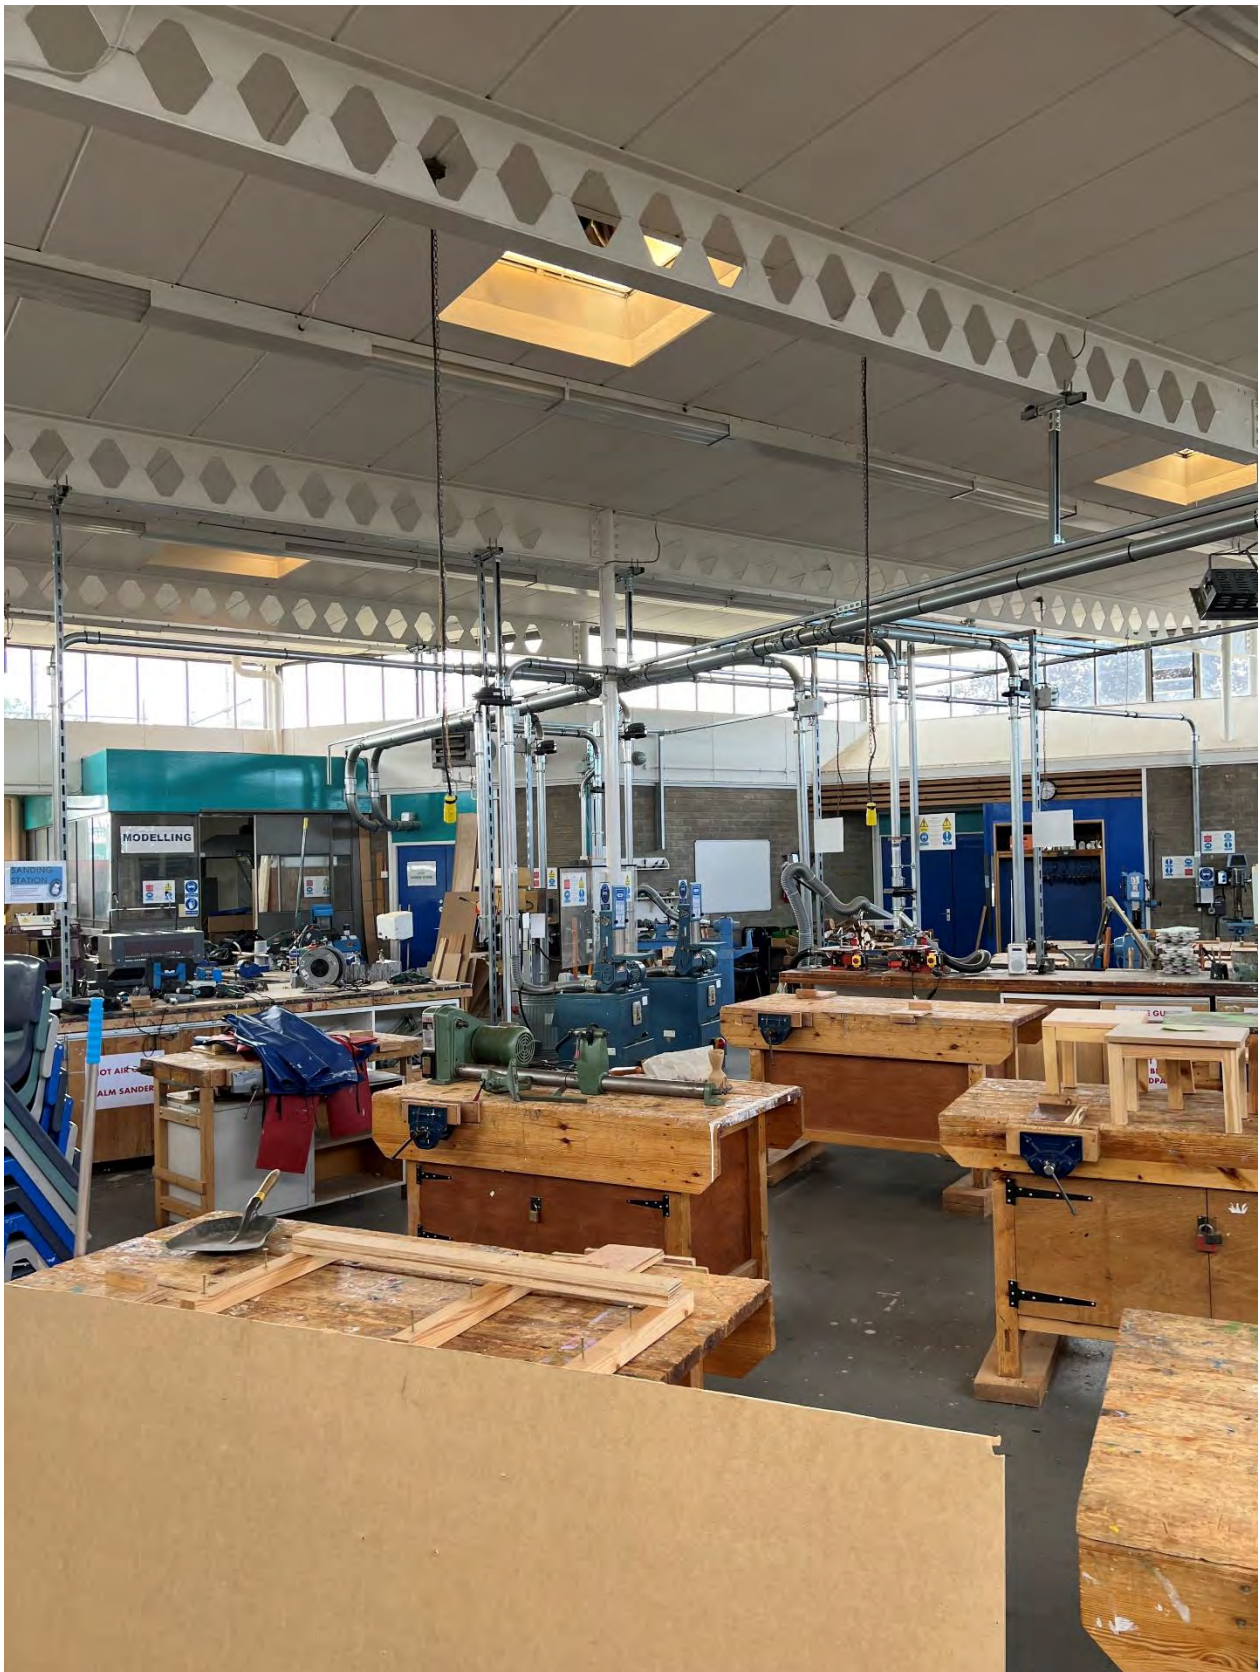
Photo N.13 Castellated beams supporting Siporex panels in Tech workshop – flange appears to be 165mm

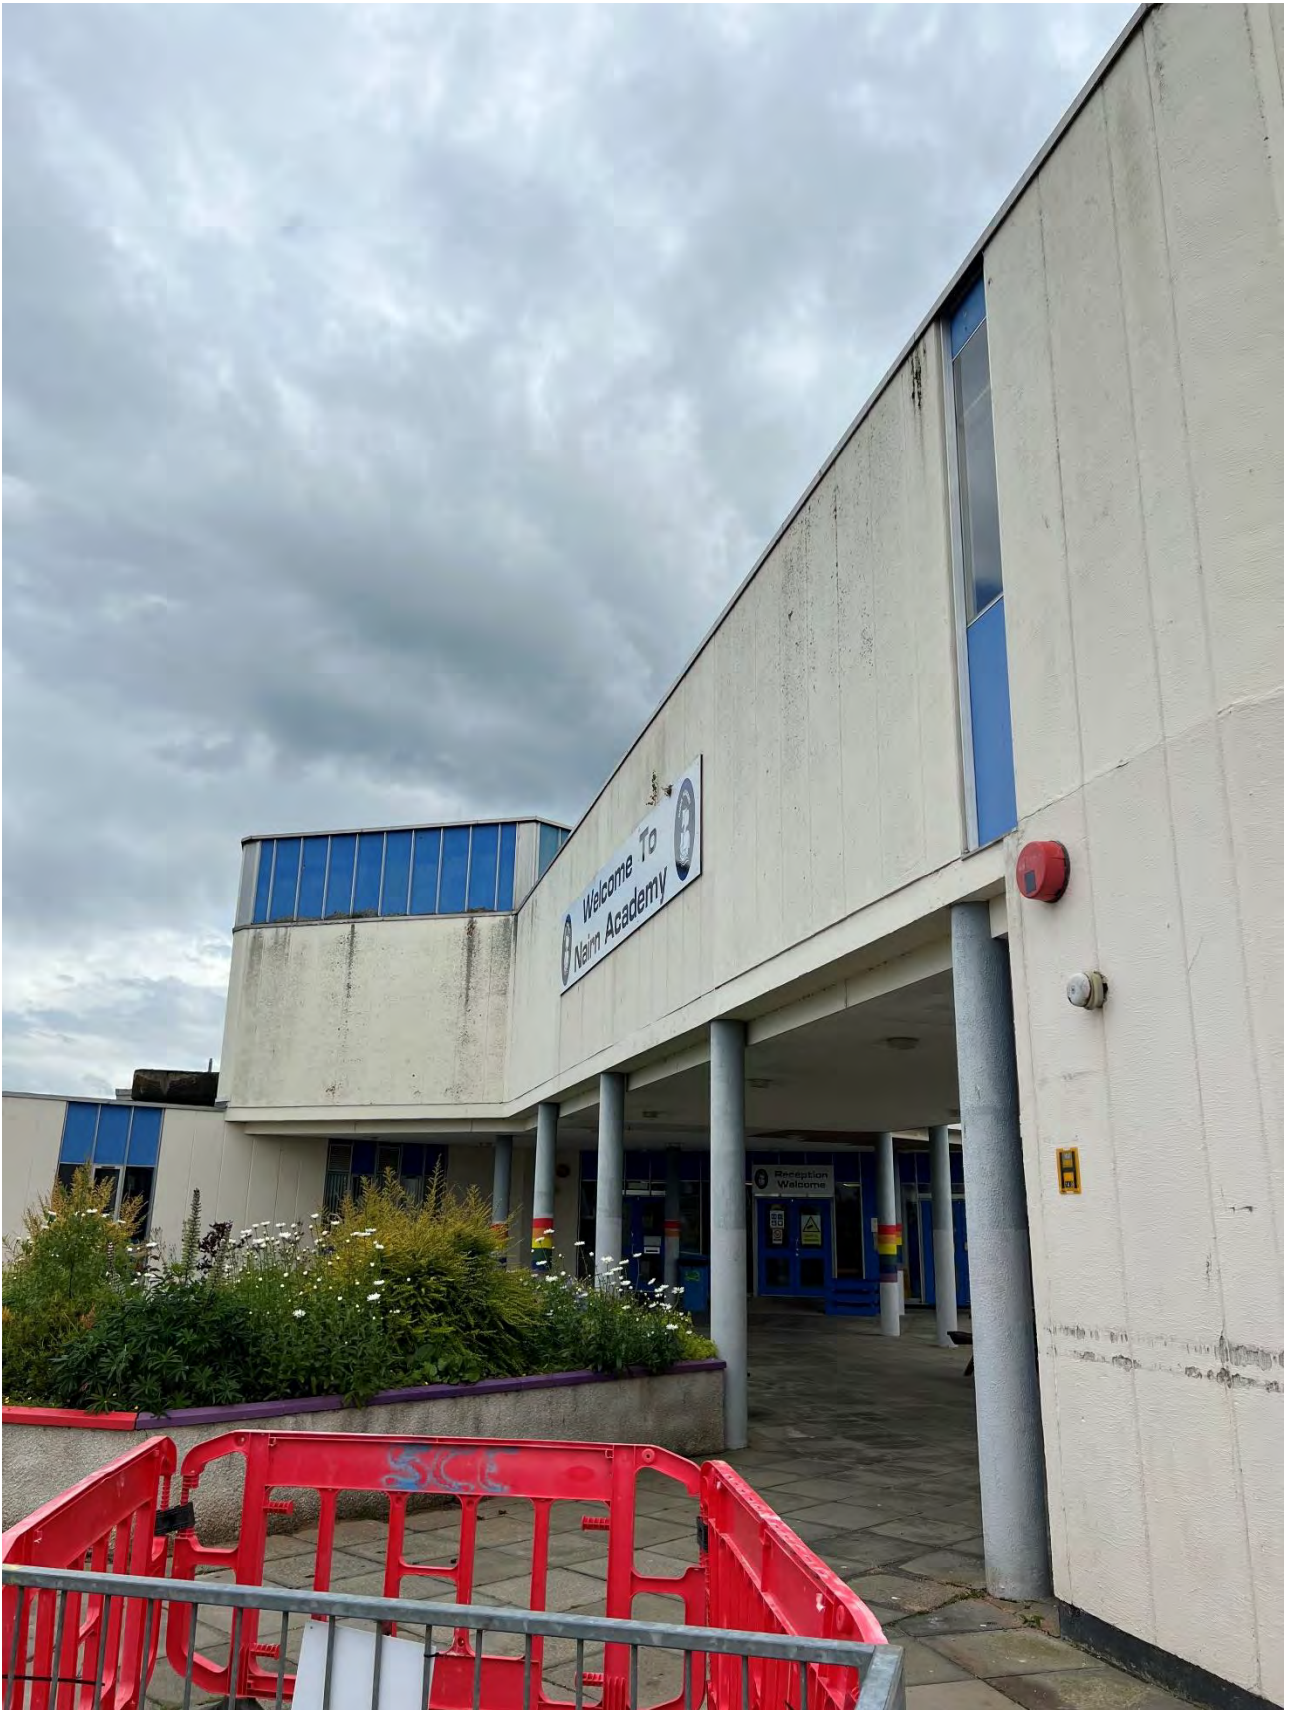
Photo N.14 External Siporex wall panels

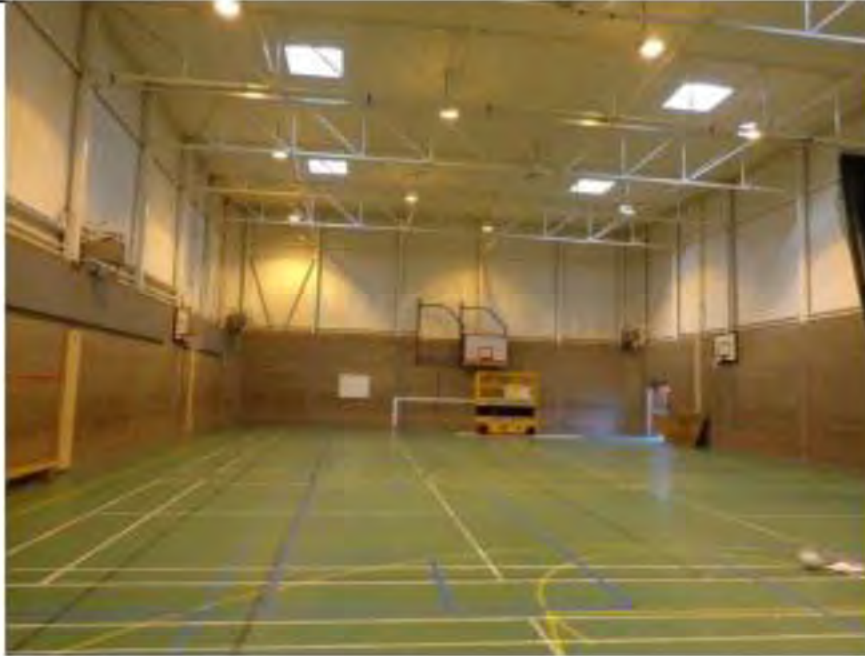
Photo No 1 – Inside Games Hall Roof & Walls

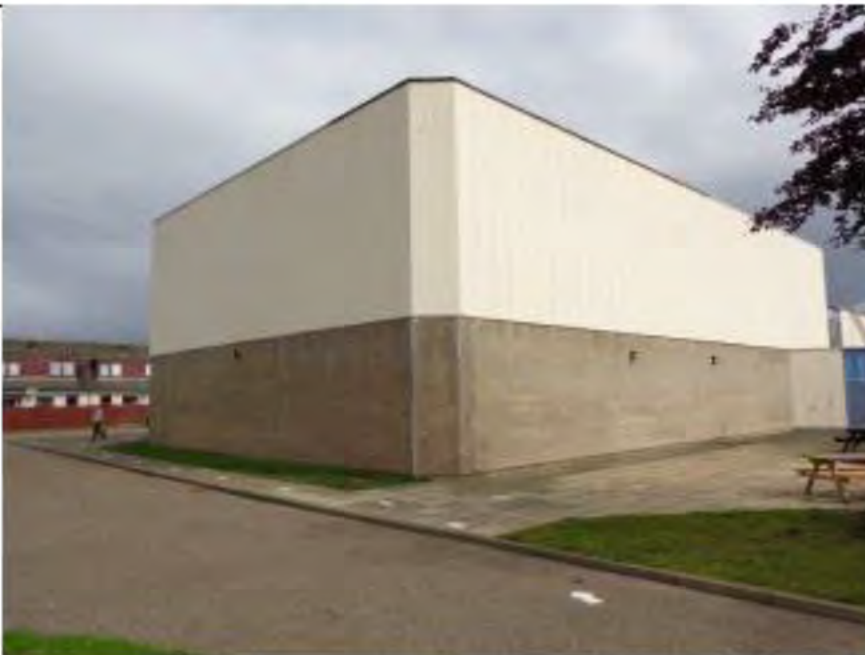
Photo No 2 – External Walls To Games Hall

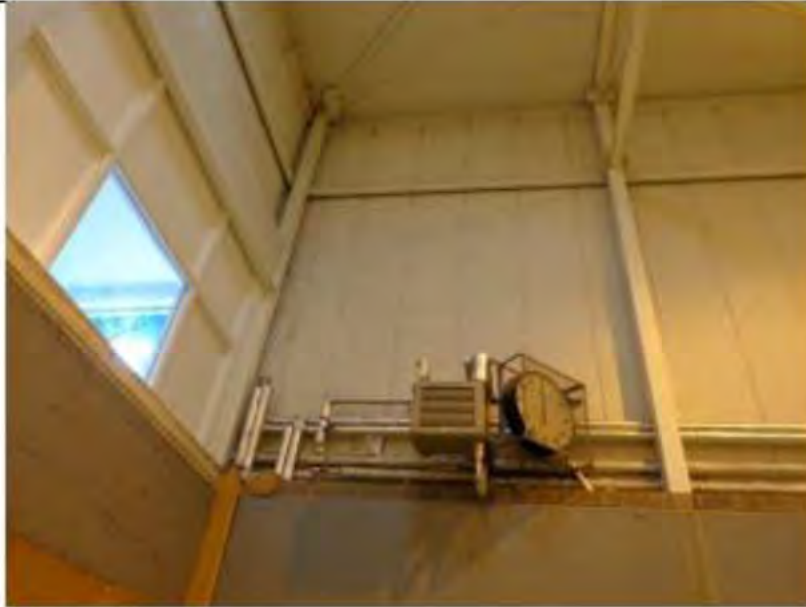
Photo No 3 – Roof & Wall Panels With Support Steelwork

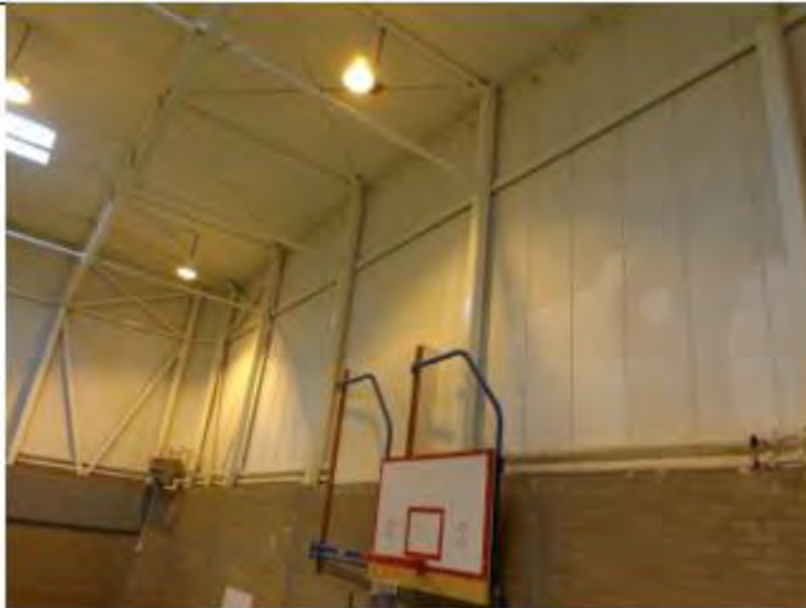
Photo No 4 – Wall Panels Above Lower Brickwork At Gable End

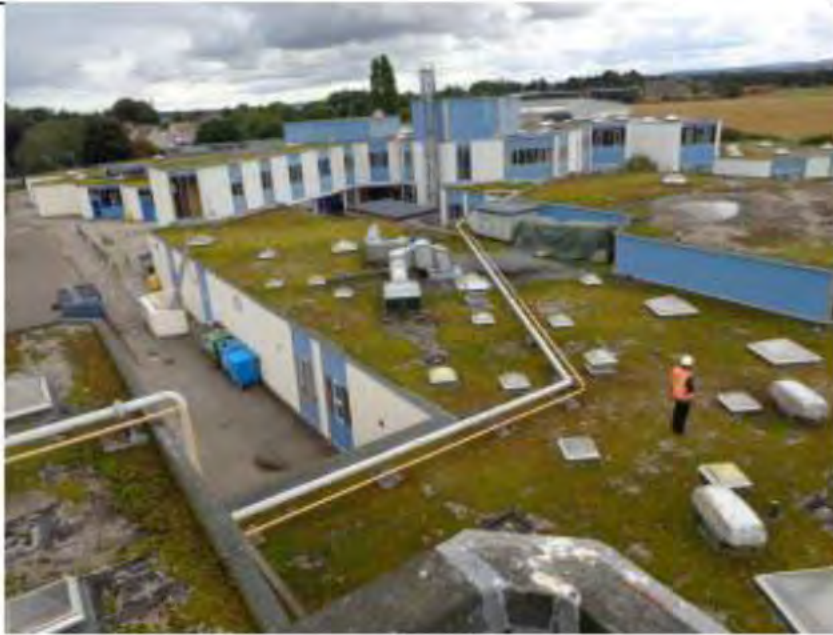
Photo No 5 – Lower Roof From Above Games Hall

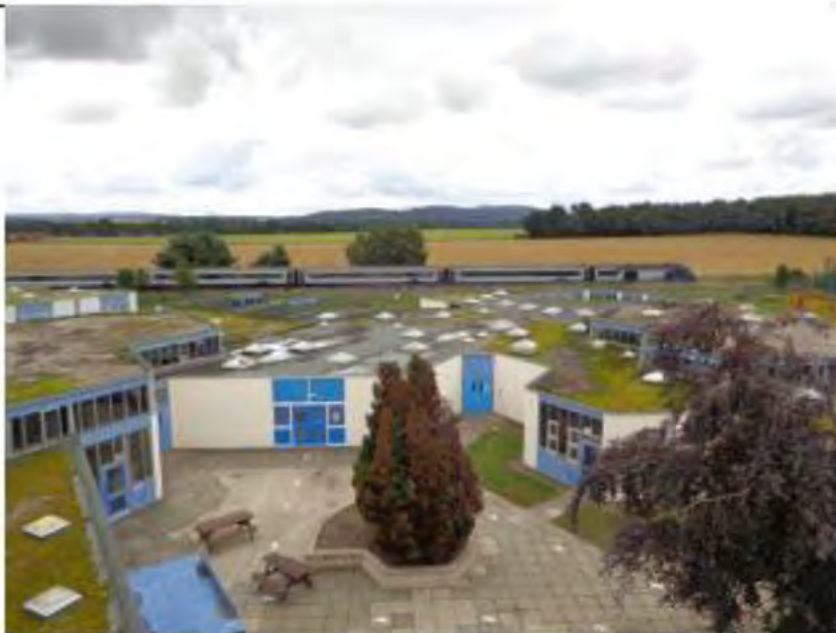
Photo No 6 – Roof Areas With Water Present

As previously reported, the falls on the roof are insufficient/non-existent, to mitigate this we would strongly recommend that a regime of squeegeeing ponding rainwater towards the downpipe locations is put in place especially after heavy rainfall events but more generally as part of a monthly maintenance programme.

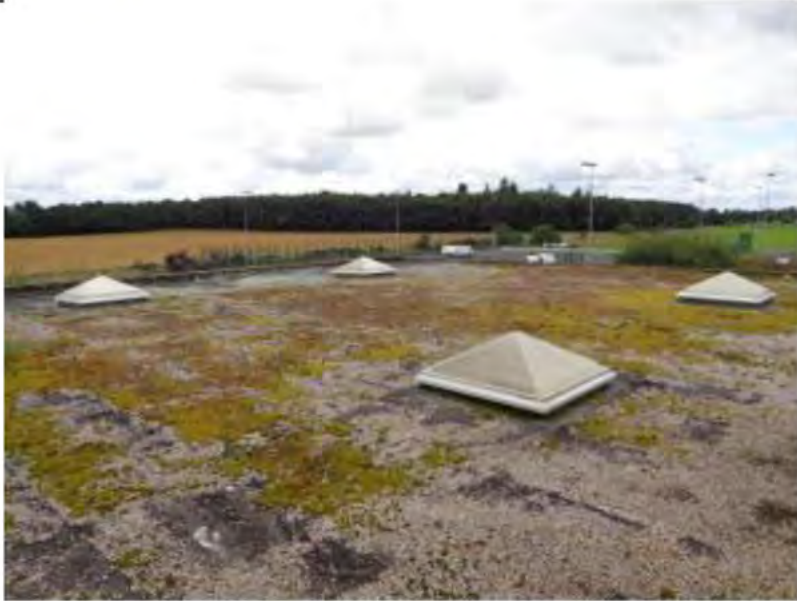
Photo No 7 – Games Hall Roof With Minor Organic Growth

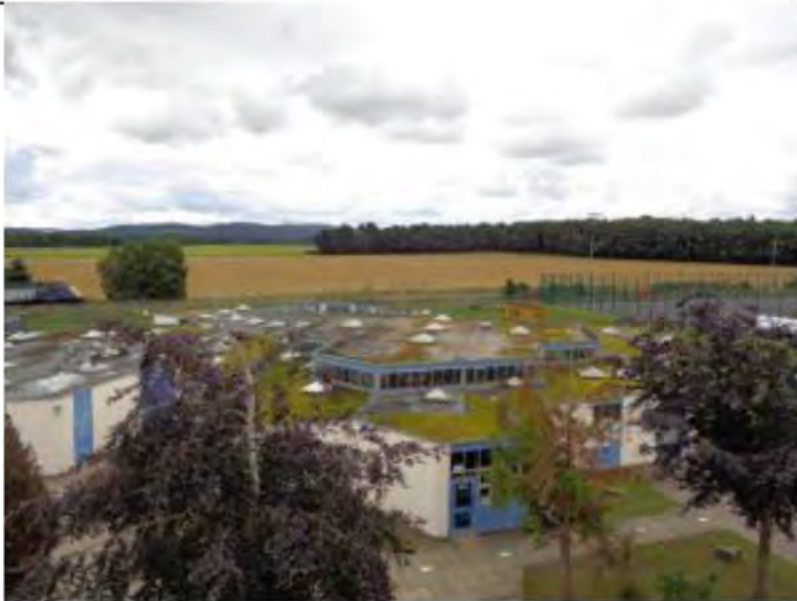
Photo No 8 – Other Areas Showing Organic Growth With Water Present

There are a number areas of the external roof affected by moss and vegetation growth which is hindering the flow of rainwater to downpipe locations as well as potentially adding additional loads from rainwater ponding onto the roof. We would recommend that the roof is cleared of all vegetation and a suitable maintenance regime is adopted to prevent excessive growth in the future.

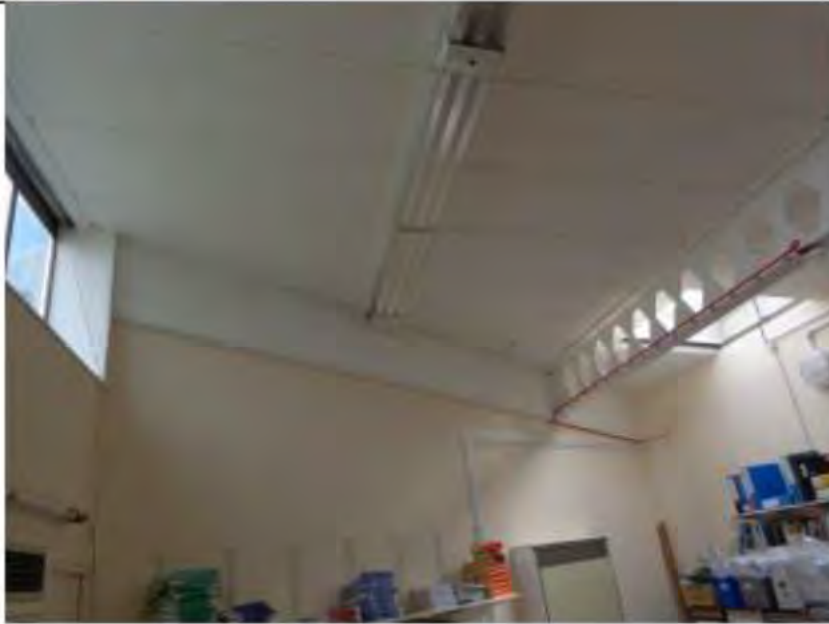
Photo No 9 – Underside Of Roof Panels Easily Checked Where No Ceiling Tiles Present

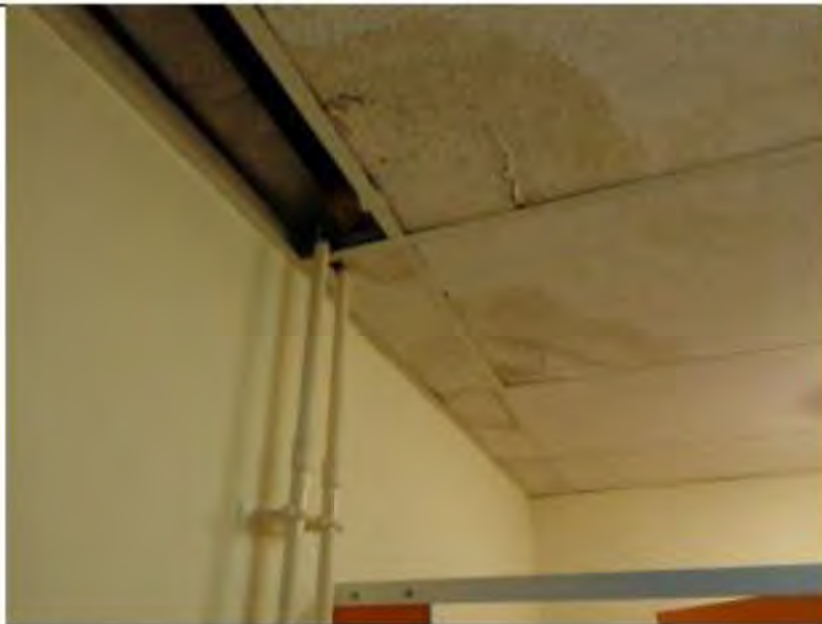
Photo No 10 – Historic Staining From Leaking Pipework

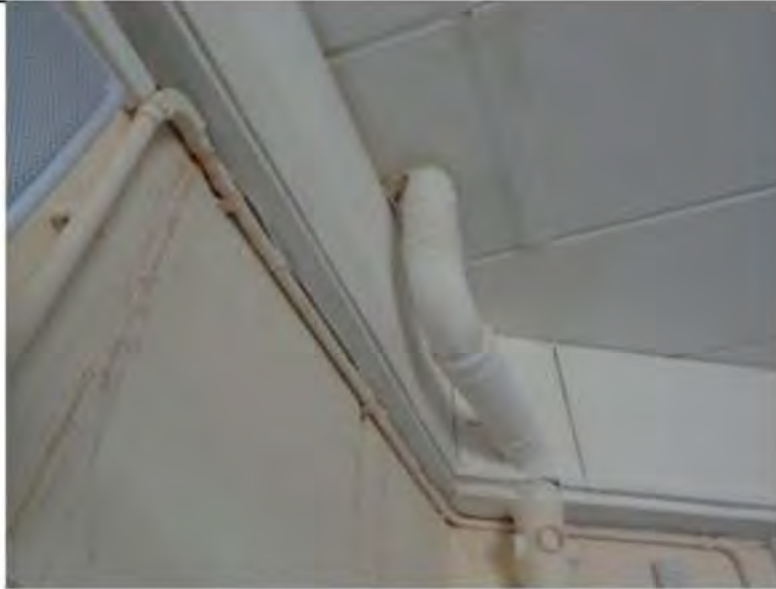
Photo No 11 – Earlier Repairs From Stormwater Drains & Water Pipes

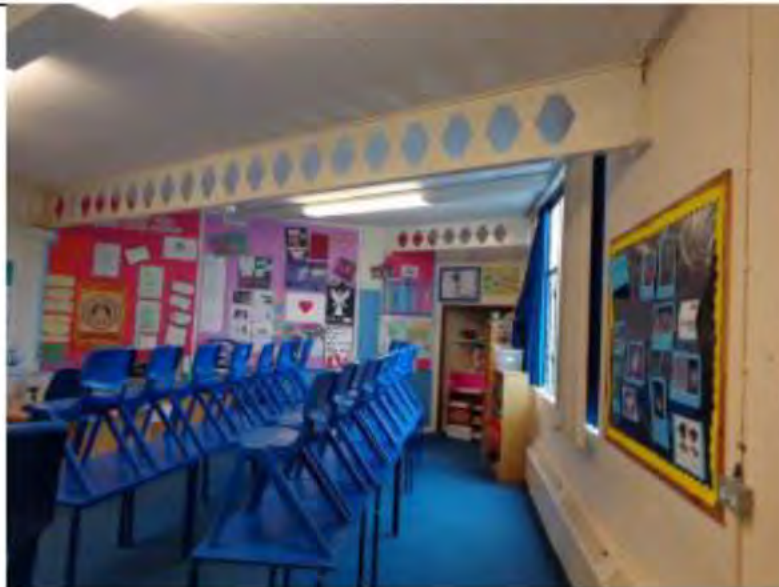
Photo No 12 – Some Panels Showing No Previous Damage Or Repairs
