Job Title
Highland School RAAC Survey –
Charleston Academy

Prepared for
Highland Council

Report Type
RAAC Survey Interim Report

Date
20 February 2024

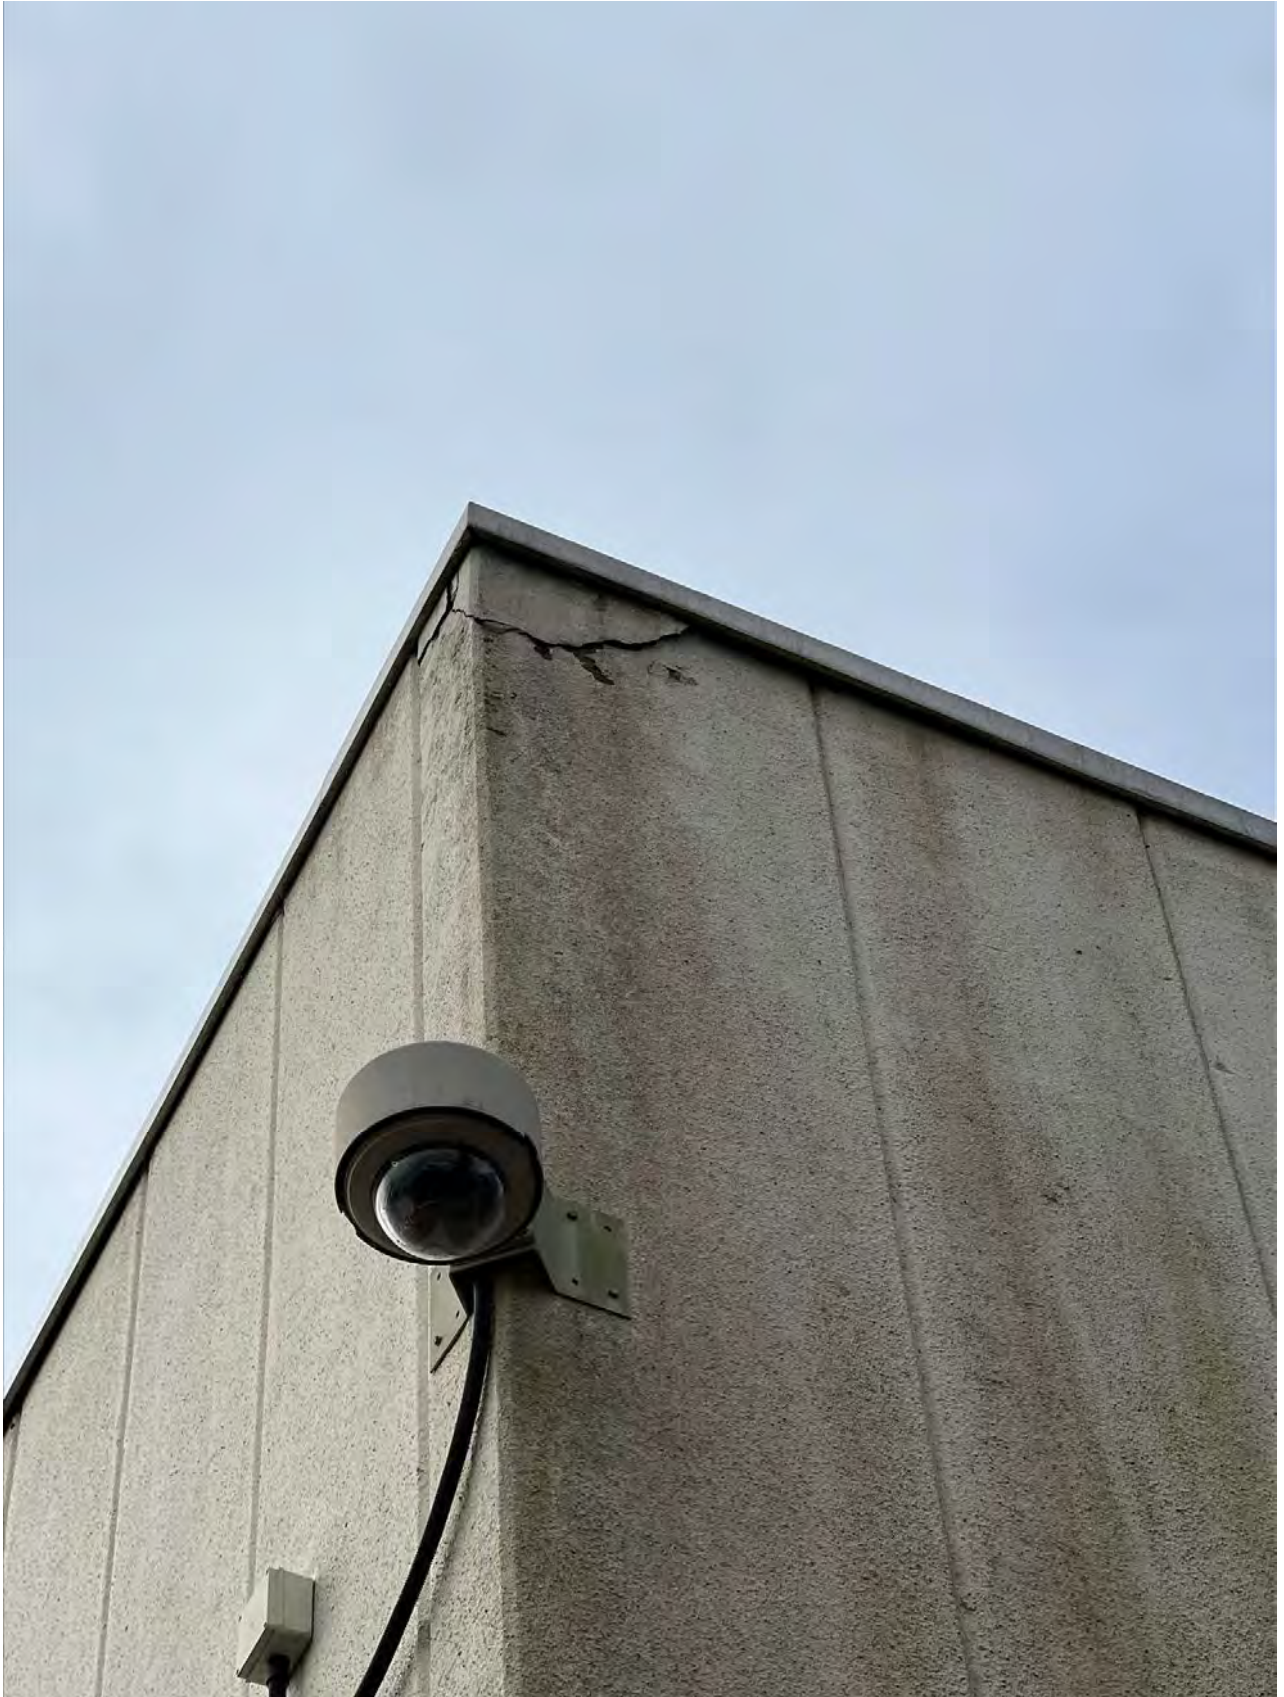
Location	Issue	Risk level pre-remedials	Risk level post-remedials	Further action
Assembly Hall	Wall Panels	Critical	High	Vertical Crack Noted during inspection – remedial detail to be developed pending high level access by fabricator
Kitchen and Storerooms	Roof Panels	High	High	Limited access has been available due to operational requirements. This area has been agreed to be surveyed once ceiling tiles can be removed at Easter holidays

Photograph 1 – Assembly Hall Wall Panel Crack at high level

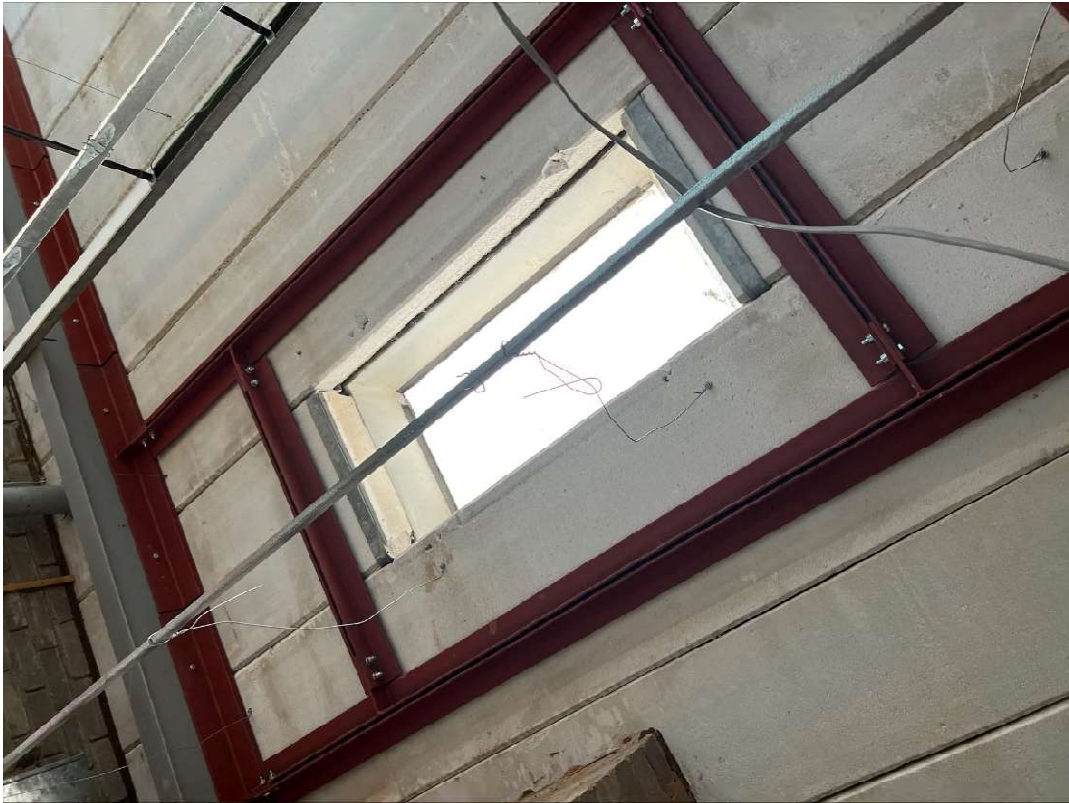
Photograph 2 – Admin Area roof light remedial supports

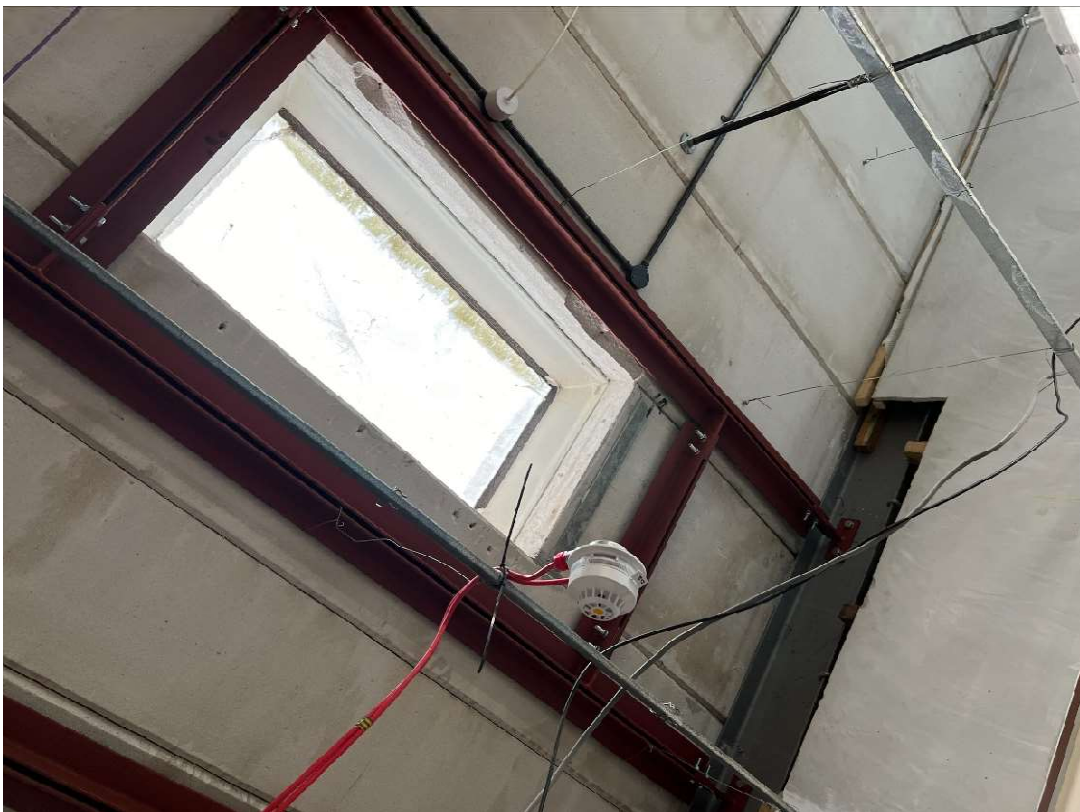
Photograph 3 – Admin Area roof light remedial supports

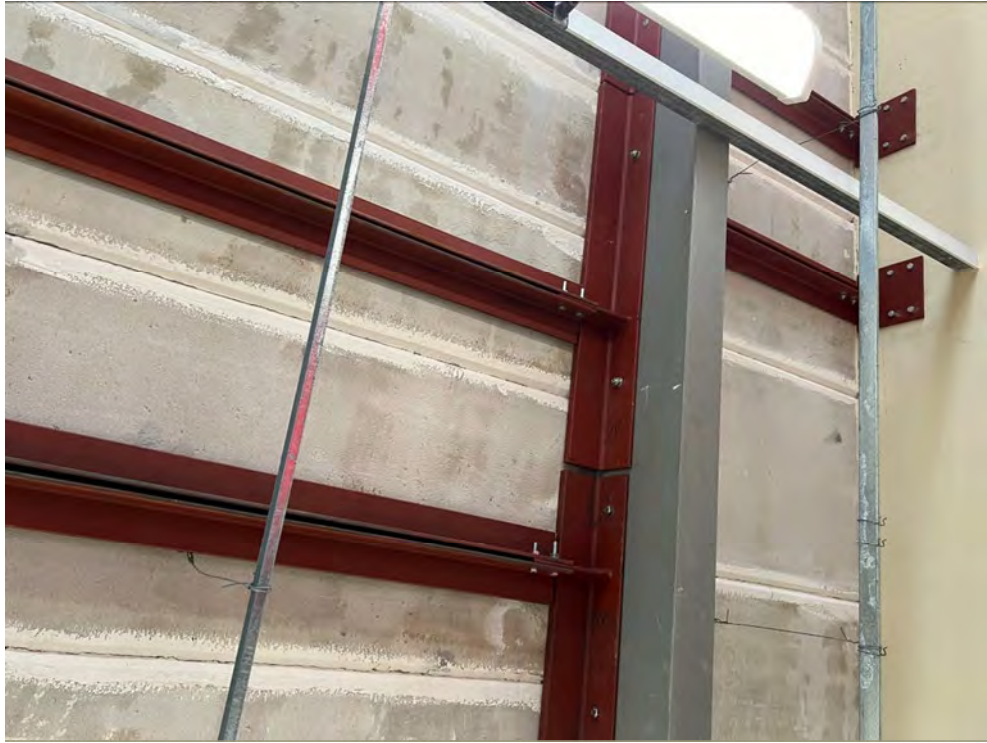
Photograph 4 – Admin Area roof light remedial supports

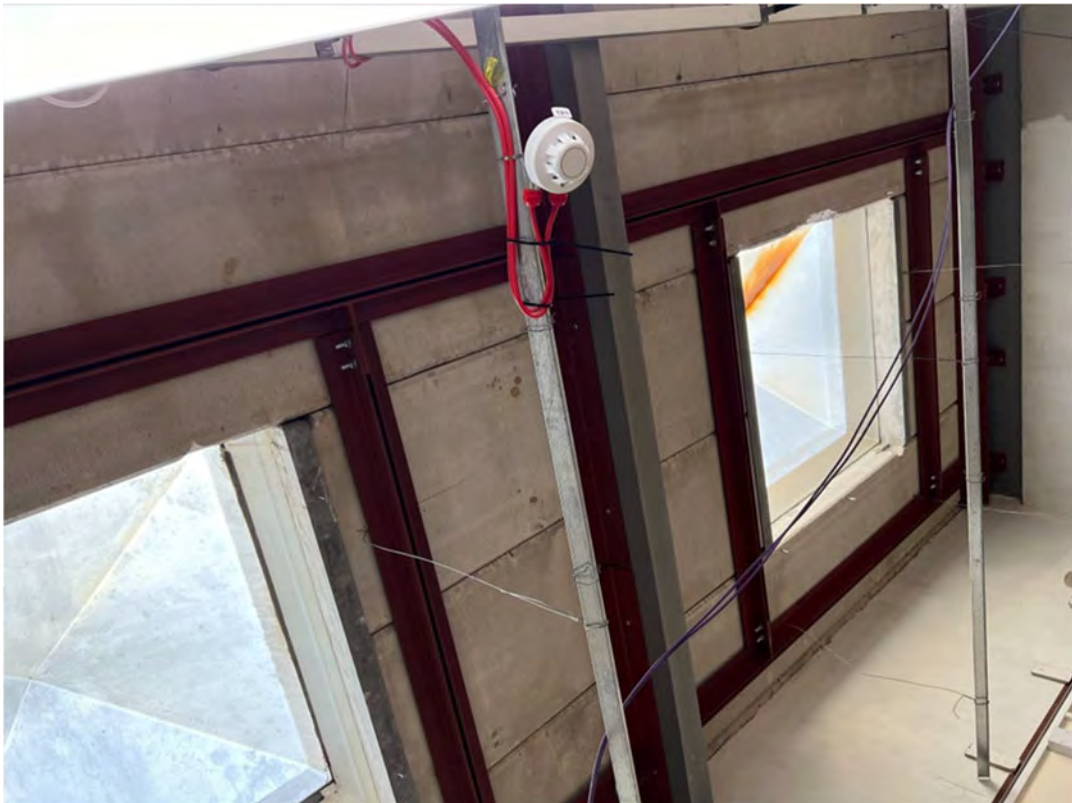
Photograph 5 – Admin Area roof light remedial supports

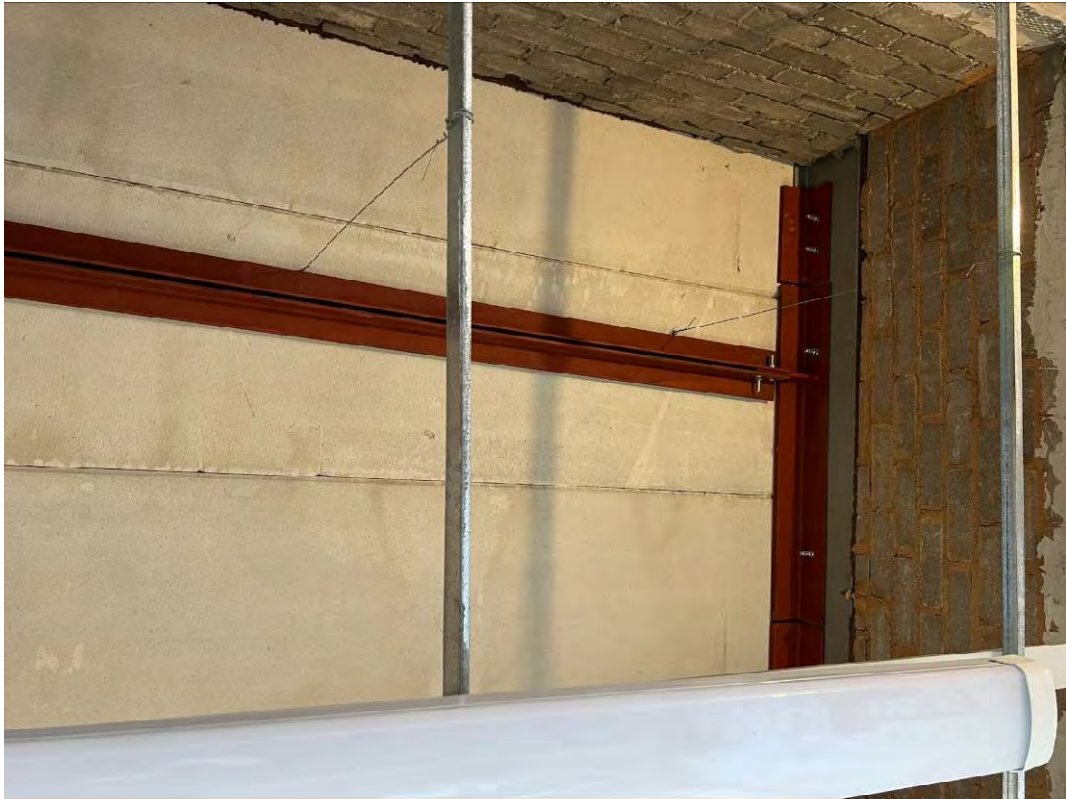
Photograph 6 – Admin Area roof light remedial supports

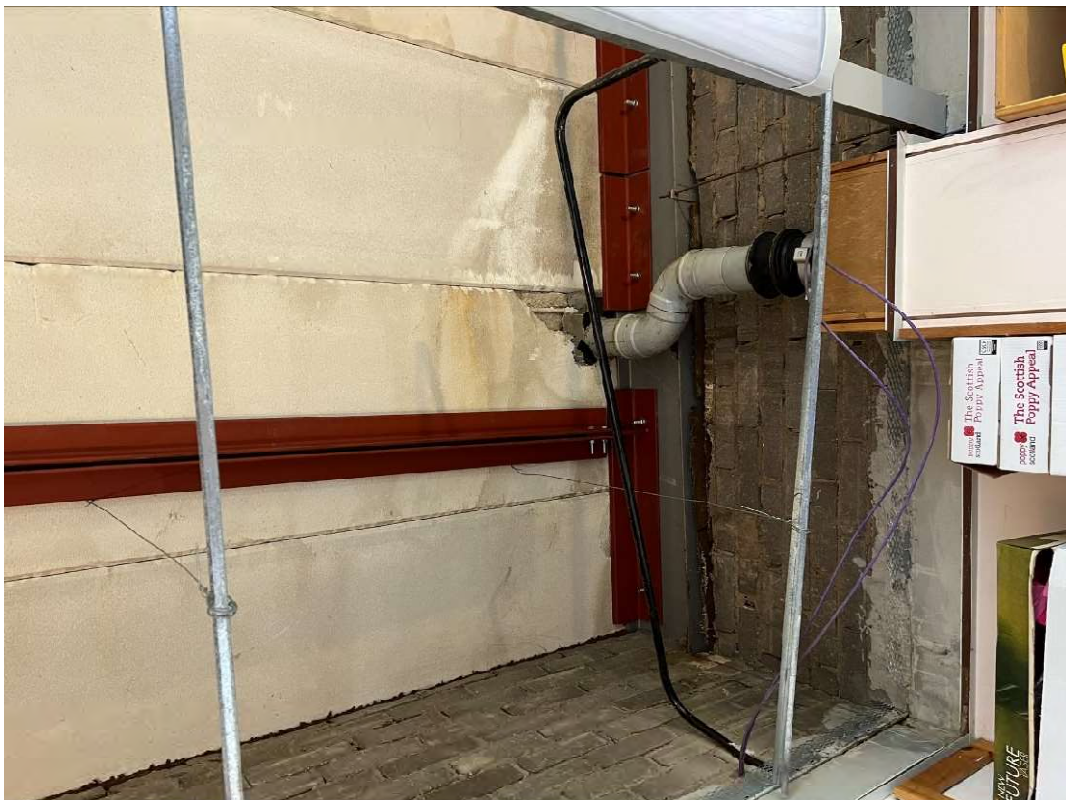
Photograph 7 – Admin Area roof light remedial supports

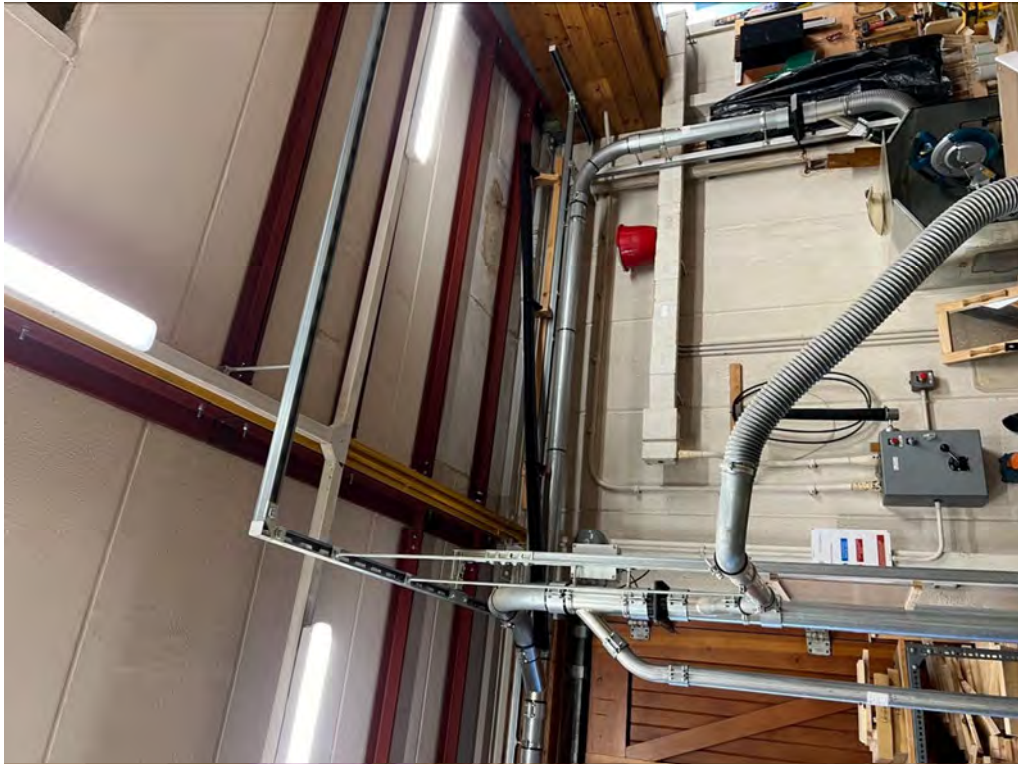
Kitchen and Storerooms	Wall Panels	Medium	Medium	Feasibility study underway for overclad option
Technical Dept - Workshops	Roof	Critical	Medium	Roof work remedials largely complete – ongoing inspections to be undertaken quarterly. See photo 8
Technical Dept - Workshops	Wall Panels	Medium	Medium	Feasibility study underway for overclad option
Technical Dept – Classrooms	Roof	High	High	Panels in reasonable condition generally however shelf angles required where they do not meet bearing requirements.
Technical Dept – Classrooms	Wall Panels	Medium	Medium	Feasibility study underway for overclad option
Art Dept & Storerooms	Roof	High	Medium	Roof work remedials largely complete – ongoing inspections to be undertaken quarterly.
Art Dept & Storerooms	Wall Panels	Medium	Medium	Feasibility study underway for overclad option
Home Economics Dept & Storerooms	Roof	Medium	Medium	Ongoing inspections to be undertaken quarterly

Photograph 8 – Technical Dept Workshop additional supports due to water ingress

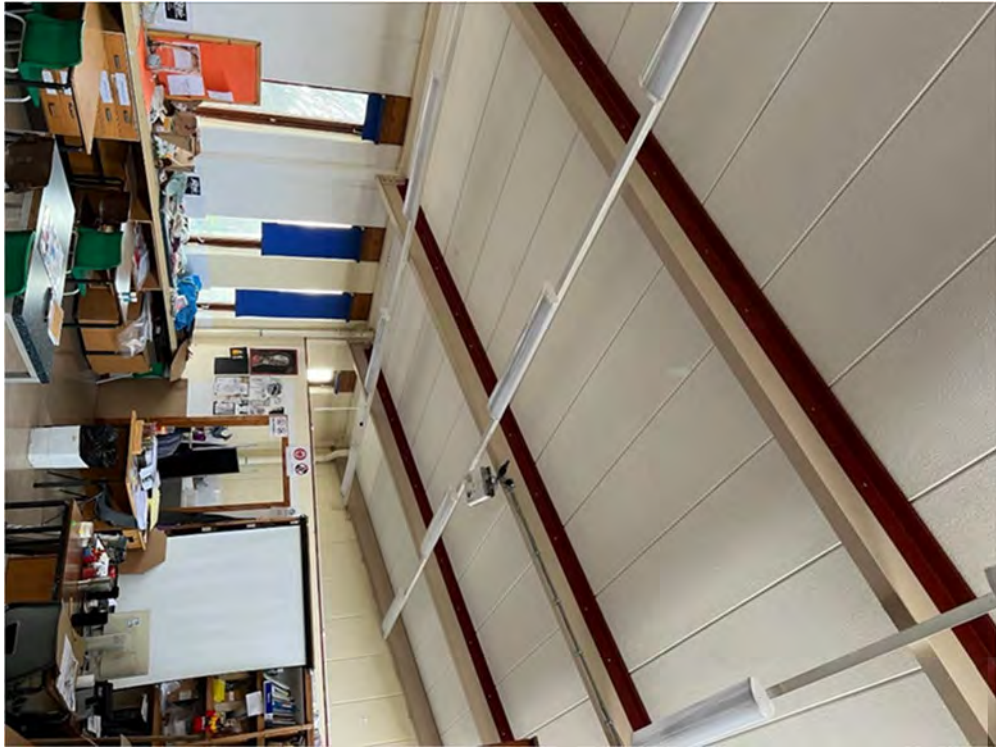
Photograph 10 – Art Dept Bearing Supports

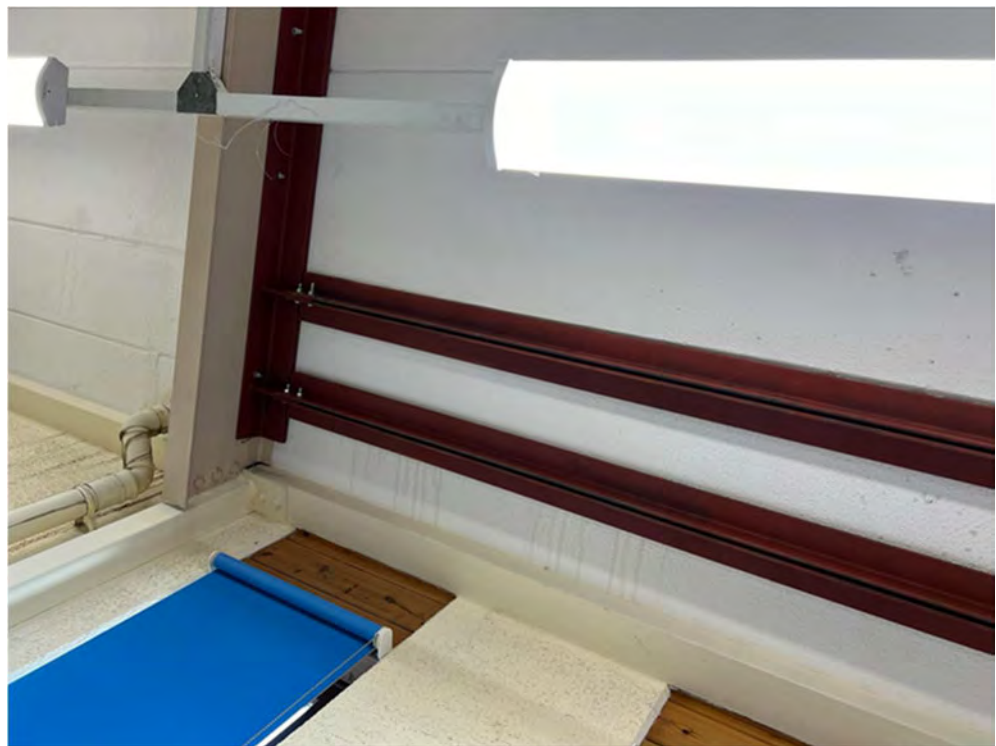
Photograph 11 – Art Dept water damaged panel remedial supports
