Job Title
Highland School RAAC Survey –
Nairn Academy

Prepared for
Highland Council

Report Type
RAAC Survey Interim Report

Date
7 March 2024

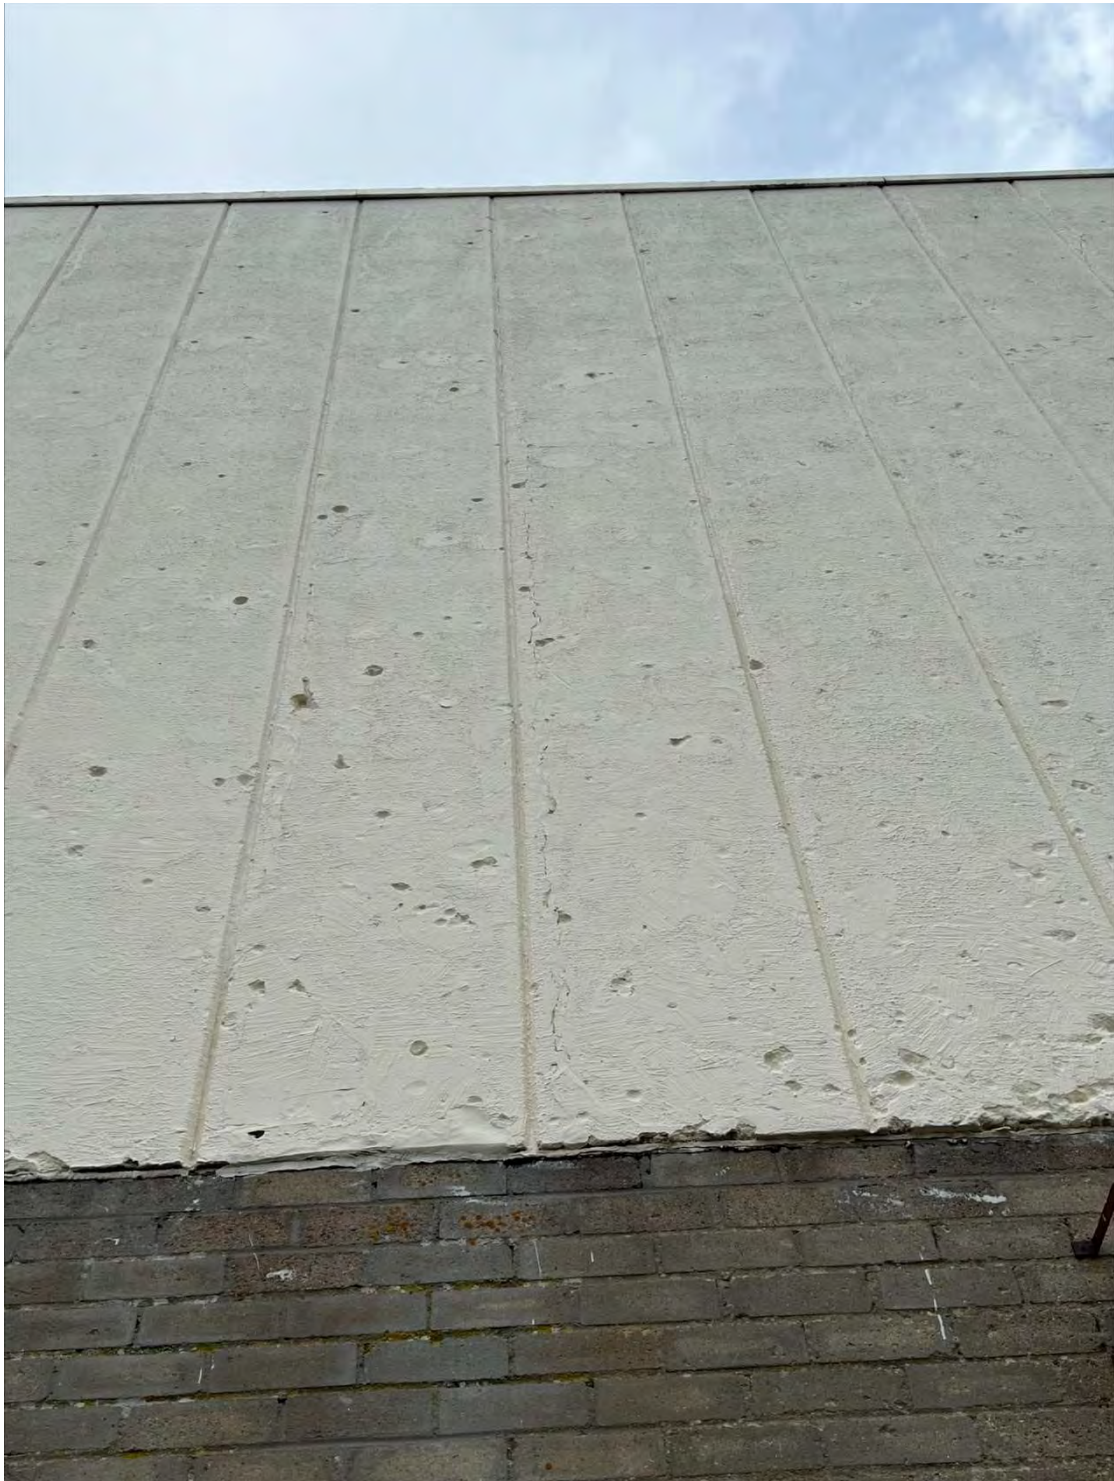
Art Dept & Storerooms	Wall Panels	Medium	Medium	External Painting largely complete – ongoing inspections to be undertaken quarterly

Photograph 1 – Gym Hall external panels post painting

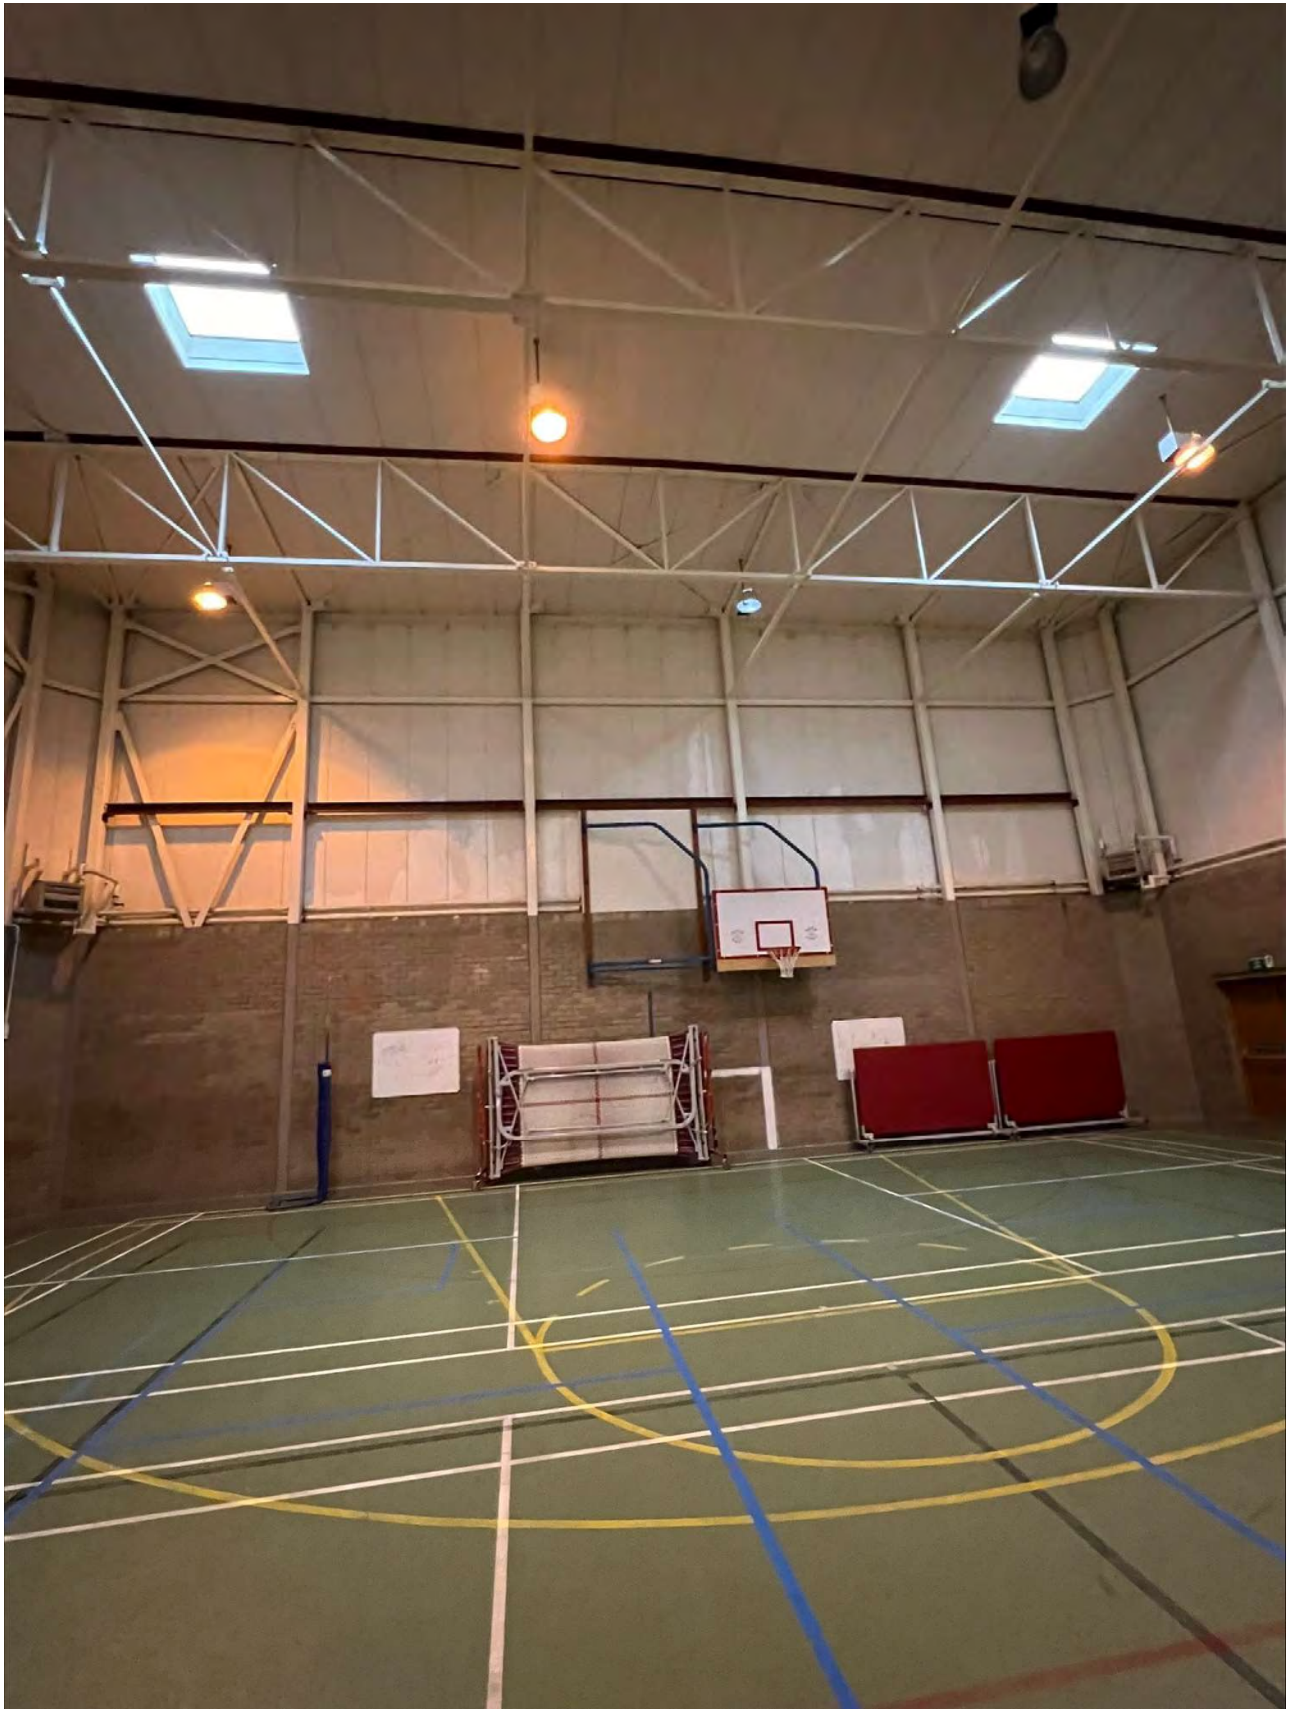
Photograph 2 – Gym hall internal mid height horizontal supports for external panels

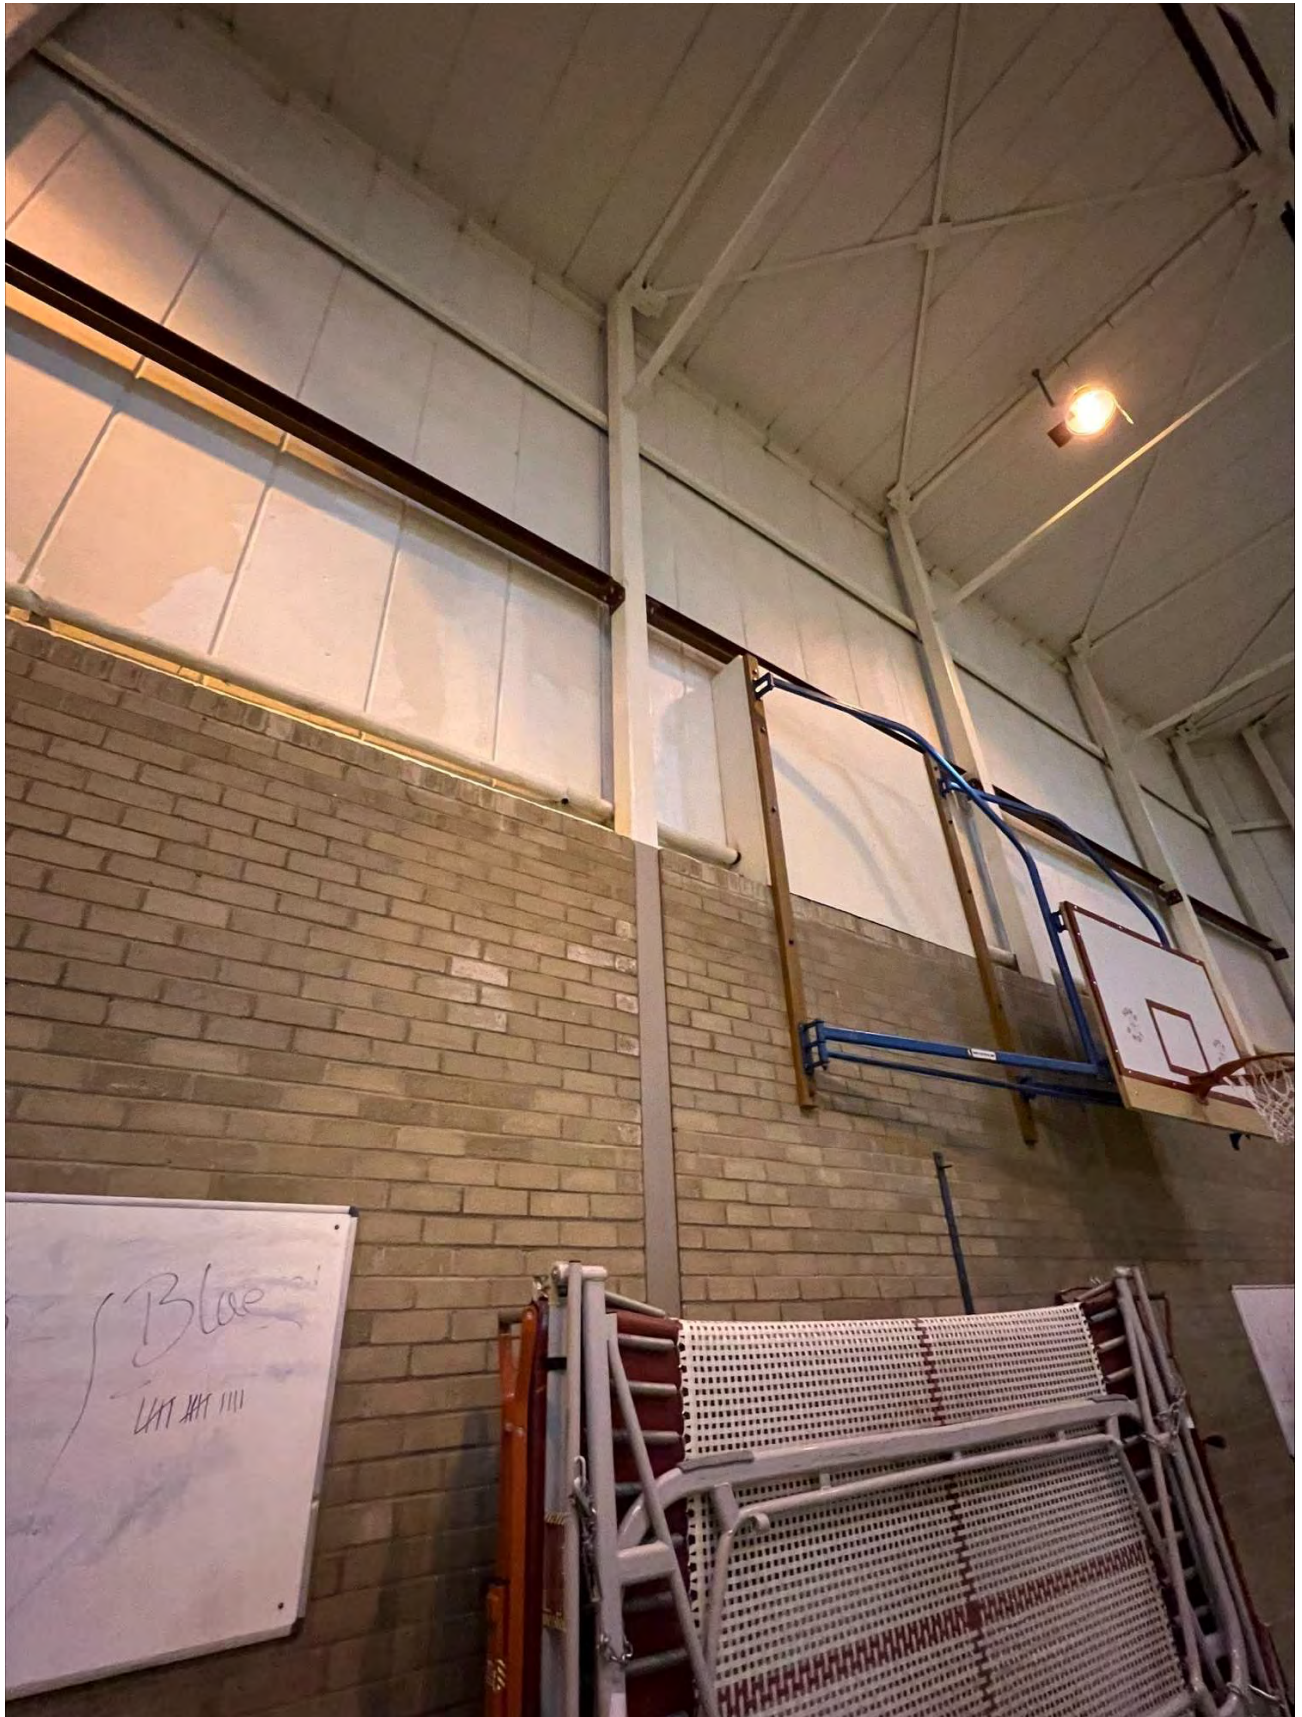
Photograph 3 – Gym Hall support beam connection details

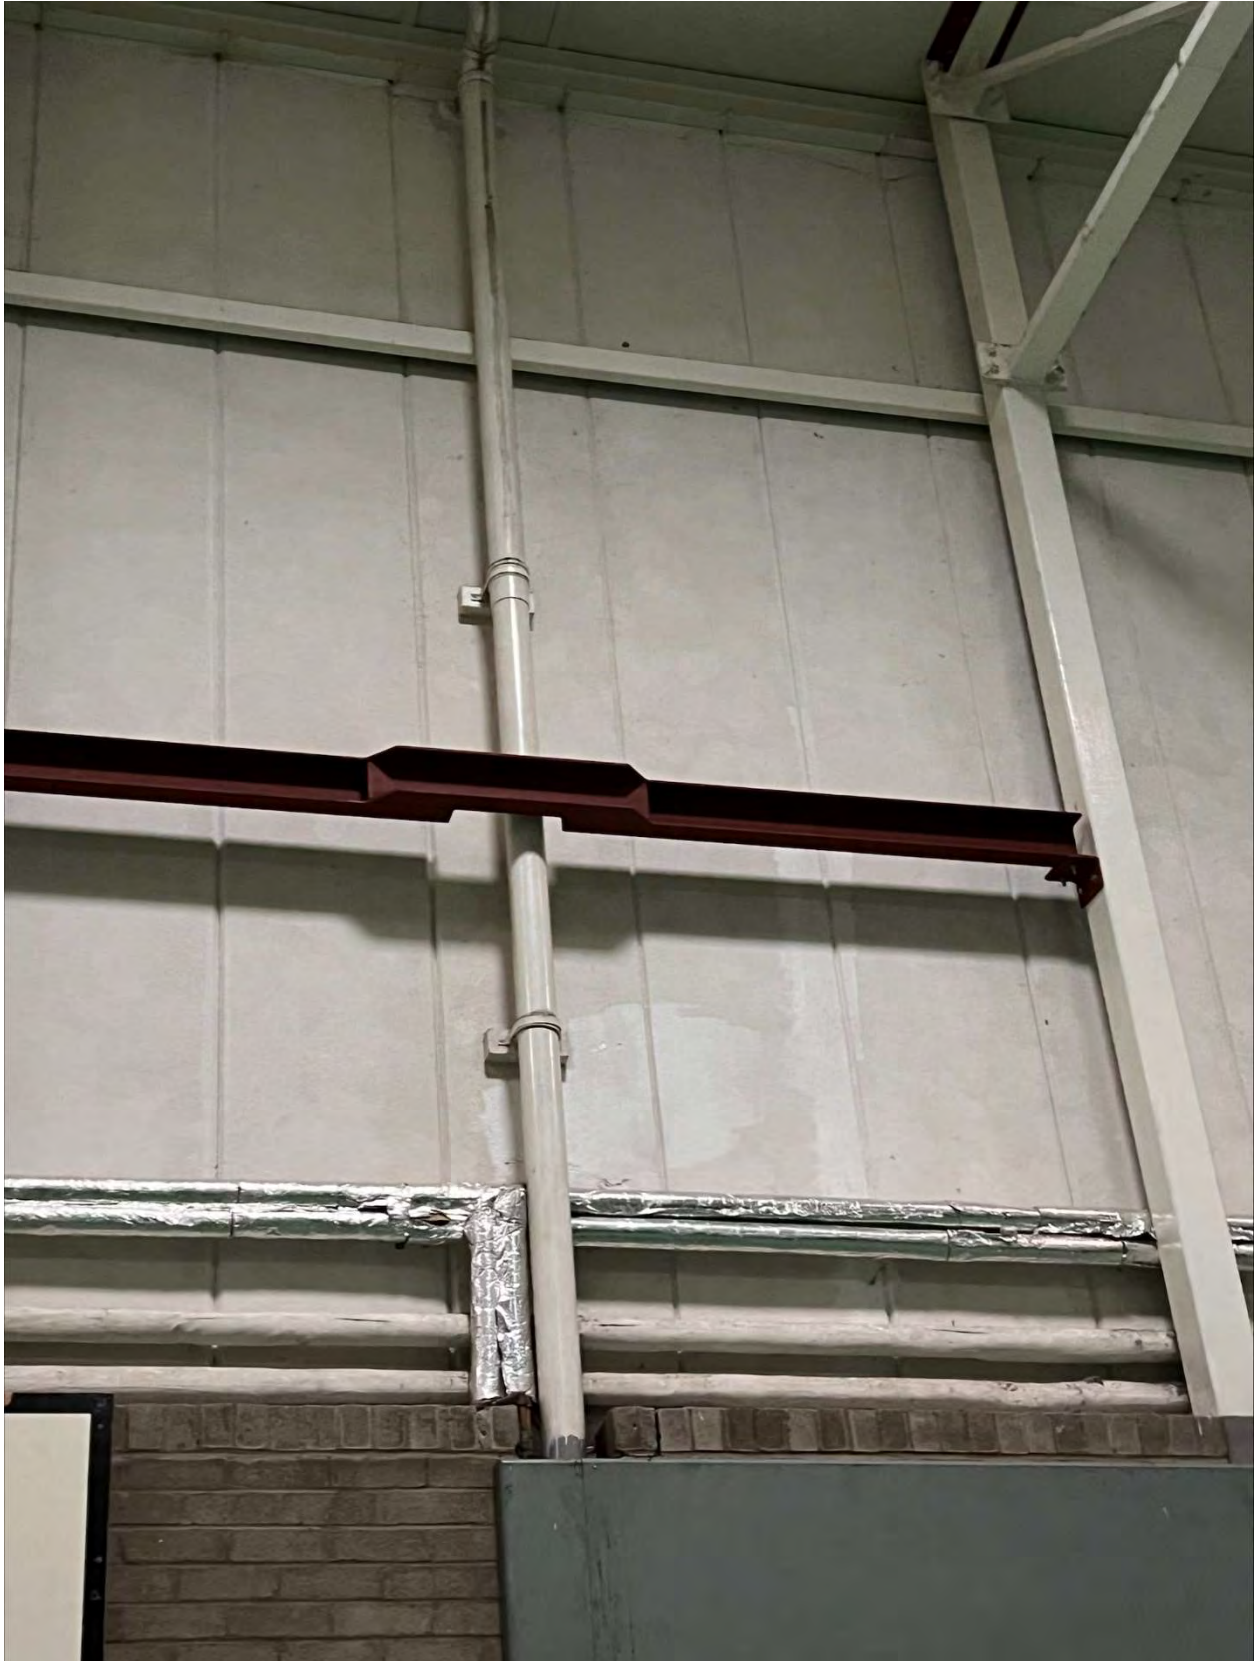
Photograph 5 – Gym hall support detail around services

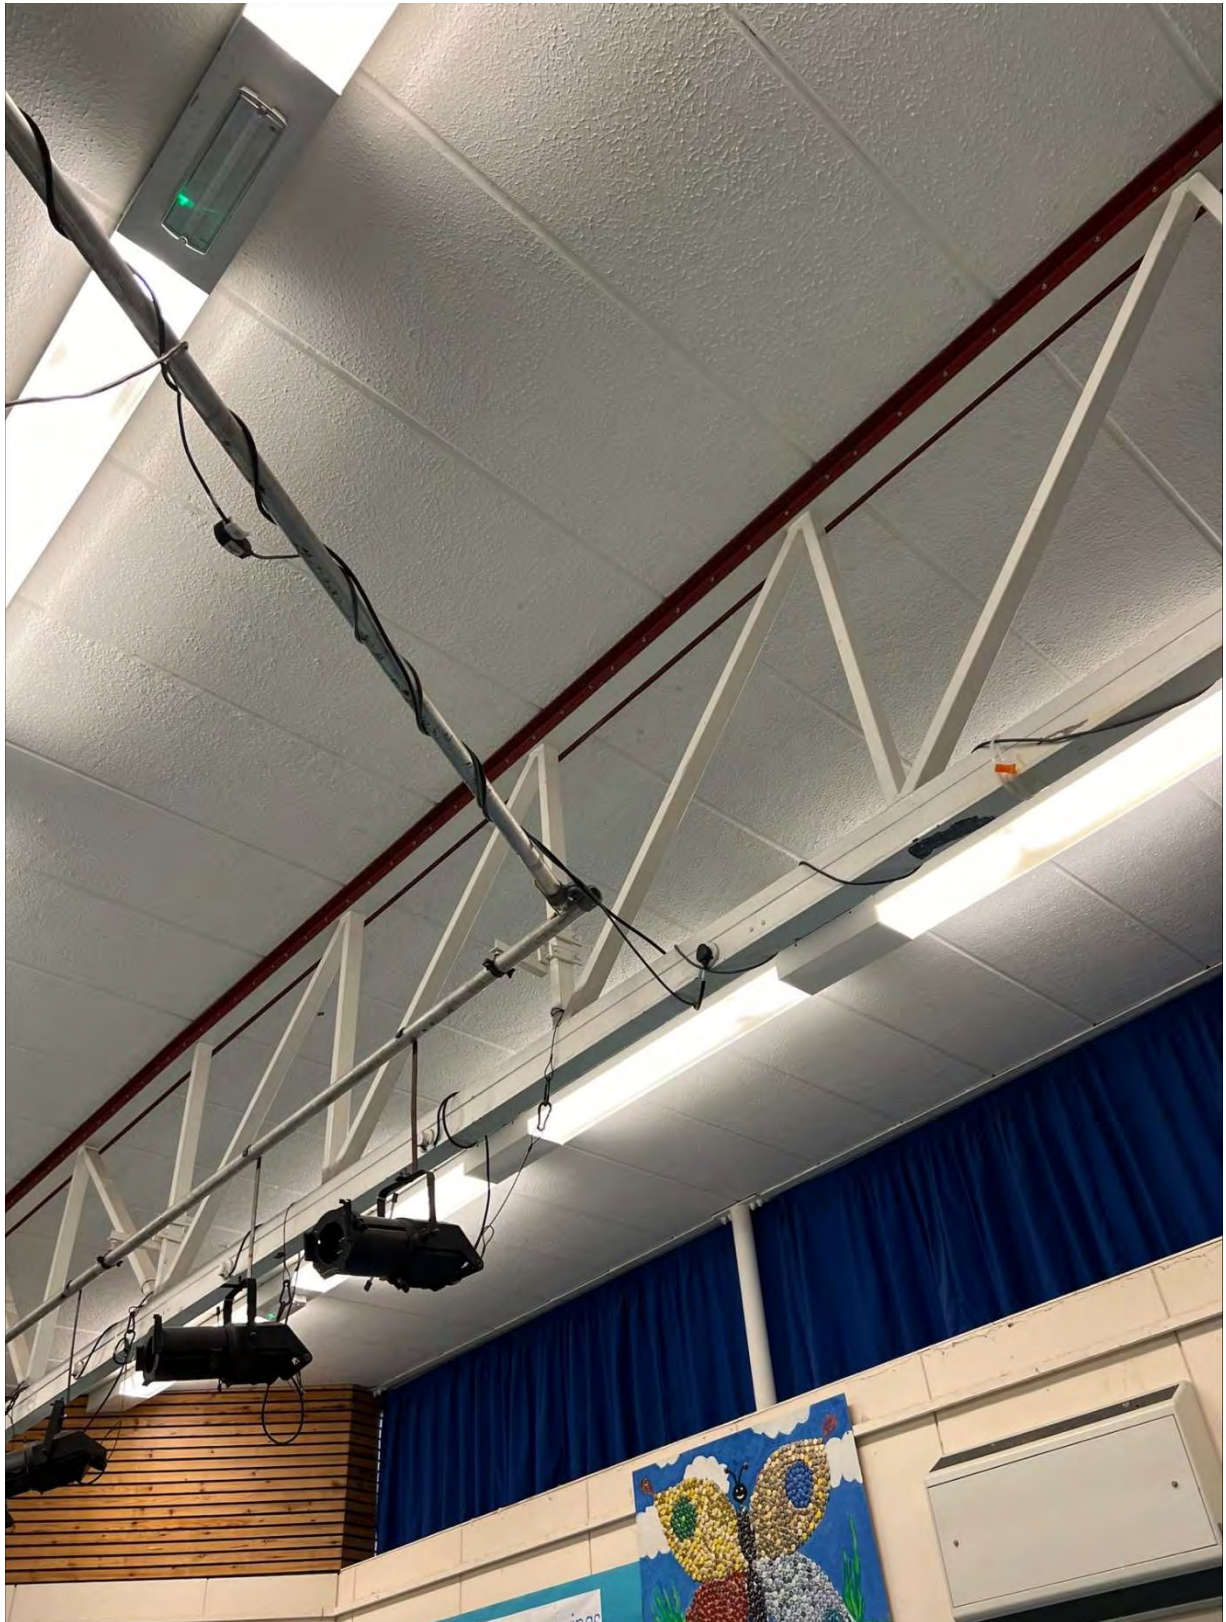
Photograph 6 – Dining Hall truss extended bearing detail

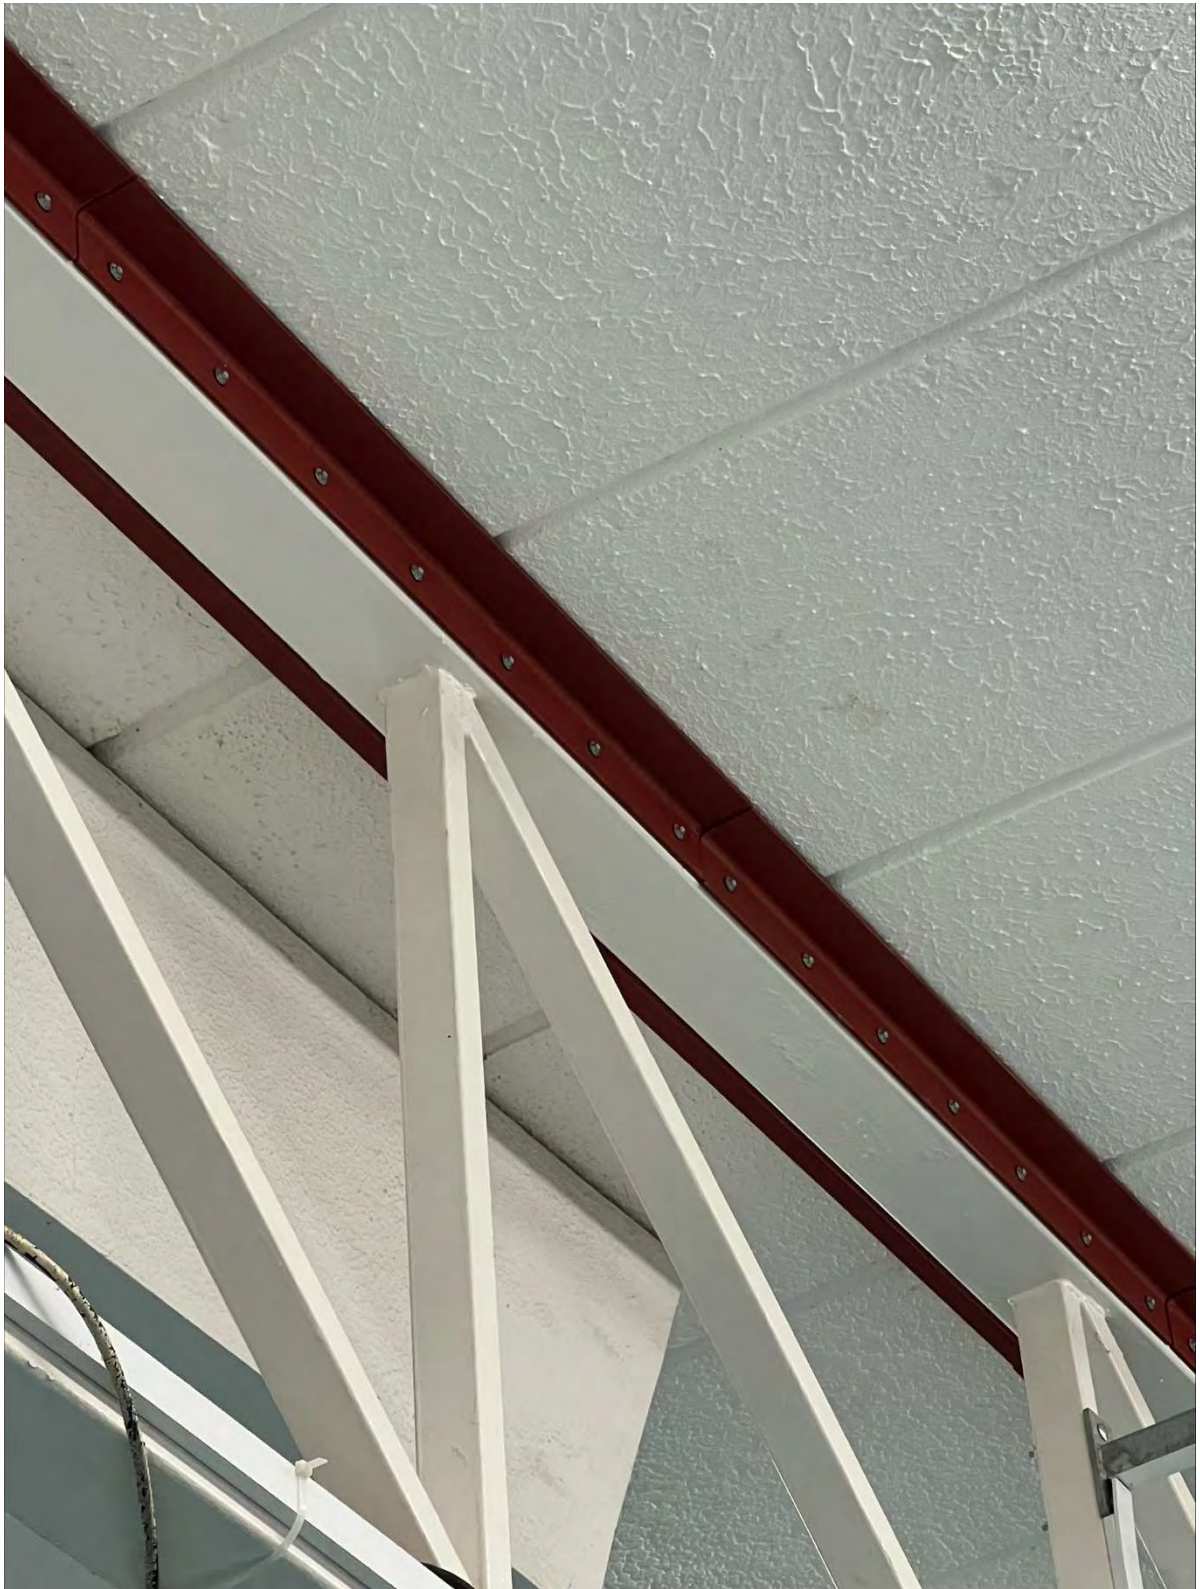
Photograph 7 – Dining Hall top chord bearing angle

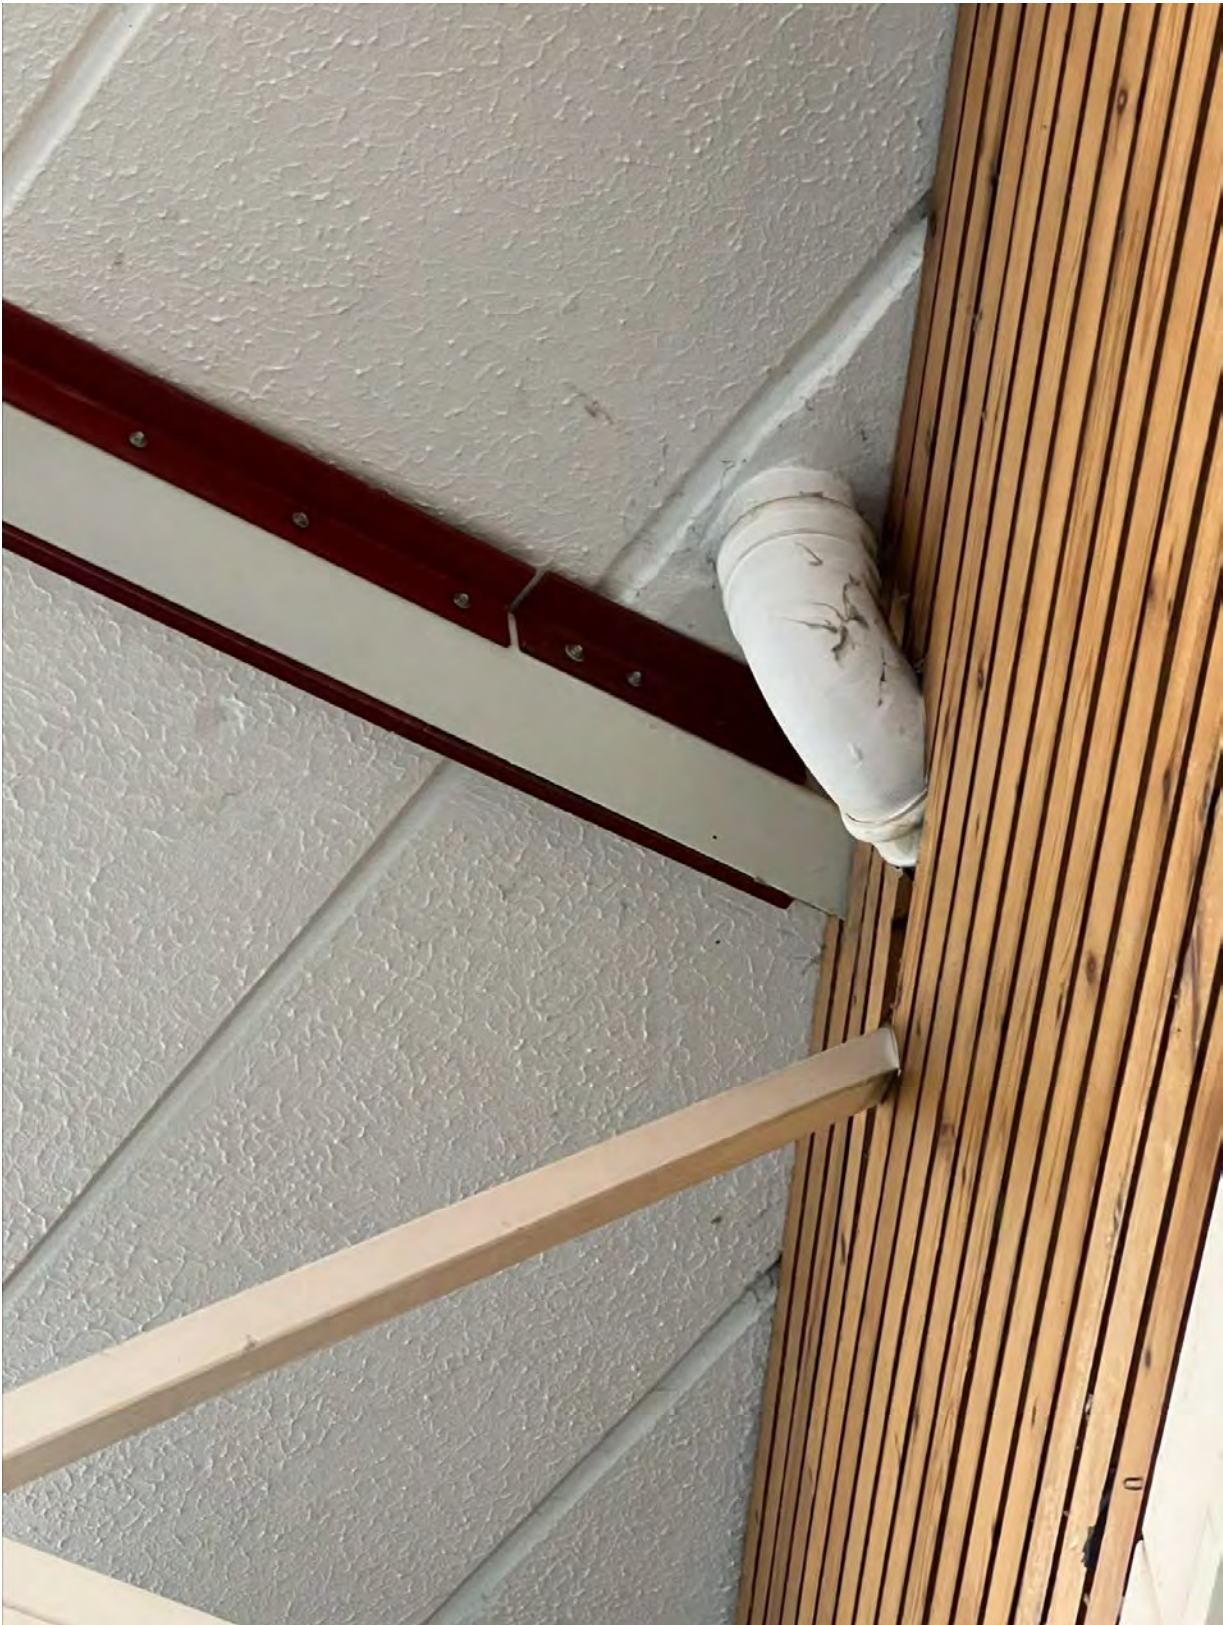
Photograph 8 – Dining Hall top chord bearing angle

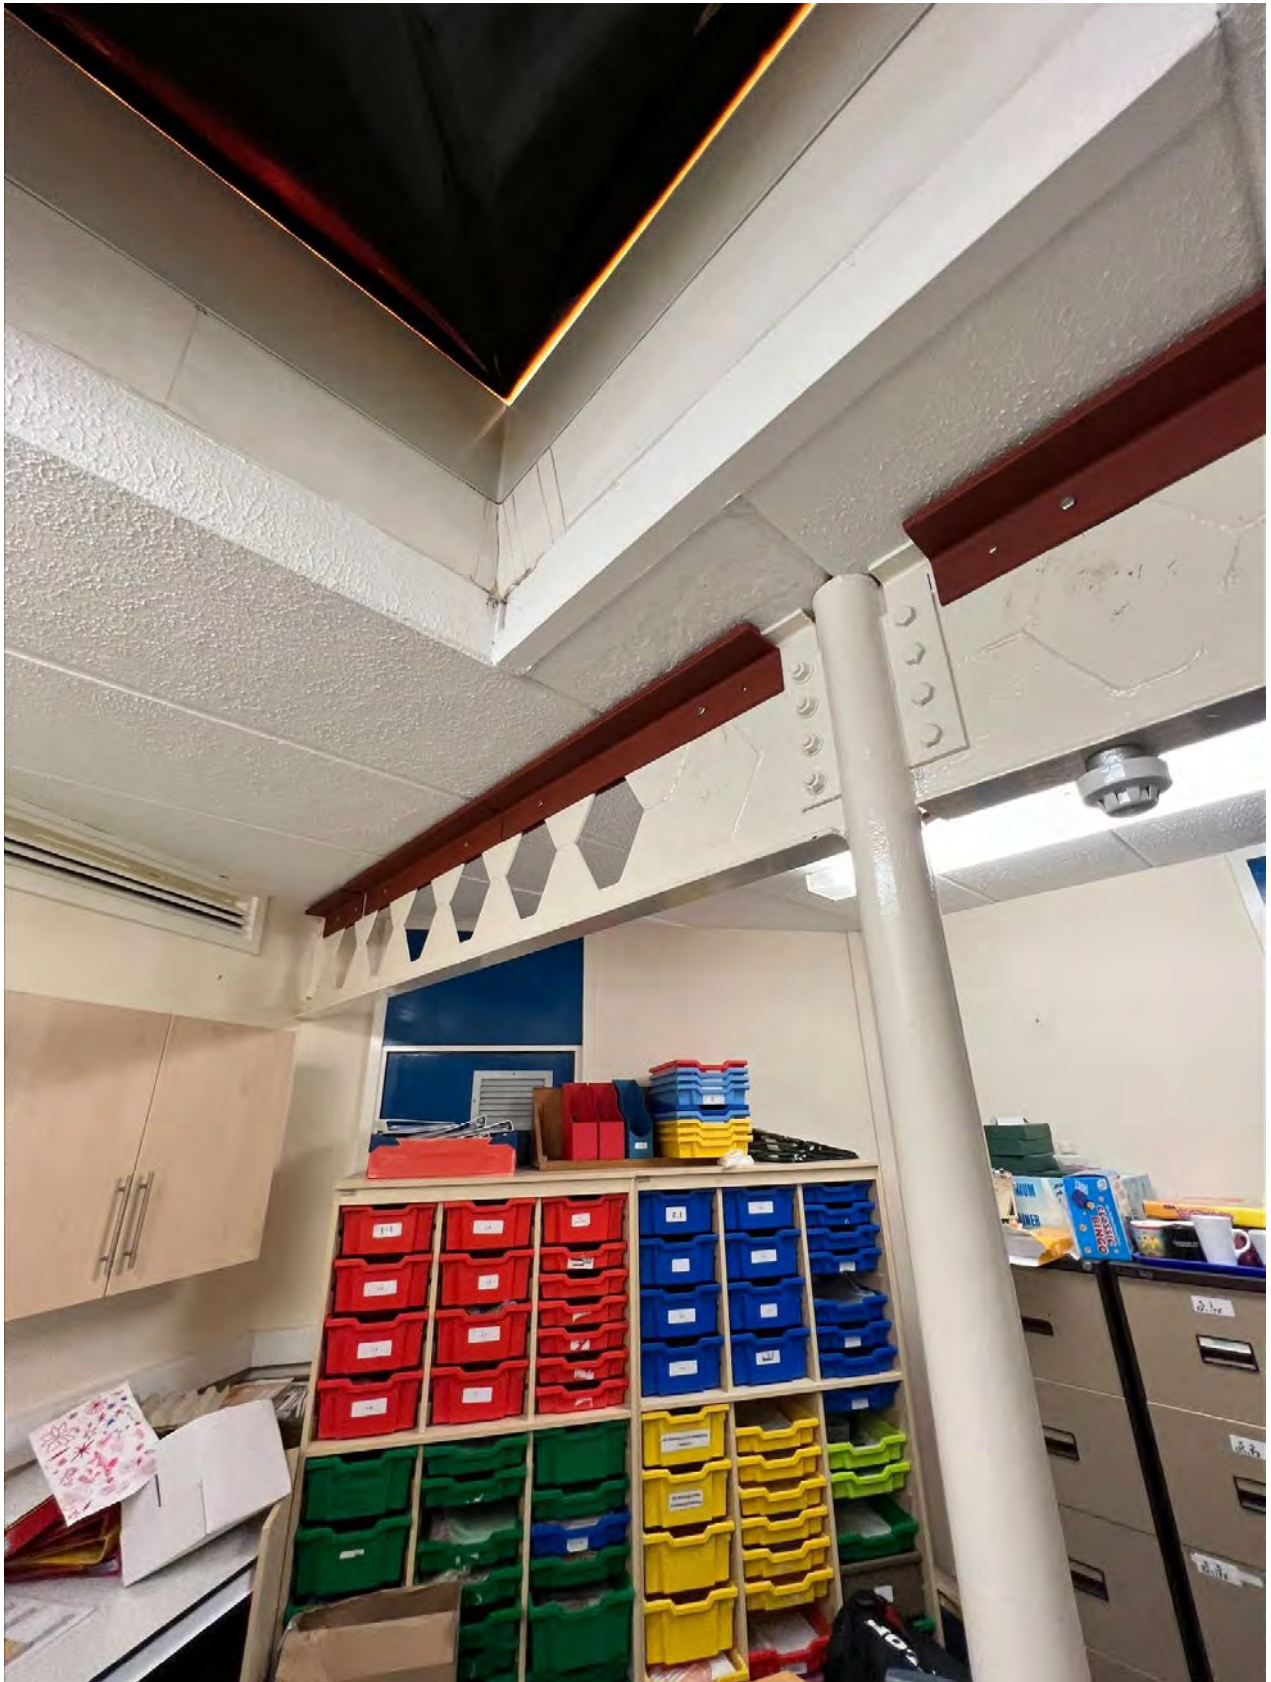
Photograph 9 – Art Dept Castellated beam extended bearing

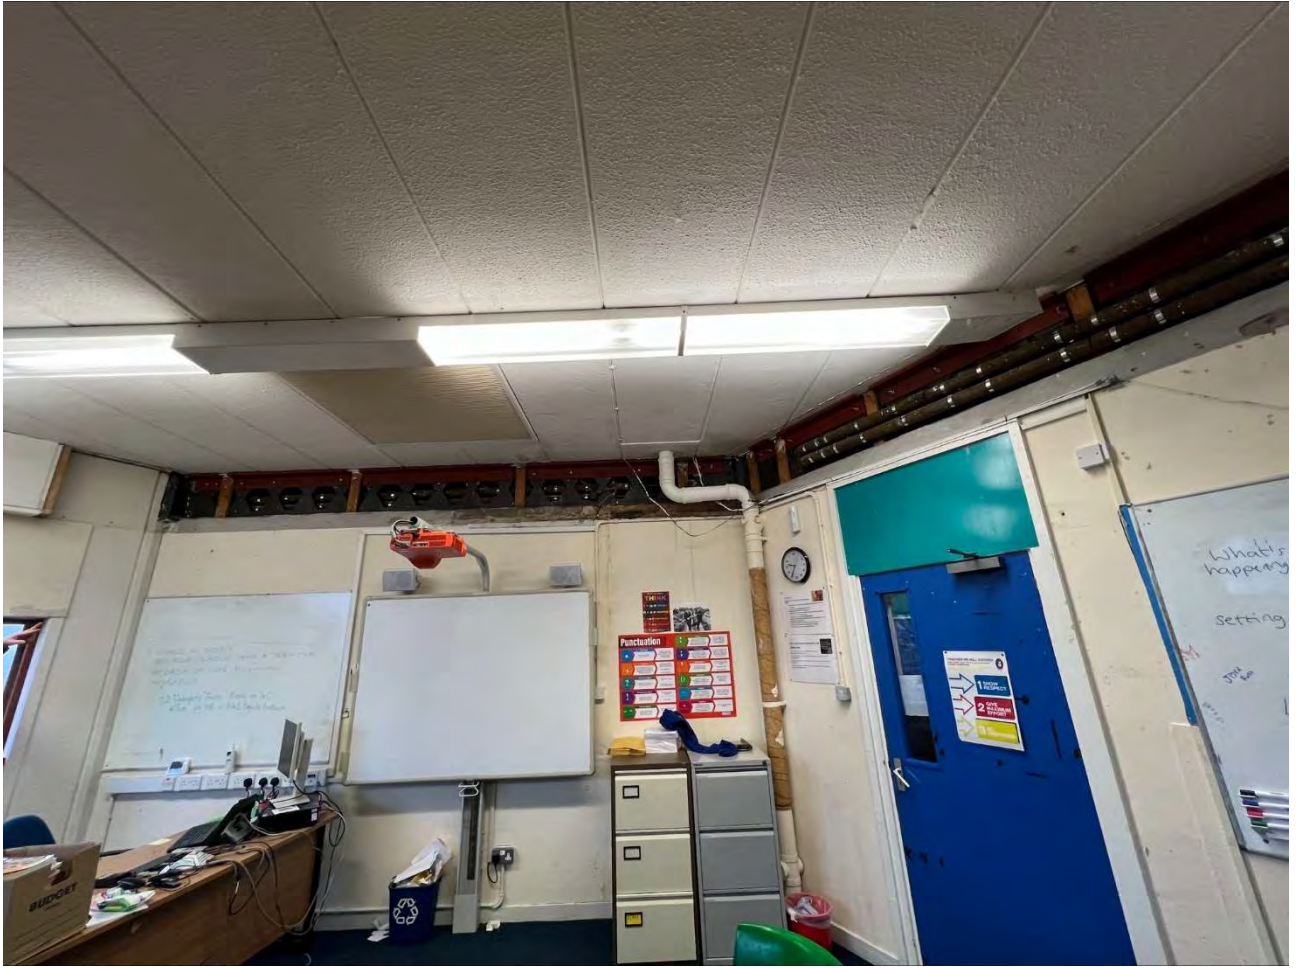
Photograph 10 – Classroom L3 extended bearing angle
