A890 Stromeferry Bypass

Annual Slope Inspection 2024

The Highland Council

Project number: 60685712
AECOM Report Ref: GLRP0008

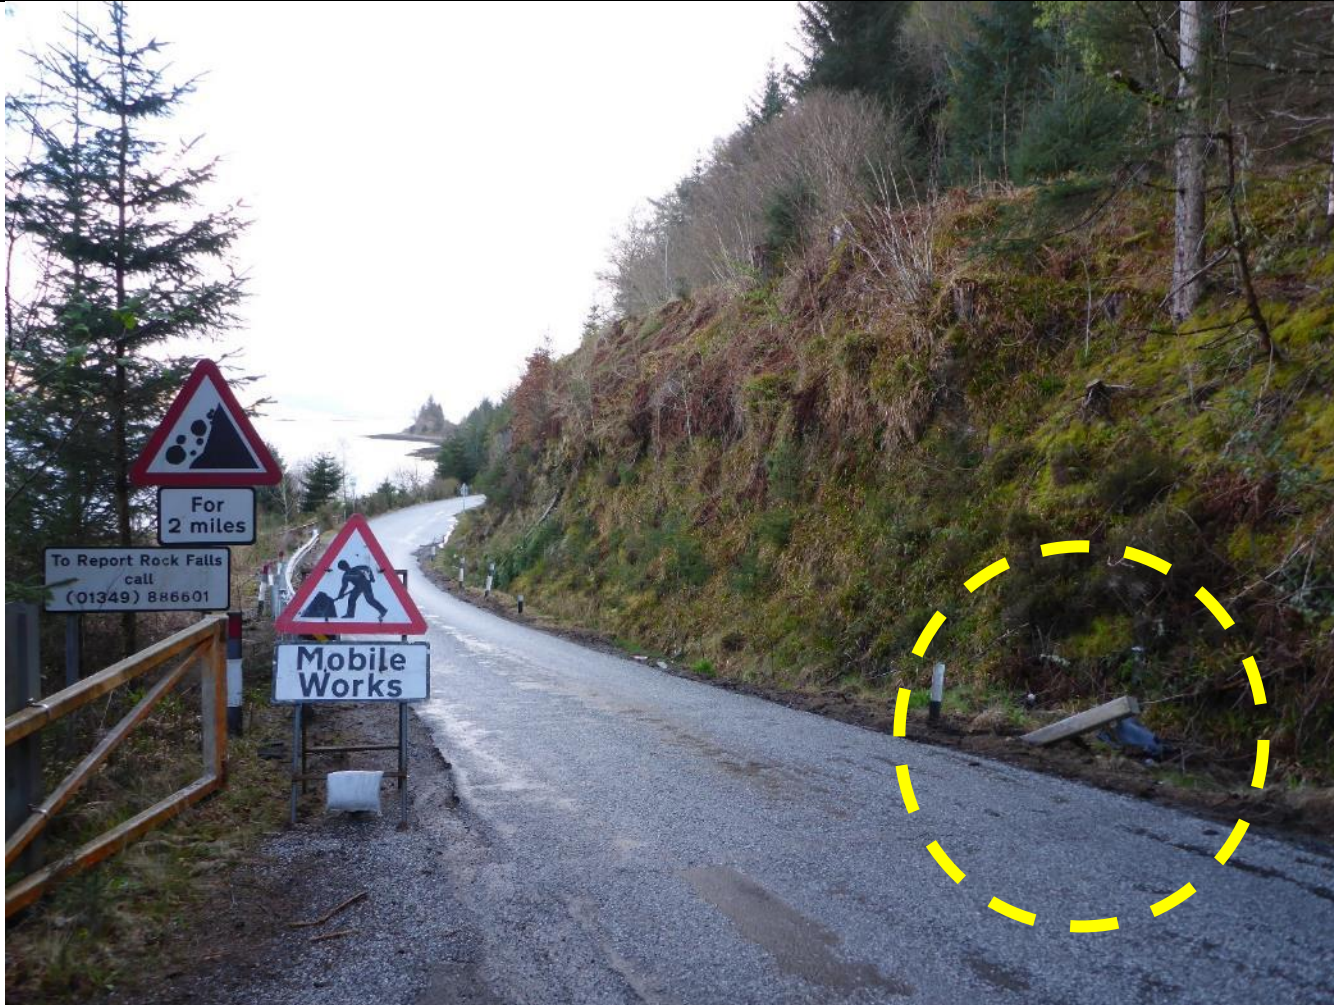
Photograph: AA1-1

Ch. 0 – Road closure gate post has been struck and knocked over. Feature circled.

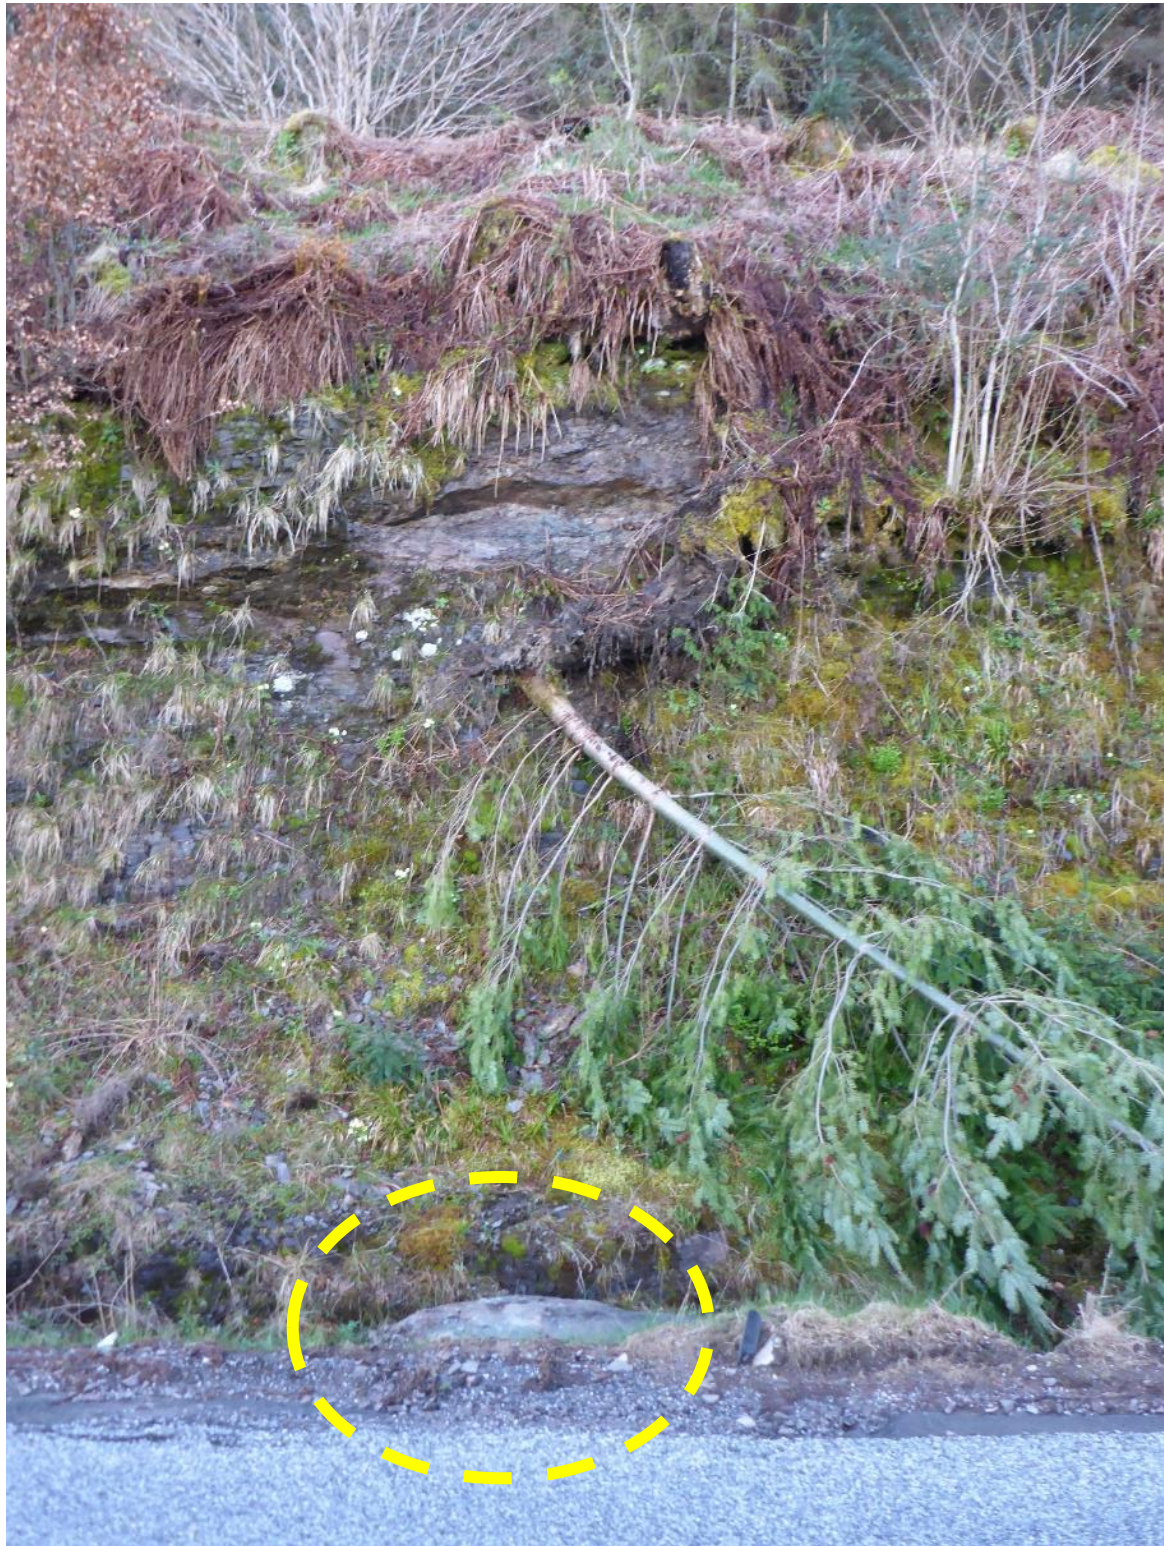
Photograph: AA1-2

Ch. 31 – Small tree growing from rock race face has fallen. Large block in ditch below (feature circled).

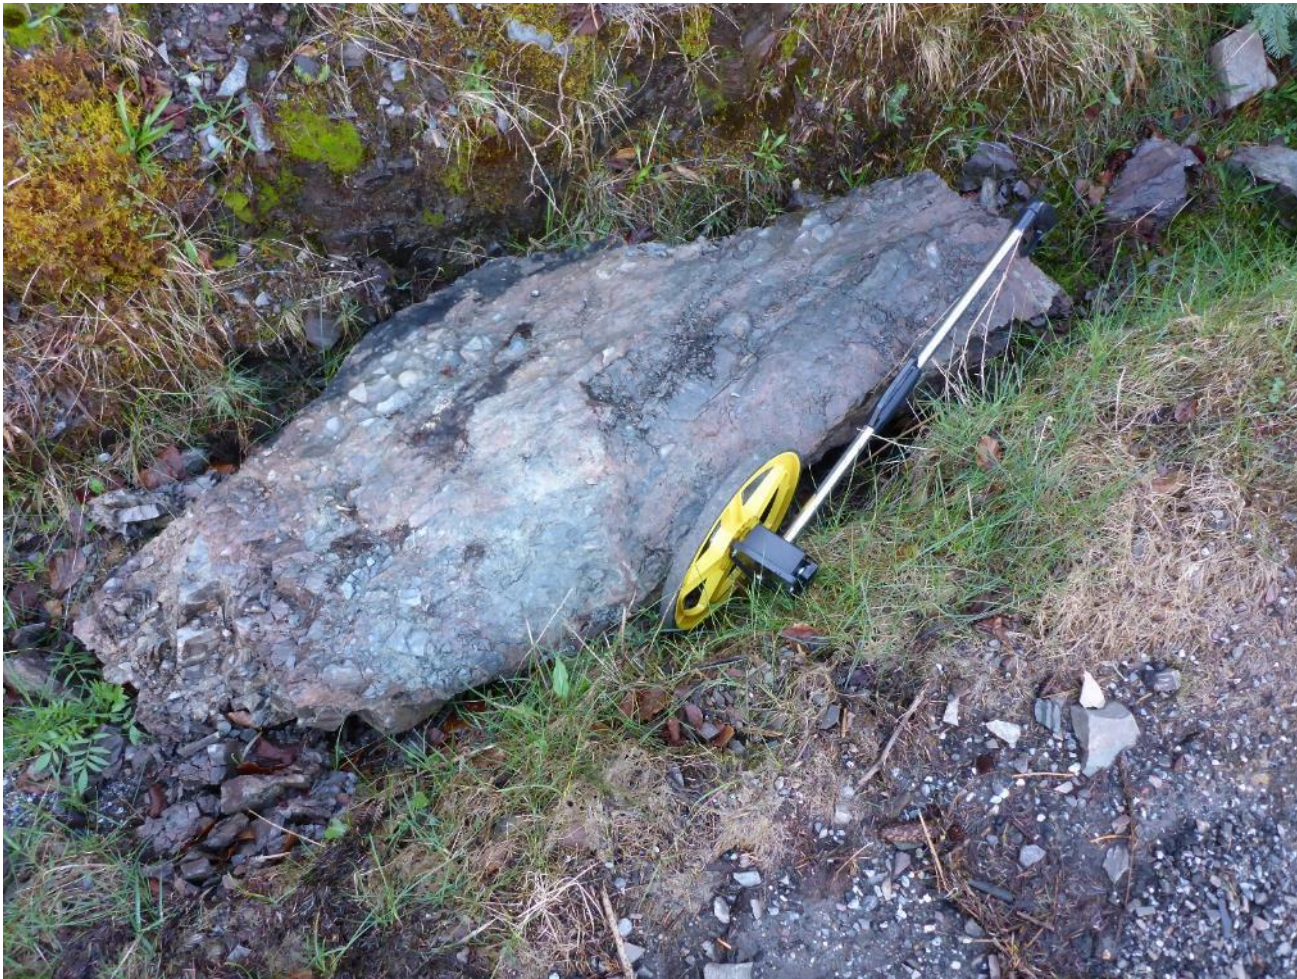
Photograph: AA1-3

Ch. 31 – Large block (1.0m x 0.5m x 0.4m) in ditch.

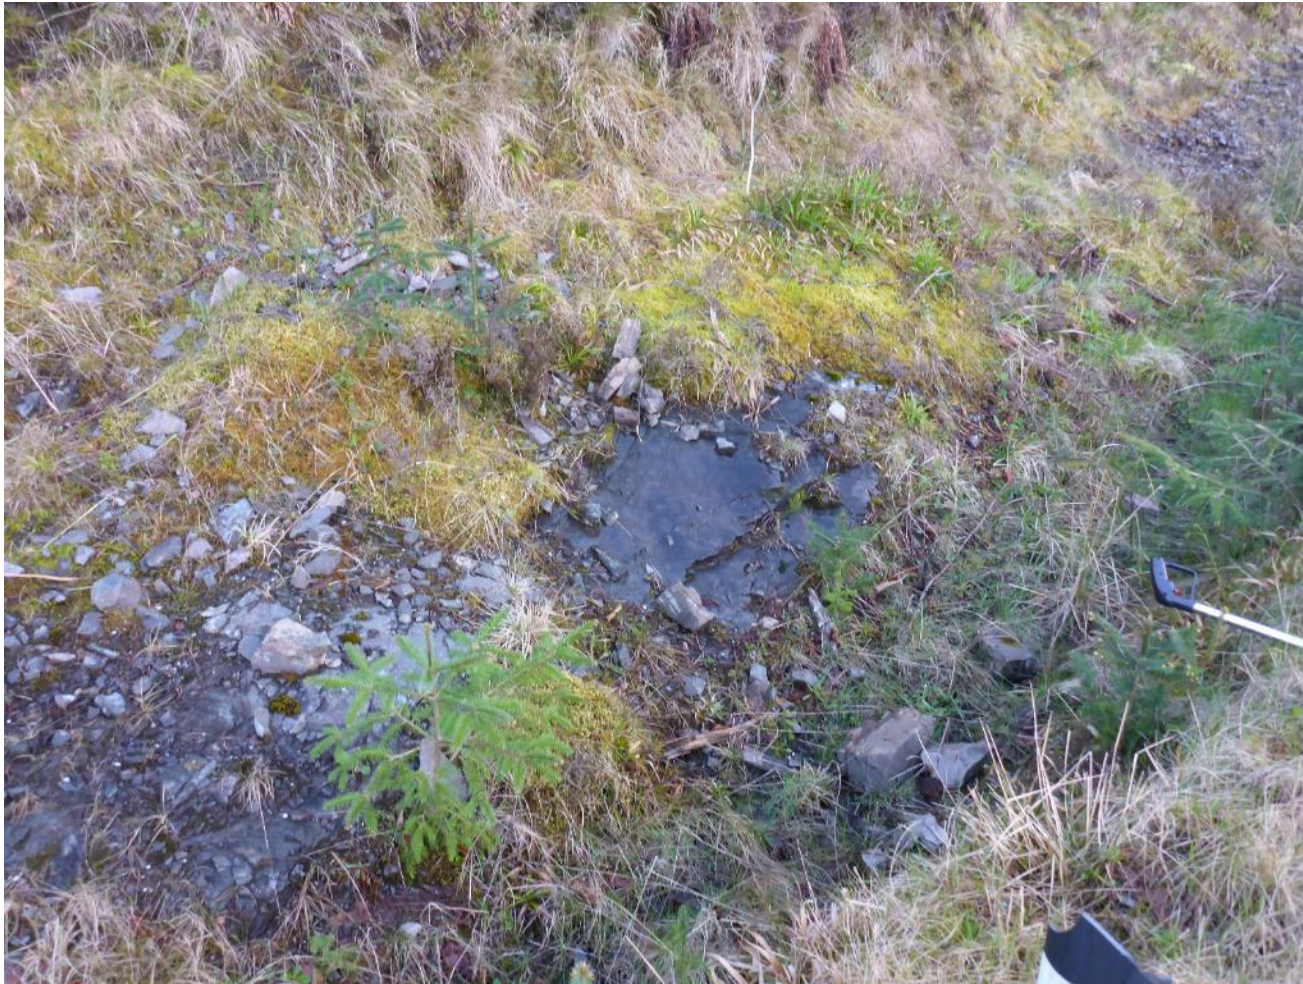
Photograph: AA1-4

Ch. 100 – Accumulation of numerous small blocks in ditch.

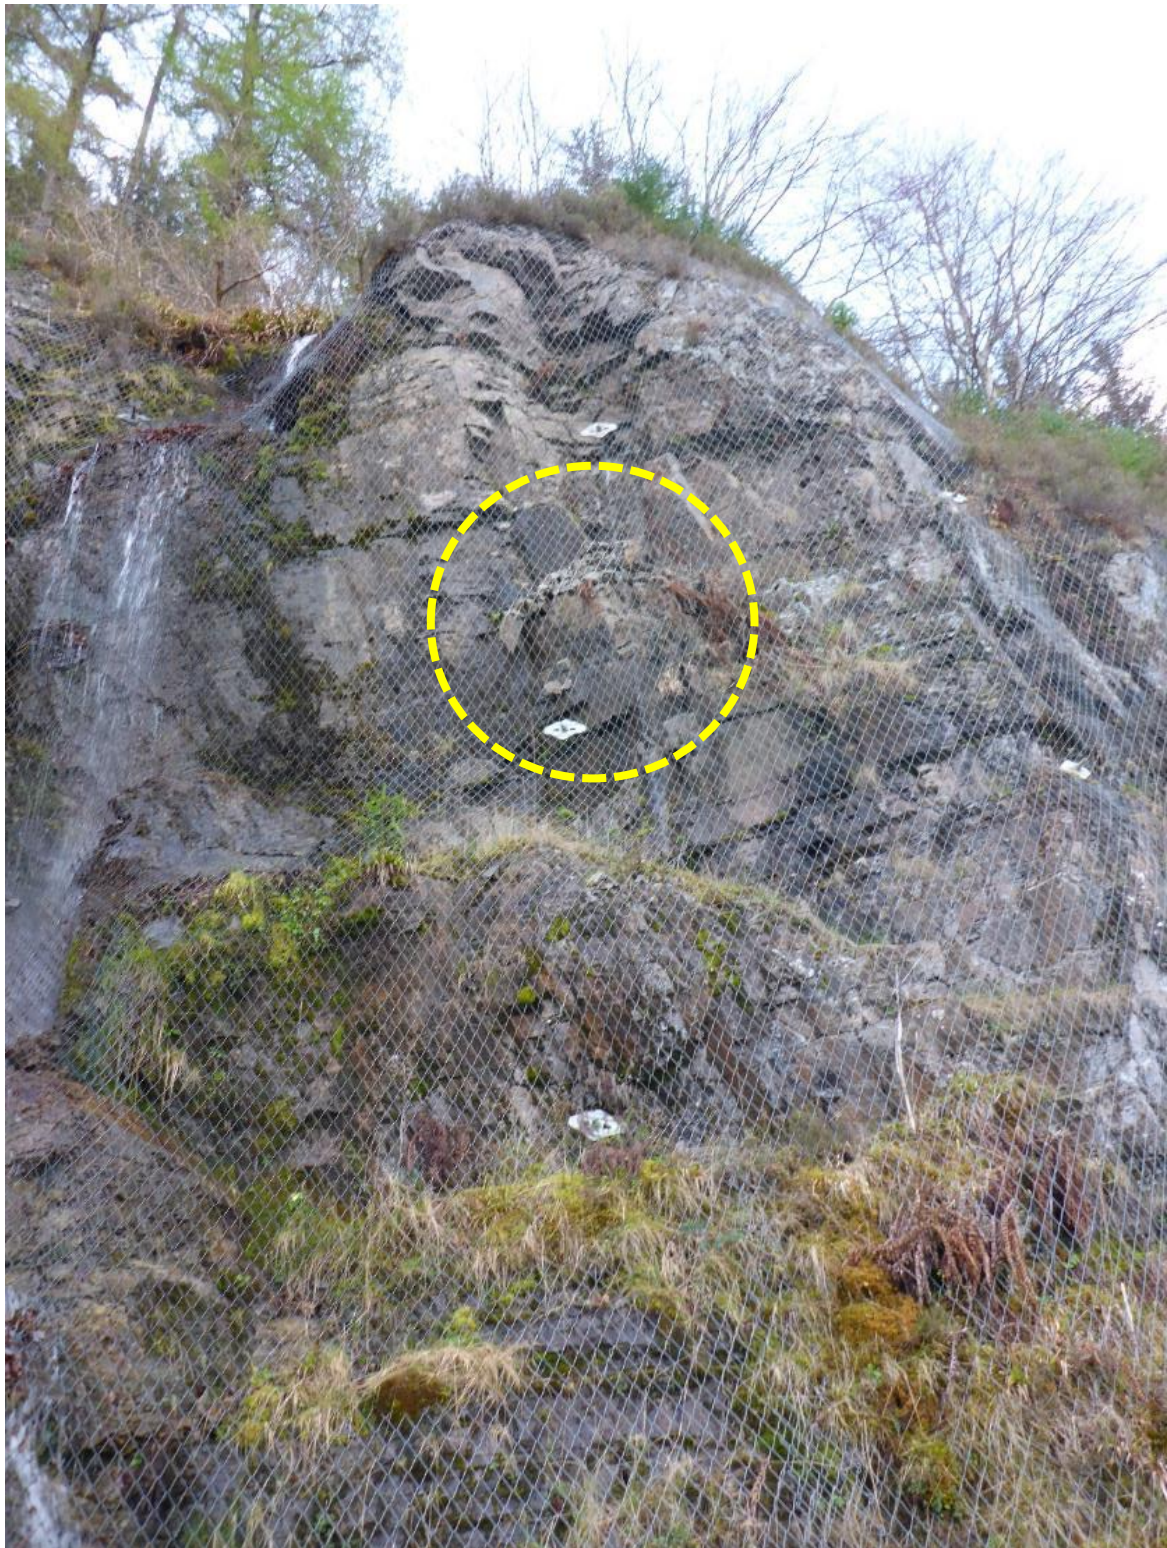
Photograph: AA1-5

Ch. 150 – Small accumulation of blocks on ledge.

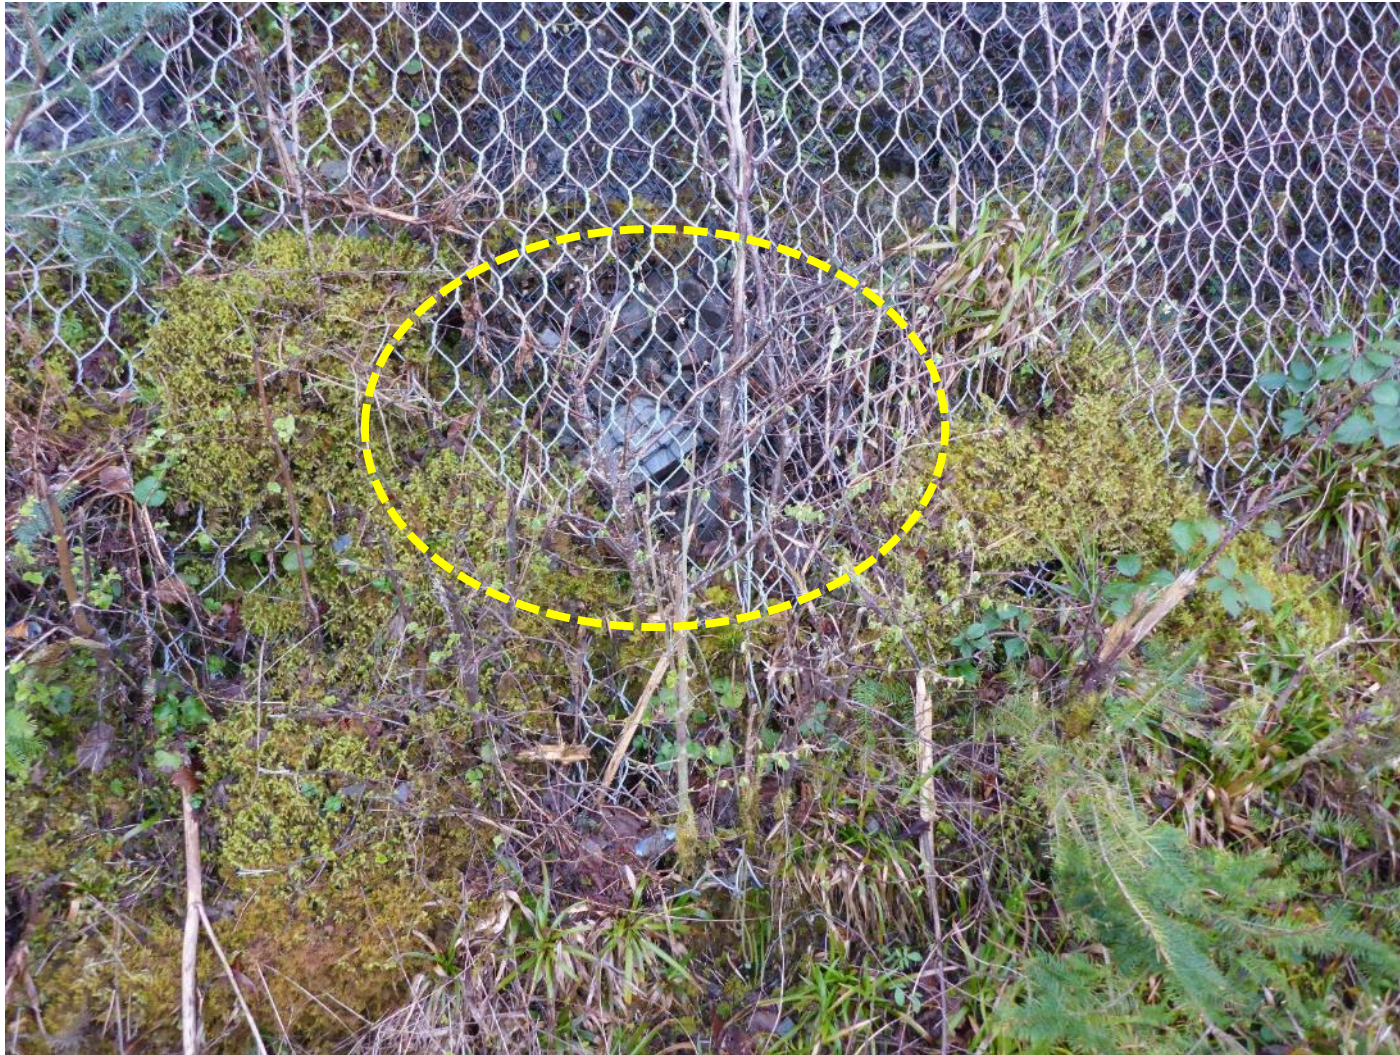
Photograph: AA2-1

Ch. 190 – Accumulation of small blocks behind netting. (Feature circled).

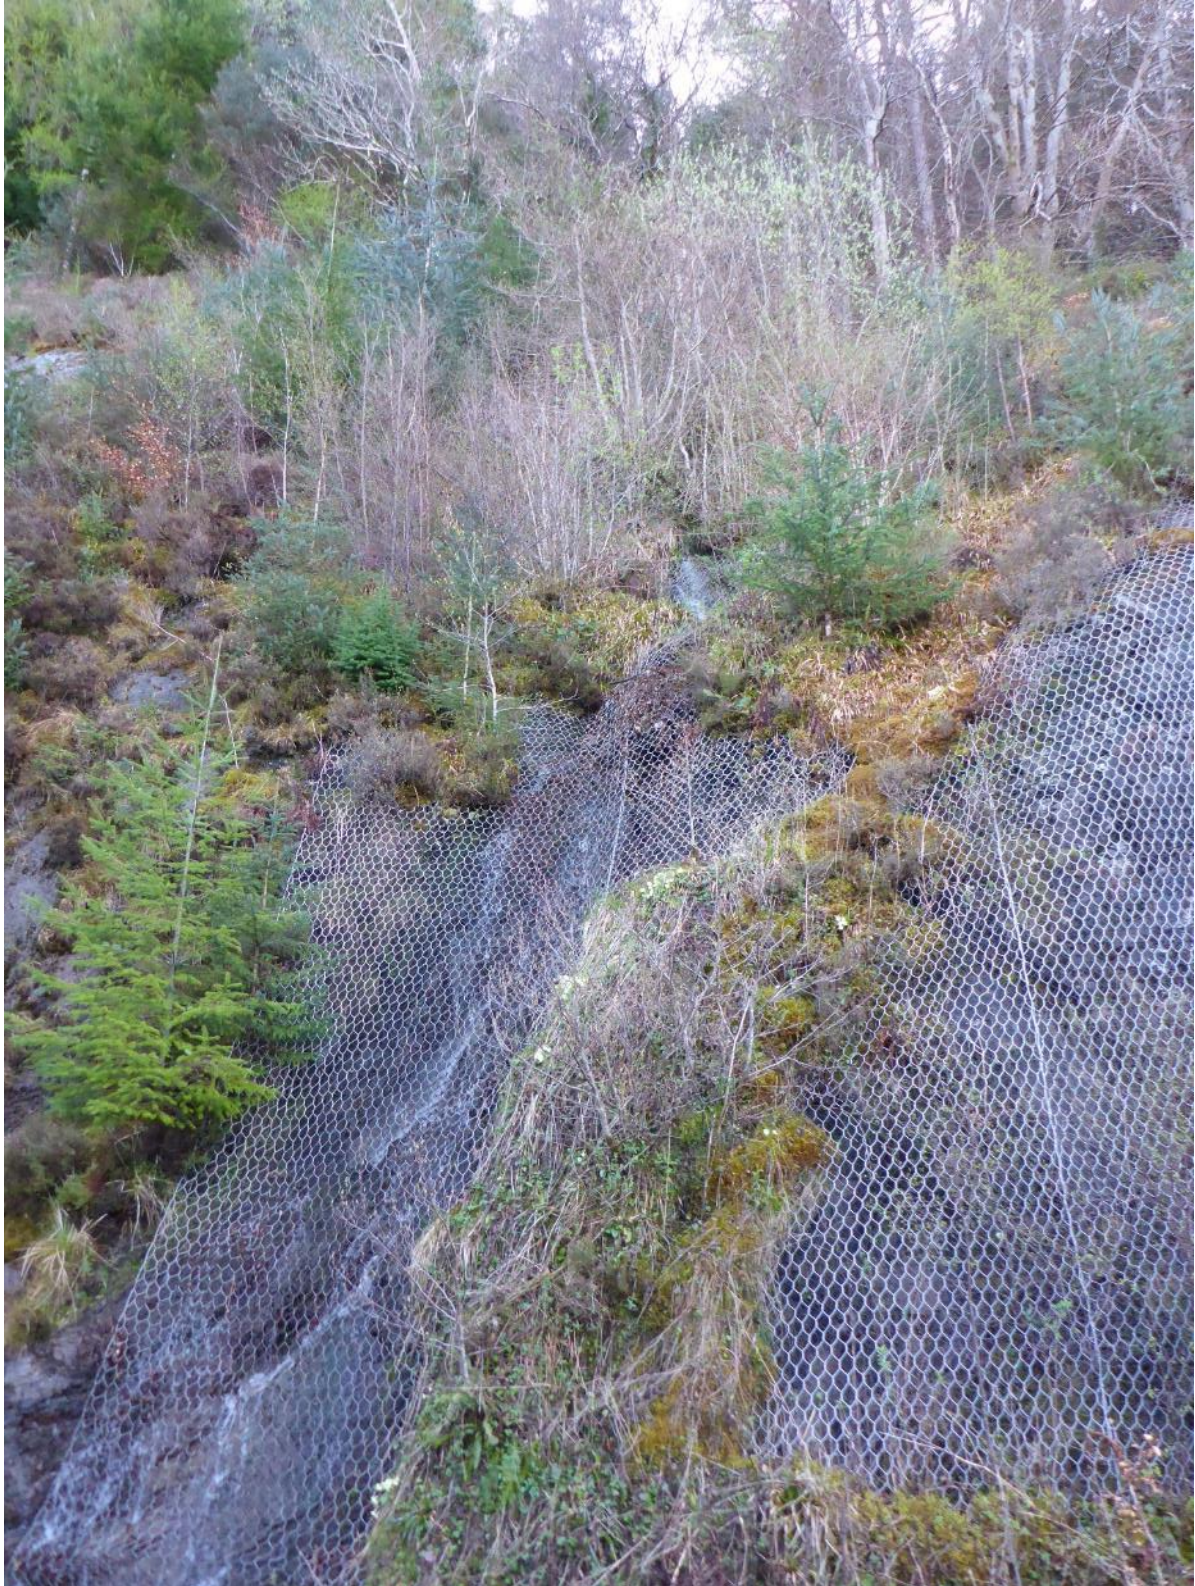
Photograph: AA2-2

Ch. 205 – 2016 observation was that trees at eastern edge of gully at crest of rock face are overhanging and at risk of falling and dislodging blocks. Additional vegetation growth made this hard to distinguish in 2024.

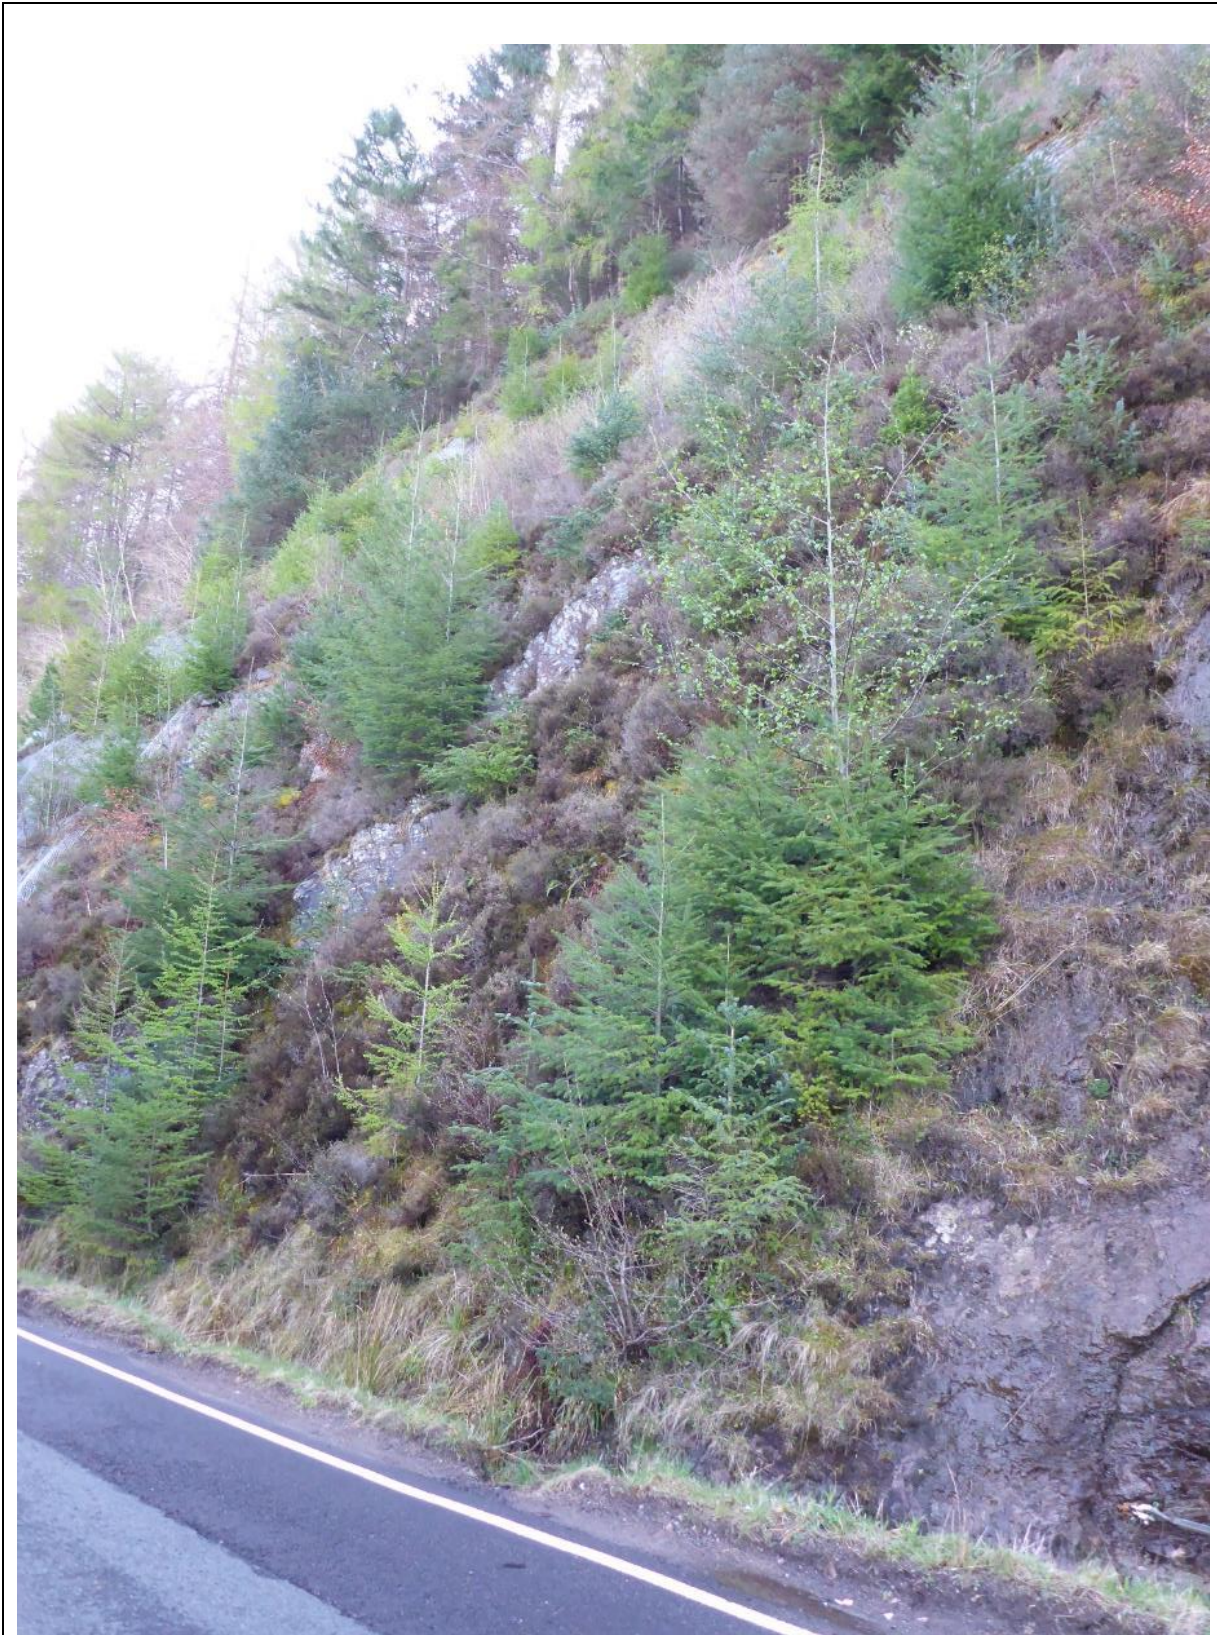
Photograph: AA2-3

Ch. 205 to 230 – No remedial measures over rock face in this area. Frequent coniferous saplings present. Root jacking may become an issue.

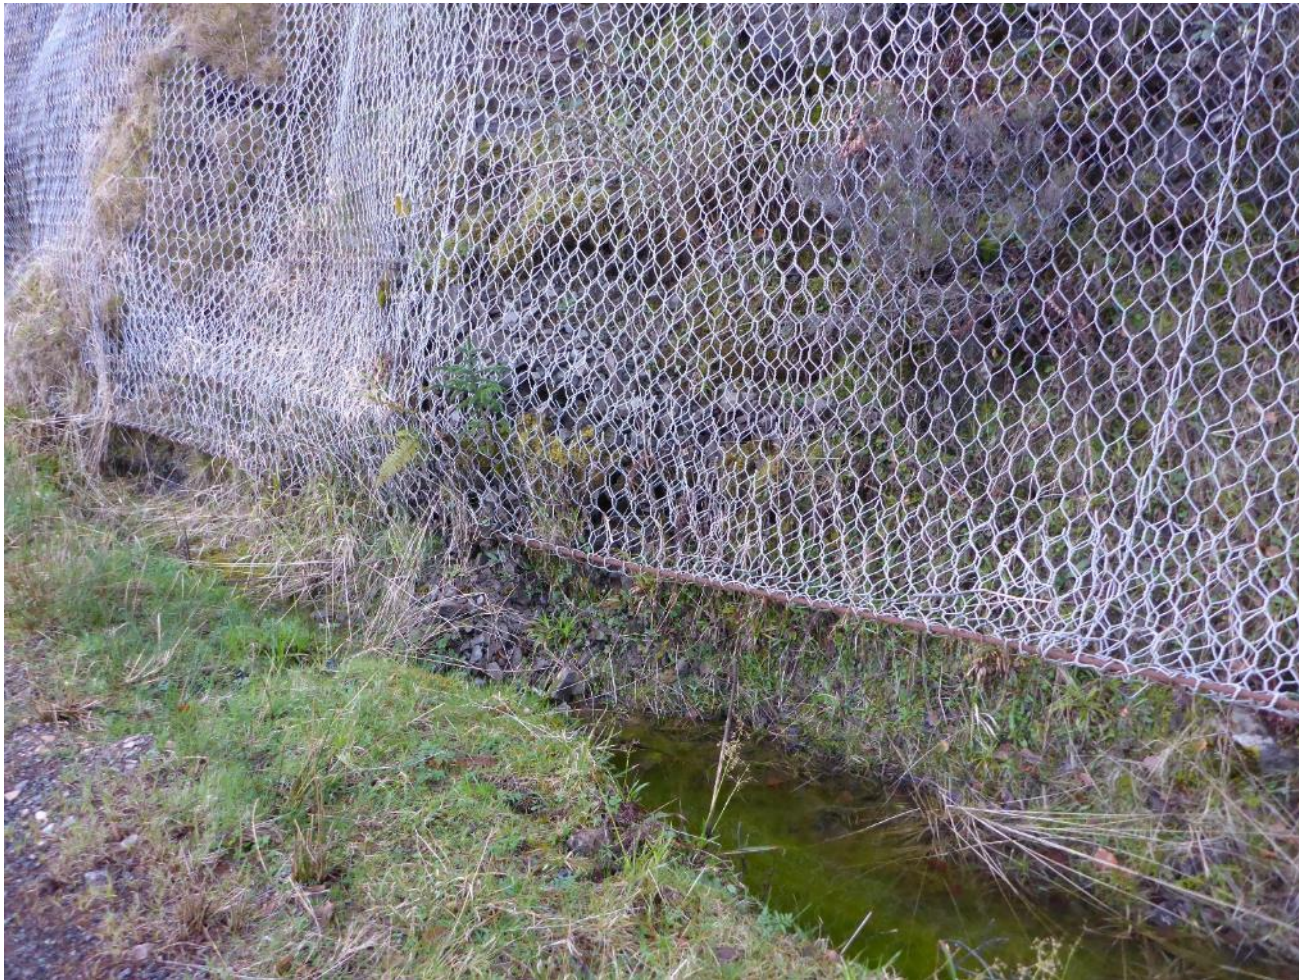
Photograph: AA2-4

Ch. 273 – Debris previously caught behind netting in 2017 was observed to have fallen out of base of netting and into ditch in 2021. No significant changes observed 2024.

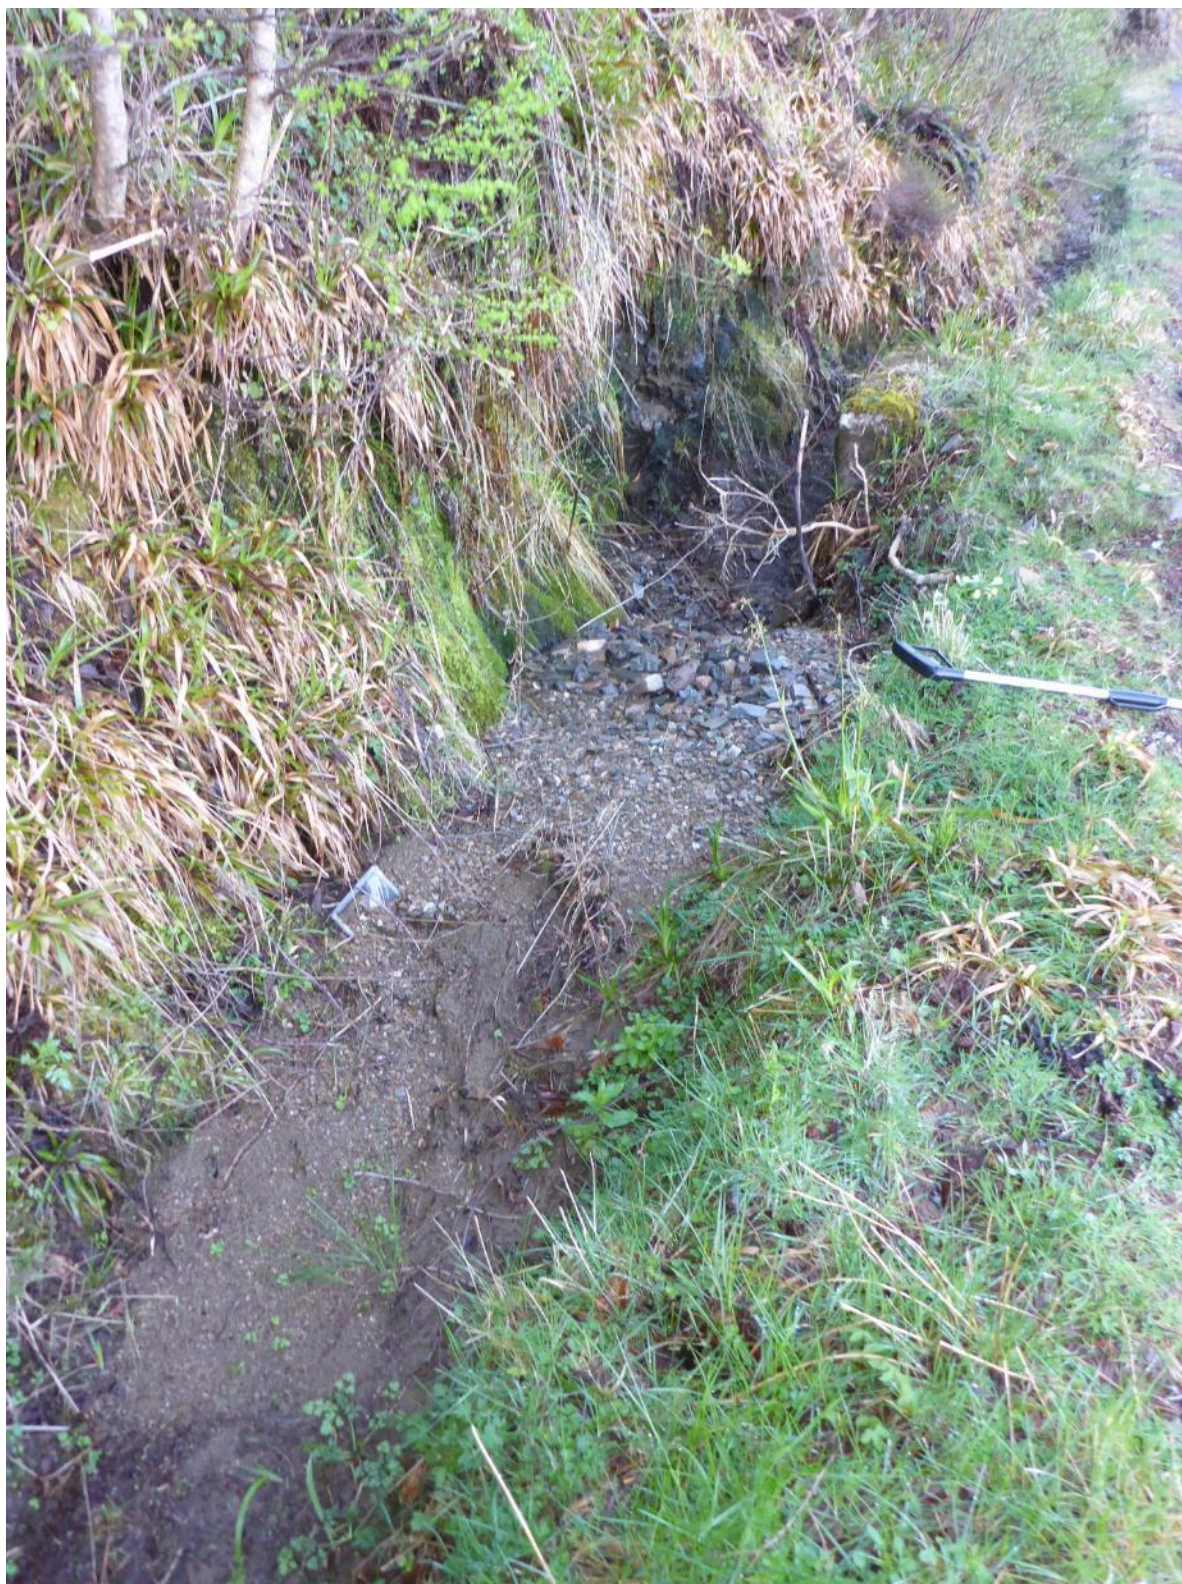
Photograph: AA2A-1

Ch. 335 – Roadside ditch filled with small granular debris and culvert blocked.

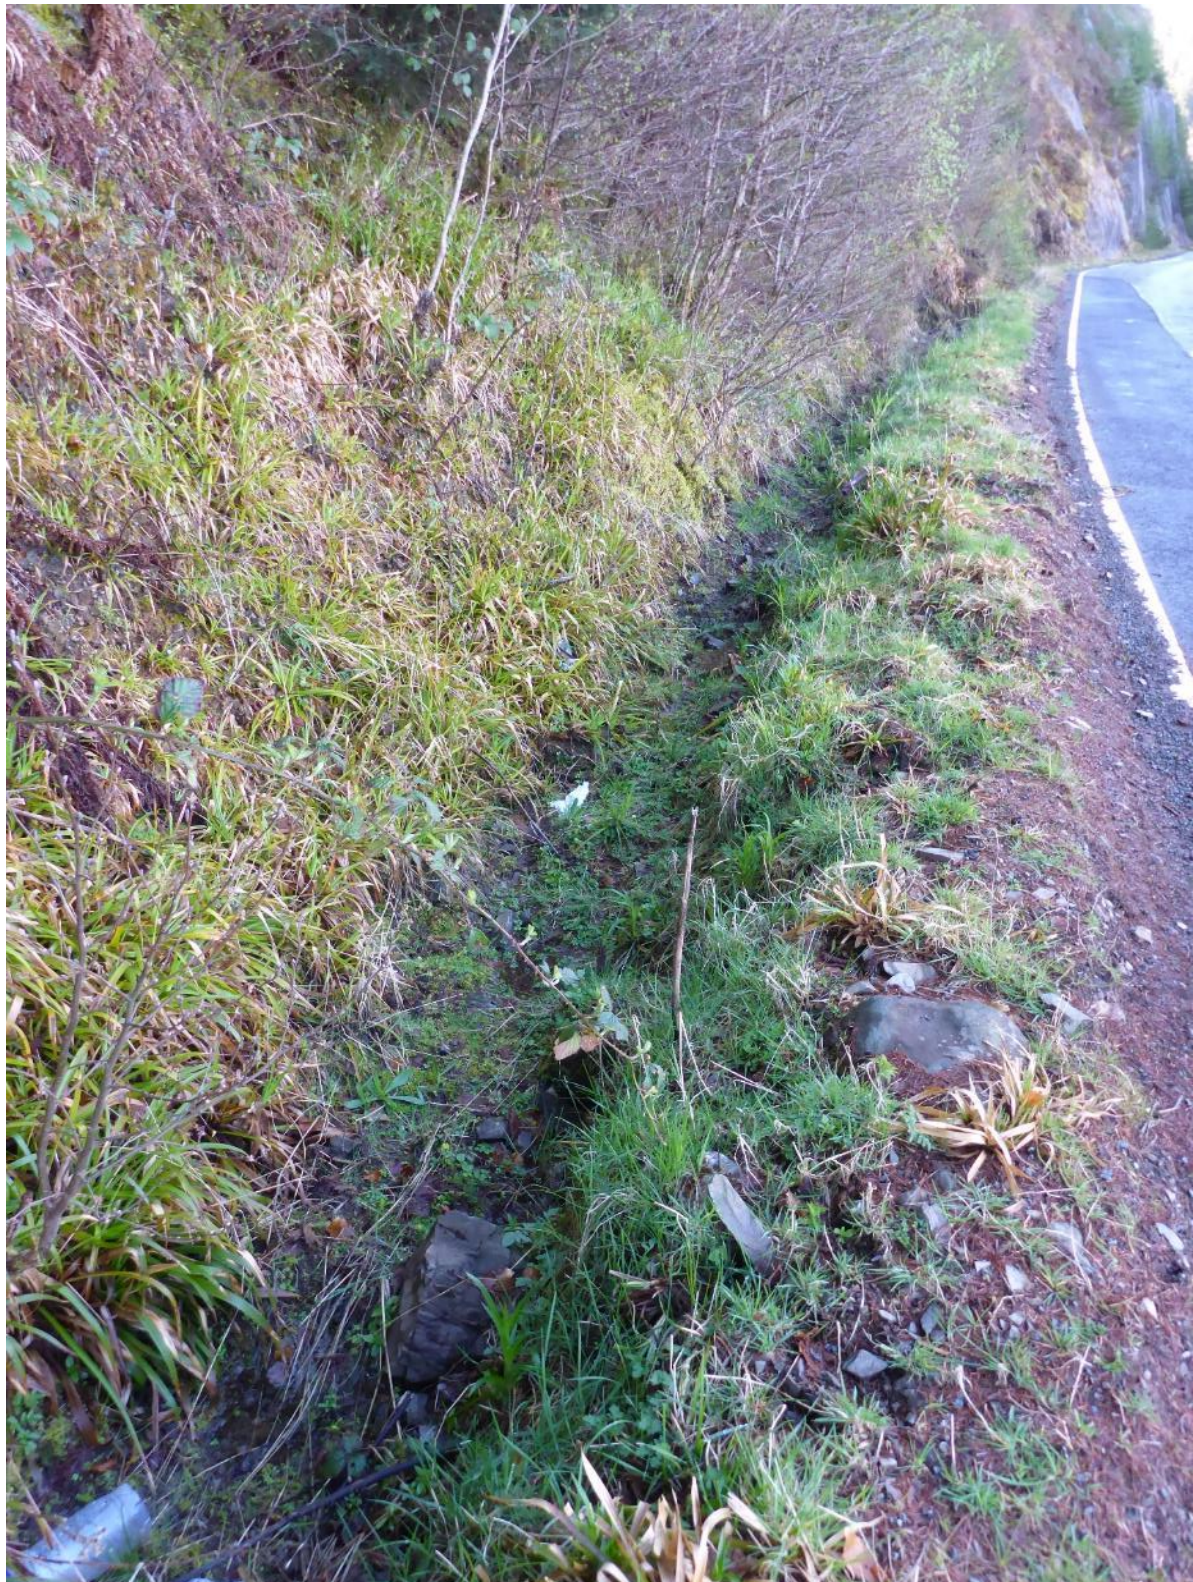
Photograph: AA2A-2

Between Ch. 350 to 370 – Ca. six 0.1x0.1x0.1m blocks in roadside ditch.

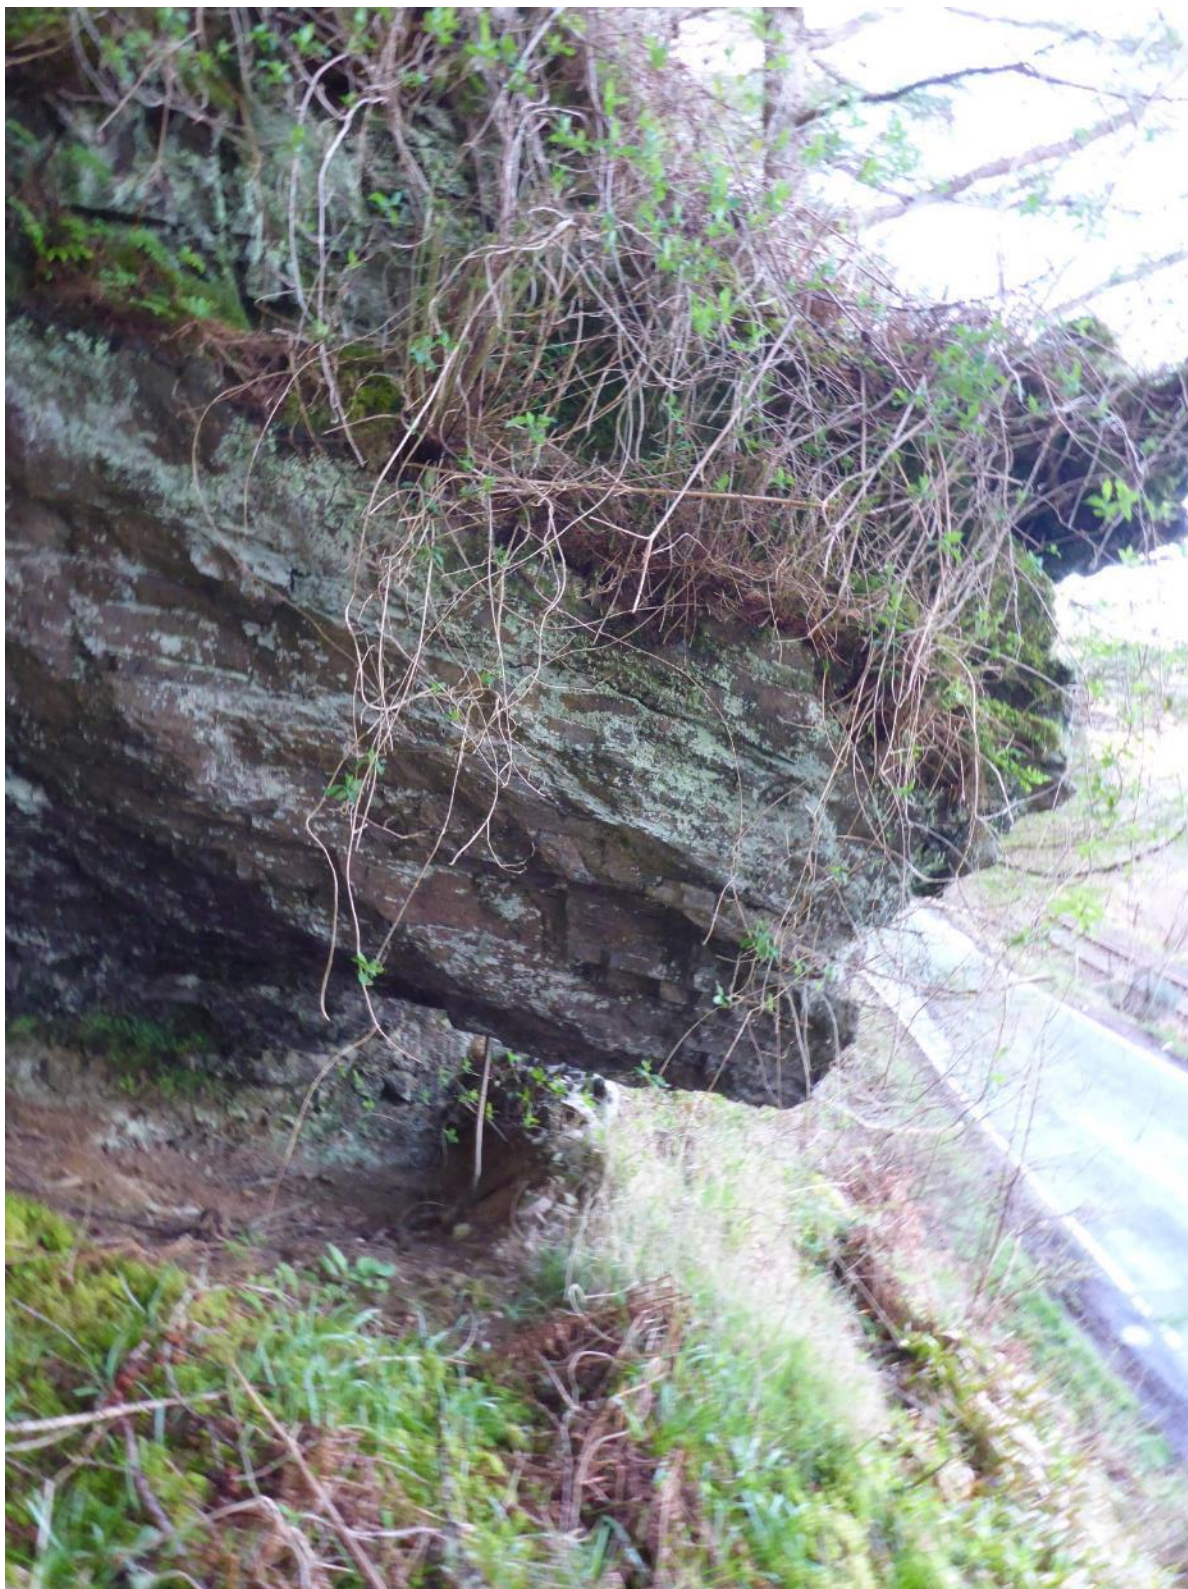
Photograph: AA2A-3

Ch. 400 – Large overhanging boulder 5m above road level.

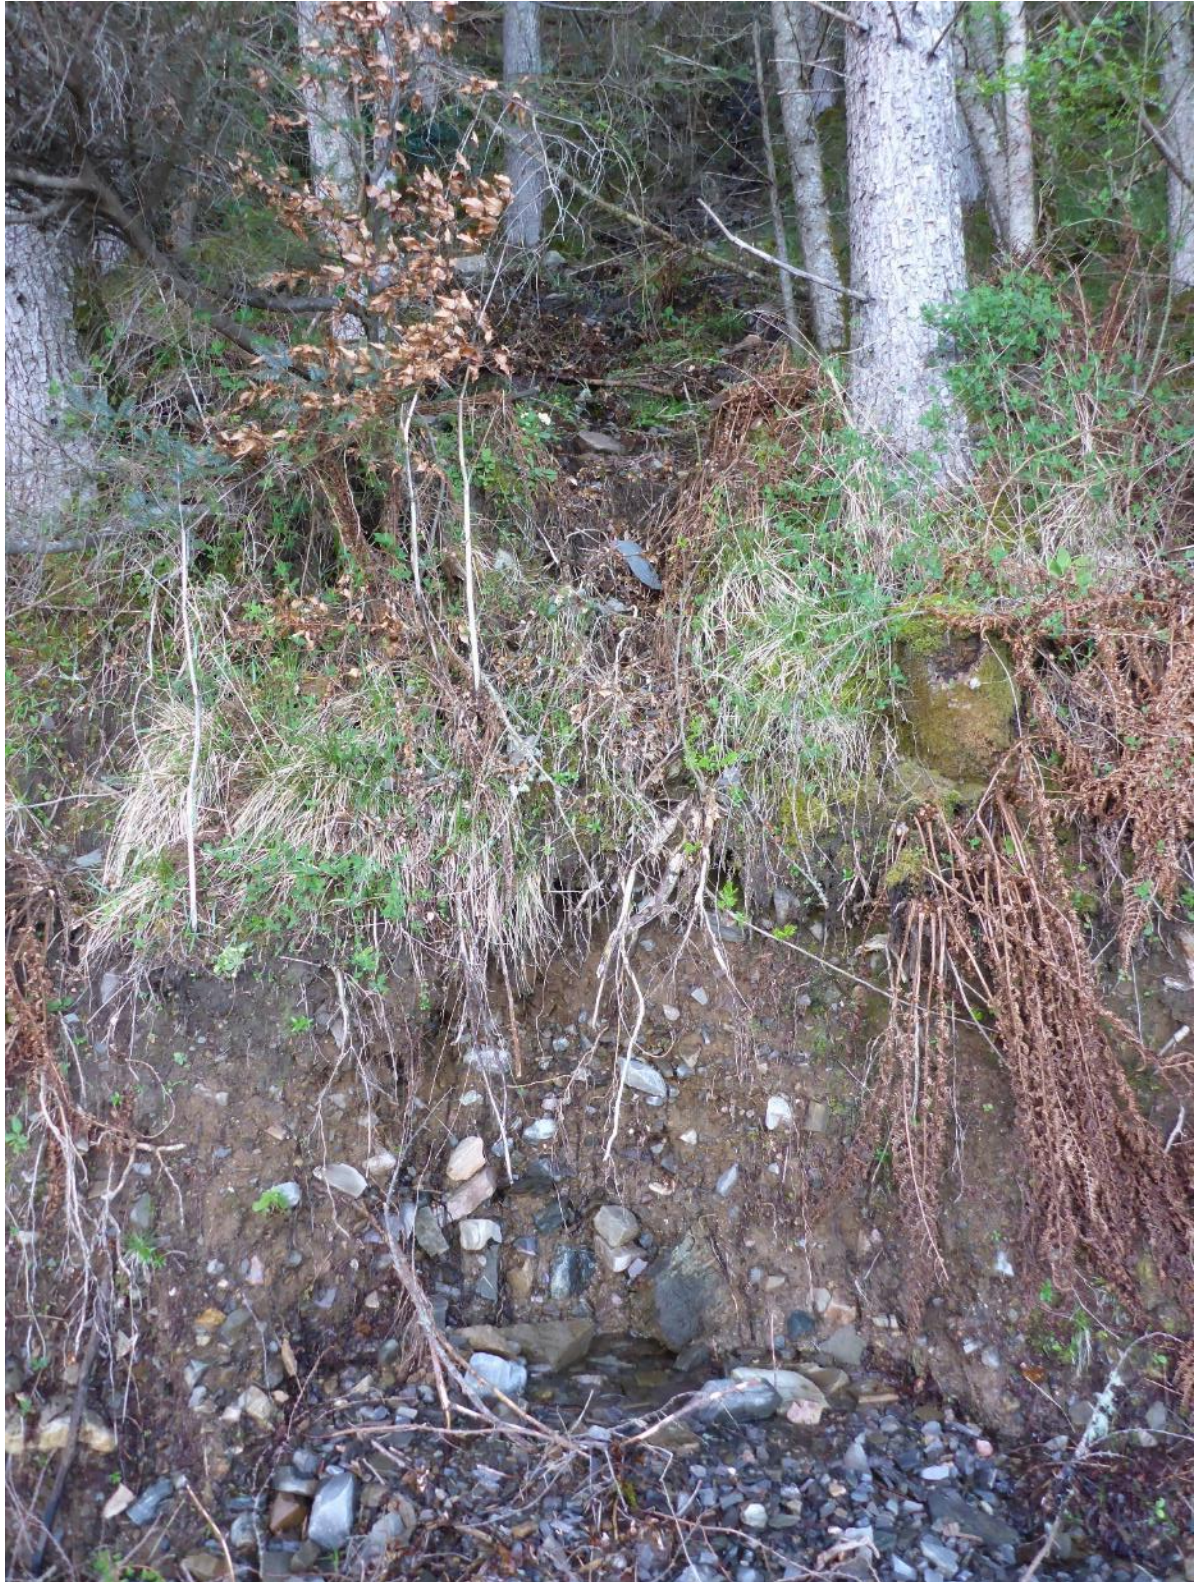
Photograph: AA2A-4

Ch. 428 – Roadside location of 2022 soil washout. No water flow observed at road level.
