A890 Stromeferry Bypass

Annual Slope Inspection 2024

The Highland Council

Project number: 60685712
AECOM Report Ref: GLRP0008

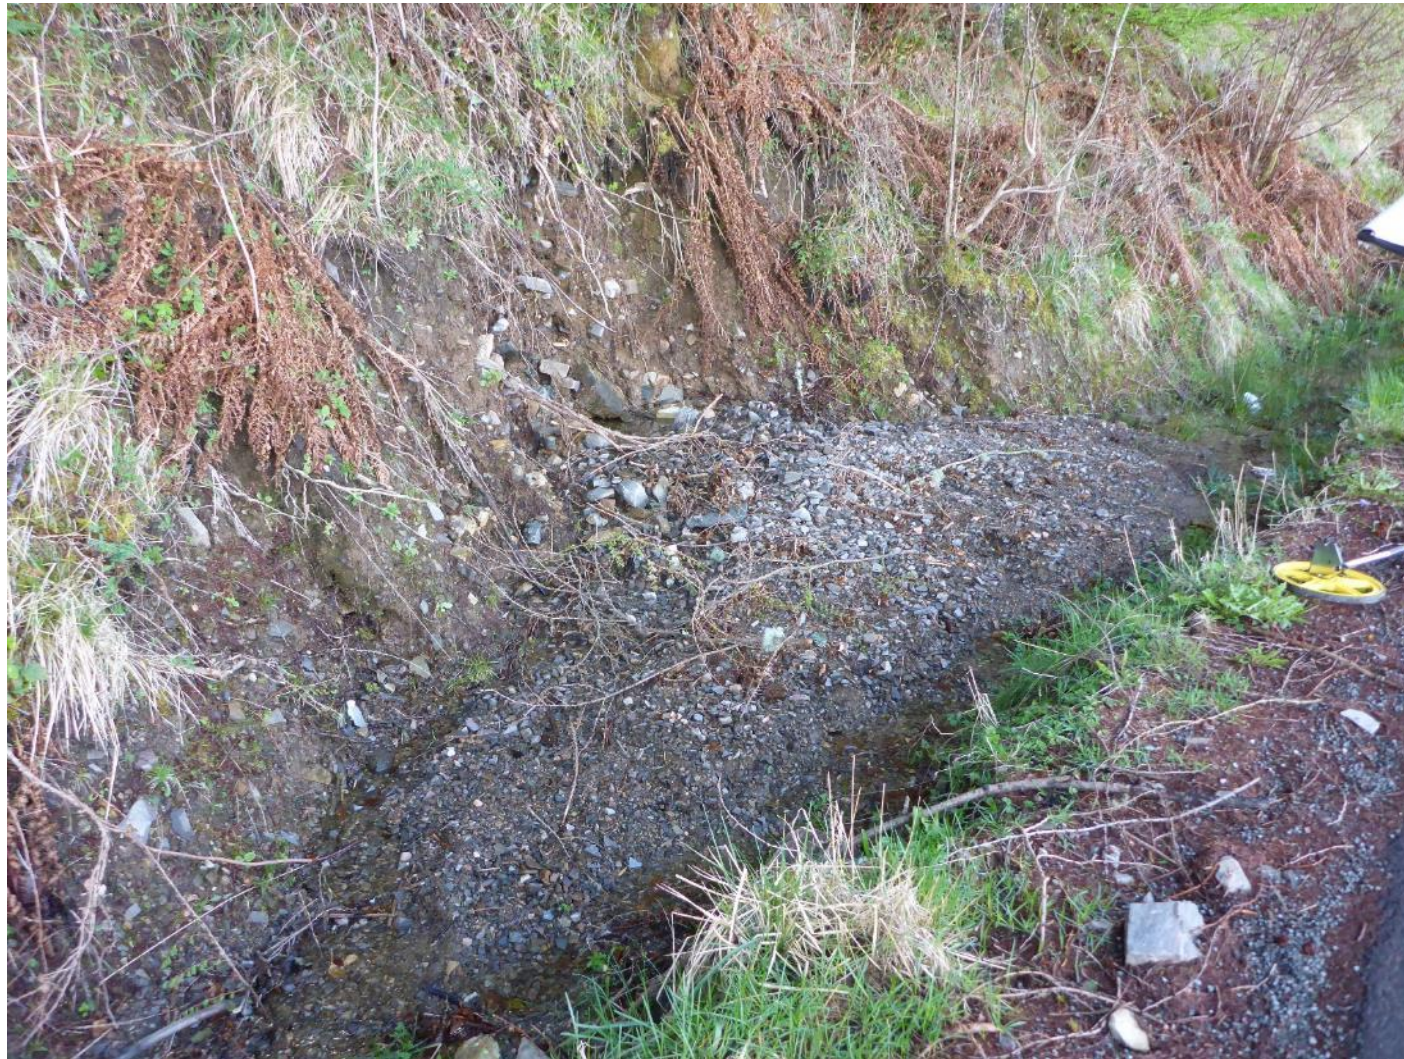
Photograph: AA2A-5

Ch. 428 – Ditch filled with small granular debris at toe of ephemeral watercourse.

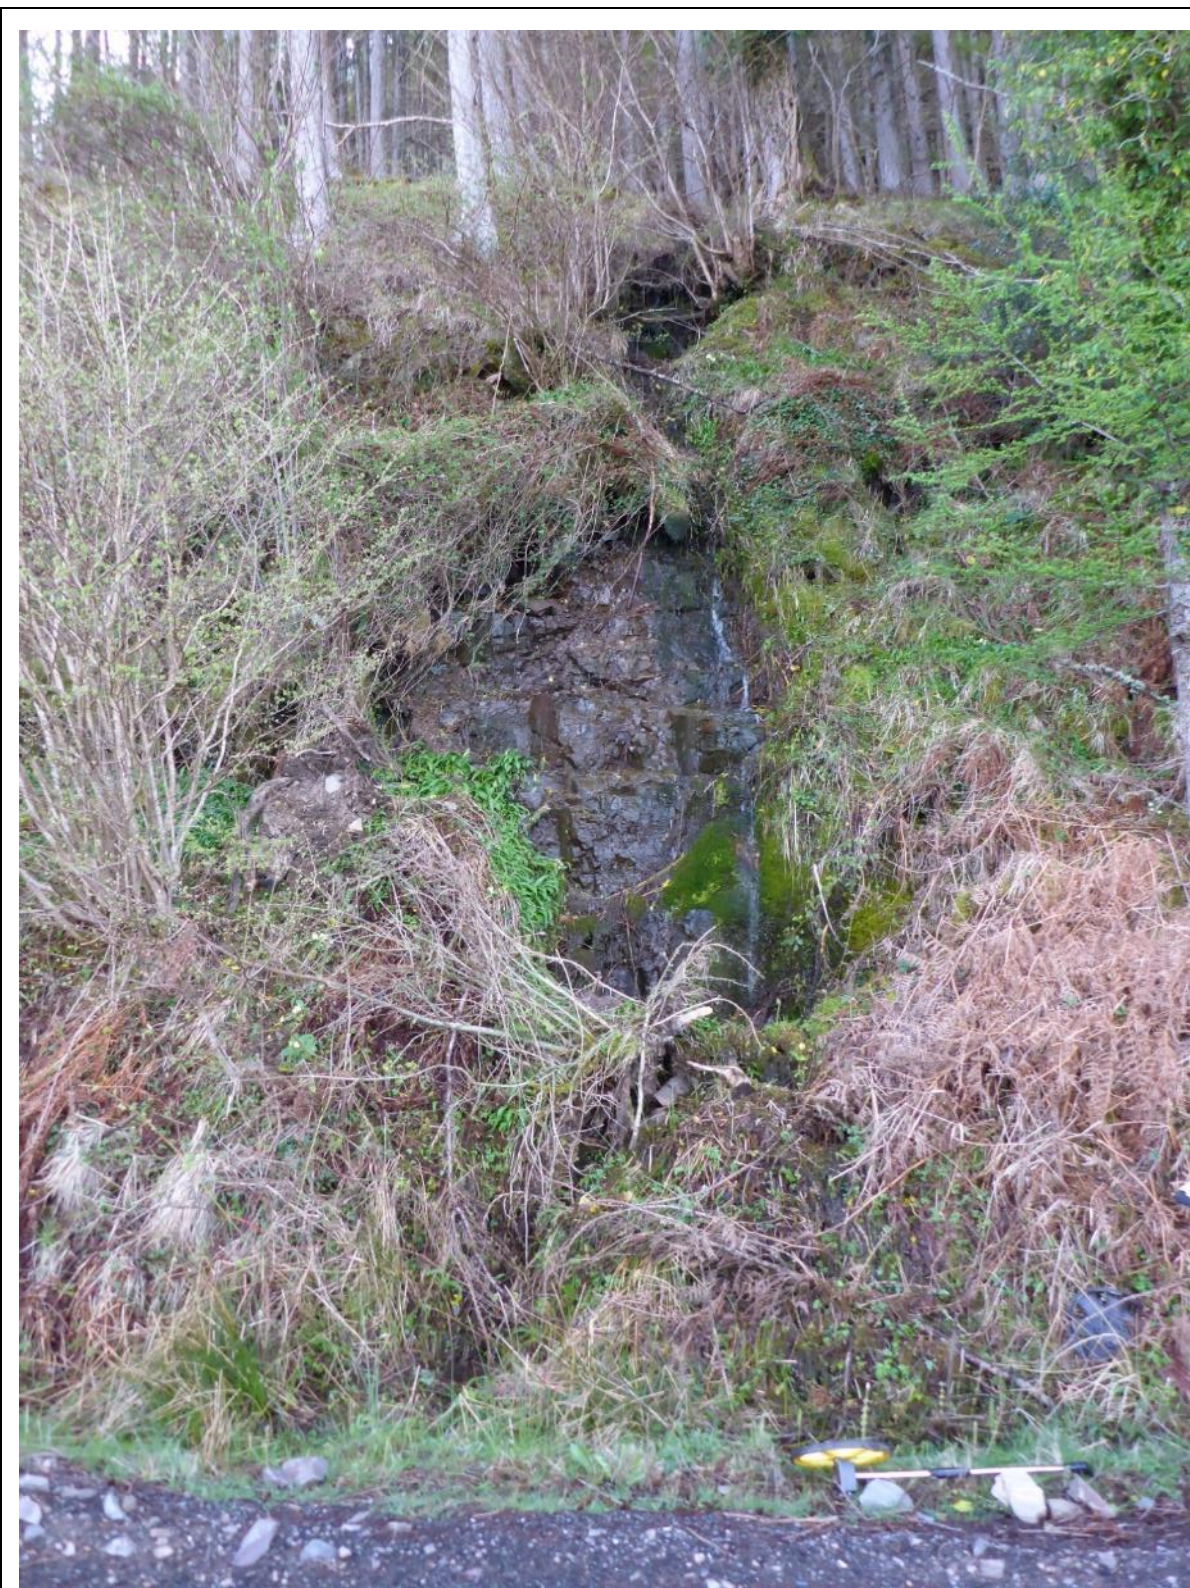
<p>Photograph: AA2A-6</p>	<p>Ch. 476 – Small downslope watercourse over rockface. Vegetation and small blocks have been stripped and gathered at toe of slope.</p>	<p>Year observation first noted: 2024</p>
---------------------------	--	---

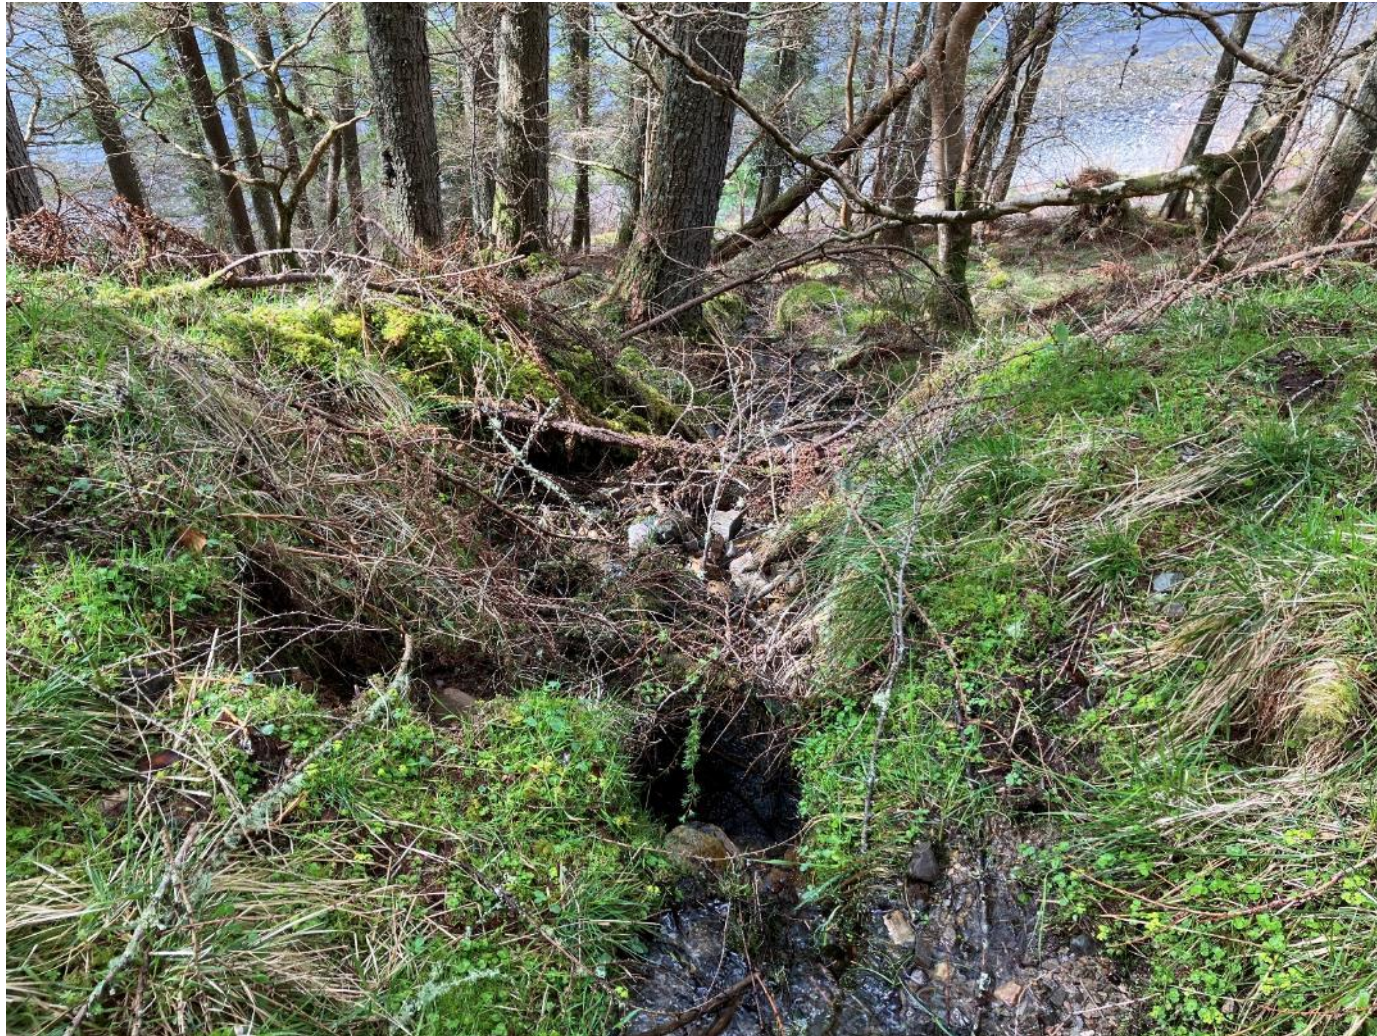
Photograph: AA2A-7

Upslope of Ch. 476 - Debris dams starting to form on down slope side of forest road.

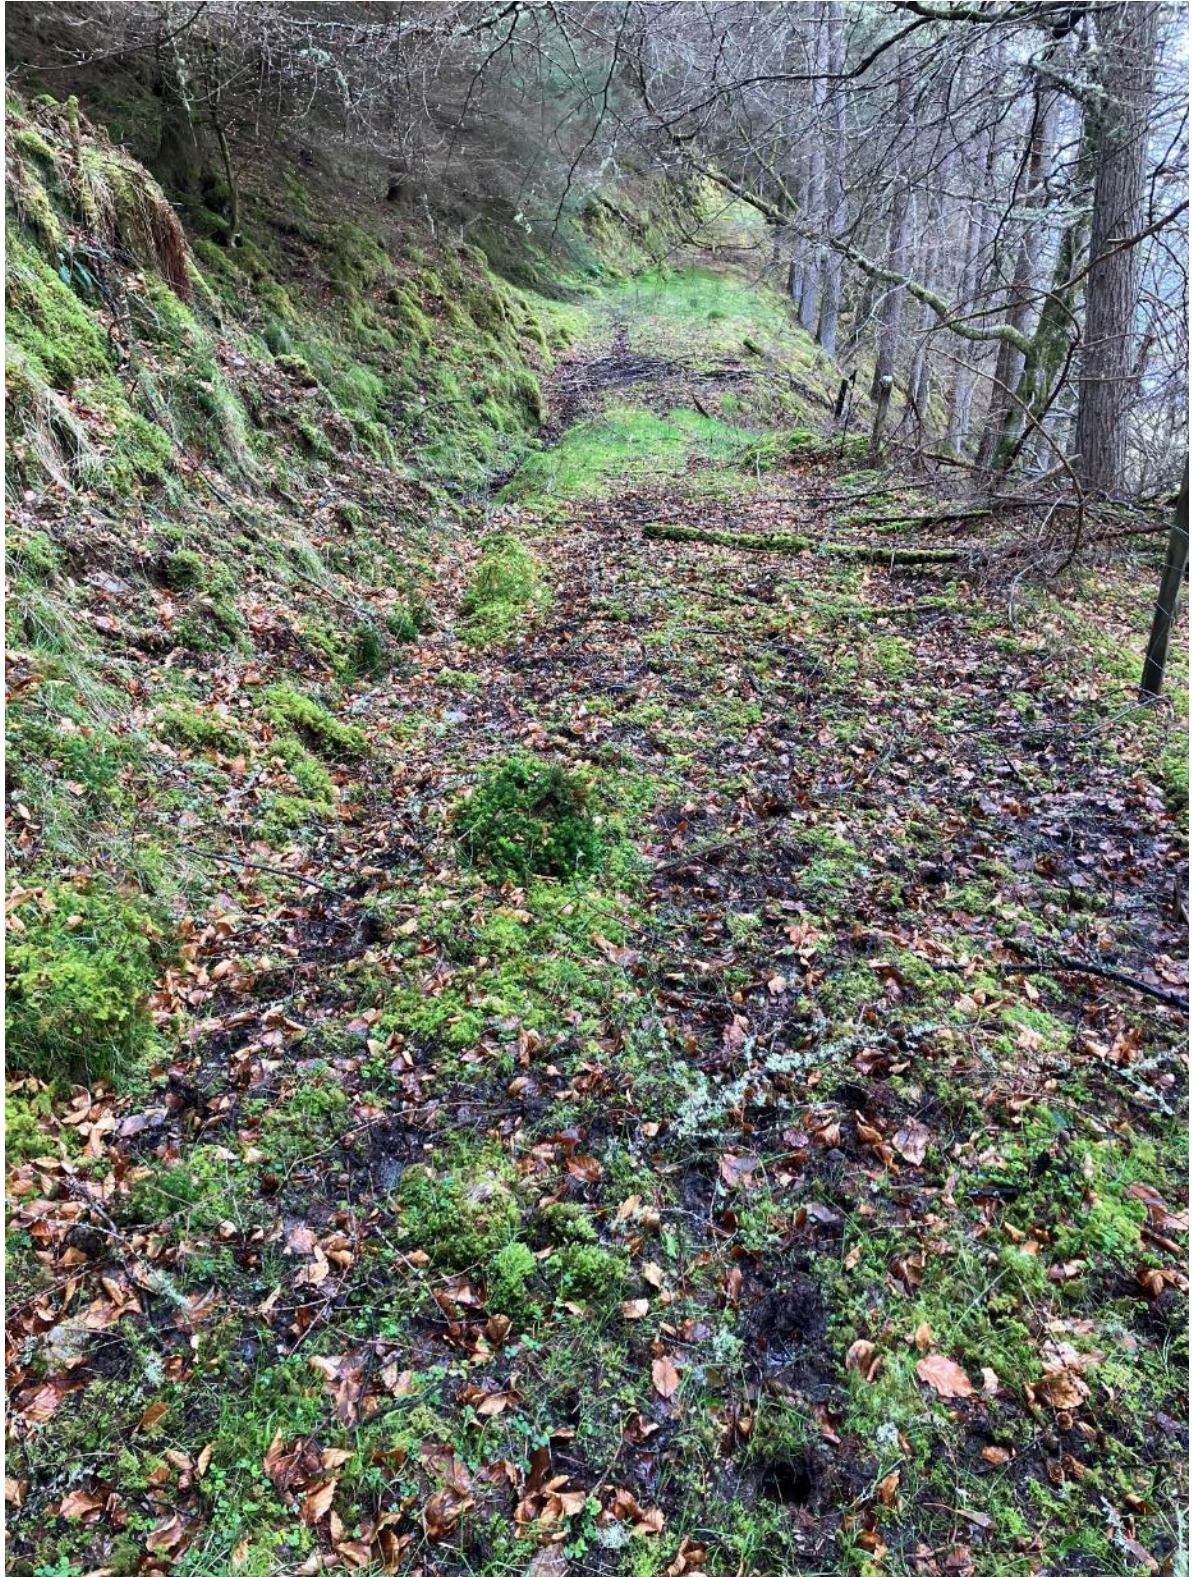
Photograph: AA2A-8

Above AA2A - Road surface waterlogged at NG 89399 35932; sitting above steep ground.

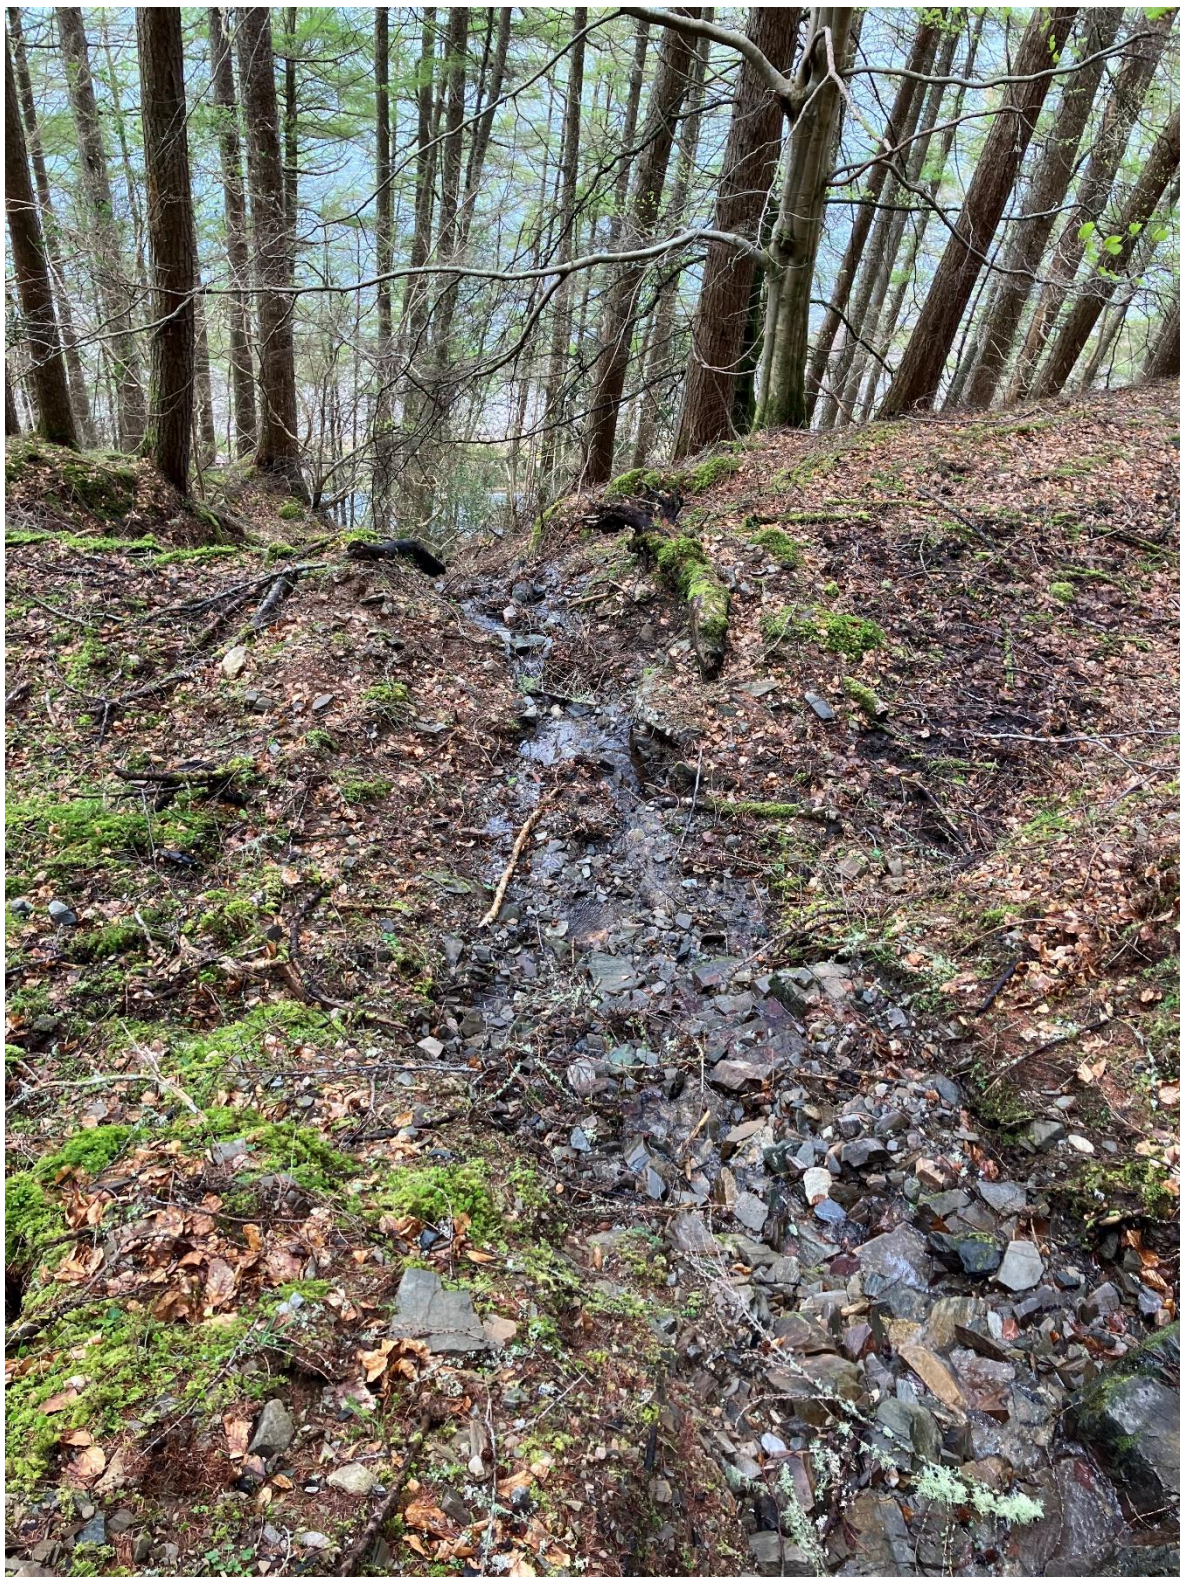
Photograph: AA2A-9

Above AA2A - Loose scree and soil remains in watercourse at track and above that could mobilise in greater flow (NG 89400 35963).

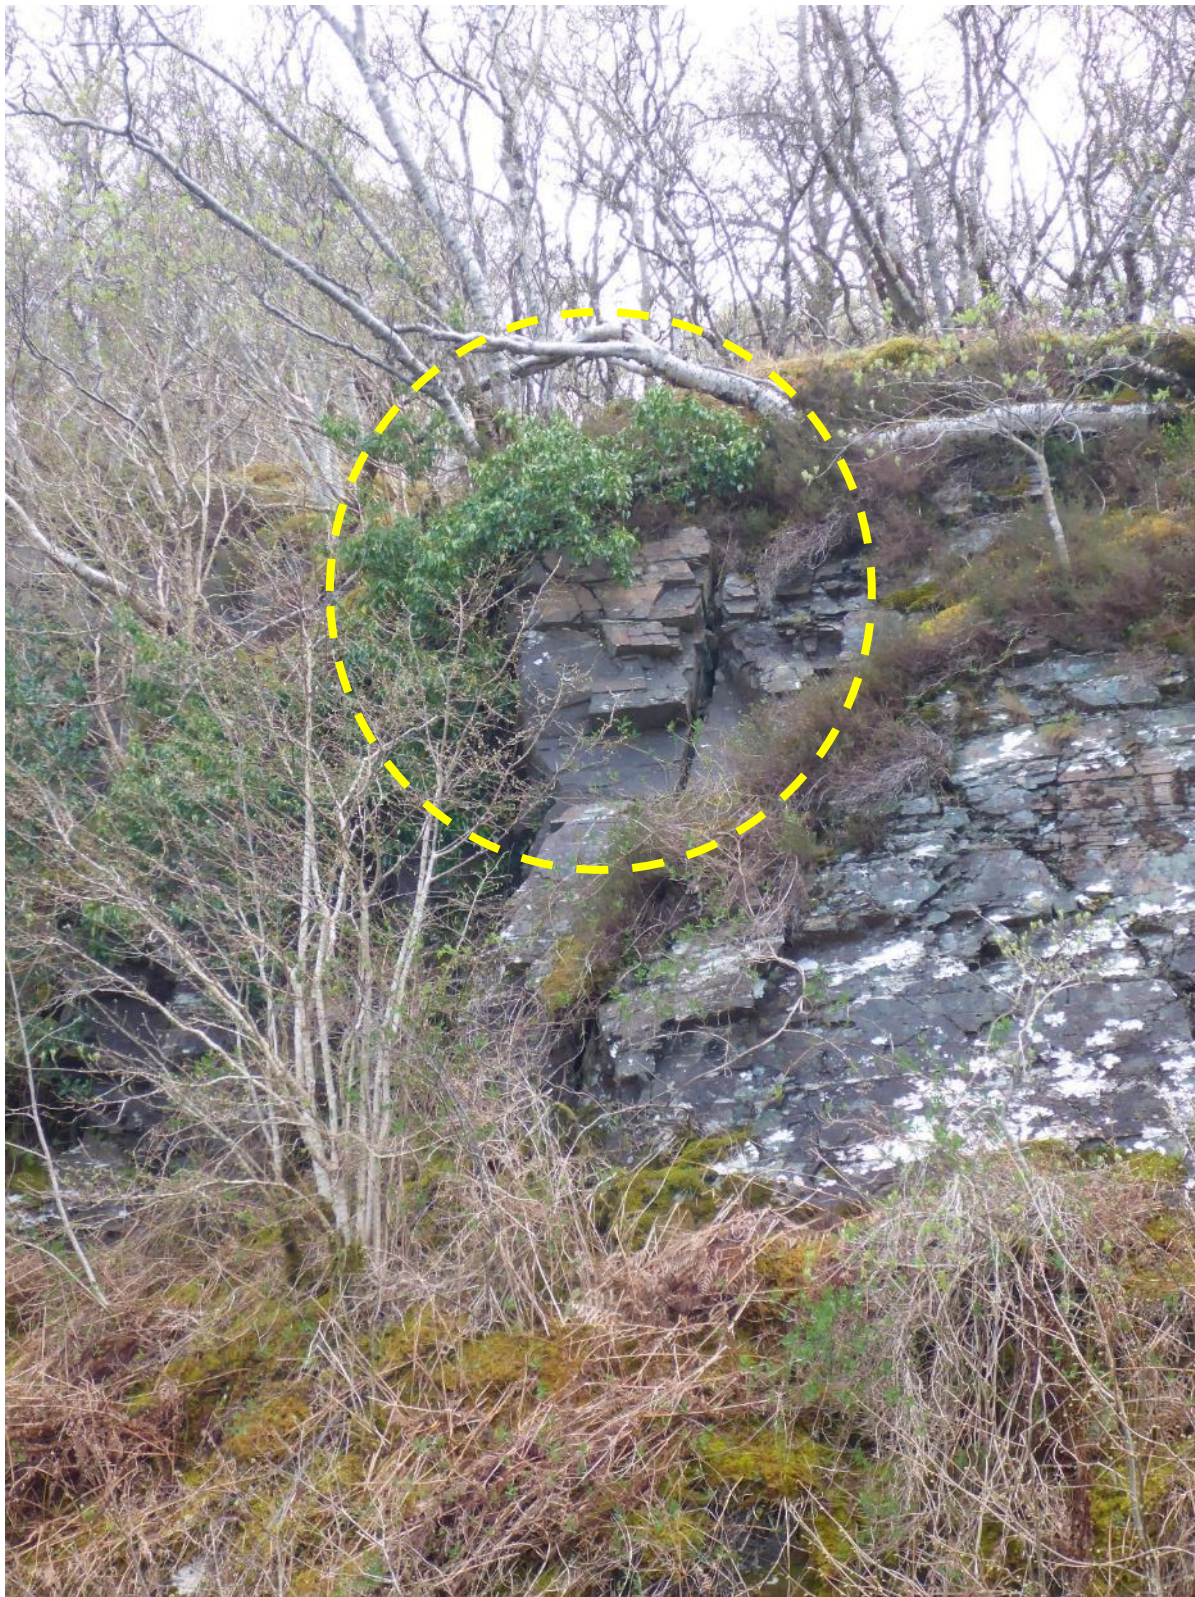
Photograph: AA3-1

Between Ch. 560 to 605 - Potential for toppling/block fall up to 2m³ originating from 5-8m above road level.

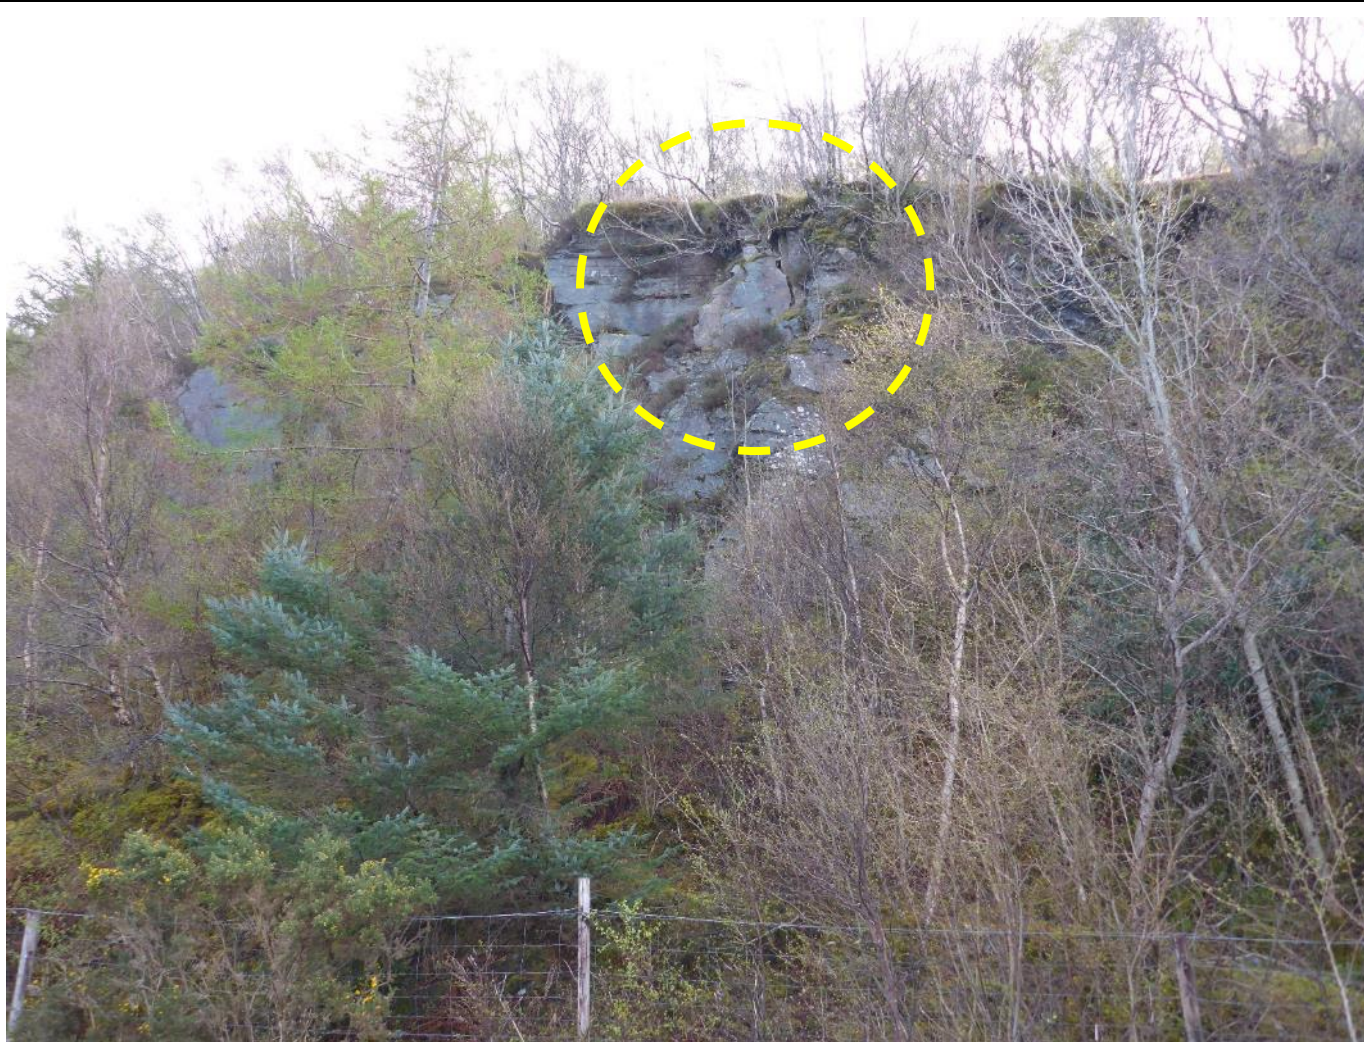
Photograph: AA3-2

Ch. 600 - Large block / slab of rock with dilated fractures and potential for root jacking at crest of rock slope (feature circled).

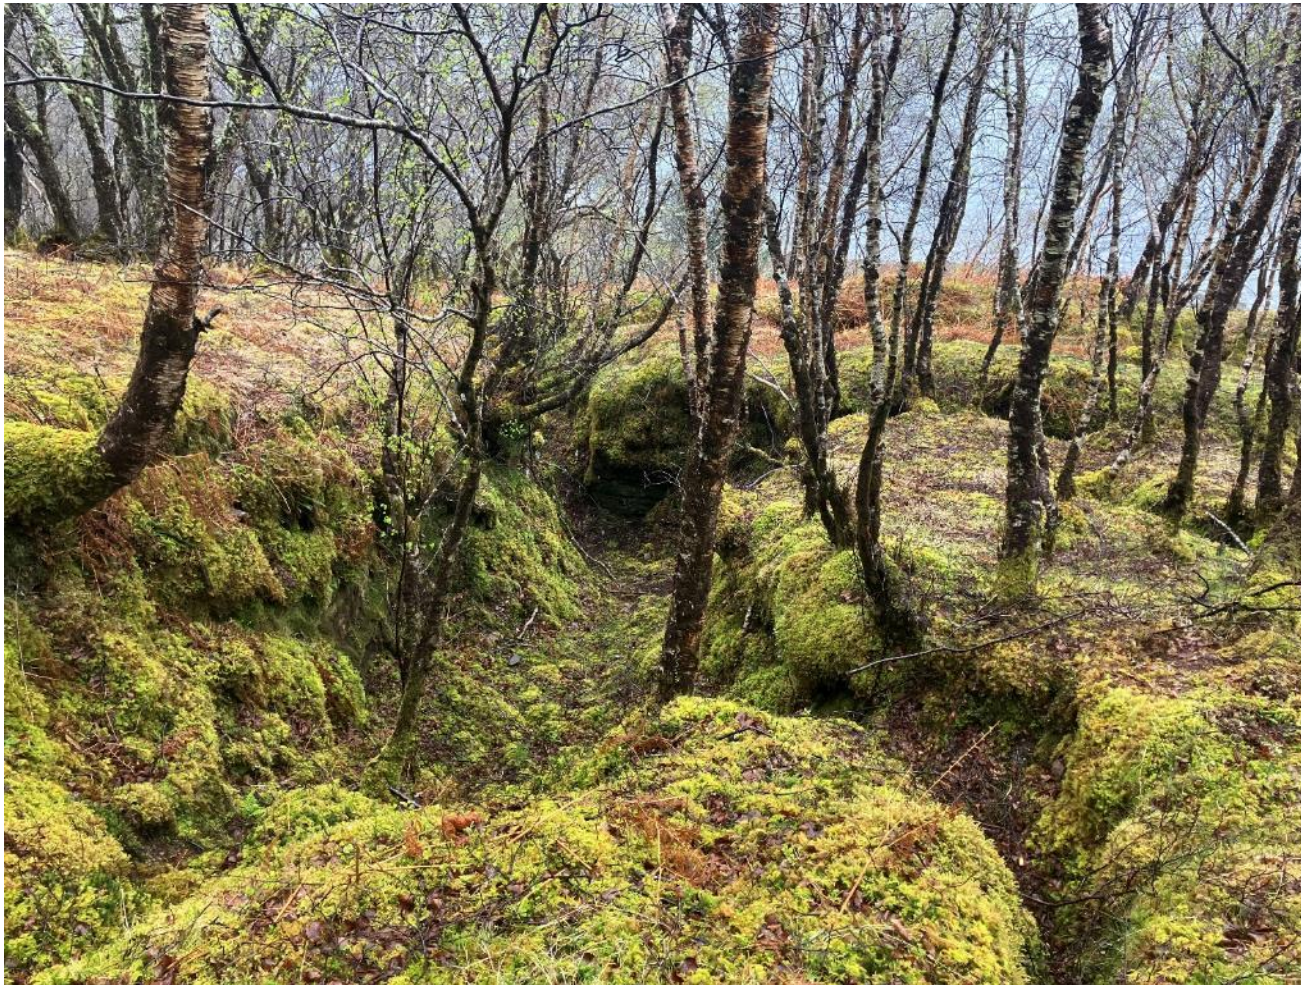
Photograph: AA3-3

NG 89467 36164 (Ch. 612) – Series of sub-parallel curved tension cracks in upper slope.

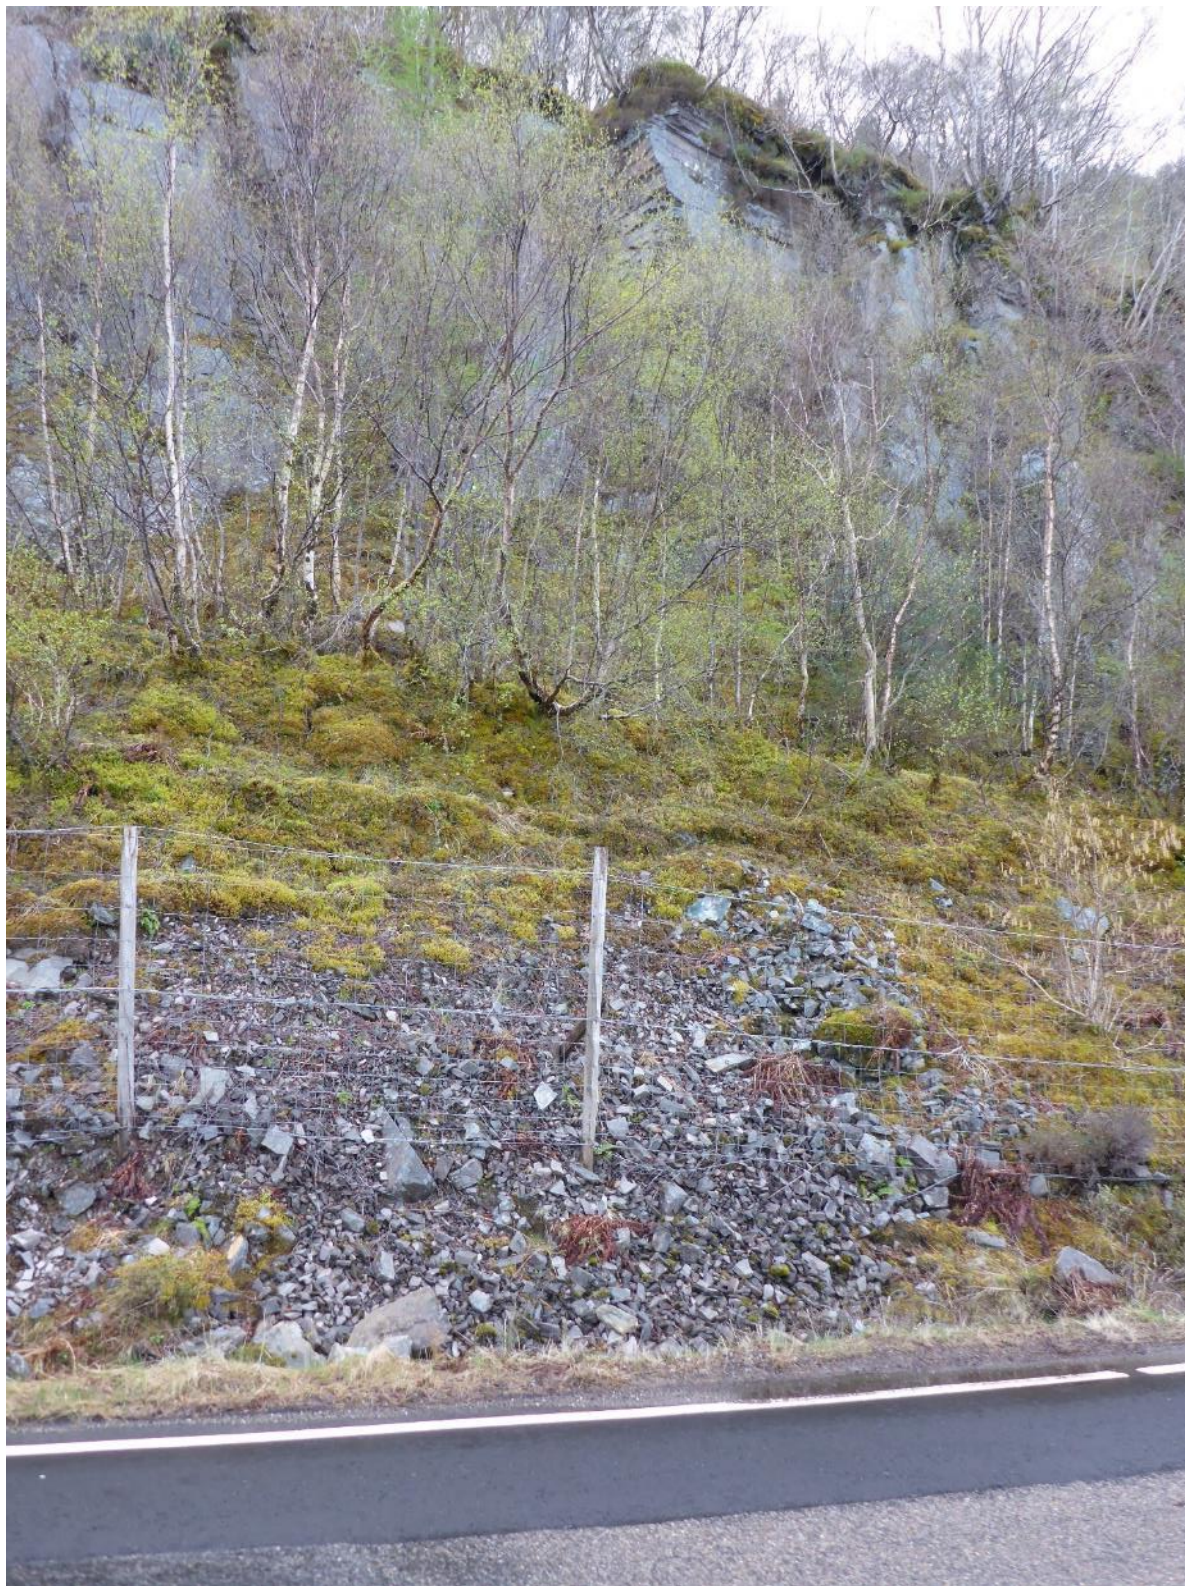
Photograph: AA3-4

Ch. 622 – Area of Loose granular fill at roadside with blocks in ditch.

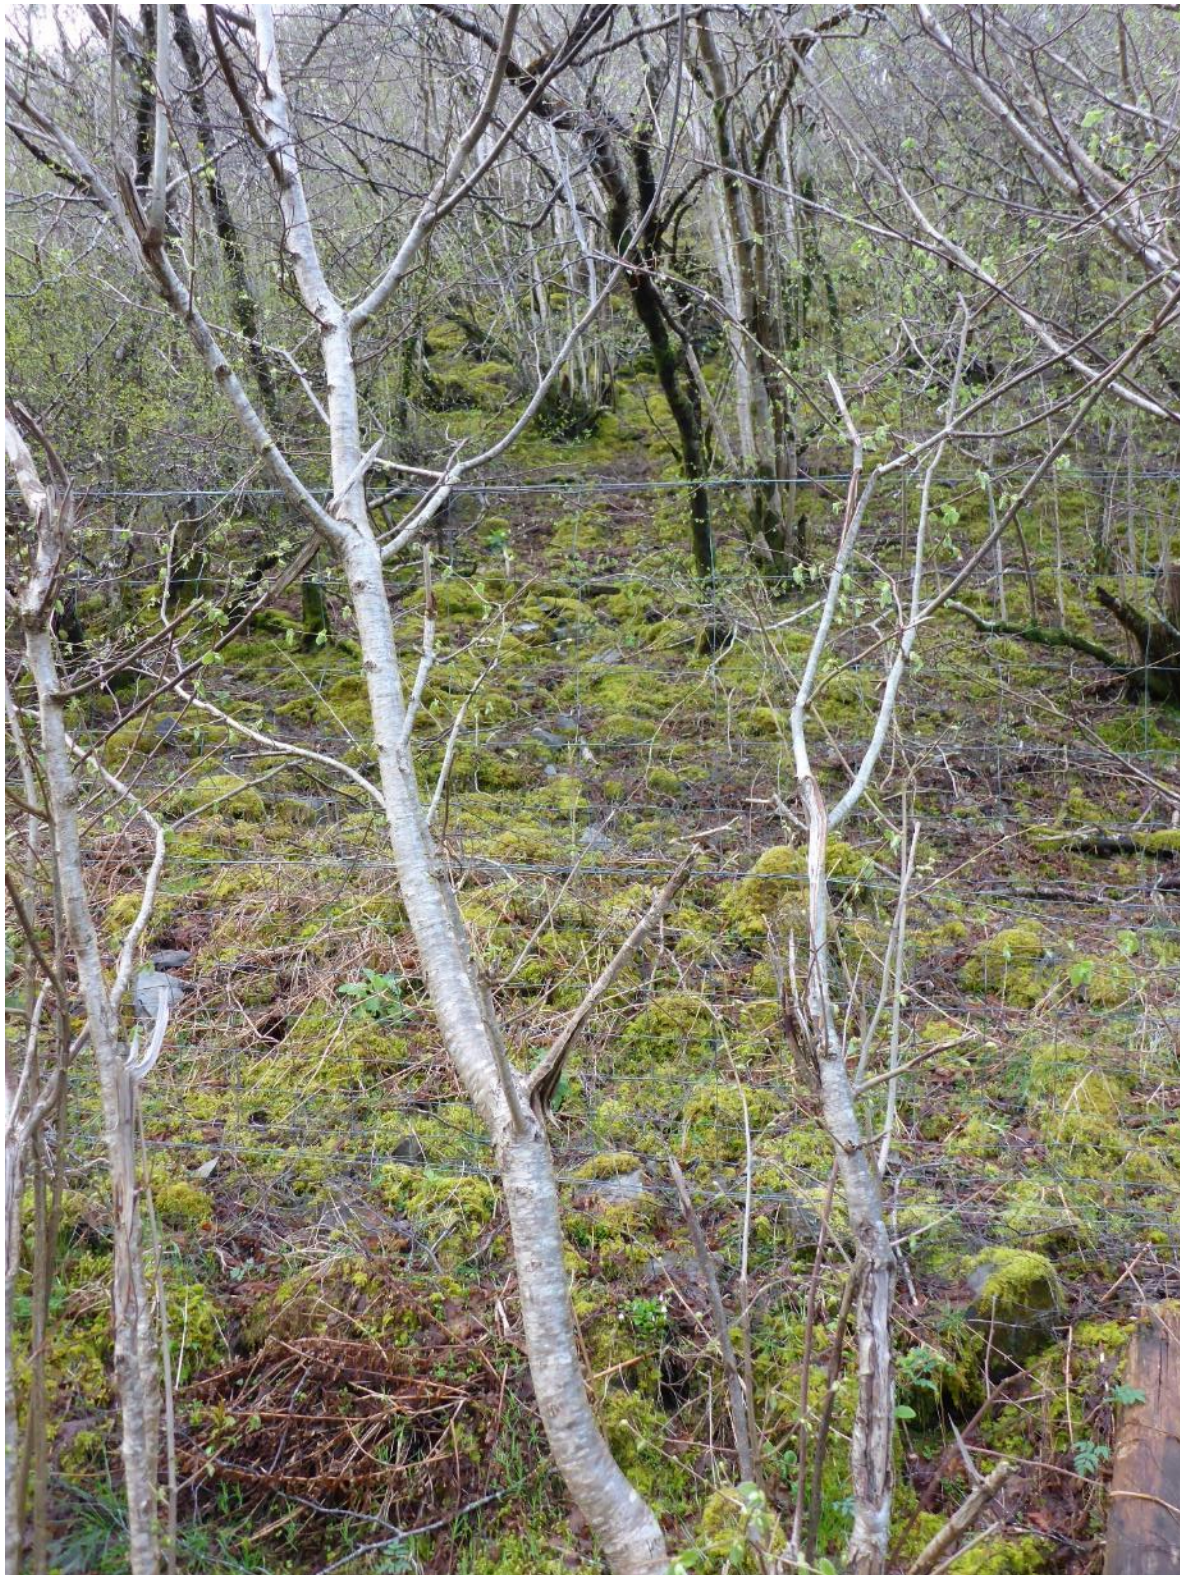
Photograph: AA3A-1

Ch. 690 - Isolated rock outcrop ca. 30m above road level with ongoing ravelling / root jacking. Some blocks have reached deer fence 1-2m above road level.

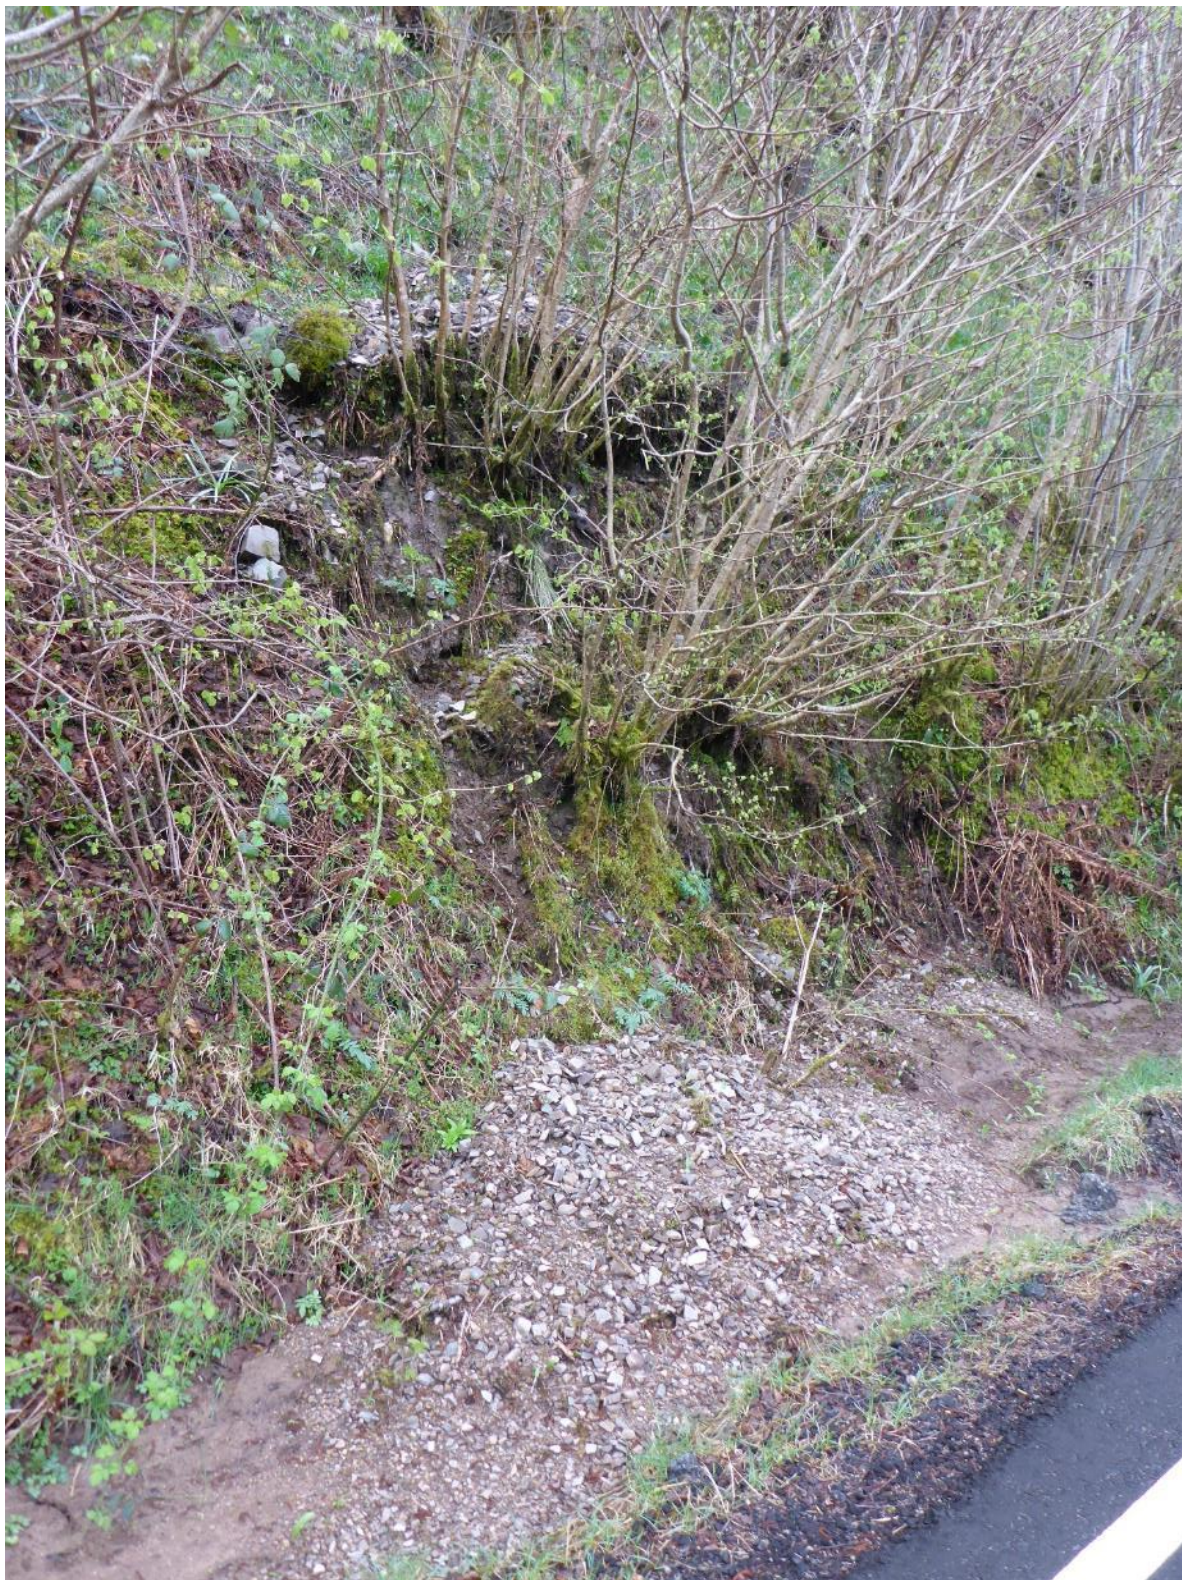
Photograph: AA3A-2

Ch. 726 – an area of waterflow down slope which has resulted in accumulation of gravel and silt in ditch.

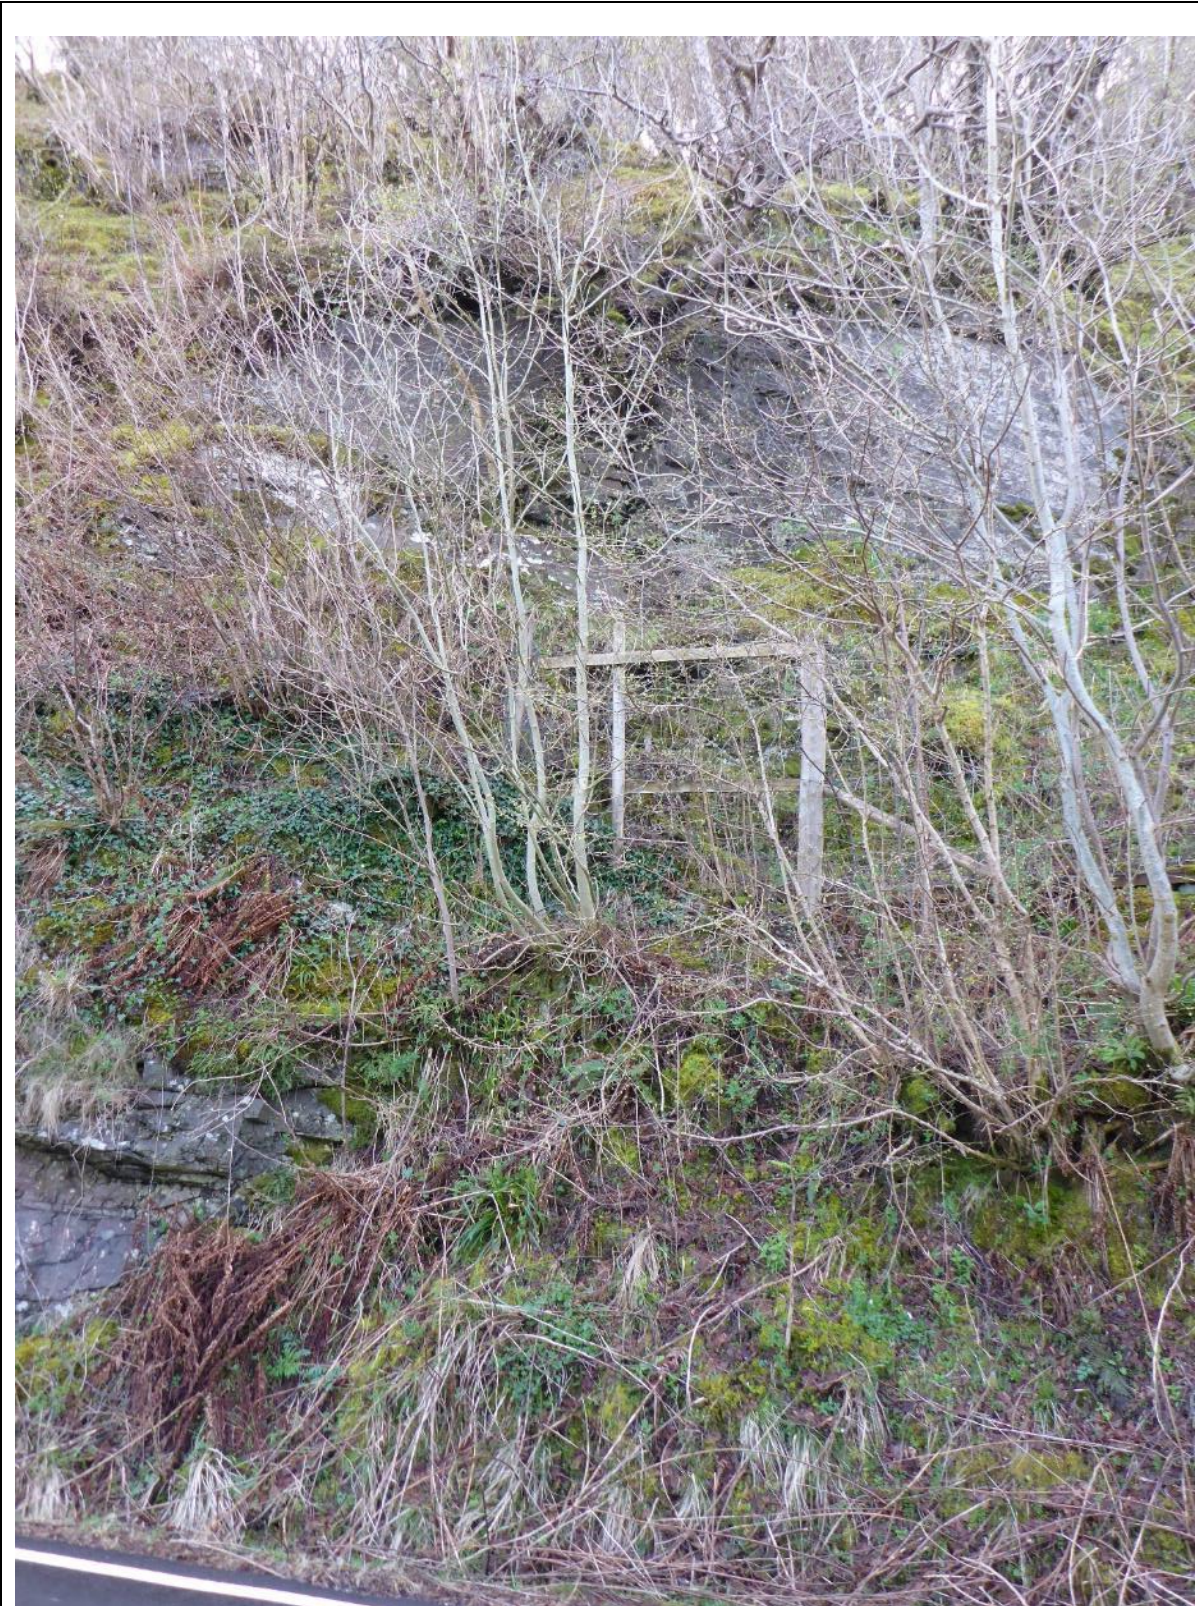
Photograph: AA4-1

Ch. 745 – Root jacking and fractured rock mass 8m above road level. Becoming increasingly obscured by vegetation.

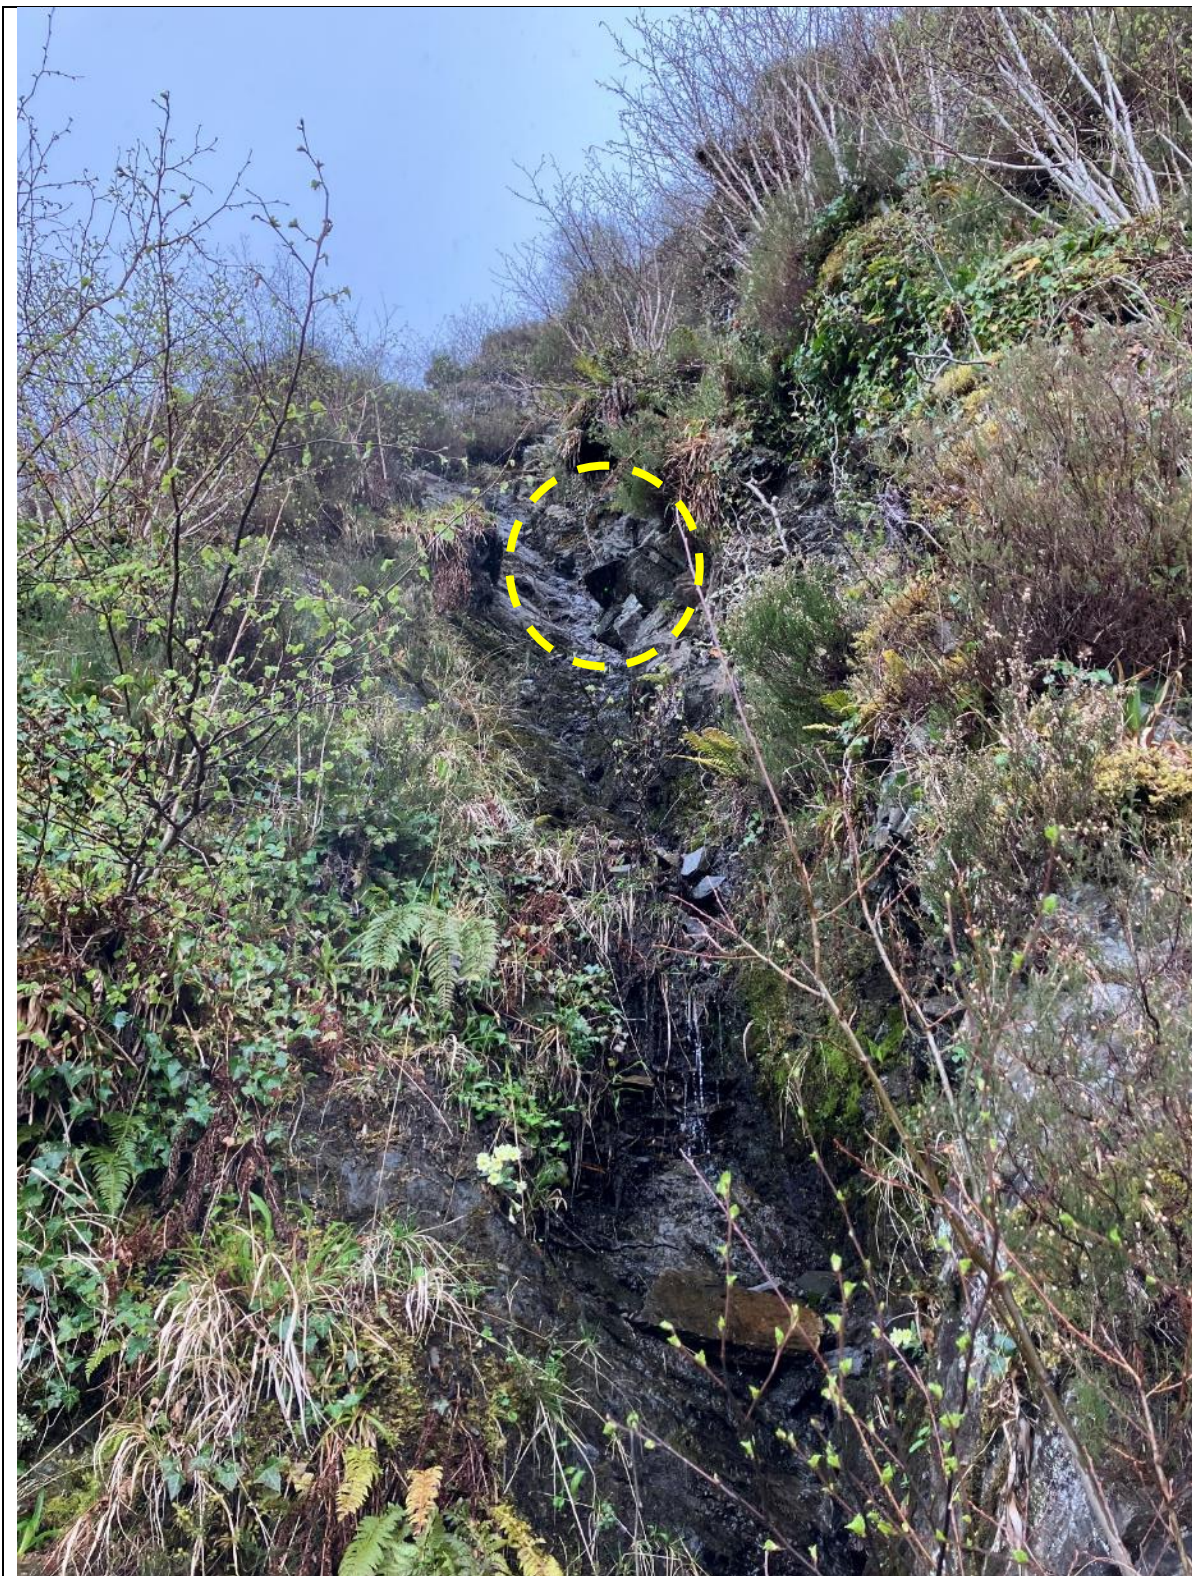
Photograph: AA7-3	Ch. 1820 - 1826 – washout of soil in gully. Fractured / overhanging rock mass ca. 18m above road level (area circled above).	Year observation first noted: 2018
-------------------	--	------------------------------------
