5.2.14 Slope Ref. AA8

GEOTECHNICAL ASSESSMENT SHEET											
Site:	A890 Stromeferry Bypass	Slope Ref:	AA8	Chainage:	1880- 1940	Start Grid Ref:	NG 90243 37019	End Grid Ref:	NG 90299 37045	Elevation:	20m AOD

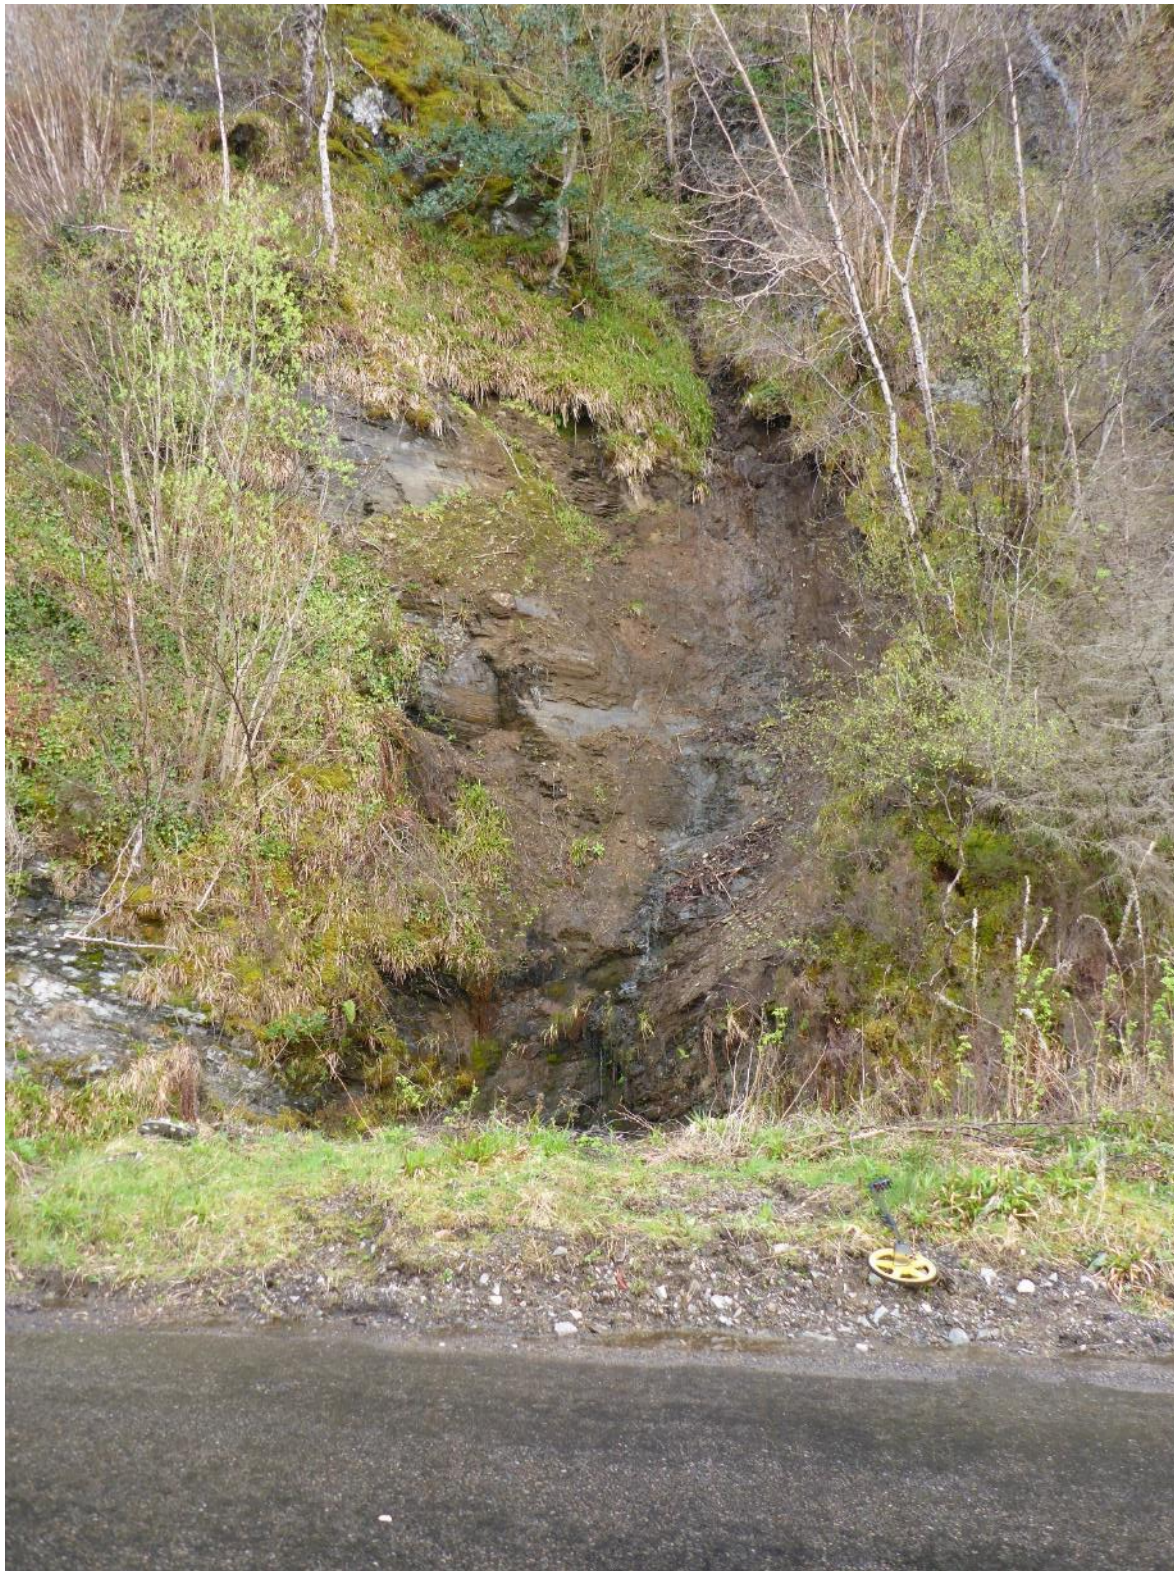
Photograph: AA8-2

Ch. 1880 – Soil slip/washout 8m above ground level.
Evidence of further washout in 2024

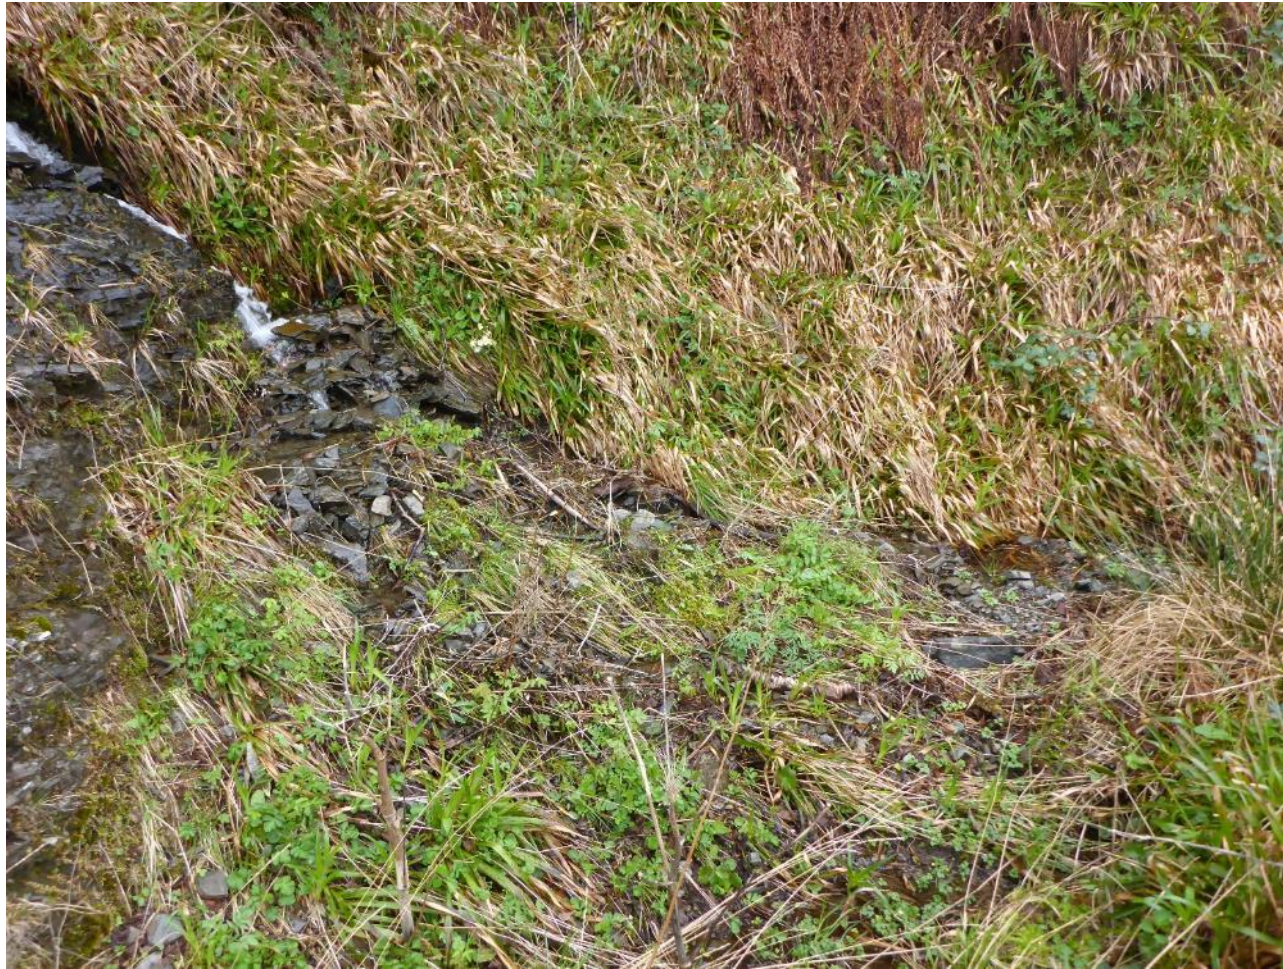
Photograph: AA8-3

Ch. 1940	2021 Inspection: A lot of overhangs towards crest. Vegetation cover c.40 to 50% and dilated fractures evident. Some accumulation of gravel to cobble sized rock debris at base of watercourse within a 1 to 2m wide x 1m deep ditch with roadside bund. Still capacity and so does not require clearance.	No changes observed during 2024 inspection.	AA8-3

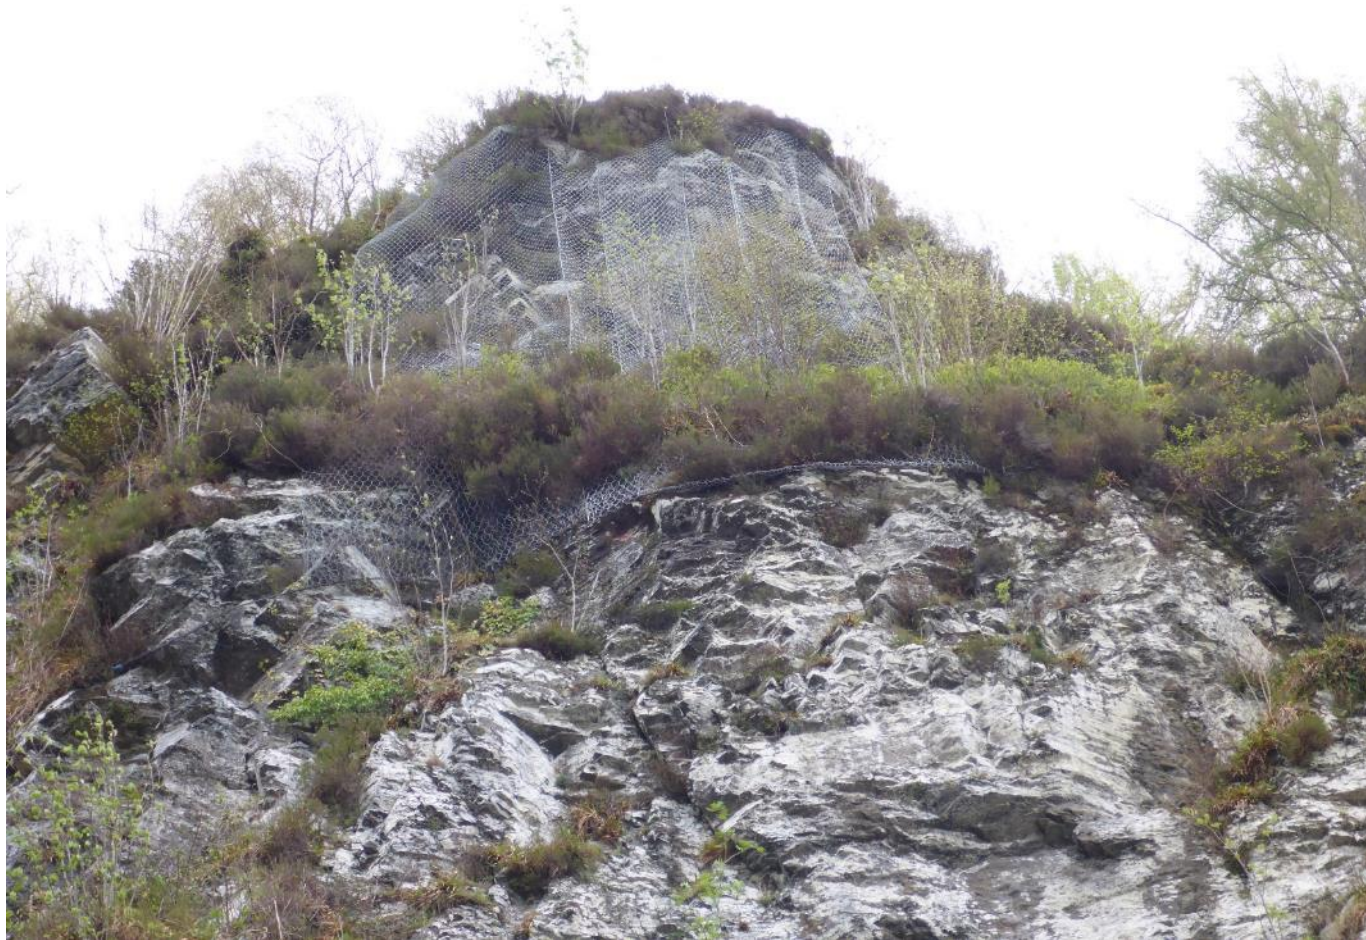
Photograph: AA9-1

Existing Netting Details or other remedial work details:			
Year of Works	Description of Works	Comments	2024 Inspection Observations
		<ul style="list-style-type: none"> - 4 cable clamps (possibly others not identified) - Netting lap connections using Spenax rings - No laps on anchors or vertical reinforcing - A 0.2m to 0.3m gap between bottom cable and rock face. <p>2022 Inspection: Bottom cable showing early signs of corrosion.</p>

Between Ch. 1965 to 1975 – Netting noted to be gaping at sides and bottom.

Recommended Remedial Works / Actions		
Large Scale Rock Fall Protection Works (Category 3)	Localised Targeted Rock Fall Protection Works (Category 2)	Ongoing Maintenance (Category 1)
N/A	N/A	- Improve netting system between Ch. 1965 and 1975.

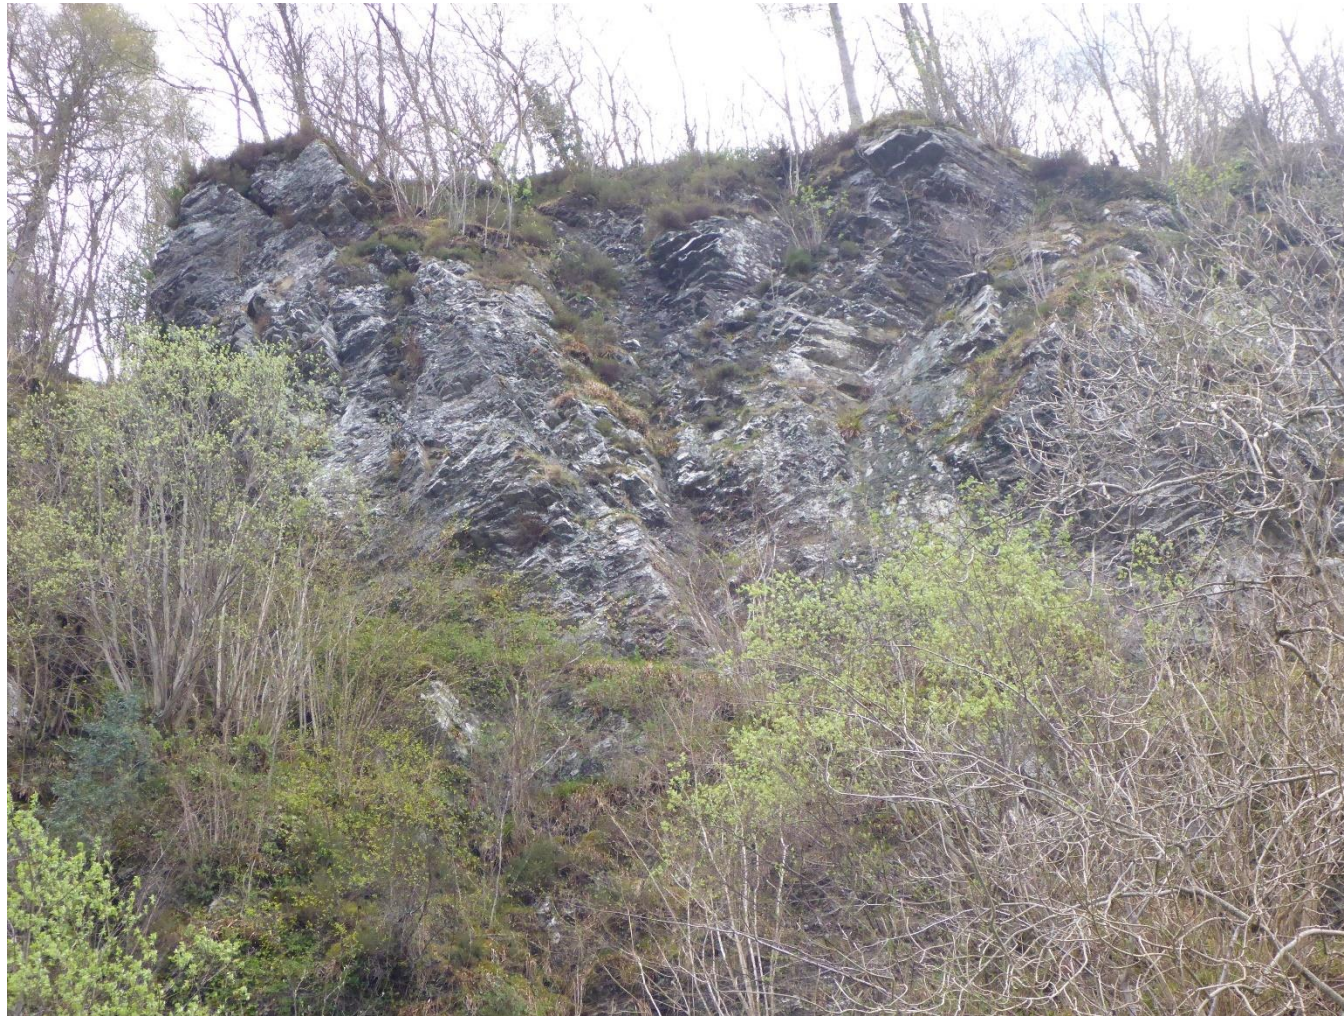
Photograph: AA10-1

Hazards Observed:			
Location	Description of Hazard (s) from Previous Inspections	2024 Inspection Observations	Photo Reference
Ch. 2000	2012 Inspection: Large scale potential wedge failure. Is c.10m wide x 10m high feature at the crest of the rock slope. No evidence of dilated fractures here and mass failure considered unlikely.	No changes observed during 2024 inspection. Still a potential hazard.	AA10-1
Ch. 2033-2188	2016 Inspection: Noted that slope is well vegetated in this area with uprooted trees. Root jacking evident, with potential to dislodge blocks. Recent failures evident. Specific hazards identified at Ch. 2068 and Ch.2130.	No changes observed during 2024 inspection.	
Ch. 2075	2012 Inspection: Potential wedge failure with root jacking identified.	No changes observed during 2024 inspection. Ivy starting to obscure view.	
Ch. 2110	2017 Inspection: Tree down c.8m above road level. Root ball has soil and rock weathering out but unlikely to be a risk to the road.	No changes observed during 2024 inspection.

RISK RATING		Comments
Overall Hazard Rating =	3	Reduced from 4 in 2018 due to detailed rope access inspection of wedge failure and accurate determination of potential failure volume.
Pathway Rating =	3	Increased from 2 in 2018 due to inspection of failure trajectory.
Receptor Rating =	1	
Risk Value =	9.0	
Risk Level =	Moderate

Ch. 2000 – Large scale wedge failure potential at crest of rock slope.

Recommended Remedial Works / Actions		
Large Scale Rock Fall Protection Works (Category 3)	Localised Targeted Rock Fall Protection Works (Category 2)	Ongoing Maintenance (Category 1)
<ul style="list-style-type: none"> - Install targeted combination of roadside rock fall catch fences and netting. 	<ul style="list-style-type: none"> - Scale potential wedge failure at Ch. 2130. 	<ul style="list-style-type: none"> - Targeted coppicing of trees growing in rock exposures and light scaling of broken/unstable rock.

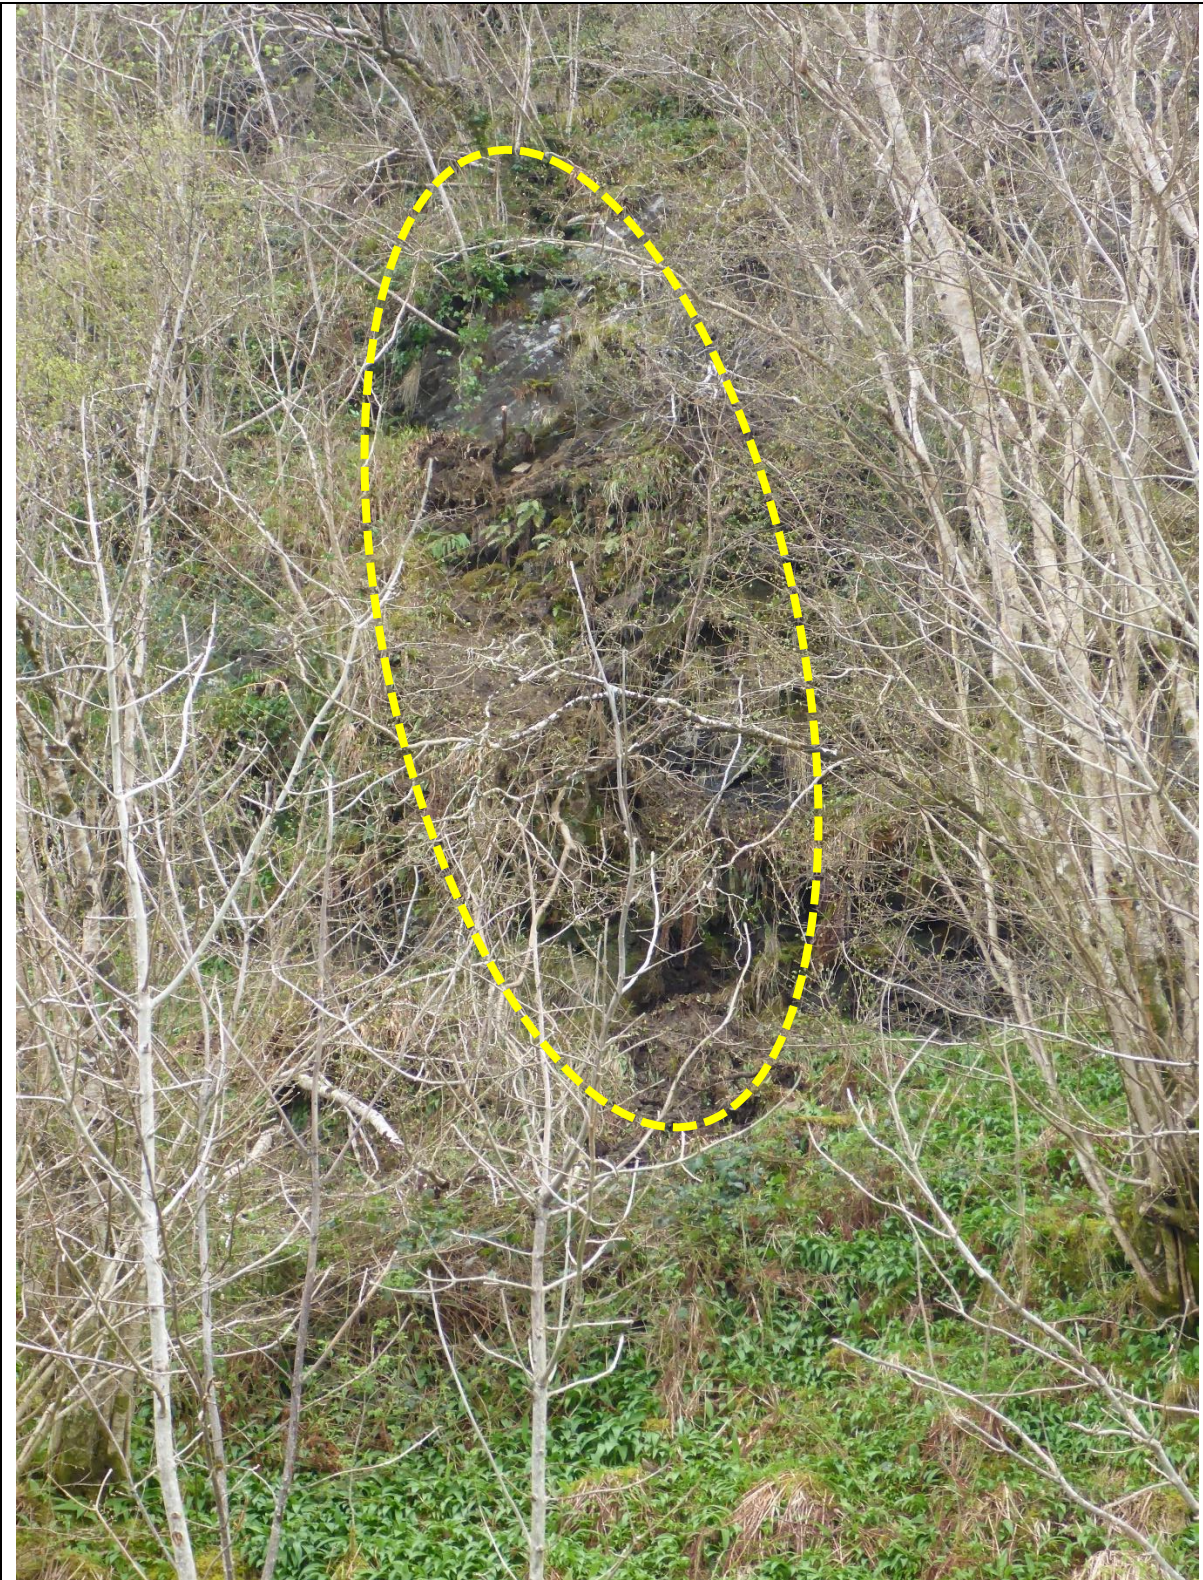
Ch. 2028	N/A	Tree has fallen down ca. 15m above road level and washout present. Soil, vegetation, and tree are resting on slope ca. 6m above road. Source area does not pose an increased risk of rock fall.	AA10-2
Ch. 2112	N/A	Several moss covered blocks present in culvert. Do not look recent. Currently are not blocking drainage gully.	
Ch. 2130	2018 Inspection: Potential wedge failure observed ~15m above road level. Potential for root jacking and release joints observed. The trajectory of a potential failure is difficult to predict, with the probable pathway to the left of the roadside outcrop. Potential failure volume is large enough to burst through the deer fence and may either come to rest in the ditch or at the edge of the road.	No changes observed during 2024 inspection.	
Ch. 2185	2021 Inspection: Small accumulation of gravel to cobble sized blocks at fence transported by intermittent waterflow in gully. No rocks past fence and at roadside so risk not considered to be significant	Accumulation of blocks has slightly increased since 2023.	AA10-3

Photograph: AA10-2	Ch. 2028 – Combination of fallen tree and washout.	Year observation first noted: 2024
--------------------	--	------------------------------------

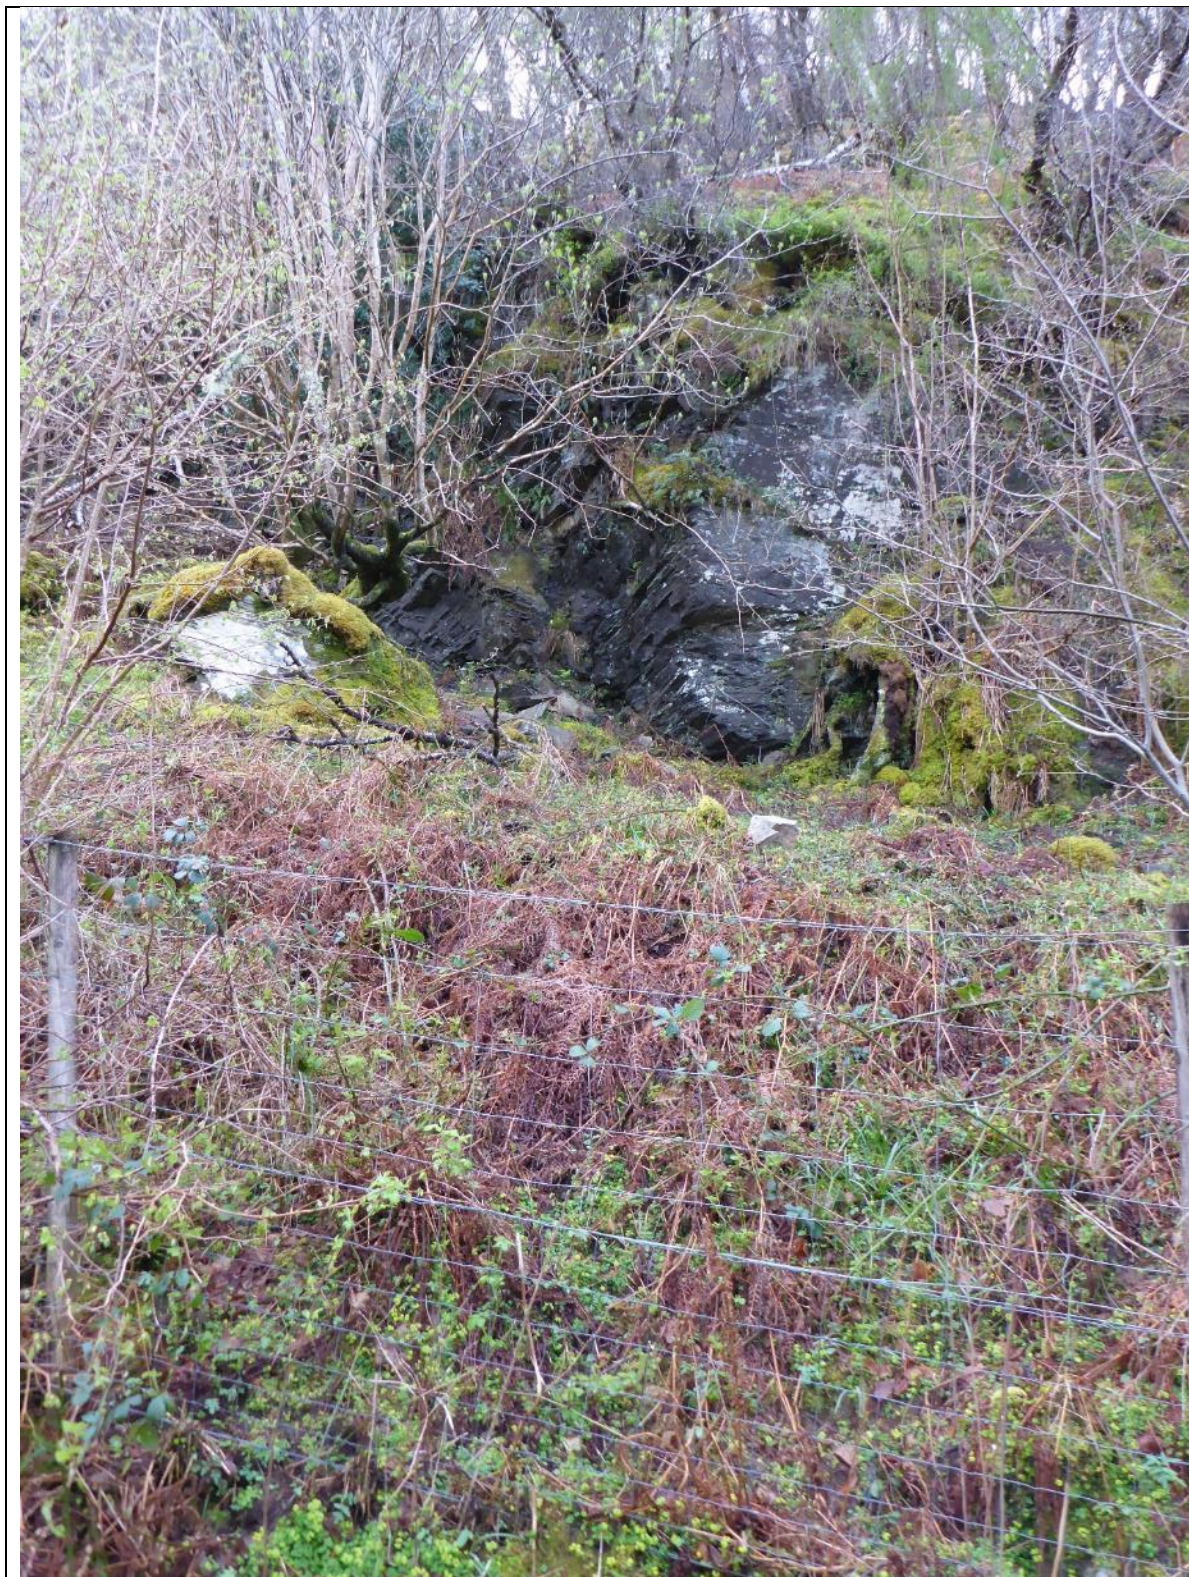
Photograph: FB-1

Hazards Observed:			
Location	Description of Hazard (s) from Previous Inspections	2024 Inspection Observations	Photo Reference
Ch. 2345	2020 Inspection: Failure reported by THC (between Frenchman's Burn and AA11) inspected. Minor root jacking on face ca. 10m back from road edge. Potential for additional material to fail (ca. 1m ³) but not posing risk to road due to verge width.	Possibly some new blocks present but well set back from the road. No other changes observed during 2024 inspection.	FB-1
Ch. 2315	2021 Inspection: Water levels are low. Both the lower and upper catch pits have good capacity.	Upper basin 50% full and lower basin 25% full but high water level so harder to visually access. Appears that debris may have been recently cleared out.

Recommended Remedial Works / Actions		
Large Scale Rock Fall Protection Works (Category 3)	Localised Targeted Rock Fall Protection Works (Category 2)	Ongoing Maintenance (Category 1)
N/A	N/A	- Clear debris from basins as required to maintain capacity

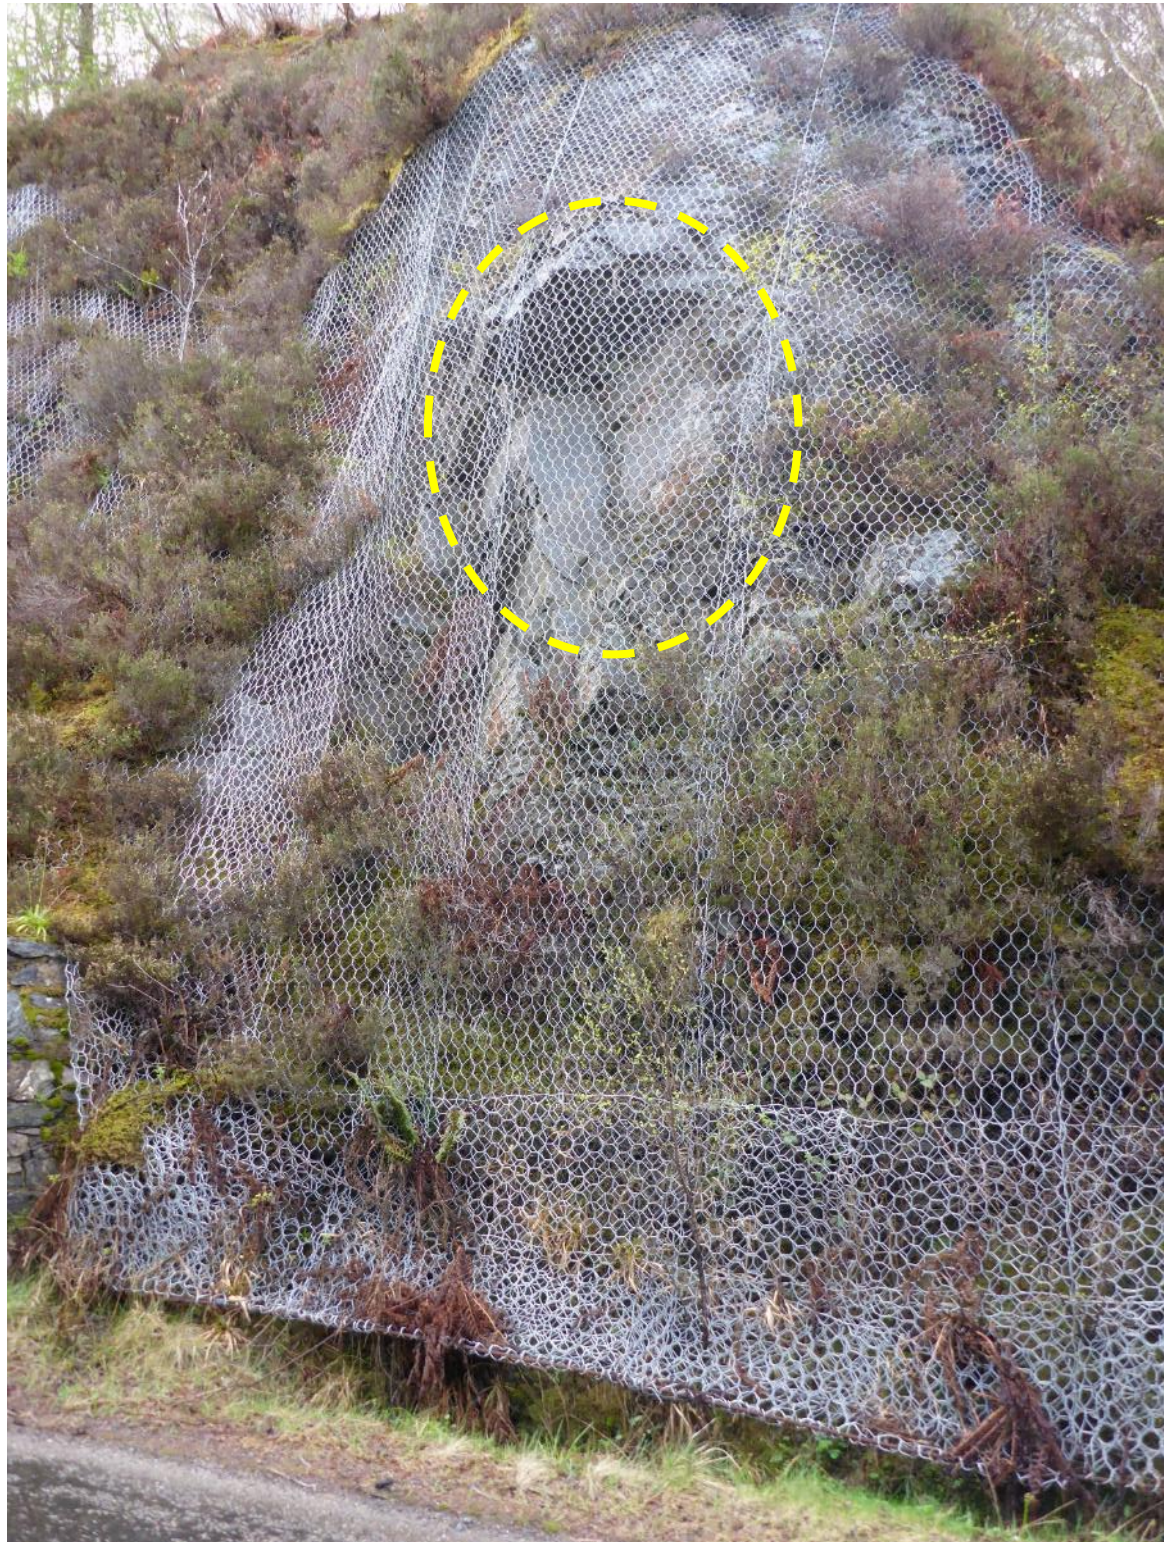
Photograph: AA11-1

Hazards Observed:			
Location	Description of Hazard (s) from Previous Inspections	2024 Inspection Observations	Photo Reference
Ch. 2364	2018 Inspection: Wedge failure identified, comprising an overhanging column of rock ca. 6-8m above road level. Wedge of rock below has previously failed, possibly during construction but joints are tight and overhang. Not at imminent risk of failure.	No changes observed during 2024 inspection.	11A-1
Ch. 2377	2018 Inspection: Overhang noted ca. 8m above road level at up chainage end of buttress. Overhang ca. 1m. Dilated fractures and potential for small blocks to free fall ca. 2-3m before impacting mesh. Maximum block size ca. 0.4m x 0.4m x 0.4m so likely to be retained by existing netting.	Water seepage present. No other changes observed during 2024 inspection.

Ch. 2364 – Former wedge failure identified, leaving behind an overhanging column of rock ca. 6-8m above road level.

Recommended Remedial Works / Actions		
Large Scale Rock Fall Protection Works (Category 3)	Localised Targeted Rock Fall Protection Works (Category 2)	Ongoing Maintenance (Category 1)
N/A	N/A	<ul style="list-style-type: none"> - Install bimetallic corrosion protection between existing galvanised cable and stainless steel eye nuts. - Replace bottom cable and install additional bottom anchors. - Replace dropper cables (allow 10No. 10m long) and install additional anchors (allow 6No.).

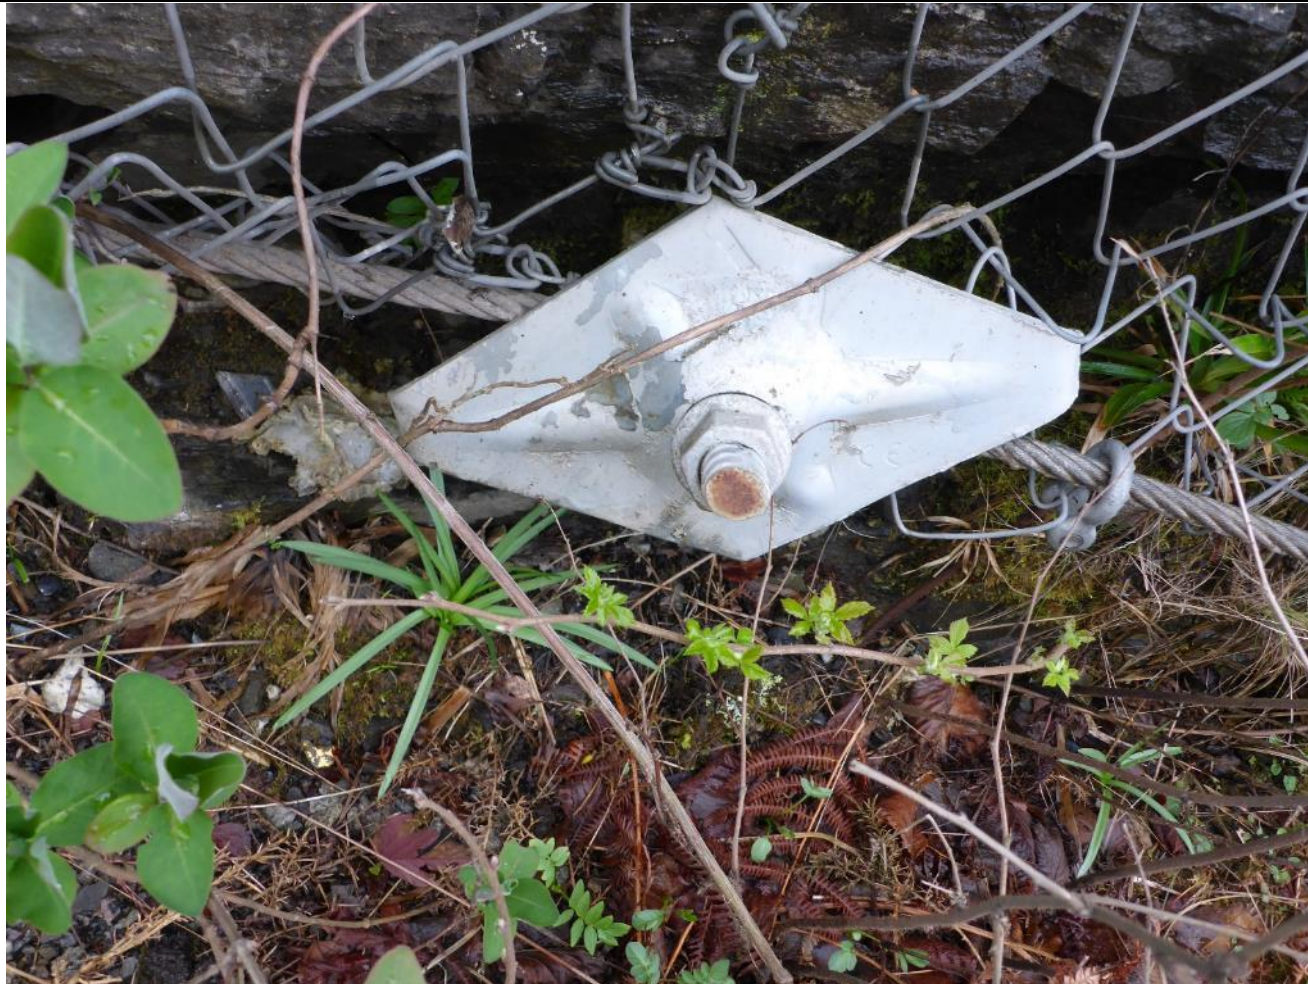
Photograph: AA12-1

General – slight corrosion on cut bar ends of anchors.

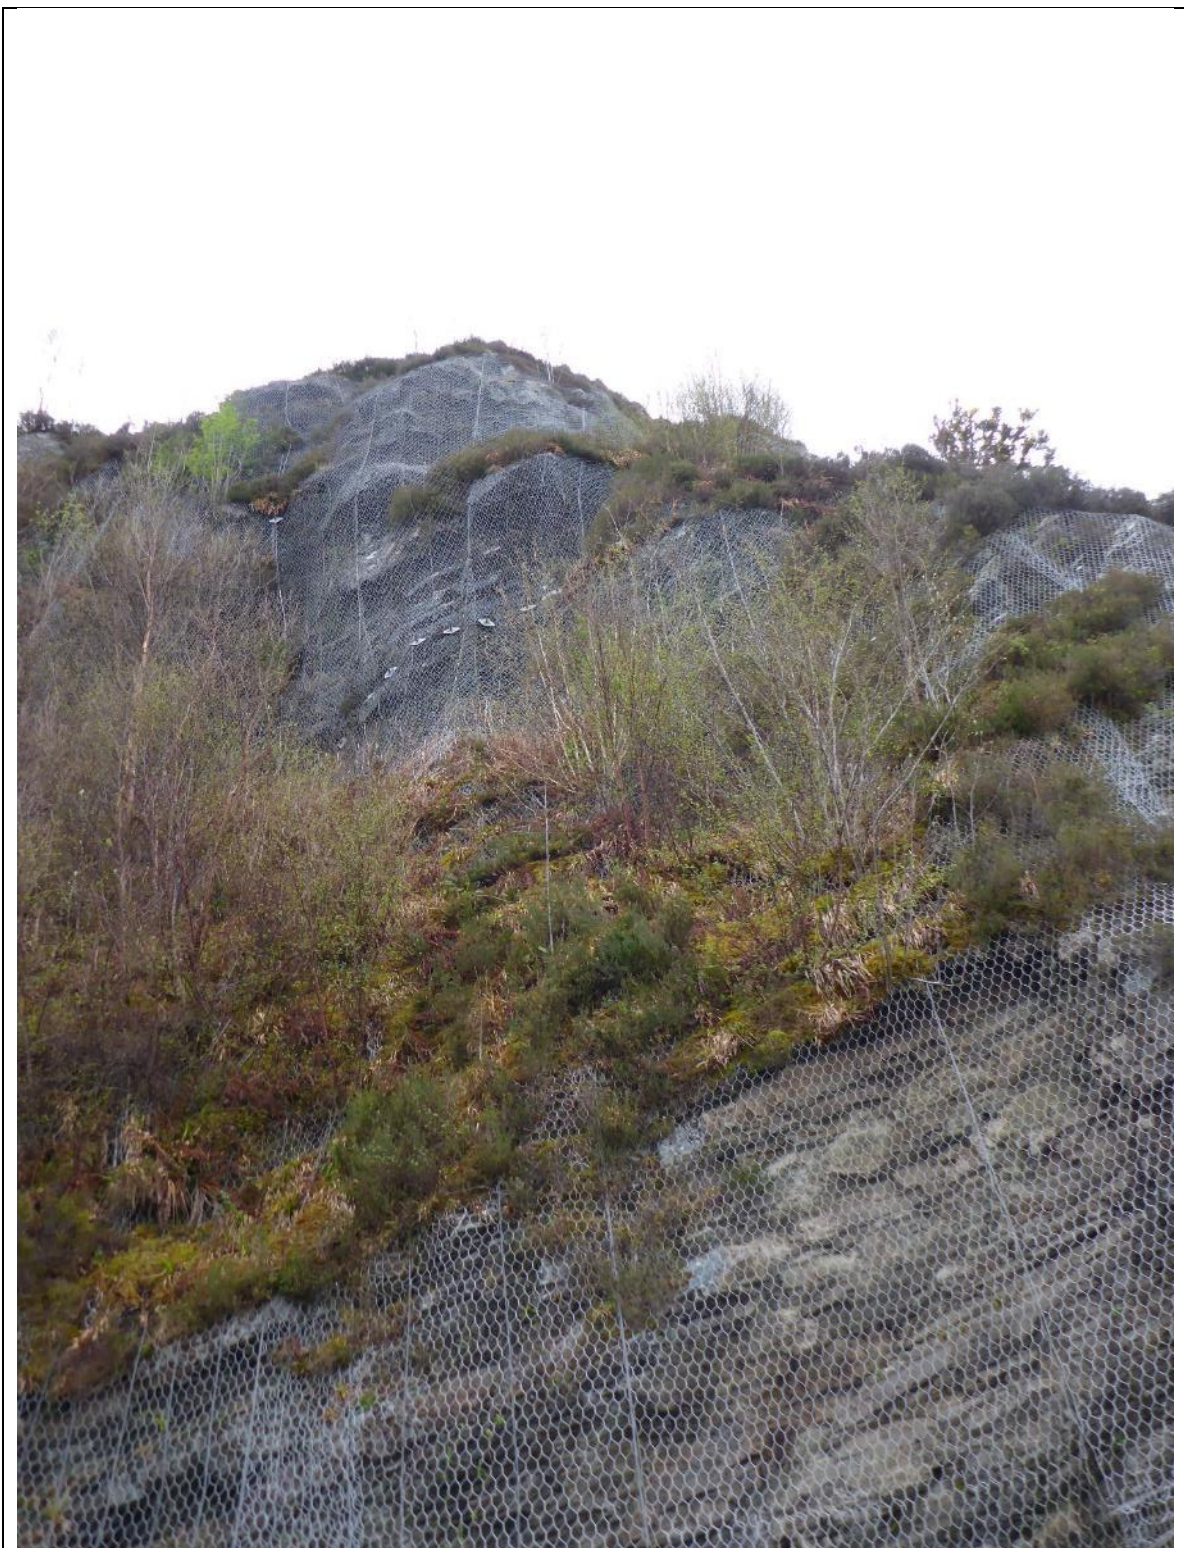
Photograph: AA15-1	Ch. 2680 – active high strength netting (Spider Netting).	Year observation first noted: 2015
-----------------------	---	---------------------------------------

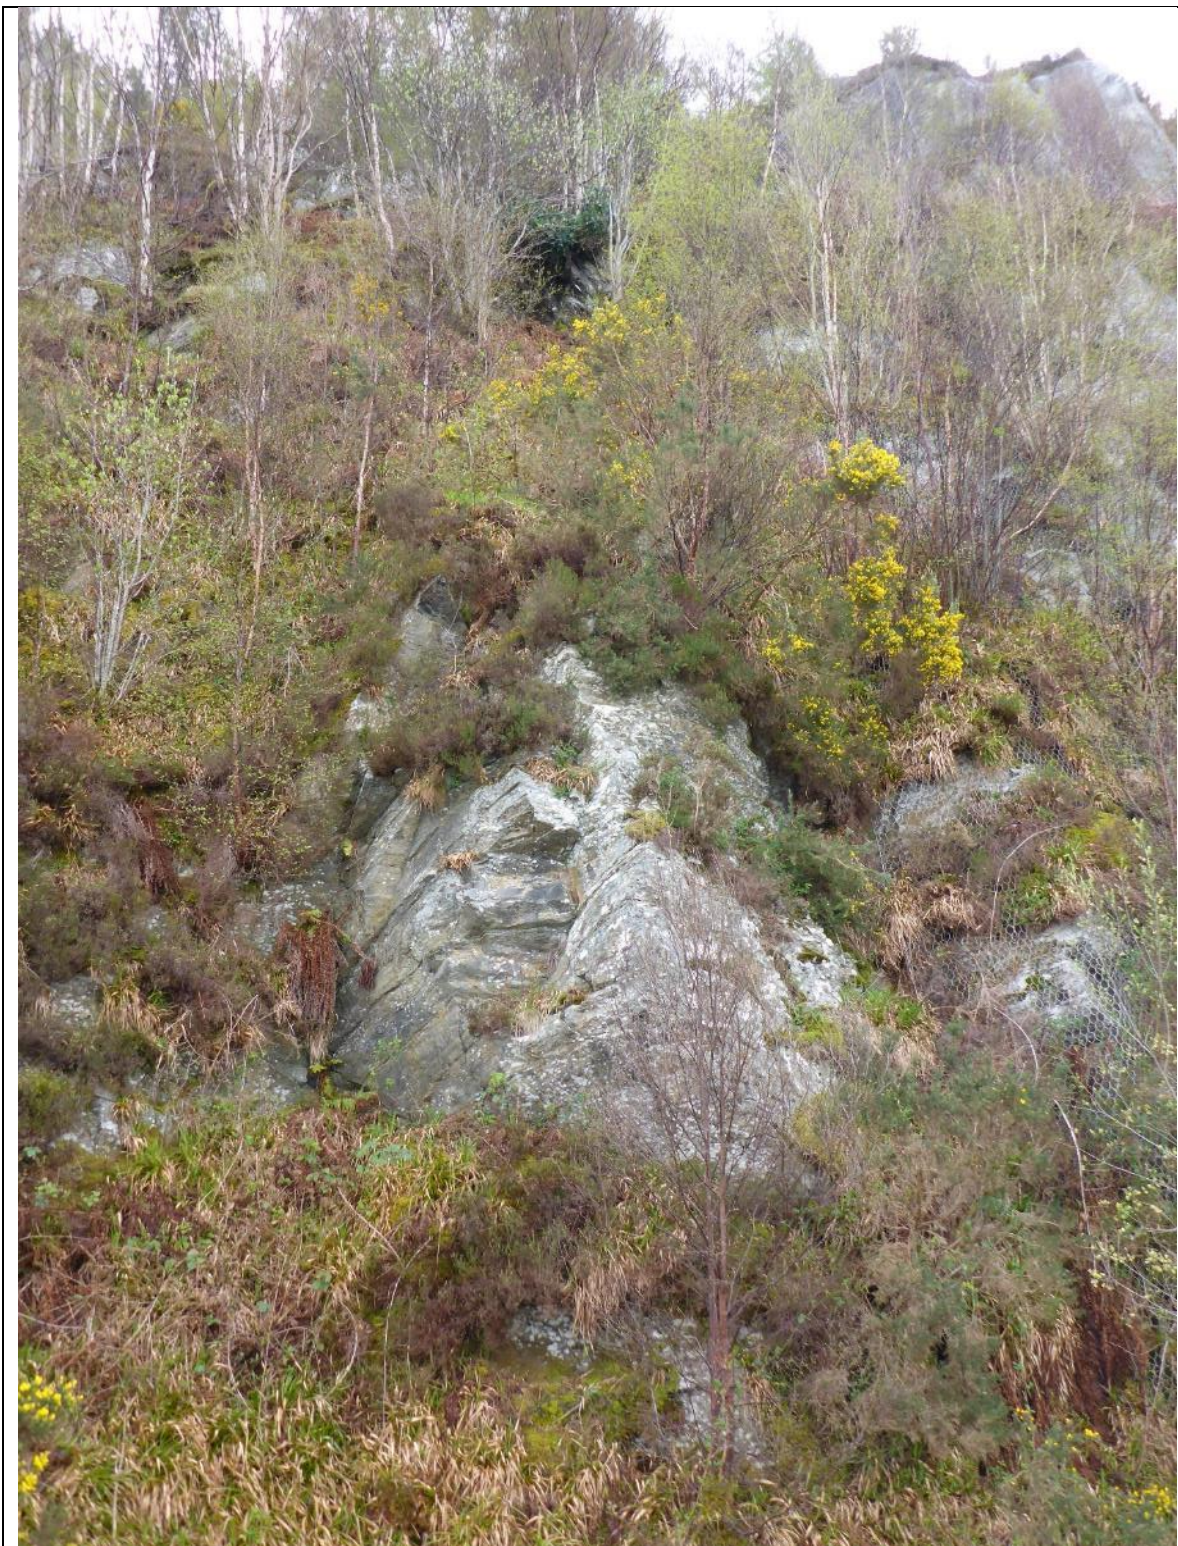
<p>Photograph: AA15-2</p>	<p>Ch. 2790 – root jacking recorded beyond end of netting approximately 10m above road level.</p>	<p>Year observation first noted: 2016</p>
-------------------------------	---	---

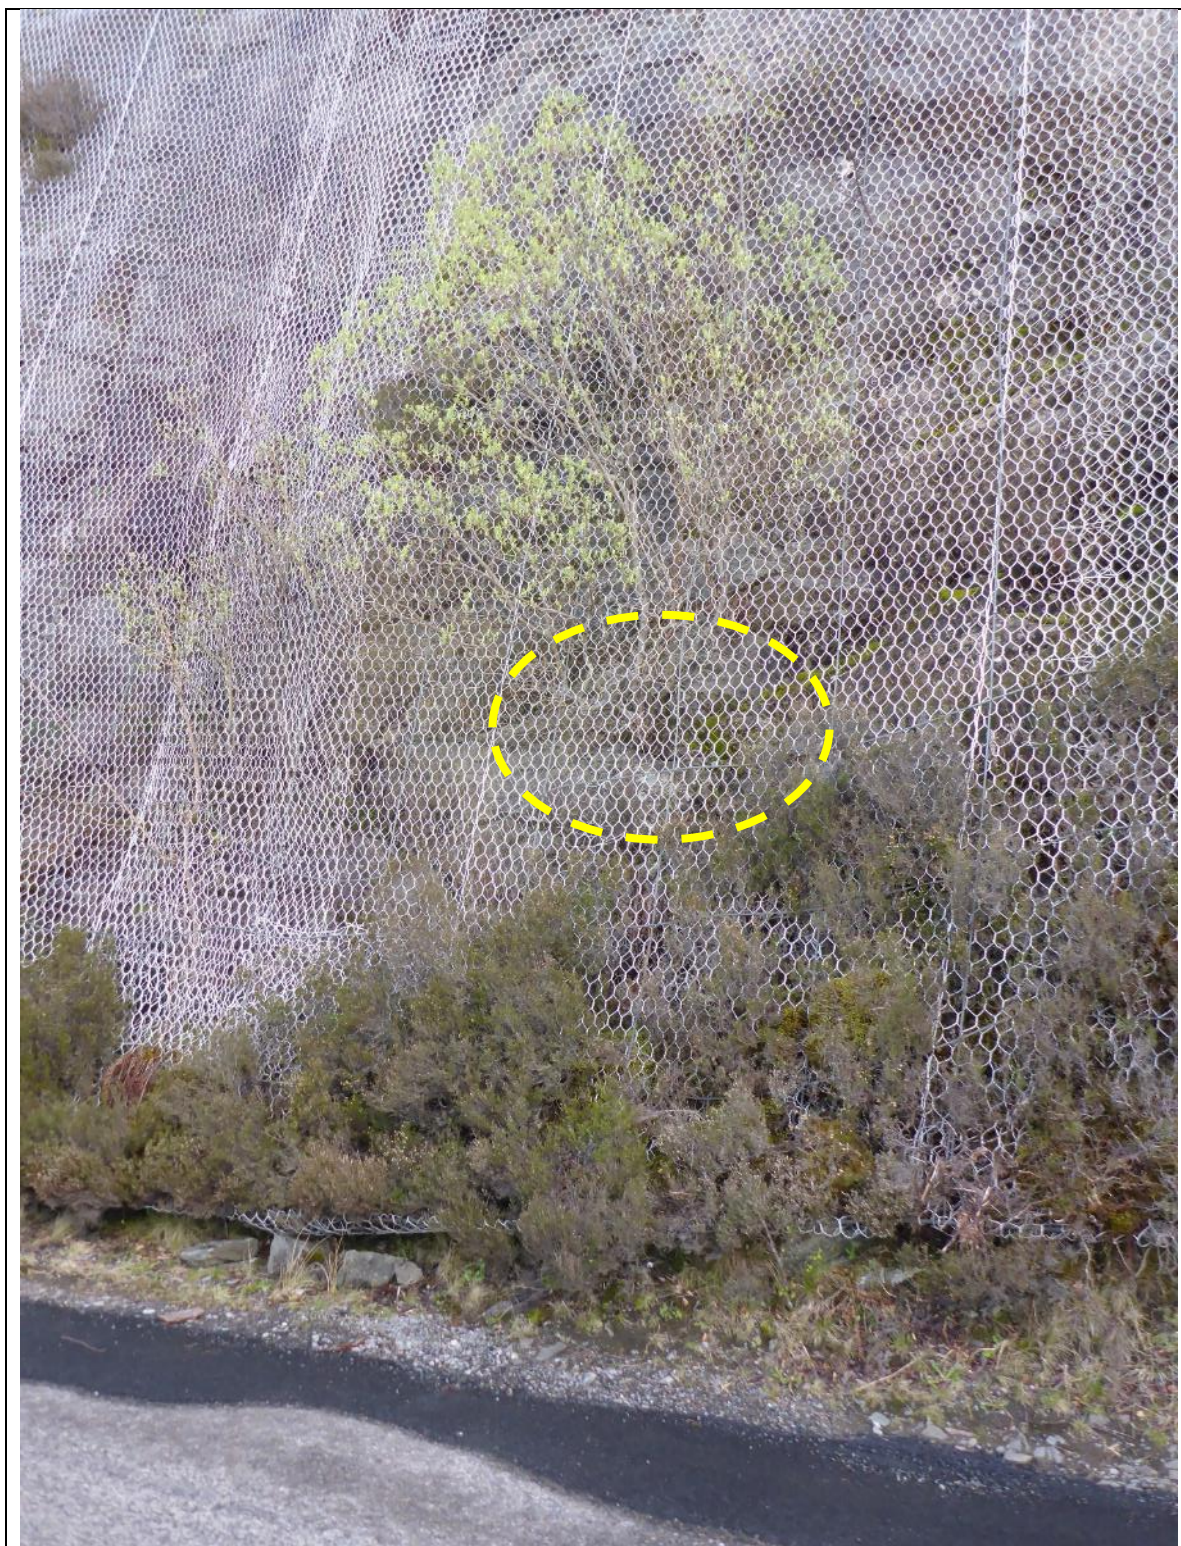
Photograph: AA21-2	Ch. 3310 – Evidence of root jacking c. 3m above toe of slope.	Year observation first noted: 2016
-----------------------	---	------------------------------------
