**5.2.36 Slope Ref. AA22A**

GEOTECHNICAL ASSESSMENT SHEET											
<b>Site:</b>	A890 Stromeferry Bypass	<b>Slope Ref:</b>	AA22A	<b>Chainage:</b>	3386- 3415	<b>Start Grid Ref:</b>	NG 91451 37842	<b>End Grid Ref:</b>	NG 91483 37882	<b>Elevation:</b>	17m AOD

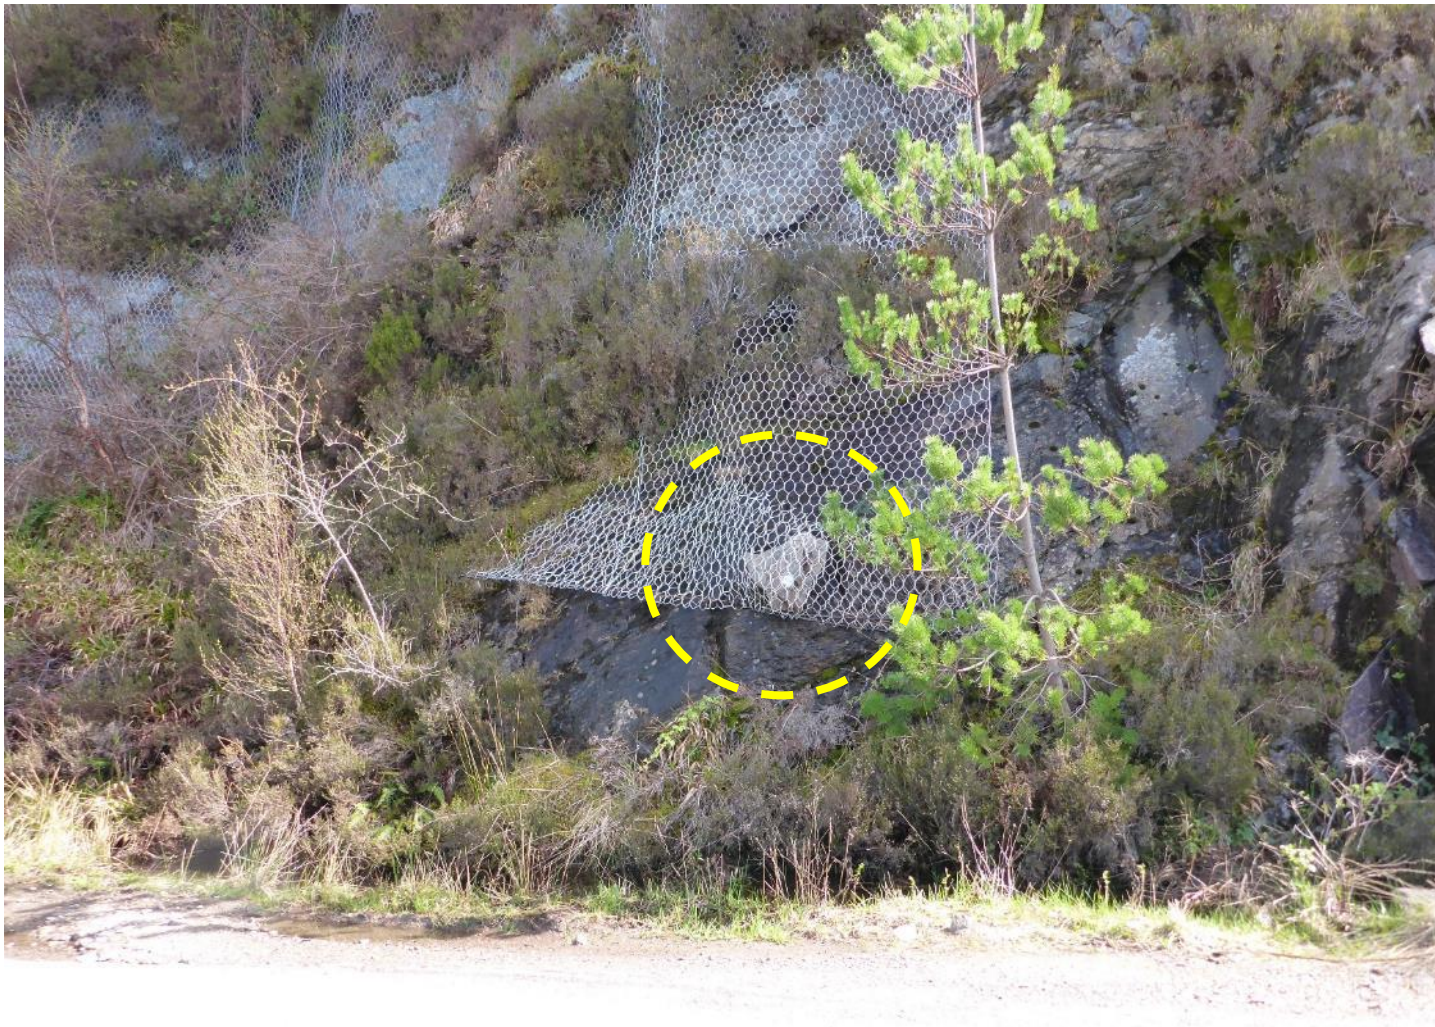
Photograph: AA22A-1

Hazards Observed:			
Location	Description of Hazard (s) from Previous Inspections	2024 Inspection Observations	Photo Reference
Ch. 3388	<b>2019 Inspection:</b> A 0.3m x 0.3m x 0.1m block retained at base of netting 1.5m above road level.	No changes observed during 2024 inspection.	AA22A-1
Ch. 3390	<b>2016 Inspection:</b> Overhanging blocks noted within blast damaged area at crest (~8m wide, 1m deep, and 2-3m high). Large gap between mesh and rock slope at this location.	No changes observed during 2024 inspection.	
Across section	<b>2021 Inspection:</b> Vegetation obscuring large proportions of rock face and potential increasing failure potential through root jacking	No changes observed during 2024 inspection.

Ch. 3388 - A 0.3m x 0.3m x 0.1m block retained at base of netting 1.5m above road level.

Year observation first noted: 2019

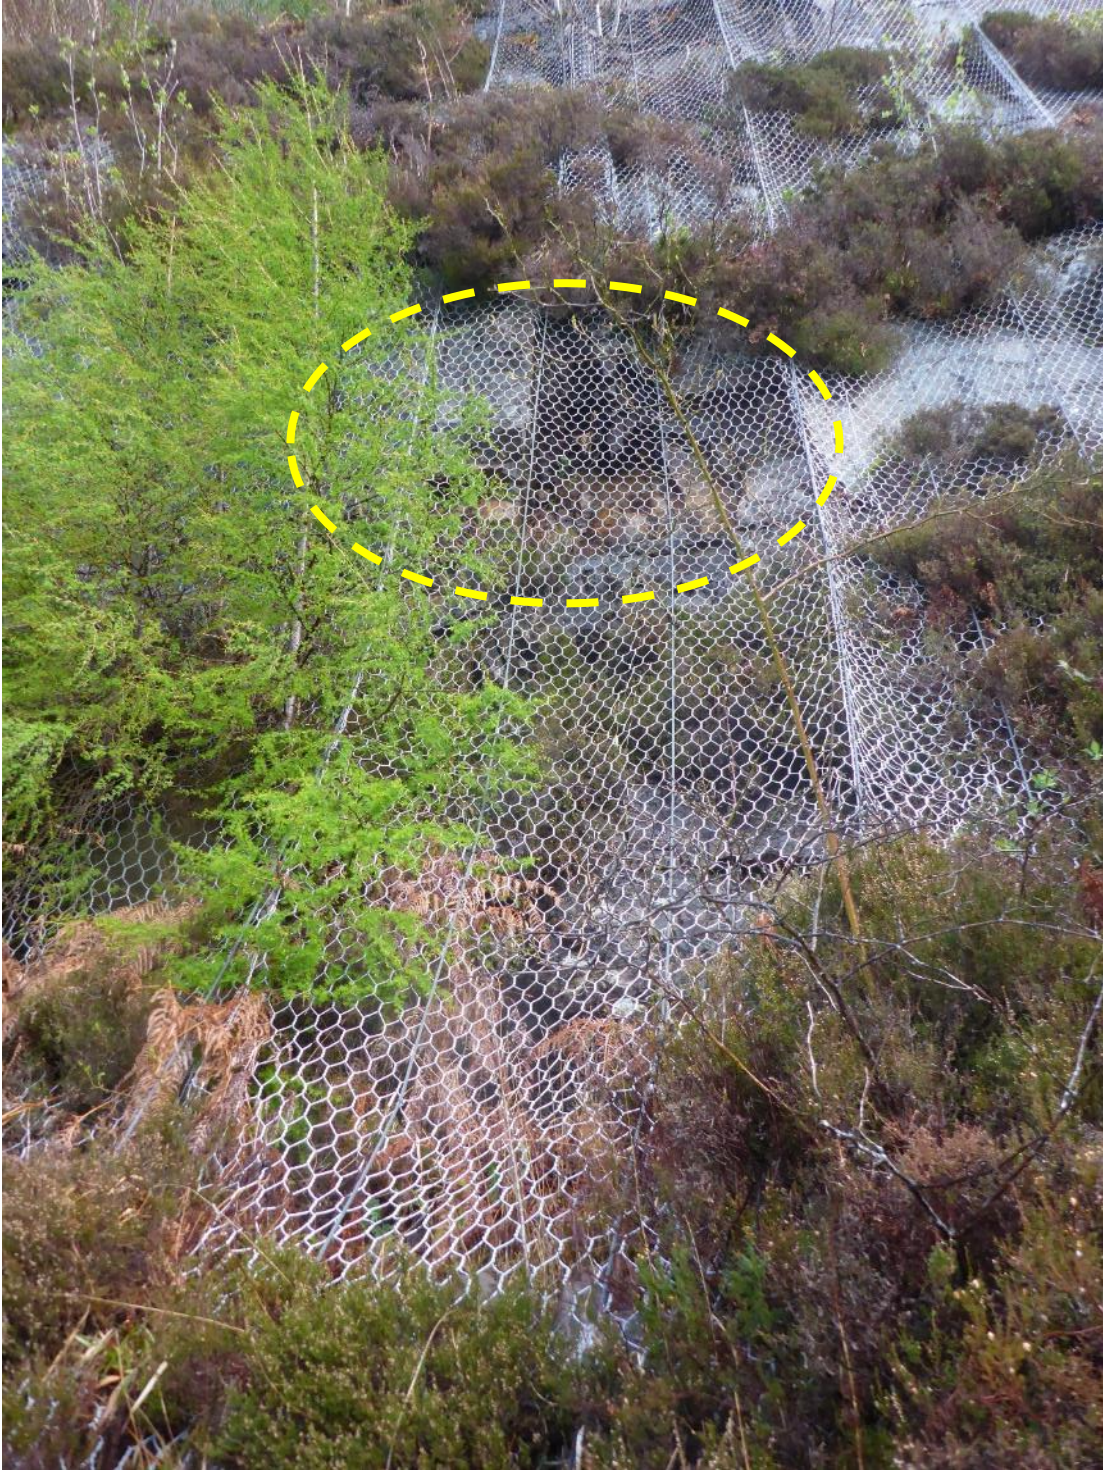
Photograph:  
AA22B-1

Hazards Observed:			
Location	Description of Hazard (s) from Previous Inspections	2024 Inspection Observations	Photo Reference
Ch. 3425	<b>2021 Inspection:</b> Failure in 2021 originating c.6m above road level where blocks (c.0.25m <sup>3</sup> ) have slid along a steep release plane and have come to rest at toe of slope behind netting. Water seepage in the area gives potential for further rock fall. It is likely that this would be a volume of c.0.4m <sup>3</sup> and a maximum block size of c.0.3m x 0.3m x 0.3m. Any future failure likely to be within the design capacity of netting but accumulation of further debris at toe of slope should be monitored.	Location of previous rock fall re-inspected. Continuous water seepage but no additional rock fall observed behind netting. No other	AA22B-1

Ch. 3425 - rock fall in 2021 originated c.6m above road level where blocks (c.0.25m<sup>3</sup>) have slid along a steep release plane and have come to rest at toe of slope behind netting. Source area circled.

Year observation first noted: 2021

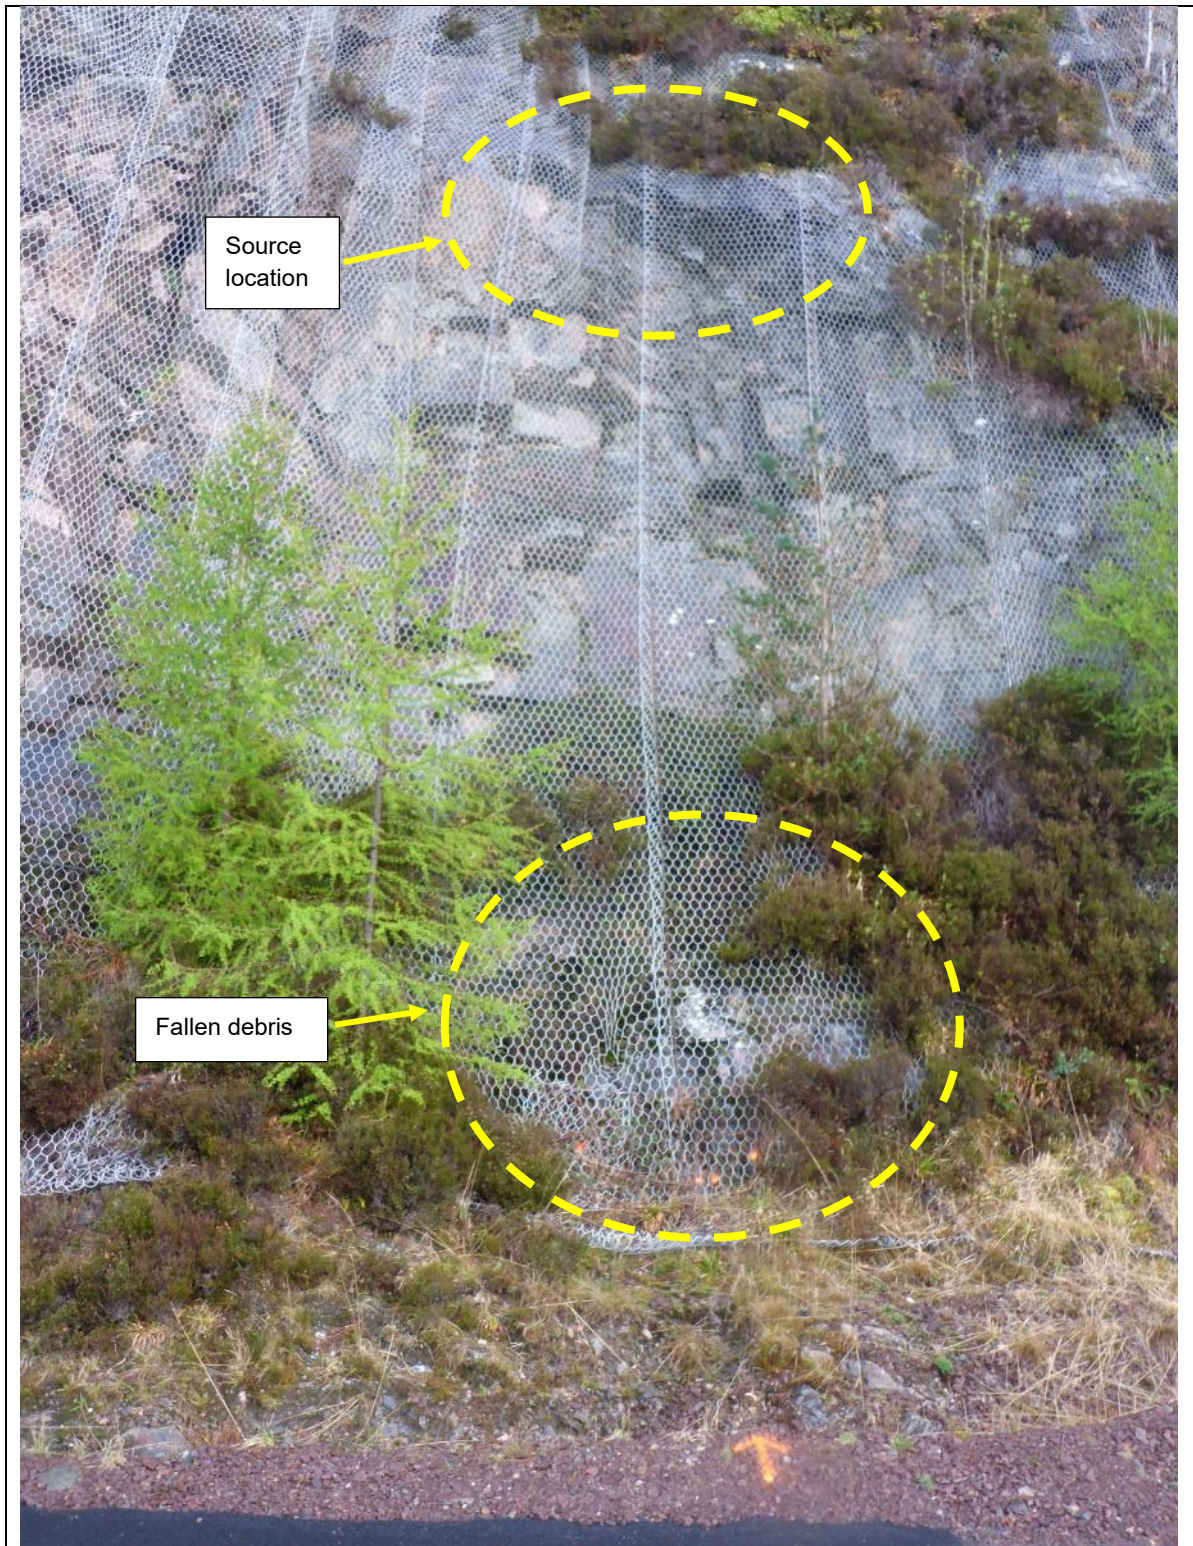
Photograph:  
AA22B-2

Hazards Observed:			
Location	Description of Hazard (s) from Previous Inspections	2024 Inspection Observations	Photo Reference
		changes observed during 2024 inspection.	
Ch.3434	N/A	Several small blocks behind toe of netting. Appear to originate from ca. 8m upslope. There is water seepage present along steeply inclined planes. Netting sits 2m away from rock slope. There is a ditch present with a small bund to road. Debris unlikely to reach road.	AA22B-2
Ch. 3454	<b>2022 Inspection:</b> Block (c.0.3m x 0.2mx 0.2m) positioned approx. 2m above ground level is being held by netting. Has fallen 5m to current position.	No changes observed during 2024 inspection.	
Ch. 3475	<b>2021 Inspection:</b> Minor rock fall with small blocks at base of netting system. Largest block c.0.4m x 0.1m x 0.1m. Seems to have originated from righthand-side base of previously observed overhang. No damage to netting. Fractured rock with dilated joints apparent along base of overhang indicating potential for further failures in this area. At this location there is a 2m wide ditch behind Armco barrier which is likely to act as an effective rock trap. Risk to road from this hazard is therefore considered to be low to moderate but should be kept under observation during future inspections.	No changes observed during 2024 inspection.

Ch. 3434 – Several small blocks behind toe of netting.  
Appear to originate from overhang ca. 8m upslope.

Year observation first  
noted: 2024

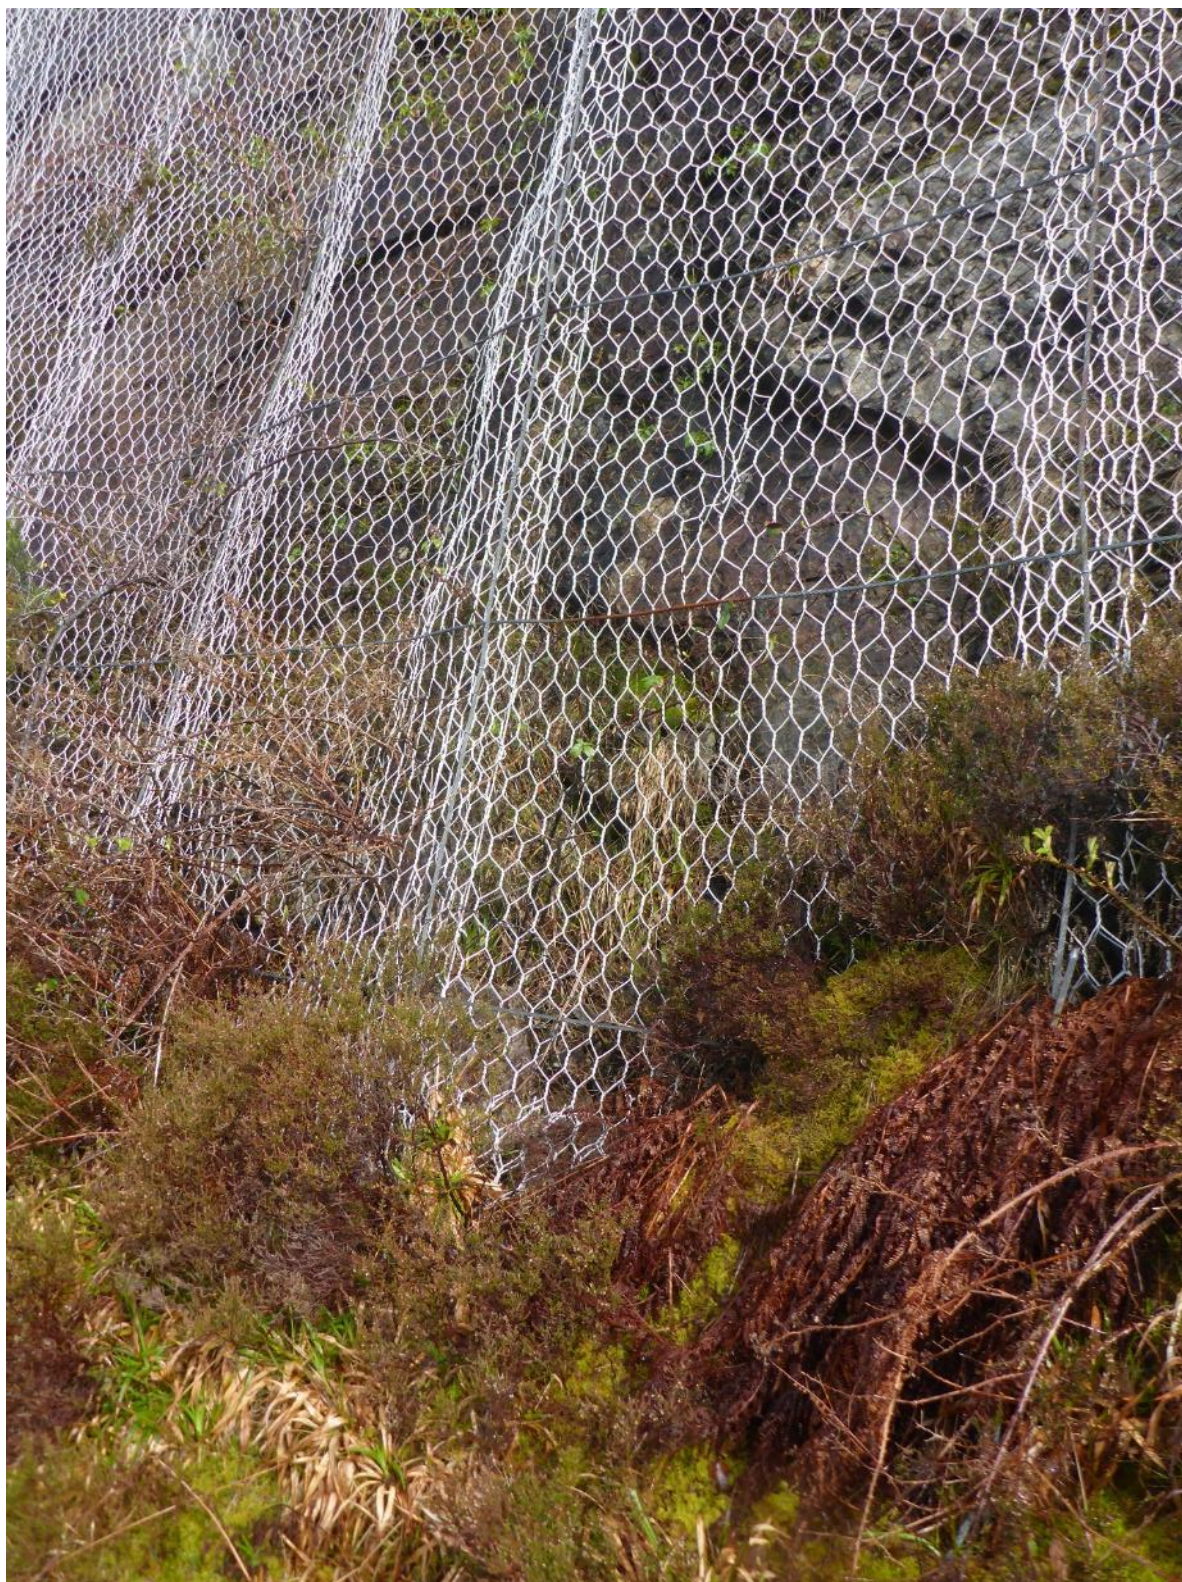
Photograph:  
AA22B-3

Ch. 3483	N/A	Two blocks retained behind netting, along with numerous small blocks. Dimensions up to 0.5x0.5x0.5m. No significant damage to netting but there is a minor distortion 2m above the toe of the slope. Source of rock fall not immediately obvious and greater than 8m above the toe of the slope. There is a ditch present with a small bund to road. Debris unlikely to reach road.	AA22B-3
Ch. 3485	<b>2021 Inspection:</b> 3 to 4 cobble sized blocks sitting on ledge behind netting c.7m above road level. No damage to netting observed. Source likely to be overhanging blocks near crest.	No changes observed during 2024 inspection.

Ch. 3480 – Two blocks retained behind netting with numerous small blocks also present.

Year observation first noted: 2024

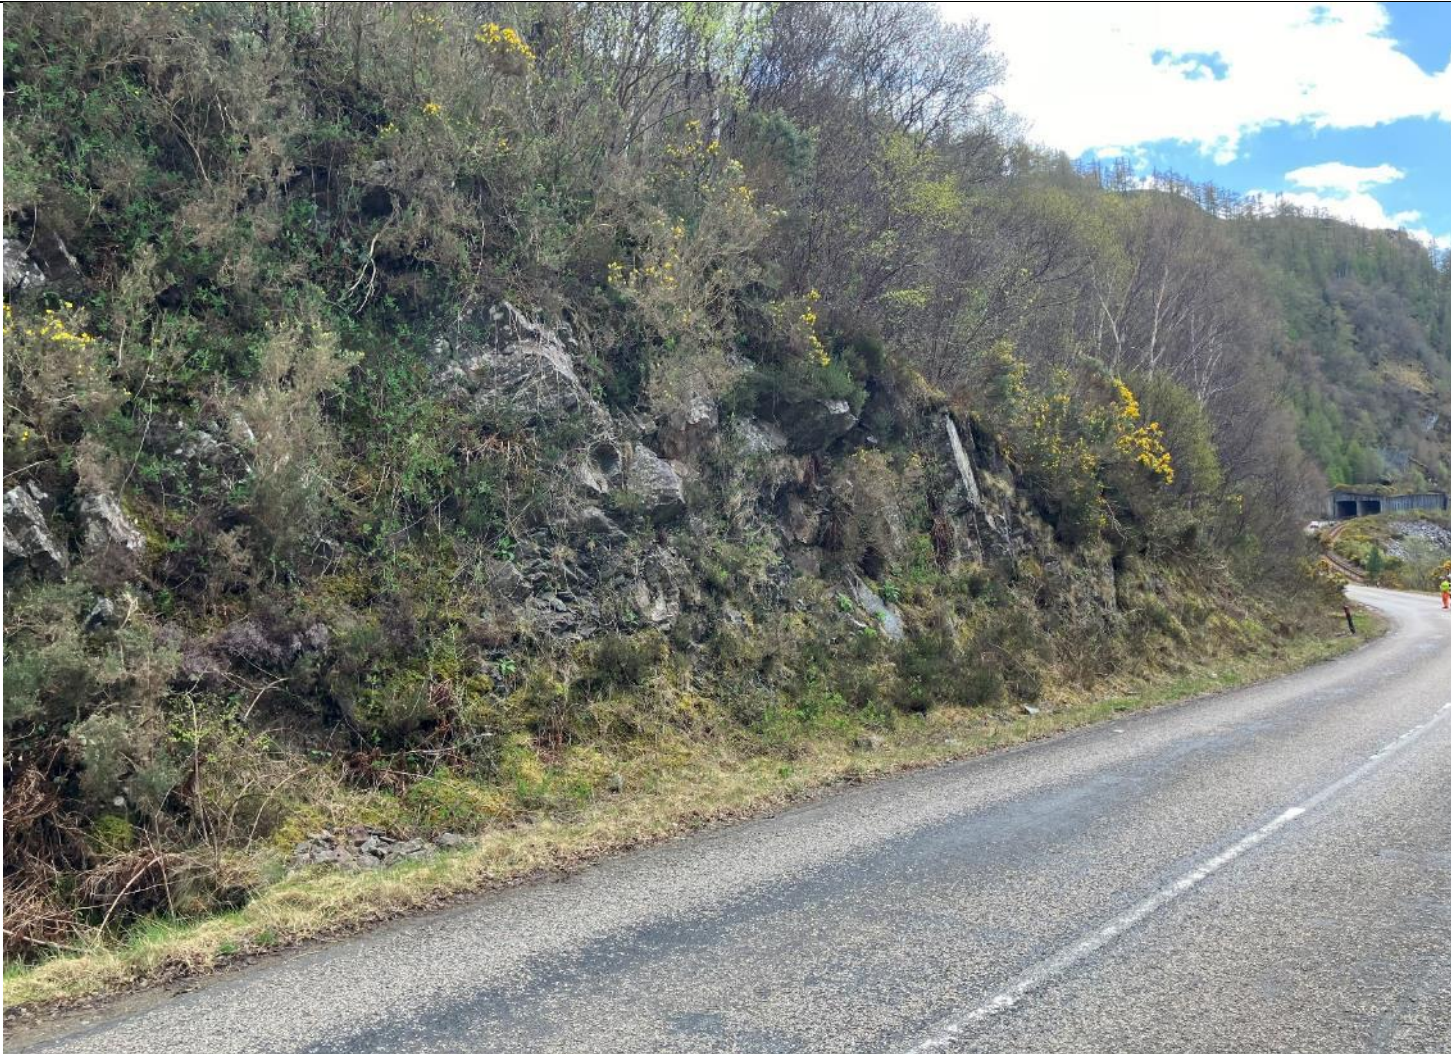
Photograph: AA23B-1

Between Ch. 3655 to 3672 – Potential for small blocks to fall due to ravelling and root jacking.

Year observation first noted: 2016

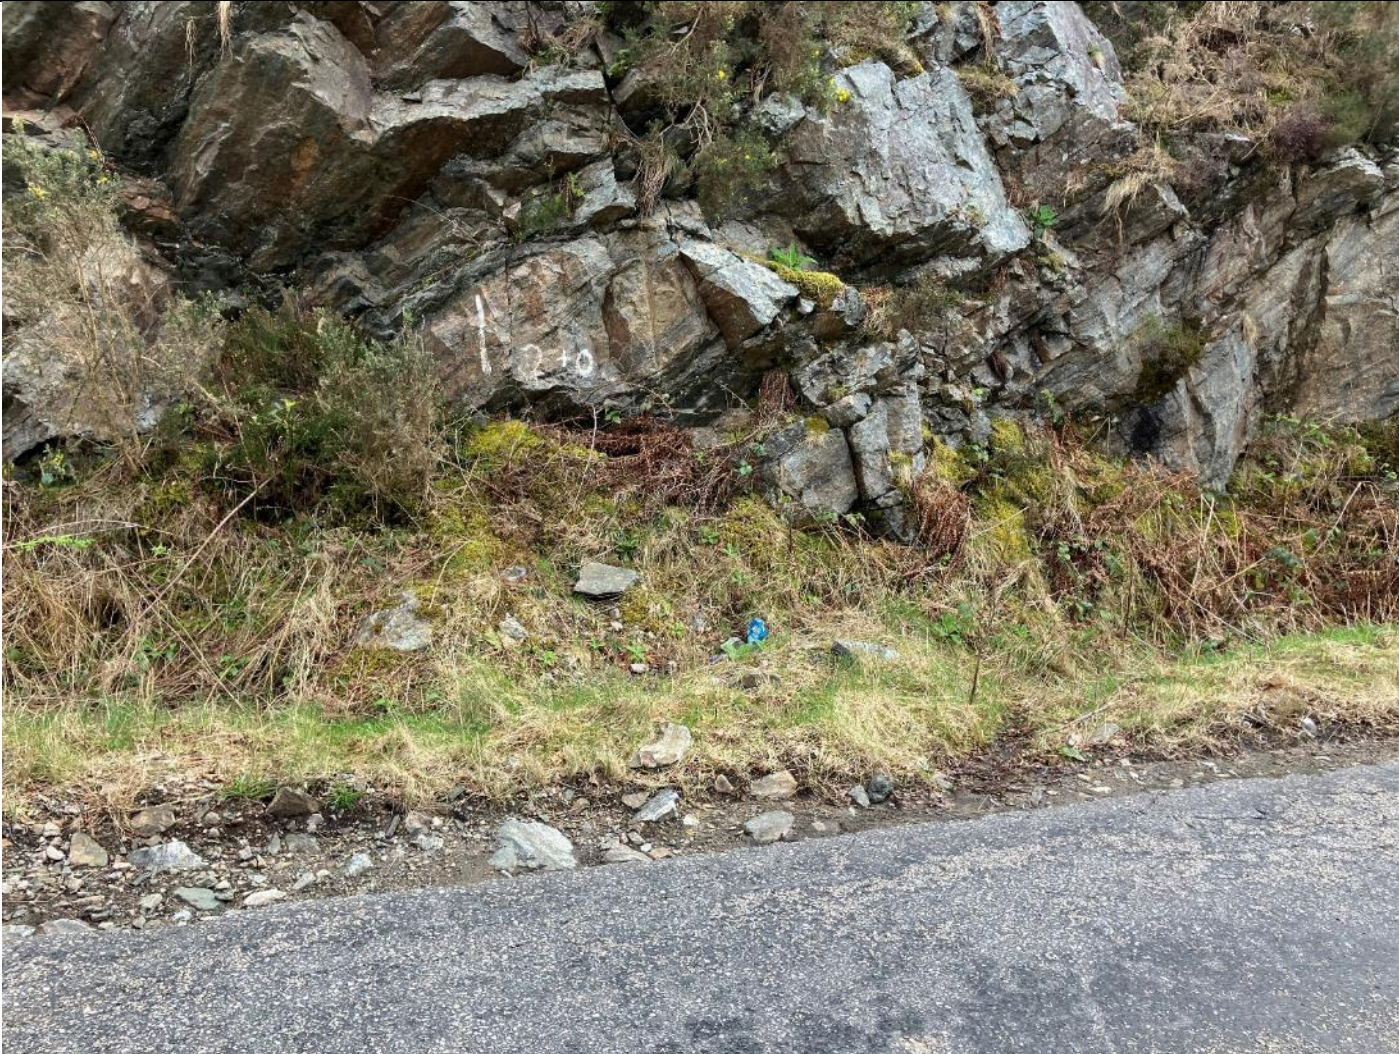
Photograph: AA23B-2

Ch. 3697 – ditch is filled with debris. Would benefit from clearance.

Year observation first noted: 2024

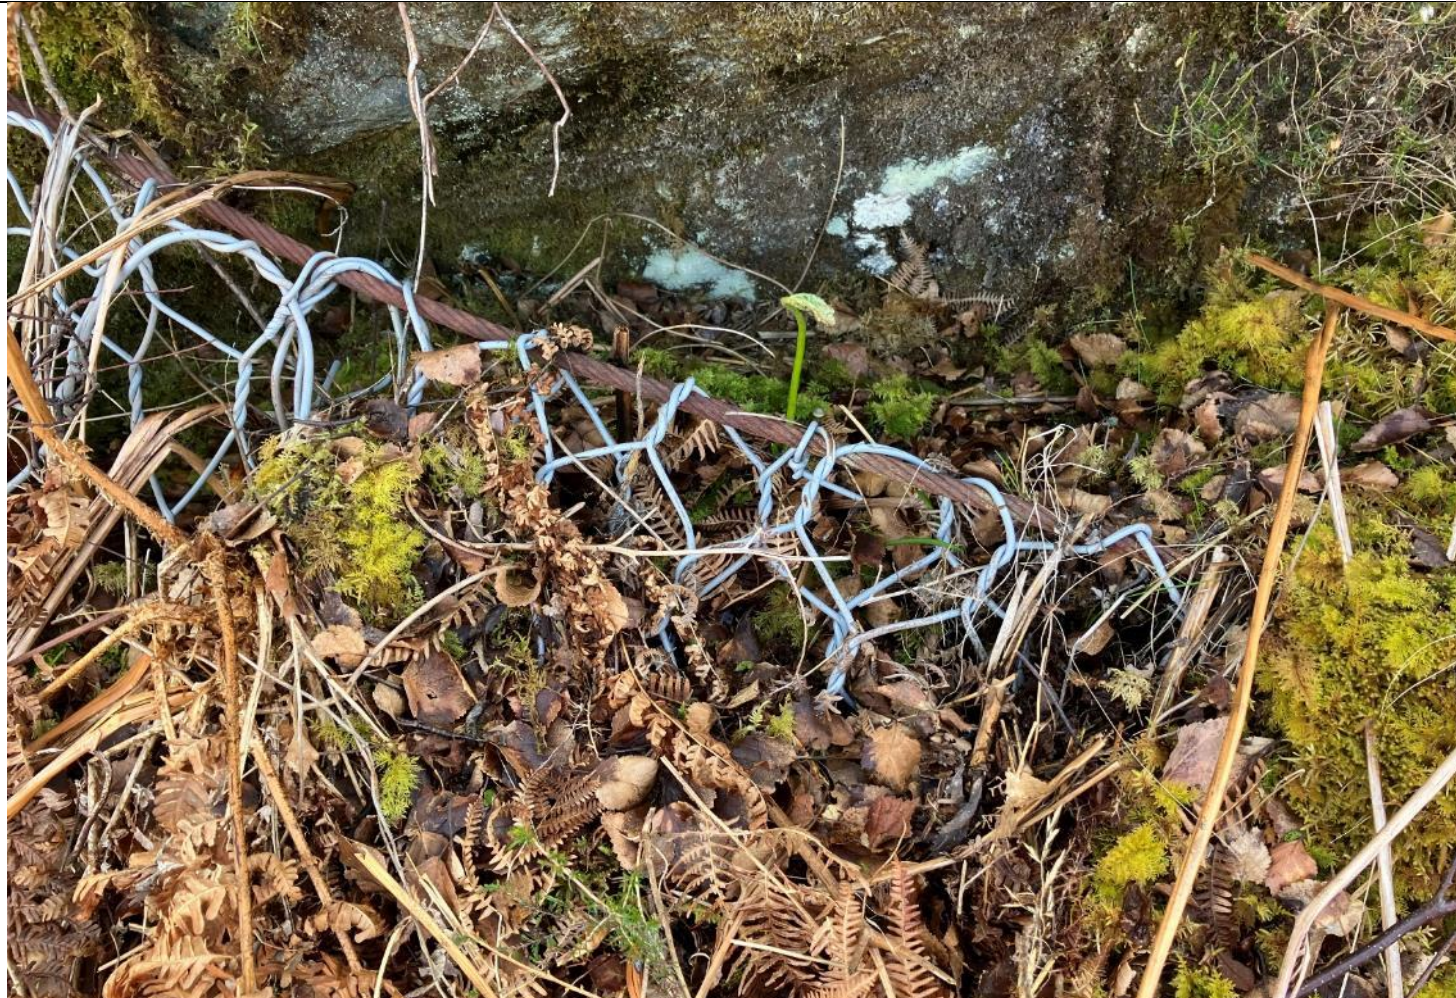
Photograph: AA24-1

Ch. 3429 Top cable has visible localised corrosion but no fraying is noticeable.

Year observation first noted: 2024

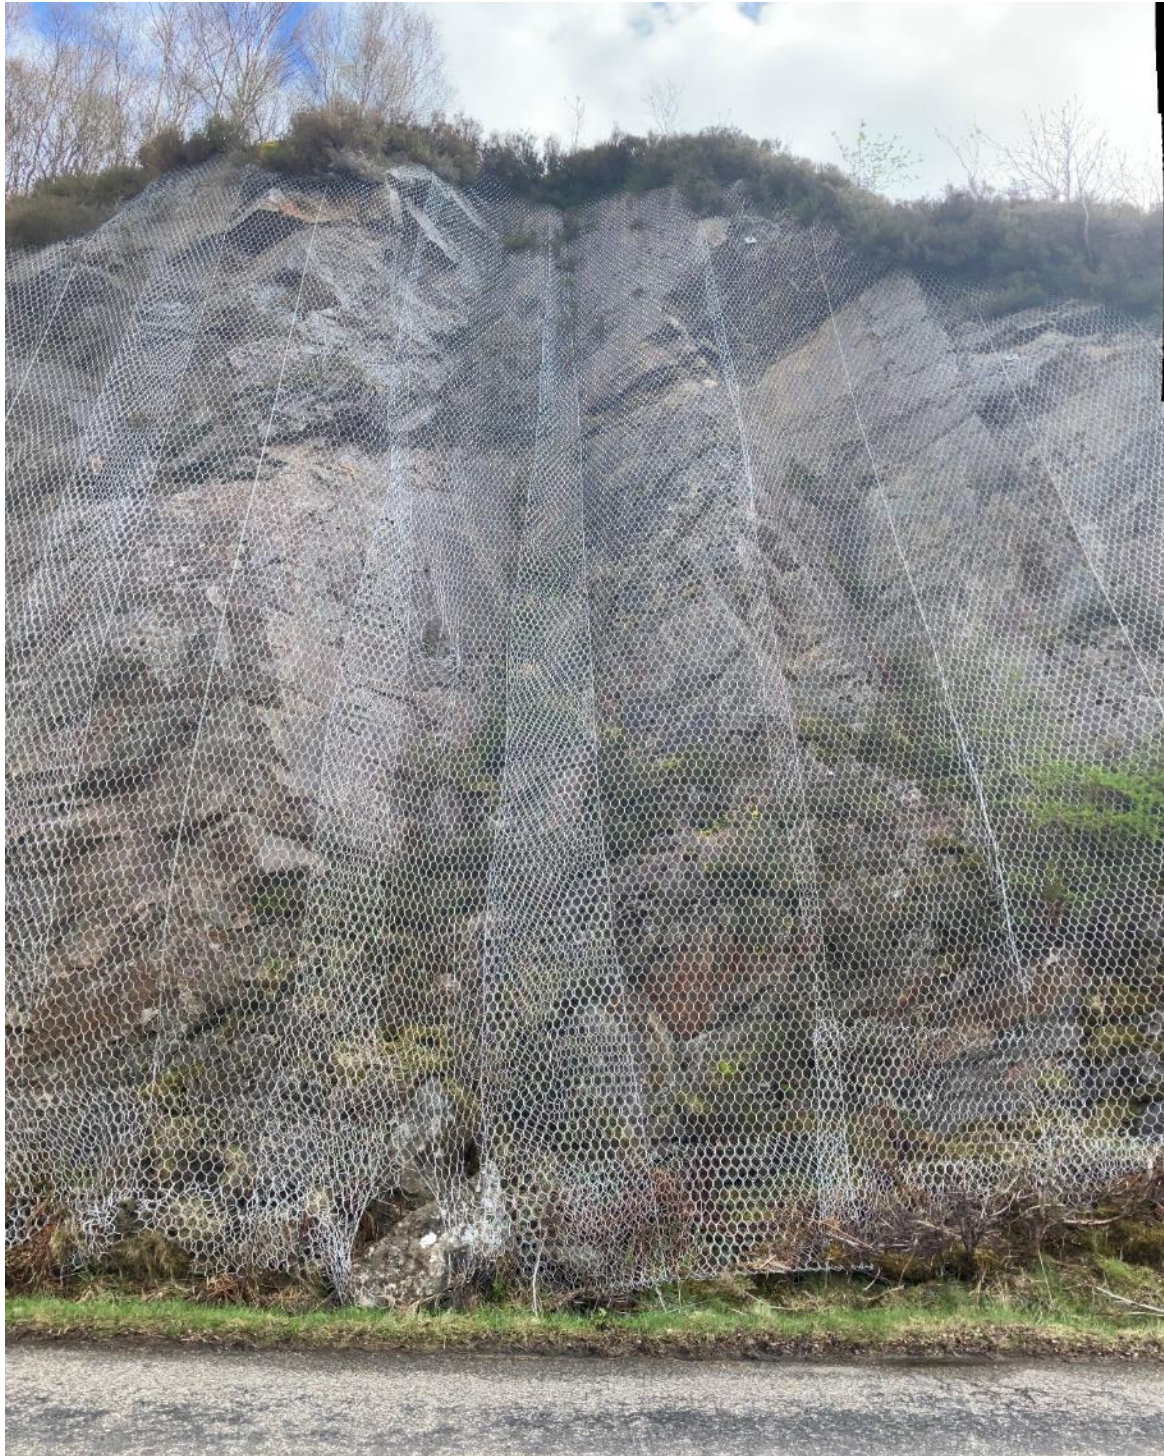
Photograph:  
AA24-2

Between 3740 to 3745 - Several blocks with dilated fractures and / or root jacking potential have been identified that are likely to fail in the future but should be contained by the Maccaferri netting.

Year observation first  
noted: 2021

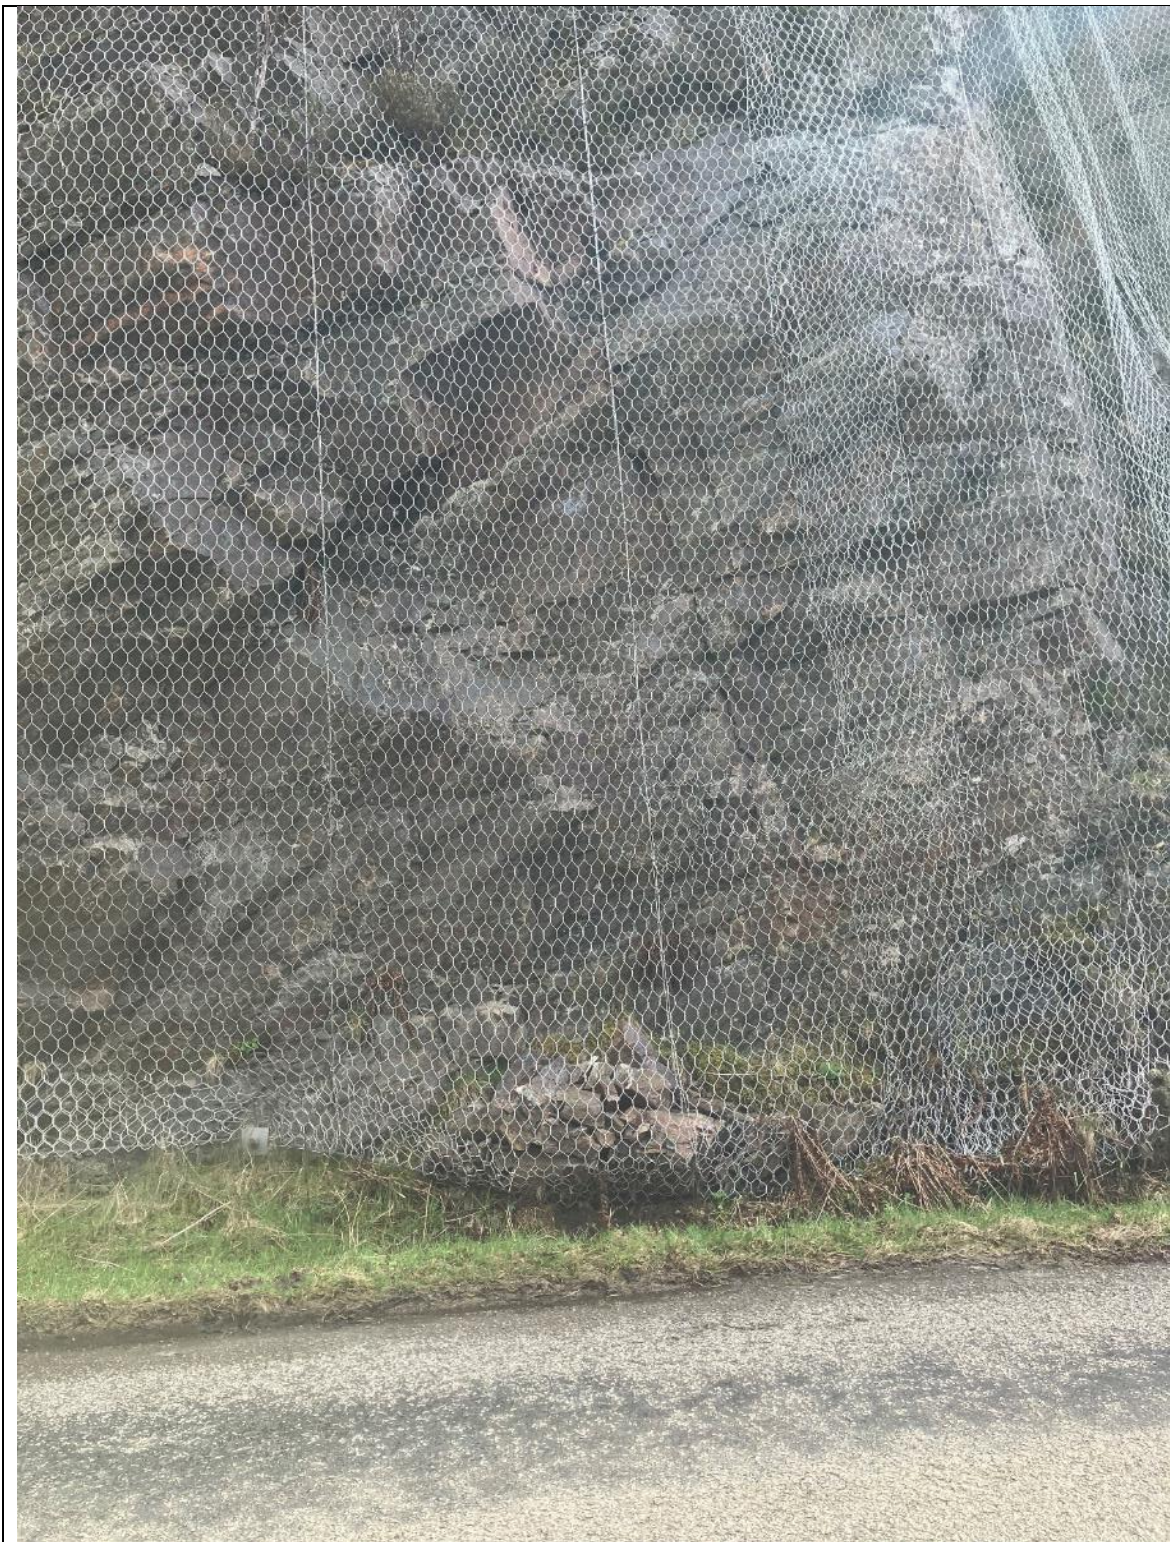
<p>Photograph: AA24-3</p>	<p>Ch. 3745 - A rock fall has occurred which has been caught by the netting.</p>	<p>Year observation first noted: 2024</p>
-------------------------------	--	---

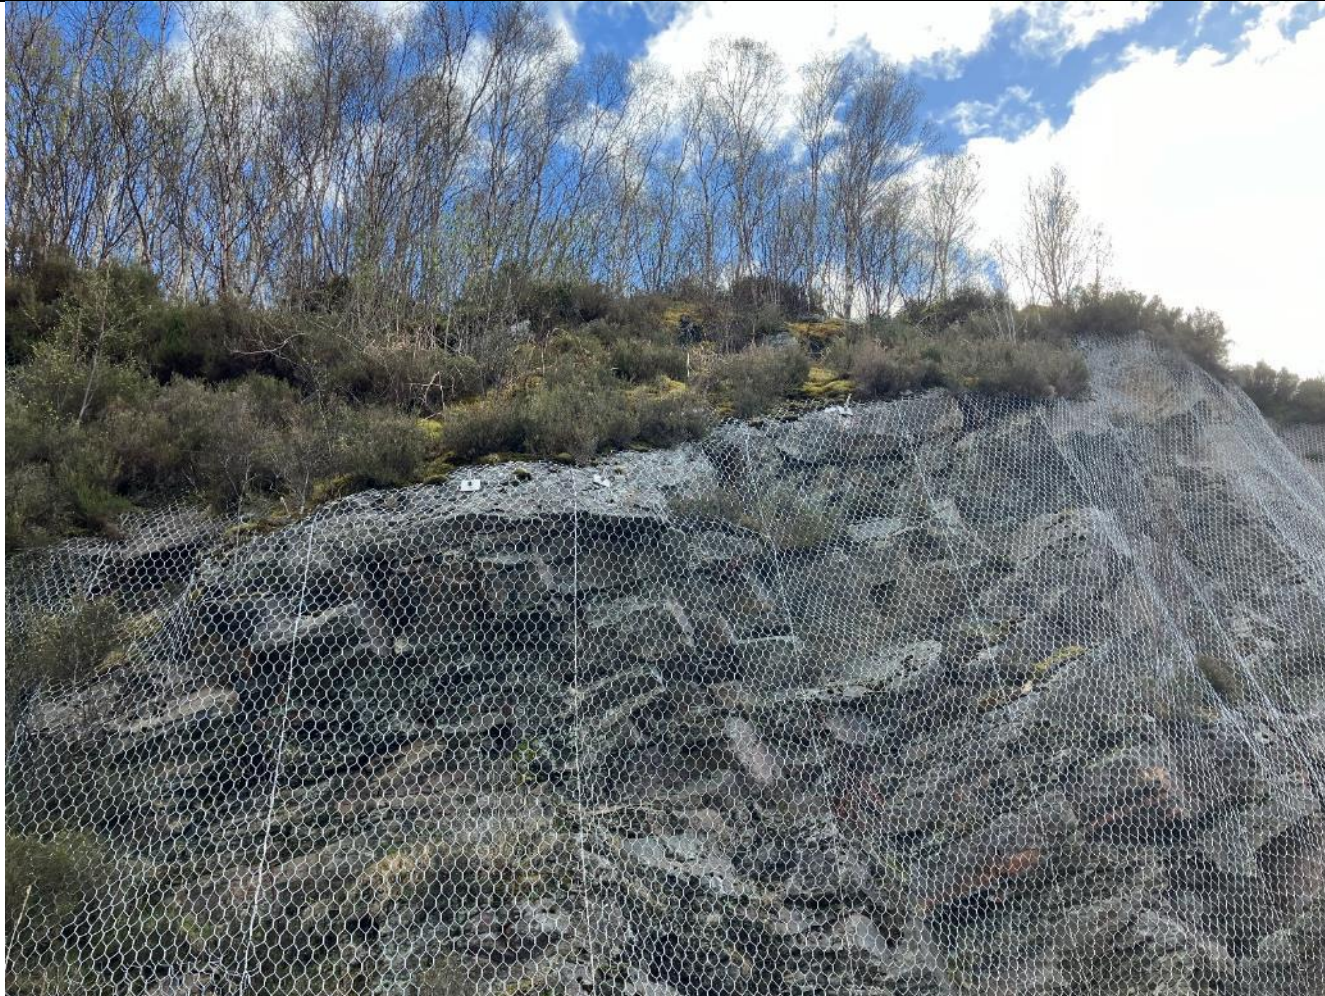
Photograph: AA24-4

Between Ch. 3745 to 3755 - The Maccaferri netting does not extend to the crest of the slope but stops at a small ledge c. 3-4m down from the crest.

Year observation first noted: 2024

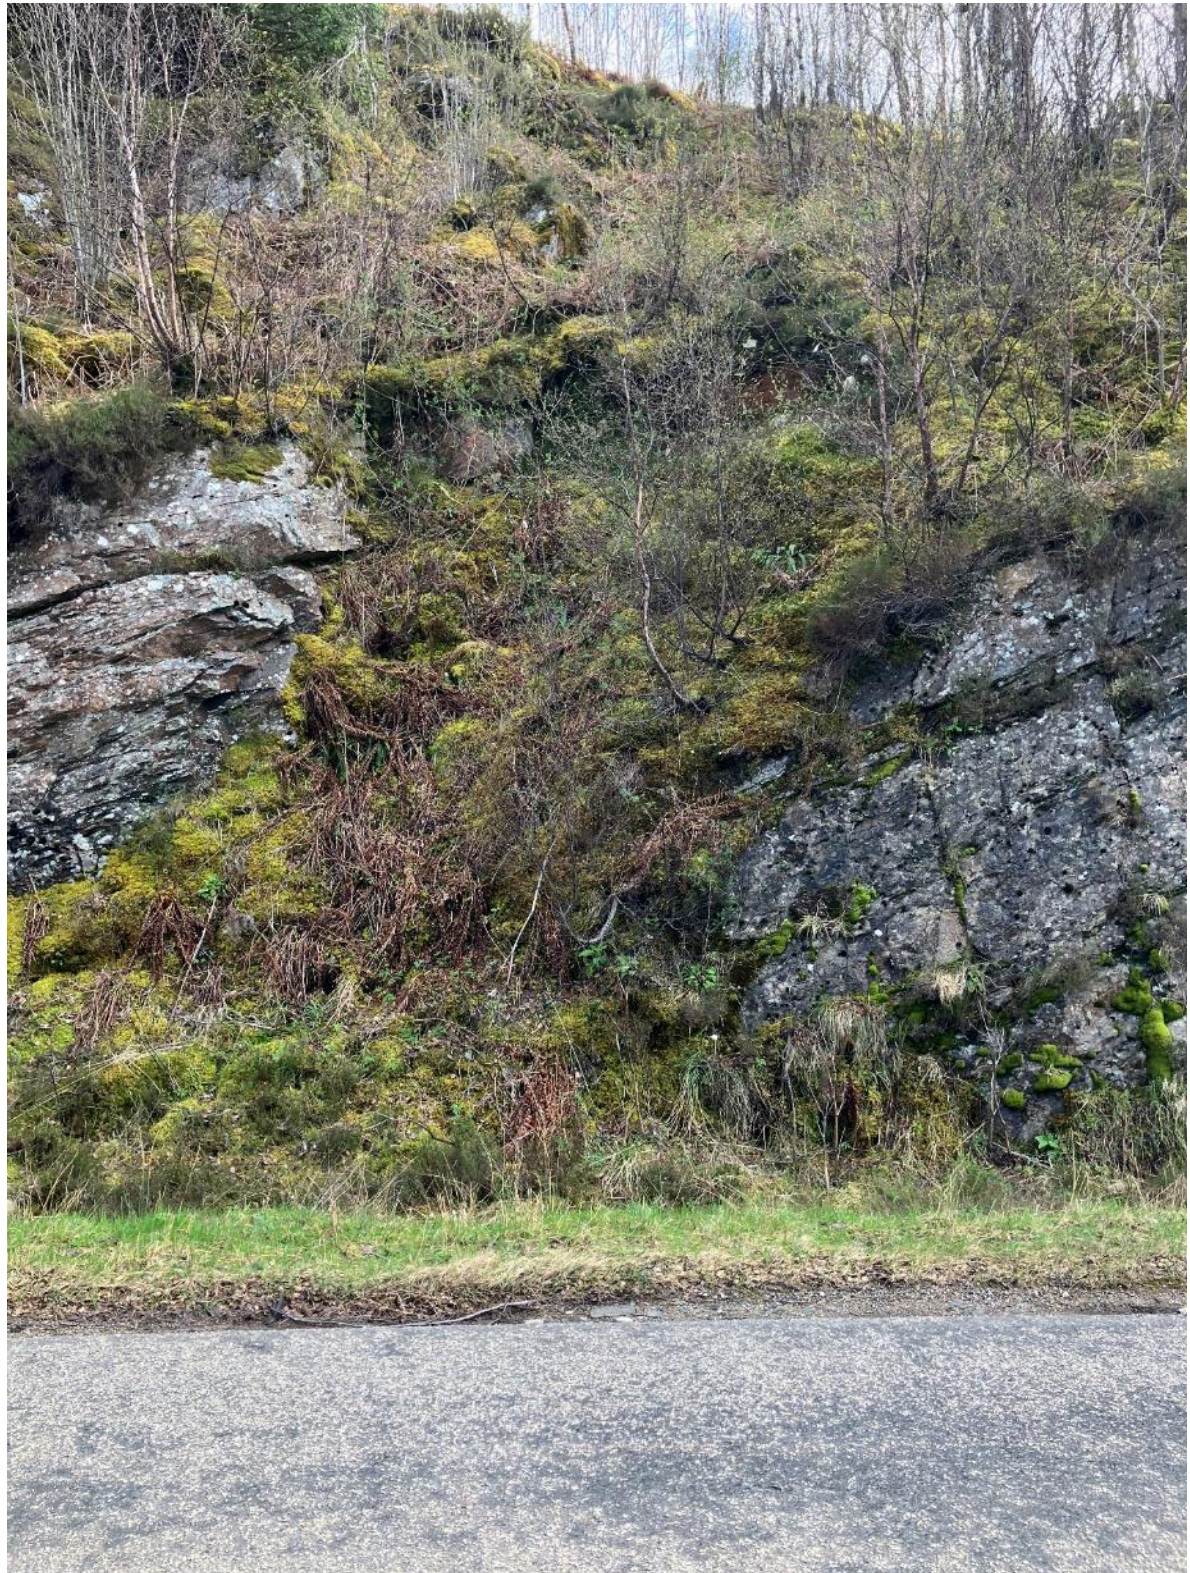
Photograph: AA24-5

Between Ch. 3783 to 3792 - Exposed soil slope 4m above road level with boulders in back scar of previous failure which could weather out and reach road.

Year observation first noted: 2016

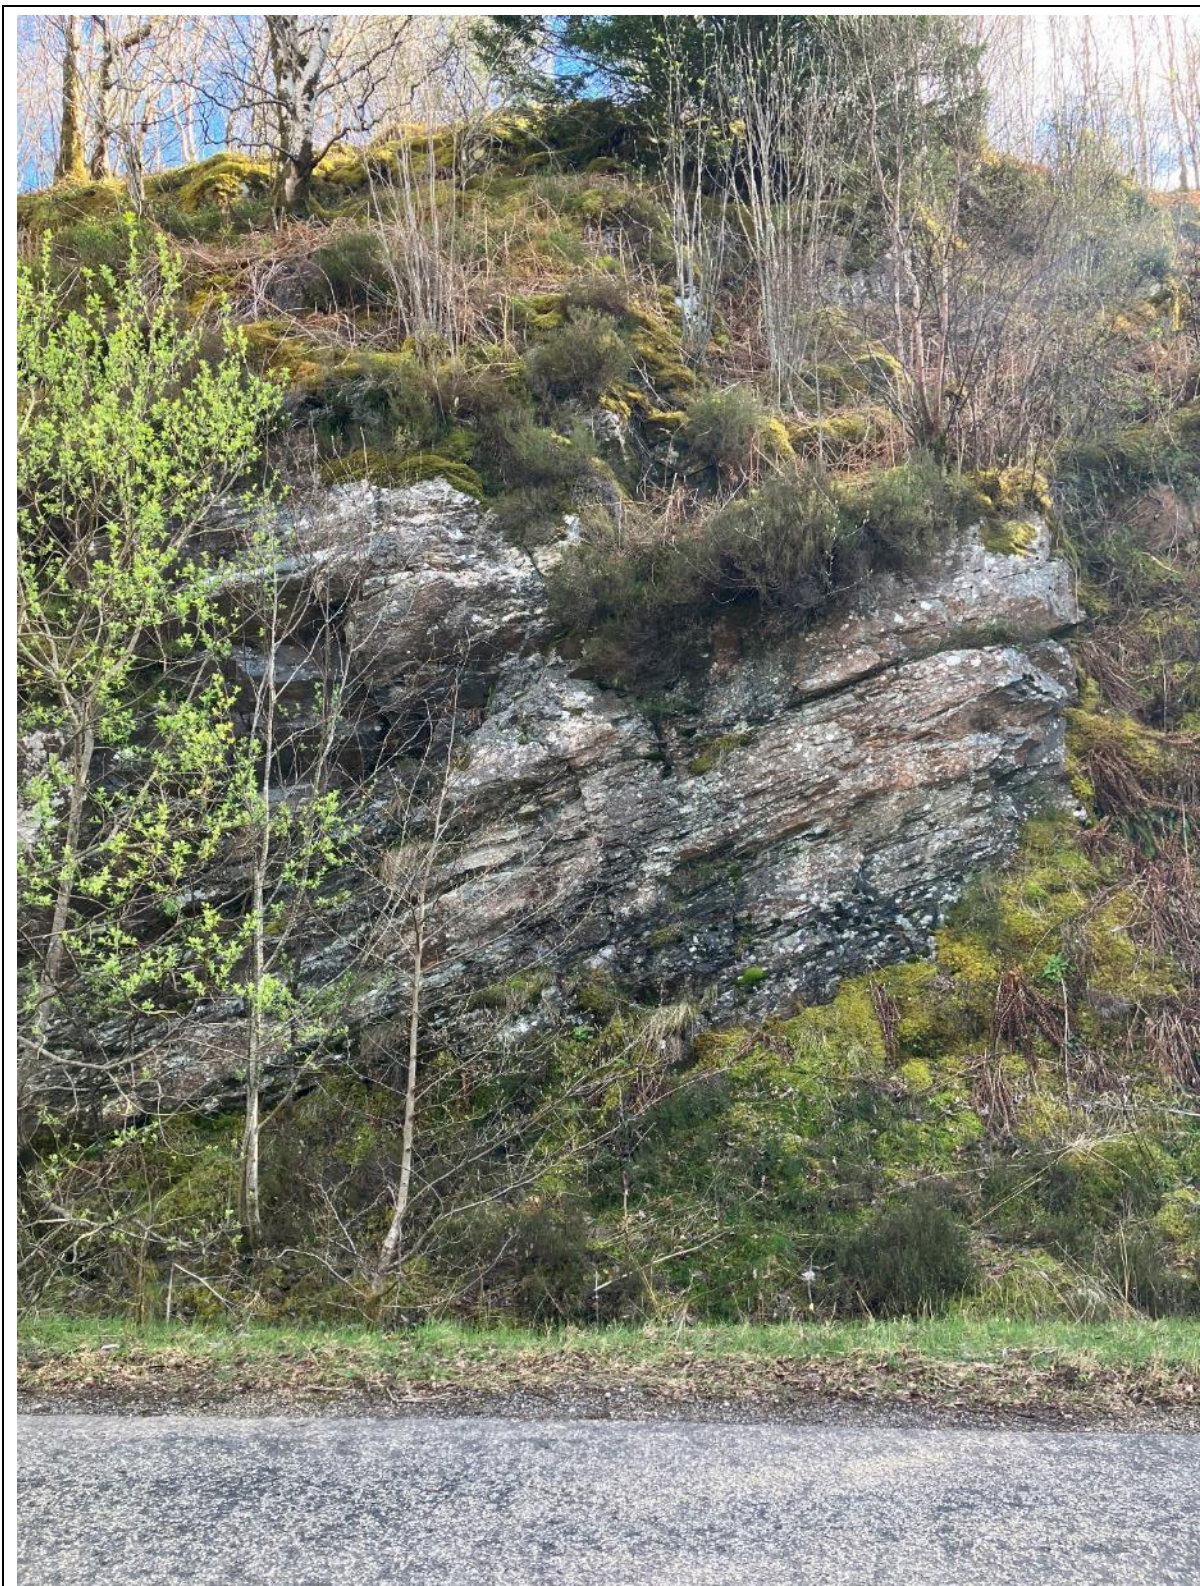
Photograph: AA24-6	Ch. 3790 – Broken rock at crest of slope.	Year observation first noted: 2016
--------------------	---	------------------------------------

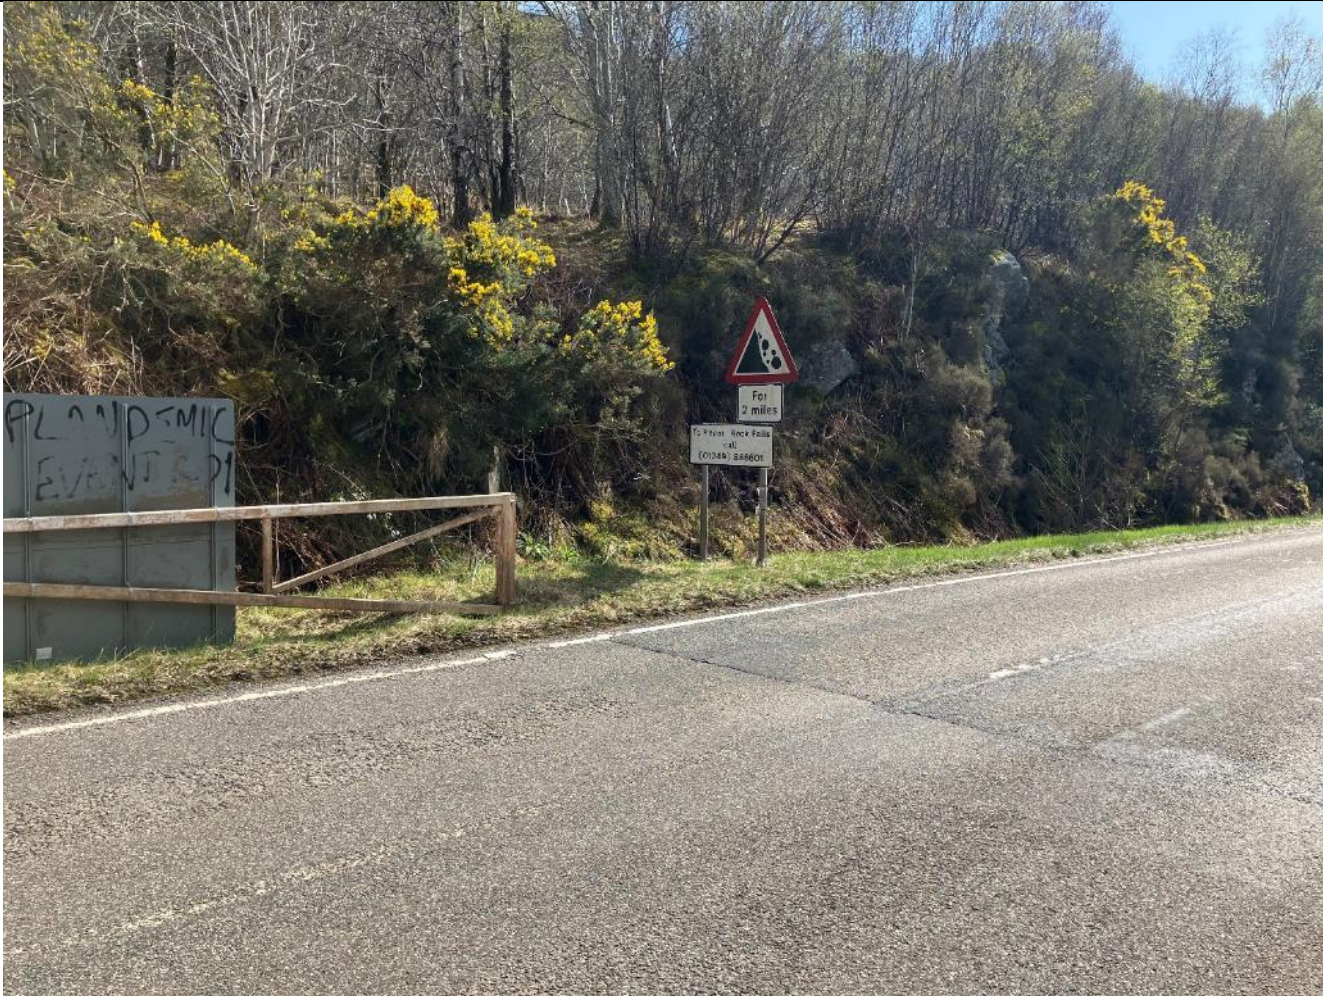
Photograph: AA24-7

Ch. 3892 - Phone number on the sign by the road closure gates is starting to weather off.

Year observation first noted: 2024
