**The Highland Council**  
**City of Inverness Area Committee**  
**3 March 2016**

**Ness Islands Structural Maintenance - Footpaths, Bridges and Riverbanks**

**Report by the Director of Community Services and Inverness City Manager**

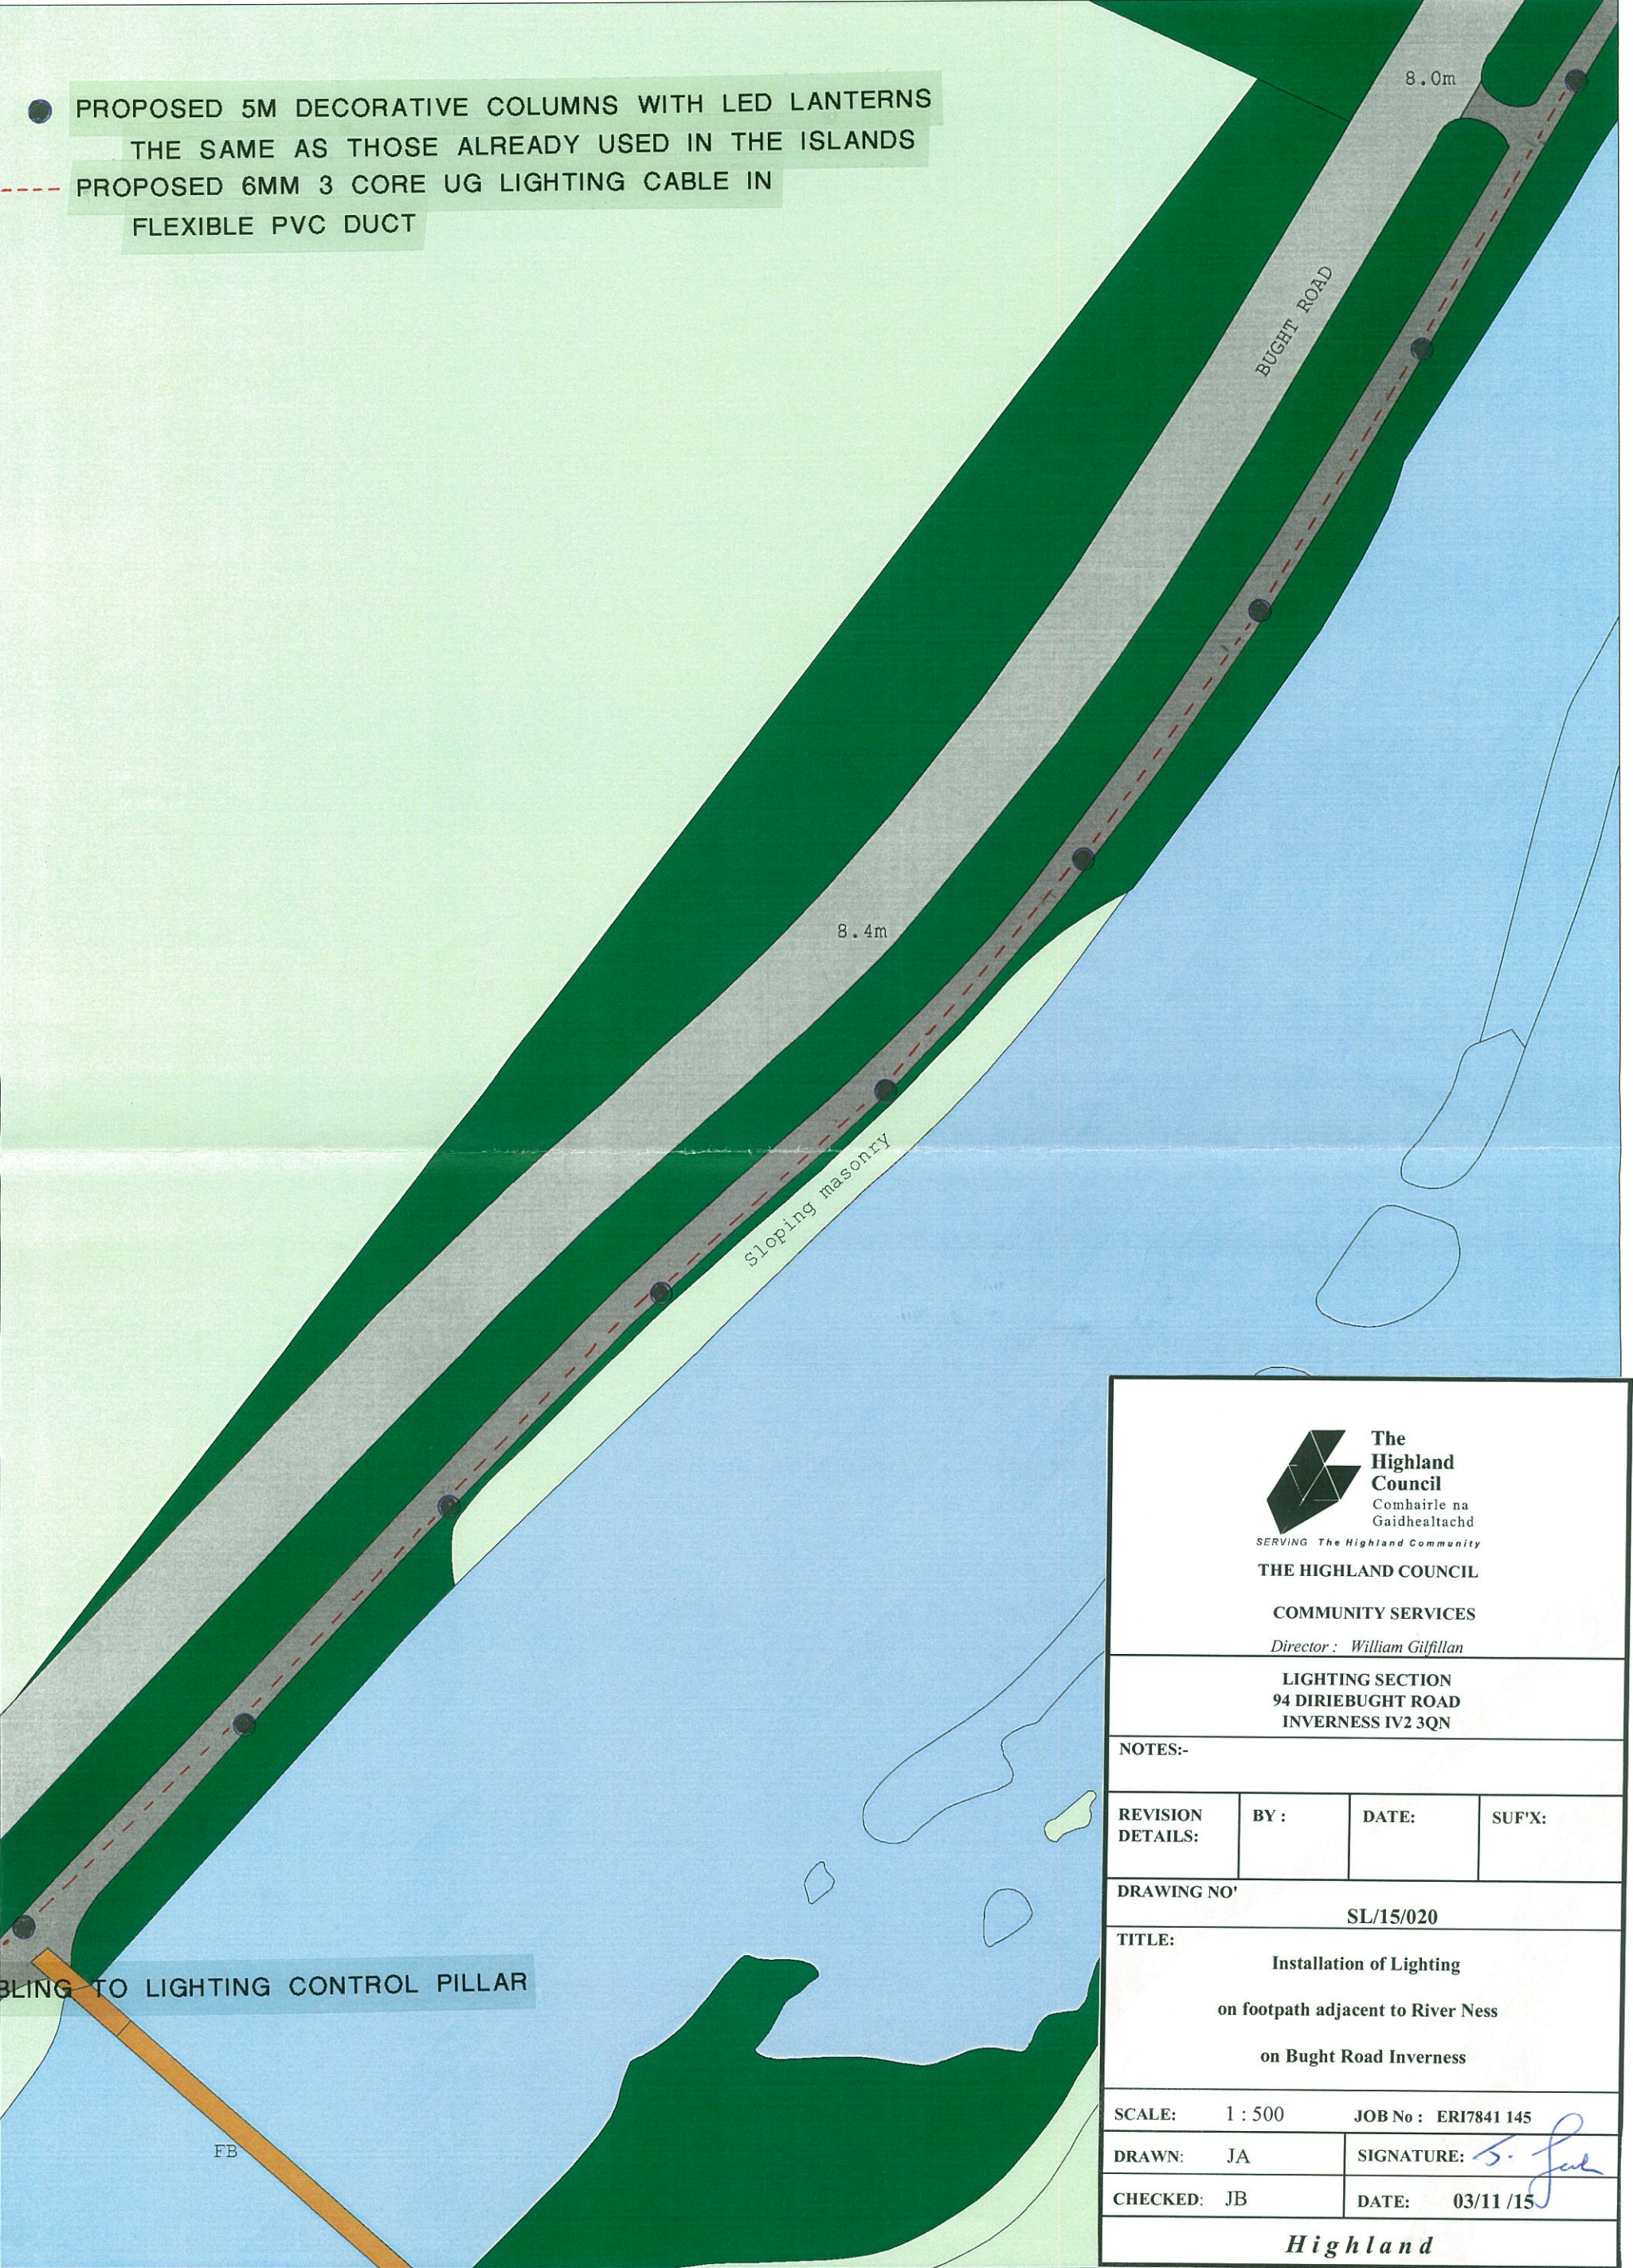
DRAWING NO' SL/15/020

Further to the recent request to consider the installation of lighting on the section of footpath from the suspension bridge to the end of the walled area, I attach a copy of my drawing number SL/15/020 marked up with my proposal.

OPTION 1 : use 9 x 5m steel columns with decorative embellishments and 32w LED Victorian style "ABBEY" lanterns, illustrations of the lantern and column is attached for information. The columns would be located against the railings on the inside of the footpath. If the columns were to be located on the opposite side of the footpath, against the wall, there is a distinct possibility of people climbing on the columns and carrying acts of vandalism to the lanterns. Light spill onto the River is a potential issue and it is proposed to paint the lantern panel parallel to the River black to reduce any light spillage. The column and lanterns may well at some locations have an impact on the tree canopy above the footpath, normally the branches would be selectively pruned and cut back however, the trees in the area are covered by a Tree Preservation Order and would require permission for the works to be carried out.

OPTION 2 : use 16 x 1m high illuminated " PHAROS " bollard with 11w LED lantern, illustrations of proposed bollard is attached for information. The footpath will be lit to the same standard as that of the "ABBEY " lantern. The bollard will be located as in Option 1 and will have no impact on the trees and any spill light will be adequately controlled. The potential for vandalism to the units will be minimal with the proposed bollard having been designed and tested for " real world " vandal resistance. The robust construction method and shatterproof lamp protector ensures that the Pharos bollard can withstand almost anything!  
Cabling and duct works along with bollard foundations will be carried out as in OPTION 1.
