**Golspie Links Coastal Protection Works**

**THE HIGHLAND COUNCIL**  
**GOLSPIE LINKS ROCK ARMOUR**

**INSPECTION REPORT**

**1741/D/001**

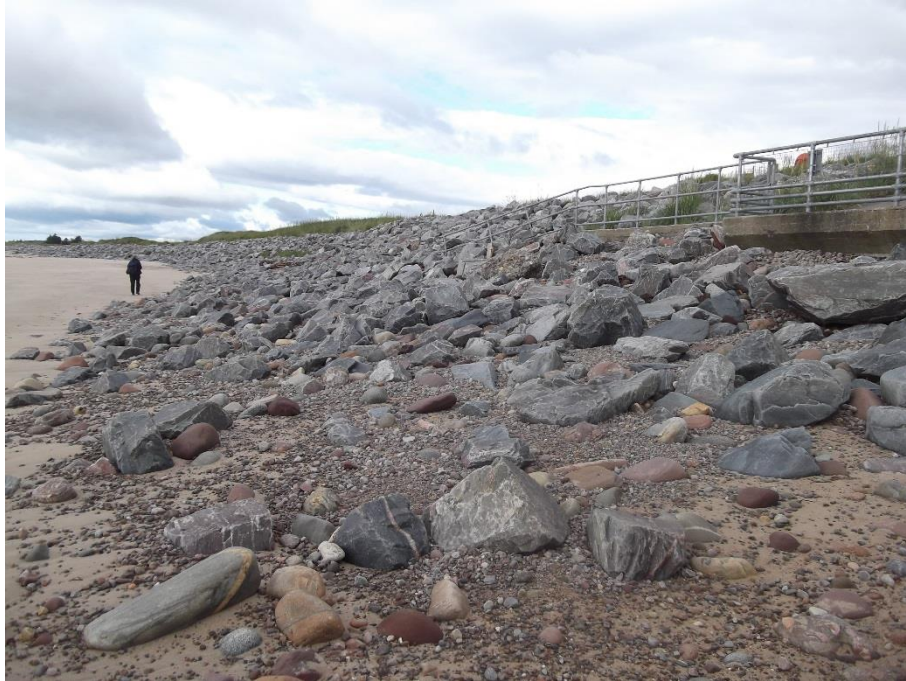
**Point 1**

Points 1 to 2 – the armour in this section is relatively flat, of mixed armour stone size (from the odd larger piece at 3t to generally 0.2t to 0.4t), the armour is poorly interlocked, resembling more of a rip rap protection than armour. The slope steepens up towards point 2 but appears too steep for the size of the armour and as a consequence has suffered damage.

The most northern section of armouring is in a poor condition with a mixture of small size armour and larger armour, but predominantly small. This has been damaged during storms and is now lying at a shallow angle more like rip rap than armouring.

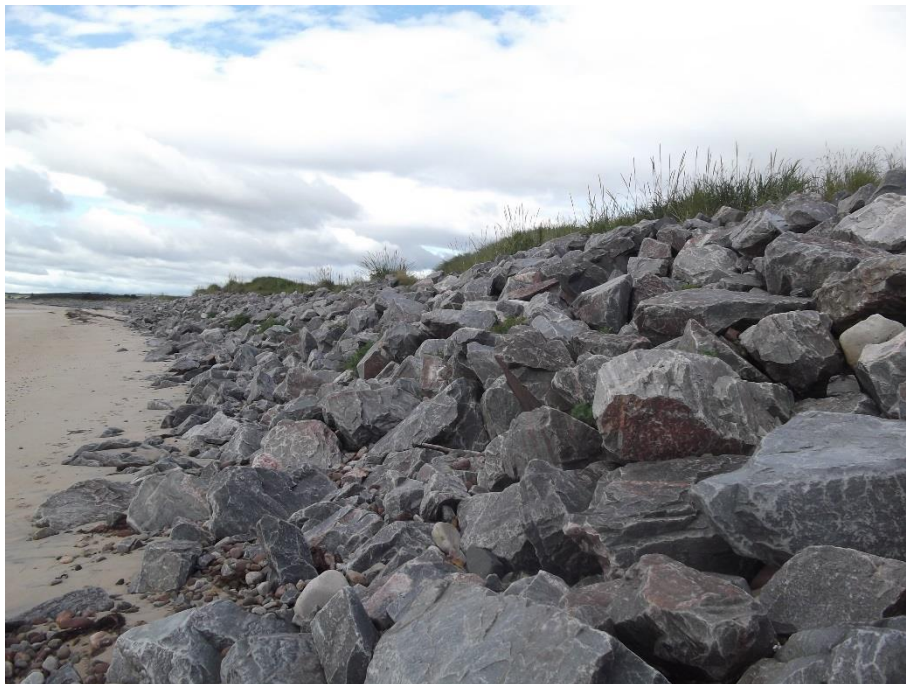
**Point 3**

Point 3 – armoured slope improved with more regular size larger armour of 1.4t but lots of gaps between stones and some armour lying on the beach.

The crest level of the armour from Points 3 to 11 is generally too low with erosion of the dune occurring at the top of the armour. There is no evidence of an underlayer (or secondary armour layer) or any geotextile to separate the rock armour and dune comprising sand and shingle.

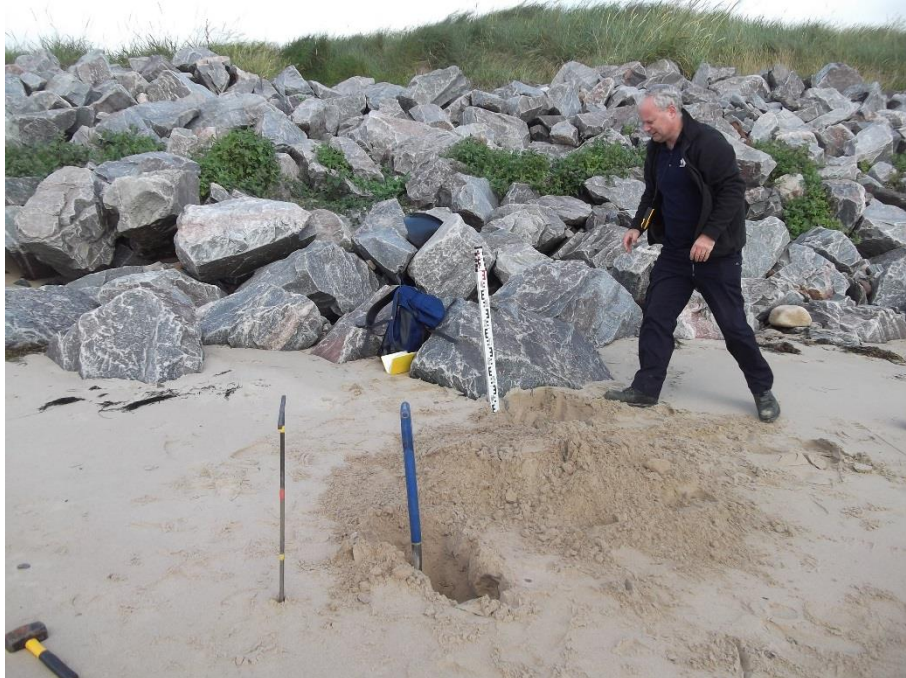
**Point 4**

Point 4 – trial pit confirmed that the toe stones are present under the sand at least 2m beyond the toe as it meets the beach.

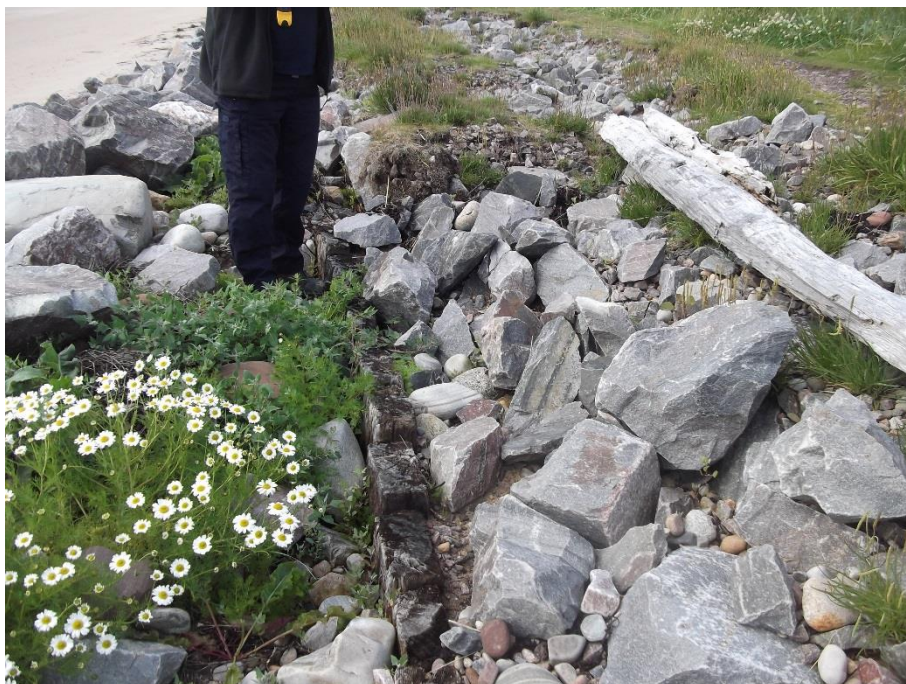
**Point 5**

Point 5 – erosion of the dune at the top of the armour with a timber sleeper wall visible.

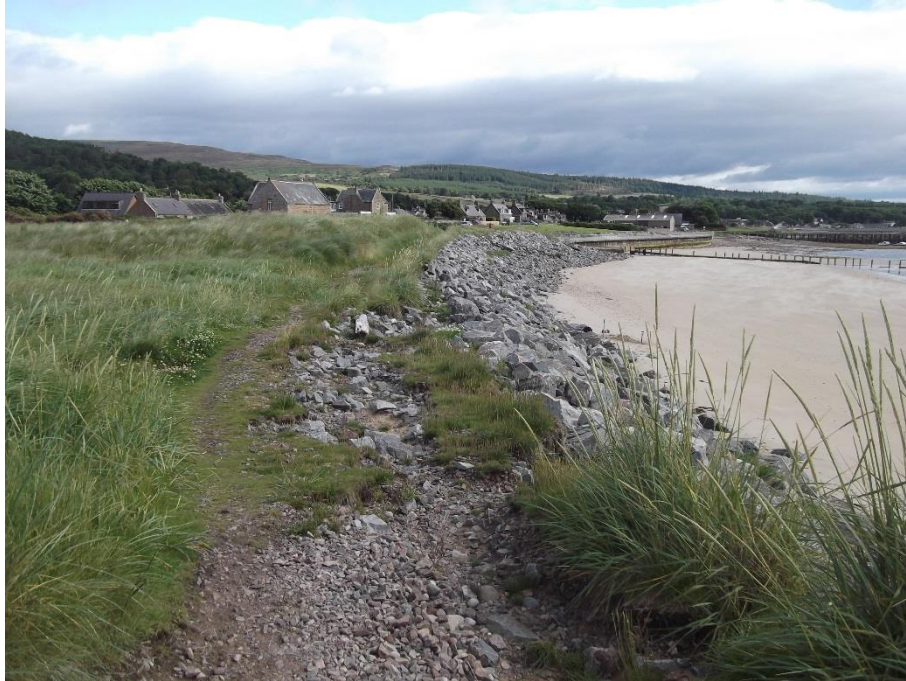
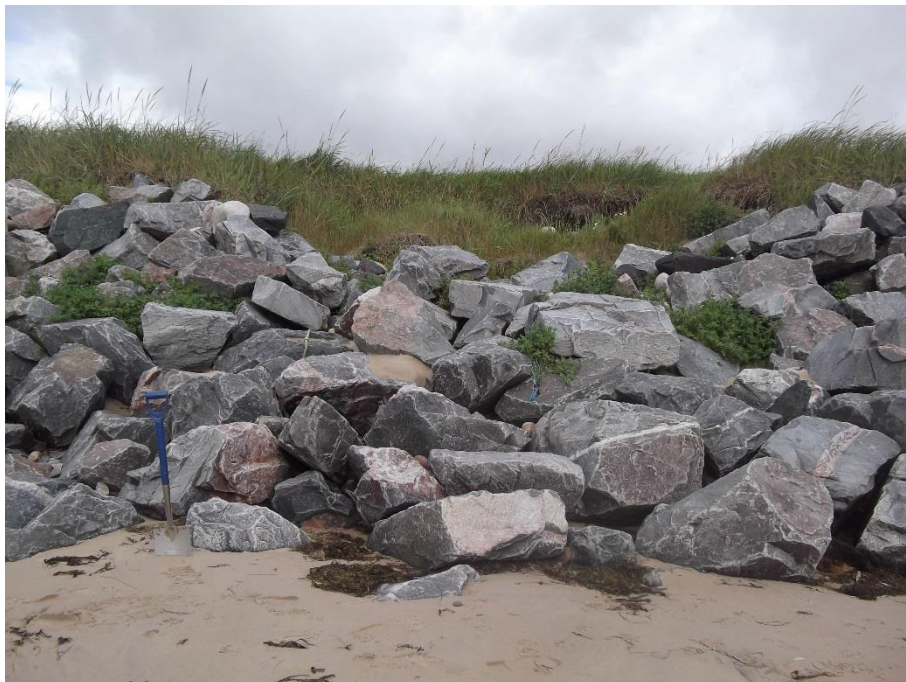
**Point 6**

Point 6 – erosion of the dune over some 6m length, with top armour stones missing.

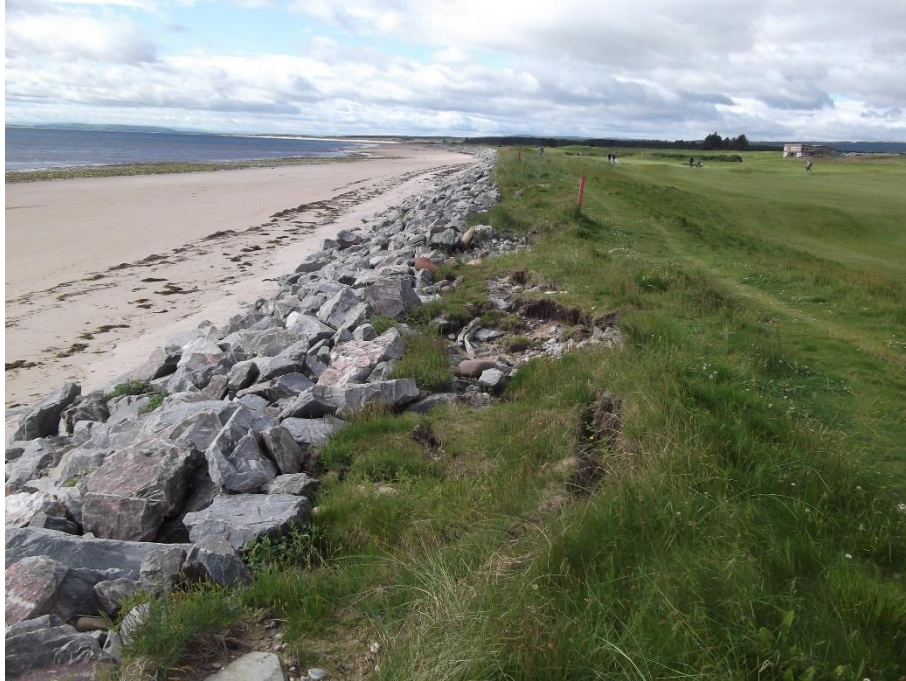
**Point 7**

Point 7 – eroded dune at the top of the armour over approximately 6m length.

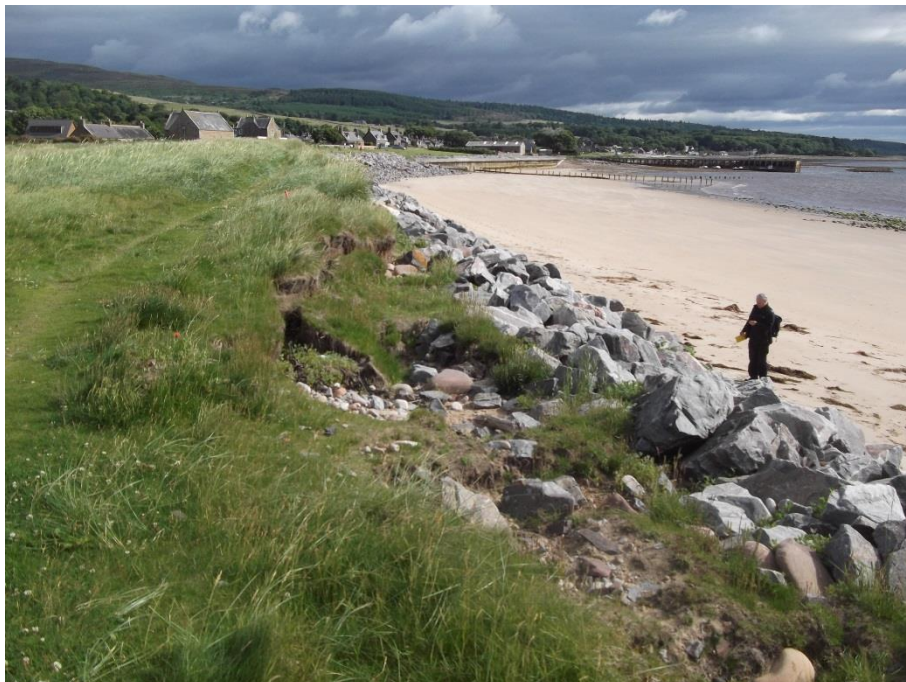
**Point 8**

Point 8 - eroded dune at the top of the armour over approximately 30m length.

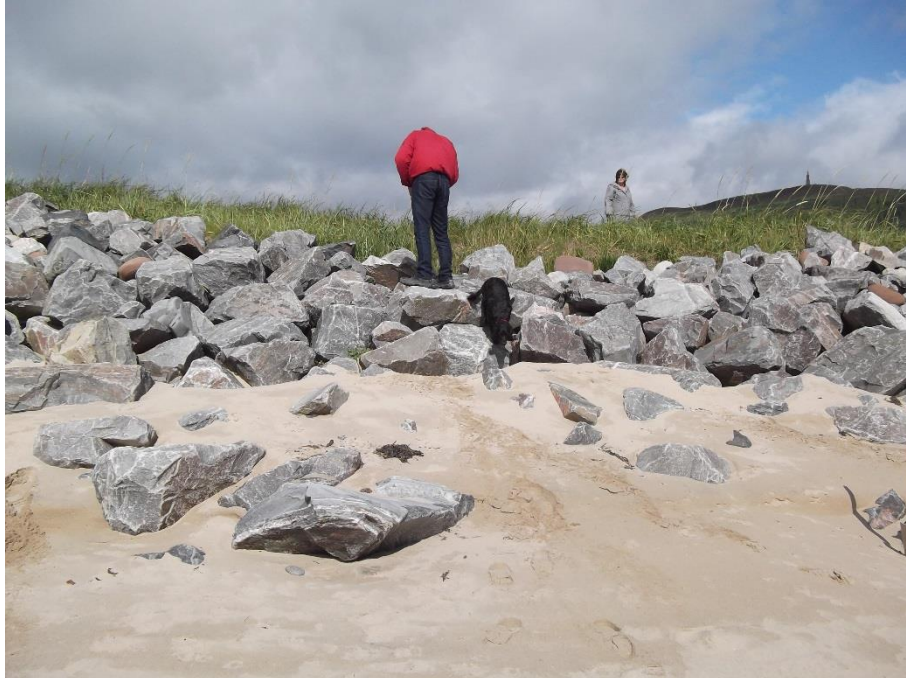
**Point 11**

Point 11 – armour buried in sand, crest height low exposing dune to erosion.

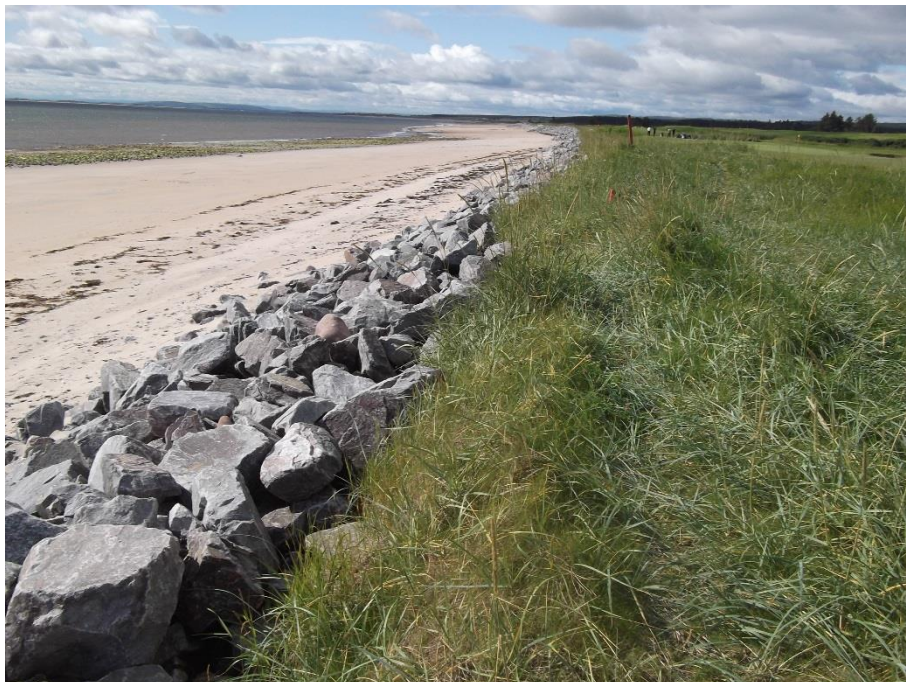
**Point 12**

Point 12 – good section of armour with crest above dune by 0.5m and armour extending landward over the crest.

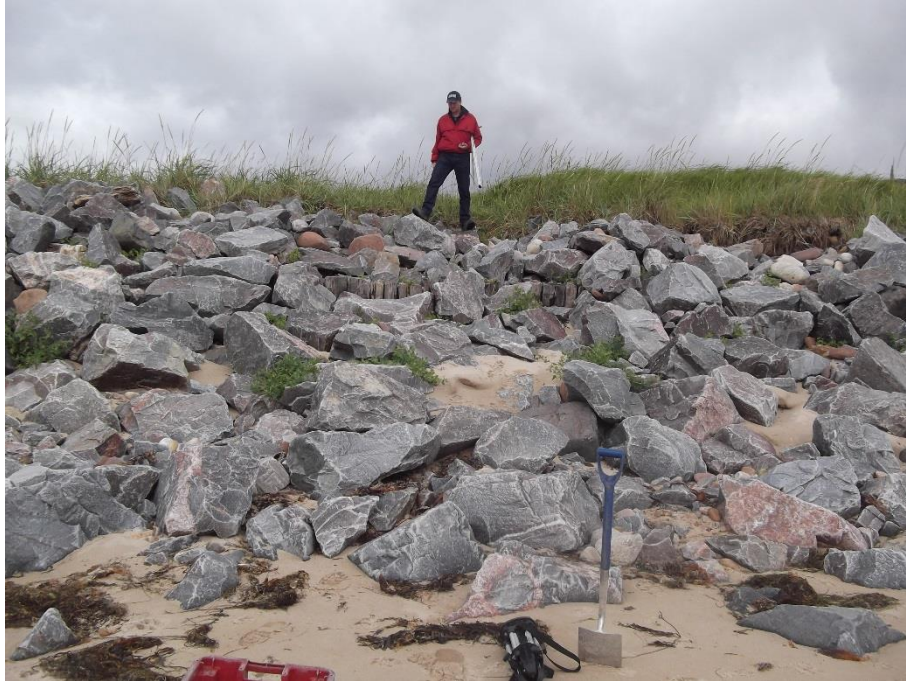
**Point 14**

Point 14 - poor section of armour with lots of gaps between stones.

Between Points 13 and 14 the armour slope is poorly constructed. There are however some good sections of armour with a crest height above the dune level and no erosion occurring.

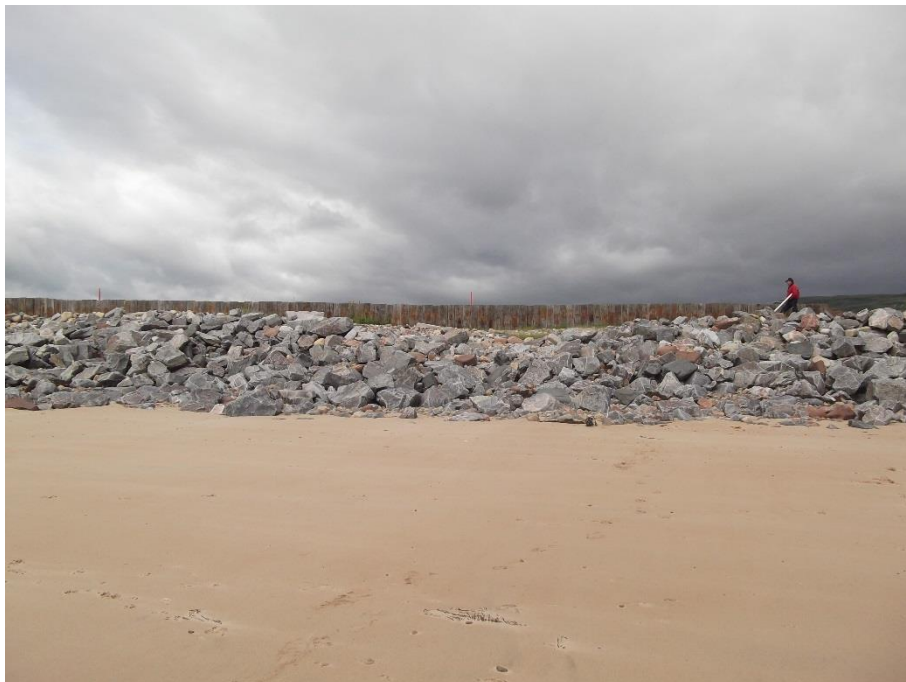
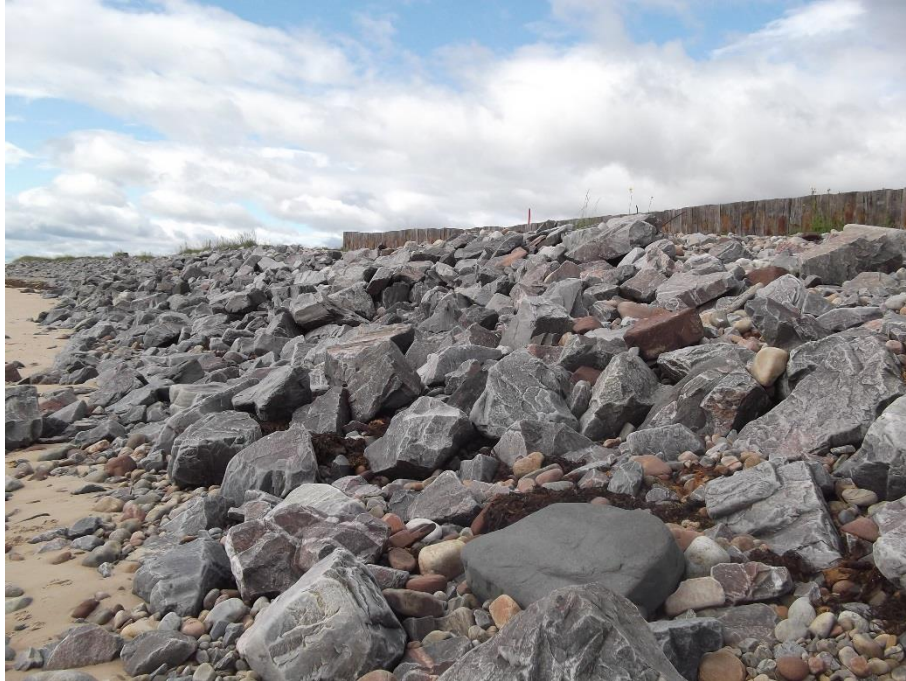
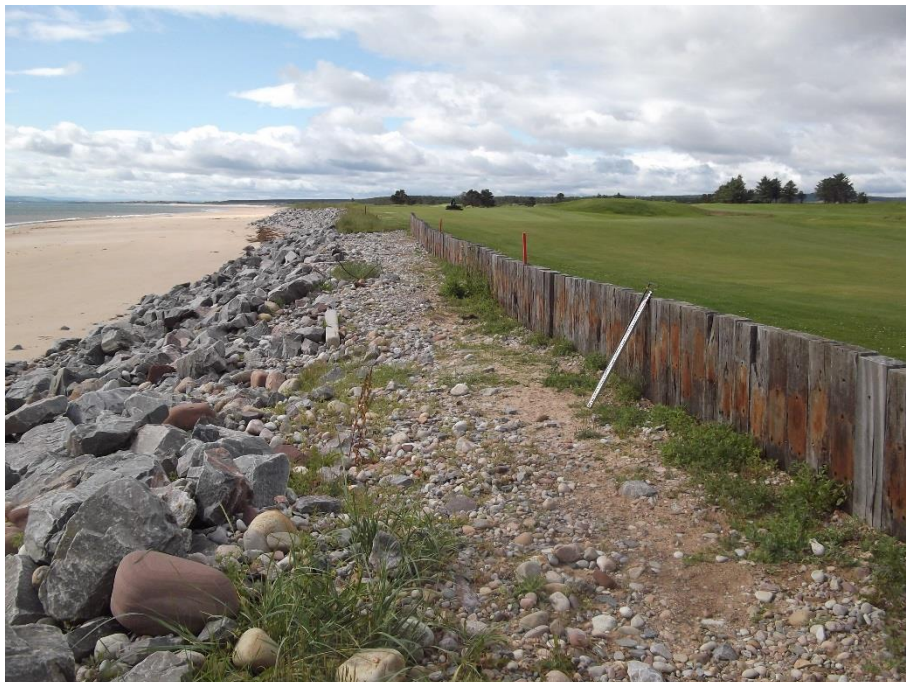
**Points 15 & 16**

Points 15 to 16 – timber wall present, crest of armour too low, armour appears to have slumped.

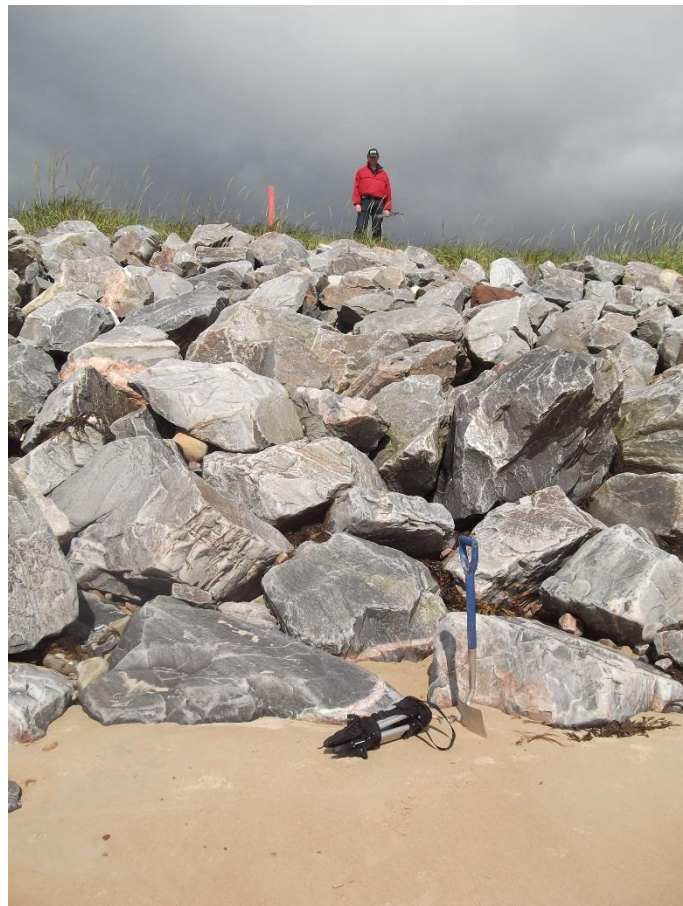
**Point 18**

Points 17 to 18 – bay with shingle in amongst armour and at base, high level of armour crest at 18.

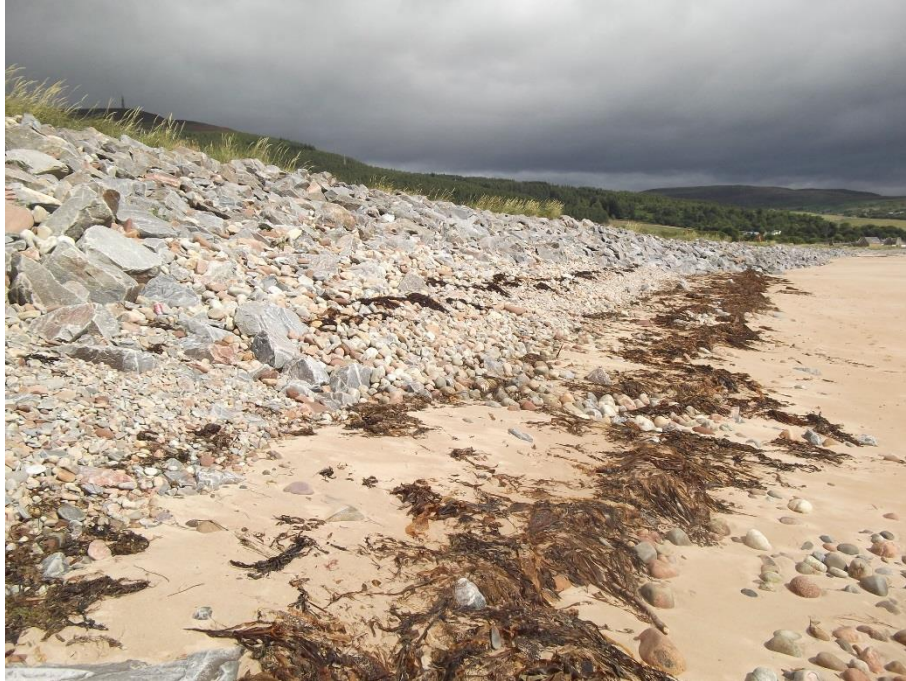
**Points 17 & 18**

The armouring generally improves beyond Point 15. However, a series of bays have been poorly armoured with the crest going down with the level of the land behind, so subject to overtopping and damage during storms.

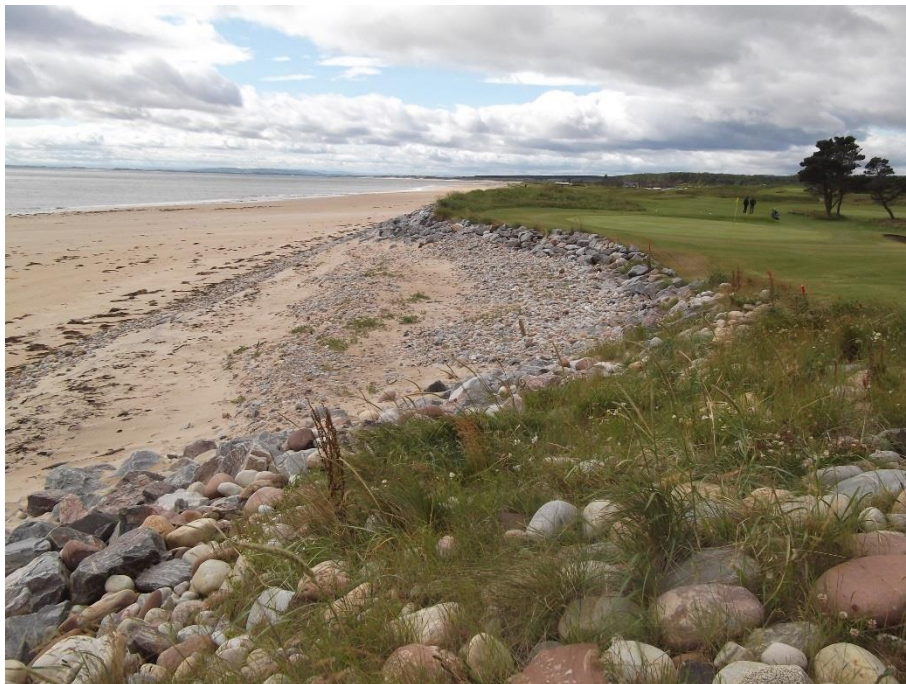
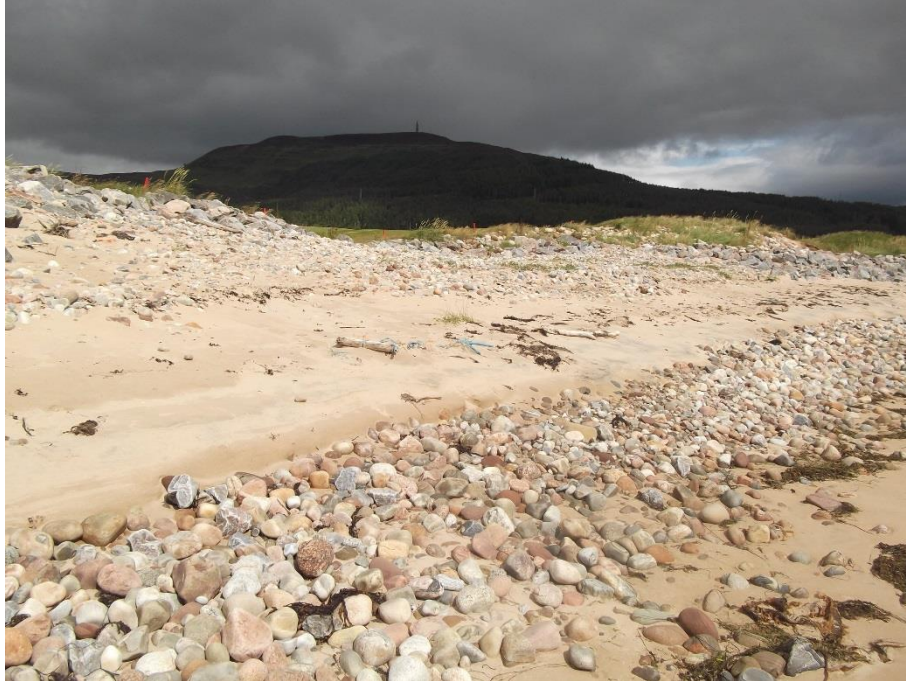
**Point 20**

Point 20 – shingle bay with very little armour next to the 4<sup>th</sup> green, crest too low and armour only 1m high.

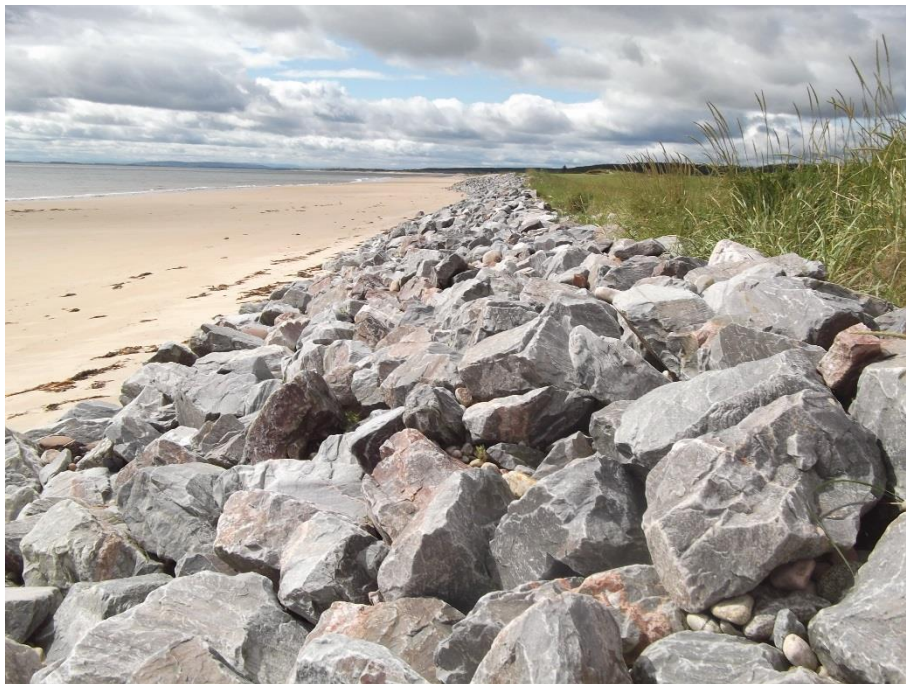
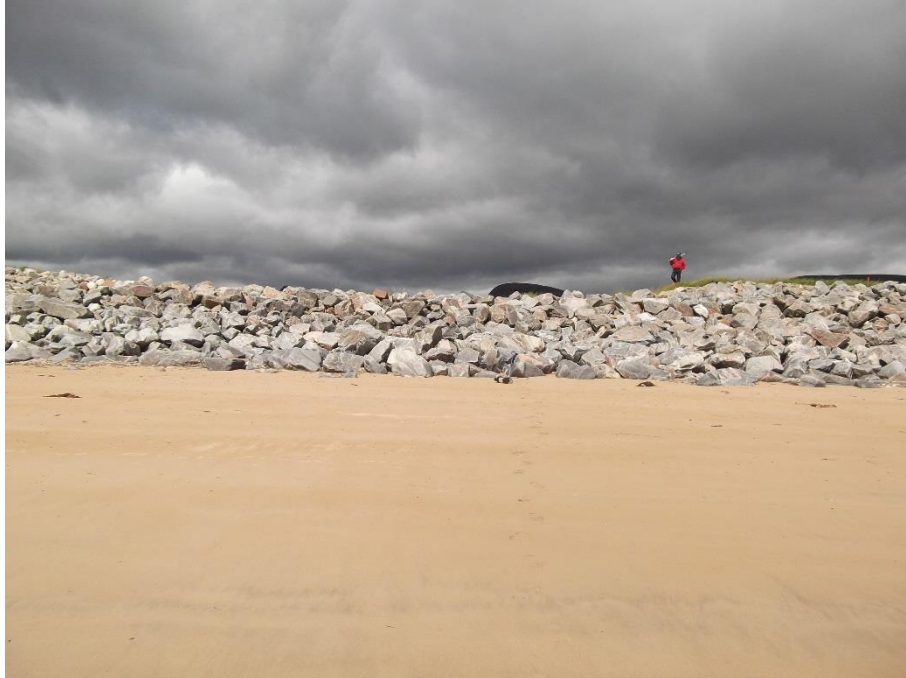
**Point 22**

Point 22 – armour done well at this bay maintaining a crest level, slope angle was surveyed at 1 in 2.9.

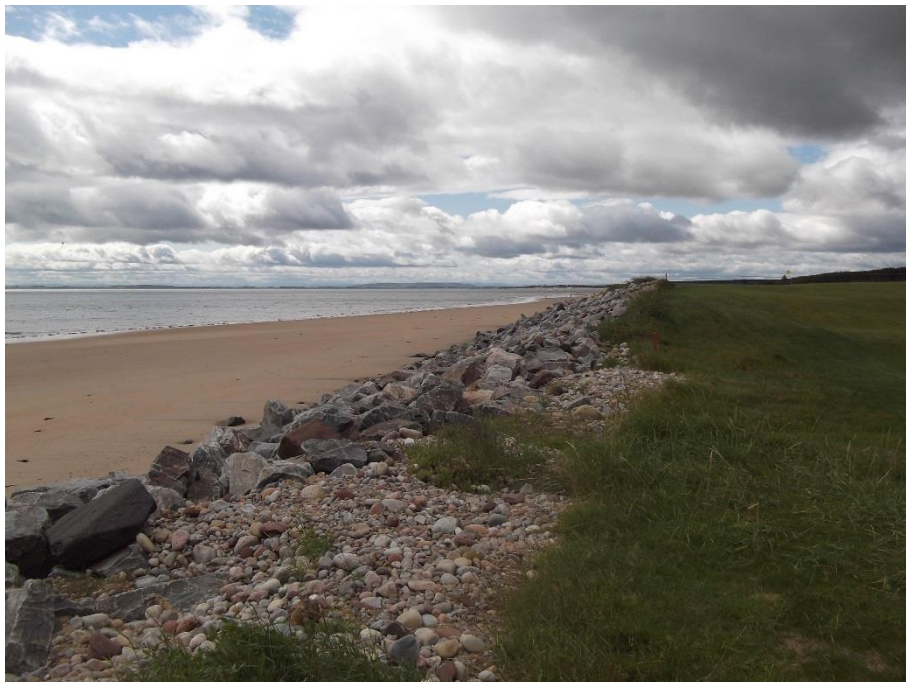
**Point 23**

Point 23 – shingle exposed on top of slope behind crest armour, some movement of crest stones and erosion at the top.

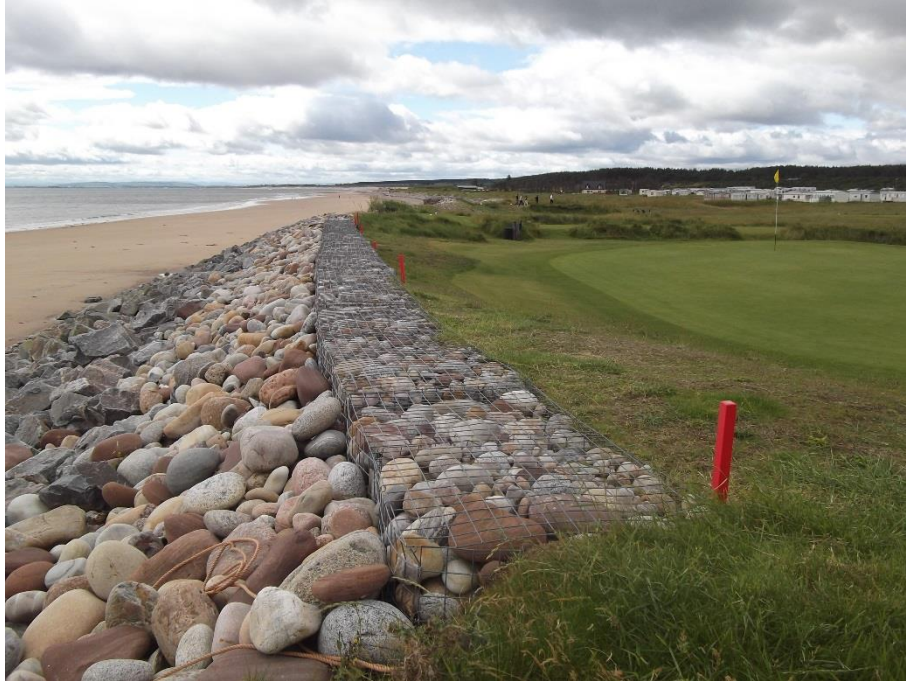
**Point 26**

Points 26 to 27 – gabion baskets at top of slope along edge of green, armour high with generally round stones at the top, these are too small and will be moved in a storm. Beyond the gabions a timber wall is present, but the same issue of the round stones placed against it. This detail extends to the next tee. The slope angle was surveyed at 1 in 2.8 at this section.

The remedial work carried out at Points 26 to 27 using rounded stones will be unlikely to survive the next significant storm event as it is under sized compared to the armour stone.

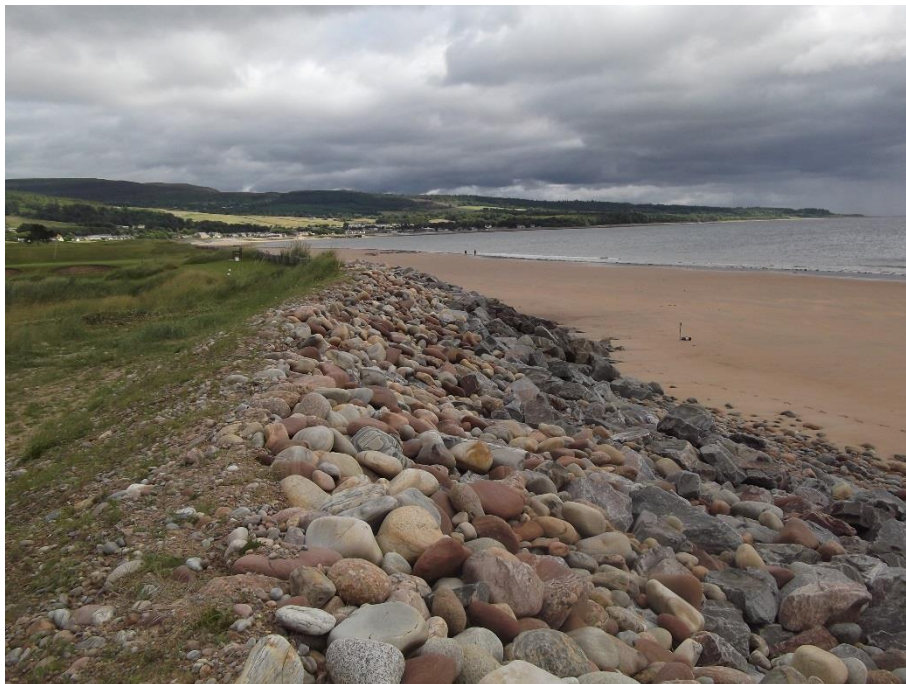
**Point 28**

Point 28 – poorly armoured slope with too small armour and use of round stones. The angle of the slope was surveyed and varies from 1 in 3 at the top to 1 in 5 at the toe.

The section of armour near the 7<sup>th</sup> tee, Points 27 to 28, is in a poor condition and already at a slack gradient. Further failure or erosion here may lead to undermining of the gabion wall.

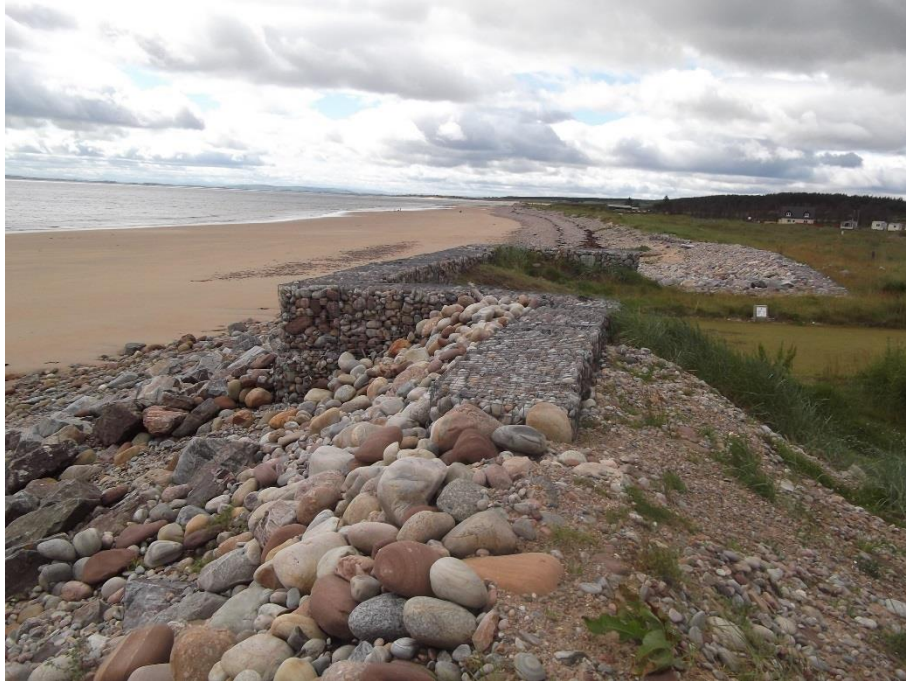
**Point 28/29**

Point 29 – gabion basket wall constructed at 7<sup>th</sup> tee, poorly armoured slope below it with a mixture of size of stone, some of which is round. Slope fairly flat, appears to be slumped.

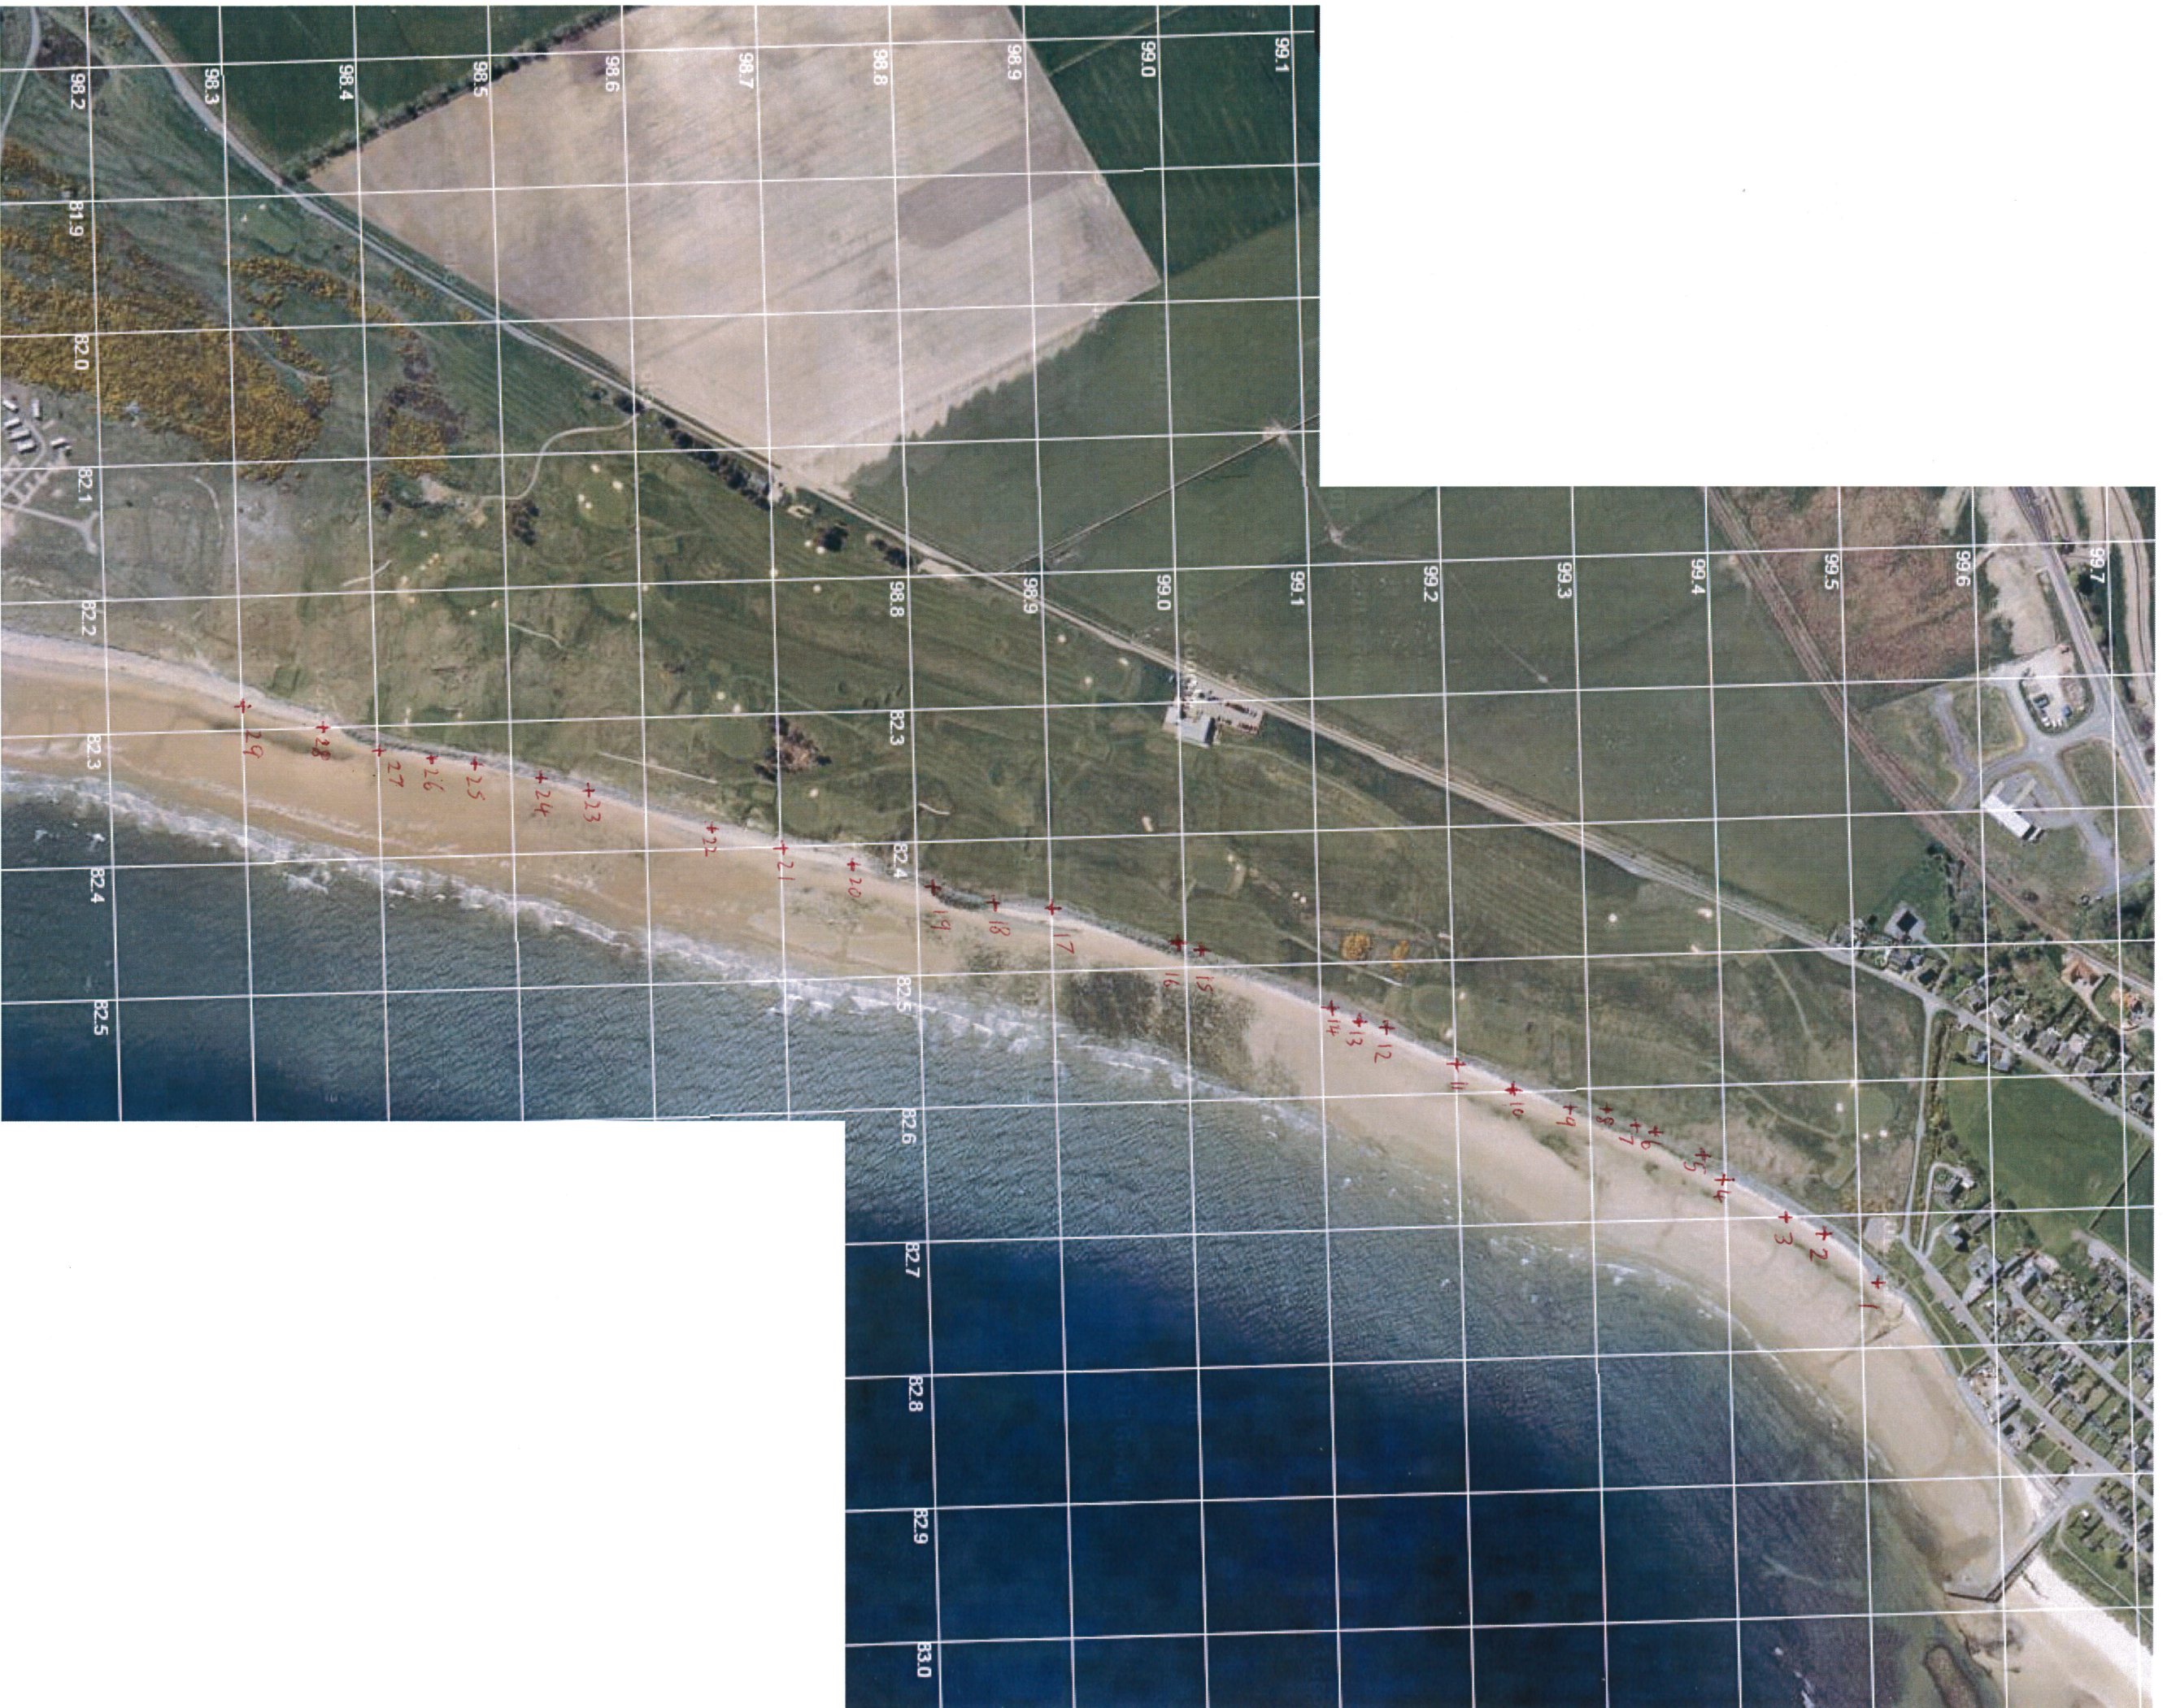
## **Appendix B - Marked up Aerial Photograph**

An aerial photograph is included in Appendix B marked up with point numbers which locate where details of the armour condition were recorded, the position fix was taken using a hand held GPS. The inspection commenced from the outfall at the beach to the north of the golf course and extended down to the gabion wall at the 7<sup>th</sup> tee. Appendix A contains photographs of the armouring.
