Agenda Item	10
Report No	SR/6/25

Report Title: Portree Harbour Update

PORTREE HARBOUR REPAIRS

FEASIBILITY STUDY

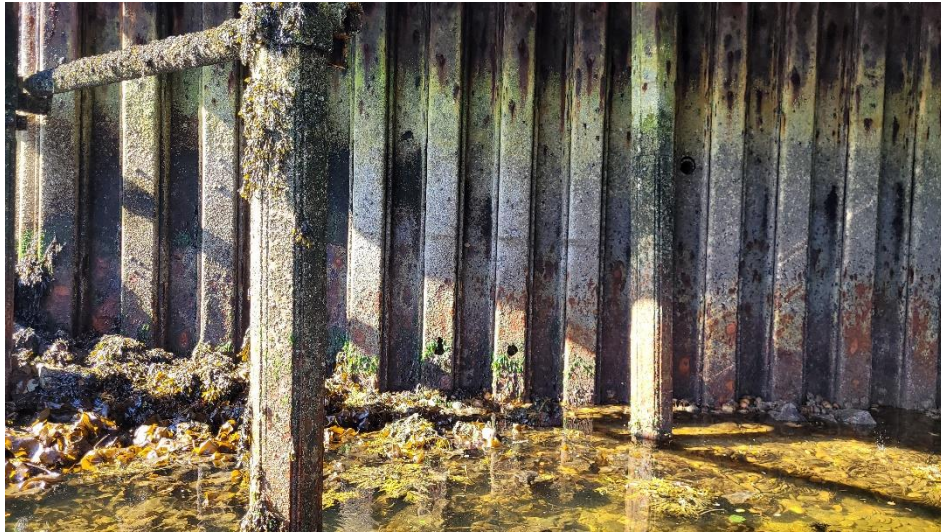
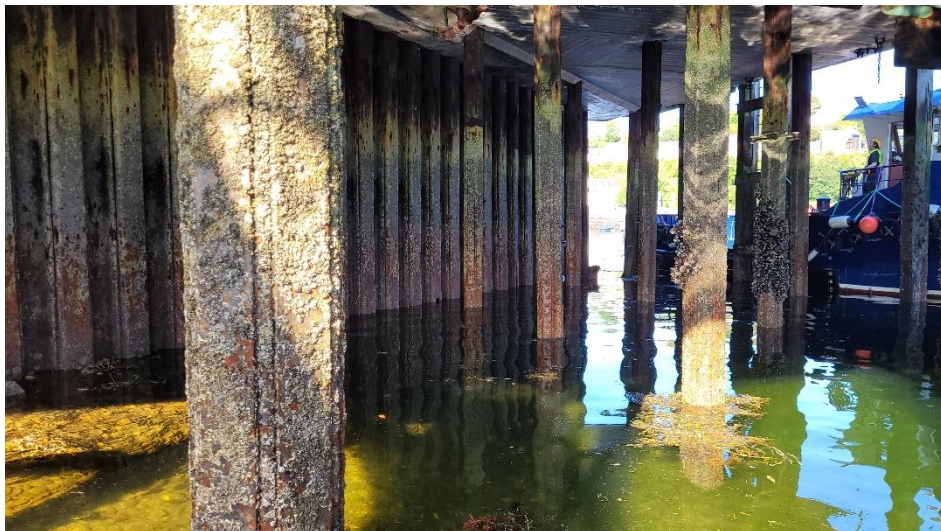
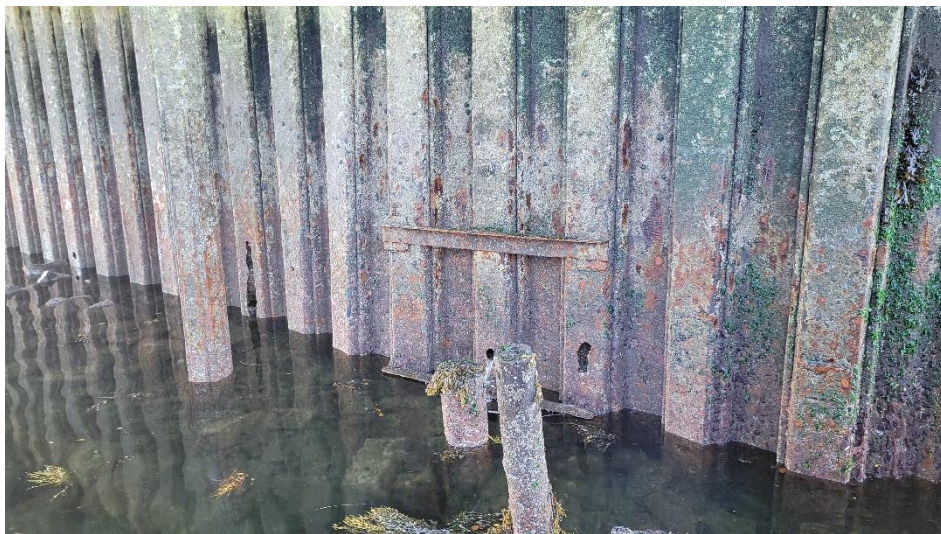
Significant loss of section due to accelerated low water corrosion (ALWC) has occurred in the sheet piles at the bed level and just above, with numerous holes in the outpans and extensive orange corrosion visible. The most recent steel thickness measurements were undertaken in 2021 and generally showed thicknesses of 5mm or more (refer to Appendix C for readings). The lowest was 3.1mm at pile 100. There were two holes recorded at piles 125 and 127. During the recent inspection more holes were visible at piles 93, 83 (long slot), 75 and 73 (refer to photos in Appendix A).

Photo 1: Sheet Piles under Deck

Photo 2: Sheet Piles under Deck

Photo 3: Sheet Piles under Deck

Given that there is a masonry wall behind the sheet piles, repairs to the sheet piles are proposed at low level only.

Welding on 10mm thick steel repair plates, localised to the holes, is the simplest solution. Based on the recent steel thickness readings, the majority of the piles still have a reasonable steel thickness remaining at high level.

Cathodic protection anodes must also be installed to the sheet piles and plate repairs. These anodes should be placed horizontally to keep them under the water as long as possible, to be most effective, but above bed level so they do not become buried by sediment. Note that the CP will only protect the sheet piles up to mid tide level. Above this level the sheet piles will continue to corrode away over time.

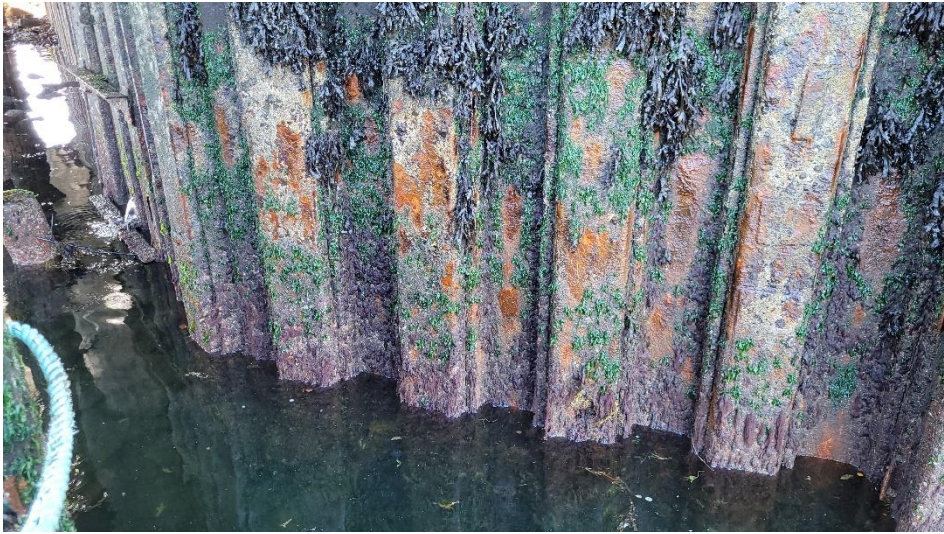
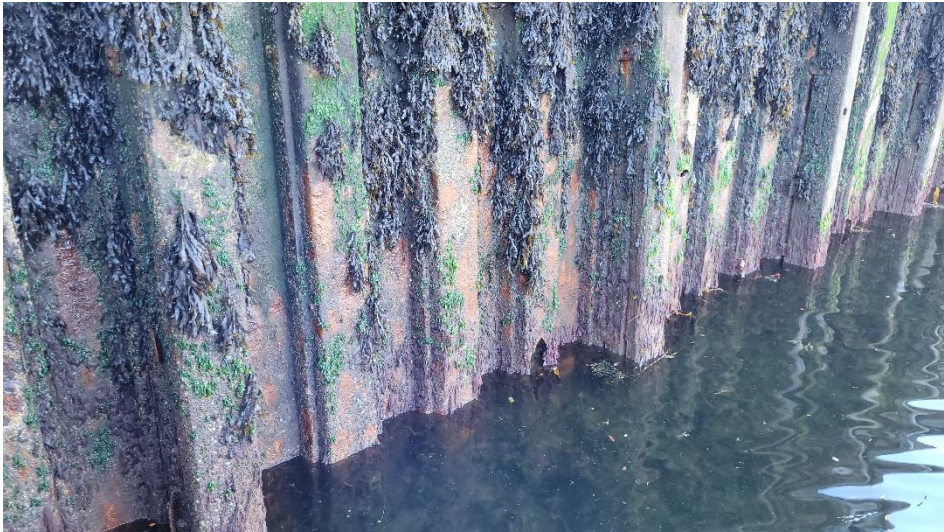
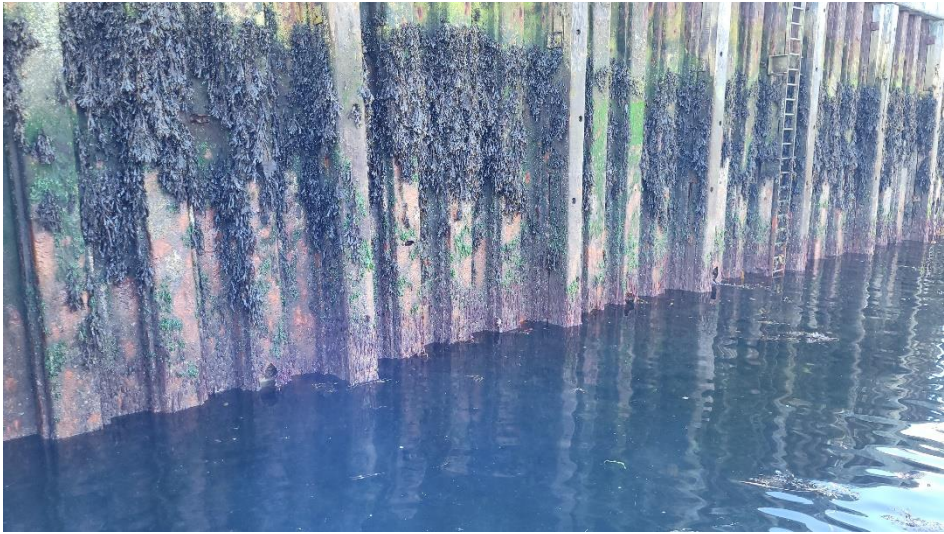
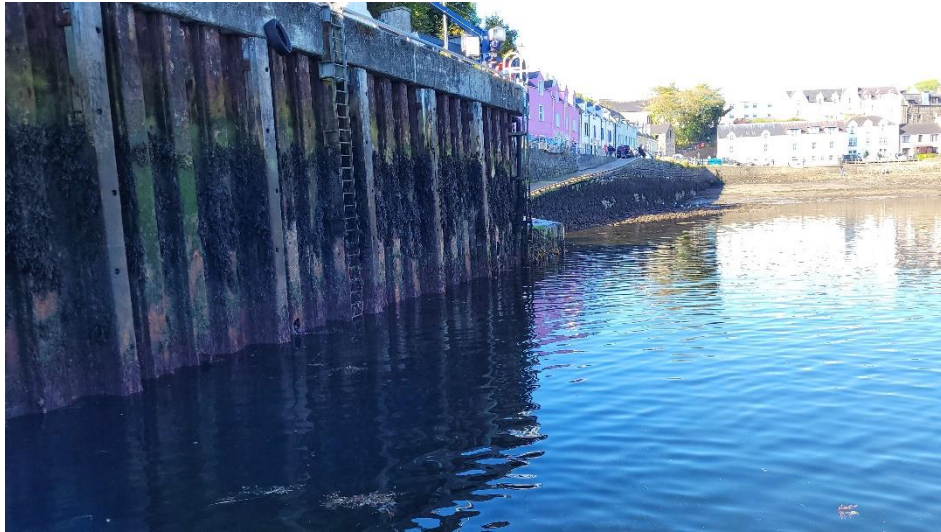
The timber fenders are taking a lot of vessel impact, are in a poor condition and are even missing at the inner end next to the ladder.

Photo 4: Sheet Piled Wall

Photo 5: Sheet Piled Wall

Photo 6: Sheet Piled Wall

Photo 7: Sheet Piled Wall

Given that there is a masonry wall behind the sheet piles, repairs to the sheet piles are proposed. As the structure is used for berthing, the repair plates need to be extended to full height to prevent a step or ledge being present which could snag vessels.

Piles and repair plates will require CP anodes to be installed to protect the steel from ALWC. Anodes will need to be as short and low as possible to keep them immersed.

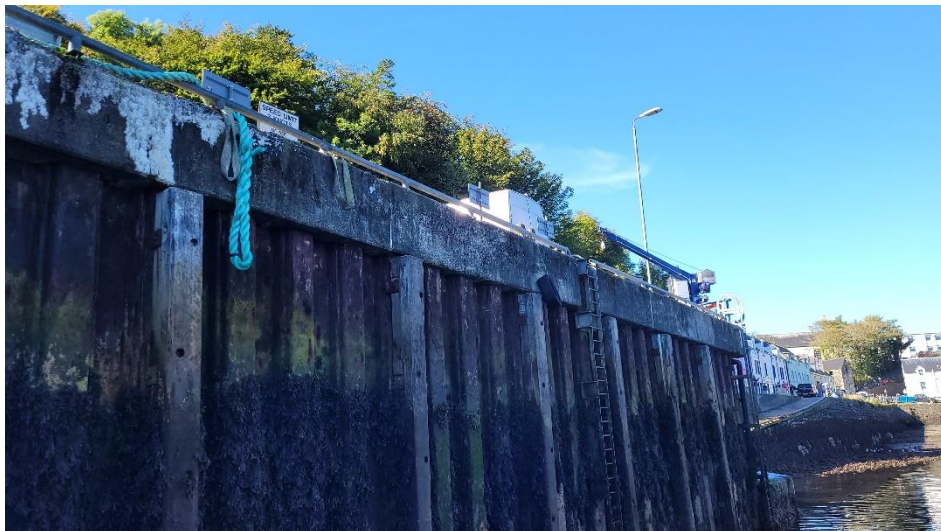
Photo 8: Sheet Piled Capping Beam & Fenders

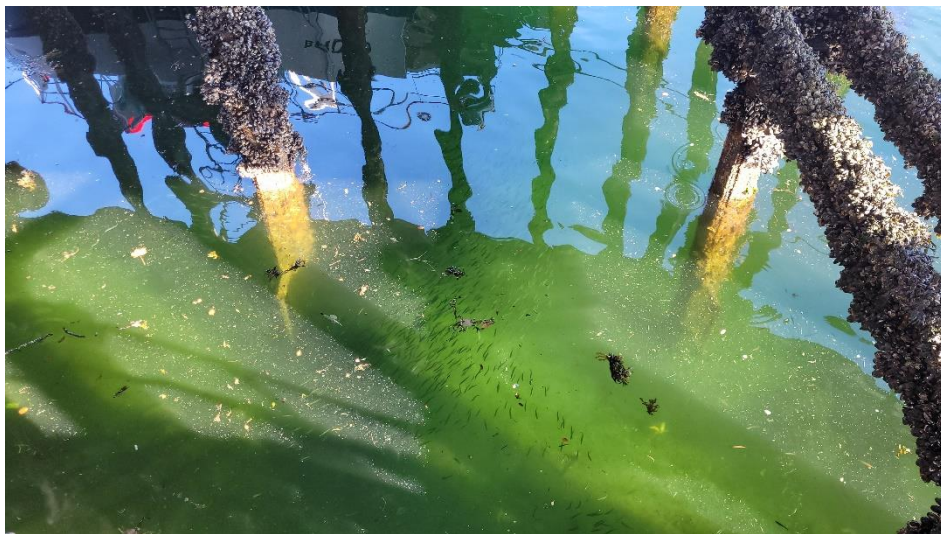
The upper portions of the piles are heavily corroded as they are unprotected by the CP (which is only effective below mid tide level) and lack any protective coating.

Photo 9: Rendhex Piles – Old Anodes

A new CP system needs to be installed to all piles. Any holes should be repaired by welding on 10mm thick steel plates.

The upper sections of the piles should be protected from further corrosion with a pile wrapping system such as Denso Seashield 70, a petroleum paste, Denso marine tape with a glass fibre outer wrap.

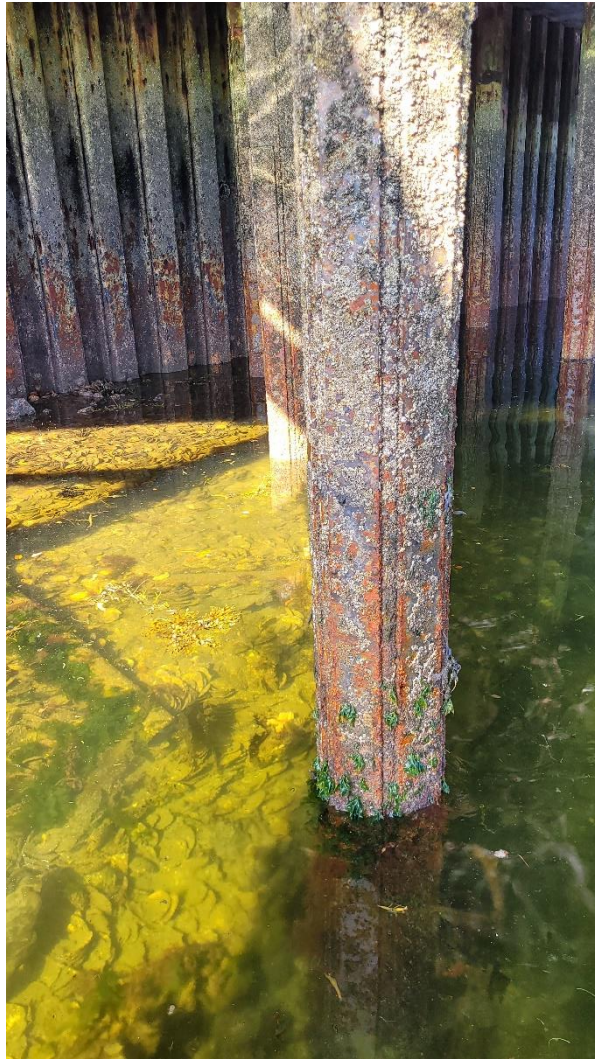
Extensive pile repairs were undertaken in 1994 organised by Bullen and Partners; comprising the welding of steel plates over corrosion holes to both sheet piles and rendhex piles. Two of the rendhex piles were fitted with a circular collar tube that was then grouted (pile reference R5 and R16).

Photo 10: Rendhex Piles – Plate Repairs Visible

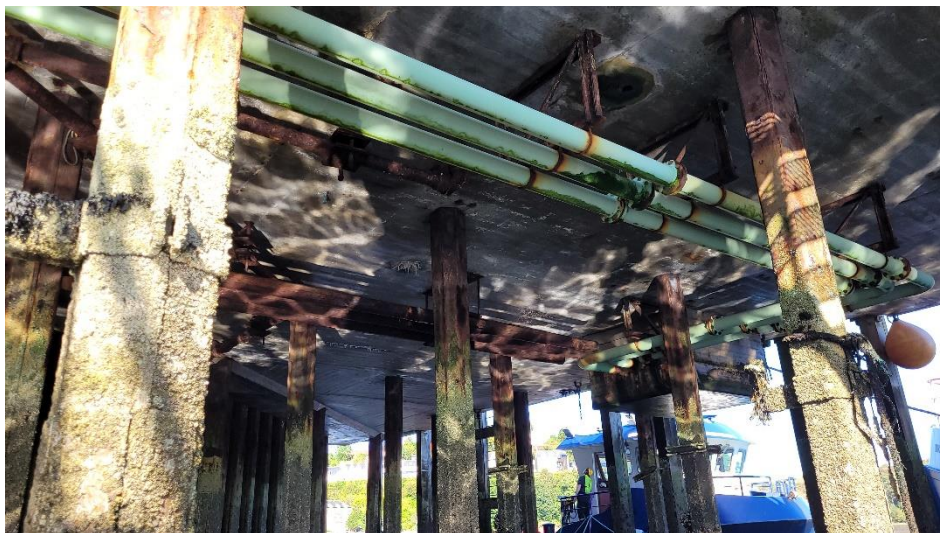
Photo 11: Redundant Pipework

4	Pier services	Removal of redundant pipework from under the pier.	All pipes	Remove redundant pipes from under the deck and cap any buried pipes.	Detail and remedial works.	Y	Y
5	Pier concrete surface	Concrete surface has suffered localised frost damage and impact damage and presenting a trip hazard. Ladder recesses and unused services chamber covers and mesh flooring present a hazard.	The outer 2m northern edge over full length of pier. Infill the 2 ladder recesses and chamber.	Concrete to be removed by hydro-demolition to below top repair and reinstated. Install rebar at infill of ladder recess and services pit and concrete these areas.	Detail a concrete repair system and rebar for the infilling of the ladder recesses and chamber.	Y	Y

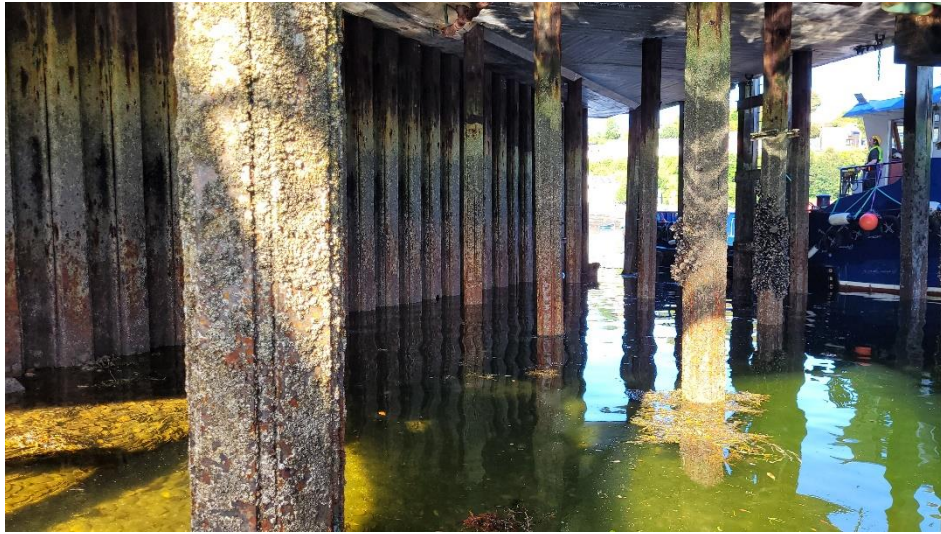
Photo 12: Rendhex Piles

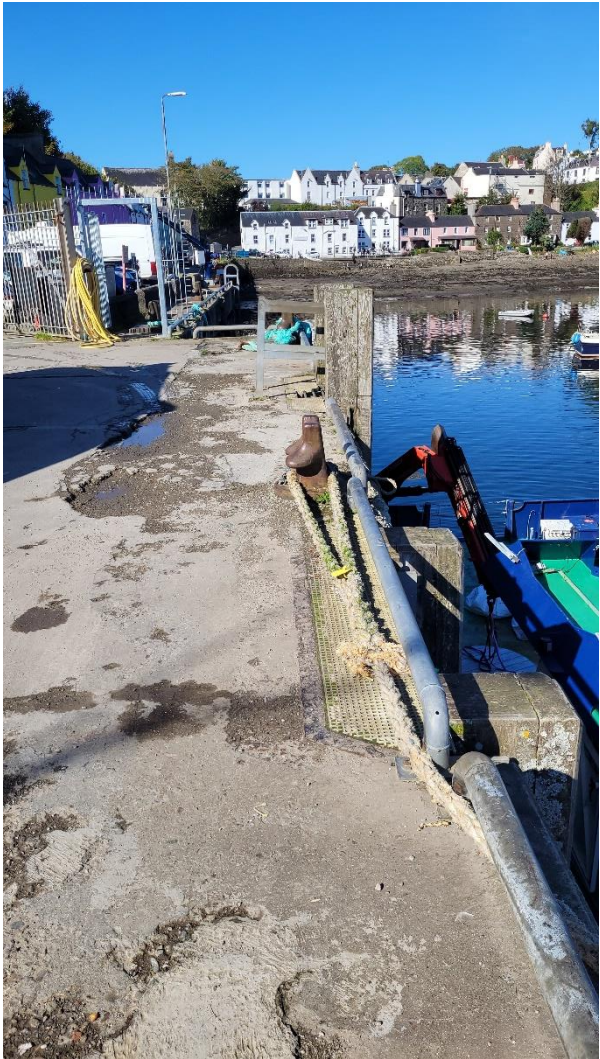
The surface of the pier edge is in a poor condition and likely caused by impact damage of dropped cargo and equipment as well as frost damage to a poor quality concrete.

Photo 16: Damaged Concrete Deck

The concrete surface is to be removed by hydro-demolition and cut back 20mm under the reinforcement bars to allow a concrete repair system to be applied. The rebar should be protected with a corrosion inhibitor paint and an R4 concrete repair product used for reinstatement. The width of the repair is over a 2m wide strip on the north side of the pier and is approximately 26m long.

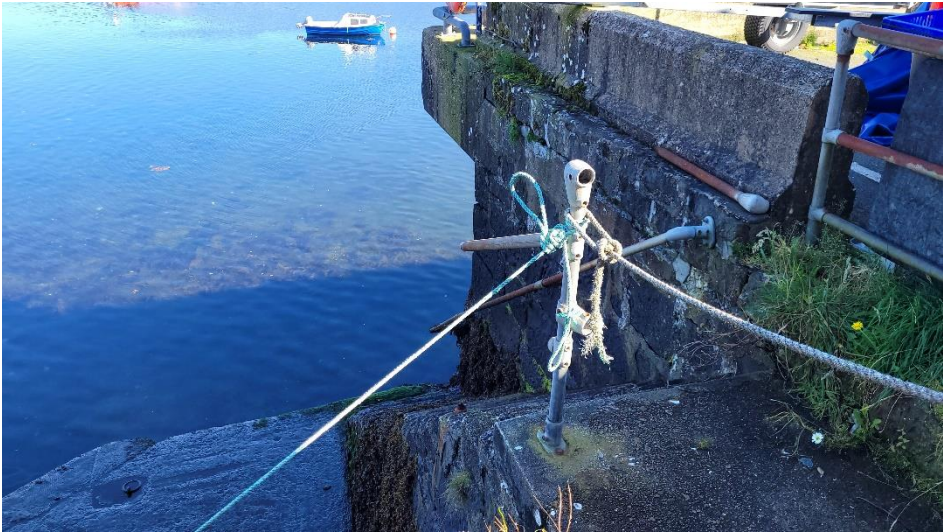
The steps at the outer end, that are adjacent to the pier, are in a poor condition and unusable, which is why they are currently barriered off. The outside handrailing is also missing.

The outer end of the steps and slipway is broken against the sheet piled wall and needs concrete repairs.

Photo 17: Pier Steps

The outer end of the steps needs to be cleaned of marine growth and damaged concrete removed to allow the structure to be recast inside a shutter to the original profile. Steel dowels will be required to attach new and old concrete together.

The existing steps should be replaced with a steel staircase with GRP or open mesh treads. The prefabricated staircase unit will have an integrated outer handrailing.

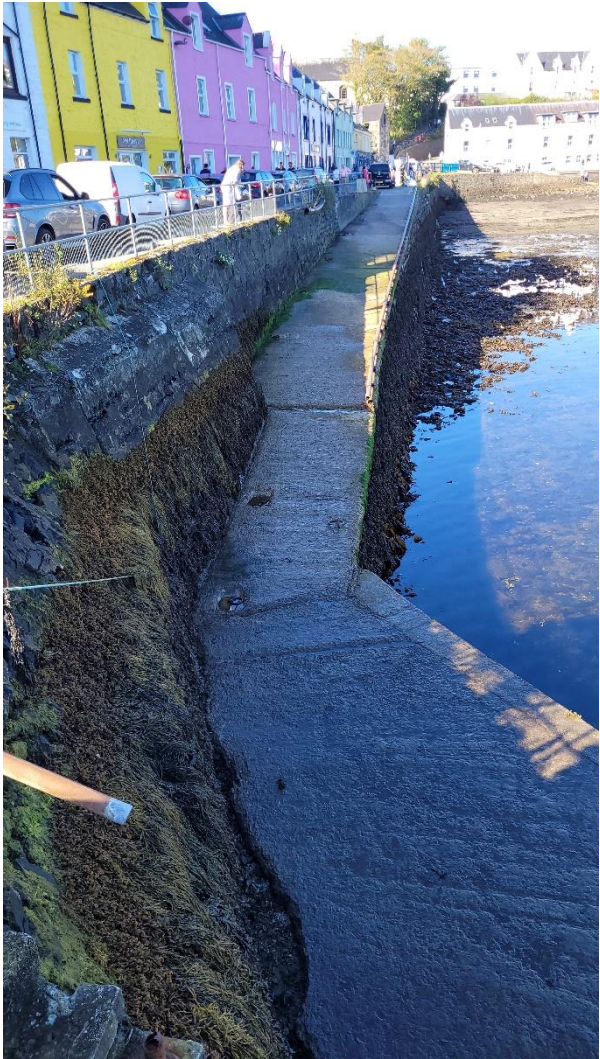
The surface of the slipway is rough and uneven, but this does help provide a grippy surface. There are two joints that are eroded and possibly being used for drainage from the inner edge channel out to the sea. This inner edge drainage channel is also eroded and has an irregular form. These are causing a trip hazard to users of the slipway.

Photo 18: Slipway

Where the inner drainage channel and two joints are damaged, these should be repaired with an R4 Concrete Repair product and shaped to provide a smooth formed channel and eliminate the trip hazards as it will be made more visible.

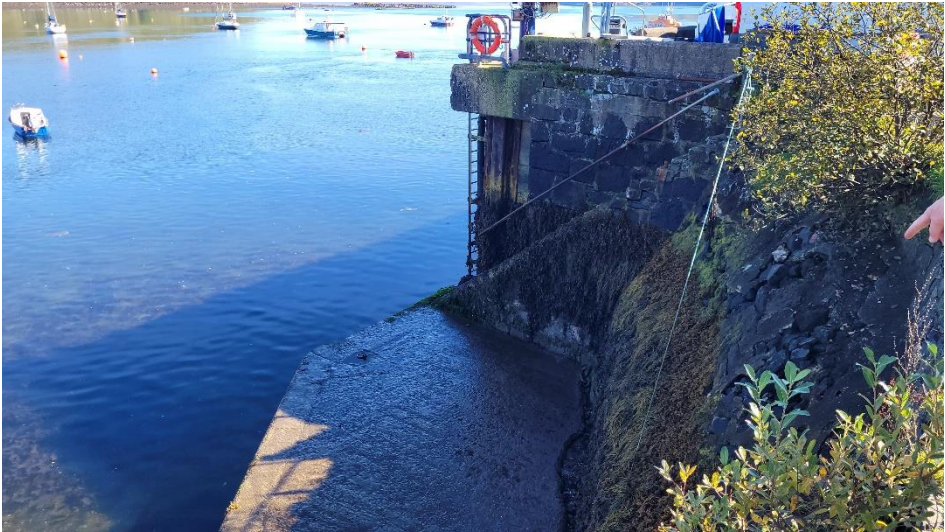
Photo 19: Bulge in Wall

A 3D laser scan is needed of this structure to confirm the extent of missing masonry stones, repointing, extent of the undermining and the geometry of the wall at the bulge.

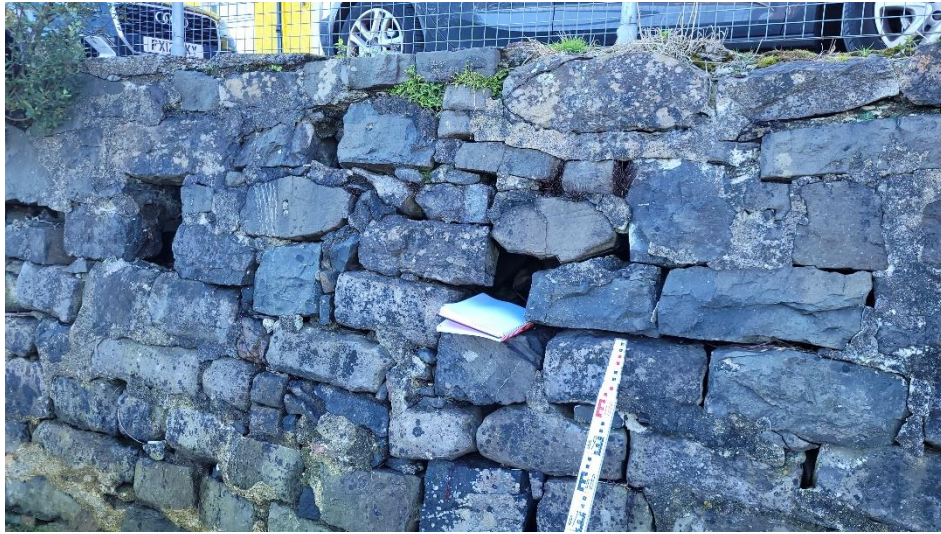
The stone masonry wall above the slipway has open joints and missing stones. It is not known whether the wall was ever fully pointed, but pointing does improve its longevity as it prevents stones becoming dislodged during wave attack.

Photo 20: Missing Stones in Retaining Wall above Slipway

The stone wall above the slipway should be repaired where stone is missing by fitting new stone into the voids and pointing the open joints. The type of mortar to be used will need to be agreed with the HC Planners as this is a conservation area.

Use of lime mortar is difficult in the tidal zone, so the use of cement mortar should be proposed. The stone looks to be a hard local stone so is not likely to be damaged by the use of cement mortars with 30N/mm² or 40N/mm² strength (such as Tarmac PPM30 or PPM40).

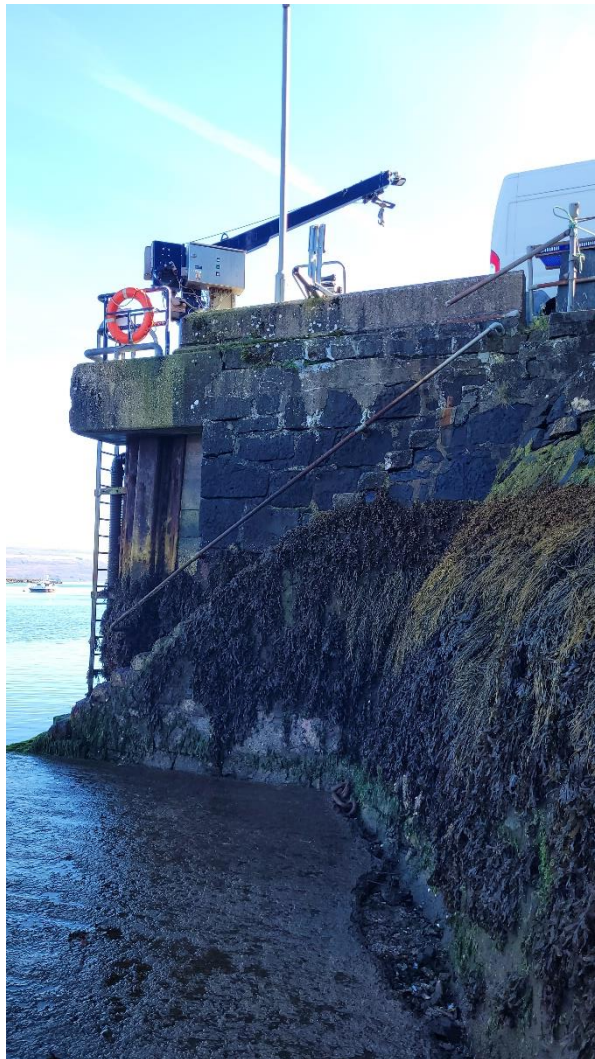
Photo 21: Eroded Channel at Back of Slipway

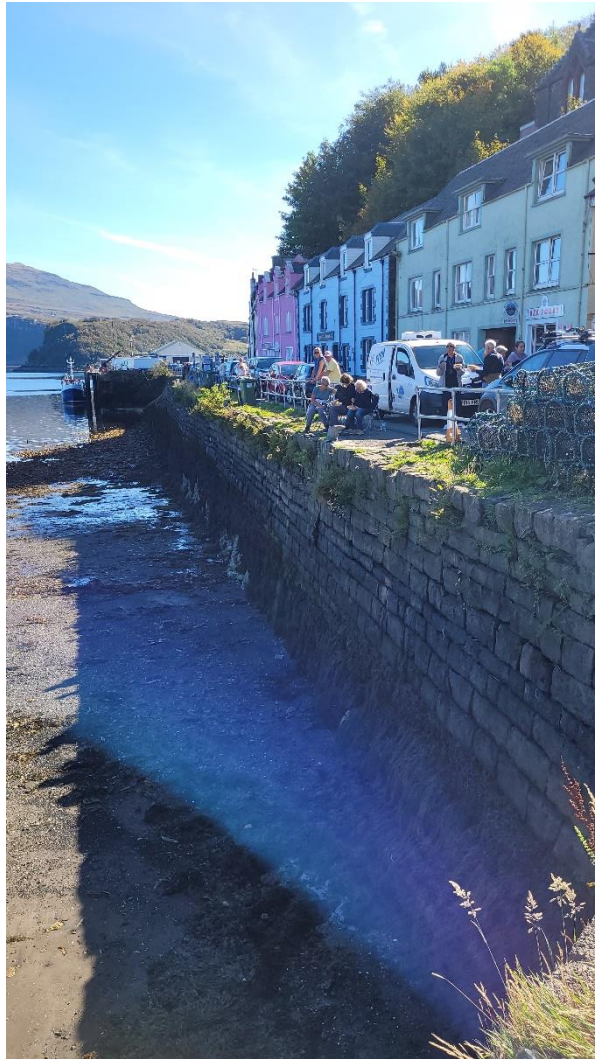
The top of the wall has three sections of 12m length of missing handrailing that permits pedestrians to access the wall and use it as a seat. This public use of the wall is unsafe with the hazard of falling into the sea or worse onto the beach at low tide. There is no infill mesh between the handrailing to prevent the hazard of children falling through the gap.

Photo 22: Missing Handrailing along Quay Street

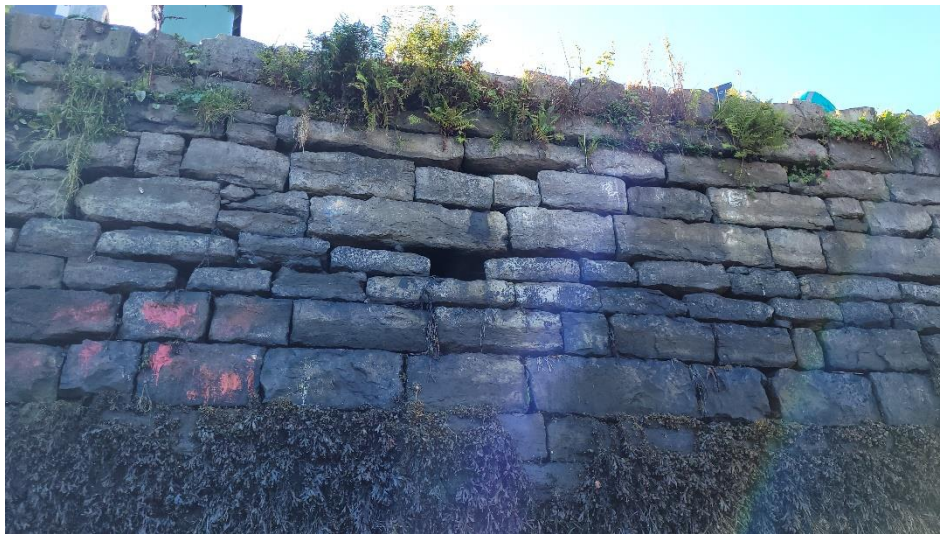
The stone masonry wall has voids where stones are missing, open joints and voids where the masonry meets the rockhead. There are also sections that are undermined at bed level due to scour.

Photo 23: Open Joints & Missing Stones at Quay Street Retaining Wall

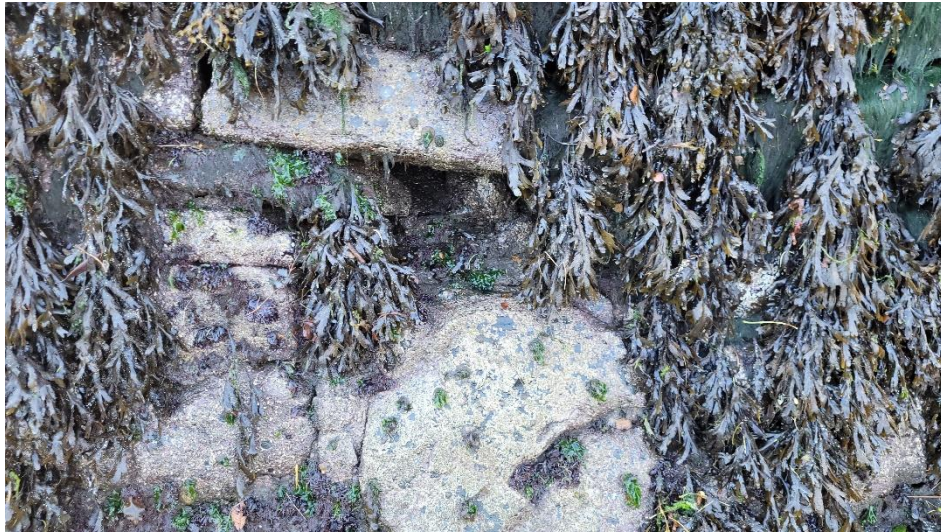
Photo 24: Voids in Wall at Rock Masonry Interface

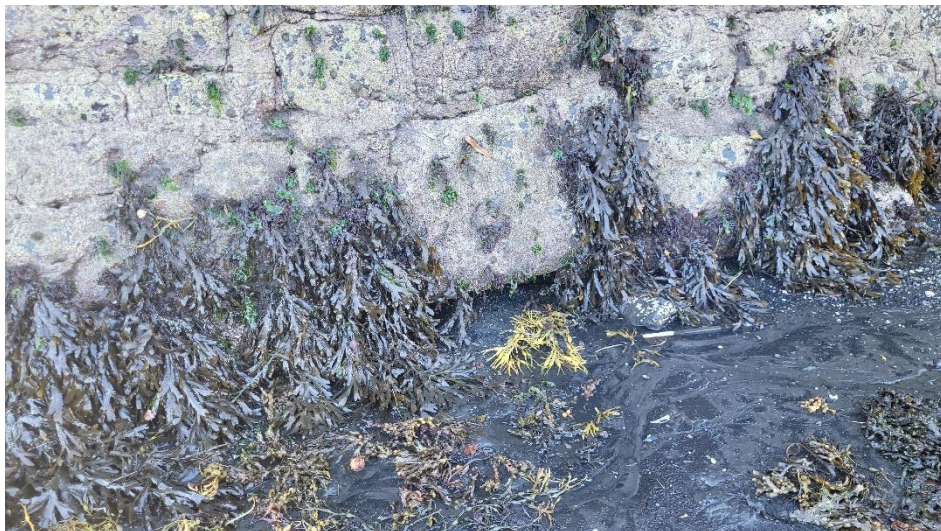
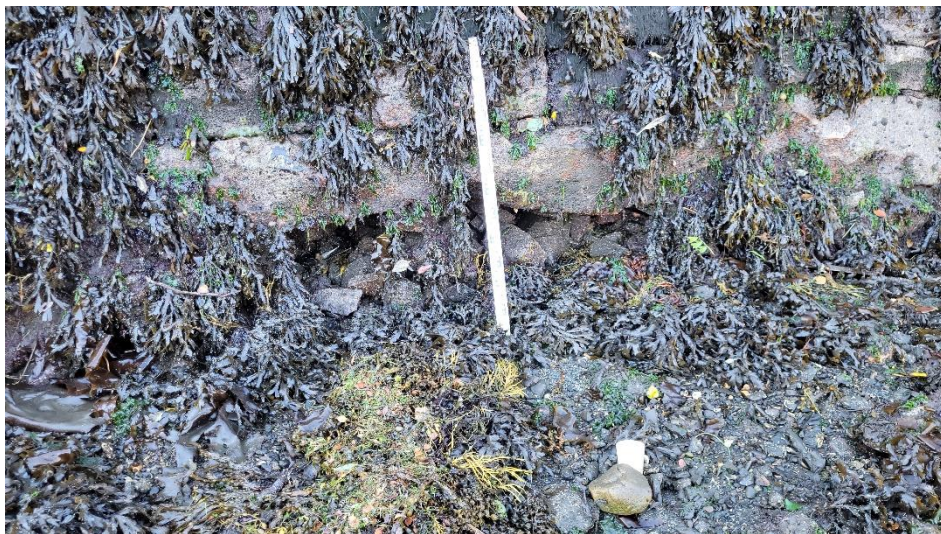
Photo 25: Undermining of Masonry Wall

Photo 26: Undermining of Masonry Wall

The lower sections of undermined wall should be underpinned with a concrete toe beam. The seabed should be excavated, and underwater mix concrete placed inside a shutter, set 100mm out from the face of the masonry. Voids and joints in this lower section should also be repaired and pointed using a quick set mortar such as Tarmac PPM/30W/QS. It is important to leave some vertical joints open to allow for tidal lag drainage as weep holes.

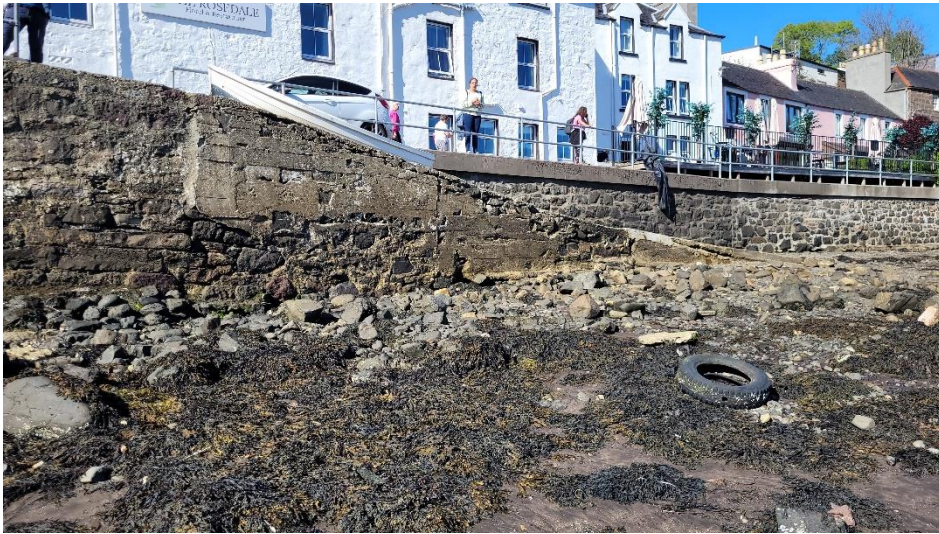
The beach access slipway at the corner of Quay Street and Beaumont Crescent has an outer wall which is in a poor condition. Historical concrete repairs are falling off, with the edge of the deck slab exposed.

Photo 27: Beaumont Crescent Slipway

Alternatively, the outer face wall could be encased in a new concrete wall using coloured concrete and a formwork liner to create a stone effect. This concrete wall would protrude out from the adjacent wall but would provide a suitable foundation to attach a new handrail on the outer edge.

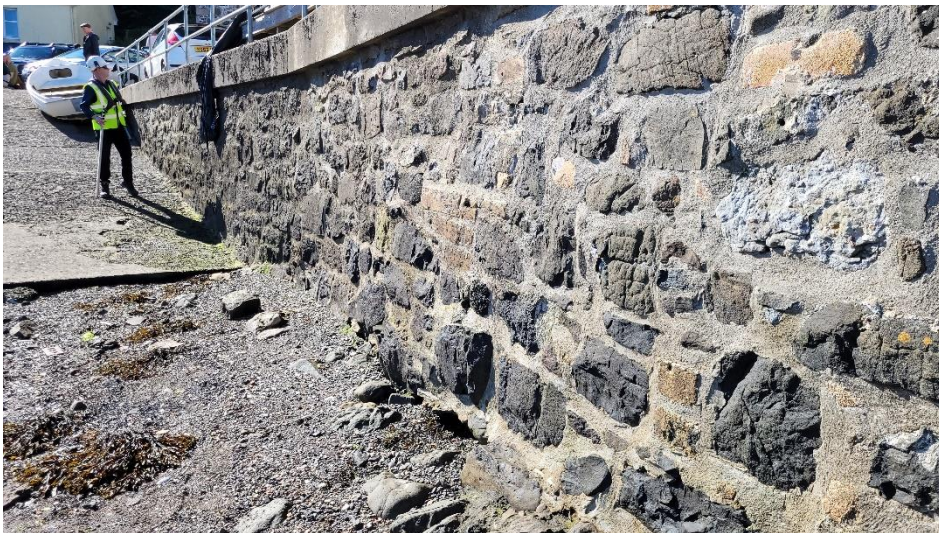
The bulge, recorded in the 2021 report, has failed and this section of the wall has been rebuilt by the Hotel. Note this work appears to have been undertaken with cement based mortar.

Photo 28: Repaired Sea Wall below Hotel at Beaumont Crescent
