Proposed Offices at Former Primary School, Achinlore Road, Fort William

Job Title:
**FORT WILLIAM OFFICE
 RATIONALISATION
 OLD ACHINTORE SCHOOL
 PAC0617**

Drawing Title:
NORTH WEST ELEVATION

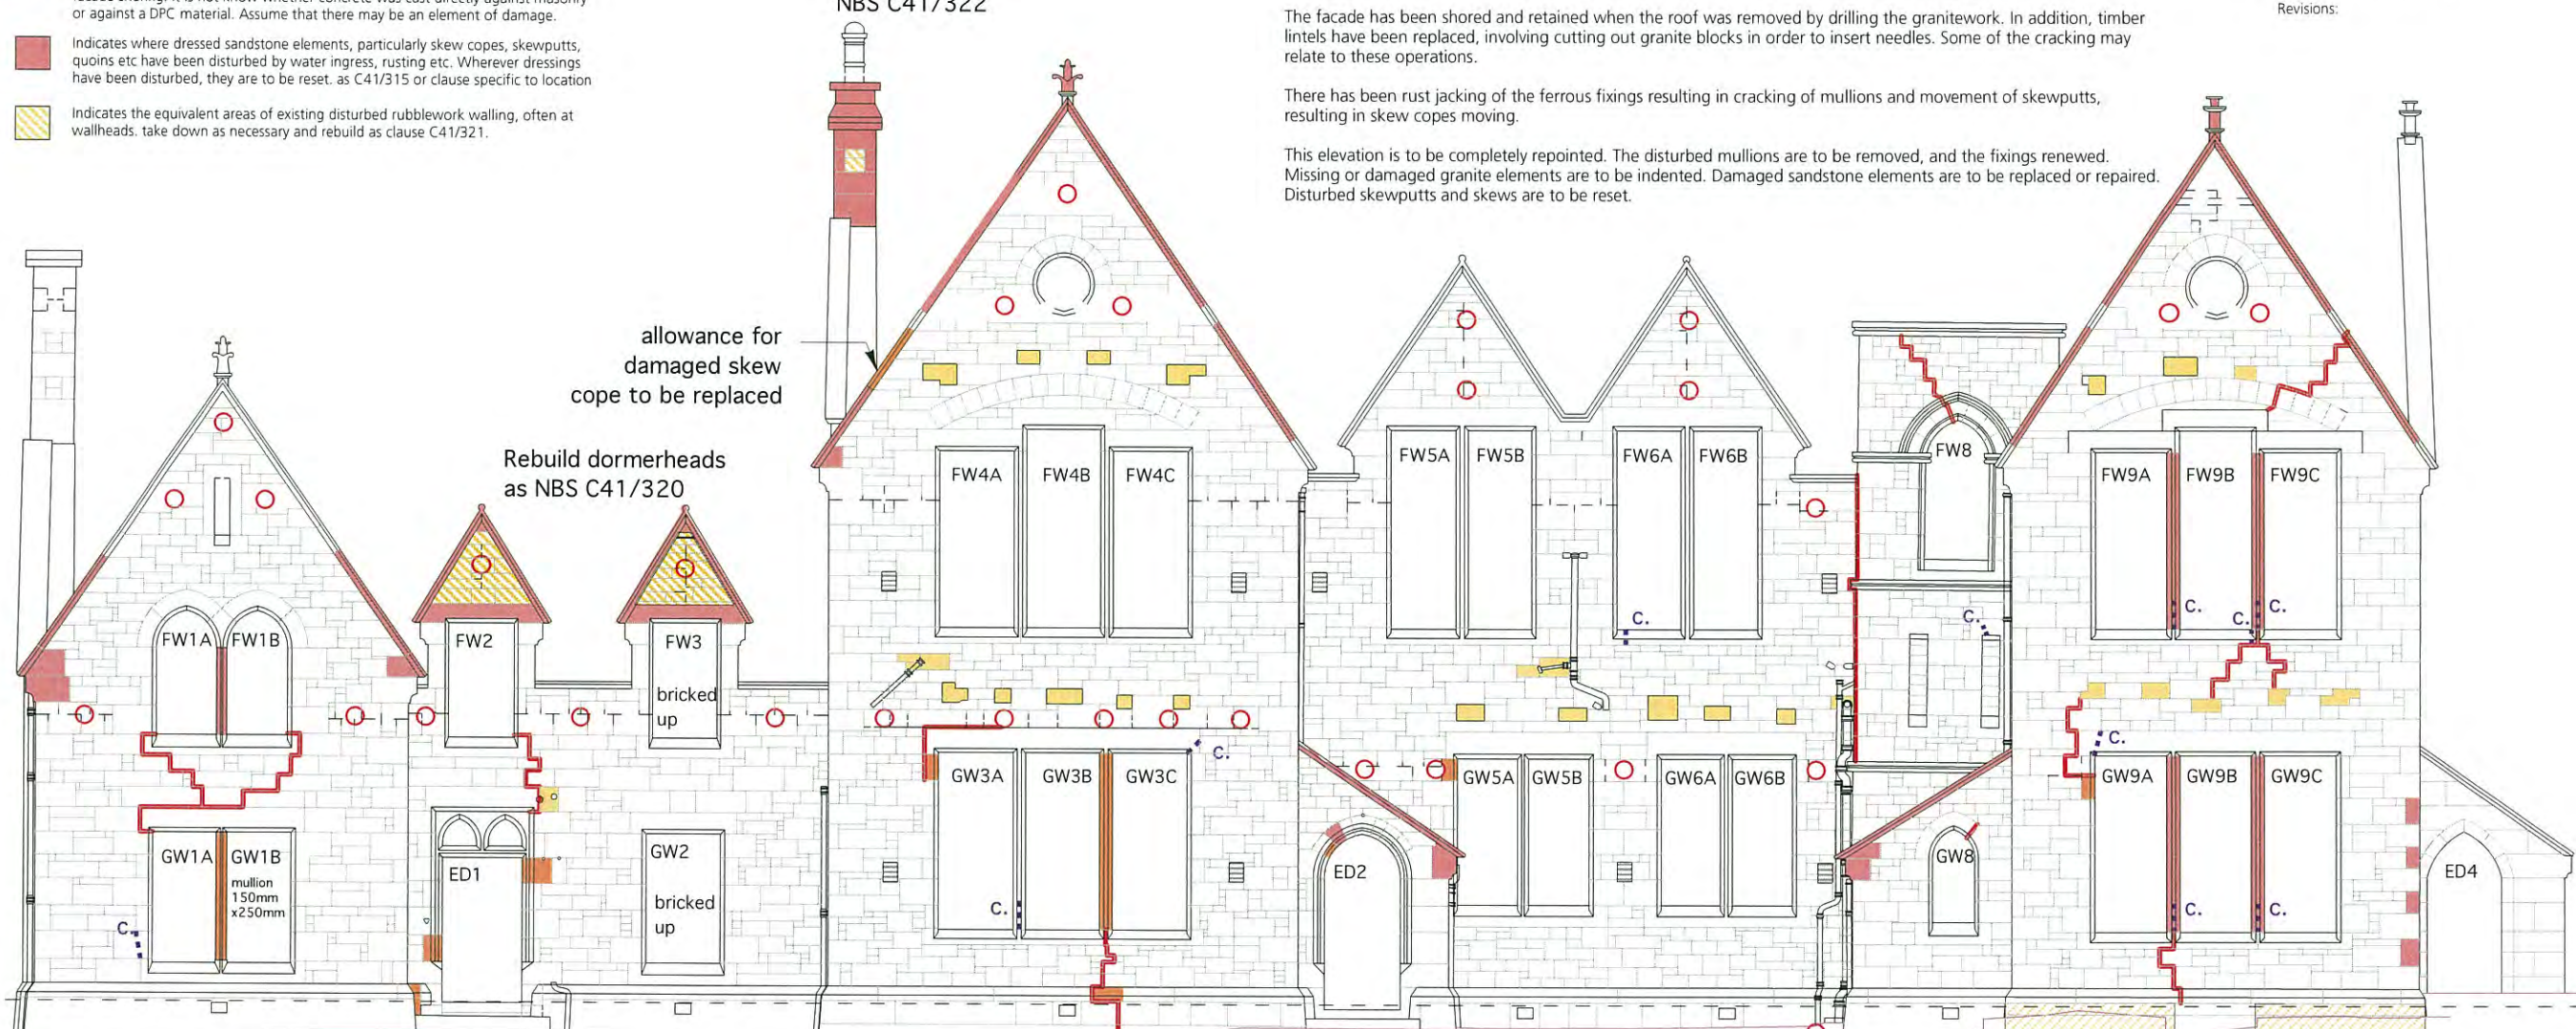
The front facade of the school comprises coursed granite walling with sandstone dressings to openings, relieving arches, stringcourses, quoins, skew putts and skew copes. The majority of the surviving pointing appears to be cement based over a soft lime building mortar.

The facade has been shored and retained when the roof was removed by drilling the granitework. In addition, timber lintels have been replaced, involving cutting out granite blocks in order to insert needles. Some of the cracking may relate to these operations.

There has been rust jacking of the ferrous fixings resulting in cracking of mullions and movement of skewputts, resulting in skew copes moving.

Cracks on both sides of chimney. Rebuild as NBS C41/322

allowance for damaged skew cope to be replaced

Rebuild dormerheads as NBS C41/320

This one and a half storey facade comprises coursed granite walling dressings to openings, stringcourses, quoins, skew putts and skew copes. The majority of the surviving pointing appears to be cement based over a soft lime building mortar

The facade has been shored and retained when the roof was removed by drilling the granitework. Some of the cracking may relate to these operations. the two gable heads over

The loss of the mullion on window GW1 which is now propped seems to be responsible for the cracking above.

This elevation is to be completely repointed. The disturbed mullions are to be removed, and the fixings renewed. Missing or damaged granite elements are to be indented. Damaged sandstone elements are to be replaced or repaired. Disturbed skewputts and skews are to be reset.

This elevation is to be completely repointed. The missing mullions is to be replaced. Missing or damaged granite elements are to be indented. Damaged sandstone elements are to be replaced or repaired. Disturbed skewputts and skews are to be reset. The two gable dormer heads are to be taken down and rebuilt.

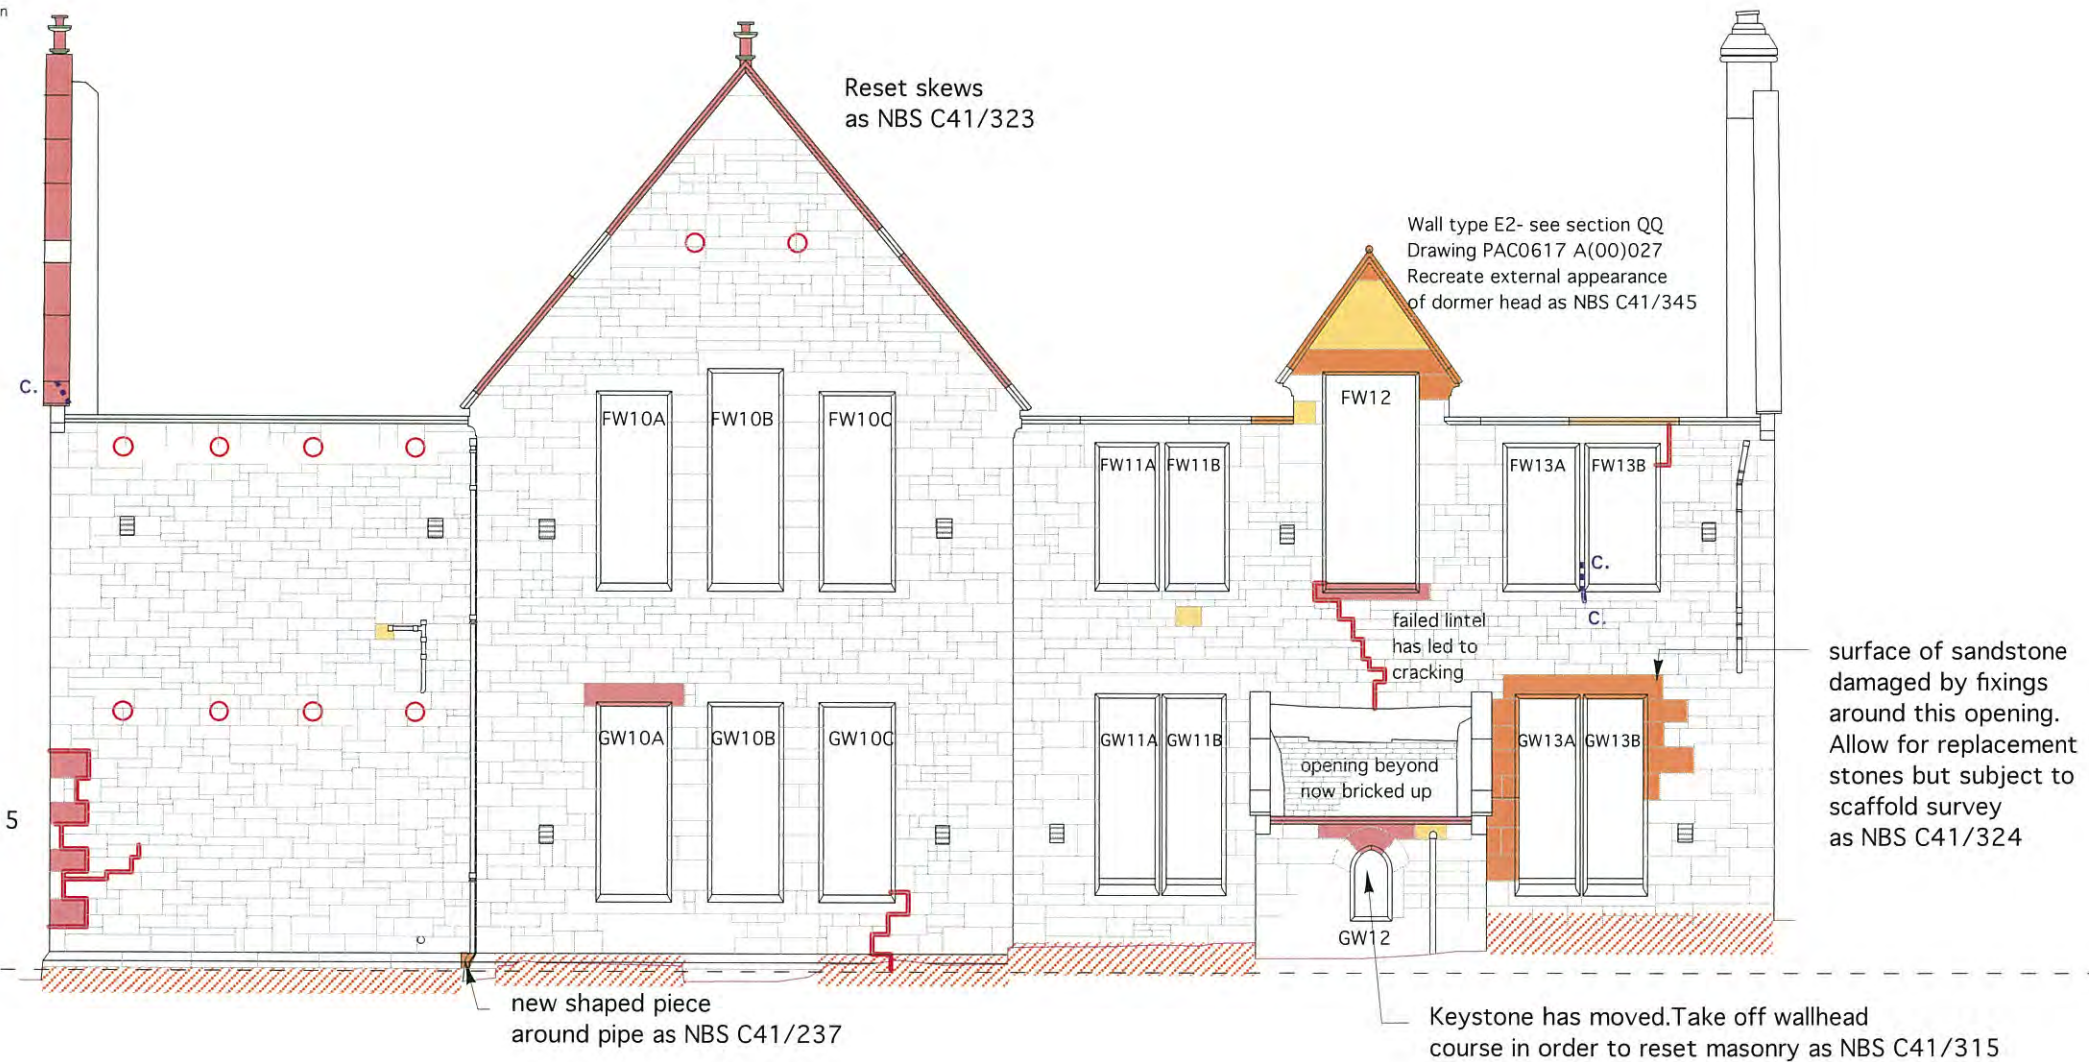
Drawing Title:
SOUTH WEST ELEVATION

The side elevation of the school comprises coursed granite walling with sandstone dressings to openings, stringcourse and wallhead courses, quoins, skew putts and skew copes. The majority of the surviving pointing appears to be cement based over a soft lime building mortar

The facade has been shored and retained when the roof was removed by drilling the granitework. Some of the cracking may relate to these operations. In addition the shoring is built off concrete kentledge and this may have resulted in damage to the stonework plinth course.

There has been water ingress and damage the ferrous fixings resulting movement of skewputts, and skew copes. The gablehead to window FW12 has been lost and requires to be replaced.

This elevation is to be completely repointed. The disturbed mullions are to be removed, and the fixings renewed. Missing or damaged granite elements are to be indented. Damaged sandstone elements are to be replaced or repaired. Disturbed skewputts and skews are to be reset. Allowance should be made for replacing dressings around window GW13 where the surface of teh sandstone is friable.

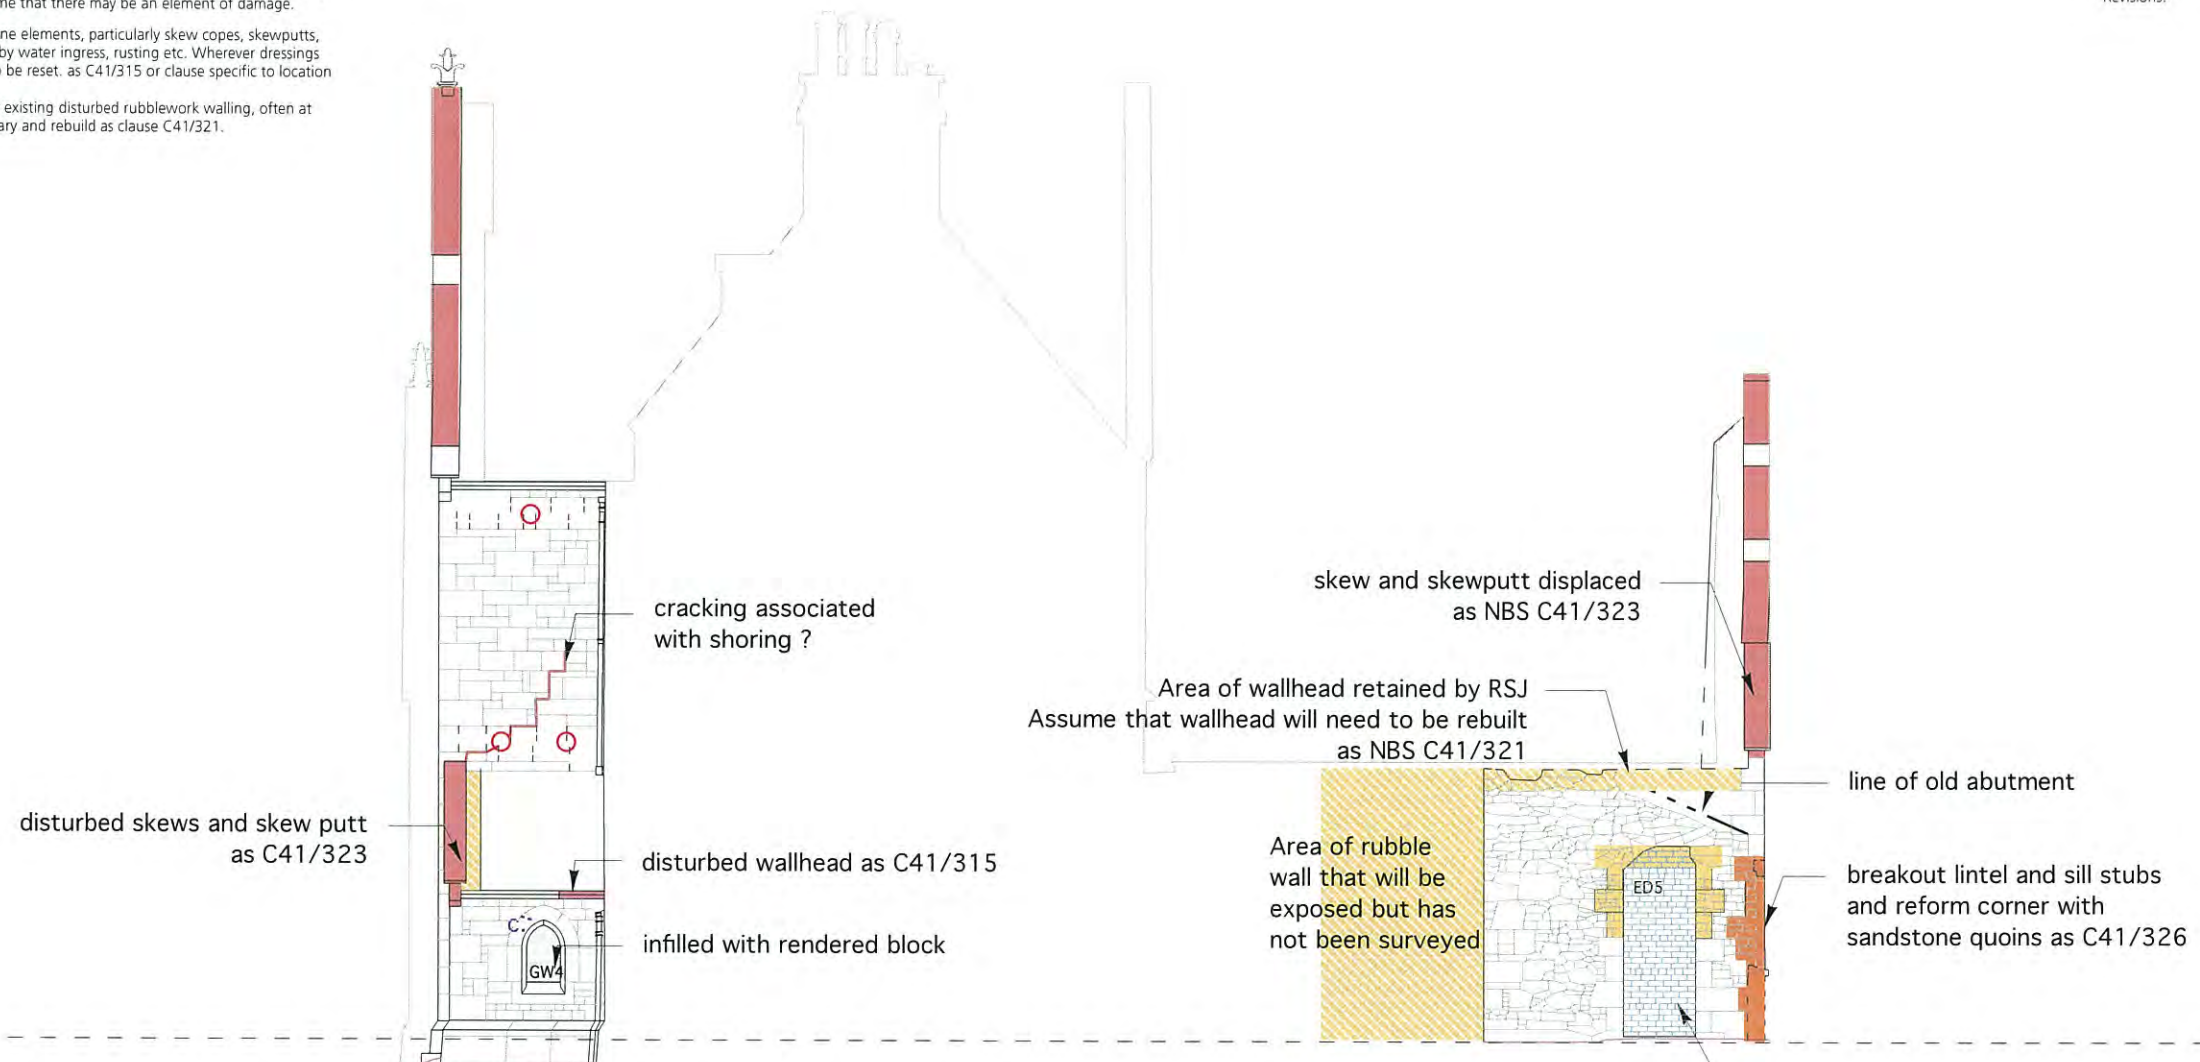
The former Cloakroom comprises coursed granite walling and plinth with sandstone quoins, window dressings, wallhead course and stringcourse.

The Porch and Tower predate when the school was rebuilt. Hence there is a risband joint or crack where the Tower abuts the upper stories.

ELEVATION NOTES:
 The former Porch comprises coursed granite walling and plinth with sandstone quoins, window dressings, wallhead course and stringcourse.
 The wall above comprises coursed granite walling with sandstone quoins and wallhead course.
 This elevation is to be repointed. The disturbed skews, skewputt and wallhead are to be reinstated.

ELEVATION NOTES:
 Once an external wall but altered when the school was extended and altered. Wall comprises local uncoursed rubblework. Opening ED5 has surviving granite dressings at low level. The corner quoins, where they survive, are sandstone. Lime pointing survives.
 This elevation is to be sneckharled. The missing quoins are to be replaced in sandstone. The missing rybats, sill and lintel to opening ED4 are to be granite to match.

This elevation is to be repointed. The damaged dressings around Porch are to be repaired. The biological growth on stringcourses and other ledges is to be treated as C41/455
