# WICK PULTENEYTOWN CONSERVATION AREA APPRAISAL

**Draft: NOVEMBER 2020**

**FOR THE HIGHLAND COUNCIL CIRCULATION to COMMITTEE.**

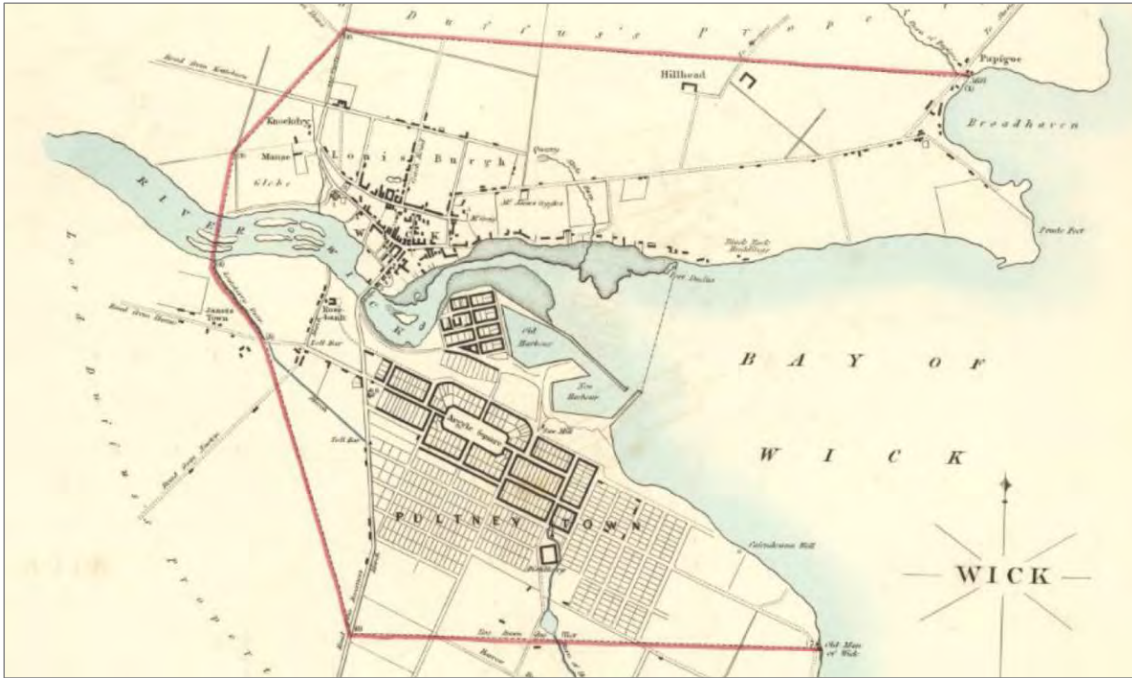
Figure 4A: *Reform Act Plan, 1832*: the earliest map representation of Pulteneytown. Whilst broadly reflecting the new town’s development, the extent and accuracy of specific buildings cannot be relied upon. ©NLS

With the original feus of the new town plan let, it appears additional lots were created including: the western end of Sinclair Terrace; on the originally open ground on the north side of Breadalbane Terrace; Harbour Terrace; and on reclaimed land in the western section of Lower Pulteneytown forming Union Street and River Street (compare figs 4 & 5; map 6.1).

By comparing historic maps (figs 3B, 4 & 7), the two blocks north of Martha Terrace were not part of the original lots, and in the 1870s this area, just above the high water mark, was the site of a number of more temporary buildings and the original lifeboat house (1848). Shortly after the 1<sup>st</sup> Ed. Ordnance Survey (1872), a new bridge was constructed (whilst Telford’s original Bridge of Wick was replaced) and a route formed from Williamson Street to the north bank of the river at the end of the High Street. The 2<sup>nd</sup> Ed. Ordnance Survey (fig 6) shows development on the western plot (currently the medical centre, built 1995) but no development on the eastern part (currently the fire station site).

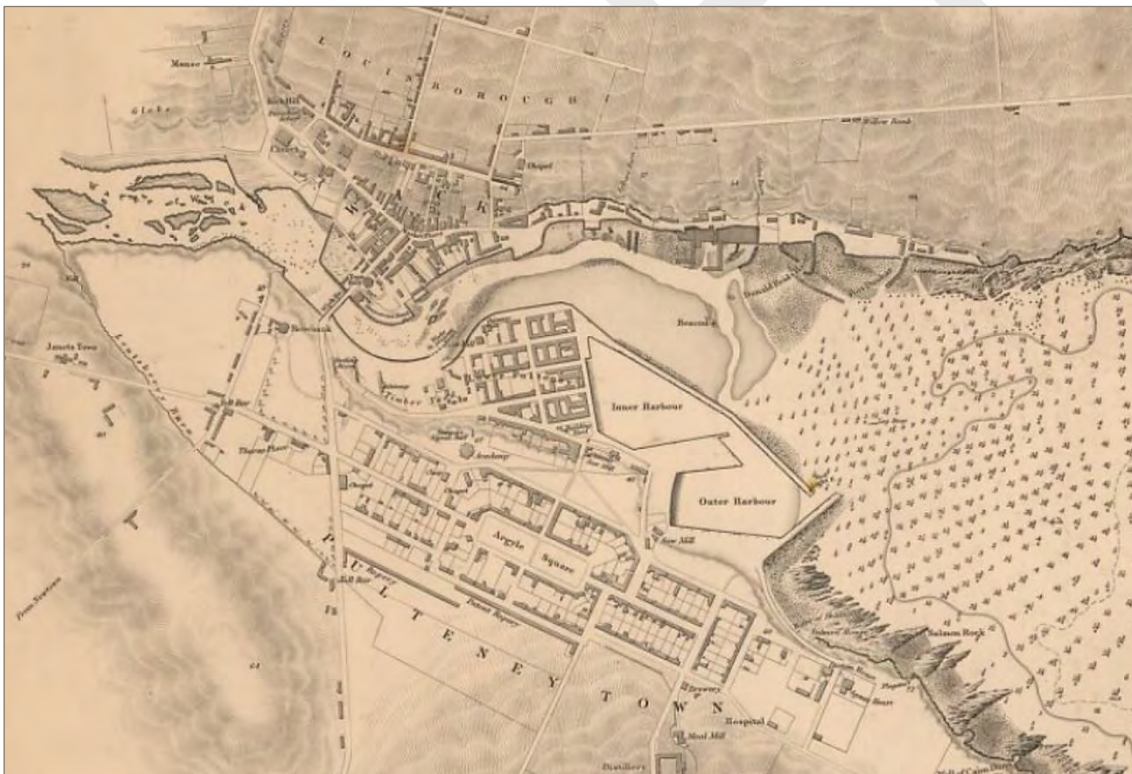
Figure 4B: *Admiralty Charts of Scotland: The Port and Vicinity of Wick* (surveyed 1839; additions 1857) provides the most detailed plan before the Ordnance Survey in 1872. Whilst additions are said to have been made to the map in 1857, the omission of a number of key buildings constructed in the 1840/50s suggests no update was made to the town plan, probably only the marine map in 1857. The plan captures Telford’s design before it extended in the second half of the 19<sup>th</sup> century to the west in Lower Pulteneytown and on the land between the lower and upper towns. Paths are indicated across this open area, which presents a level of formal grandeur to in particular Breadalbane Terrace. Development of the upper town to the east (Huddart and Vansittart Streets) and to the south (Moray Street, Brown Place and Kinnaird Street) is clear with the ‘Ropery’ south of Brown Street clearly marked. In the lower town the map states that works are progressing on River Street. ©NLS

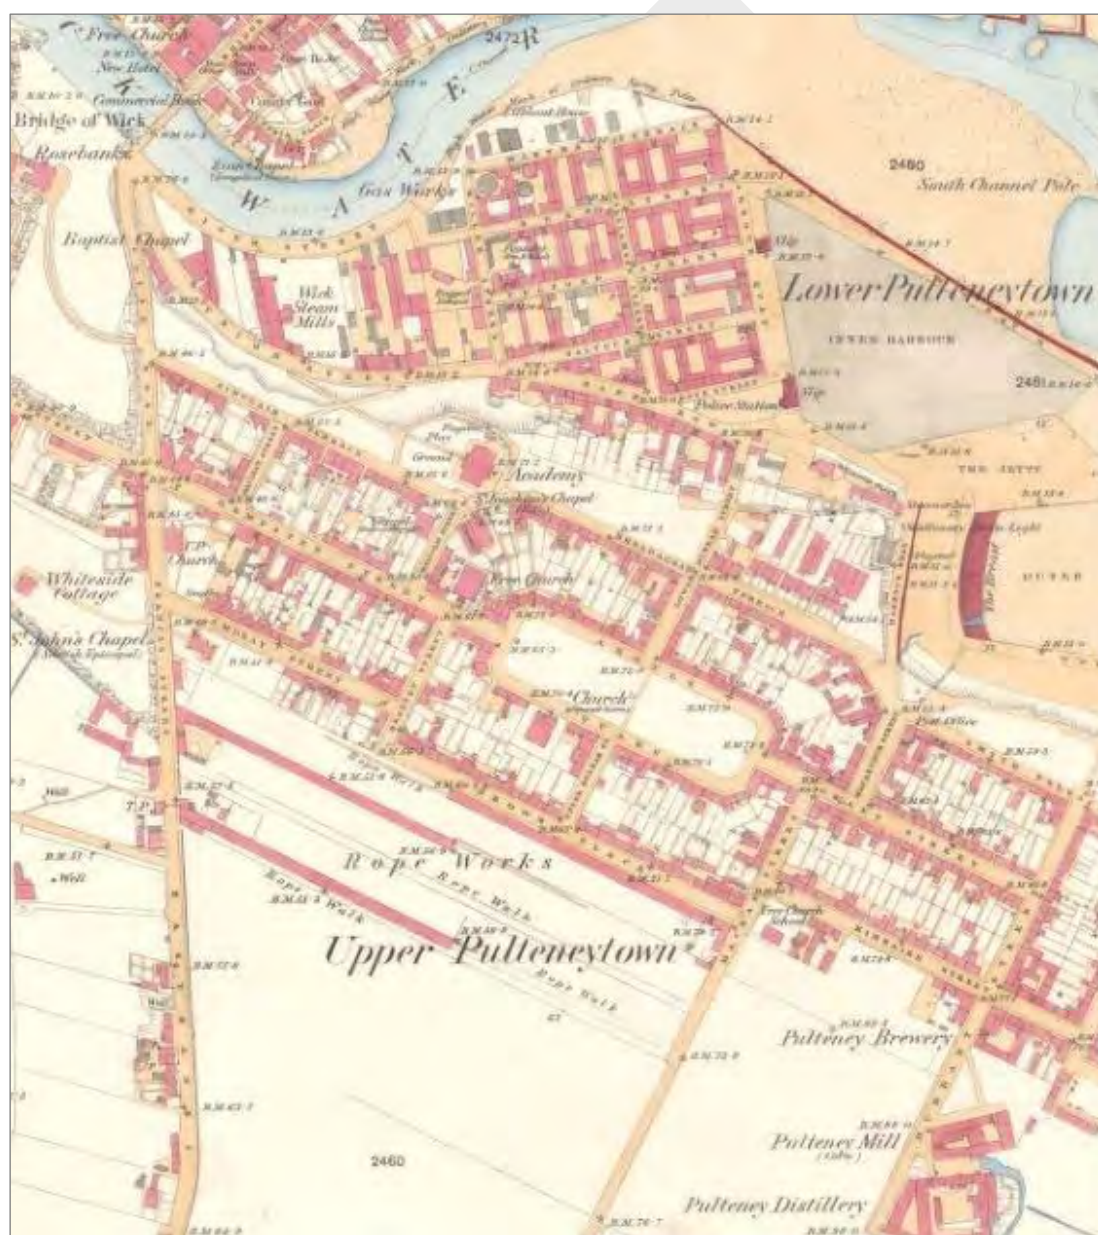
Figure 7: 1st Ed. OS 25" Plan 1873 (surveyed 1872) © NLS

The second open green space is the Academy Braes, a semi-natural green space on sloping land separating the lower and upper towns at Sinclair Terrace and Union Street. Two diagonal pedestrian routes crossing the space are visible on the 1<sup>st</sup> Ed. Ordnance Survey map (fig 7), one originally leading to the Pulteneytown Academy. This green space has also changed as trees have matured and grown. Again older images reflect the changing appearance of this space and the resultant effect on the built environment around it, including views to and from the area, as well as the enclosure and natural light levels on Union Street (fig 24).

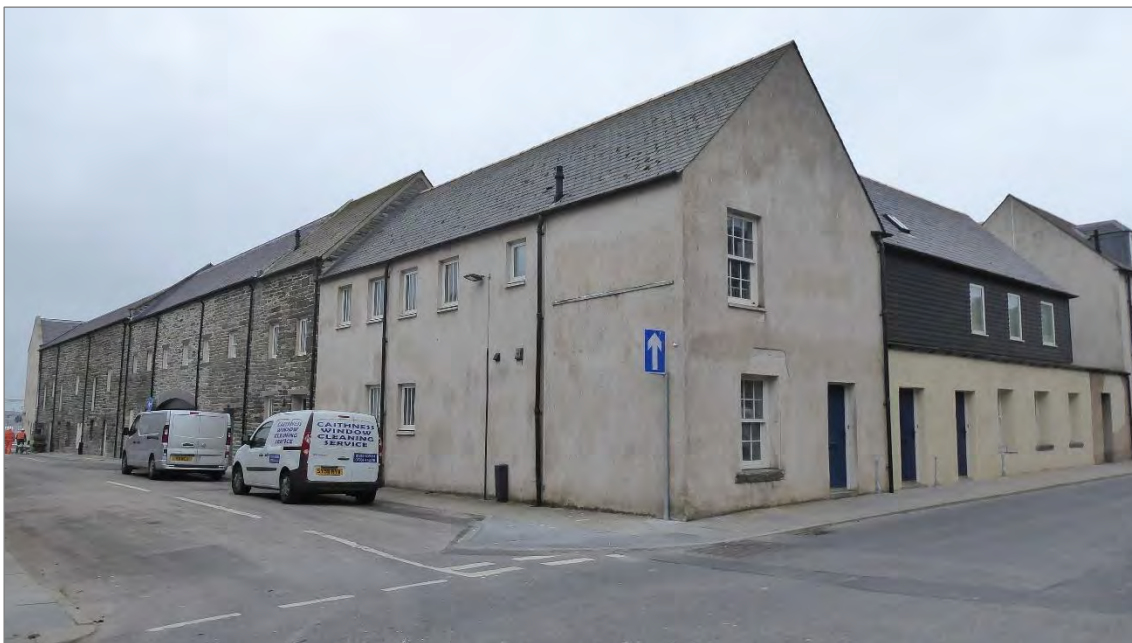
Figure 9: the typical hard urban grain of the original Lower Pulteneytown lots with buildings constructed on the street line.

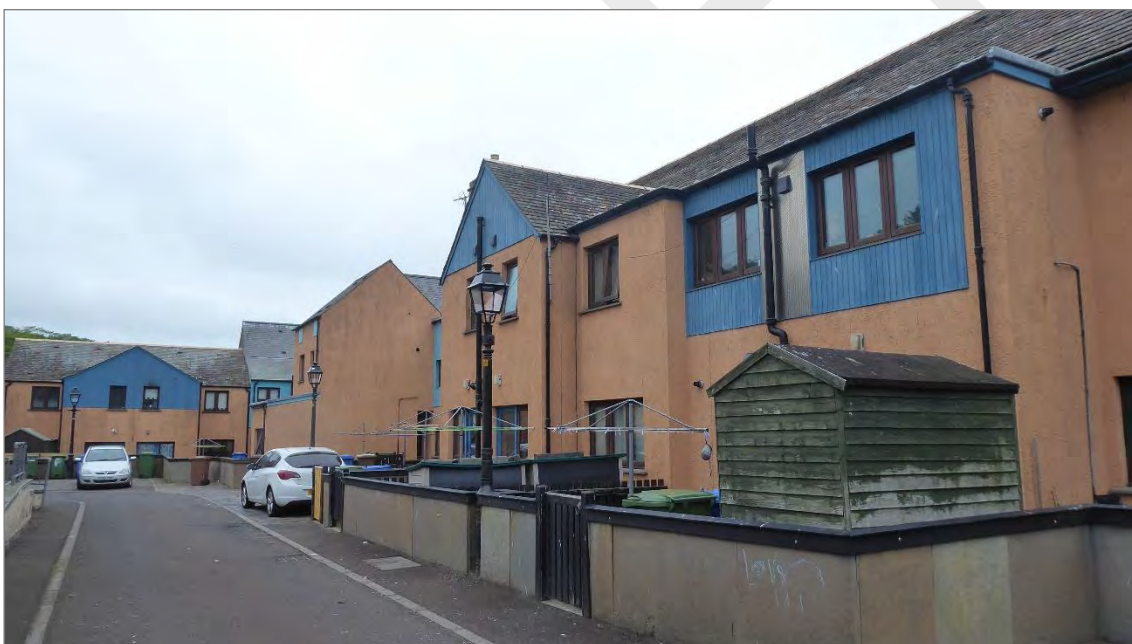
Figure 10: recent redevelopment on Saltoun Street has reduced the hard frontage of the block and set housing back from the street line with small front yards and parking.

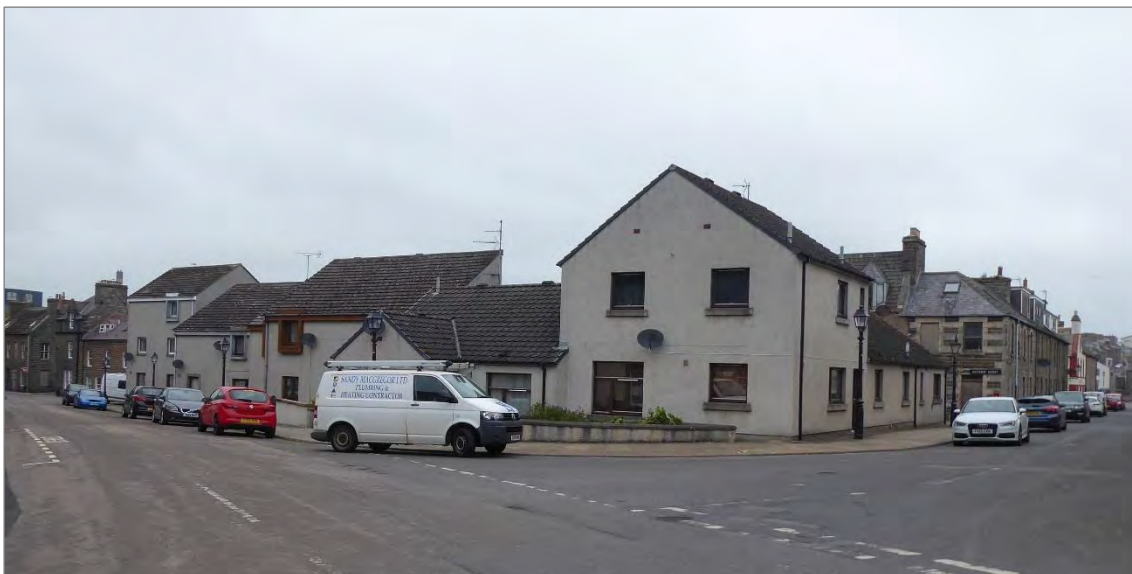
Figure 11: later 20<sup>th</sup> century redevelopment of the triangular block on Bank Row. The houses have been set at an oblique angle to the street line; the considerable variation in building height is also not in keeping with the original 2-3 storey buildings.

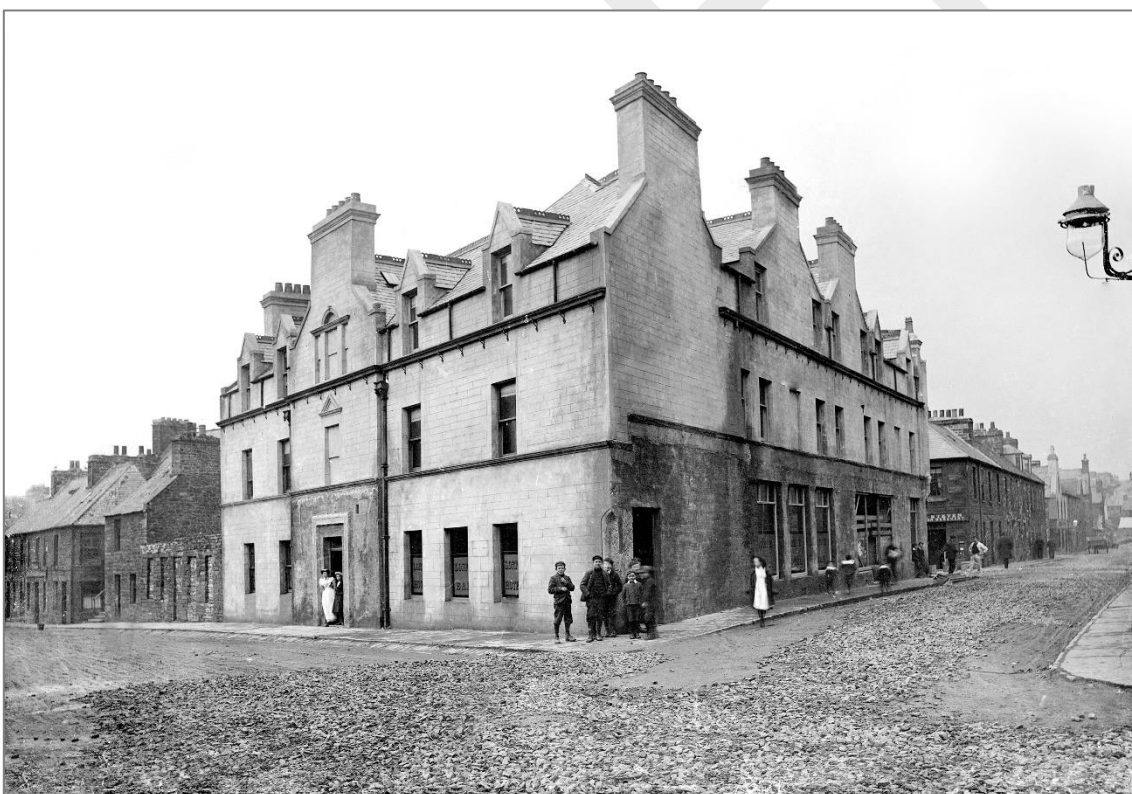
Figure 12: the Lorne Hotel occupied the corner of Bank Row and Williamson Street, pictured here in 1900. In comparison to the redevelopment above, the form and scale of the hotel provided a strong corner and reaffirmation of the urban structure of the industrial area. Note the road surface made up in sea gravel and Caithness stone pavements. © The Wick Society - The Johnston Photographic Collection

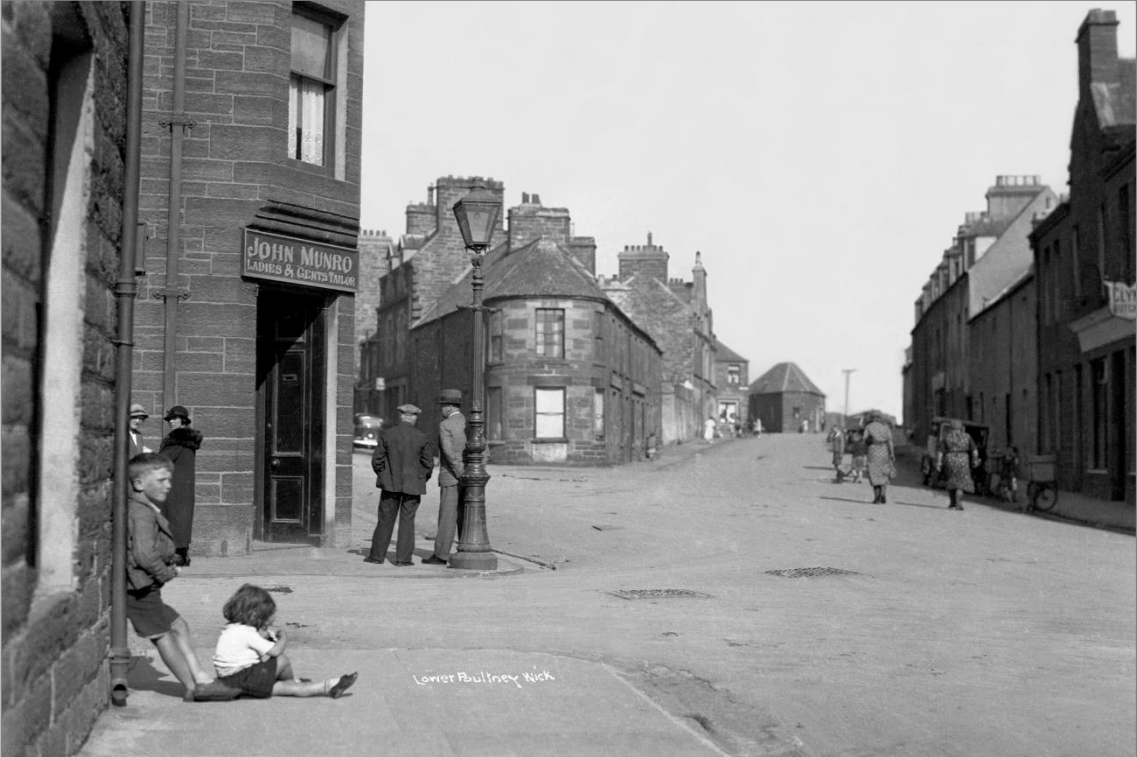
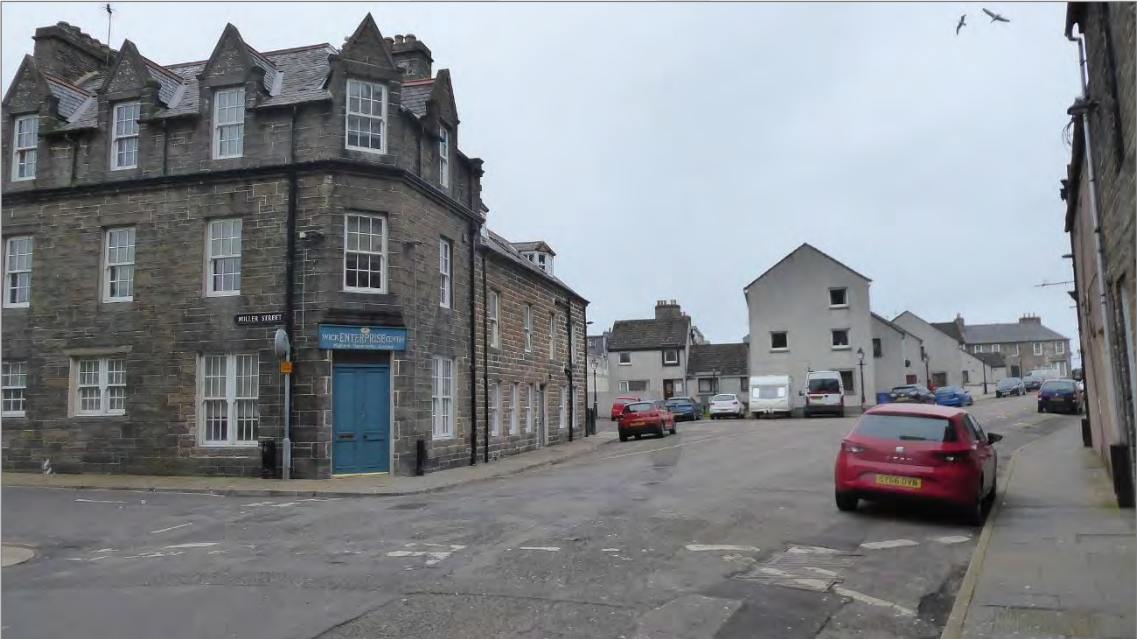
Figure 13: (top) looking east on Bank Row in the 1930s, with the triangular block on Saltoun Street on the left and the former police station buildings at the end of the boat yard site in the distance (now demolished) © The Wick Society - The Johnston Photographic Collection; (below) similar view in 2019, the Saltoun Street block has been redeveloped with later 20<sup>th</sup> century housing.

World War bombing resulted in the loss of several buildings at the eastern end of Bank Row including the Crown Hotel on the corner of Bank Row and the Black Steps. This creates a void in the urban structure where the buildings have not been replaced, and there are views to the rear of the large properties on Breadalbane Crescent. The wedge of space between Bank Row and Rose Street was once the site of a boat yard and the town's police station and jail (fig 13). It is currently undeveloped but defined by low masonry walls.

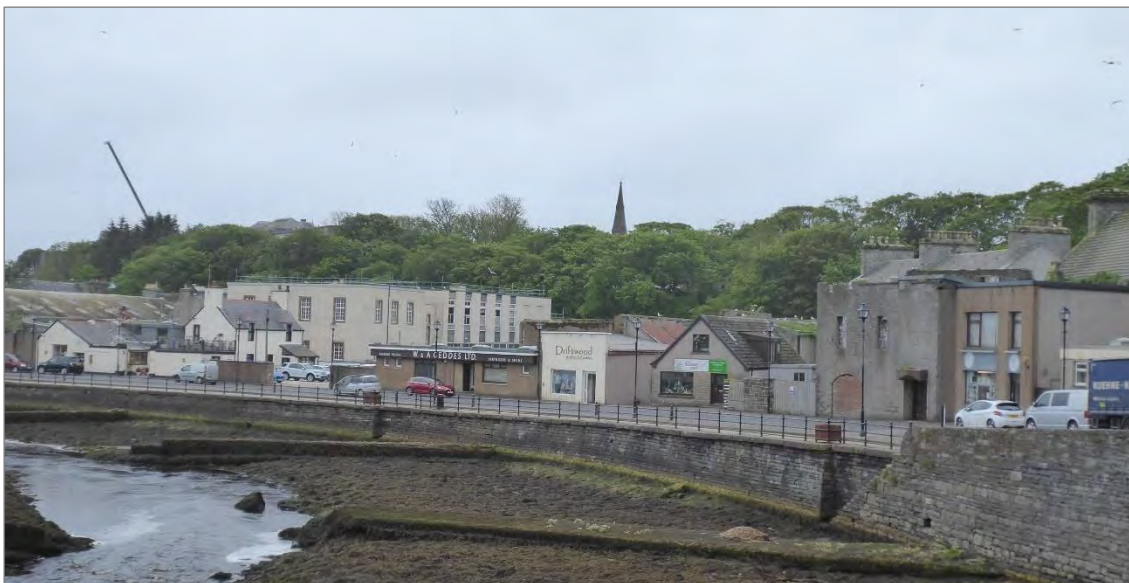
Figure 14: view of the River Street frontage from the Bridge of Wick. Note the irregularity of the street frontage which developed on the ends of the lots extending through from Union Street. There are gaps where buildings or high walls have been lost and the form and height of the 20<sup>th</sup> century Telecoms building is inconsistent with the traditional industrial buildings.

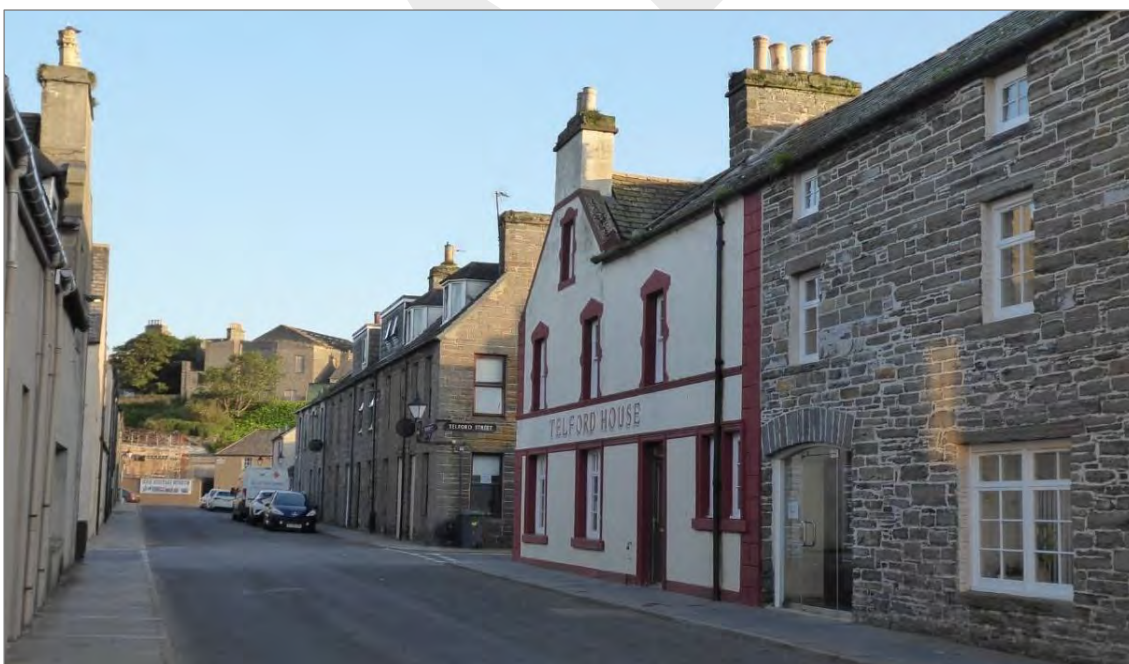
Figure 15: the consistent eaves line on Williamson Street (west side). Note how the 3-storey warehouse on the right maintains the eaves line of the neighbouring 2-storey Telford House.

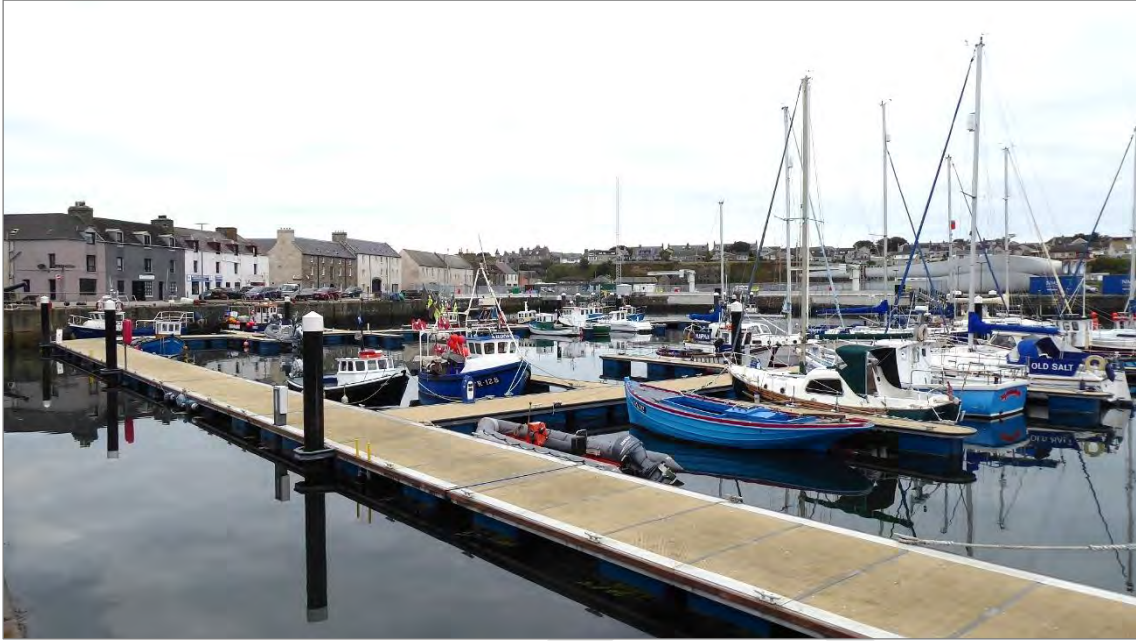
Figure 16: view of the Harbour Quay street frontage where the warehouses and support buildings are 2 to 3-storey in height with the tallest warehouses at the centre providing a balanced and attractive backdrop to the harbour.

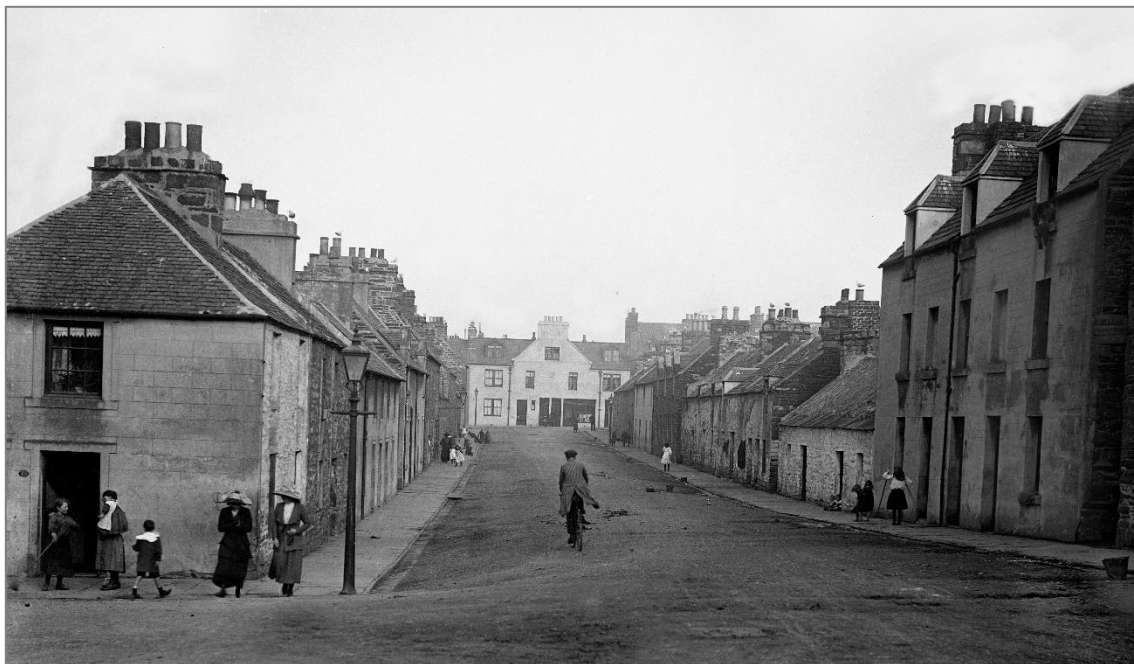
Figure 19: Grant Street in the early 20<sup>th</sup> century, the right hand side of the street is now demolished but note the contrast of the single storey cottage and the neighbouring buildings. There was a noticeable variation in building heights here. © The Wick Society - The Johnston Photographic Collection

Telford supplied standard house designs for both single and 2-storey models. He suggested that the Feu Charter determine where houses were to be 2-storey and in which streets single storey houses would be an option (GD9/289/51). The 2-storey house was to be a minimum of 17 feet to the eaves (a foot lower than in the industrial area) with a door 6 x 3 feet and windows 5 x 3 feet. Single storey houses were to be at least 8 feet at the eaves with the same door size but slightly smaller window openings at 4 x 3 feet. In construction, 2-storey houses predominated, with single storey buildings being extremely rare in the conservation area on the street elevations, although a few survive in the adjoining streets (e.g. Brown Place) and are evident in historic photographs (fig 19, Grant Street).

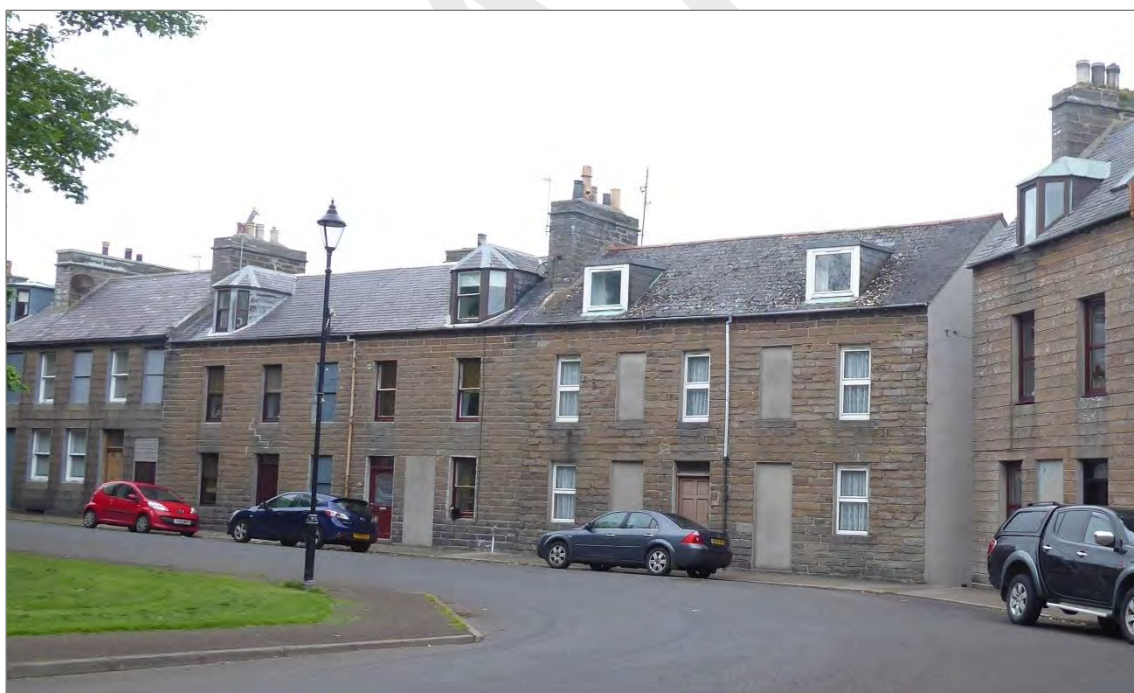
Figure 20: Argyle Square: note the variation on the height of the windows to the eaves, and also the height of the eaves line, which is slightly different between lots.

Admittedly there is some variation in the height of these 2-storey buildings, nevertheless there is an overall consistency. However as can be seen on Argyle Square, independent builders produced design variations which may also have been influenced by the date of construction. For example the relationship of the upper window position to the eaves can vary, and whether there was an attic storey with dormers (fig 20).

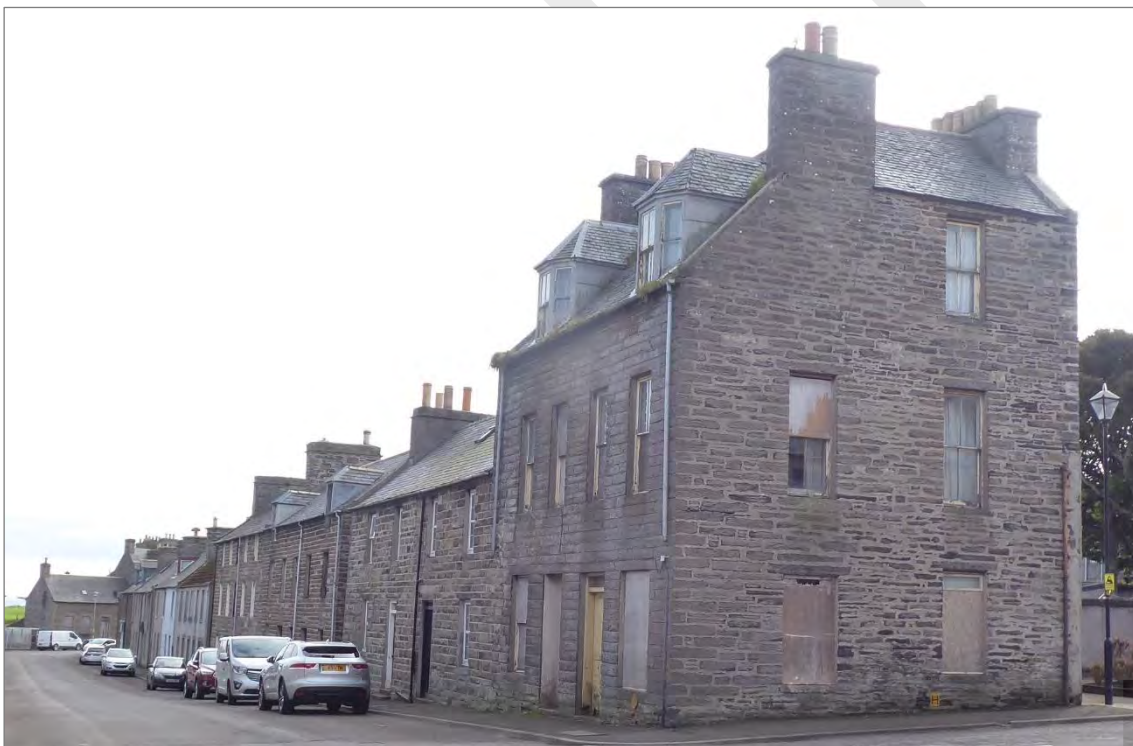
Figure 21: the Draft Feu Plan for the east side of Breadalbane Terrace and below the development on those lots. Note the larger scale of the corner building in comparison to its neighbour, shaded on the plan (lot 9) and one of the earliest buildings on the terrace constructed by 1813. The incline of the site has allowed progressively taller buildings to the east ending in the 3-storey at Nos 22-23. © SRO/GD9/337/1

Upper Pulteneytown streets are wider than in the lower town, with the Draft Feu Charter indicating 44 feet from the front of each house which would have accommodated Telford's specifications for roads to be 30 feet wide with 6 feet wide pavements and kerbs each side; the only street which appears to be wider is Macarthur Street (SRO/GD9/337). Generally lots were to be 50 feet to the street frontage and 100 feet deep although this did vary for example at corner lots (figs 17 & 21). This produced a consistent

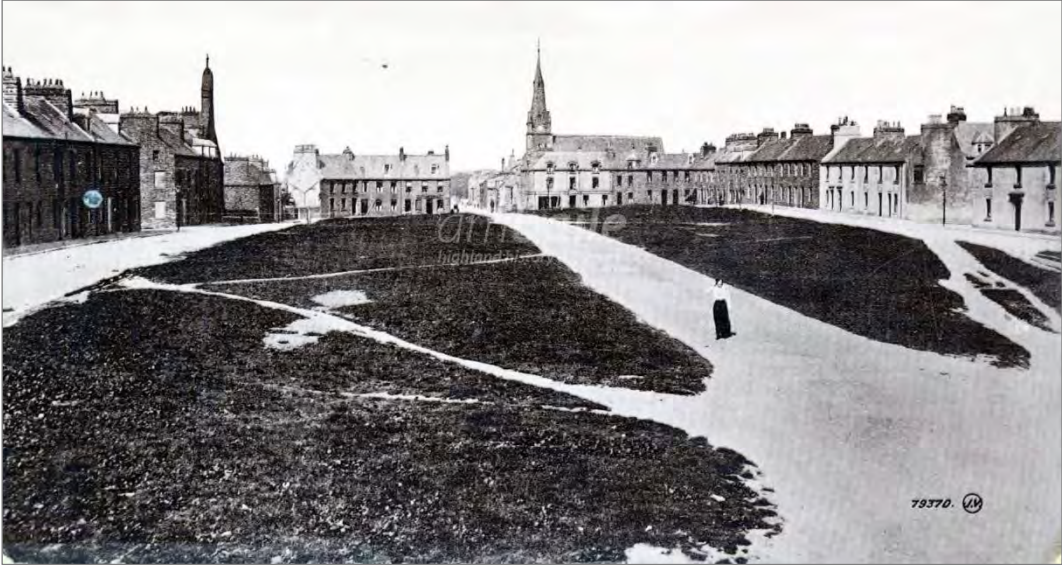
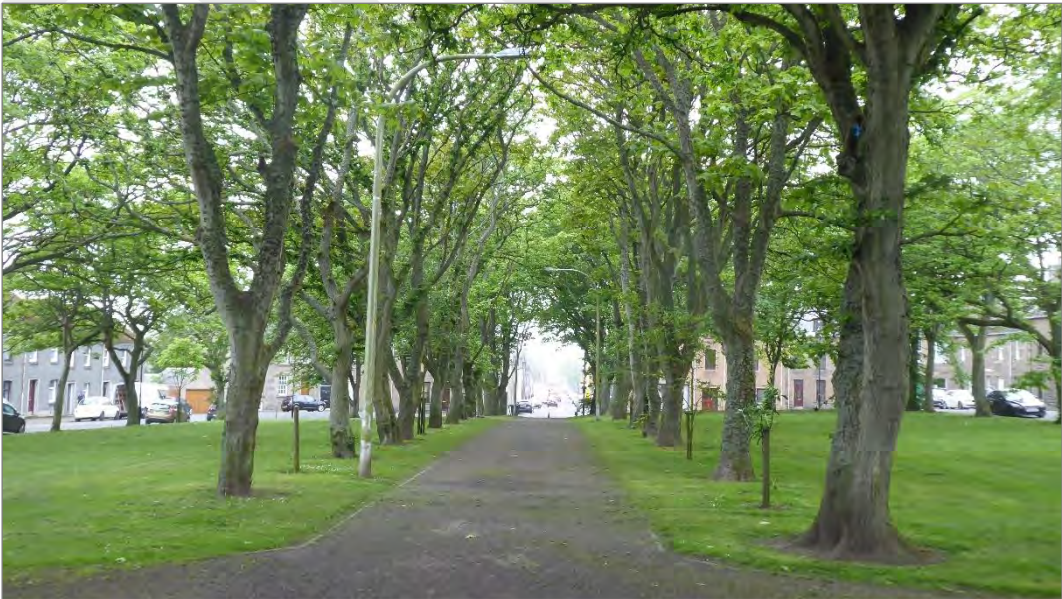
Figure 23: change to the nature of Argyle Square from the turn of the 20<sup>th</sup> century (top); tree planting possibly 1930s; and today a tree-lined avenue. © Am Baile

There are two large green spaces within the conservation area. The principal open space is Argyle Square, Telford's designed space at the heart of residential Upper Pulteneytown; with pedestrian routes crossing east-west and north-south. Its appearance has changed quite dramatically over time (fig 23) from an open treeless environment to the more enclosed and secluded tree-lined avenue we see today. The trees may have been introduced as late as the 1930s (HES, LB report 42267). The long central path east-west was not there originally (refer fig 22) but is recorded on the 2nd Ed. Ordnance Survey, referred to a 'Drying Green' (1905; fig 6).

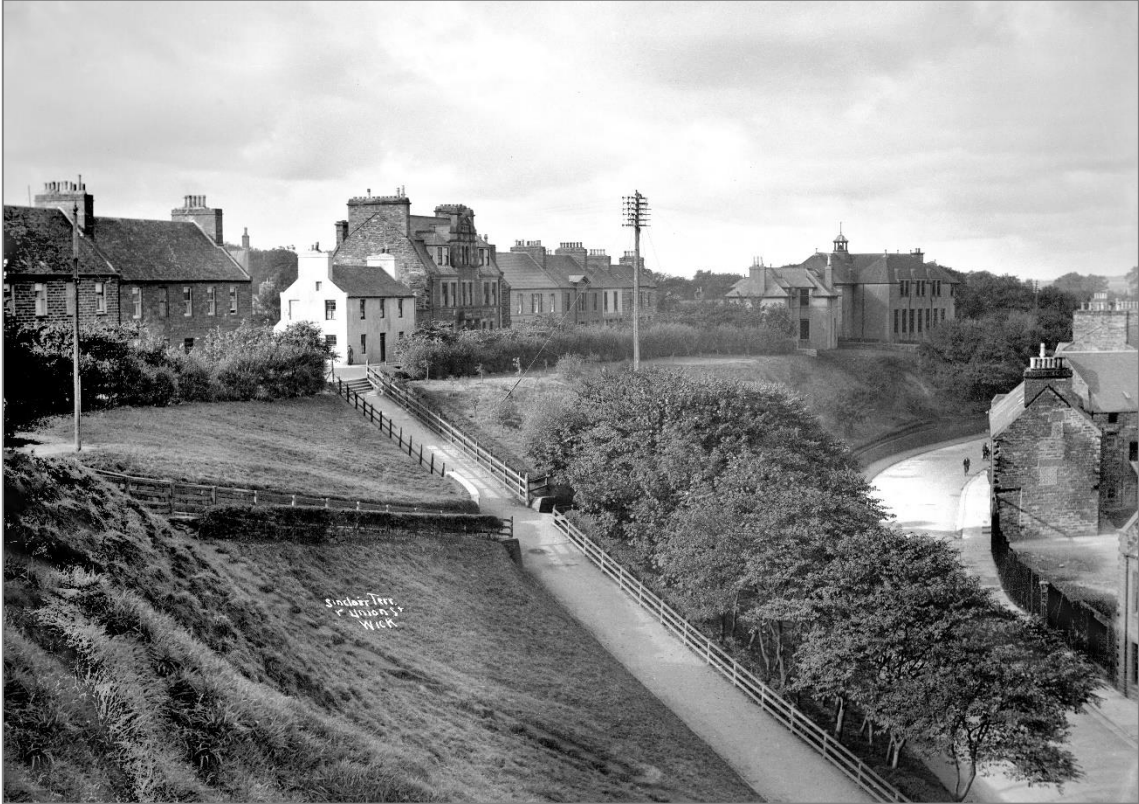
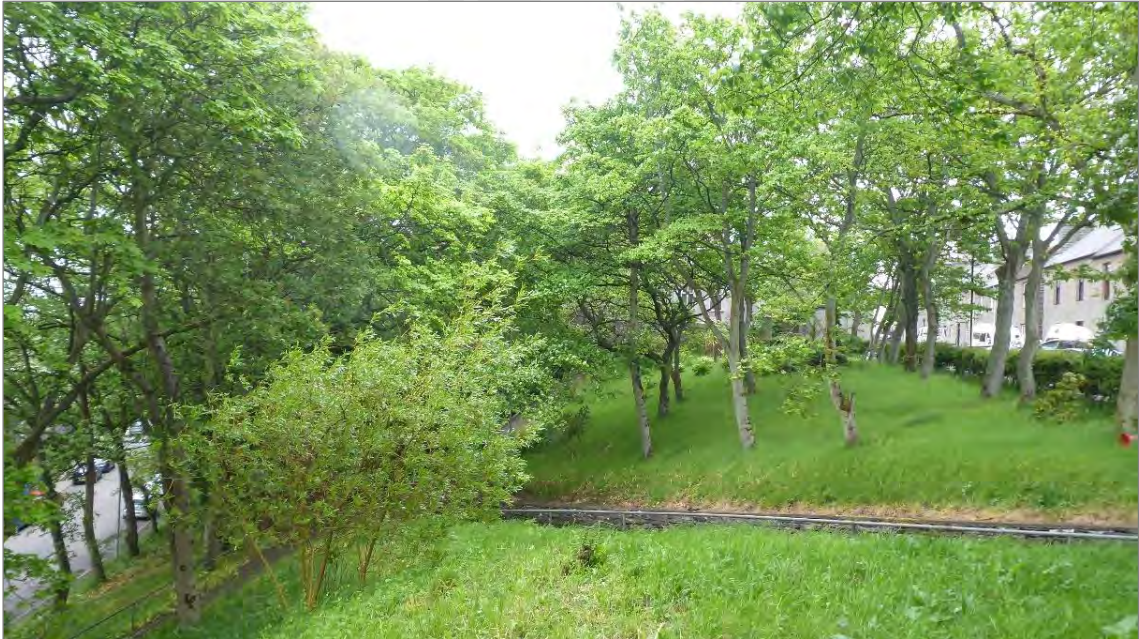
Figure 24: Academy Braes: (top) in the 1920s. Note the openness of the space at this time which afforded views to and from Sinclair Terrace © The Wick Society - The Johnston Photographic Collection; (below) the braes in 2019.

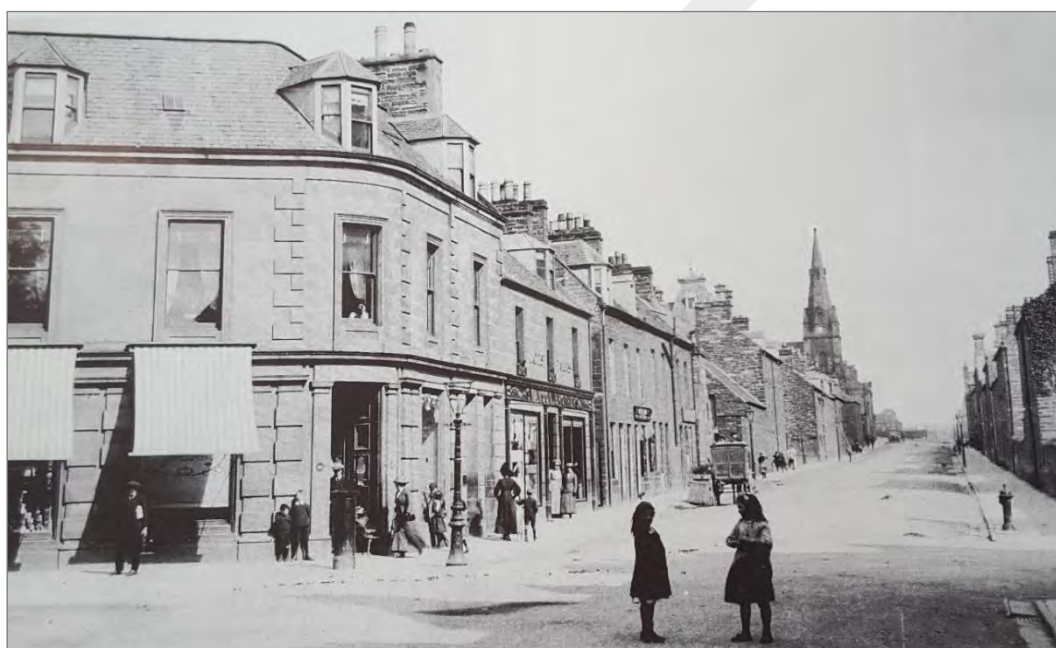
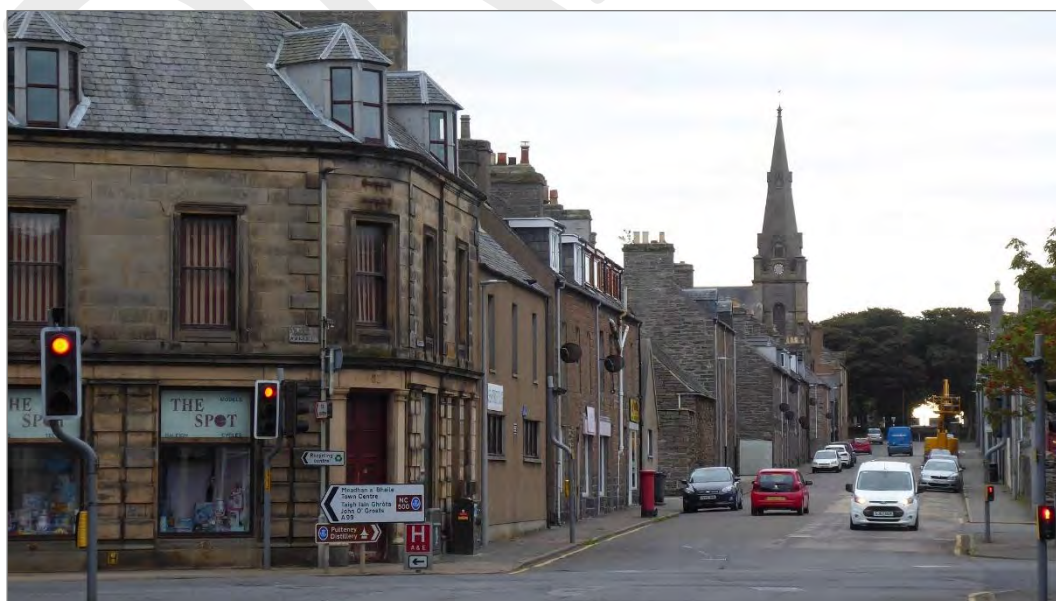
Figure 25: (top) the long vista looking east to Argyle Square from the crossroads at Francis Street in around 1910. Note the spire of the former Pulteneytown Free Church added in 1862 (now Wick Baptist Church), and no tree growth at that time © The Wick Society - The Johnston Photographic Collection; (below) the same view in 2020.

Pulteneytown forms part of the south-east section of the town of Wick. It has no major routes passing through it and as such it could be said to be fairly hidden from the main landward approaches into Wick. Francis Street, the main approach (A9) from the south, forms an edge to the streets around the upper part of the conservation area. The most significant point is the crossroads of Francis Street (and its continuation as Cliff Road) with Thurso and Dempster Streets. This junction is a mixture of enclosure on its south-west and north-east corners and more open ground; the south-east corner is marred by a modern petrol station, formerly the site of the West Church. Dempster Street, of which only a very short section is within the conservation area, provides the important long vista toward Argyle Square including the approach from the west on Thurso Street (fig 25).

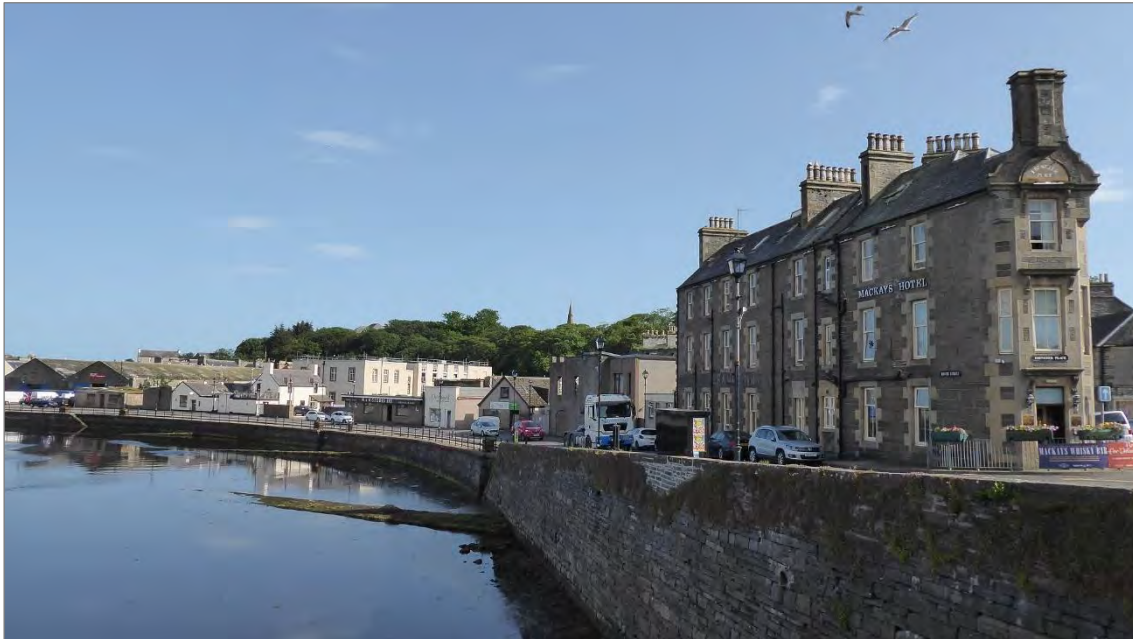
Figure 26: view of Lower Pulteneytown (River Street) from the Bridge of Wick. The majority of the street frontage has an inconsistent form and scale; however the street is anchored by the prominent Mackays Hotel cleverly fitted onto the narrow triangular site where River and Union Streets meet.

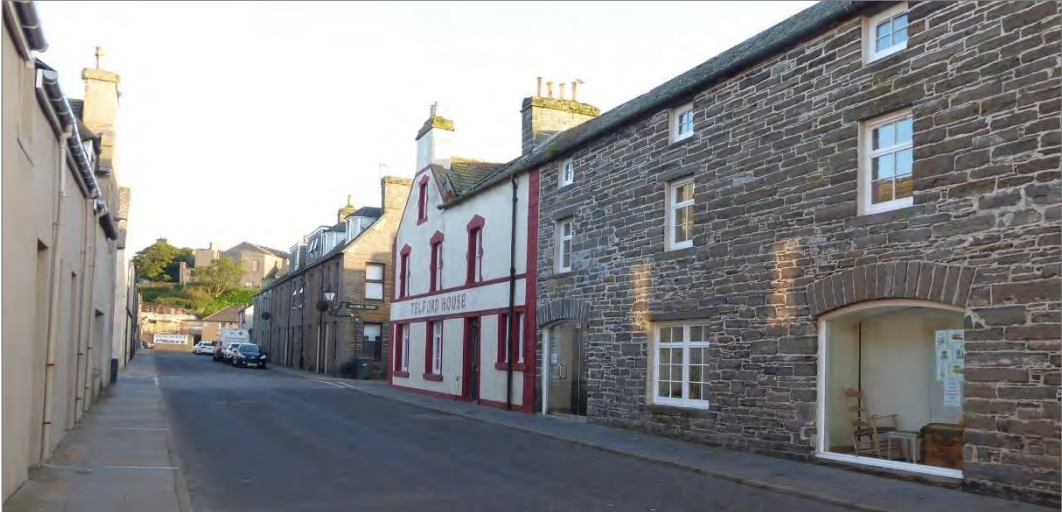
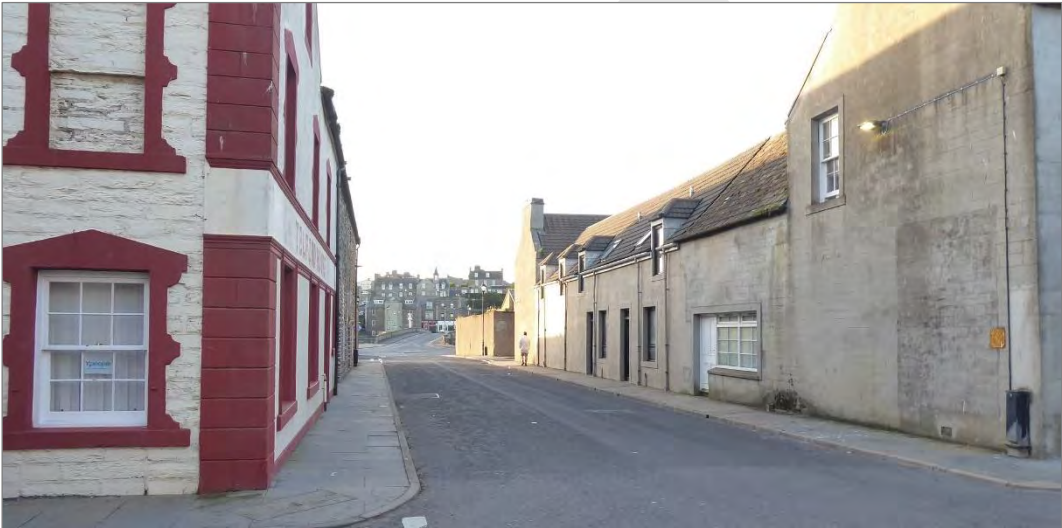
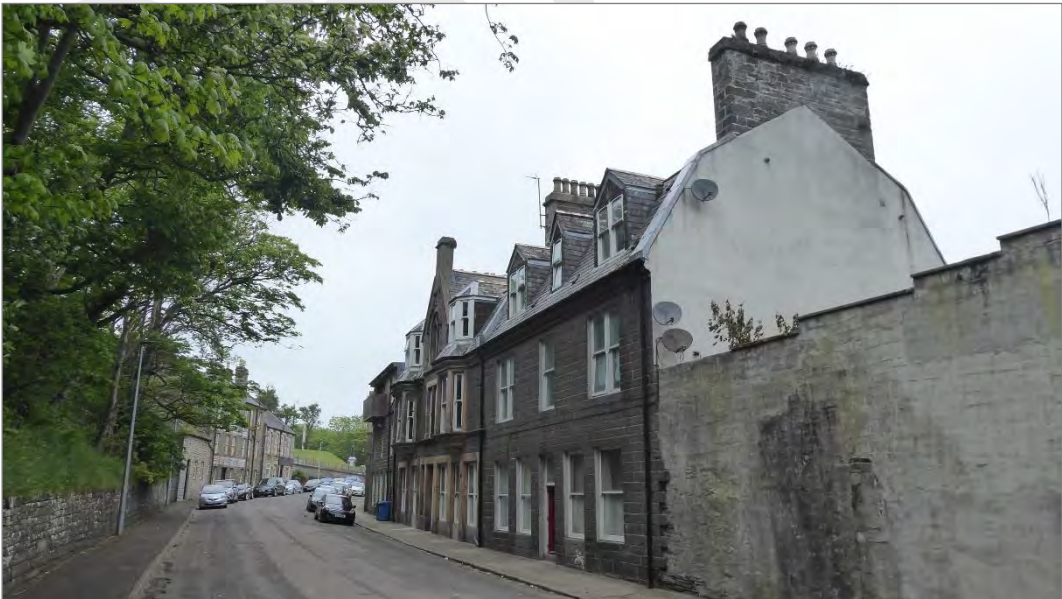
Figure 27: the long vista on Williamson Street in Lower Pulteneytown (top), looking south to Upper Pulteneytown elevated in the distance, with green space and trees at the rear of Breadalbane Crescent visible; (centre) the same position looking north to 'old' Wick. (Below) the curve of Union Street creates anticipation.

An alternative approach from Wick town centre is across the Wick Harbour Bridge which connects to Williamson Street. One of the principal views in Lower Pulteneytown is this long vista on Williamson Street looking from the Wick Harbour Bridge in the north, to Upper Pulteneytown in the south and creating a visual connection between the old and new towns (fig 27). The rear of the large public buildings on Breadalbane Crescent are prominent, in particular the large gabled elevation of the former Free Presbyterian Church.
