# WICK PULTENEYTOWN CONSERVATION AREA APPRAISAL

**Draft: NOVEMBER 2020**

**FOR THE HIGHLAND COUNCIL CIRCULATION to COMMITTEE.**

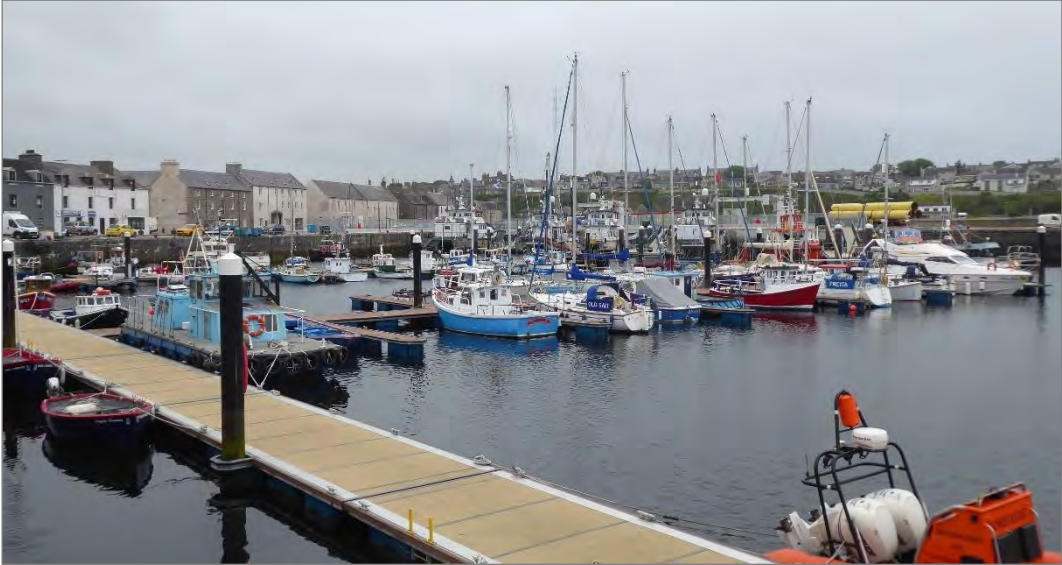
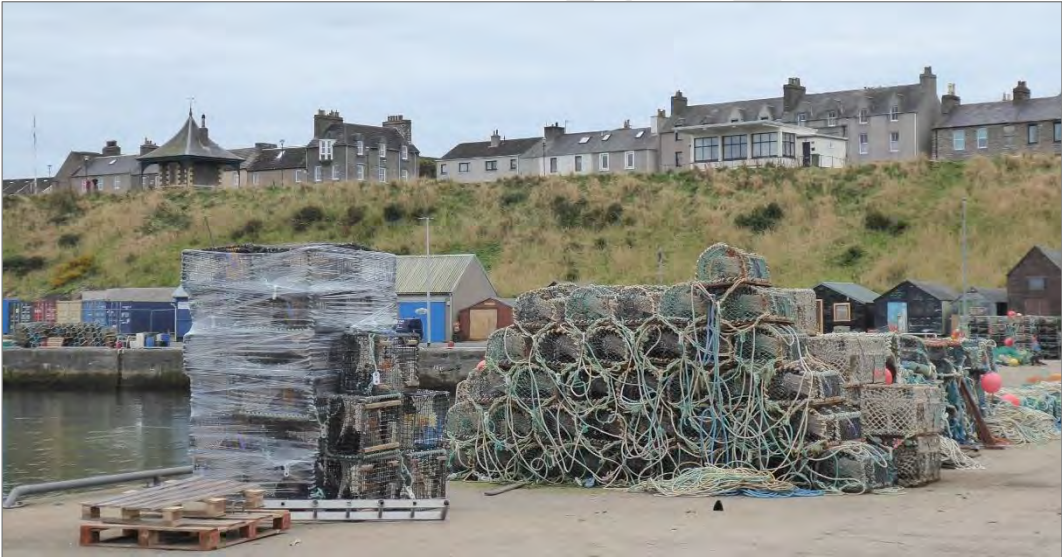
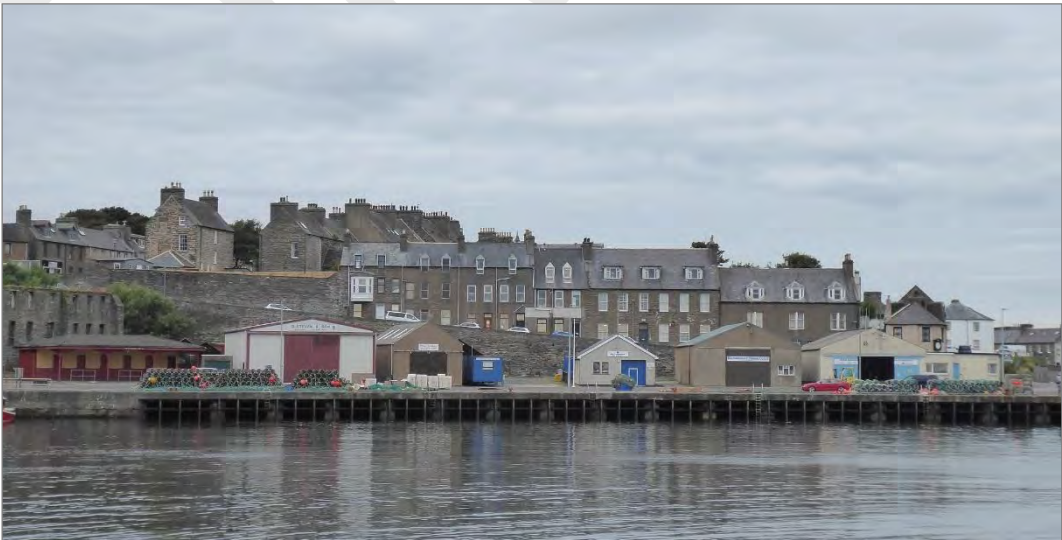
Figure 28: harbour approaches present views of Harbour Quay (top); Smith Terrace (centre); and Harbour Terrace (below); making the condition and integrity of design and materials on these properties particularly important to the overall impression of Wick Harbour.

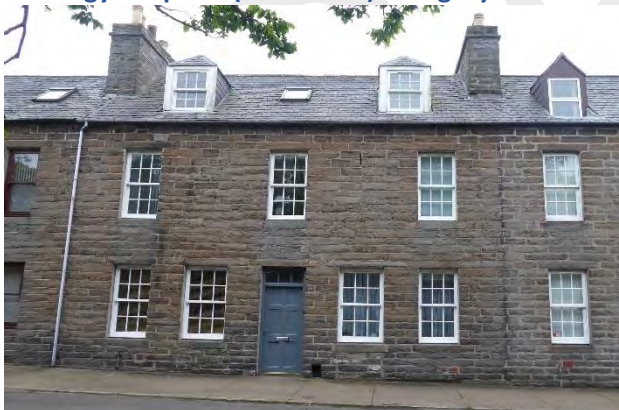
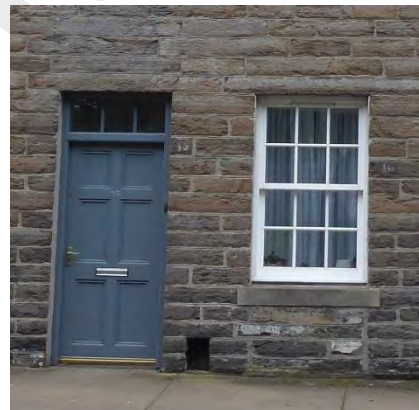
### No. 15 Argyle Square (south side) Category B listed

This house is part of one listed building record for Nos. 11-18 Argyle Square:

*“Thomas Telford, circa 1840. Terrace of, 2-storey, predominantly 2-bay, symmetrical, rectangular-plan, gabled town houses....Squared and tooled, long coursed Caithness stone slabs, some harled. Regular fenestration, irregular to rear.”* (HES, LB report 42269).

No. 15 (with Nos. 16-18 & 20-23) were the first houses to be constructed on Argyle Square and recorded in the Society’s Agent’s detailed report in March 1818 (GD9/376/1). No. 15 is a 3-bay frontage with additional windows flanking the central door. Two piend dormers and small central rooflight. Stout stone chimney stacks project from the gable walls with a simple tabling course below the cope. This property received grant assistance during the CARS for reinstatement windows and entrance door. Similar to a number of properties on Argyle Square, it is presumed there has been reconfiguration of the properties internally, as can be seen by the infilled doorway (No. 16, now a window; the painted house number can still be made out on the right of the window), suggesting this lot originally comprised two houses, possibly one at the rear.

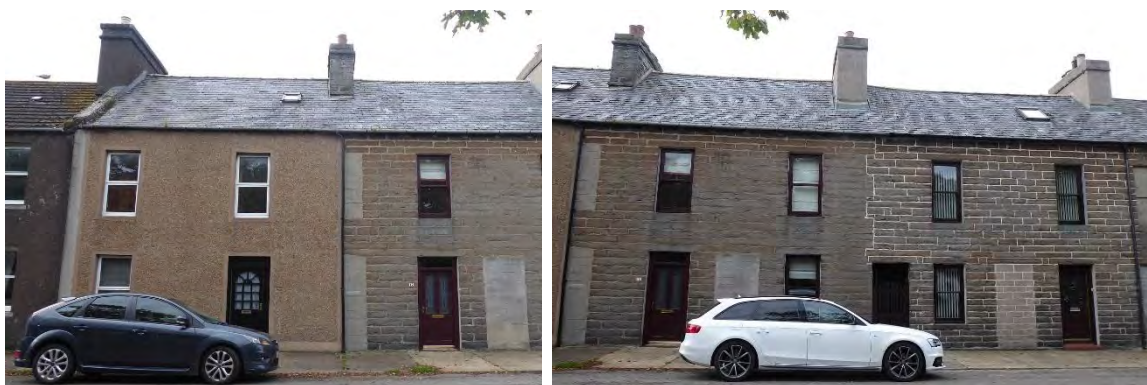
### No. 12 Argyle Square (south side) Category B listed

This house is part of one listed building record for Nos. 11-18 Argyle Square. In comparison to No. 15, the house at No. 12 has a smaller frontage with no dormers or rooflights. (No. 13 next door was repointed with roof and chimney repairs with grant assistance during the CARS). Similar to a number of properties on Argyle Square, it is presumed there has been reconfiguration of the properties internally, as can be seen by the infilled doorways. No.12 was originally part of the lot with No. 11 (harled to the left) and the principal boundary can be defined by the slightly larger chimney stacks at the boundaries. Note the pend on the right to No. 13 visible on the Town Plan.

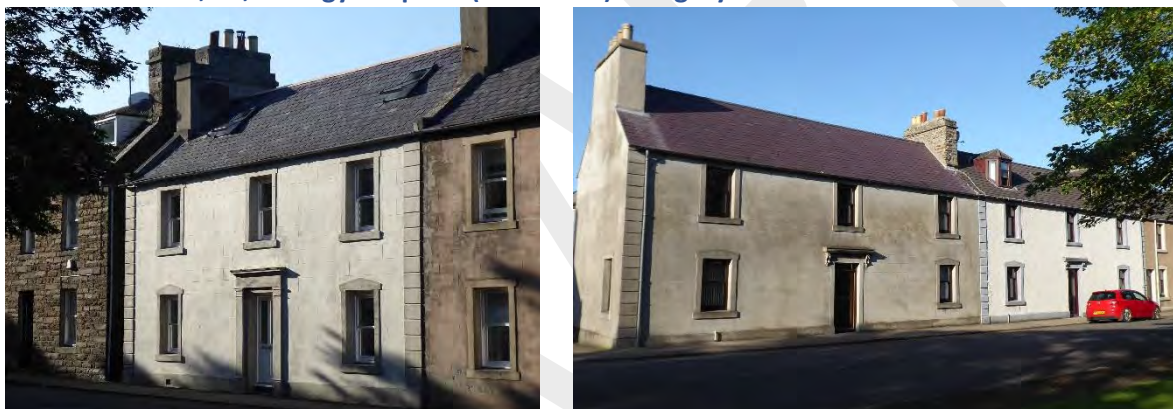
### Nos. 48-49 & 51, 52, 53 Argyle Square (north side) Category B listed

Nos. 48 & 49 are part of one listed building record for Nos. 35-49 Argyle Square.  
Nos. 51-53 are part of one listed building record for Nos. 51-59 Argyle Square.

These houses on the north side of the square have more refined detail than the majority of the other houses on Argyle Square. All have well defined 3-bay, symmetrical frontages, with pronounced base courses and channeled quoins. All occupy the full width of the lot as one house. The walls are rendered, presumably imitating the original smooth renders of the Regency period which were often 'ruled out' to look like fine ashlar stonework. Similar Regency features are the expression of the margins around the doors and windows, which on Nos. 50-53 have delicate incised decoration, the entrance doors also have cornice hoods over, on decorative console brackets (Nos. 51-53) or pilasters (No. 48). Other original features include stepped skewputts at Nos. 48, 49 and with flat stone copes over the gable wallheads at Nos. 48-49 and 53-54. There is a pend at No. 53. There are later alterations evident: No. 49 has adaptations to form a commercial shopfronts; No. 52 has canted dormers and a small central rooflight; No.53 has larger rooflights. All timber entrance doors appear to have been replaced (although the possible original feature of a rectangular fanlight has been retained), as have the original timber sash & case windows. The material for the render appears to be cementitious and finished in modern paint or dry dash (No. 53). At No. 48, the west side is enclosed by a blind gable end forming a narrow passage with its neighbour, as was required by the British Fisheries Society's building regulations.

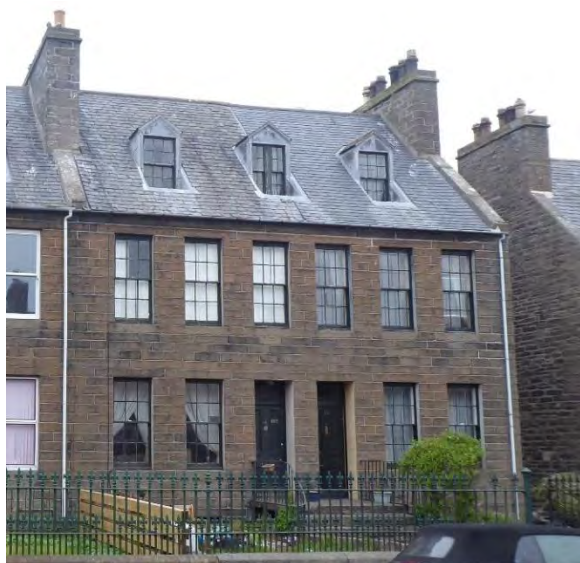
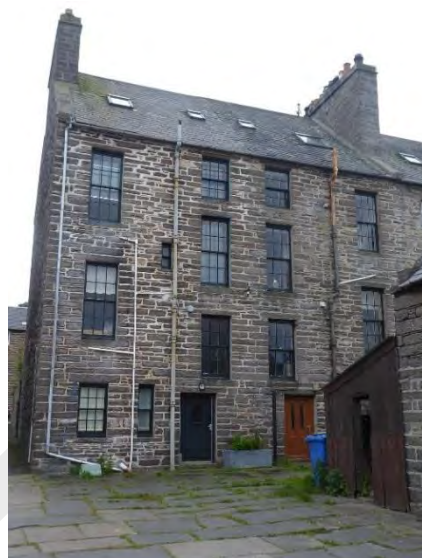
**Nos. 10-13 Breadalbane Crescent Category B listed**

Built circa 1860-1865 and considered to be the “homes and workplaces of the herring fishing entrepreneurs” and wealthier merchants (Beaton, 1996, 41).

Symmetrical block of 4 terraced 3-bay townhouses of 2-storey with basement and attic, gable ended constructed of coursed Caithness stone. 4-panelled entrance doors with 3 pane rectangular fanlights above. Nos. 10 & 11 appear to retain original 6 over 6 timber sash & case windows, and small gabled dormers, the central dormer at No. 10 expressing the division between the two houses. Grey slates, with flat copes and raised skewputt, gable chimney stacks with simple tabling course below the copes. Rear yards are paved in Caithness flagstones and contain cooperages, long single storey former industrial buildings (refer below). Low stone boundary walls enclose front gardens with original decorative cast iron railings. Walls have saddle-backed copes and are terminating with tall stone piers with pyramidal caps at the entrance lanes to the cooperages.

Nos. 4, 6, 8 & 9 are very similar but comprise 5-bay townhouses. Outbuildings to the rear would have originally included stables, bothies for itinerant workers and cooperages.

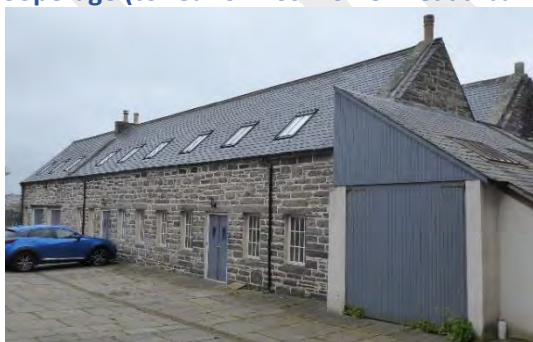
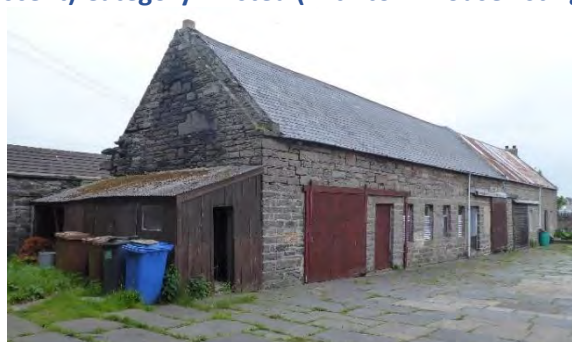
**Coopage (to rear of Nos. 10-13 Breadalbane Crescent) Category B listed (with townhouse listing)**

Coopage behind No. 9 restored using CARS funding to form 2 houses (left).

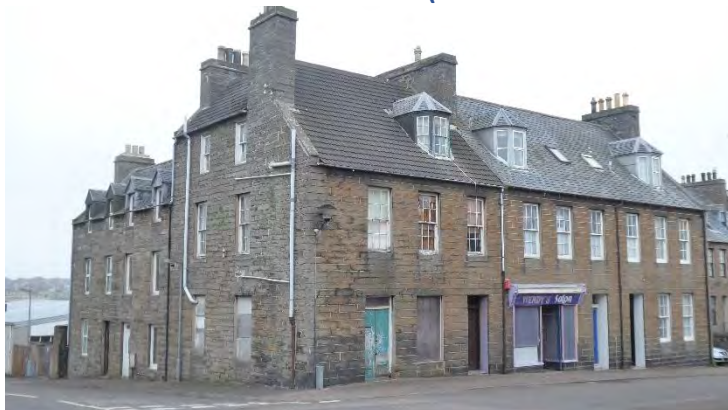
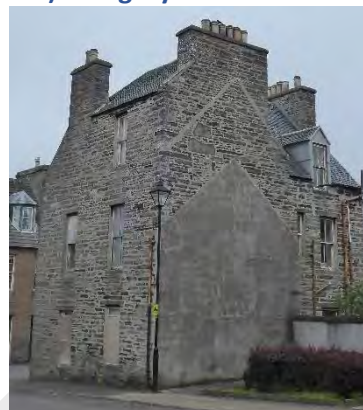
**Nos. 14-18 Breadalbane Crescent (corner of Lower Dunbar Street) Category B listed**  
**Nos. 28 & 29 Breadalbane Terrace (corner of Lower Dunbar Street) Category C listed**

Nos. 14-18 (c.1860 in HES, LB report 42291) are a terrace of 2-storey and attic, 3-bay, symmetrical, gable ended houses constructed in coursed Caithness stone. Nos. 14, 15 & 17 retain original 4-panelled entrance doors with rectangular fanlights above. Traditional 6 over 6 timber sash & case windows, and canted dormers (No. 17 retains its possibly original 4 over 4 windows). Grey slates, with flat copes and raised skewputt at each end of the terrace; 3 (possibly originally 4) gable chimney stacks with simple tabling course below the copes. Some adaptation including small plate glass shop front with recessed entrance door at No. 16. Concrete roof tiles to Nos. 17-18. No. 17 & 18 appear vacant.

The building forming Nos. 28-29 Breadalbane Terrace, directly opposite Nos. 17 & 18 Breadalbane Crescent is almost a mirror image; although with a loftier façade and (possibly later) 2 over 2 traditional timber sash & case windows. As well as retaining these windows it also has an unusual arched panelled door (fig 34c) thought to be a local design. HES, considers this to be of an earlier date than the opposite terrace, c. 1820 (HES, LB report 42295) and a house is recorded on this lot in 1818 (SRO/GD9/376/1). Nos. 28-29 vacant.

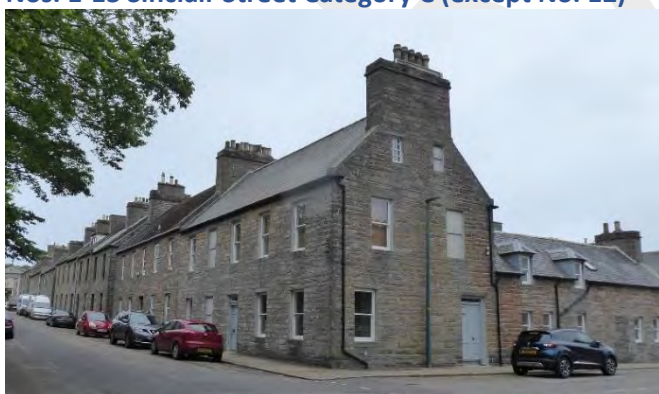
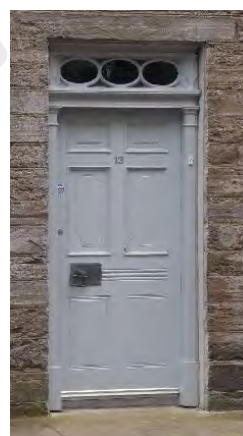
**Nos. 1-13 Sinclair Street Category C (except No. 12)**

A very consistent terrace of 5 and 2-bay houses in four blocks separated by narrow lanes. All original main doors survive except at Nos. 5, 6 & 9, several of unusual design thought to have been made by local joiners and several with original fanlights. Of particular note are Nos. 7, 8 & 10 which have central roundels, and Nos. 12 & 13 with a delicate 6-panel doors with pilasters supporting a 3 oval fanlights above (Nos. 3 & 4 without fanlight detail). A number of doors also retain original heavy bronze door ironmongery. No. 13 ends the terrace, with an adjoining single storey block extending along MacLeay Street. A traditional garret window survives at the attic level.

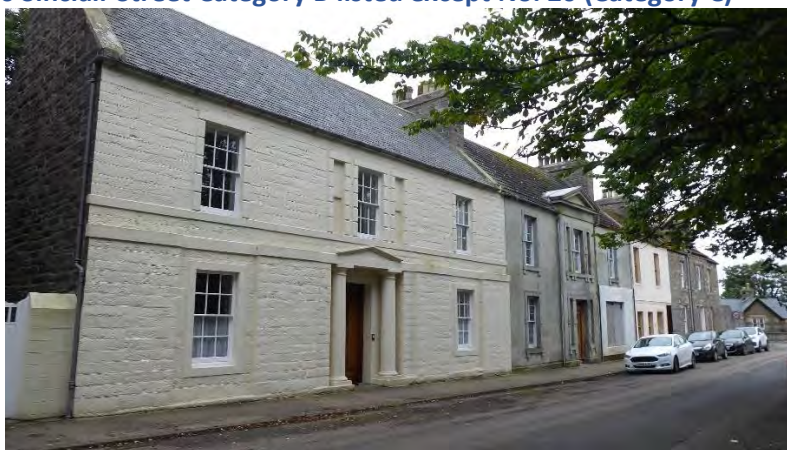
**Nos. 17, 18 & 20 Sinclair Street Category B listed except No. 20 (Category C)**

A distinctive group of three 2-storey, 3-bay, symmetrical, gable ended houses with refined architectural design and detail to their frontages. No. 19 (unlisted) forms a short 2-bay elevation.

No. 17 has a slightly recessed door entrance with Doric columns and pediment forming a portico. Unusual tripartite paneled door to centre, with very decorative fanlight above (below). Slightly recessed window bays at ground floor. Raised, broached and droved ashlar margins to upper storey openings; centre tripartite window, centre flanked by narrow blind windows; dividing band between floors, and 1st floor cill course. 6 over 6 timber sash & case windows.

There has been some adaptation to No. 18 with a commercial premises to part of the ground floor with a large plate glass window disrupting the regular design. Next door, No. 19 is not listed and is a 2-bay property. No. 18 and 19 received grants for windows works during the CARS project.

The façade treatments vary across the buildings which diminishes its group impact. No. 17 has painted coursed Caithness stone; No. 18 is smooth rendered (and ruled out) and No. 20 has exposed Caithness stone with later ribbon cement pointing. HES dates these buildings to c.1830 (HES, LB reports 42331, 42332, 42333) however not part of the 1813 Draft Feu Plan and likely after 1840.

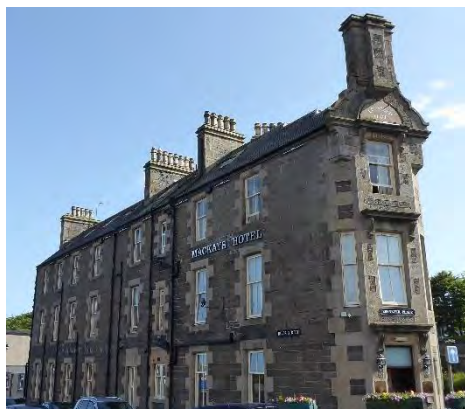
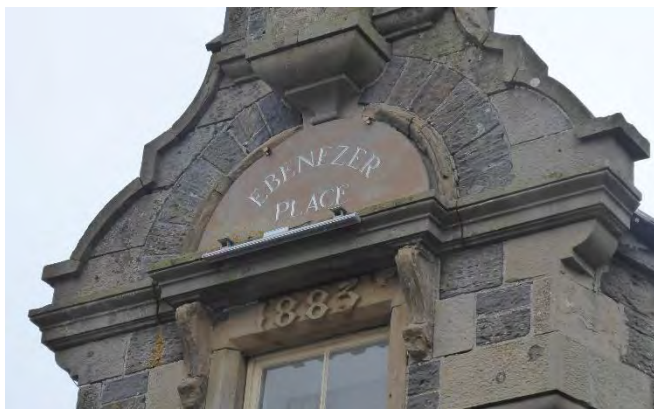
### Mackays Hotel, Ebenezer Place/ Union Street / River Street, not listed

Built in 1883 by Alexander Sinclair as a Temperance Hotel, it is described by Beaton (1996, 37) as “filling a narrow triangular plot as regally as a ship’s prow...” with apex chimney stack and date stone below the incised Ebenezer Place. Ebenezer Place is in the Guinness Book of Records as the smallest street in the world at 6’9” (2.05m) across. Later 20<sup>th</sup> century function room extension next to the former Baptist Church (1868; currently owned by hotel but not in use).

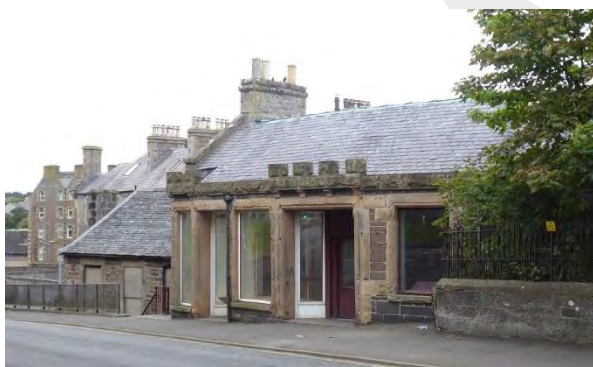
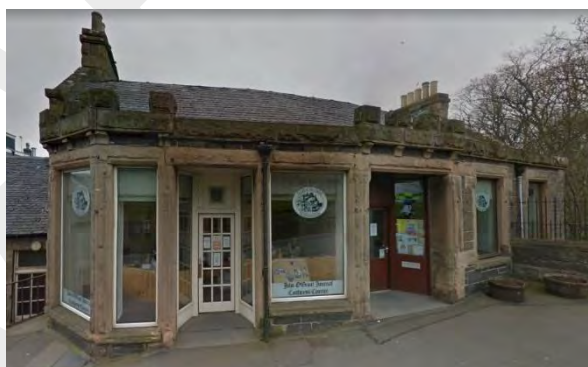
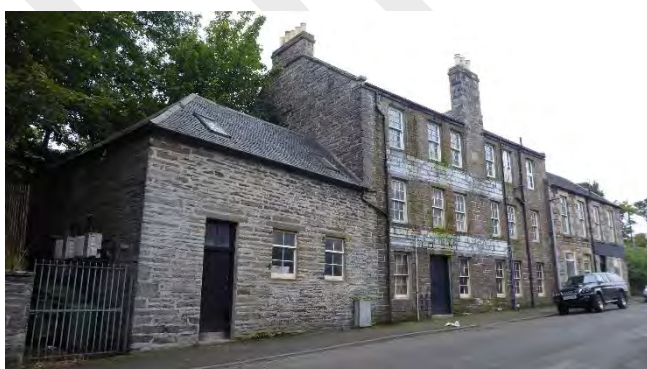
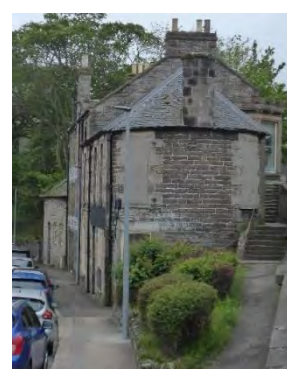
### No. 42 Union St / Cliff Road, The North of Scotland Newspapers Category B listed

Terrace of 3 linked buildings of varying height spanning the site at the western tail of the steep bank that separates Lower and Upper Pulteneytown, with external steps connecting Union Street and Cliff Road. The building appears as a single storey cottage on Cliff Road, with 2 and 3-storey works and offices to the rear (Union Street). Until 2020, the home of the John O’Groats Journal and Caithness Courier. Key features include the typically Georgian elegant bow end in coursed Caithness stone with sandstone window margins. The plate glass and rubble face stonework to the shop front on Cliff Road is a later adaptation.

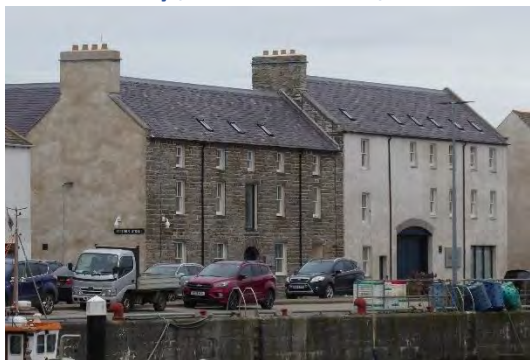
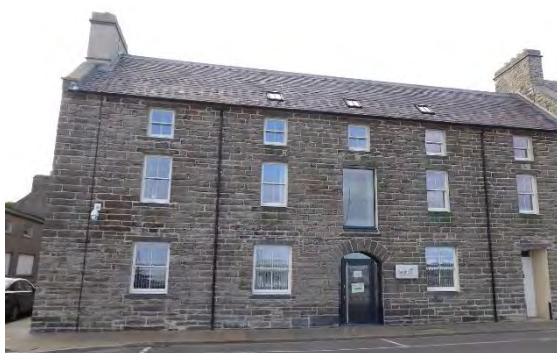
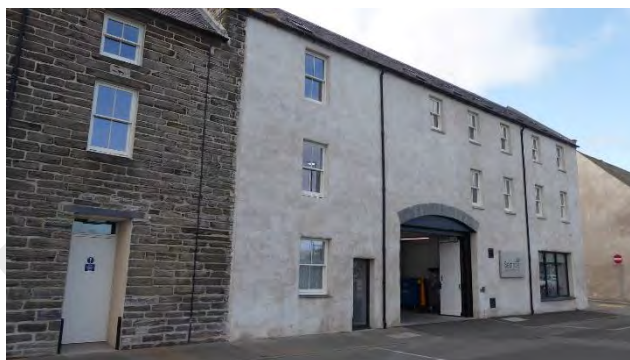
**Harbour Quay / Saltoun Street / Telford Street block. Category C listed**

Street block comprising two 3-storey, 5-bay, gable-ended storehouses constructed in coursed Caithness stone; partly lime harled during recent adaptation and restoration. Building on the corner with Saltoun Street has regular fenestration with a segmental-arch (originally a pend) at the centre at street level and above a former doorway at 1<sup>st</sup> floor above (now glazed); smaller windows to 3rd storey. Blind gable with stout chimney stacks, simple tabling course below the cope. Building on the corner of Telford Street, harled; previous large vehicle entrances slapped to centre and right. 2-storey walls ran the length of the plot on the side roads to enclose a herring curing yard; blocked windows were reinstated during restoration. The building recently adapted and brought back into use with SSE funding for use by the Beatrice Offshore Windfarm.

In 2002, HES stated that: “... this storehouse displays the best-preserved elevation of a typical Pulteneytown storehouse/curing yard although the interior curing yard had been covered over. The building materials of stone and slate, and the overall dimensions, height and length, for the storehouses that form the Lower Pulteneytown grid were drawn up by Telford as part of his overall town plan and were laid down in the BFS’s Building Regulations. However, the central segmental arched pend that forms the central feature of the storehouses, where remaining, was not specified by Telford but appears to be a practical design that was widely adopted, thereby forming a local design type. The buildings are in effect complete fish processing factories rather than simply storehouses. The original layout, repeated throughout, was of a large gabled storehouse and offices building facing the main street and running the entire length of the feu, i.e. a whole or half block. The central archway led through a pend to a large open air flagstoned curing yard behind. The curing yard was surrounded on the remaining three sides by ancillary stores and workshops such as the salt stores, cooperage and smokeries. From the outside the continuous high walls of the yards, running round the entire block, hid the industry within.” (HES, LB report 48404).

Comprising 2 of the original lots auctioned in 1808 (lot 3 & 4 on the Draft Feu Charter 1813; fig 8), a building on Saltoun Street was recorded in 1813, the lot described as “...enclosed by a wall 9 feet high. Salt cellars and a cooperage in the yard are the only houses yet erected” (SRO/GD9/376/1, 1, 1818). The storehouse therefore built sometime after March 1818.

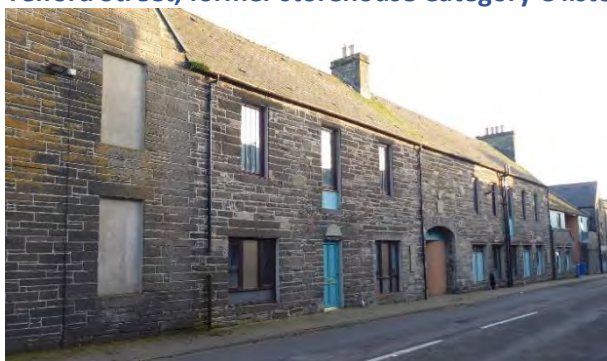
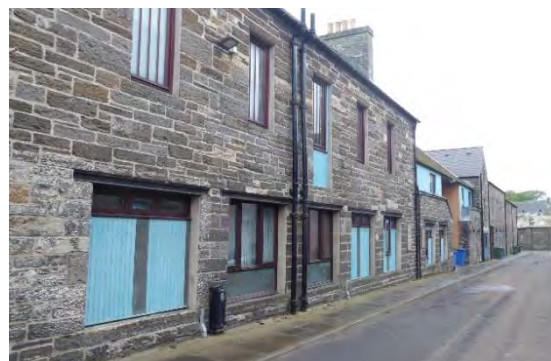
**Telford Street, former storehouse Category C listed**

Formerly disused 2-storey, 9-bay storehouse with central pend constructed in coursed Caithness stone slabs. Feued in 1814, but possibly built c. 1830 (HES, LB report 48410). Earlier alterations such as the large square windows to the ground level were present before more recent adaptation to housing funded by the Heritage Lottery Fund. This listed building abutting the Williamson Street terrace housing to the east now forms part of a larger housing development with other unlisted buildings on this section of Telford Street.

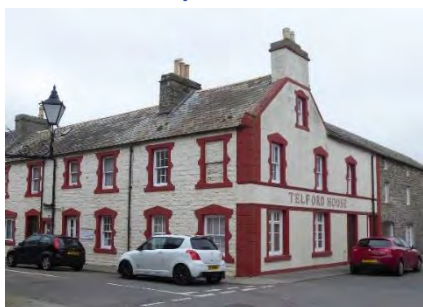
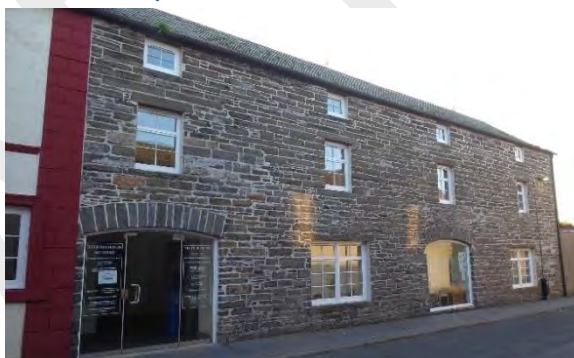
**Telford House / offices on Telford and Williamson Streets, not listed**

A wide 4-bay storehouse on Williamson Street with two pend entrances has been converted to office space and sits alongside the contrasting style of Telford House, possibly built as offices / housing. It has details typical of the more refined Upper Pulteneytown houses with unusual raised margins to the openings and moulded string courses to the ground floor lintols and 1<sup>st</sup> floor cills; unusually the gable end is not blank, as was common in the warehouses, and is pronounced by channelled quoins and banded cope and decorative skewputt; it also features a central garret window. This level of detail contrasts with the typically plain stone façades of the other lower town housing for example the block south of this on Williamson Street (fig 15).

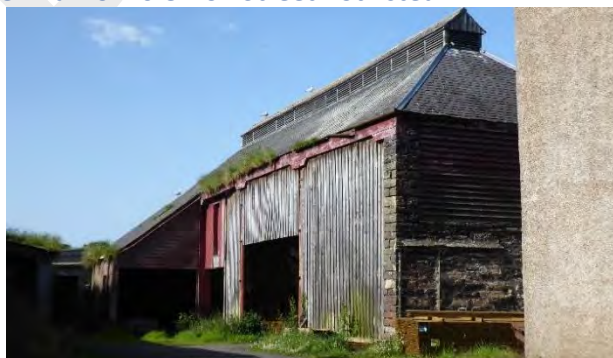
**Former kippering kiln behind No. 16 Union Street not listed**

Thought to be an original kippering kiln later adapted for timber storage, at the rear of a Union Street lot in a former curing yard (1<sup>st</sup> Ed. OS Town Plan; Canmore ID 100253). The long ridge ventilator and the open slatted gable are typical features.

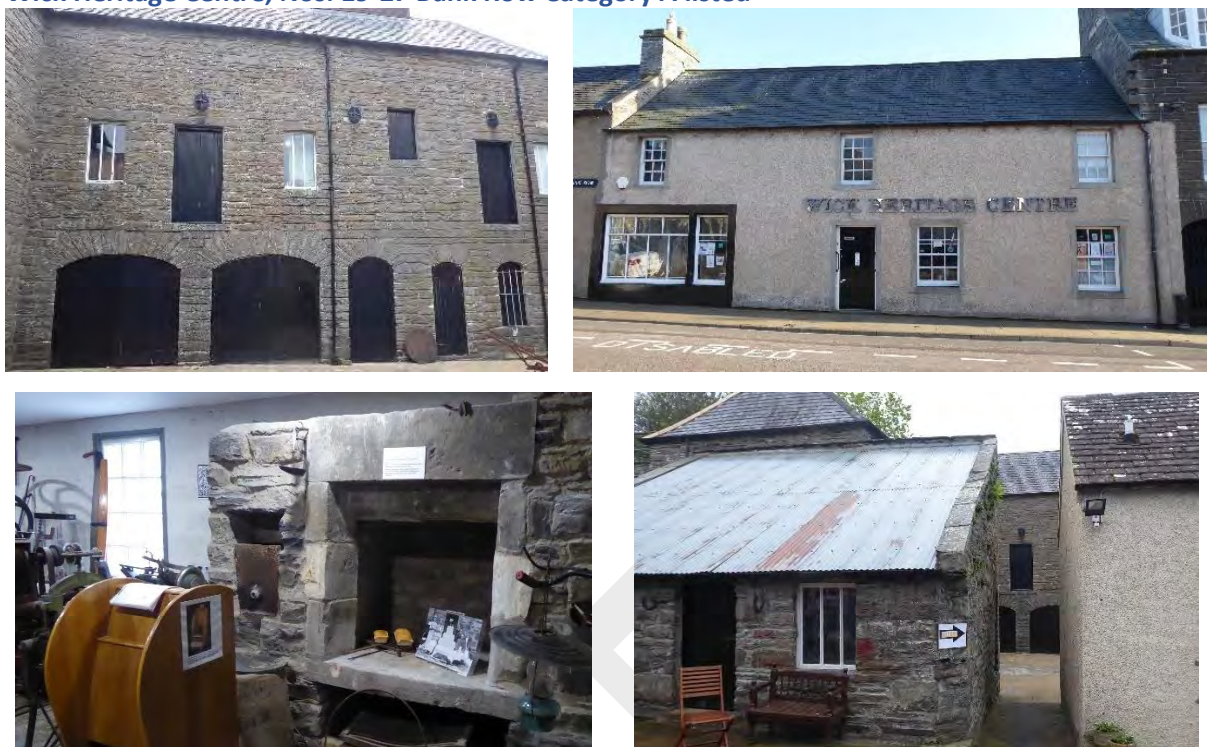
**Wick Heritage Centre, Nos. 19-27 Bank Row Category A listed**

The Heritage Centre comprises a complex of buildings including dwelling houses on the street frontage, curing yard, cooerage, kippering house/kiln, and blacksmith’s. It forms part of the terrace backing onto the steep slopes below Upper Pulteneytown. Segmental arched pend leading to the yard enclosed by buildings some with very fine masonry detailing (fig 29). Buildings gifted to, and opened in 1981 by The Wick Society. CARS grant for comprehensive repair of roofs, and joinery including the shop front. HES (LB report 42286) states that the Wick Heritage Centre is listed Category A as the last surviving example of a traditional herring curing house in what was, from 1820 to 1914, the busiest herring port in Britain and northern Europe. Interiors of particular interest include the herring drying and smoking racks and the cooerage.

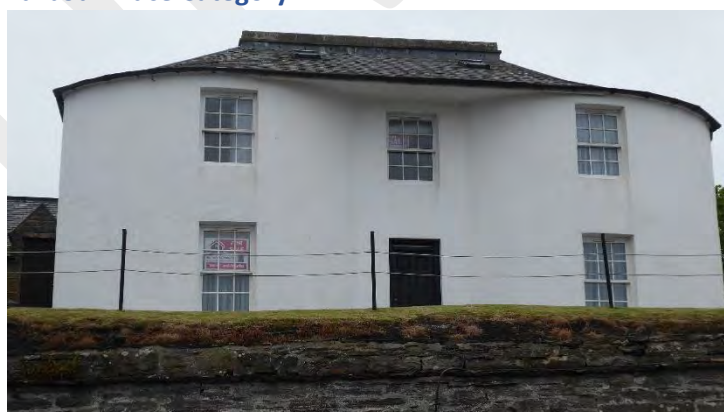
**The Round House, Harbour Place Category B**

The Round House was designed by Thomas Telford and built by George Burn in 1807, who was responsible for constructing Telford’s original Wick bridge and the Inner Harbour. Later occupied by James Bremner who built the Outer Harbour. Occupying a commanding position overlooking the harbour, the house has a striking and elegant double bow front with over hanging eaves, the elegant design emphasised by the smooth rendered finish and shallow piend roof; the original long row of chimney stacks have sadly been reduced to a flat coping (refer Beaton, 1996, 44). CARS grant for reinstatement of windows and doors, and repair of the original ‘Roman cement’ render finish.

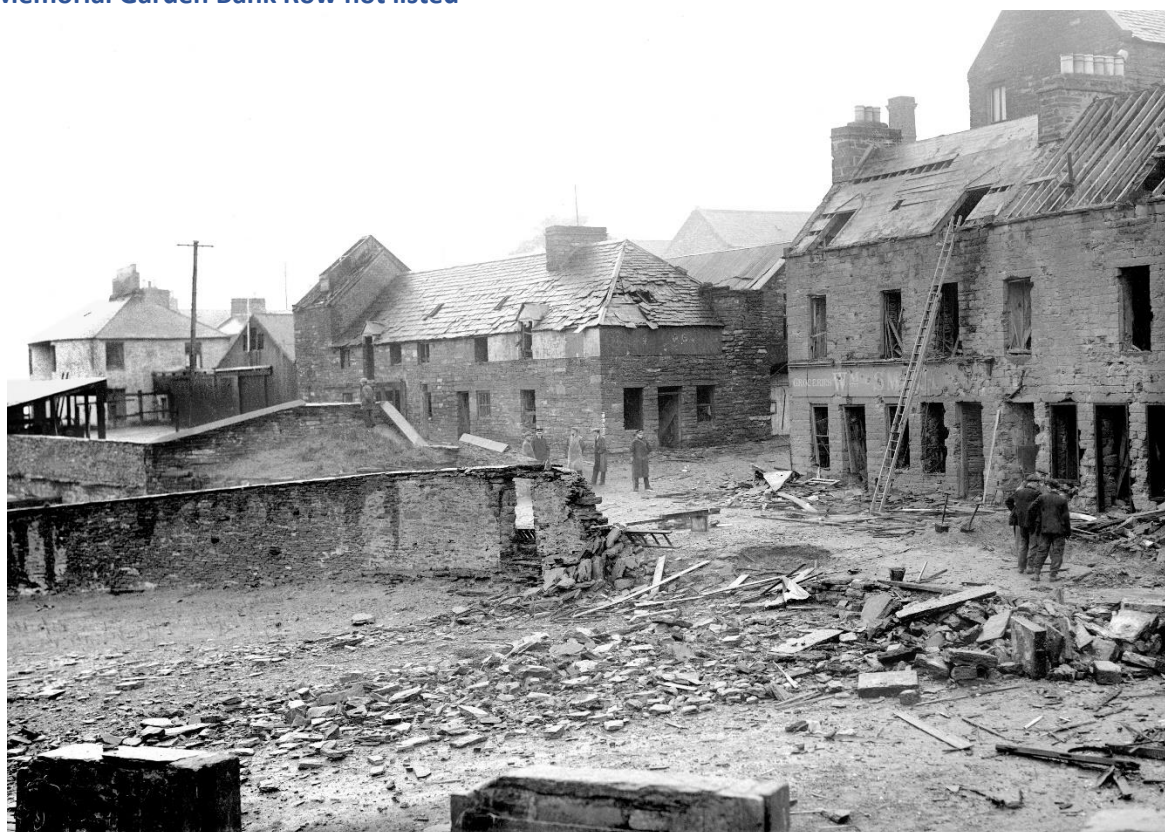
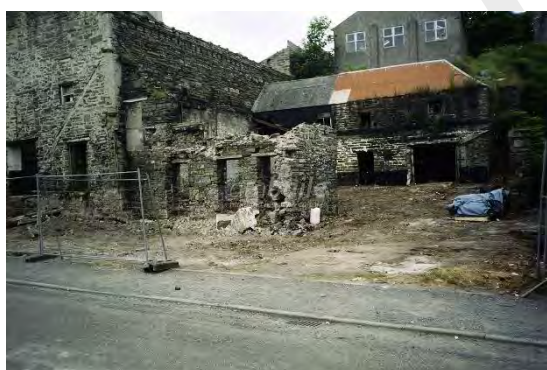
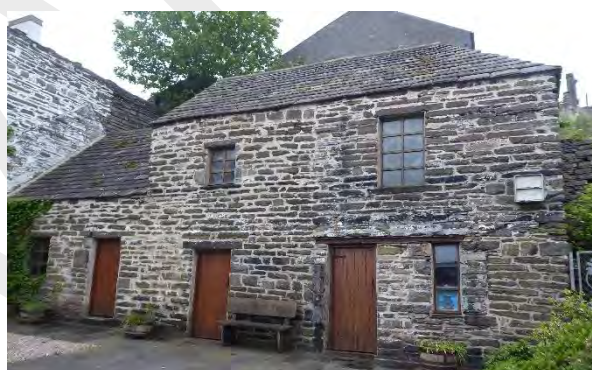
**Memorial Garden Bank Row not listed**

Surviving traditional building at the rear of one of the lots bombed during the Second World War and where the street fronting buildings were damaged and subsequently demolished. The top image illustrates the bomb damage adjacent to the garden on the corner at the Black Stairs © The Wick Society - The Johnston Photographic Collection.

Having laid derelict for many years, the area is now a Memorial Garden to those killed in the Wick bombings and the building has been restored with a Caithness slab roof. (left image prior to restoration © Am Baile).

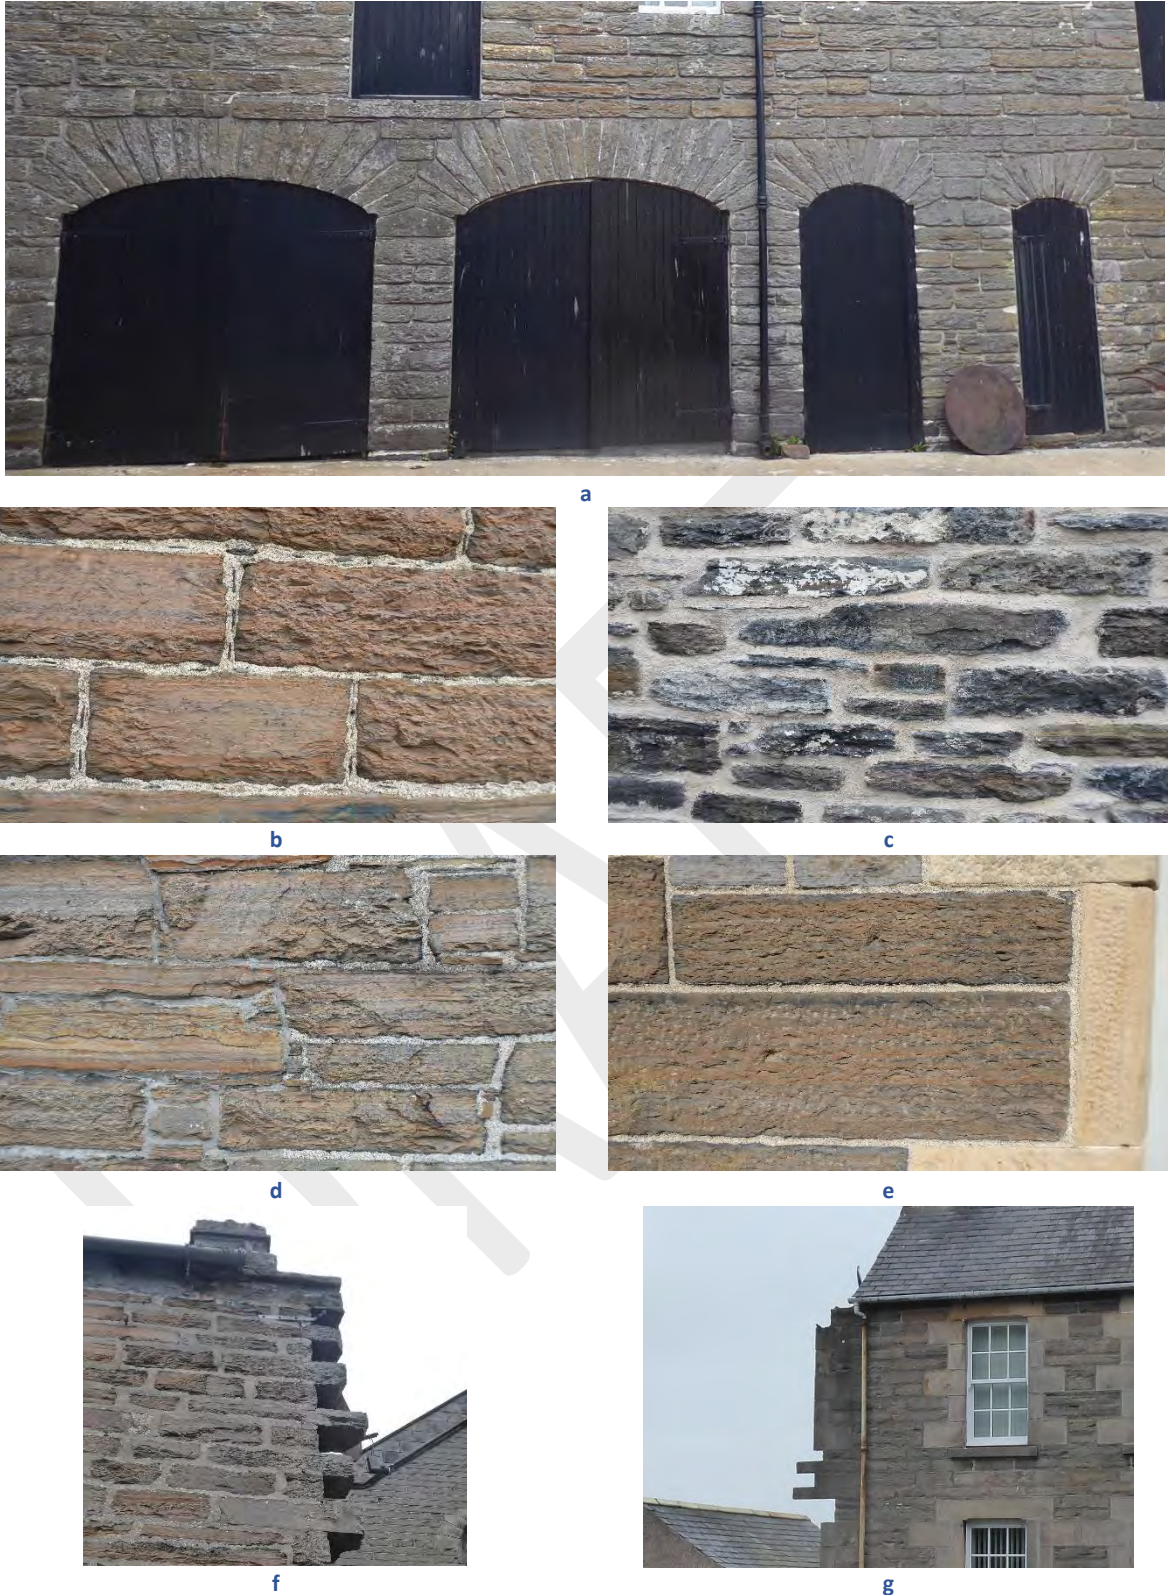
Figure 29: Masonry details: a: very fine examples of the segmental arches used in Pulteneytown particularly in the industrial buildings and to access internal yards, here at the Wick Heritage Centre; b: squared blocks of a warm brown Caithness stone with lime mortar and slate pinnings; c: walling recently repointed in lime on Saltoun Street warehouse, note the stones are more irregular in shape and darker grey in colour; d: a similar wall on a domestic property with irregular stones and courses, the gaps made up in smaller stacked stones; e: shaped Caithness stones on a Victorian building, cut to size, and used with sandstone dressings for openings; f and g: examples of masonry with projecting stones, known as ‘tusking stones’ or ‘tuskers’; left for bonding into the adjoining façade; image g showing the dressed window stones for the next property.

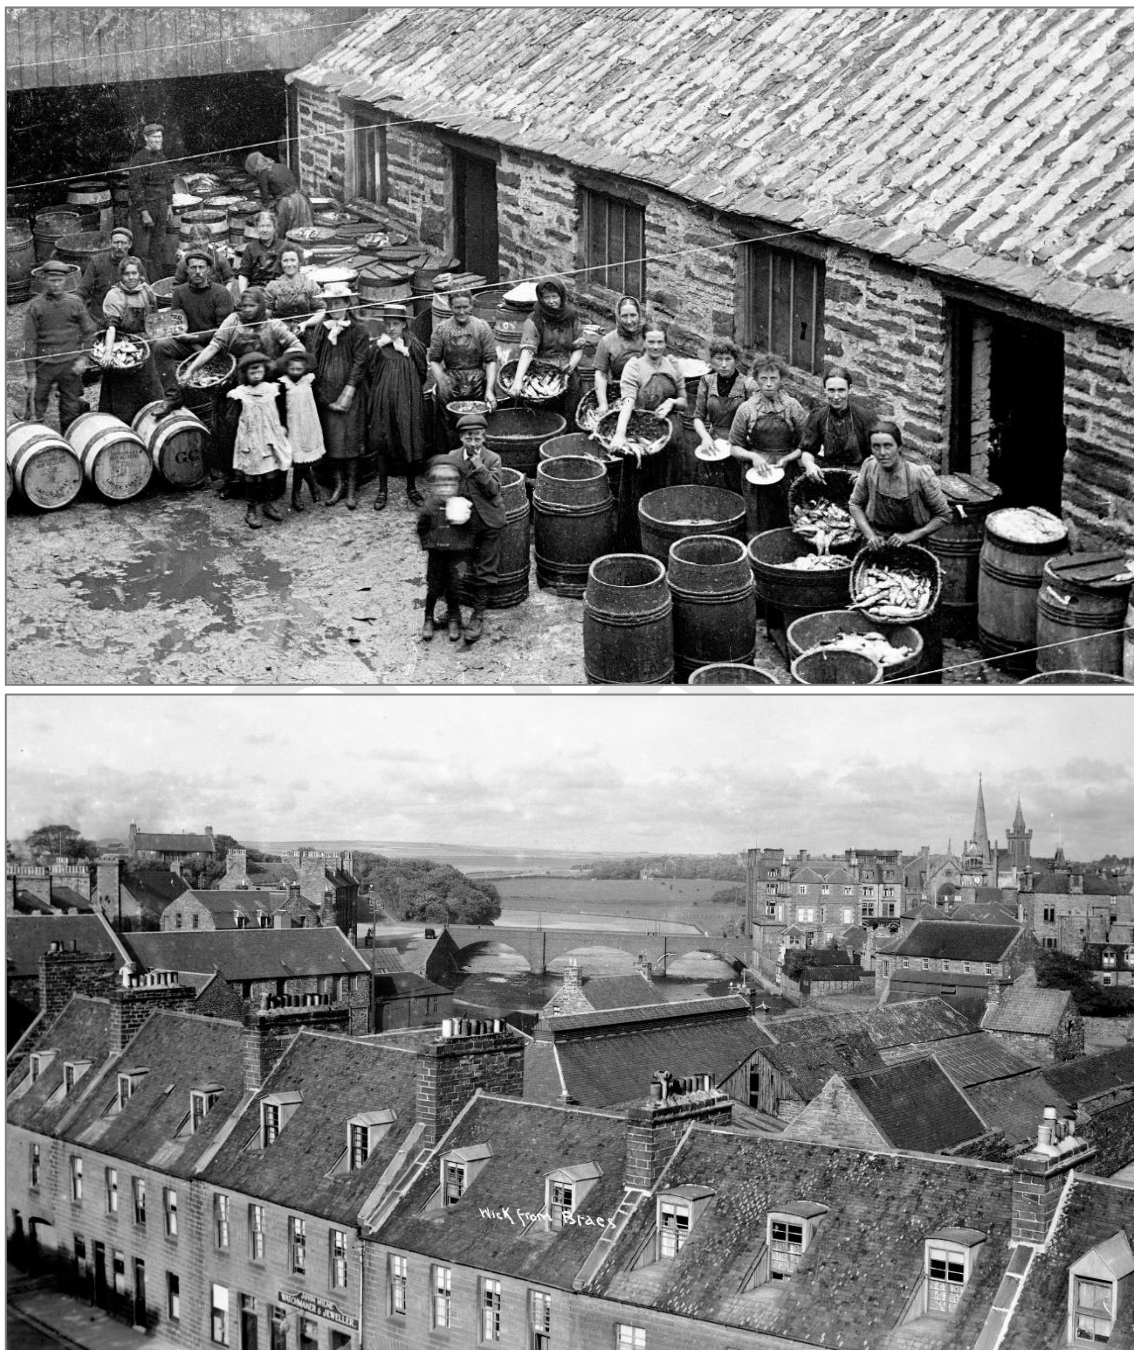
Figure 31: (top) George Cormack’s yard in Lower Pulteneytown in 1900s with pantiles on the roof of the single storey building and what looks to be a Caithness slate easing course at the eaves; a rough cobble stone finish to the yard; (below) Historic view over the roofs in Union Street illustrating the predominance of slate roofing but with other finishes including pantile on some industrial buildings. © The Wick Society - The Johnston Photographic Collection

The roofs of the Georgian houses are pitched on timber rafters and sarking boards, and predominately gable ended (a small number are piend). It is likely that the timber was imported as there was no reference to using local timber in the feu charter, unlike other materials. Telford asked that roofs have a slate finish preferably, and the ability to take local 'slate' is mentioned in the feu charter. This may suggest use of heavy Caithness slate, however only a very small number of buildings today have a Caithness slate roof, for example the restored building in the Memorial Garden (section 4.2.2), and a cottage on Brown Place (out with the conservation area currently). Looking at historic images similarly indicates only a very small number of flagstone slate roofs and suggests that thinner slates were more commonplace probably brought in by boat from either the West Highland quarries or from the Welsh slate quarries. Historically there may also have been clay pantiles brought by boat and tiles do occasionally appear in older images on buildings in the internal yards (fig 31).

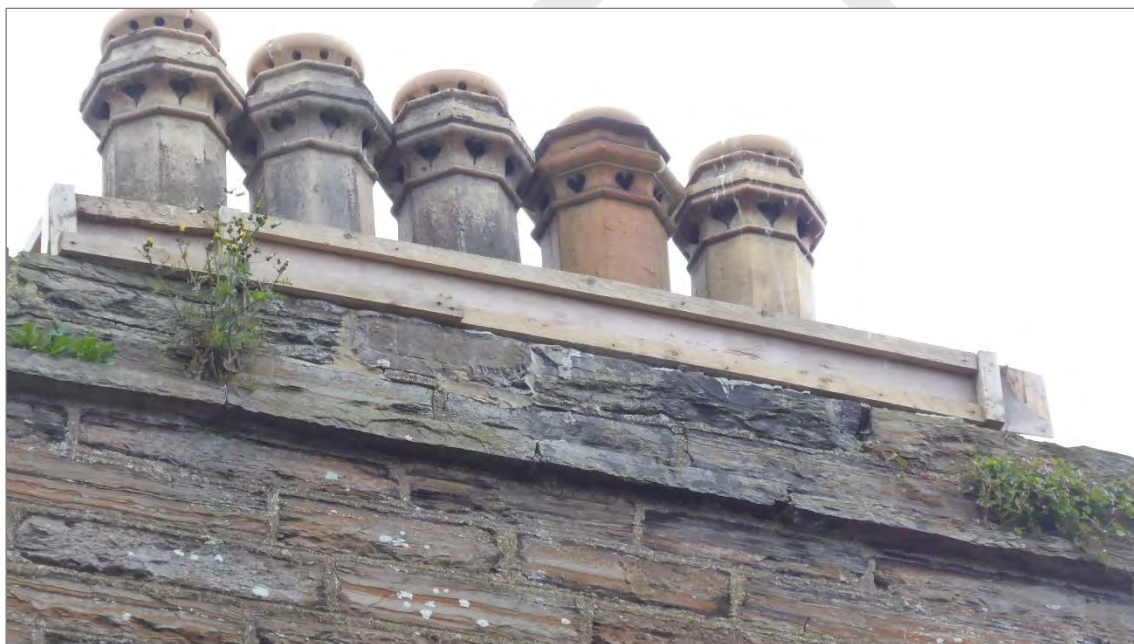
Figure 33: a typical Pulteneytown chimney with a thin flagstone slab forming a projecting tabling course detail before a further one or two courses of stone form the cope. Here with more elaborate hexagonal buff coloured chimney pots.

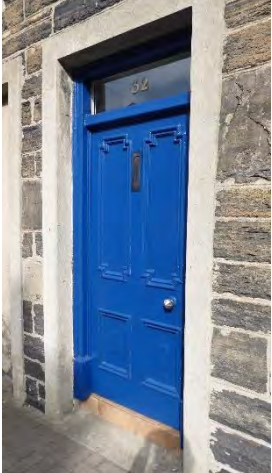
a: 3 Sinclair Terrace

b: 8 Sinclair Terrace

c: 12 Sinclair Terrace

d: 28 Breadalbane Terrace

e: 17 Argyle Square

f: 55 Argyle Square

g: 15 Breadalbane Terrace

h: 32 Dempster Street  
(not in CA)

i: 1 Bexley Terrace  
(not in CA; former Custom House)

Figure 34: Windows and doors: the variety, distinctive detail and carpentry skill evident in surviving original doors.

There are a good number of surviving traditional entrance doors (fig 34 a-i), and as Beaton (1996) describes some are very attractive and distinctive, including a significant number of original doors on Sinclair Terrace (section 4.2.2), Breadalbane Terrace, Argyle Square, Union Street and Dempster Street (out with the conservation area). Most have rectangular fanlights above, often with decorative timber work dividing the glass in a number of designs including circles (No. 49 Breadalbane Terrace; fig 30b), ovals (No. 13 Sinclair Terrace, section 4.2.2 and No. 12 Sinclair Street fig 34c), and more elaborate shapes (No. 17 Sinclair Terrace; section 4.2.2). These small but refined details are important in defining the character of the properties, and conserving surviving joinery is an important consideration.
