# WICK PULTENEYTOWN CONSERVATION AREA APPRAISAL

**Draft: NOVEMBER 2020**

**FOR THE HIGHLAND COUNCIL CIRCULATION to COMMITTEE.**

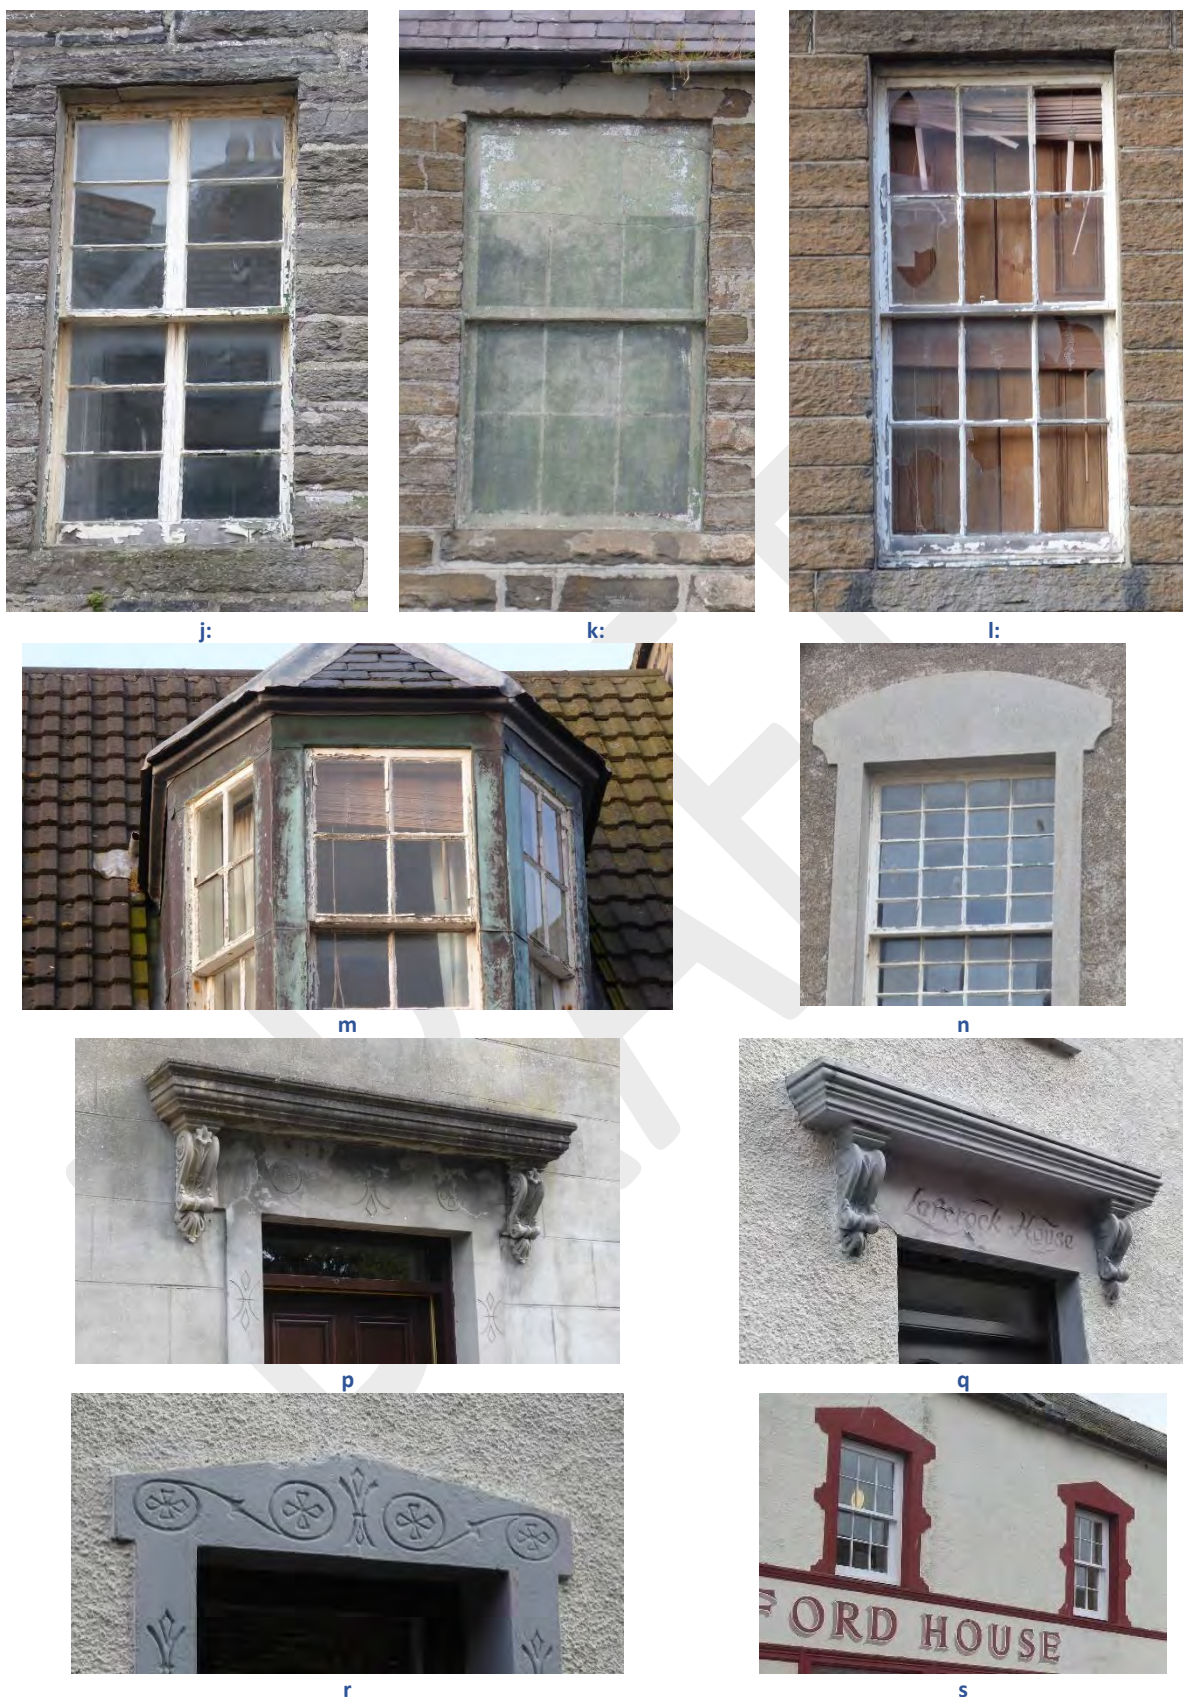
Figure 34: Window and doors: j: original lying pane windows at 2 Union Street; k: blind window on Smith Terrace; l & m: typical 6 over 6 Georgian window with internal shutters at 17 Breadalbane Crescent, with 4 over 4 pane dormer window to attic; n: distinctive multiple pane window on former Wick Free Church on Malcolm Street; p-r: examples of incised detail on door surrounds, console brackets and moulded lintels in Argyle Square; s: unusual window margins to Telford House in Lower Pulteneytown.

several properties had this design, with original windows surviving on No. 2 Union Street, which also displays the Georgian 'blind window', a blank window used to maintain the symmetry of the elevation (fig 34). Other fenestration patterns include 2 over 2 (as original or mid-Victorian replacements) and which can be seen for example of No. 29 Breadalbane Terrace (fig 21). More unusual window patterns are reserved for public buildings such as churches with both St Joachim's and the Martyrs' Free Church having multiple pane windows. Examples of original windows or traditional windows of some age are fairly rare notwithstanding the examples above, although other examples may survive to rear elevations.

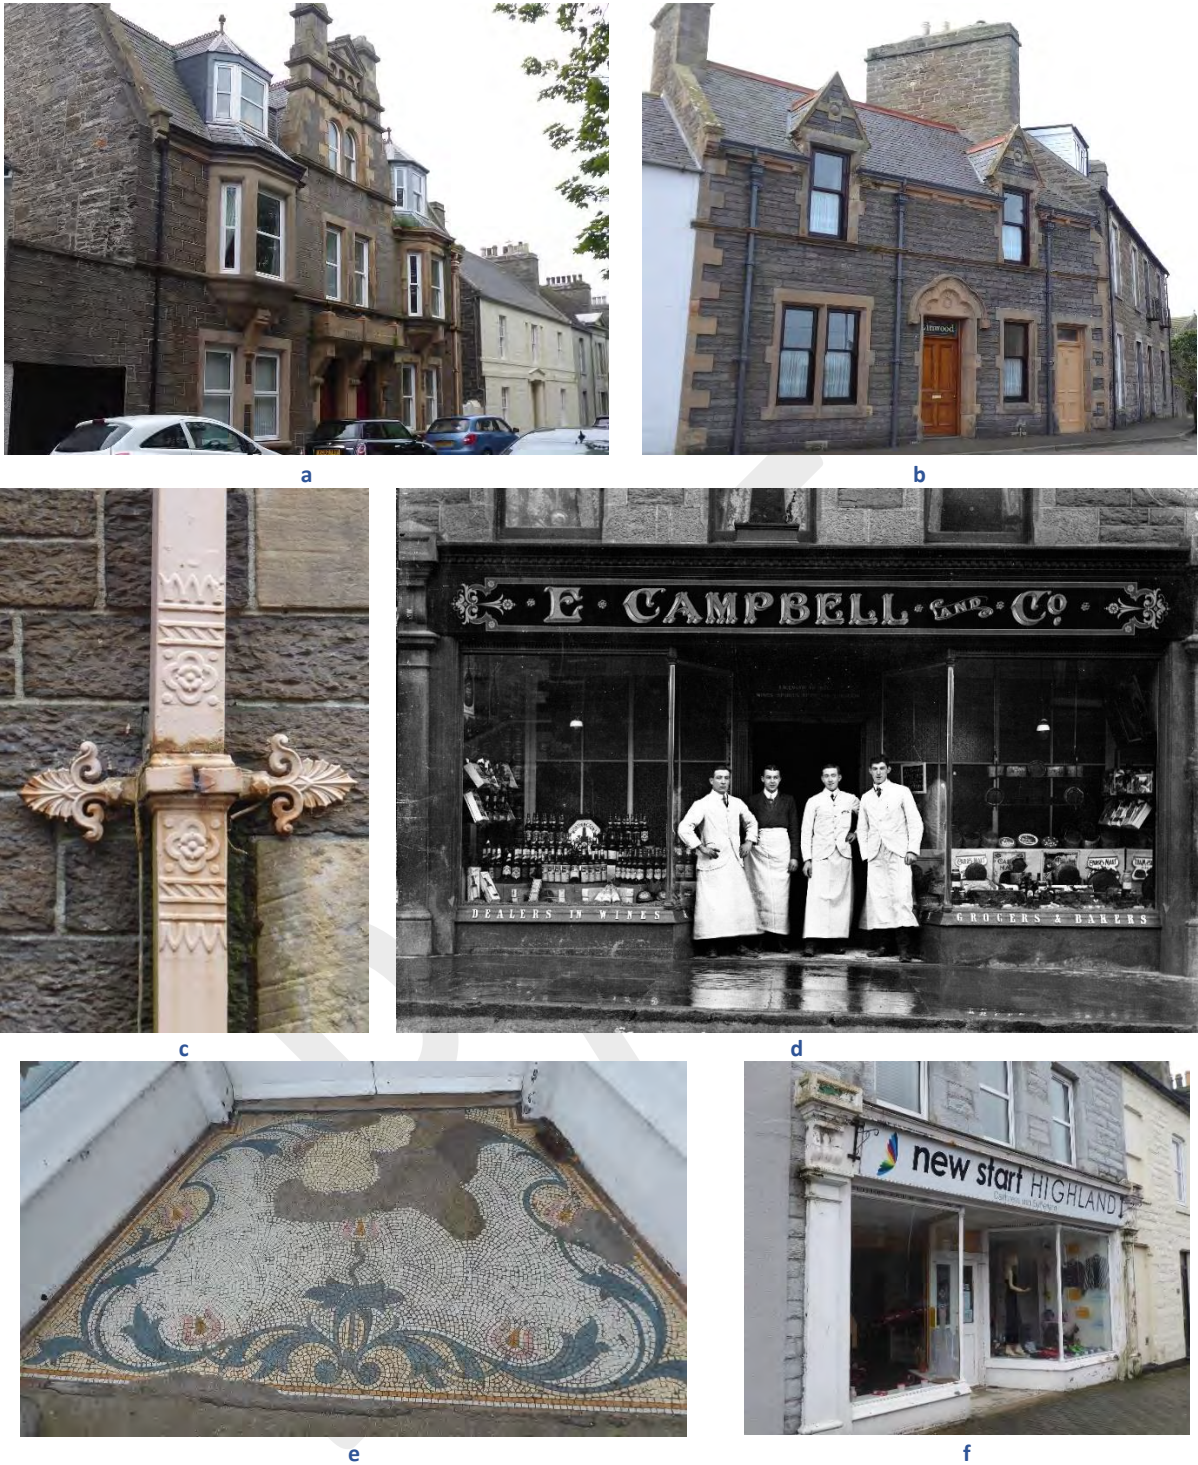
Figure 35: Victorian buildings: a: Nos. 15 and 16 Sinclair Street are elaborate Victorian style houses which dwarf their Georgian neighbours and exhibit much of the change in design and material use by the end of the 19<sup>th</sup> century; b: a more modest Edwardian house on Breadalbane Terrace built in 1911 with again more intricate stonework and decorative cast iron rainwater goods; c: decorative square downpipes and acanthus holding brackets at 15 and 16 Sinclair Street; d-f: just out with the conservation area, a late Victorian shopfront survives with a traditional terracotta mosaic entrance platt, originally E. Campbell & Co. Grocers. (Historic image © The Wick Society - The Johnston Photographic Collection).

The only traditional shopfront close to the conservation area is on Dempster Street, originally E. Campbell & Co. Grocers (fig 35d) and now New Start Highland (fig 35f). It retains a late Victorian shopfront and attractive mosaic entrance platt (fig 35e).

An example of this building type is Nos. 15 & 16 Sinclair Terrace (fig 35a), a tall 2 ½ storey semi-detached house with corbelled bay windows at the first floor and heavy moulded sandstone corbels and lintol hood over the entrances, and an elaborate front gablet above the eaves line stones. The rainwater goods are designed into the façade with decorative square pipes and acanthus holding brackets (fig 35c). The wall masonry is still Caithness stone, but the block size is smaller and refined into a neat coursed rubble contrasting with the blond sandstone dressings. A very similar, if less elaborate house, built sits on Union Street with the same bipartite gablet window and bay fronted dormer windows (1884; fig 30d).

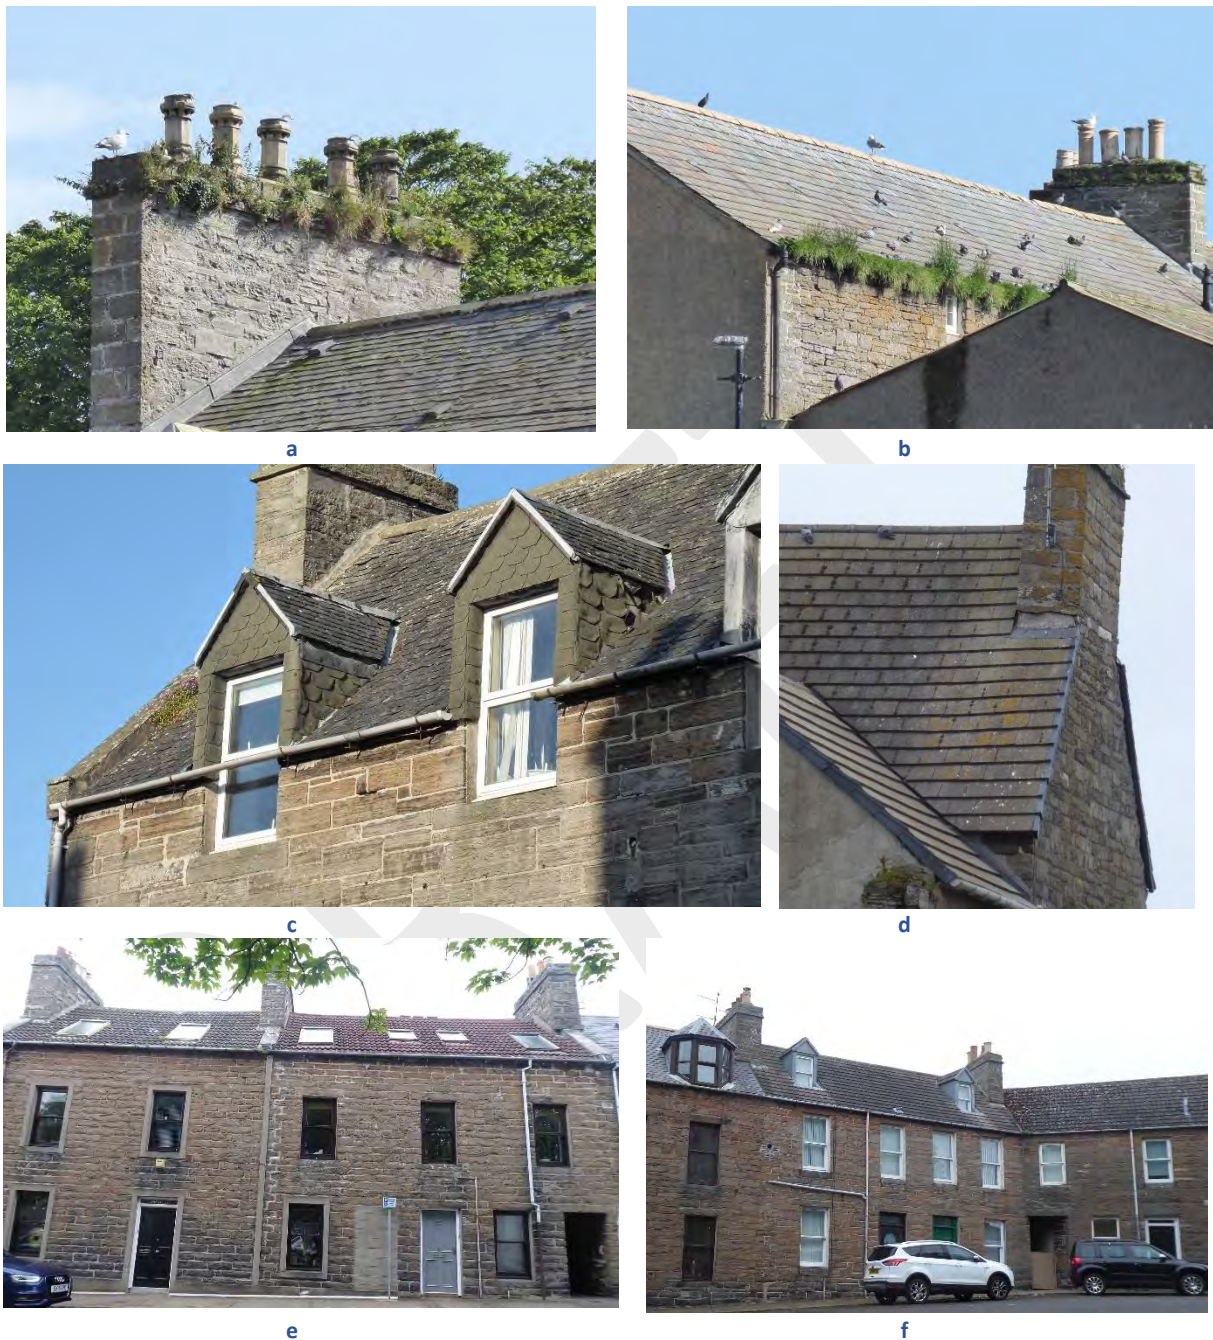
Figure 36: two common examples of vegetation growth leading to different defects and courses of action: a: plants taken root in open mortar joints in the masonry chimney. This is significant and roots unattended will continue to grow into the masonry and expand, over time destabilising the chimney stack; b: grass growing in a presumably blocked gutter with debris forming a soil for the vegetation. Here the blockage will lead to dysfunction of the rainwater system and overflowing of rainwater over the masonry walls and potentially backing up under the roof slate into the interior of the building; c: inappropriate materials, felt tiles, applied to two traditional gabled dormers; d: concrete tile replacement roof with possible removal of stone copes at the gable wall head, replaced by a plastic edge trim; e & f: inappropriate tile roof replacements on the terraced rows in Argyle Square; e: two different tiles, one red in colour both with large replacement rooflights; f: again two different tile finishes with a new slate finish on the left and a later large canted bay dormer.

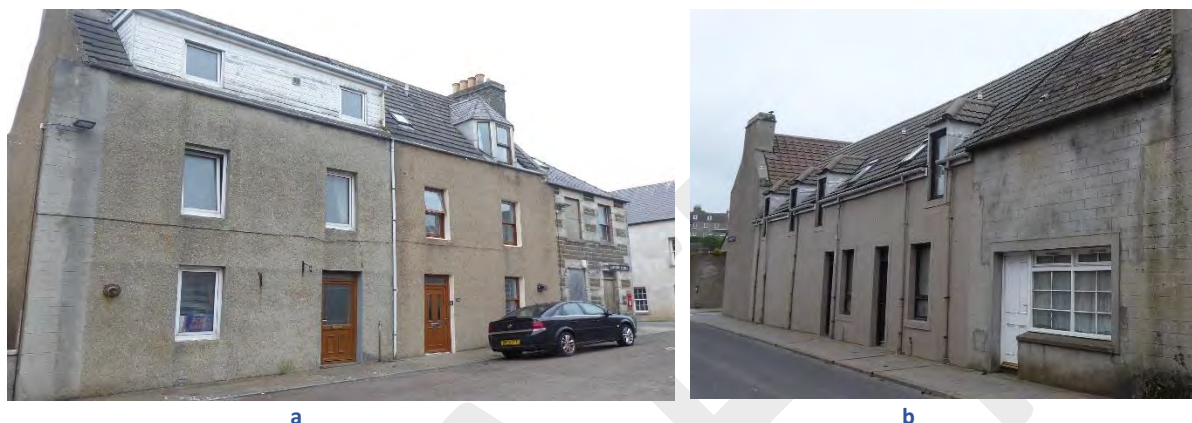
Figure 37: modern cement finishes applied to traditional buildings; also note on a: the large box dormer which has a negative impact on the building frontage and roofscape; and b: again shows the presence of concrete tiles, here next to a restored traditional Caithness slate on the roof to the right.

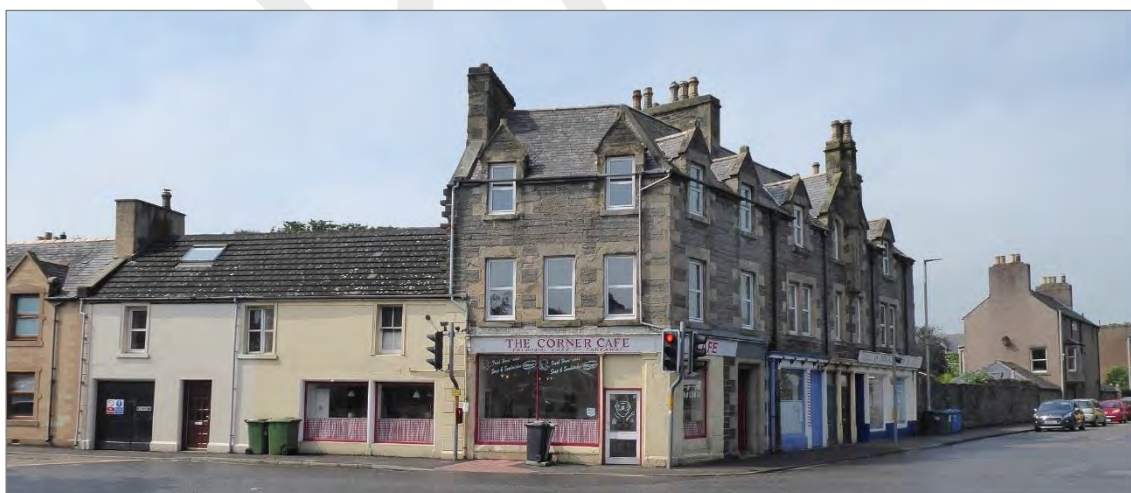
Figure 40: corner of Francis Street and Thurso Street looking west. Note the corner block redeveloped (1872-1905) and adjoining on Francis Street the earliest buildings constructed in 1815 but altered at street level.

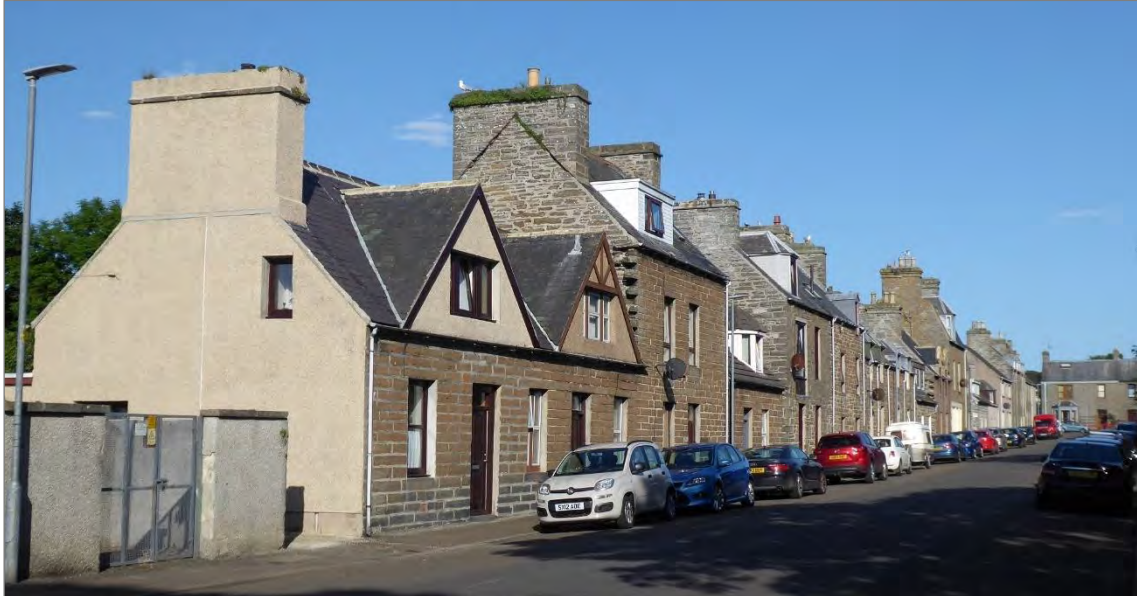
Figure 41: north side of Moray Street.

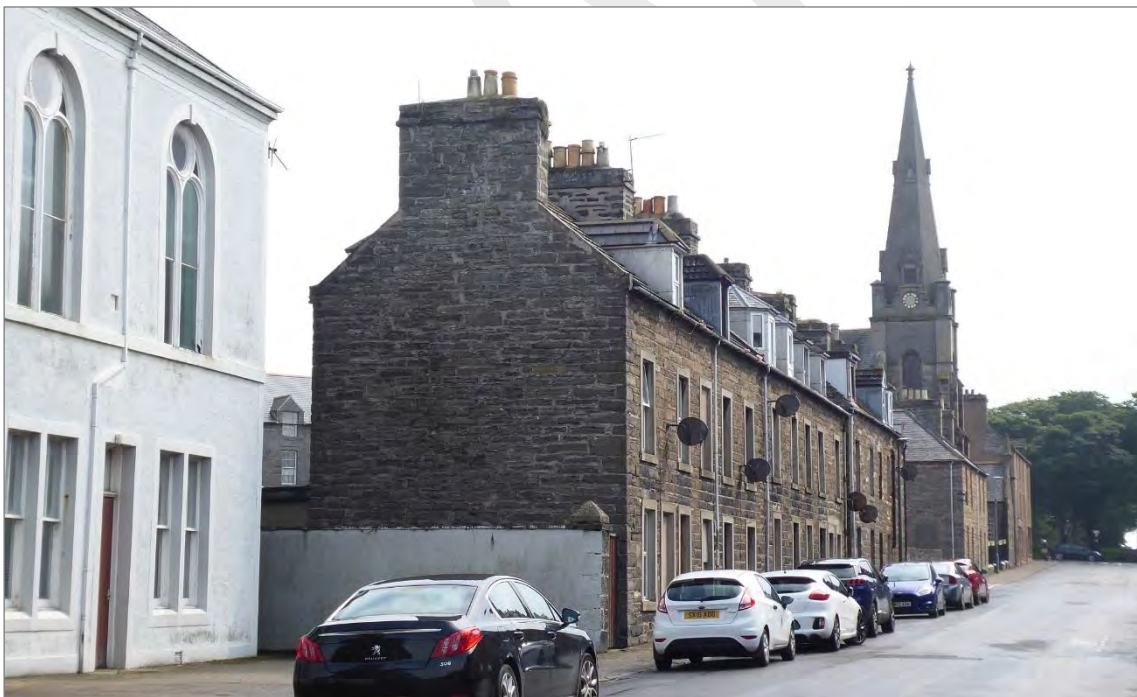
Figure 42: traditional rows on the north side of Dempster Street with the former Drill Hall on the left.

All three streets were part of the original feus except the south side of Moray Street; the latter however having been developed by 1839/57. Whilst there has been incremental change, the majority of the original buildings remain, and the changes are comparable with those in the conservation area. Dempster Street (fig 42) forms a particularly important vista from Francis Street into Upper

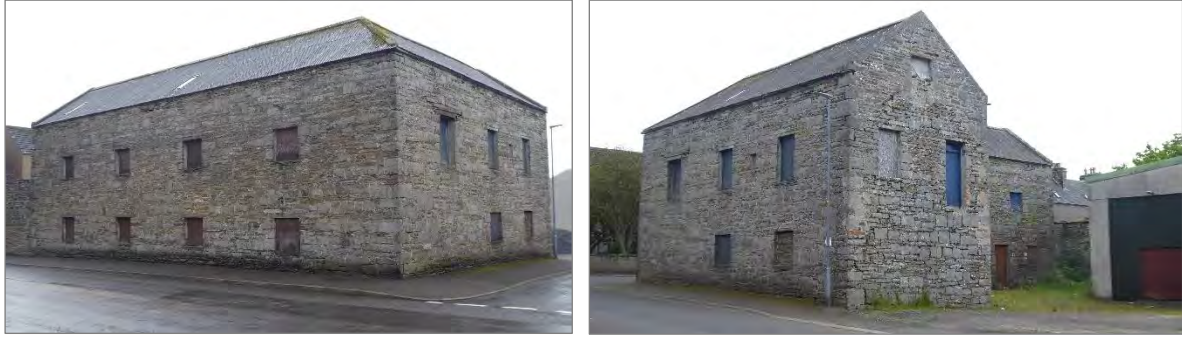
Figure 43: industrial building which formed part of the rope works on Brown Place at Macrae Street corner.

Pulteneytown and in views to and from Argyle Square (fig 25). Similarly Brown Place (fig 44) forms the stop end or back to the Argyle Square lots and has a strong traditional character. The remaining warehouse, and walls of the contemporary rope works, should also be considered for inclusion in the conservation area, and /or as an independent listed building (fig 43).

- Former rope works warehouse Brown Place/ Macrae Street (fig 43)
- Former Drill Hall, Dempster Street

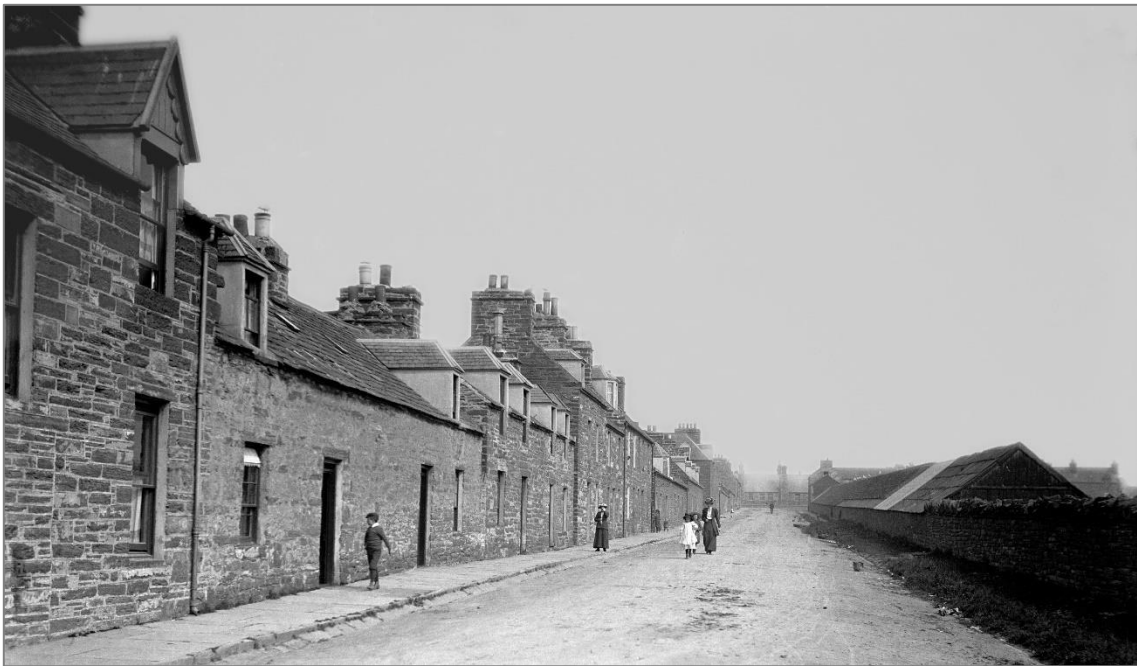
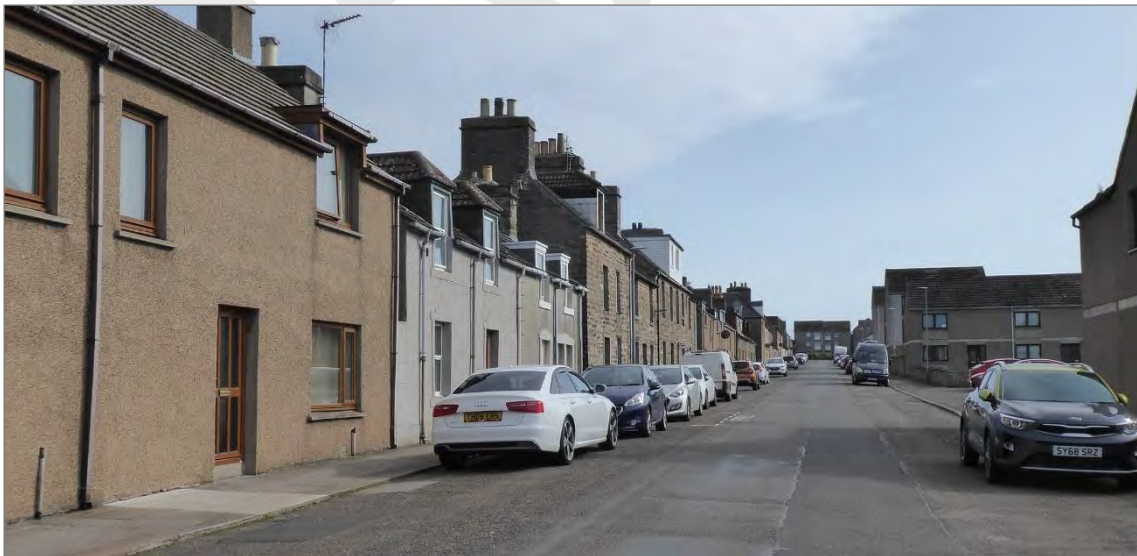
Figure 44: Brown Place: (top) looking east at the turn of the 20<sup>th</sup> century with the rope works on the right © The Wick Society - The Johnston Photographic Collection; (below) the same view in 2020.

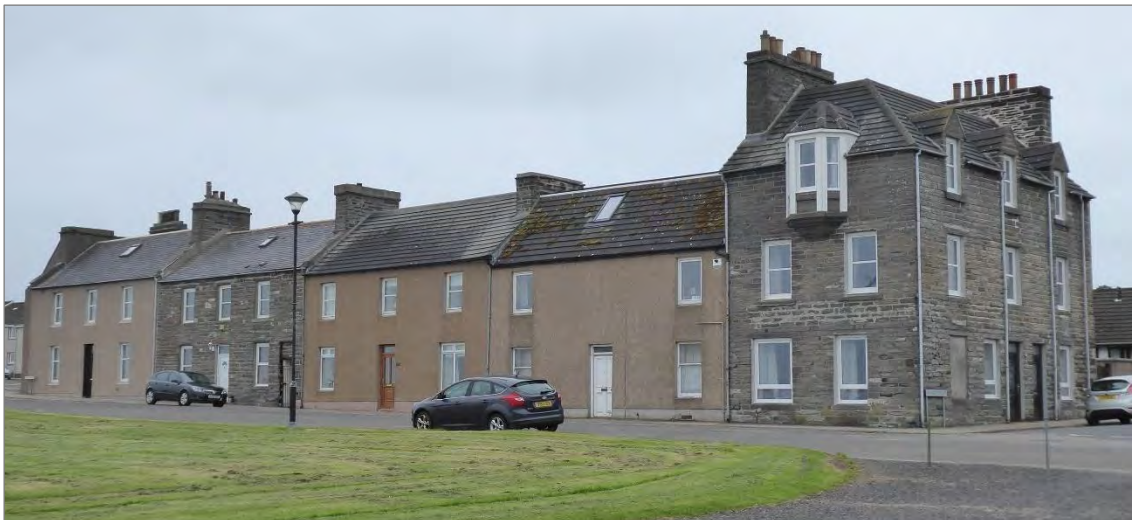
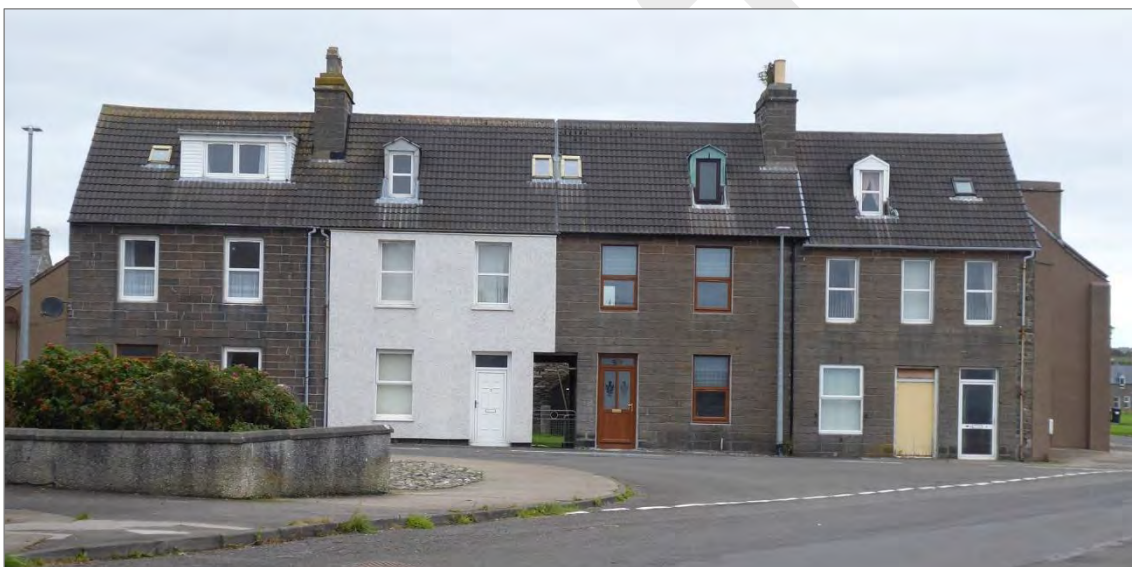
Figure 45: (top) pre-1839 properties forming the eastern row of Smith Terrace and similar original houses on Vansittart Street (below) all part of Telford’s plan and having been feued by George Burn; part of Lot 1 on Vansittart Street was constructed by 1813, thought to be Nos. 5 & 6 on the left of the pend. Both rows out with the conservation area.

The seaward facing Smith Terrace is the only part of Telford's design which retains its intended open 'terraced' outlook, over Braehead to the estuary. The eastern row, enclosed by Huddart and Vansittart Streets, was part of the Draft Feu Charter in 1813, and constructed by the date of the Admiralty Chart (fig 4B). Its eastern corner meets a terrace of traditional houses on Vansittart Street. These two surviving rows on Smith Terrace and Vansittart Street were originally feued by George Burn who constructed the Inner Harbour; the earliest houses possibly Nos. 5 & 6 Vansittart Street (by 1813) and a house, now lost, on the corner.

Area F: housing rows on the important seaward facing Smith Terrace and return onto Vansittart Street. The green space is important in the setting of these buildings and is the location of the Pilot's House. The site at the corner of Smith and Harbour Terraces is a focal point in views of the upper town. Recommend for inclusion.

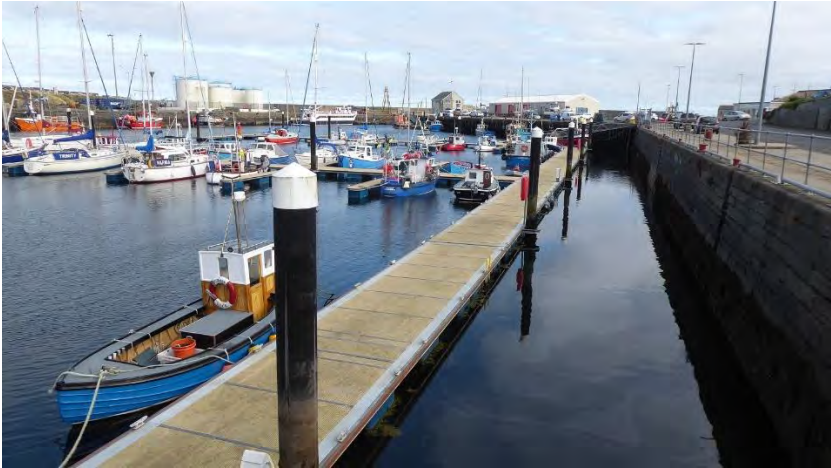
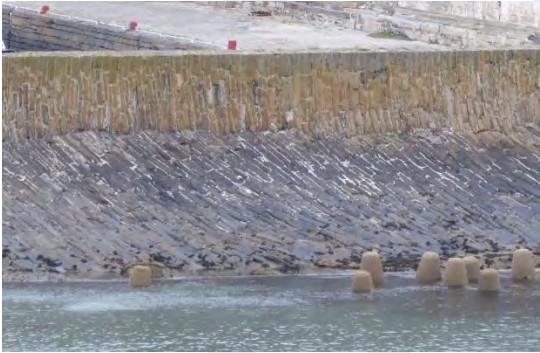
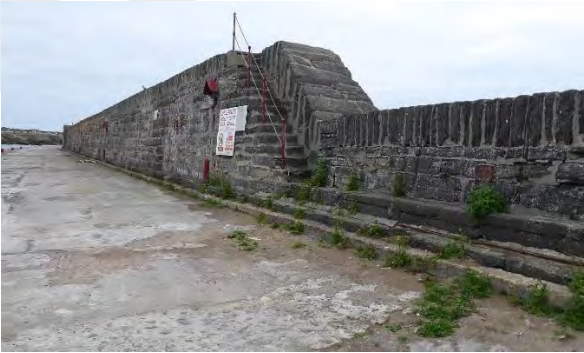
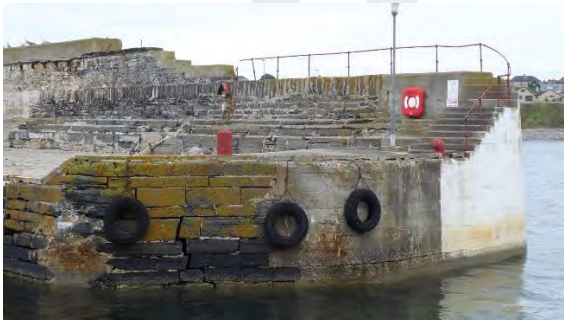
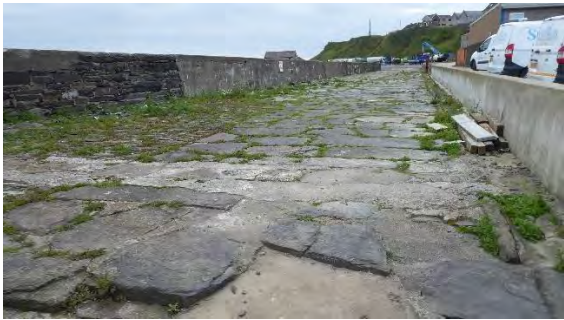
Figure 46: a: Inner Harbour, original stone walling on the right; b: Outer Harbour general view with both lighthouses; c-d: traditional stonework forming the outer harbour’s south pier; e: eastern end of the north pier; f: flagstone quay at eastern end of the South Quay.

A fundamental part of the design of Pulteneytown is the infrastructure which forms its harbour (figs 46 & 47). The Inner and Outer Harbours provide the wider setting of the modern day town and have a significant influence on the character and appearance of Pulteneytown and activity within the area. Buildings and structures in this area have a direct impact on the town beyond and on the appearance of the town on seaward approaches. Several industrial buildings have a positive impact such as the small wooden fishing gear sheds (Beaton, 1996, 43; fig 47) on South Quay.

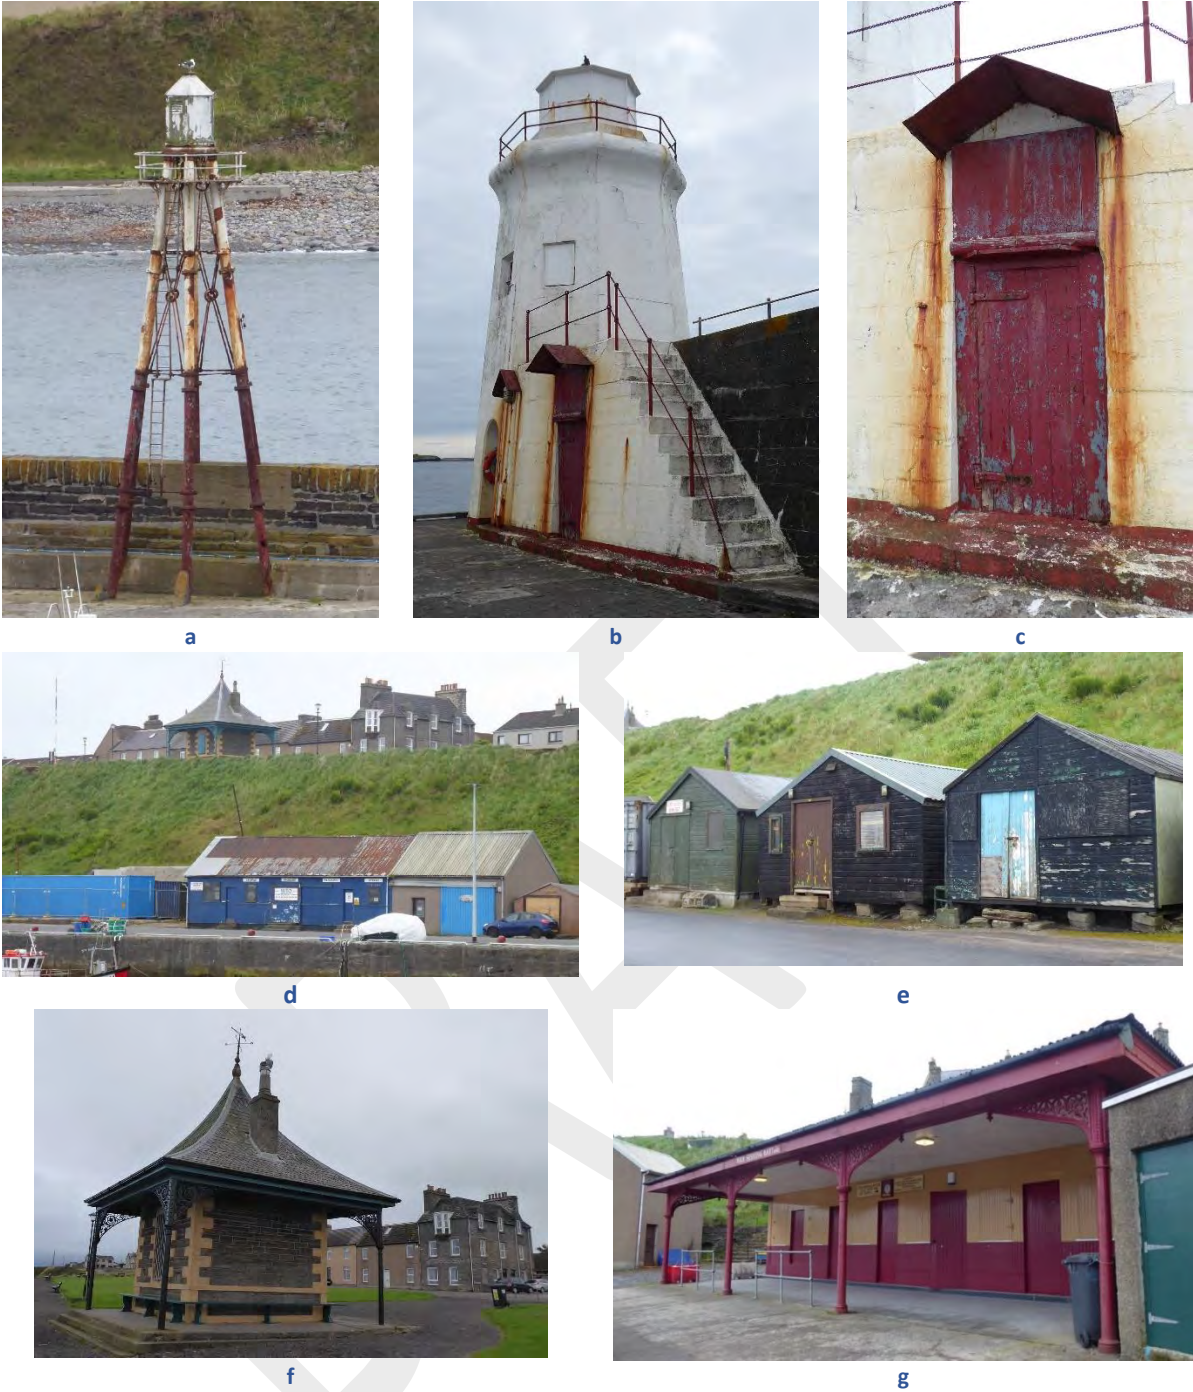
Figure 47: a: north pier lighthouse; b -c: south pier lighthouse; d-e: small traditional style timber fishing sheds on South Quay, d: with Braehead behind, note the small structure of the Pilot's House and beyond the traditional houses on Smith Terrace, all currently out with the conservation area; f: the Pilot's House; g: the historic Fishing Mart on the South Quay.

The open space of Braehead, formerly a drying green for the houses and now a popular public space, is important in maintaining the open views from these properties and in views to Pulteneytown from the harbour. The Pilot's House dating to 1908 is a unique and very attractive building which is unlisted. Whilst later in date than the majority of the new town, it is nevertheless an important part of the history of the port and should be protected through inclusion in the conservation area and / or listing.

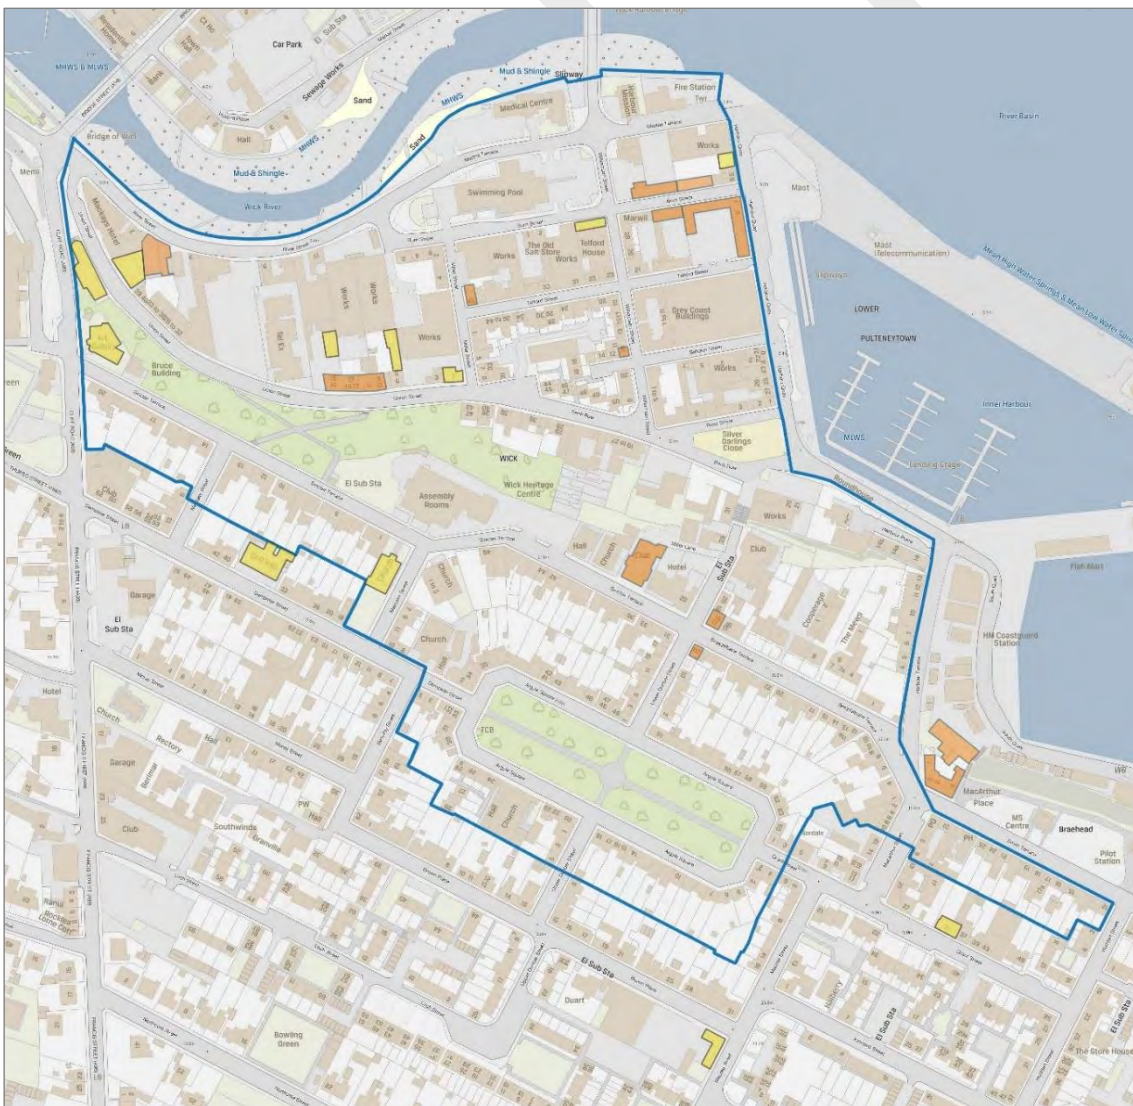
Map indicating Buildings at Risk on Register in orange, and not on Register in yellow. Current Wick Pulteneytown Conservation Area boundary outlined in blue. © THC/Crown

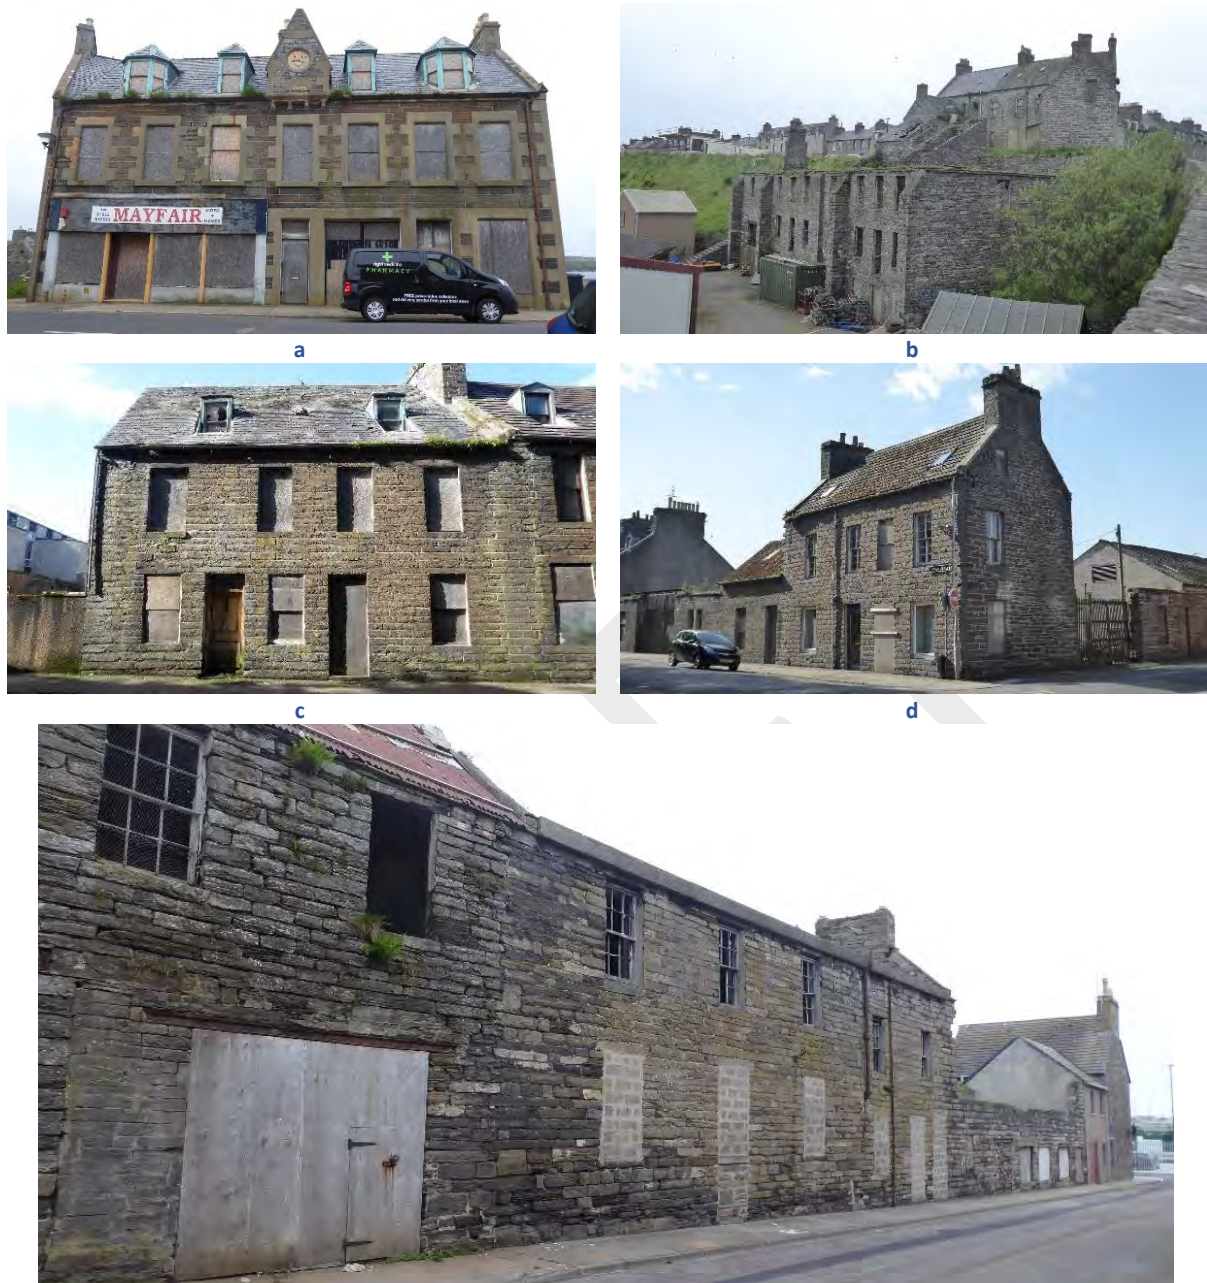
Fig 49 a: former Cooperative store at Nos. 1-4 Macarthur Place (not in CA); b: former Cooperative bakery, South Quay (not in CA); c: Nos. 15 & 16 Union Street; d: No. 2 Union Street; e: partially roofed buildings on Burn Street.

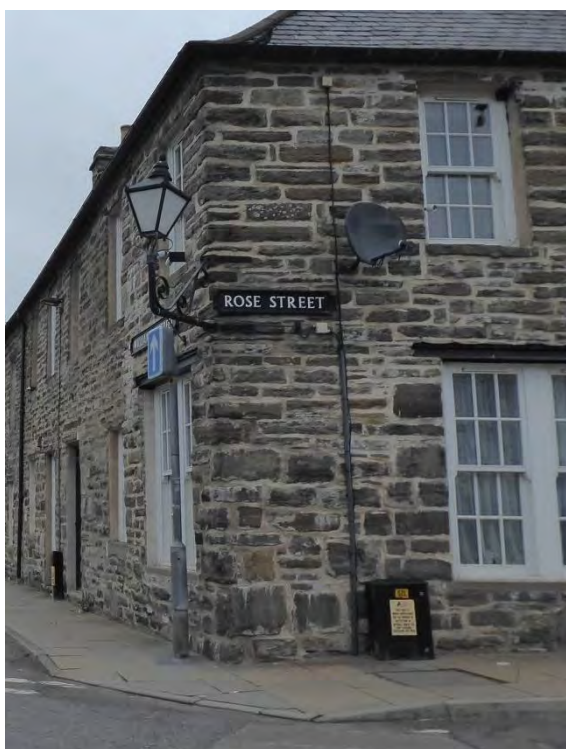
Mixed and cluttered street furniture: enhancement gained by using a traditional lantern and street sign is offset by cabling, satellite dish position and standard one-way road sign. Note the dropped kerb using Caithness flagstone.

Figure 50: inappropriate street furniture and unattractive streetscape.

the otherwise high quality historic environment. Where traditional and original finishes and architectural detail such as walls, railings and gates survive these should be appropriately maintained and repaired. Argyle Square is a significant feature and community asset; however, some elements of street furniture are of standard or poor design quality, such as the use of ‘wheelie’ bins for litter on the central path, and generally there is a lack of continuity in the design and materials used for information boards, seating and street furniture. In Lower Pulteneytown some streets have not been enhanced, for example Union Street where tarmac pavements are in poor repair (fig 50). Other reinstatement and enhancement measures have been effected by damage or introduction of other finishes which detract or create a cluttered appearance (fig 50).

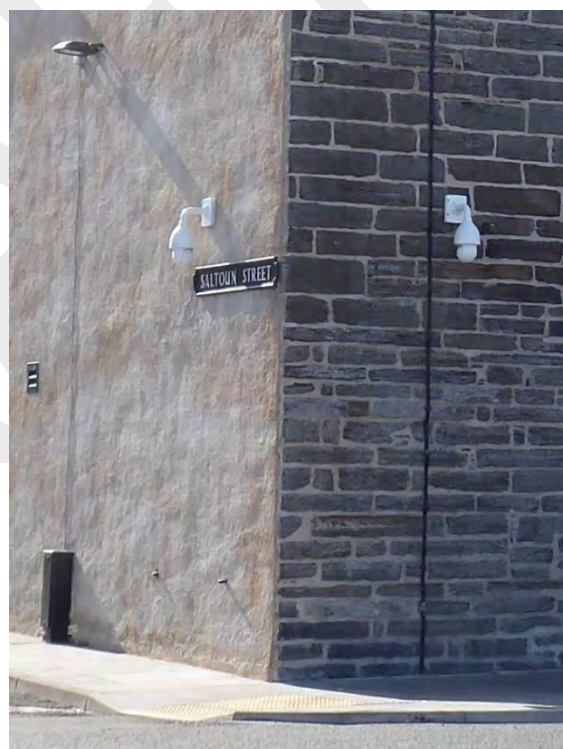
Reinstated lime harling on prominent gable with traditional street sign alongside a standard flood light and two modern white lamps showing a lack of appropriate and coordinated design. Note dropped kerb constructed using textured concrete paving which is not in keeping with the Caithness flagstone.

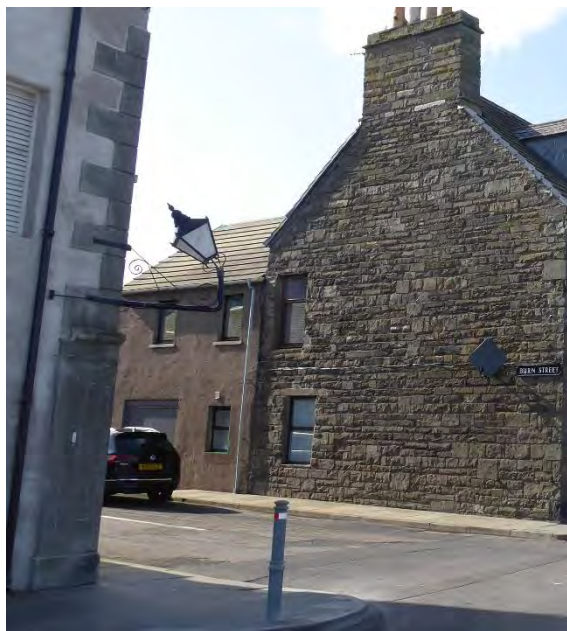
Mixed and cluttered street furniture: enhancement gained by using a traditional lantern and street sign is offset by a grey standard reactive bollard and poorly positioned satellite dish. The lantern has suffered impact damage.

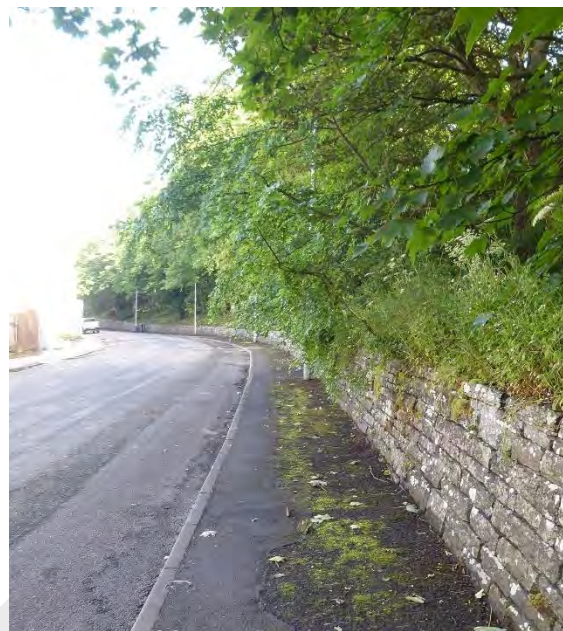
Union Street was not part of the enhancement area for the previous THI programme. The tarmac pavements are in poor repair and the management of the green space has been highlighted. Both offer opportunity for enhancement.
