# WICK PULTENEYTOWN CONSERVATION AREA MANAGEMENT PLAN

**Draft: NOVEMBER 2020  
FOR THE HIGHLAND COUNCIL CIRCULATION to COMMITTEE.**

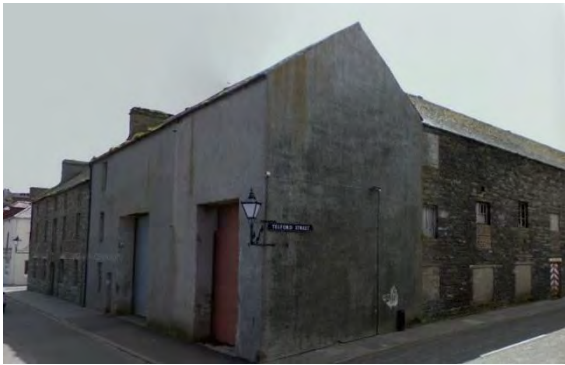
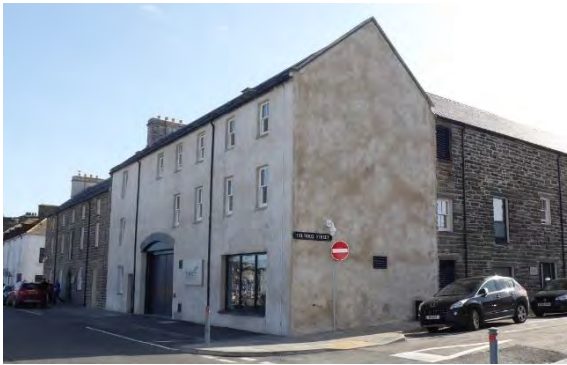
Before and after of Telford/Saltoun Street east block adapted for Beatrice Offshore Windfarm Ltd, opened in 2019; SSE funded (left) © Google Maps 2008

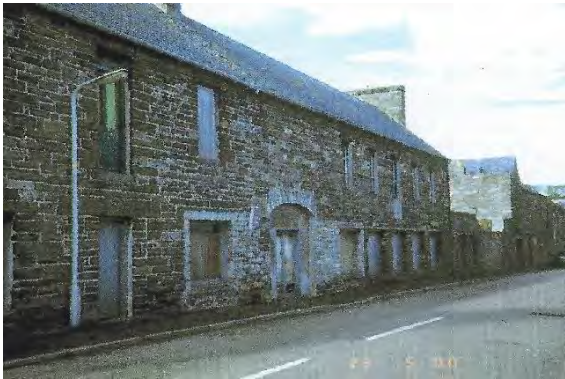
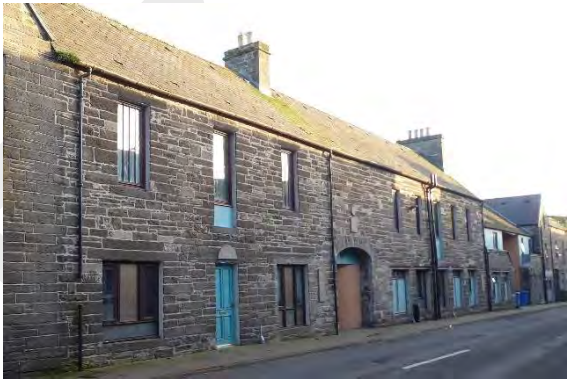
Before and after of Telford/Saltoun Street west block adapted to provide 16 dwellings for Pentland Housing Association, opened in 2004; part of THI (left) © Google Maps 2008

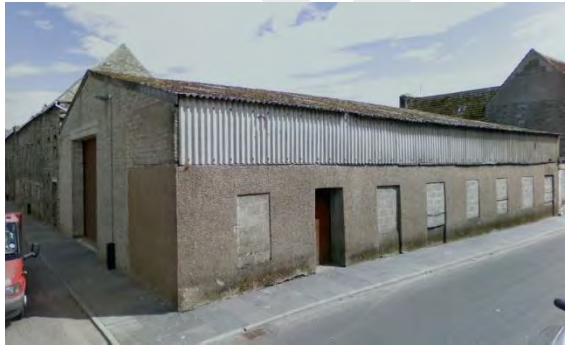
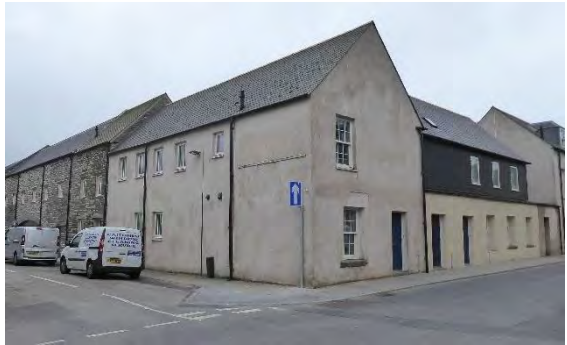
Figure 3: repair, adaption, heritage interpretation and enhancement in Wick Pulteneytown Conservation Area

Before and after of Telford/Saltoun Street east block at Williamson Street with adaptation and reconstruction of traditional buildings to provide 11 new dwellings; part of CARS (left) © Google Maps 2008

Figures 3 and 4 illustrate some of the projects undertaken which focussed on repair, reuse, enhancement of the historic environment (buildings and streetscape), and heritage interpretation.

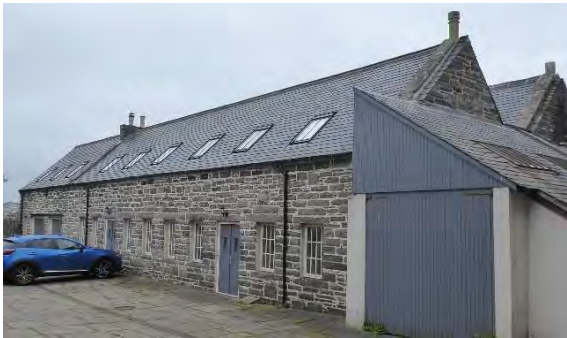
Former cooorage repaired and converted to two dwellings; part of CARS.

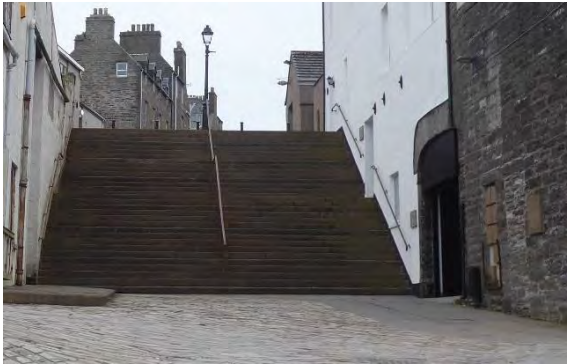
Repair of Black Stairs and streetscape enhancement using Caithness flagstones; part of THI 2008

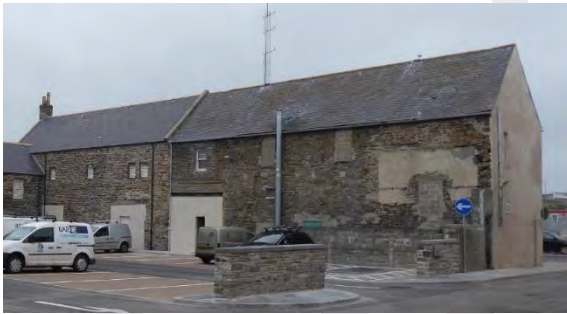
Telford/Burn St east block made wind & water tight during Beatrice development and CARS c.2012.

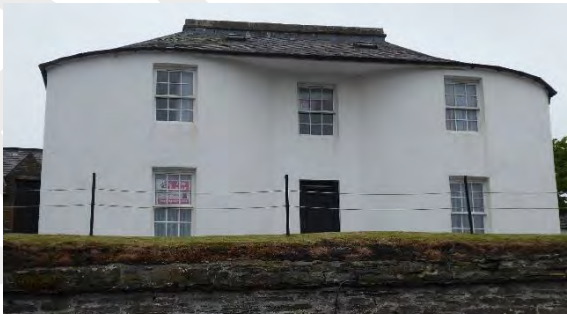
The Round House designed by Telford, repaired under the CARS.

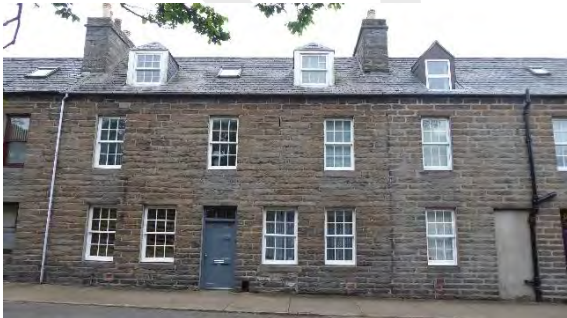
Example of several smaller projects for traditional repairs and window reinstatement under the CARS

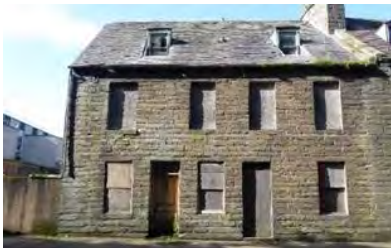
<p>Buildings at Risk Union Street</p> </div> <div style="text-align: center;">

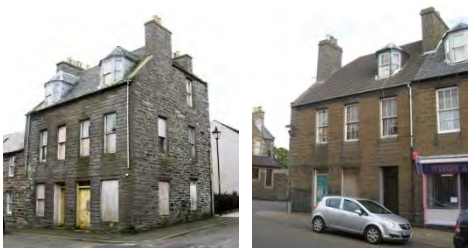
<p>Vacant building Breadalbane Terrace</p> </div> </div>

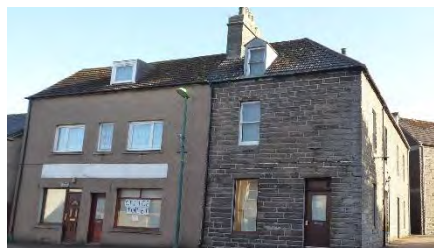
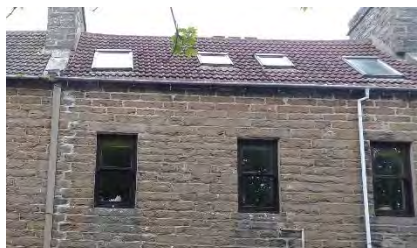
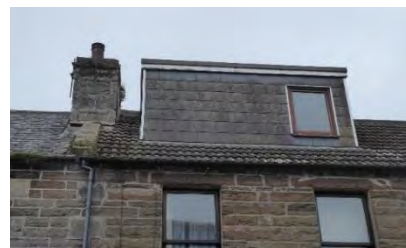
Unsympathetic alterations

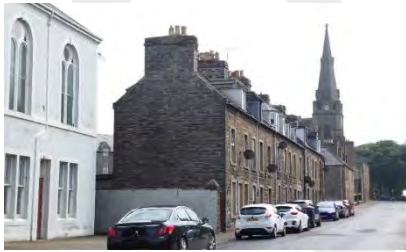
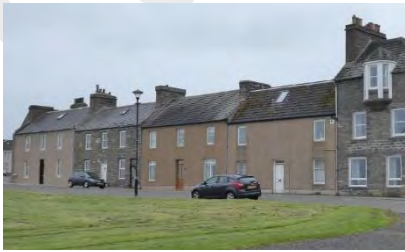
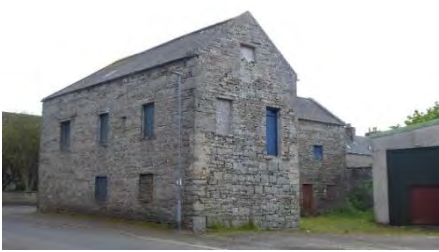
Some of the rows on Dempster Street, not in the conservation area or listed.	Pre 1857 houses on Smith Terrace, not in conservation area or listed.	Industrial building from rope works, not in conservation area or listed.

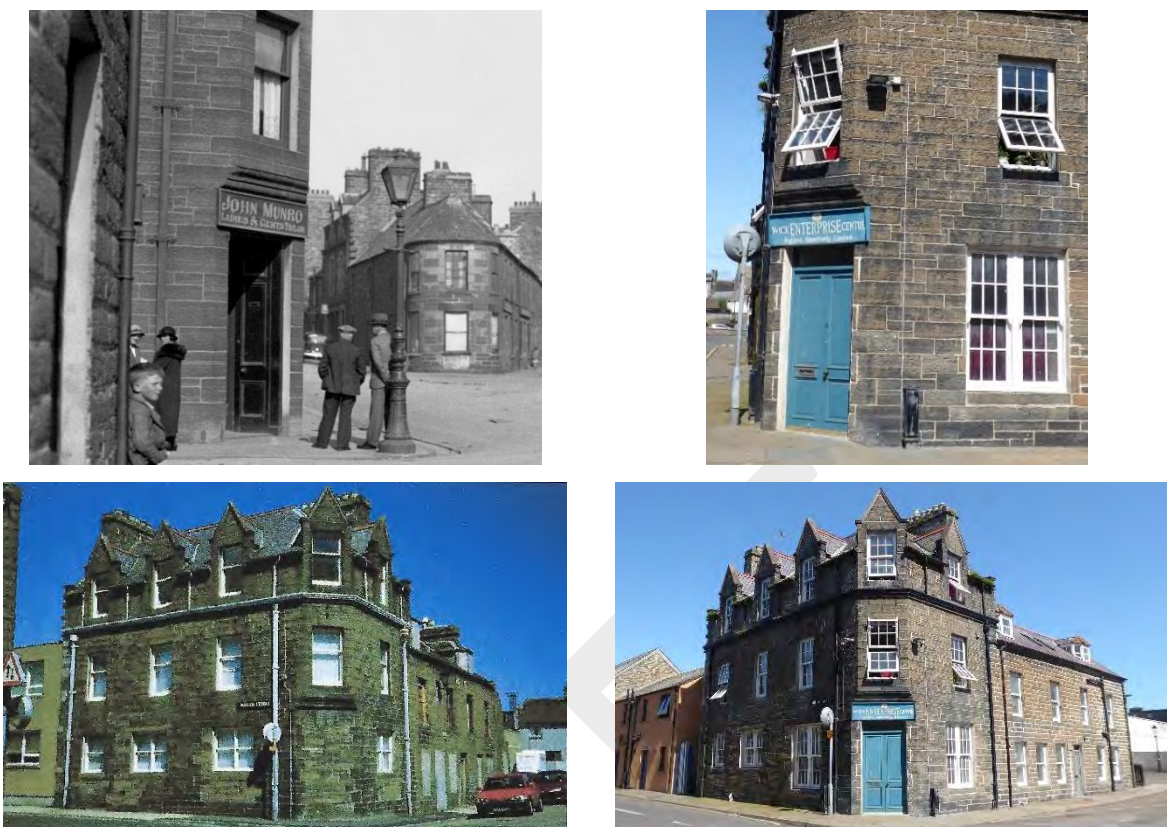
Figure 5: illustrating the importance of following window guidance fully. On the left an image from the 1930s showing likely original window and door design with below the building in 2000 with the same window pattern (door built up). The building in 2019 (right) has new replacement windows which have not replicated historic evidence and the opening form does not comply with current guidance that window opening methods should not disrupt the elevation. 6 over 6 pane windows may be the correct pattern for some earlier buildings in the conservation area, but the date of this property in the late 19<sup>th</sup> century would suggest it is less likely and such windows would rarely combine ‘horns’ in the original design. The reinstatement of the door is however a positive enhancement.

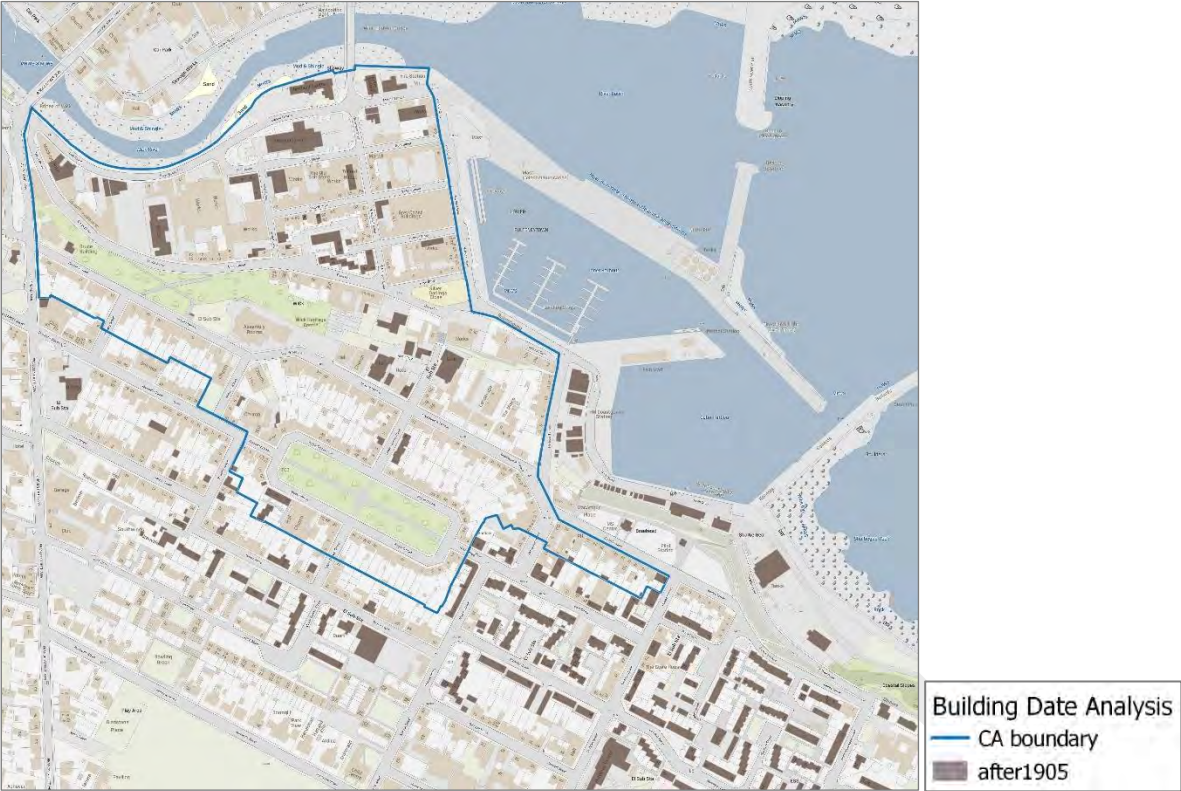
Figure 7: (top) Current Ordnance Survey map overlaid indicating 20<sup>th</sup> century buildings.  
© THC /Crown

There is a small proportion of later development (i.e. after 1905) in the conservation area (fig 7 & CAA, Map 6.2). This is principally in Lower Pulteneytown and involved redevelopment of a number of former redundant industrial sites, such as the gas works in the mid-1990s, which occurred shortly before the greater part of Lower Pulteneytown was designation as a conservation area in 2000. In Upper Pulteneytown, redevelopment was more prevalent immediately to the east out with the conservation area boundary and comprises local authority housing constructed over a number of periods, but most notably from the 1970s.

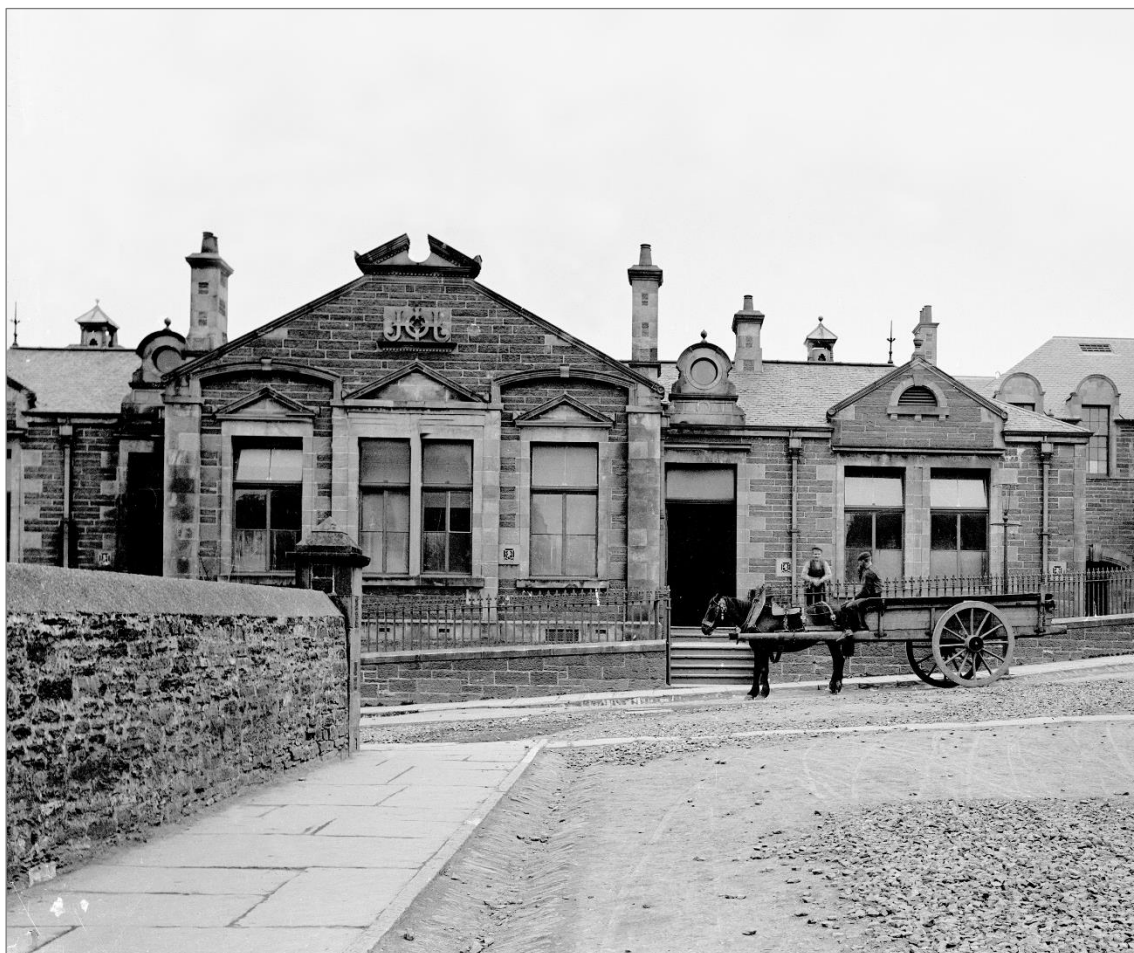
Figure 9: Inappropriate alterations: the importance of retaining architectural detail can be illustrated by comparison of the historic image of Assembly Rooms on Sinclair Terrace and its form in 2019. Constructed as the Pulteneytown Academy in 1838, stripping the building of its architectural features has removed much of the building's original character. Note historic image shows original 'sea gravel' on road and Caithness stone pavement and kerb. © The Wick Society - The Johnston Photographic Collection.

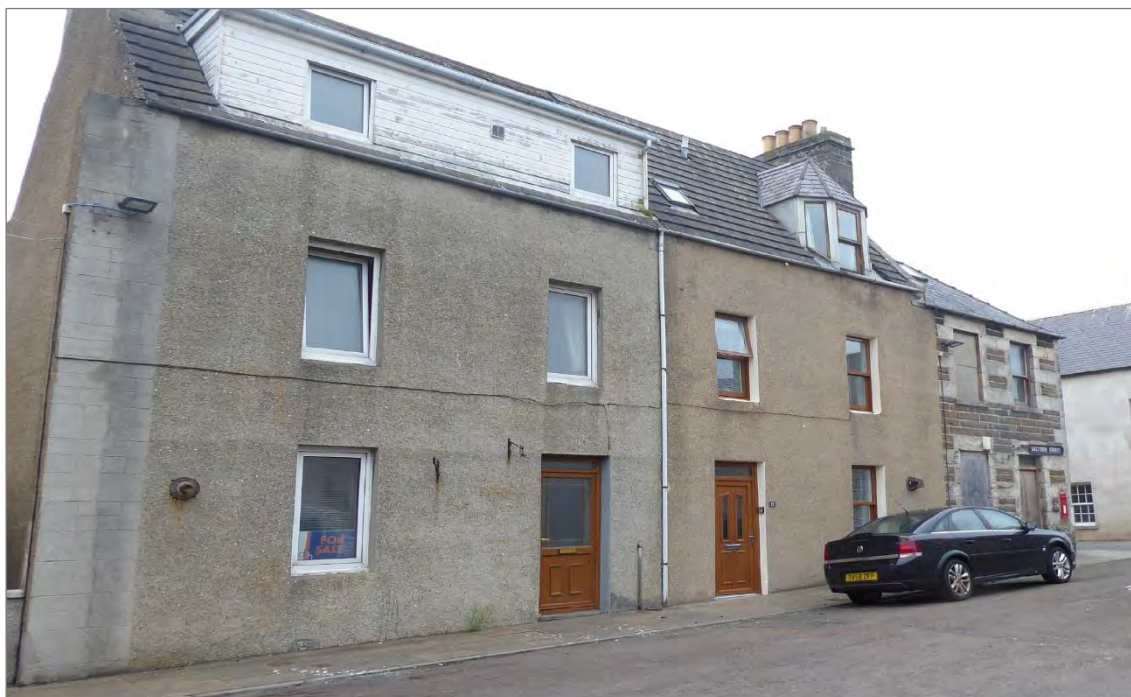
Figure 10: Inappropriate alterations: an example of past unsuitable change to a traditional building of heritage value which results in a negative impact. The original Caithness stone has been covered by a modern cement finish, the original windows and doors have been replaced; the window design and opening method has been altered; a large box dormer has been constructed which changes the form of the roof and obscures the original pitched slope; the original slate finish has been replaced in concrete tile. Buildings such as this can be enhanced and restored when opportunities arise through planning management.

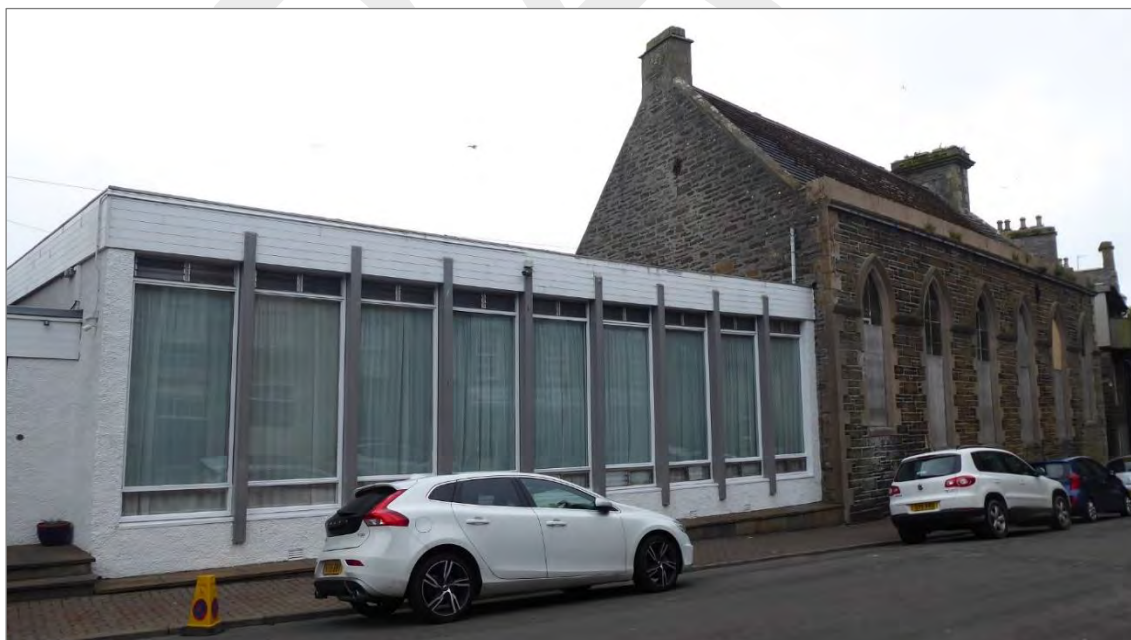
Figure 11: Inappropriate design: an example of a later 20<sup>th</sup> century building design which is inappropriate to the character and appearance of the conservation area in terms of form (low horizontal emphasis and flat roof), materials and colour, the bright white is in stark contrast to the adjacent stonework and draws further attention to the building. Buildings such as this may offer opportunities for redevelopment or enhancement through planning management.

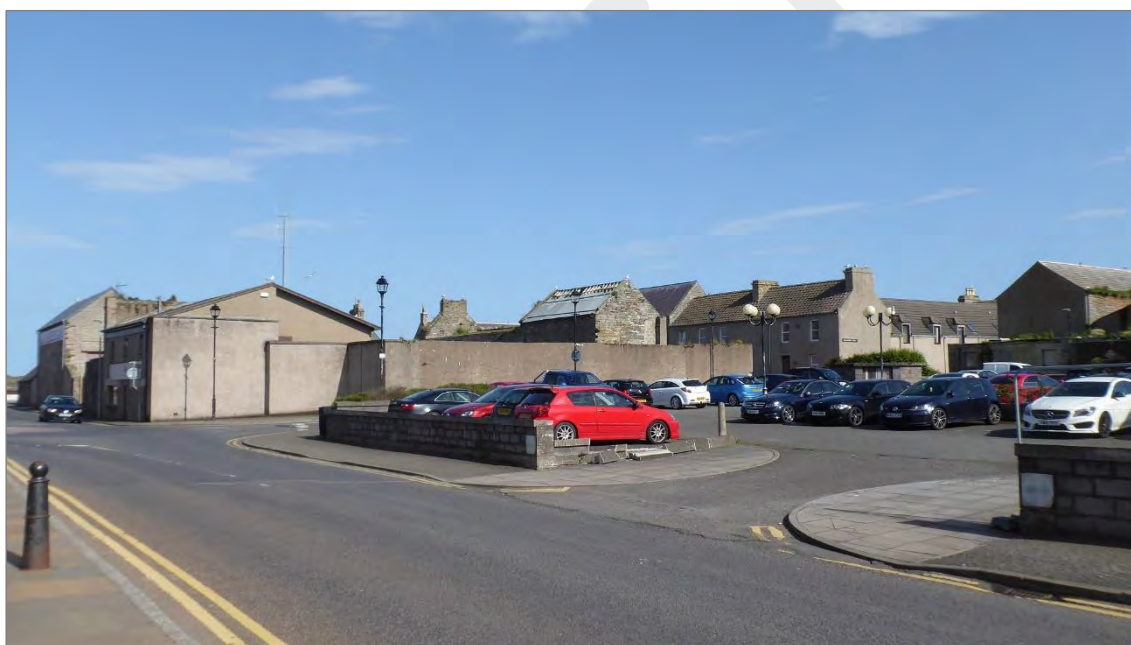
Figure 12: view towards Williamson Street with the expanse of the former swimming pool car park in the foreground having a negative impact on the conservation area. The original buildings on this block and the corner buildings to the east on Burn Street have been removed effected in part by the introduction of a roundabout (on left). Reinstatement of street fronting buildings or a suitable high quality finish to the car parking area would be beneficial to the conservation area.

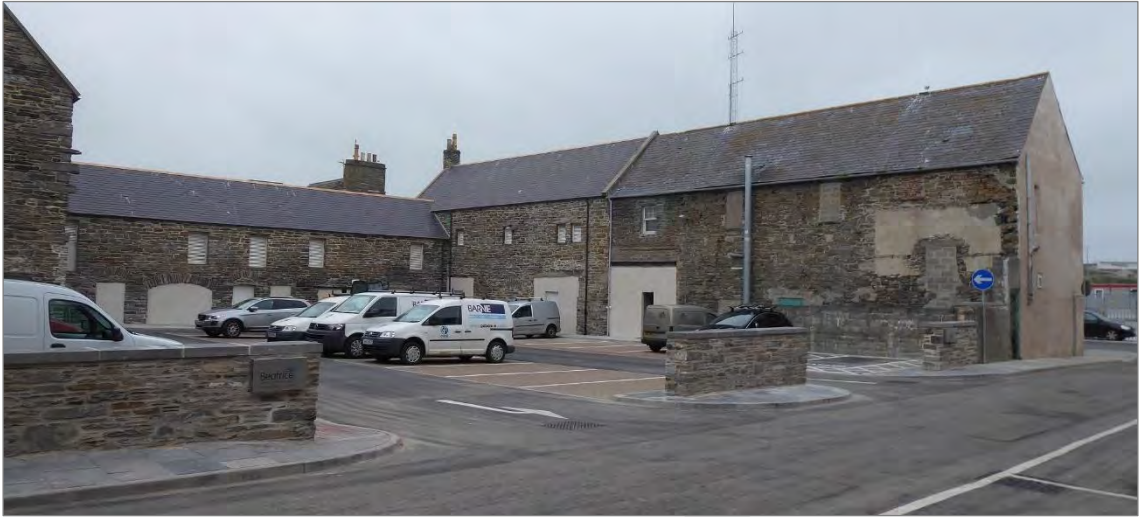
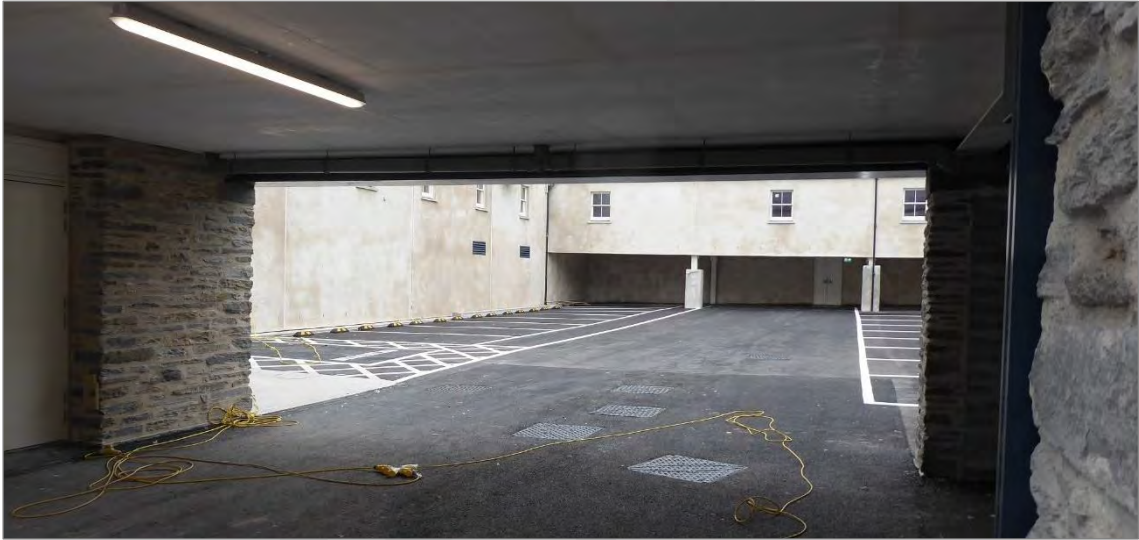
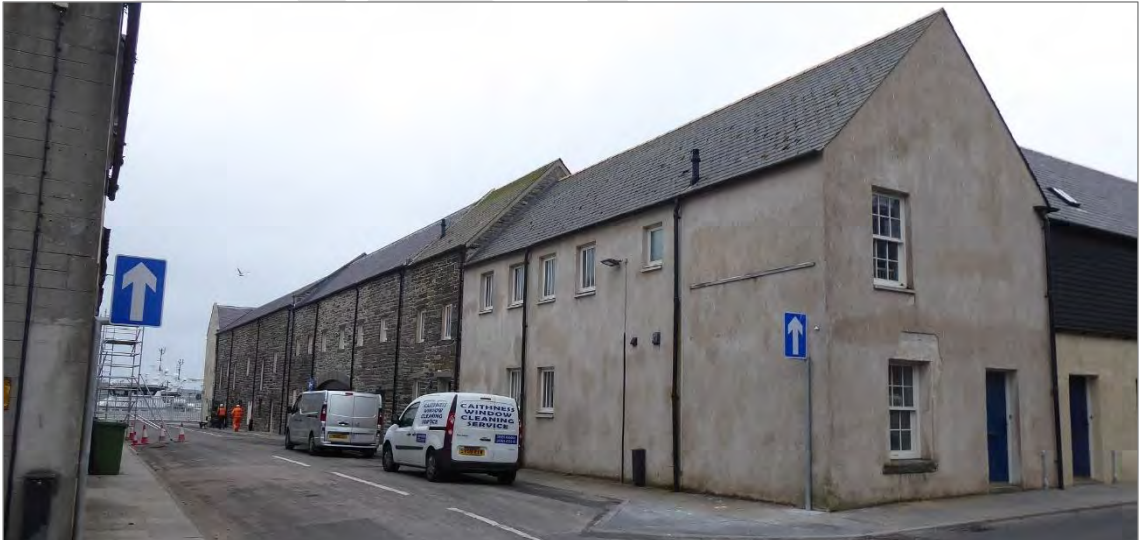
Figure 13: Parking and changes to traffic movement introduced as part of the regeneration of the eastern urban blocks either side of Telford Street: (top) open parking area created from former curing yards after loss of internal and street fronting buildings; parking area is highly visible; (centre) partly obscured parking within the block is a more sensitive approach although the finishes are still standardised they are less visible from the public realm; (below) to facilitate new uses Telford Street has been made one way with the standard blue signage standing out against the traditional finishes.

In Lower Pulteneytown there is parking on-street and at larger premises such as the medical centre, former swimming pool and recently for the Beatrice facilities on Telford Street (fig 13). Each of these car parks create large expanses of tarmac often having a negative visual impact emphasised by boldly coloured traffic signage. Whilst safe movement for parking is essential there are likely to be more sensitive means to provide this such as the use of alternating surface textures and suitable colour changes.

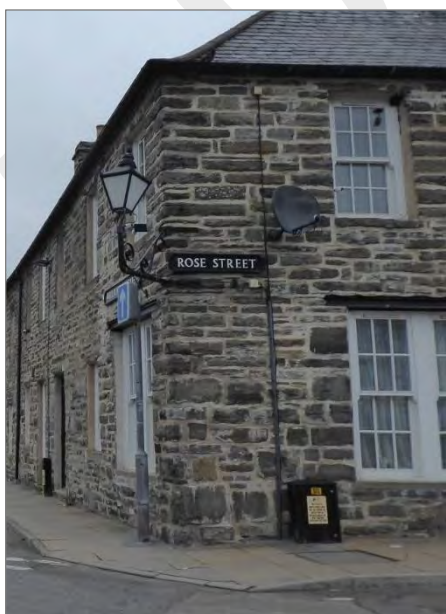
Mixed and cluttered street furniture: enhancement gained by using a traditional lantern and street sign is offset by cabling, satellite dish position and standard one-way road sign. Note the dropped kerb using Caithness flagstone.

Figure 14: inappropriate street furniture and unattractive streetscape.

This priority also recommends that changes are made to assist DDA compliance. Whilst this is a desirable functional change to improve access and movement for all, the method and materials for this intervention need to be carefully considered and sensitively designed to the historic environment and not be standard coloured concrete paving blocks (fig 14).

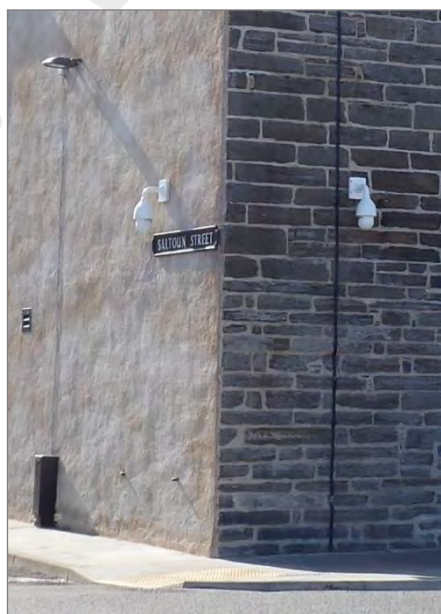
Reinstated lime harling on prominent gable with traditional street sign alongside a standard flood light and modern white lamps lacking appropriate and coordinated design. Note dropped kerb constructed using textured concrete paving which is not in keeping with the Caithness flagstone.

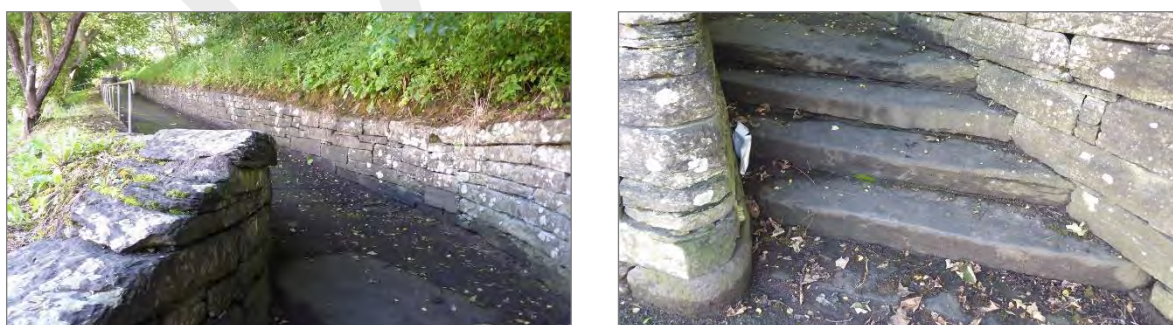
Fig 15: the well-established route across Academy Braes, leading to the upper town, and originally Pulteneytown Academy (now the Assembly Rooms); the original Caithness stone walling and steps remain although the former rough shingle path has been tarmacked with a standard modern metal handrail fitted. A management plan for this green space should include architectural features such as the walling and steps and plans for their retention, maintenance and future repair using appropriate materials and methods. Whilst the green space is semi-natural (rather than a formal landscape) it is very overgrown.

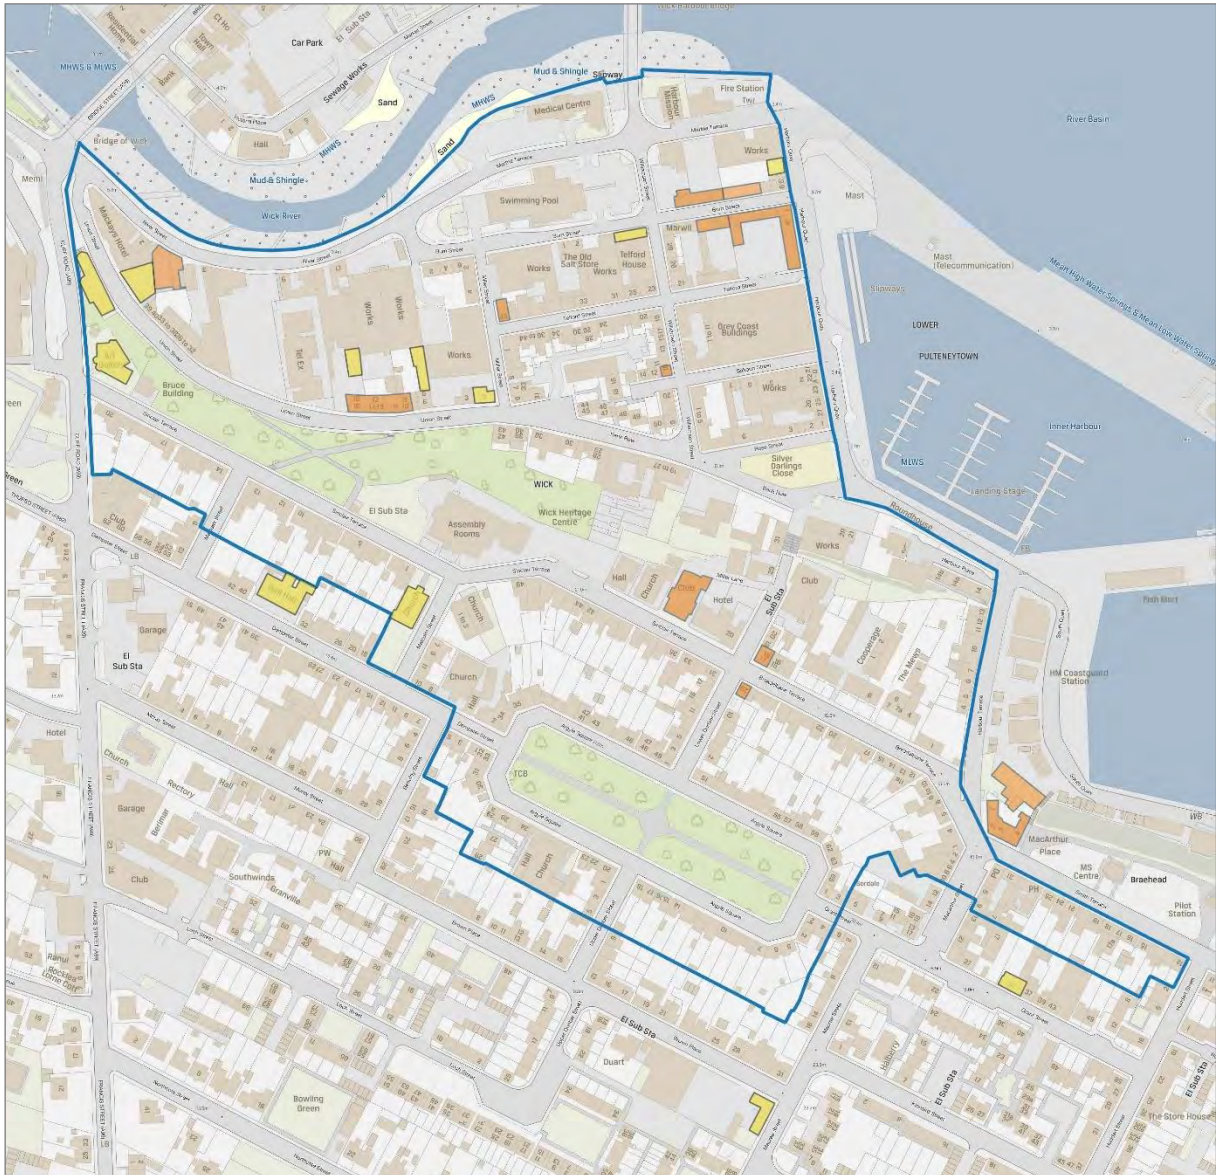
Map indicating Buildings at Risk on Register in orange, and not on Register in yellow. Current Wick Pulteneytown Conservation Area boundary outlined in blue. © THC/Crown

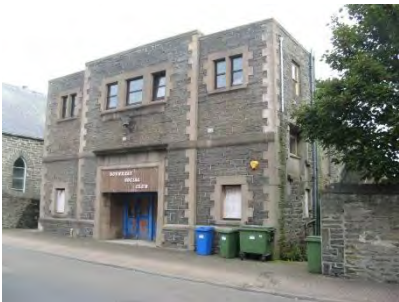
© HES 2013	At Risk Condition: Fair 09/2013	Building remains vacant and at risk. Condition had deteriorated with roof becoming dangerous. Roof cover removed in 2019 under Dangerous Building Notice. Structure now open to the elements, not clear if wallhead have been stabilised / capped.  Included in CAMP Appendix 5-2.

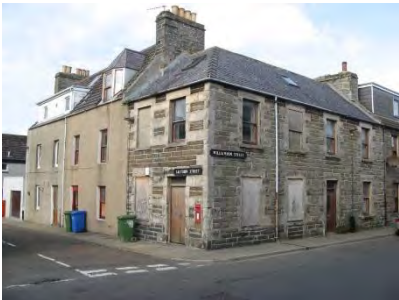
<p>© HES 2013</p>	<p>At Risk Condition: Good 09/2013</p>	<p>Building remains vacant and at risk. No significant change apparent since 2013.</p> <p>Positive building on prominent corner.</p>
<p><b>De-roofed building</b> Burn Street (CAA fig 49)</p>   <p>© HES 2013</p>   <p>2020</p>	<p>At Risk Condition: Poor 09/2013</p>	<p>Building remains vacant and at risk. No apparent action, condition deteriorated since 2013. Traditional timber windows survive at upper floor. Possible flat roof not seen.</p> <p>Important industrial survivor enclosing the south side of one of the original 1808 feus, constructed prior to 1813, possibly store house, offices or housing.</p> <p>Continuous frontage with roofed building on the neighbouring western lot (see below). Ruinous building on eastern lot mentioned in same BARR listing.</p> <p>Discussion in early CARS report of joint redevelopment of sites on this block. Buildings were priority project under CARS in 2008 but did not proceed. Also THC considered conversion to housing c. 2000 as pilot under Empty Homes Initiative.</p> <p>Included in Appendix 5-3.</p>

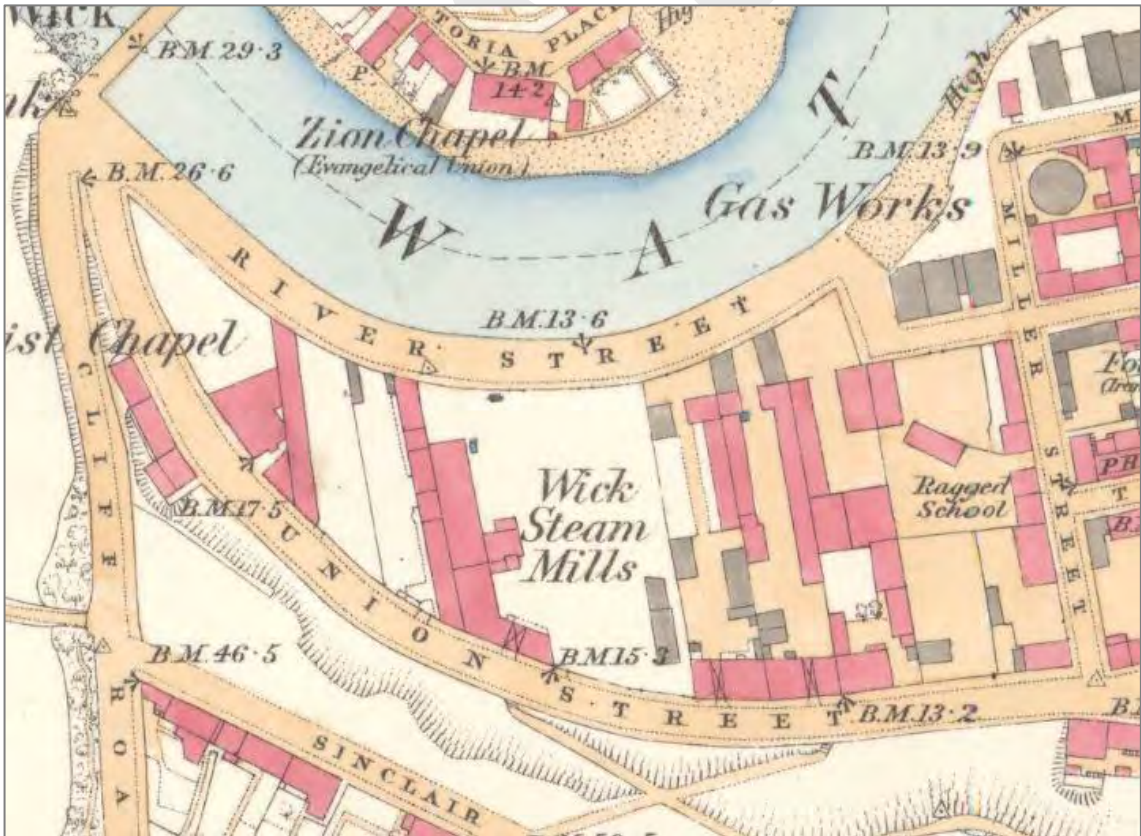
Figure 4: 1<sup>st</sup> Ed. OS 25 inch map 1873 (surveyed 1872) © NLS

*Background:* This area of Lower Pulteneytown developed from the mid-19th century (refer CAA, Map 6.2) after additional river works had taken place to reclaim land and create River Street. The Admiralty Charts of Scotland: *The Port and Vicinity of Wick* (surveyed 1839; additions 1857), and the 1<sup>st</sup> Ed. Ordnance Survey Town Plan captures this work in progress (figs 3 & 4). As such the area was not described in Telford's original plans, and west of Miller Street, Telford's grid iron plan was not continued and the plots are generally long narrow strips extending from River Street in the north to Union Street in the south. These lots appear to have originally housed supportive industries including mills and timber yards as well as additional curing yards. Street fronting buildings were constructed on Union Street with industrial buildings generally laid out at right-angles on long narrow footprints. This created an irregular frontage along the river which is still evident and presents an inconsistent form to the riverside and the historic burgh in the north. At the far western end of the area, as River and Union Streets merge, the lots become increasingly truncated until they terminate in the narrow triangular site now occupied by Mackays Hotel (1883).

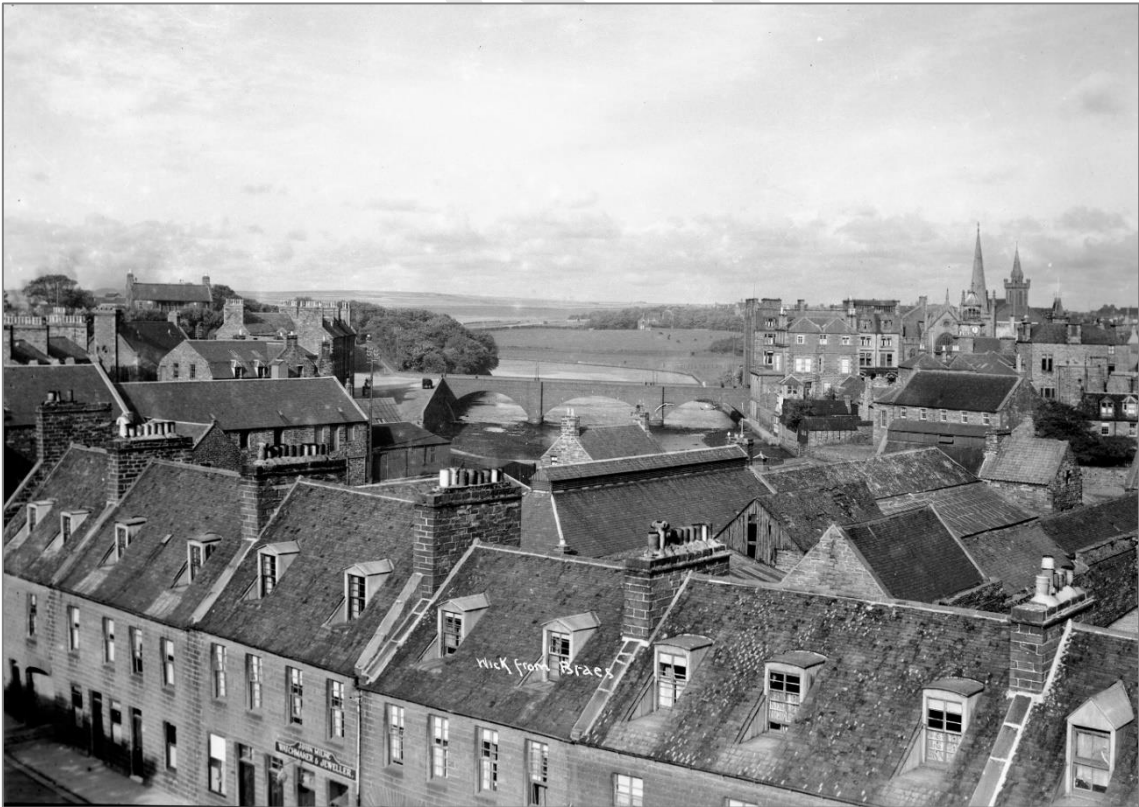
Figure 7: Historic view over the roofs in Union Street illustrating the predominance of slate roofing and also the original building forms with long double pitched roofs extending at right angles to the Union Street frontage. © The Wick Society - The Johnston Photographic Collection. Note kippering kiln with its distinctive ventilator.

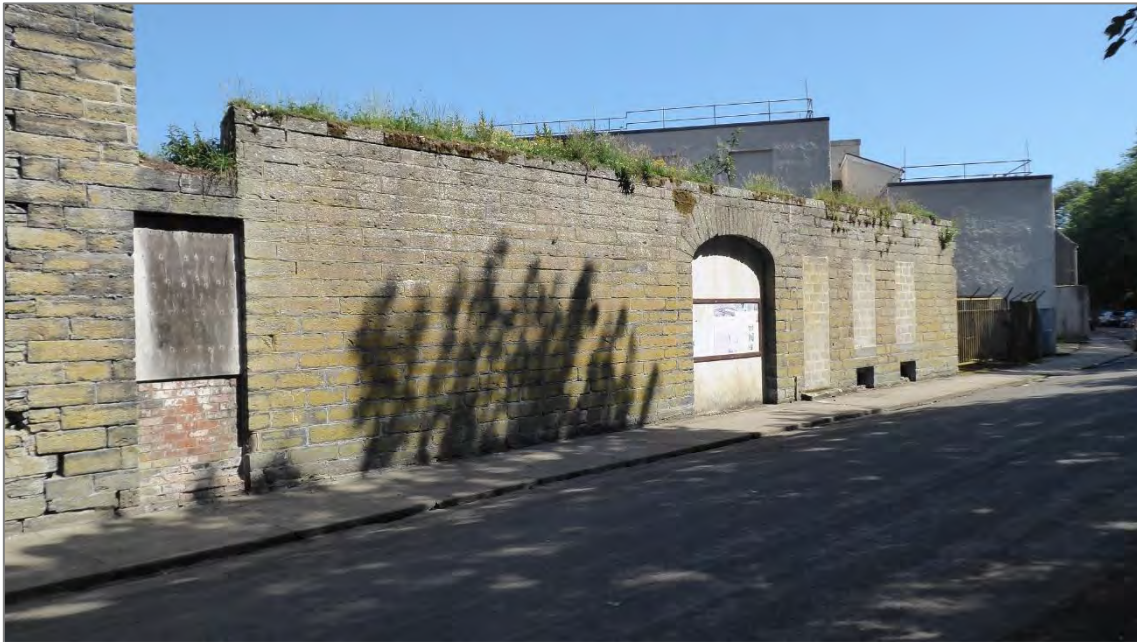
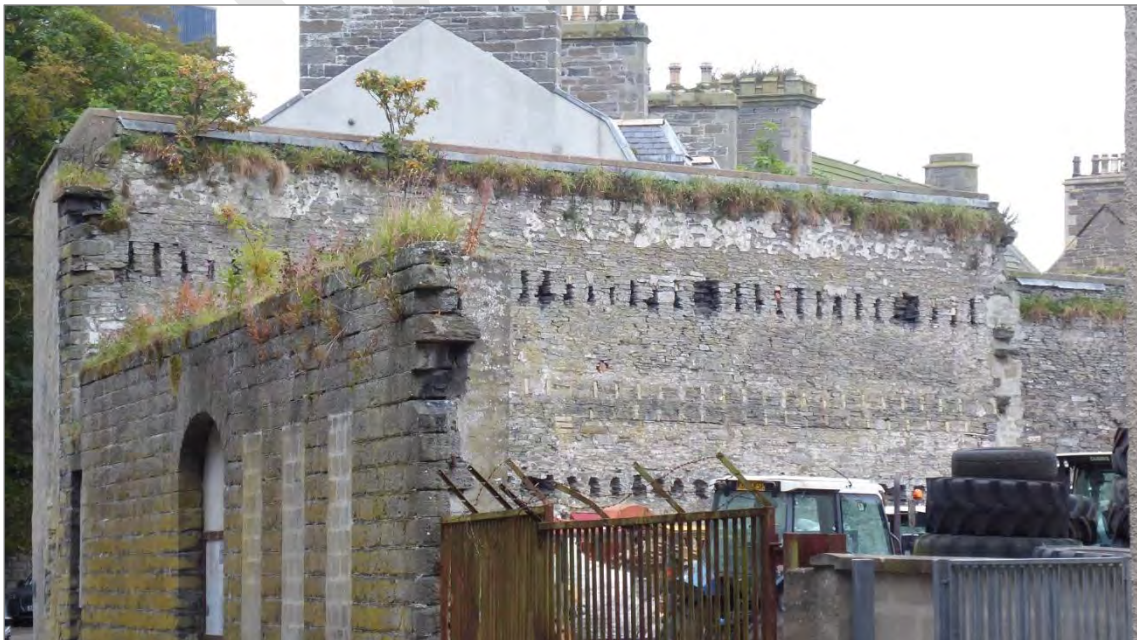
Figure 9: (top) part of the surviving elevation of the former Wick Steam Mills on Union Street with arched opening; (below) masonry side elevation also remaining.

Part of the W&A Geddes site (west of the Telecom building) looks to retain high (2- 2½ storey) masonry walls from the former Wick Steam Mills (corn and saw mills) on this site (refer OS Town Plan & Johnston images). The Union Street elevation (or part thereof) of the mill building is still standing with its central arched pend opening (fig 9). This building is thought to have been 2-storey and visible in historic images (fig 8).

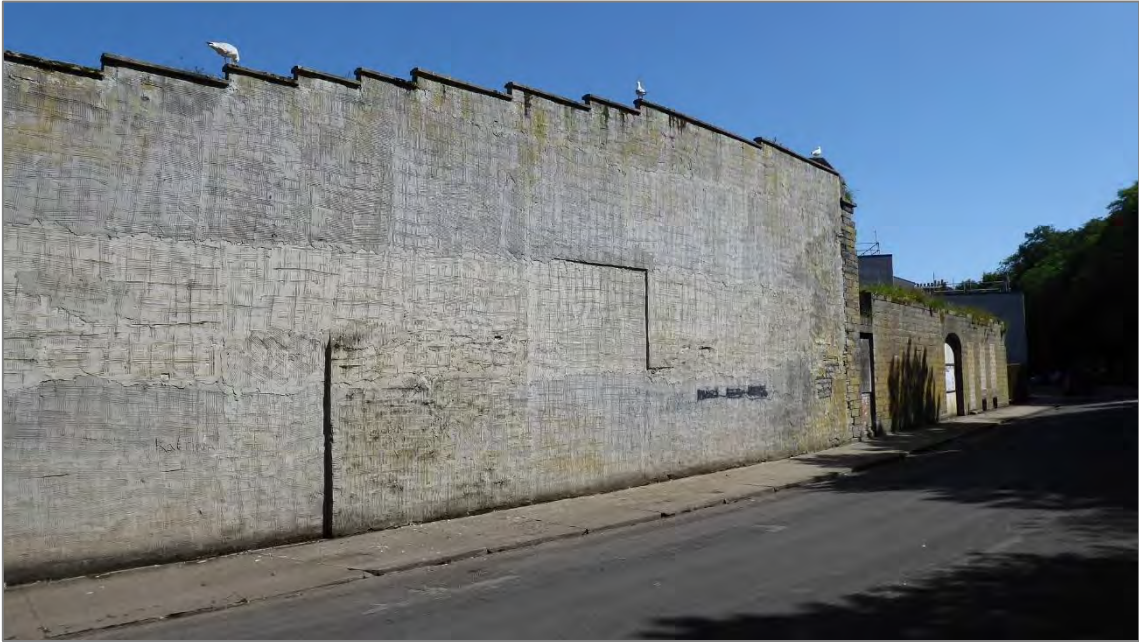
Figure 10: high masonry wall enclosing a plot on Union Street has a negative impact in terms of scale, materials, quality and monolithic style. It is unclear if original masonry fabric may survive below the rendered finish; earlier buildings on this site can be seen in historic images (e.g. fig 8)

- British Telecom building (monolithic scale, form and articulation of the building, materials used, position on plot).
- Later 20<sup>th</sup> century buildings particularly low single storey and flat roofed structures such as the MacKays Hotel extension and nearby business premises fronting River Street; as mentioned the inconsistency of the form and scale of the River Street buildings has a negative impact on the river frontage and views from Wick Town Centre.
- Union Street the large cement rendered wall enclosing a full plot width (fig 10).
- The loss of the traditional roof form at 45 Miller Street creates a negative impact.

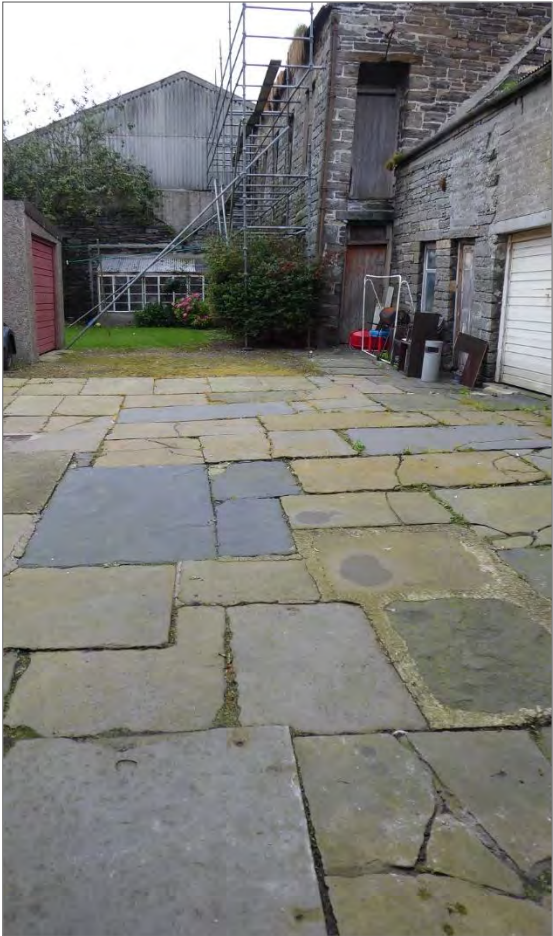
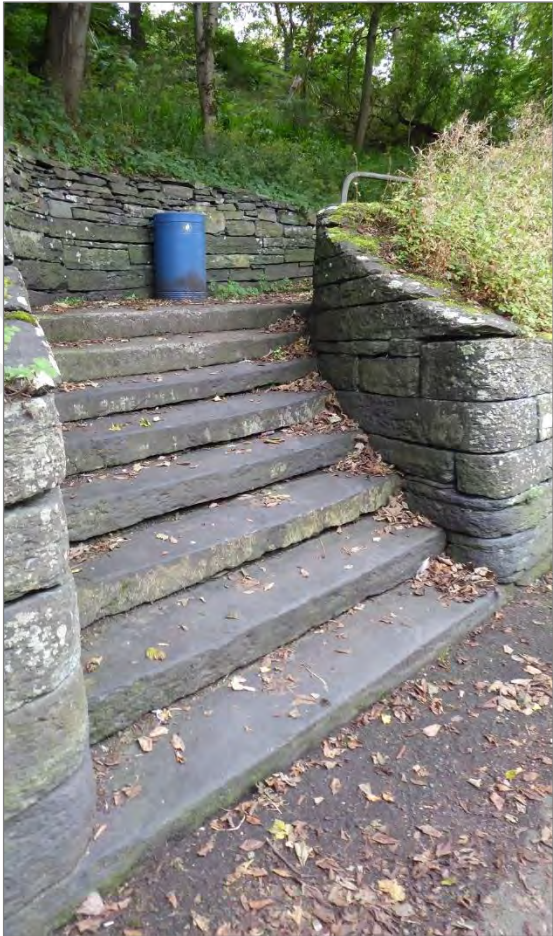
Figure 11: (left): flagstone pavement to yard behind 5 & 6 Union Street; (right) high quality masonry walling and stone steps at the entry points to Academy Braes.

On the south side on Union Street, there are low stone retaining walls to the Academy Braes, original stone steps and high quality stone walling details (fig 11).

Original paving survives in the yard and pend behind 5 & 6 Union Street and provides considerable character (fig 11). Further traditional finishes may remain within these lots.

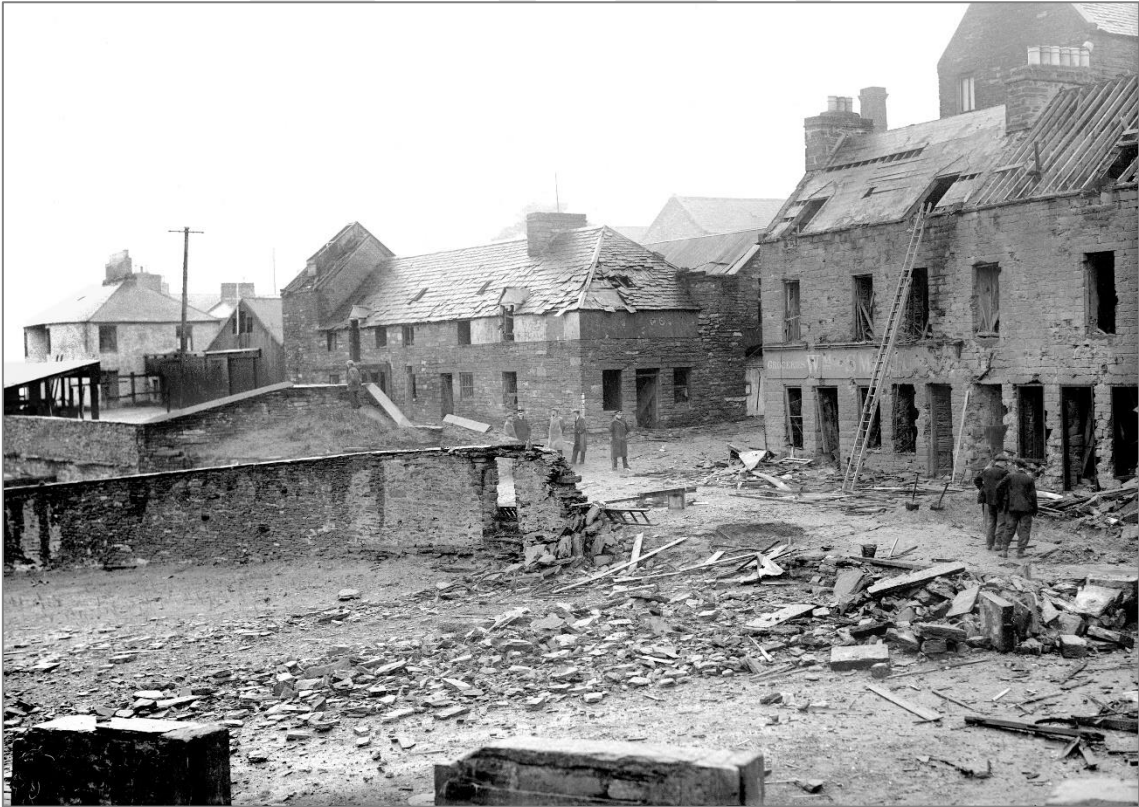
Figure 6: bomb damage in 1940 with the boat yard site in the foreground showing damage to the boundary walls, and looking at the end of Bank Row (right; now demolished) and the buildings at the foot of the Black Stairs. © The Wick Society - The Johnston Photographic Collection ref JN21143B011
