# WICK PULTENEYTOWN CONSERVATION AREA MANAGEMENT PLAN

**Draft: NOVEMBER 2020  
FOR THE HIGHLAND COUNCIL CIRCULATION to COMMITTEE.**

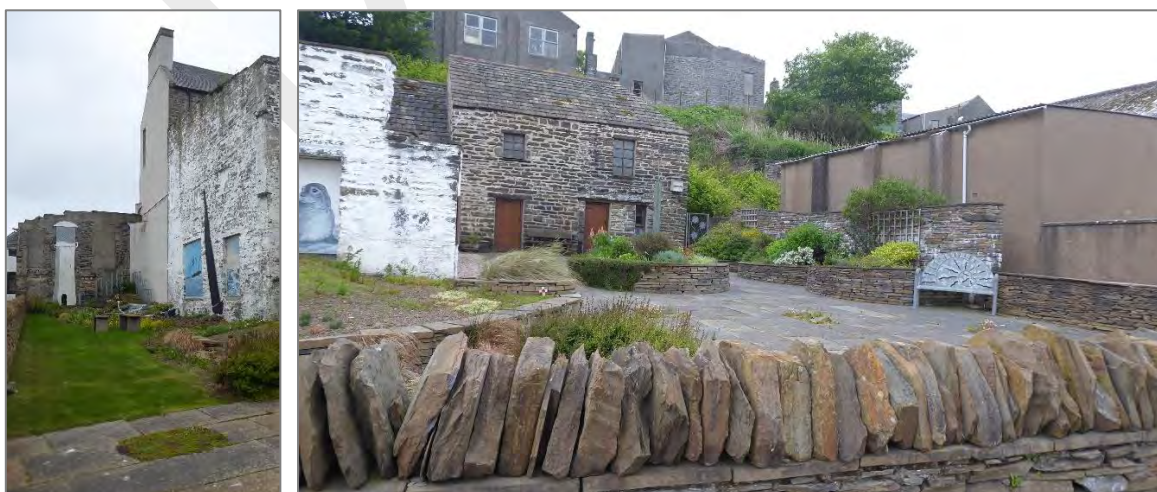
Figure 8: the Memorial Garden opposite the former boat yard site; on the left 3-storey walls of a former building have been consolidated and painted white, paint finish is failing.

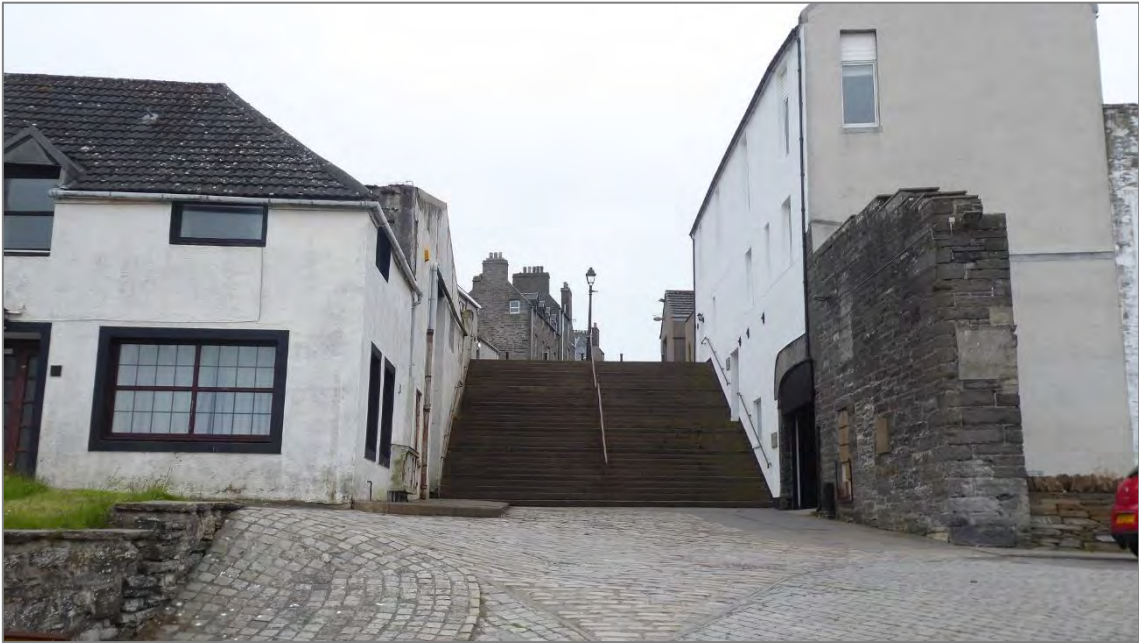
Figure 9: the foot of the Black Stairs, note previous inappropriate alterations to the traditional building on the left (horizontal windows, painted masonry, concrete tile roof); enhancement works as part of previous investment has reintroduced traditional street finishes.

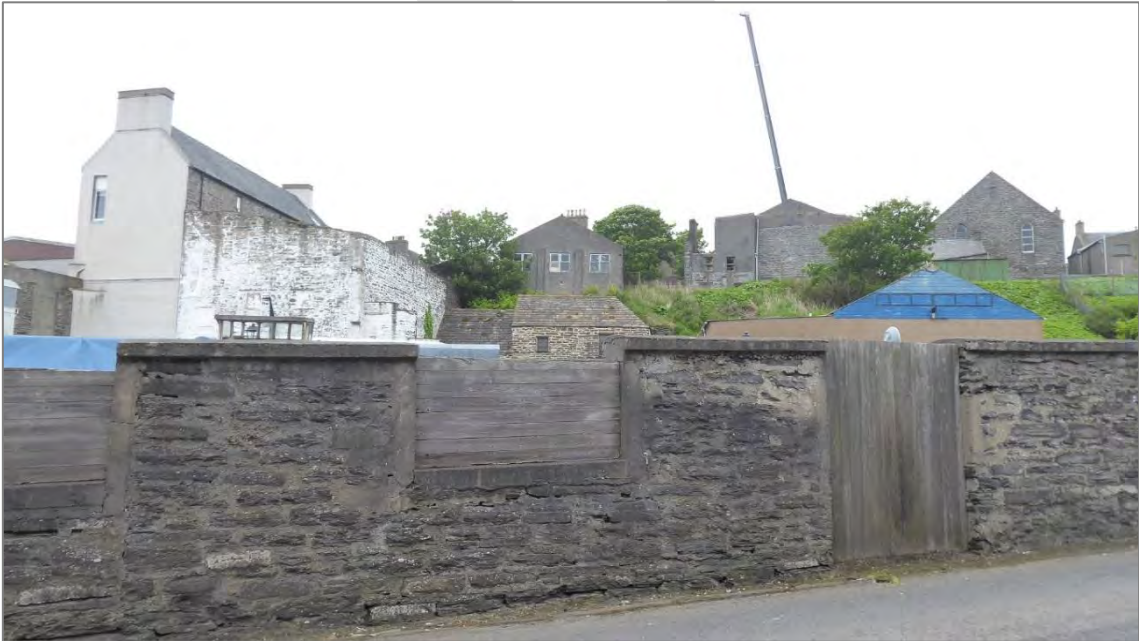
Figure 10: view with the stone boundary wall of the former Boat Yard in the foreground, and the rear of properties on the higher ground on Breadalbane Crescent beyond. Note the prominence and impact that the rear of the properties on Breadalbane Crescent have on the site.

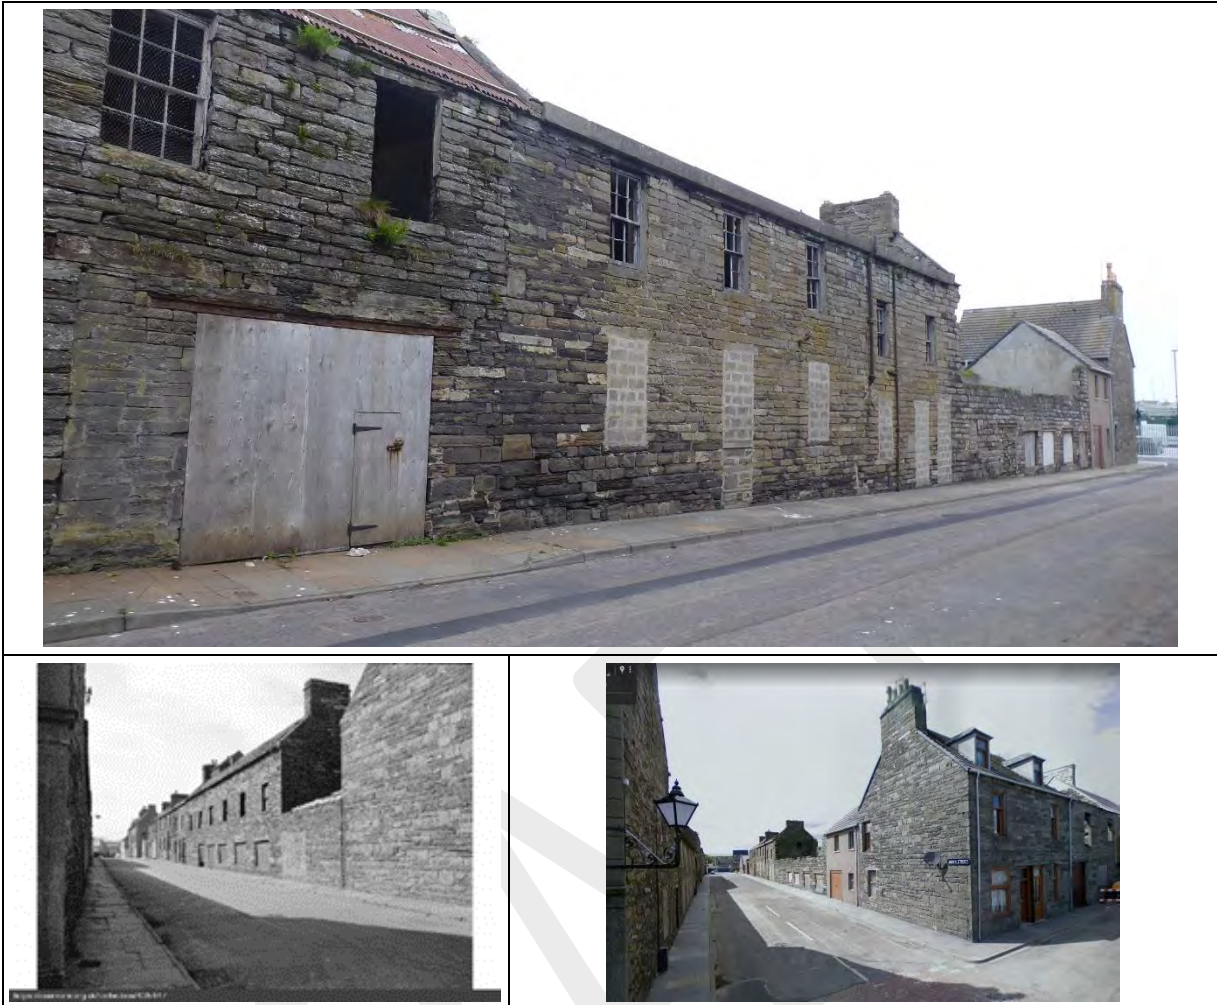
Figure 8: (top) Buildings at Risk on the north side of Burn Street looking east to Harbour Quay, 2019; the buildings span three separate lots; two street fronting buildings remain largely intact, the third has been reduced to a single storey. The 2-storey building in the distance is a later infill incorporating an original single storey yard entrance, it appears somewhat small in scale in comparison to the traditional buildings and the modern render finish is out of character.

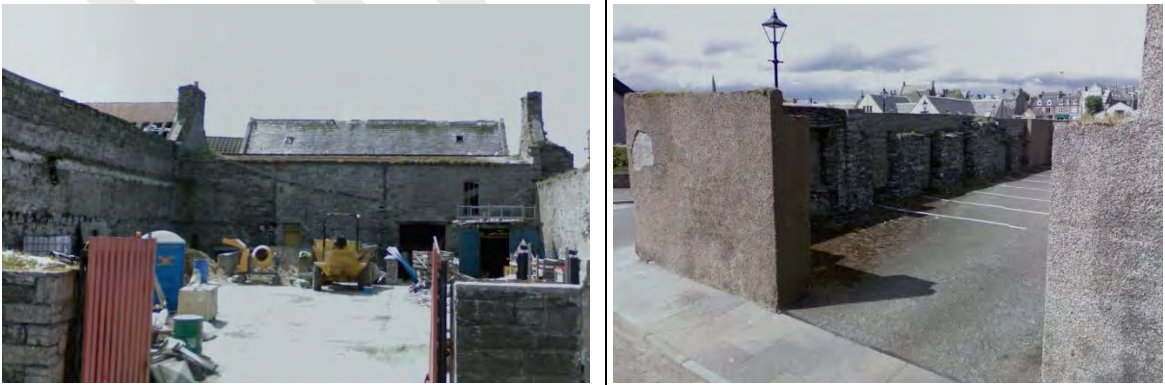
(Above left): potential gap sites include the yard next to GMR Henderson retaining high stone walls defining the original lot; the rear elevation of the de-roofed building on Burn Street is visible at the rear (image 1974 © HES); (right) remains of original Caithness stone walling on the internal face of the boundary wall on Williamson Street (betw. Burn Street and Martha Terrace).

There are two 'gap' sites which retain partial remains of the earlier buildings on Burn Street (fig 8) and on Harbour Quay.

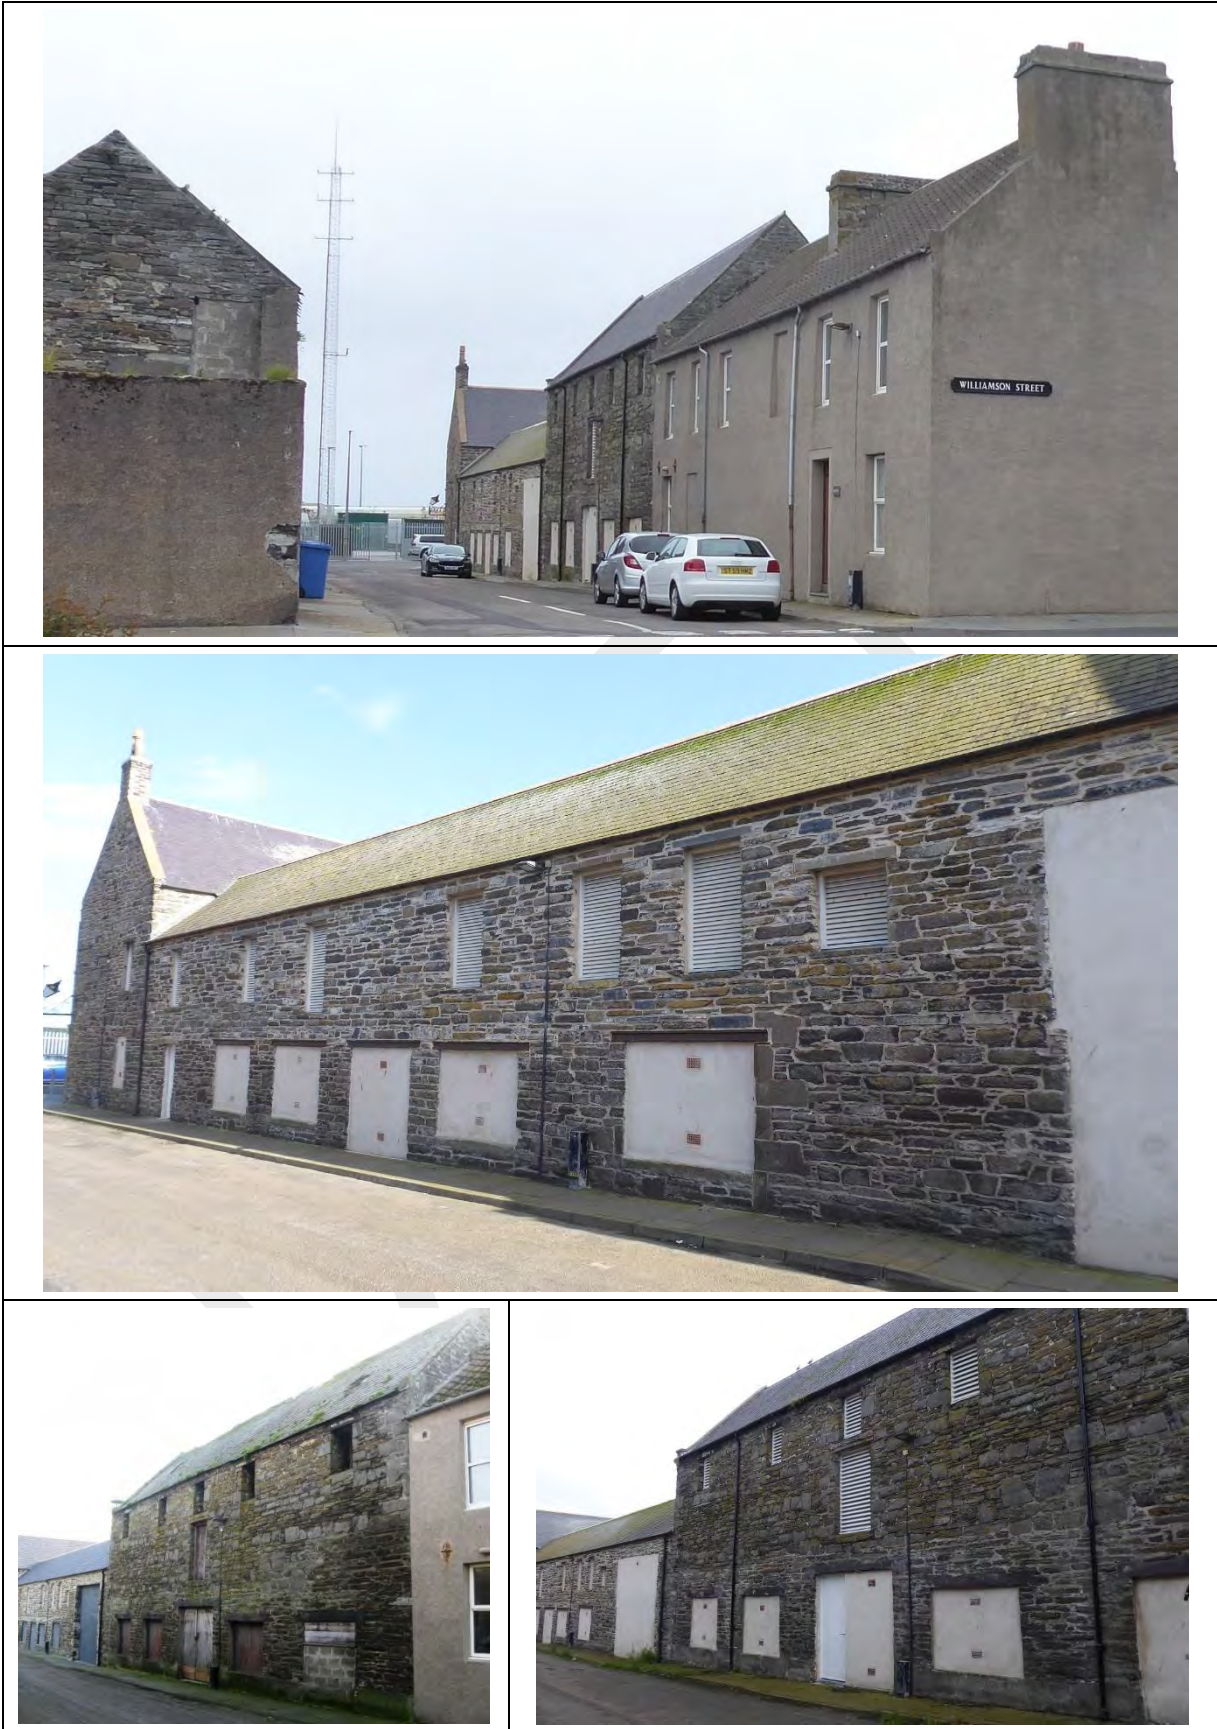
Figure 9: (top) south side of Burn Street looking east to Harbour Quay, 2019; the eastern lots of former curing yard warehouses were repaired in 2012, but still awaiting a new use; (bottom left: BARR 2013 © HES) an early herring house partly repaired sometime after 2013, also vacant.

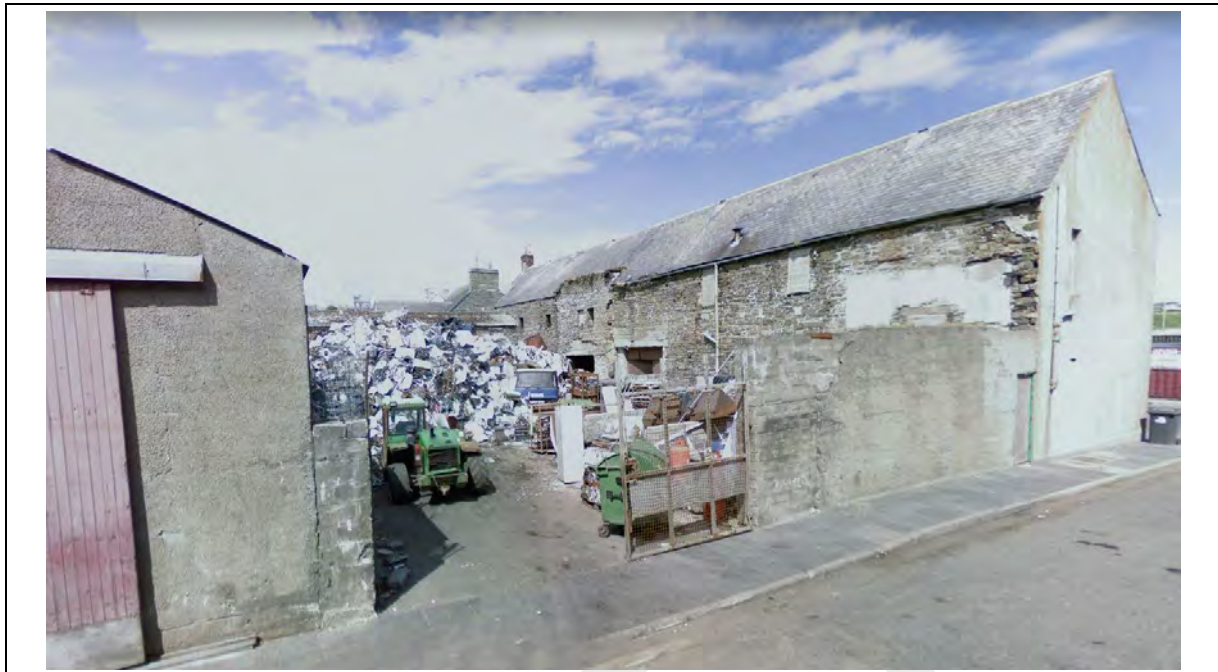
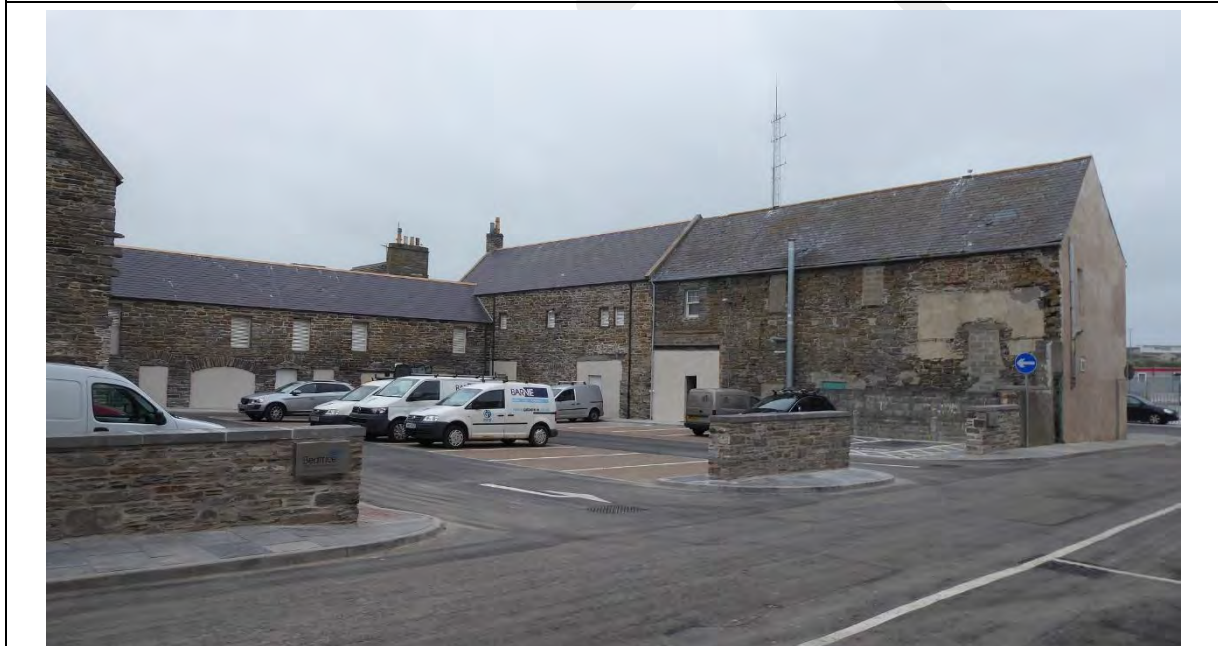
Figure 10: Two lots on north side of Telford Street which address Harbour Quay were repaired c.2012 as part of the Beatrice Offshore grant / investment. The buildings are still awaiting a new use. The former heriring curing yard was a scrap metal yard in 2008 (top, © Google Maps); the Telford Street fronting buildings appear to have been demolished sometime before the repair work, which consolidated existing buildings (below 2019). No structures remain from the original buildings which divided the two lots. The site offers further potential for street frontage infill which would also obscure the open car parking site from view.

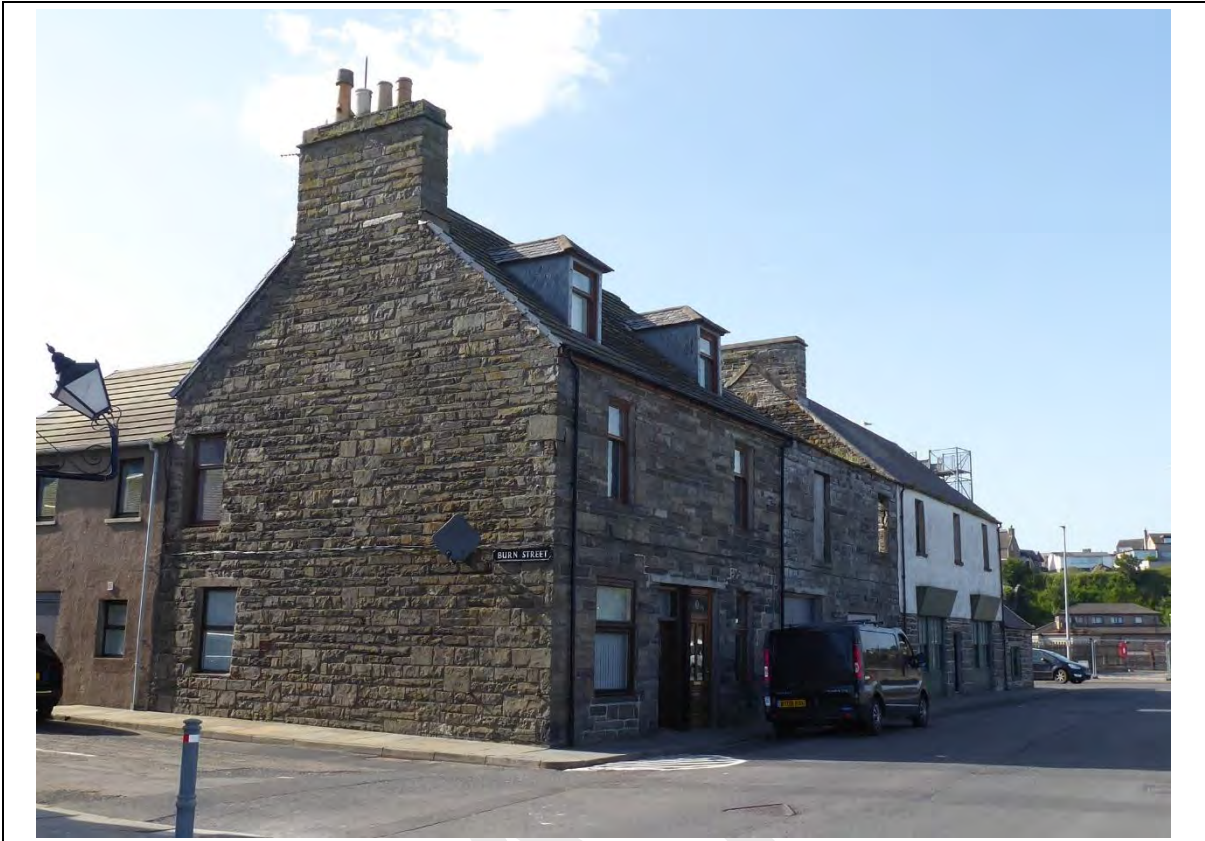
Figure 11: Gap site with surviving façade on Harbour Quay

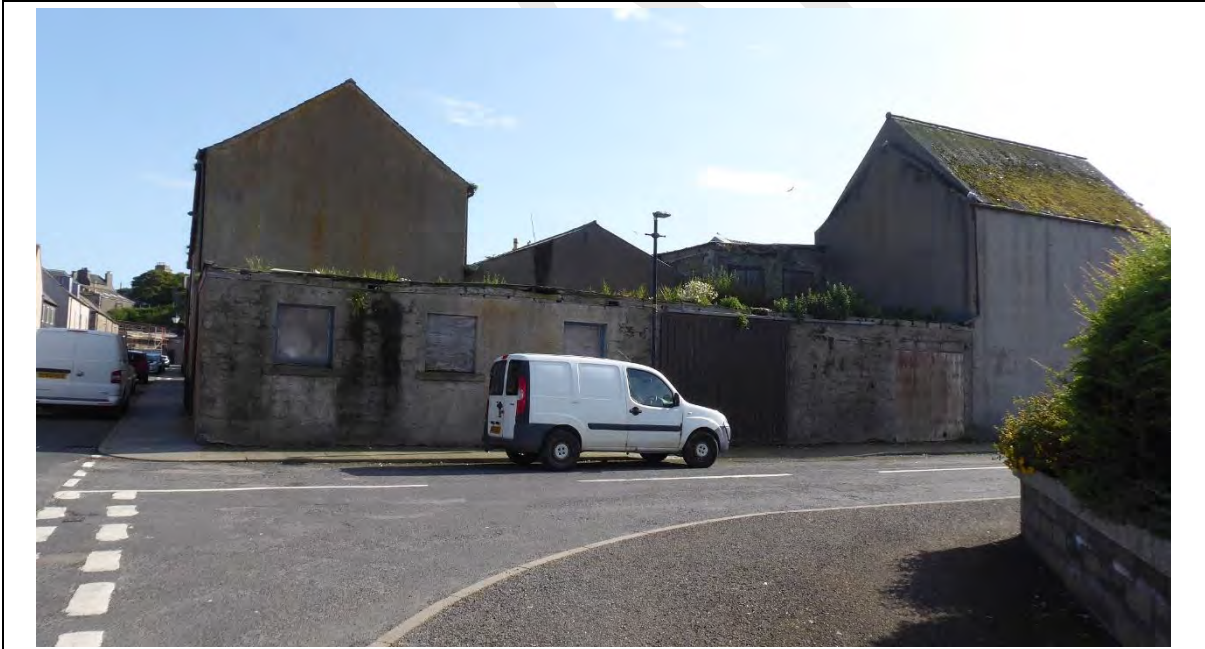
Figure 12: single storey structure on the SW corner of Burn Street and Williamson Street

- two derelict buildings on the south side of Burn Street and adjoining surviving single storey partial building (fig 8);
- former herring house, curing yard and buildings on the south side of Burn Street, part of block with Harbour Quay and Telford Street north side (fig 9);
- Gap site/partial building (façade only?) on Harbour Quay (fig 11);
- Yard next to GMR Henderson on Martha Terrace (fig 8);
- Single storey flat roofed structure at the south-west corner of Williamson Street / Burn Street next to Caithness Voluntary Group building (fig 12).

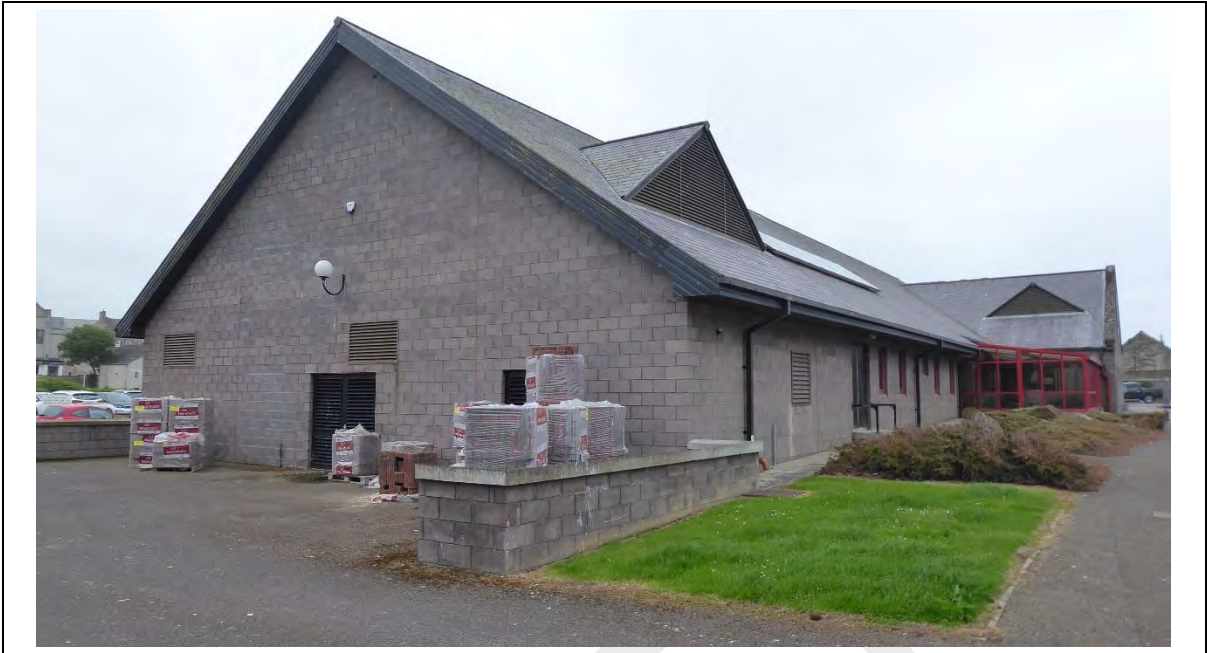
Figure 13: former swimming pool now redundant

Regarding the swimming pool, the charrette noted it would be surplus to requirements once a new public pool is constructed at the Wick Academy, with potential for the building to be converted for an alternative use (with precedents of infilling the pool cavity to create space such as a dance studio, or office space).
