## HIGHLAND COUNCIL

**Committee:** Easter Ross Committee

**Report Title:** *Draft Tain Conservation Area Appraisal and Conservation Area Management Plan*

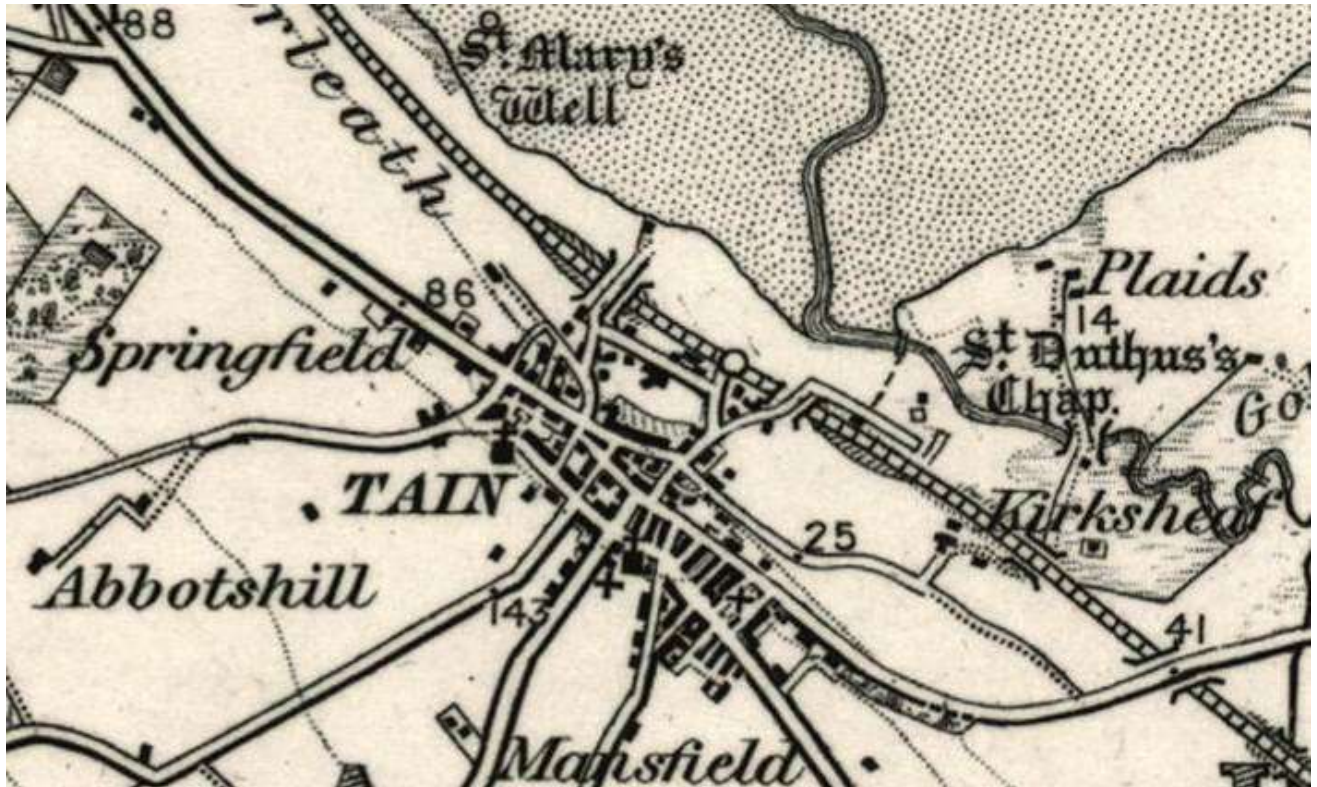
There has been very little new development in the town centre since the Edwardian period and in many ways Tain offers a snapshot of a late Victorian/Edwardian county town (in all but name). The map below shows the extent of Tain in 1911.

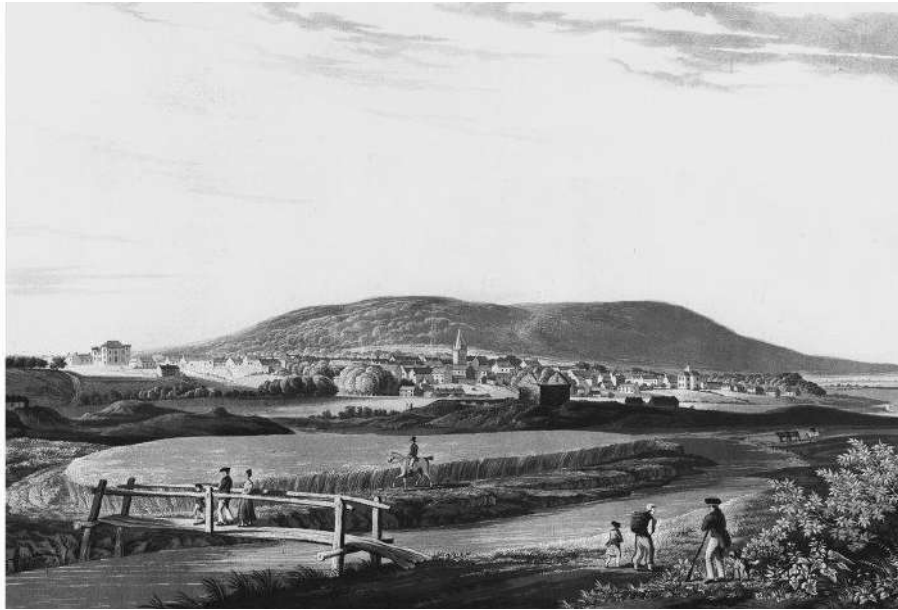
Engraving showing view of Tain. Insc: 'The Town of Tain'; 'Drawn on the spot by J. Clark and Engraved by Robt Havell'; 'London, published by Smith Elder & Co., 65 Cornhill, 1828

The early 19<sup>th</sup> century view of Tain, left, illustrates the points noted above – the town is viewed from across the River Tain with the ruin of the old St Duthuc's Chapel on the rise, centre right, with the tower of the Tolbooth beyond and just to the left, unencumbered by the later, high extensions. Cnoc an t-Sabhail rises behind the town with the Dornoch Firth just visible at its foot on the extreme right.

The magnificent new building on the far left is the recently built parish church.

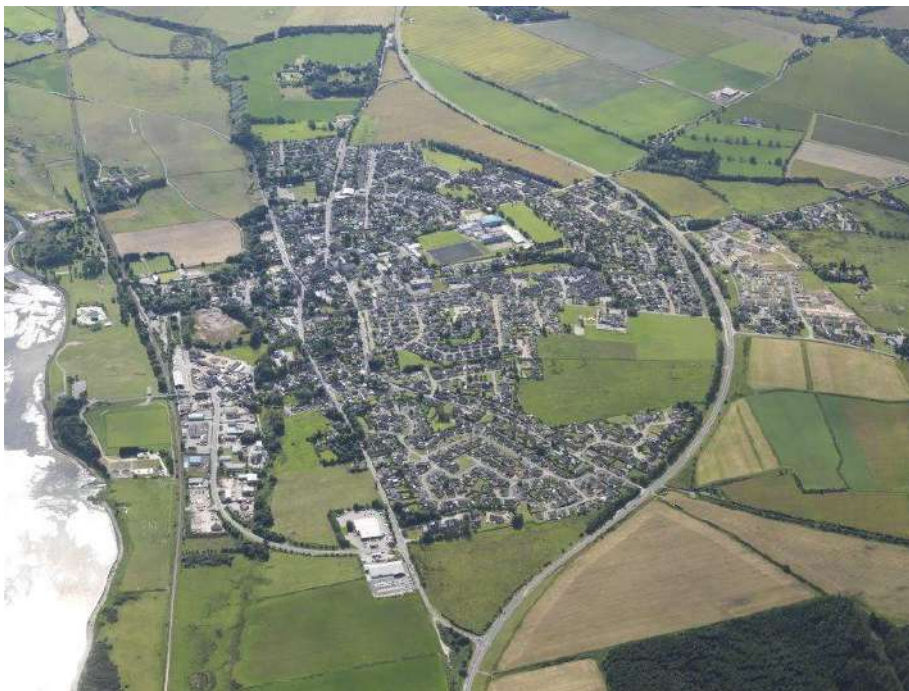
RCAHMS

This aerial view is from the north west, looking south east, with the shore of the Dornoch Firth on the left, inland from that is the railway. Old St Duthuc's Chapel is in the wooded churchyard between the shore and railway. The lower ground adjacent to the railway is occupied by the town's industrial quarter, with some dwellings in the wooded area. The line of the escarpment runs from bottom left (near the railway) straight up in this view until it kinks left close to the top – it is marked by a line of trees. The new A9 curves round the town to the right.

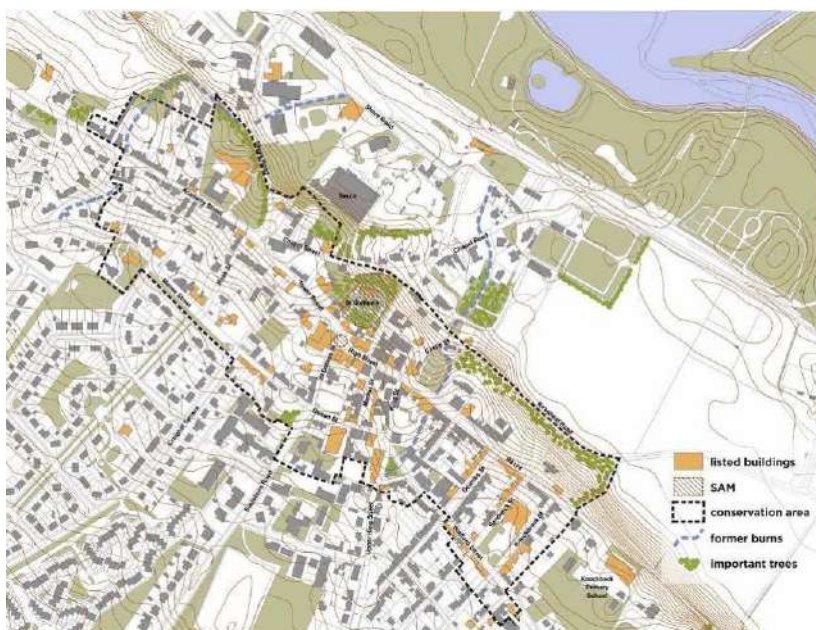
Left is the current plan showing the extent of the conservation area with contours. The old St Duthuc's Chapel is on the extreme right, beside the River Tain. Tain's irregular form is unlike most other Scottish Burghs (where High Streets and long burgage plots prevail) and owes everything to its medieval origins as a pilgrimage centre. Although largely hidden from the main streets it is St Duthac's Church and churchyard that give Tain its purpose and generate the form of the town centre.

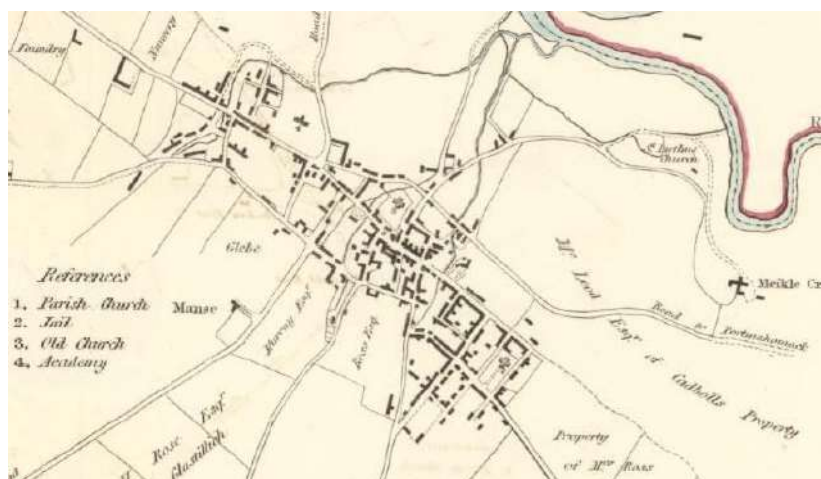
1832 Great Reform Act Plan

The original roads are most clearly seen on the 1832 plan. The main route is from the north west, leading in directly to the Tolbooth, while the road from the south east enters Tain by what is now Stafford Street to meet King Street at Cadboll Place, with King Street then leading steeply down to the High Street. From Cadboll Place, Queen Street, then Manse Street lead north west, but then have a narrow link down to the main road via Hill Street. Queen Street is higher than the High Street so the links down - King Street, Market Street and St Duthuc's Street - as well as a number of smaller lanes, are all quite steep.

Tower Street kinks round the Tobooth to meet the High Street.

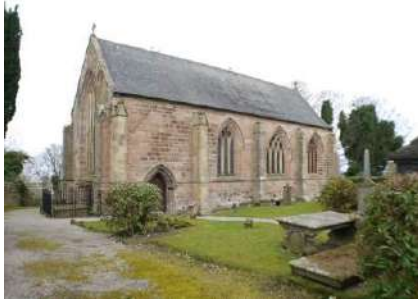
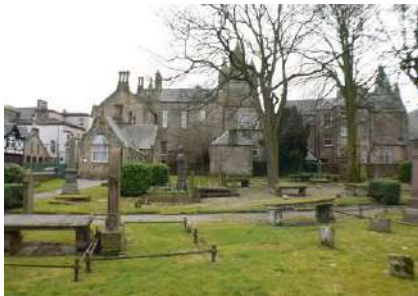
century graveslabs. The church was re-roofed circa 1752 and later restored, by Robert Matheson in 1849-82 and Hippolyte J. Blanc in 1896. The retaining wall to the graveyard, with late 19<sup>th</sup> century spearhead railings, to Castle Brae and the 19<sup>th</sup> century lodge give the churchyard the feel of a Victorian cemetery; however the Collegiate Church is a significant early building and close examination reveals graveslabs of much earlier date (there are 17<sup>th</sup> century mural monuments in the walled enclosure).

The churches and church yard occupy a promontory advanced slightly from the rest of the escarpment. Tall trees now occupy the bank and obscure the site from below, but it would have been very much more visible before (see J Clark's view of 1828).

The lower of the two photographs, left, shows how the High Street and Tower Street buildings butt right up against the churchyard and it appears certain that the secular town developed in close relationship to the church, giving rise to the irregularity of the streets. The Tolbooth is prominent amongst these.

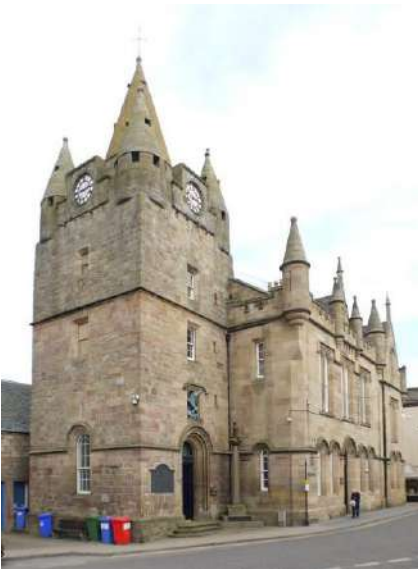
#### **Court House 1848-49 & 1873 – A listed**

It is one of the earliest court houses in Scotland to use Scots baronial detailing (as design of court houses in the early 19<sup>th</sup> century tended towards neoclassical or Renaissance styles). Tain Sheriff Court was constructed in two significant phases. The first was designed by architect Andrew Maitland and built in 1848-49 to replace an 1825 building which had burnt down in 1833. The arched entrance at the base of the Tolbooth tower, on the High Street elevation, is contemporary with the 1840s courthouse design and originally served as its principal access. The second phase of construction was in 1873, with the addition of the four-bay block facing Castle Brae designed by Andrew Maitland & Sons.

Together these buildings give a sense of civic purpose and gravitas to the town centre and are a key element of the townscape. Unfortunately, while fulfilling their function in the administration of justice, this means that community use the buildings for wider community/civic purposes are limited. While contributing significantly to the townscape they do not contribute significantly to the civic and cultural life of Tain.

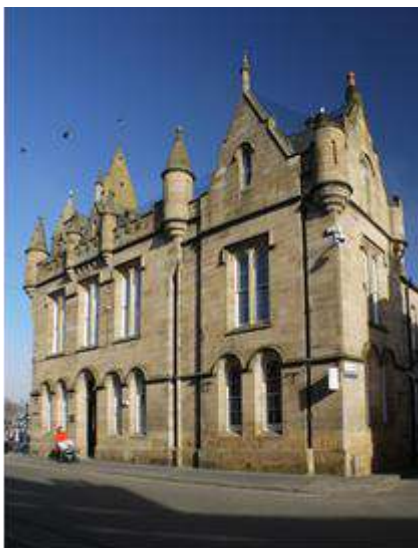
#### **Market Cross - Scheduled Monument**

Tucked in the corner between the tollbooth tower and courthouse is the Market Cross, category B listed.

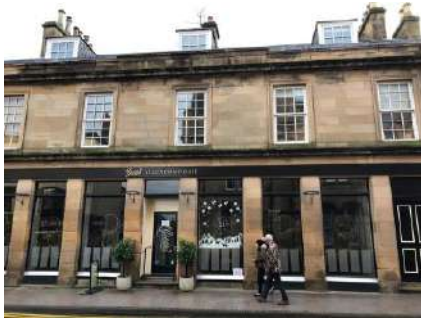
11-15 High Street, circa 1840, B-listed

These three buildings contribute greatly to the townscape and show an interesting enrichment of style as each decade passed. This variety has been achieved while maintaining quality and a similarity in form and scale. While alterations have taken place (the fenestration patterns in particular have changed, for example 1-3 has later 4-pane windows and canted dormers) it is significant that the original openings and stone piers have survived and the rhythm of the ground floor openings and piers contributes to the character of the street.

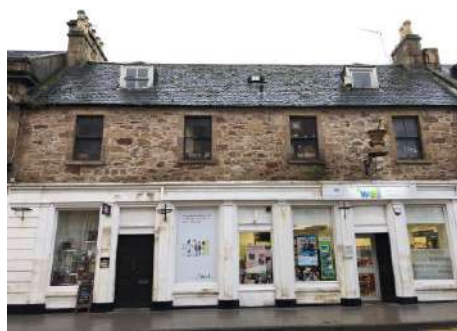
5-9 High Street, 1817, B-listed

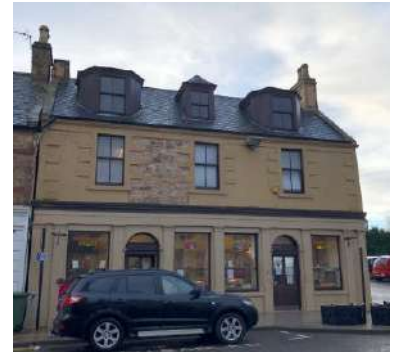
1-3 High Street, circa 1830, B-listed

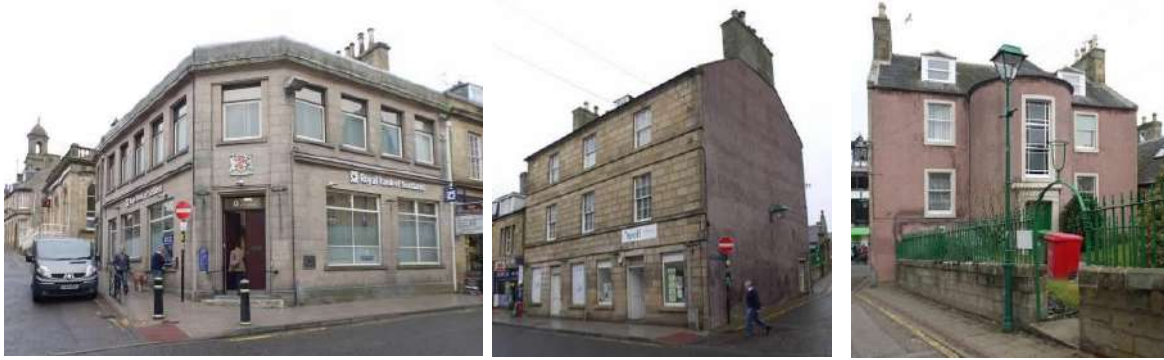
The corner buildings to Market Street are less successful although maintain the interesting variety of the High Street. The Royal Bank of Scotland at least follows the scale and cornice lines of the adjoining earlier building (11-15) and turns the corner competently into Market Street, but its mid- 20<sup>th</sup> century plain detailing and frosted glass windows make it a little detached from the commercial life of the street. On the opposite corner, the B-listed 23-24 is an impressive, almost over-scaled, Georgian composition, slightly compromised by the commercial needs of the ground floor shop fronts. Interestingly the rear has a rounded harled stair tower. This and the harled gable contrast with the High Street elevation to the point of looking like two different buildings.

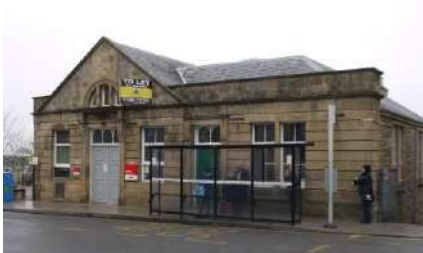
The former Post Office in Lamington Street, a category Grade B listed Maitland building of 1911-3 is now in shared use as a sorting office and a hairdressers.

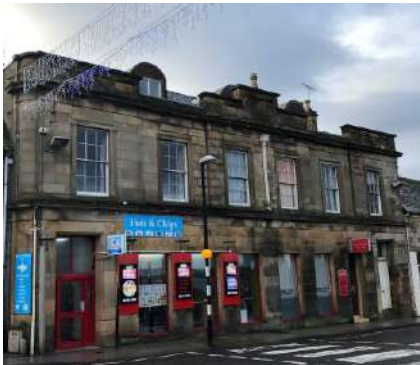
The next building along could be seen as visually marking the end of the High Street, but is, in fact, 1-5 Lamington Street and could also be seen as marking the start of the eastward expansion. One of the difficulties in assessing Tain is the seamless way that, in several places, one street merges into the next.

It is C listed and of the same period as 11-15 High Street and has some similarities, although the parapets and dormers are more flamboyant.

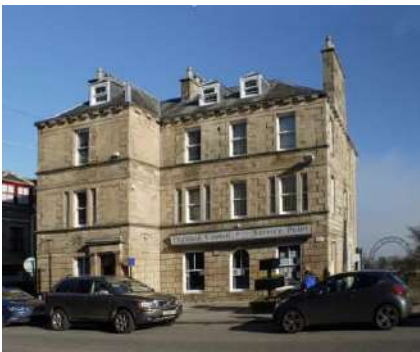
Diagonally opposite the Highland Council offices mark the east ward end of the High Street on the north side. The building dates from 1828 and was formerly the Commercial Bank. It is B listed and a substantial composition, although John Gifford described it as *'ineptly detailed, with the rusticated quoins of the corner and windows colliding'*. Despite this it has presence in the townscape and provides a civic use in the High Street. It is particularly important in terms of providing a defined end to the High Street above the valley of the Polcalk Burn, now a rose garden commemorating the 1066 charter from King Malcolm III.

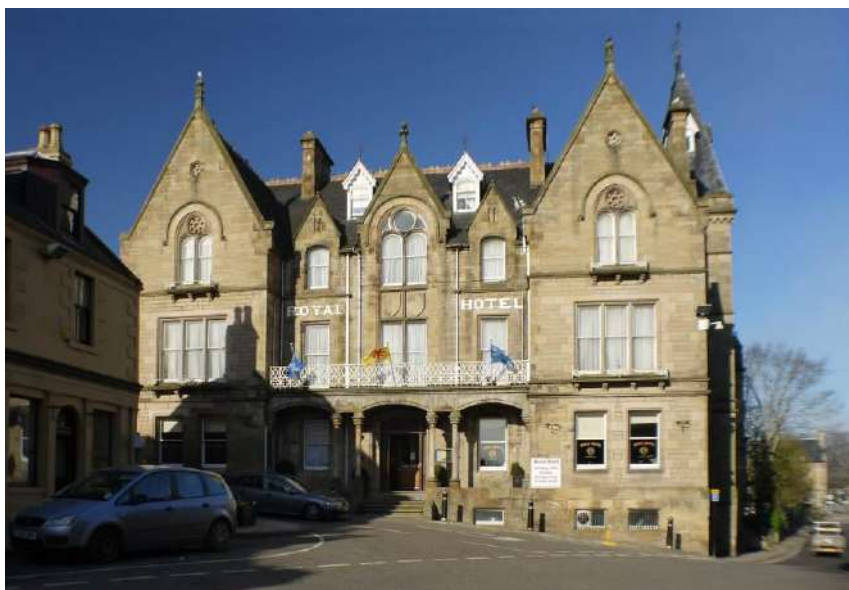
### Royal Hotel, B-listed

A Maitland and Sons, B-listed, 1872, French Gothic design, occupies the prominent site at the end of the High Street, terminating the view from the east and giving the High Street a sense of enclosure. Gifford describes it as *'gabled and gableted Gothic; across the centre, a stone verandah topped by cast ironwork. At the N end, a steeple stepping out to join the Town Hall'*.

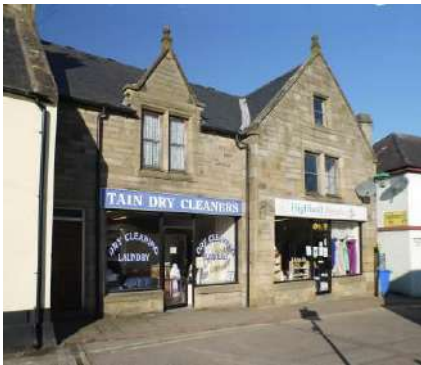
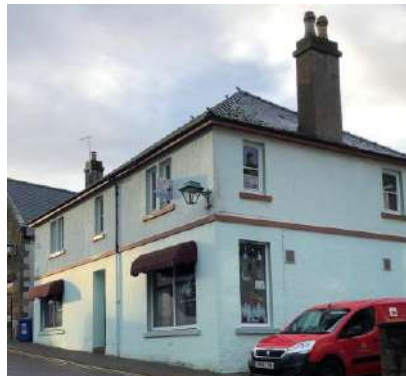
King Street appears originally to have been the main entry to the town from the south, although the northern section is shown on the 1832 map, and particularly on the 1878 town plan, as quite narrow. Some of the earlier buildings have survived at the south end where two, rendered, dormered vernacular houses give an idea of the early 19<sup>th</sup> century scale (although a corner building has been removed).

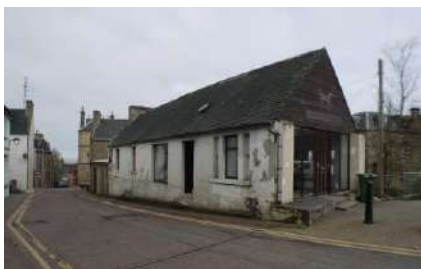
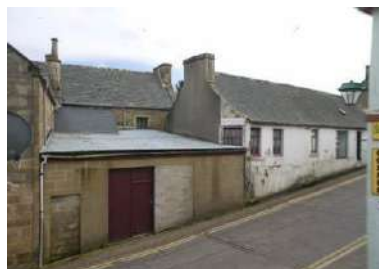
Although the east side starts (at the south end) with a distinctive late 19<sup>th</sup> century commercial building (with a corbelled entrance almost identical to that at 18 High Street) unfortunately it now stands in isolation, as most of the east side of King Street was demolished and the area is now taken up with a car park.

As well as introducing surface parking into the town centre the area opens up the rear of properties that were not intended as public elevations and destroys the tight urban grain. It marks one edge (or rather corner) of the town centre.

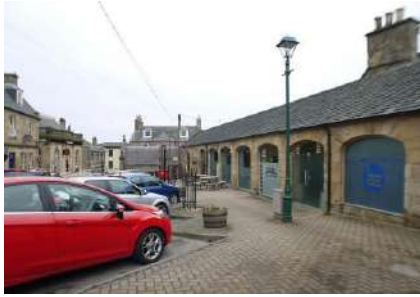
Towards the High Street end a remnant of the east remains, much altered and run down and with an unfortunate response to the new open space – with what was probably once a mutual gable, chopped off and infilled with poor quality timber weatherboarding and a modern shop front. It now appears empty and in poor condition.

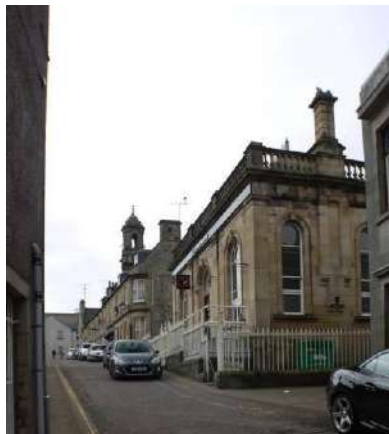
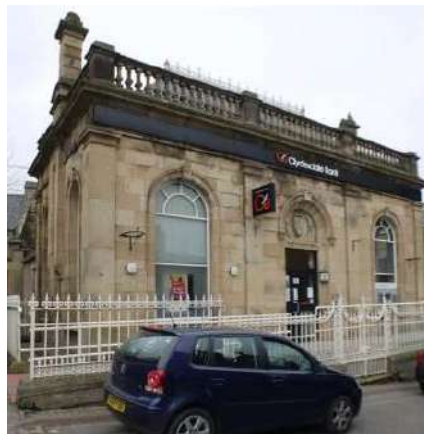
### Clydesdale Bank

Andrew Maitland & Sons 1878 richly detailed free renaissance bank has a presence in the street greater than its physical size and retains its original detailing, including the ornate cast iron railings and cresting to the roof. At the time of writing, the bank has closed and the building is unoccupied.

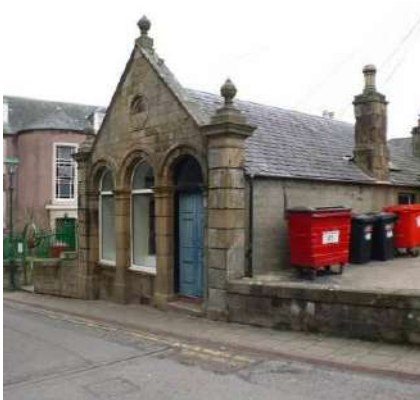
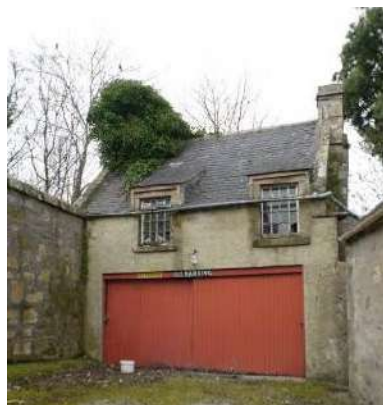
Opposite the bank is an elaborate Victorian Gable with finials and three arched openings, set on an otherwise plain building.

Set back beside the bank is a small building with traditional dormer windows but an altered, wide garage opening at ground floor. The Burgh Survey identify this as a surviving early building (16<sup>th</sup> or 17<sup>th</sup> century).

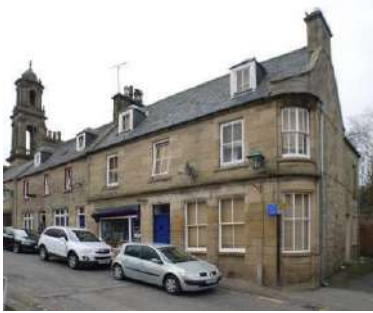
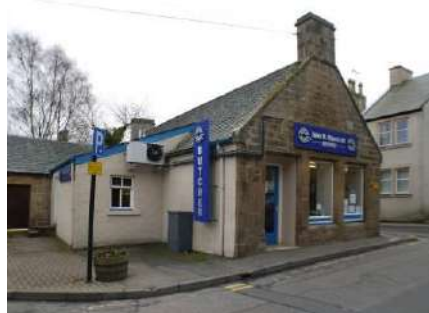
terrace of good quality 19<sup>th</sup> century buildings built or adapted for commercial use at ground floor, The third in the row (15-17) with more recent widened openings.

The butchers shop presumably predates the market as it appears to have fronted onto Queen Street; however, openings in the gable link it in to Market Street and the gable closes off the street visually. The poor quality extension and fan unit detract from what has become a good quality urban space.

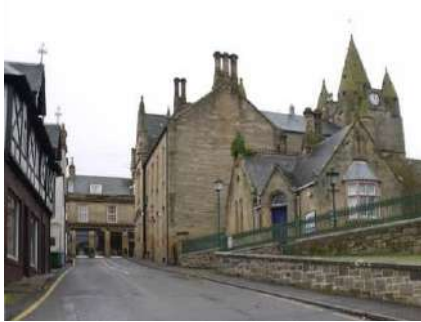
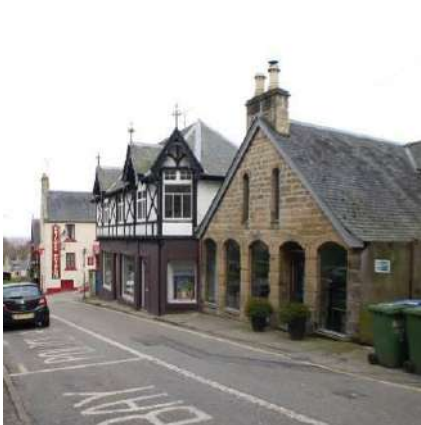
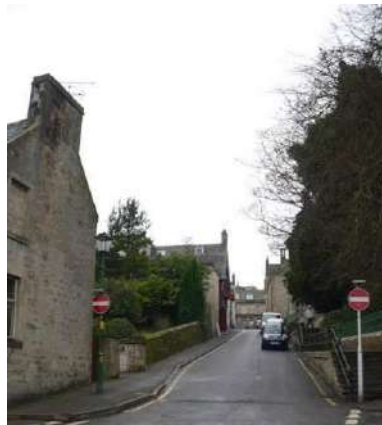
The 19<sup>th</sup> century town plans do not feature this as the street seen today, in fact the 1878 Town Plan shows the High Street buildings continuing across the entrance to the street although a pend is probably indicated. The same map shows the building running down the hill on the west as the Royal Hotel, so perhaps this does not reflect Andrew Maitland's rebuilding of the Royal Hotel on its present site (formerly the St Duthus Lodge and St Duthus Hotel) in 1872 and his extension to the Court House in 1873. The bartizaned corner block gives way to a much plainer wing on Castle Brae, but still of a scale commensurate with its civic purpose.

On the opposite, east side of the street there is a mix of buildings. The gable to the gallery with its five arches, two narrow first floor windows and prominent barge boards and chimney is in marked contrast to the mock Tudor half timbering next door while the earlier building that is now the Railway Hotel juts out to enclose the street. These buildings continue the character of the town centre some way down the street.

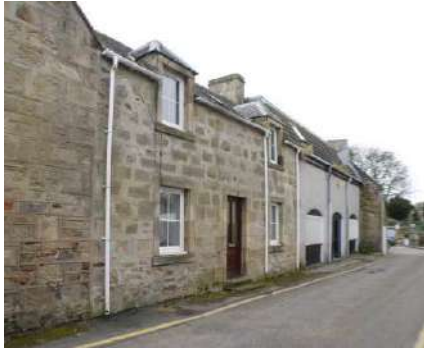
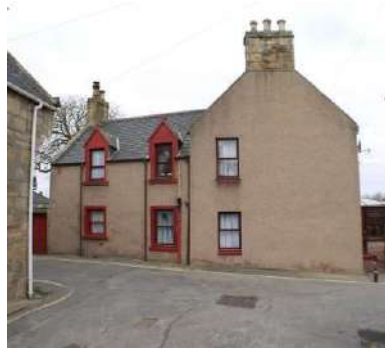
This is a relatively short street and perhaps serves best in containing the rear of the High Street. The Railway Hotel perhaps started life before the railway came as a typical late 18<sup>th</sup>/early 19<sup>th</sup> century three bay house that was either then extended or took over an adjoining property. An upper floor window has been enlarged. The harling is in poor condition and the paintwork somewhat garish. Much could be improved; however, the building is part of the Town centre and brings some activity to the street.

Castle Hill is a substantial house, actually facing east onto its garden so that the gable and rear wing form the visual stop to Bank Street. It is a C listed building with some interesting detail but suffers from having been pebble dashed and the loss of its original windows. The conservatory on the east side detracts.

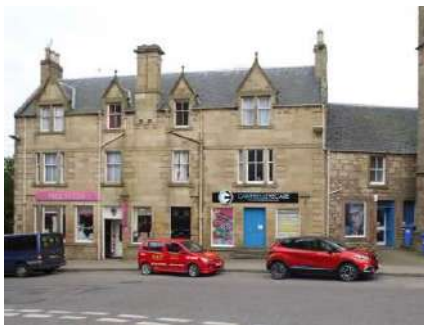
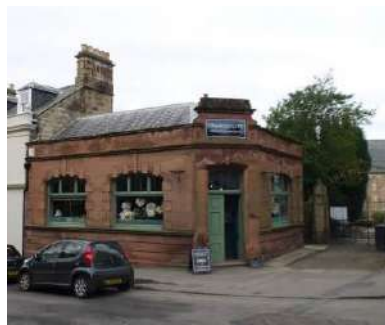
The entrance to St Duthuc's is of significance – easily missed at first and poorly paved, it is almost ignored by the tall tenement to the east but the single storey commercial building on the west makes a good attempt at turning the corner into the entrance.

The tenement (24-28) is reasonably well detailed and is B-listed, described as 'mid 19th century terrace, raised to 3 storeys circa 1870-80'. Its scale suits the location opposite the very tall gable of the Royal Hotel; however, the older, small, 2-storey building squashed between it and the Tower is almost lost between its large neighbours.

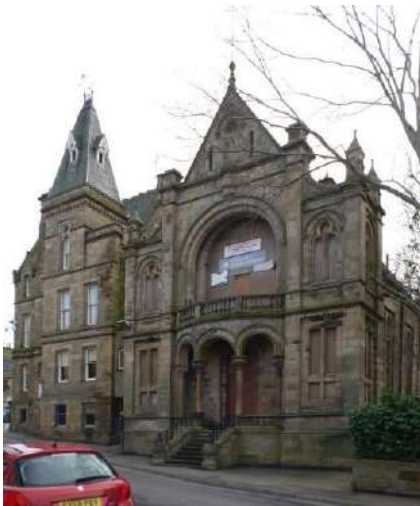
The tower also eclipses the intricate façade of the former B-listed Town Hall next door. It was also designed by Andrew Maitland & Sons and built 1874-76 as a private profit-making venture. Bought by the Town Council in 1902 it was upgraded and reopened in 1903 (financed by Andrew Carnegie). It was converted to the Town Hall Cinema in the 1920's, re-named in 1937 as the Picture Palace. In 1954 it was being operated by Caledonian Associated Cinemas Ltd. and Cinemascope was installed. The Picture House had gone from listings in the late 1960s.

The owners, the Tain Heritage Trust, in conjunction with the Tain & Easter Ross Civic Trust and the Tain & District Development Trust, are currently restoring the building for future community use. The façade is complex, as the list description makes clear:

*“Renaissance former Town Hall. Ashlar 2 storey, 2 bay gable front to Tower Street with recessed centre entrance at head of flight steps under convex columned and arched arcade supporting balcony. Large round arched opening above; narrow side bays with windows in recessed panels to ground floor. Mullioned and transomed to ground floor: circular tracery to 1st floor windows under hoodmoulds with arcaded gable. Pinnacles above, and central niche. 5 round headed 2-light mullion and transom windows set in oblong recessed panels to west elevation. Slate roof with tiled cresting”.*

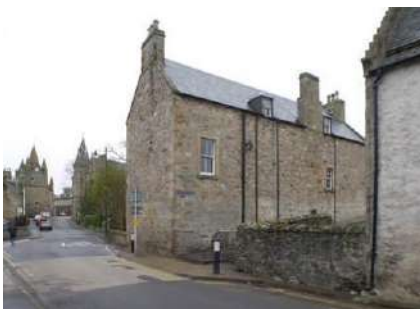
The next building, also described as Tower Gardens is a substantial early 19<sup>th</sup> century three storey building facing east onto a private courtyard separated from the street by a low wall (with gate piers) and railings, now in poor condition. The gable and wall are set out right onto the present road edge and the rear, west facing elevation sits directly on Quarry Lane.

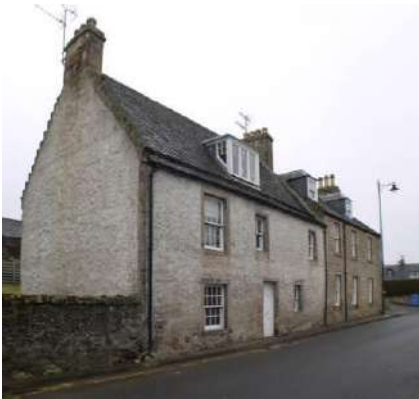
No. 3 (C listed) and no. 5 (B listed) Tower Street return to a more traditional pattern by being built directly on the street. No.5 is given in the list description as “Mid/late 18th century”; however, its detailing looks older and, the Burgh Survey notes “indicate a late 17<sup>th</sup> /early 18<sup>th</sup> century date”.

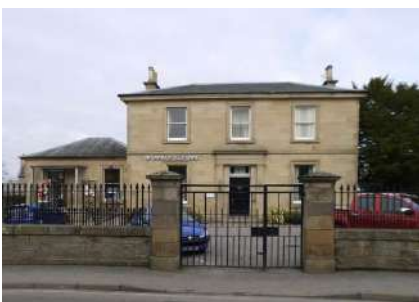
14 Tower Street, the next building, breaks the pattern being set back behind garden walls with railings but is a substantial building. It is B listed, designed by George Angus, 1845 and built as the British Linen Bank (now home to the Bank of Scotland). It is a classical, regular composition of polished ashlar fine architectural detail to windows, door and other elements. The near contemporary single storey wing on the west gable is marred by a modern porch. Research on 14 Tower Street has been carried out as part of the Scotland’s Urban Past project.

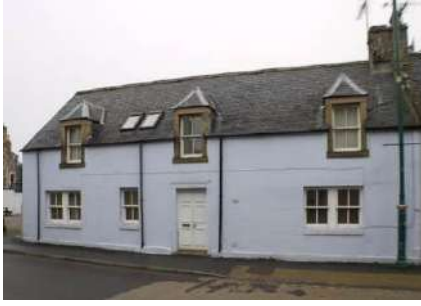
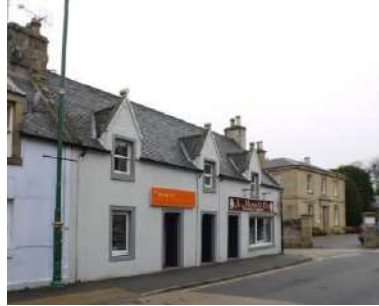
The next short terrace returns to the more urban pattern and the architect's and insurance broker's offices maintain a commercial use although their scale drops to that of the more domestic expansion of Tain. 8-12 is more finely detailed, with its gabled dormers, in contrast to its neighbour, no.6.

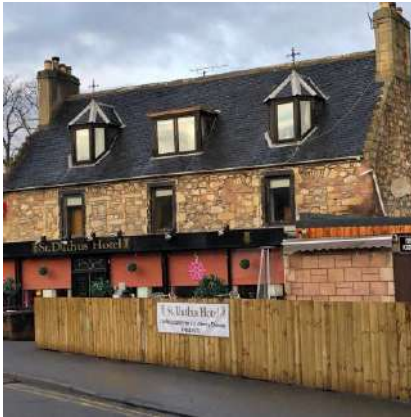
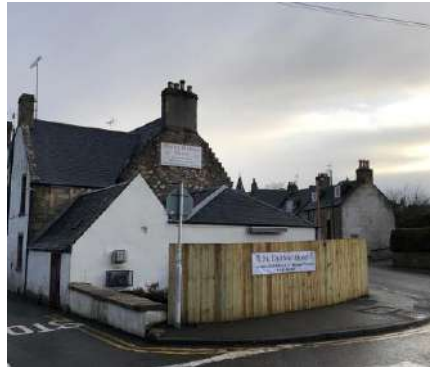
The much-altered St Duthus hotel has remnants of detailing, such as the blocked up chamfered windows and crow stepped gables that suggest that it is of 'some antiquity', perhaps late 17<sup>th</sup>/early 18<sup>th</sup> century like its near neighbour opposite (5). The modern extension, box dormer, plain glass openings and fire escape stair on the gable all detract from what should be an interesting early building. The 1878 Town Plan shows the building sitting in its triangular plot which is shown as garden, sadly now lost to a poorly finished car park. Research on St Duthus Hotel has been carried out as part of the Scotland's Urban Past project.

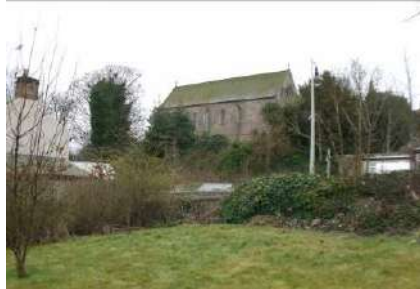
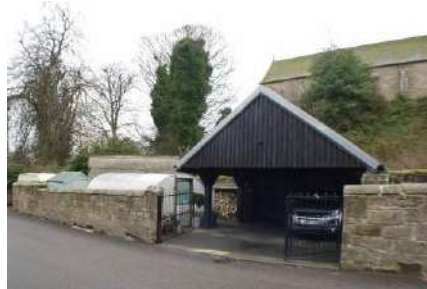
As the road continues to drop, St Duthuc's Church and the wooded slope of the escarpment begin to dominate, although there is a house with garden and garage tucked in under the bank.

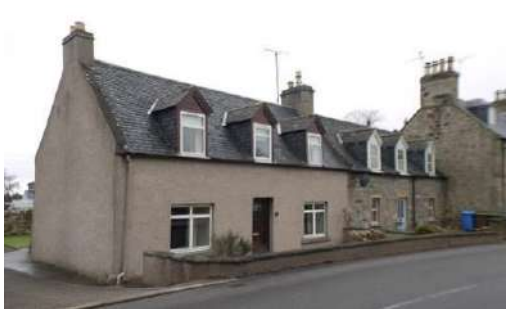
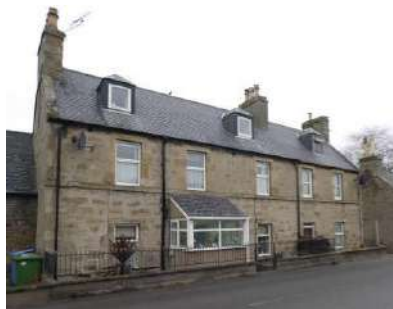
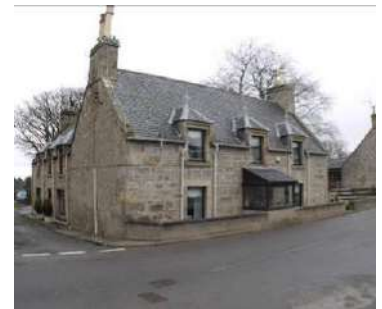
Murray Street has a very narrow entrance off Morangie Road. The four single storey terrace cottages, stepped down the slight incline, have distinct character and good detail. The street name is carved in an outband of no.3. The row ends in a tower house style dwelling of recent construction.

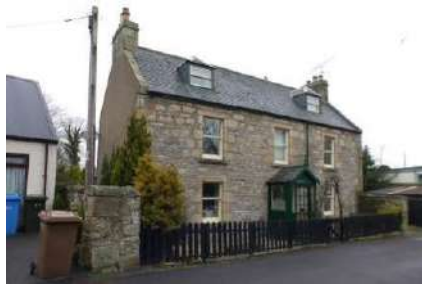
On the left is the only listed building in this group, the B-listed Dunrobin House (no. 4) described as *"circa 1800, 2 storey, 3 bay with centre door; harl pointed rubble, tooled dressings; harled gables; later glazed timber porch"*. It has raised, cement-based ribbon pointing and has lost the original astragals from its windows.

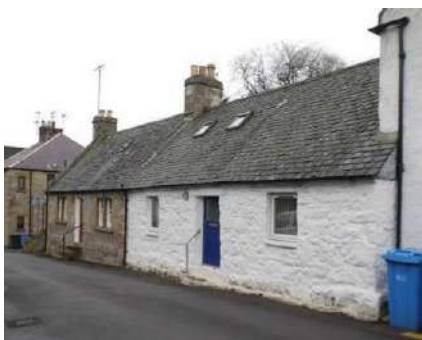
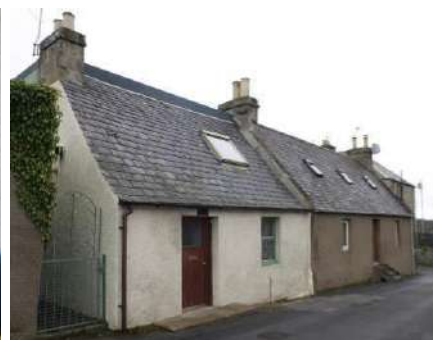
They are modest in scale and have been altered over time, although the white painted no. 3 retains small window openings. No. 6 (white harled cottage) has a very large rear extension, just visible in the photograph (near right).

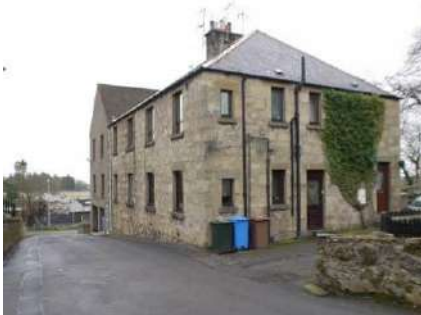
At the north end of the street are two blocks of stone-built flats, possibly built by the local authority (1930s?), now with modern windows and the block on the east extended with a large pebble dashed wing to the north. Currently these are excluded from the conservation area. (Refer to section 6.0.) While rather plain and larger in scale than the older houses, the buildings at least reflect the street pattern and provide containment to the north end of Dunrobin Street. The garden wall of the eastmost block turns the corner and continues into the boundary wall at the rear of the former Tain Royal Academy.

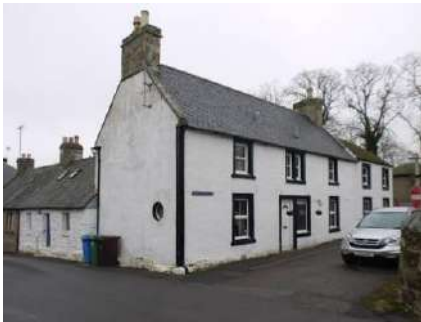
Returning to Drummond Street, there is a substantial dwelling on the corner with Dunrobin Street, possibly early 19<sup>th</sup> century and possibly originating as two houses (the arrangement of door and window with paired windows above might indicate an original division). Now altered, with modern PVC windows and a large concrete tile roofed extension to the east.

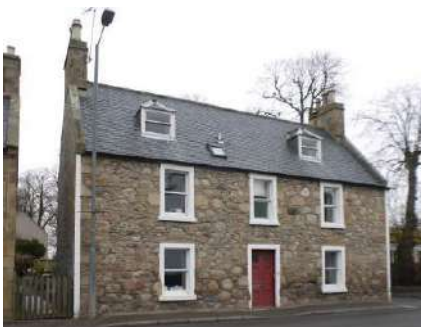
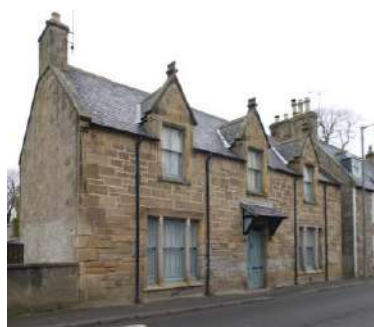
No 12, C listed (far left) dates from the earlier/mid 19<sup>th</sup> century and is a substantial 2 storey and attic, wide 3 bay house, although abutting the similarly sized no.2 Drummond Street

The adjoining house, also substantial, is a later 19<sup>th</sup> century house with gable dormers and large tripartite windows at ground floor.

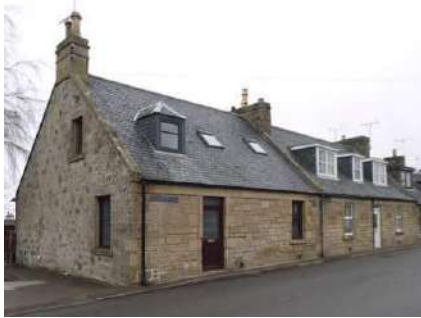
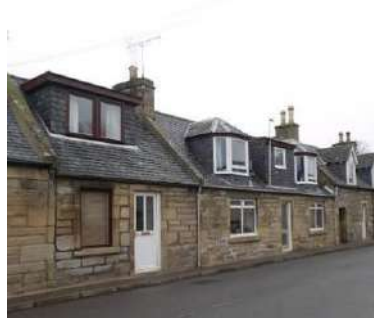
After the gap at the south end of Dunrobin Street (and the set back house) there is a continuous terrace of seven cottages, the first two and a half storeys and the remainder single storey with dormered attics – the dormers in a variety of styles and periods. Some of these may be quite early buildings (late 18<sup>th</sup> century?) relating to ‘Little Tain’.

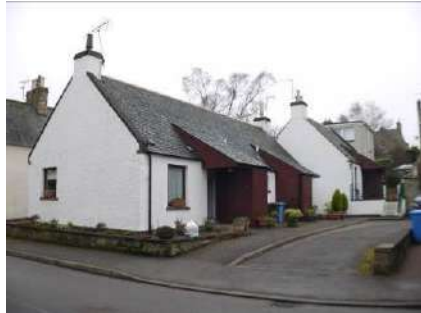
Similarly, the next building to the west is also gable to Academy Street but set back and with access off a cul-de-sac labelled Murray Place. The building has modern porches; however, the stone ridge capping suggests that it may be a largely reconstructed earlier building.

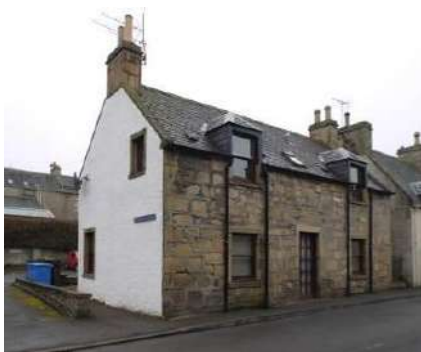
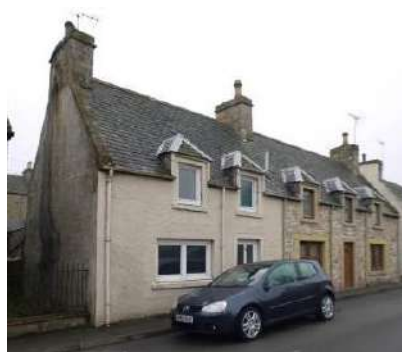
The houses are one storey and half, generally significantly modified, with wider window openings, modern windows and different render and paint finishes (although the detached house retains a stone frontage). They are coherent when seen as a group with the similar terraces opposite and both sides of the street appear on the 1832 plan.

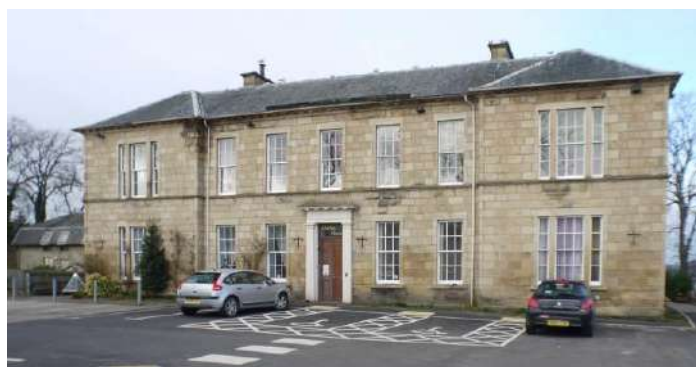
The building is described as a "Simple late Georgian classical façade, 2 storeys, 7 bays. Ashlar frontage, rubble flanks with Ashlar dressings, centre Doric pilastered doorpiece with decorative fanlight and paired panelled doors with reeded detailing. Wide outer bays advanced with triparties in ground and 1st floors; 1st floor windows linked by moulded cill course 12-pane glazing. Mutule cornice; paired cornice stacks; piended slate roof".

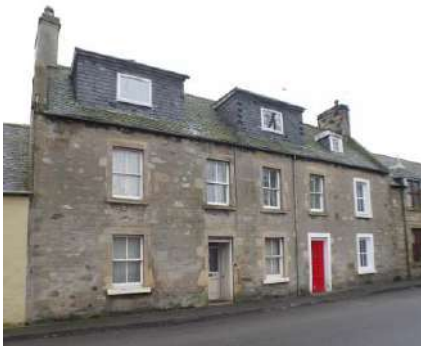
The buildings along the south side of Academy Street perhaps reflect the infilling of the street frontage from both ends over time. The building at the corner of Rose Street is a substantial earlier 19<sup>th</sup> century house with some distinguishing architectural features (its stone gable chimneys, tripartite windows and stone banding to the openings and front corners) but is flanked by much smaller scale, possibly earlier dwellings. Perhaps the presence of the Academy raised the status of Academy Street and encouraged investment – after the small cottage another pair of houses reflect the more imposing scale. Sadly, the box dormers detract from the appearance of the stone built, 3-bay house on the left.

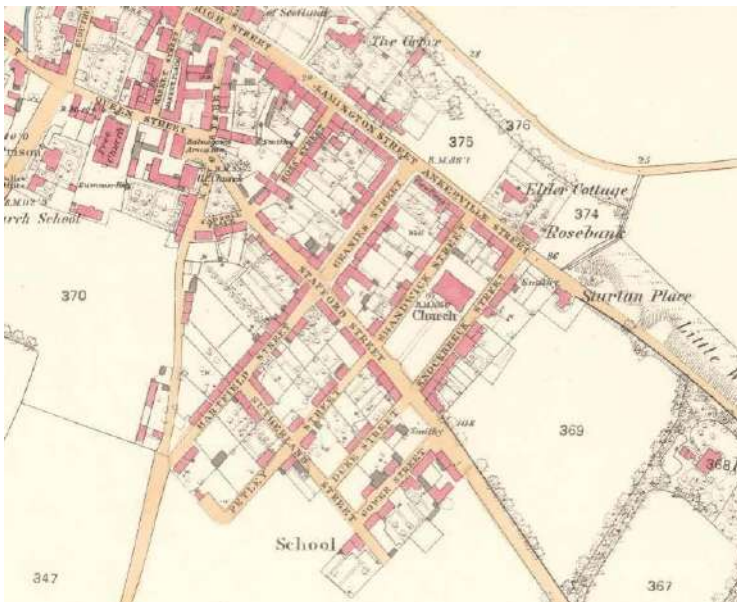
1878 Town Plan (Extract)

The 1878 Town Plan shows the area more or less complete and much as seen today, although there have been additions along Ankerville Street and a few replacement buildings or modern infills. Tain has, of course expanded greatly to the south and east in the 20<sup>th</sup> century; however, these areas are outwith the conservation area.

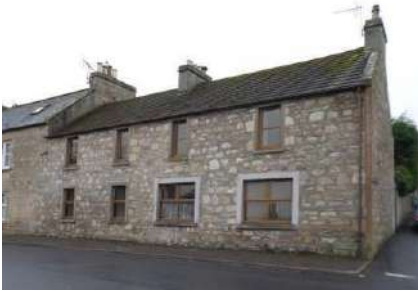
Beyond Shandwick Street, the next block comprises two dwellings, the first possibly having started as two houses facing onto the street but now combined into a large dwelling with a former doorway built up and access taken from Shandwick Street into the garden side. Its neighbour is a familiar style - a substantial three bay house, although it appears to have subsumed a smaller corner house (a blocked-up doorway can be seen close to the mutual gable).

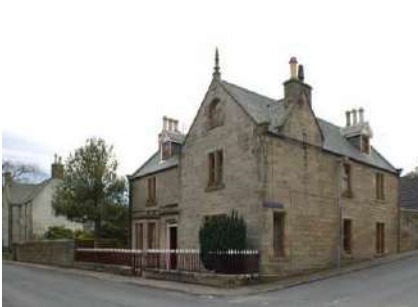
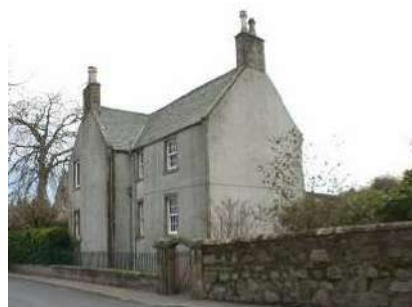
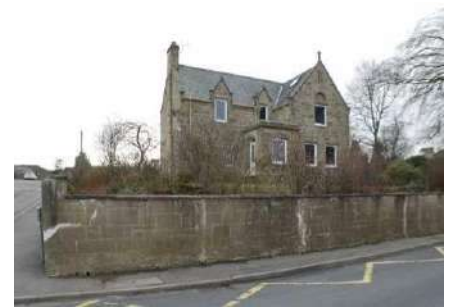
Beyond Knockbreck Street the character changes markedly. The corner house (which marks the current limit of the conservation area) and the third house are substantial later Victorian villas in large plots while the middle house (middle photo below, shown as Sturton Place on the 1878 map) is earlier, although not on the 1832 plan. The Victorian villas have features in common with ‘Murrayfield’ opposite the Episcopal Church in Manse Street and reflect the prosperity and confidence of Tain in the later 19<sup>th</sup> century.

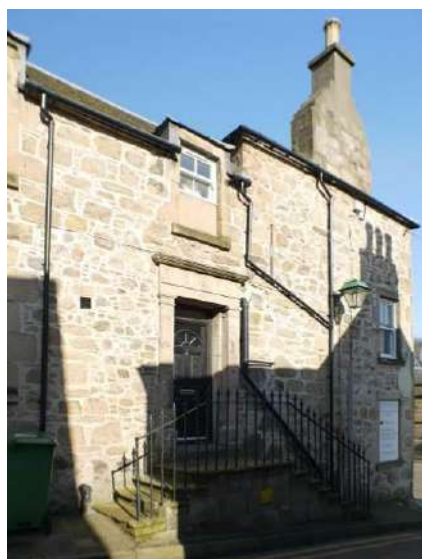
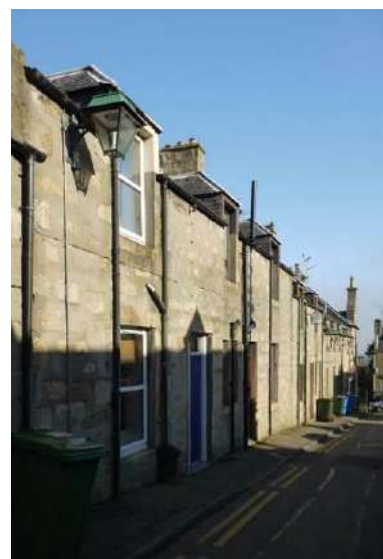
Although Ross Street appears to fit in with the planned expansion to the south east and is the first street encountered, it is much narrower than the grid of streets starting with Geanies Street and may owe its origins to the bridging of the Polcalk Burn in 1788. At the south end, the right angled turn in the street is to accommodate cottages that actually face south onto a courtyard behind the Carnegie Library and may pre-date Ross Street. At the north end the three storey corner building handles well the transition in scale from Lamington street into Ross Street and the change in level is dealt with by an elegant forestair and railings serving the aediculed front door.

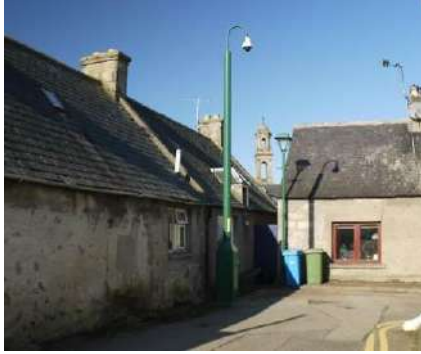
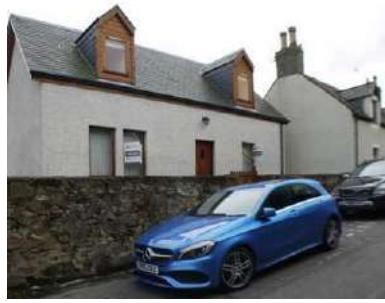
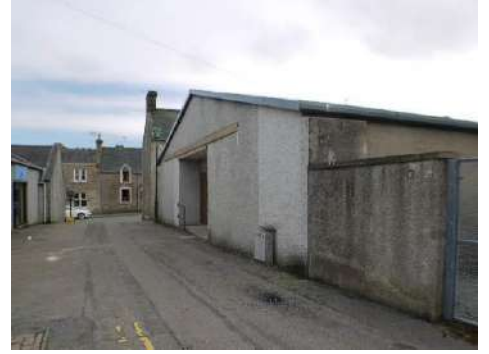
Unfortunately the east side of the street is a mixture of gaps, workshops and cottages. The corner cottage (at the south end) is a traditional one and a half storey 19<sup>th</sup> century cottage with dormered first floor windows while its neighbour is a modern pastiche.

The eastern leg of Ross Street accommodates sheds, a sub-station and gardens and is very much a 'backlands' area with none of the character of the built-up streets.

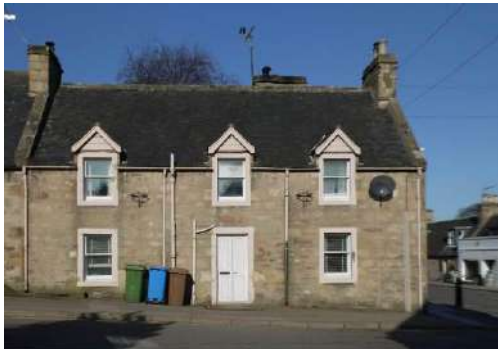
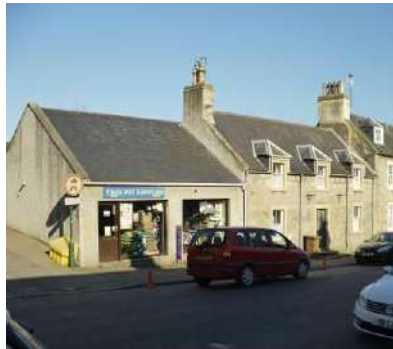
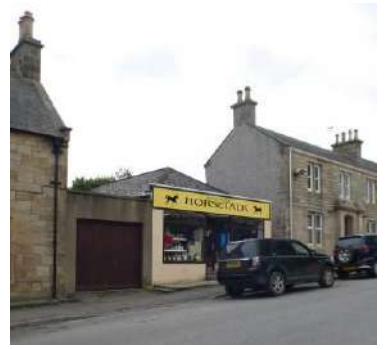
Geanies Street forms the core of the grid of streets set out in the early 19<sup>th</sup> century. Many of the plots are shown in the listing notes as having been feud out in 1827 and the purchasers seemed to cover a broad social spectrum, clearly with different ambitions and resources. For example, no. 5, left, B-listed is noted as “Site feud by Mr Daniel Ross of London, 1827 - map of Newton of Tain Macleod Esq of Geannies”. While the smaller house with dormers (bottom left) is perhaps more typical. The west side of Geanies Street is shown developed by 1832, although there is an unfortunate more recent shop on the corner of Ross Street, while there are significant gaps on the east side including towards the north end where the large garden of View Place and more recent shop (below right) break up the street frontage to some extent.

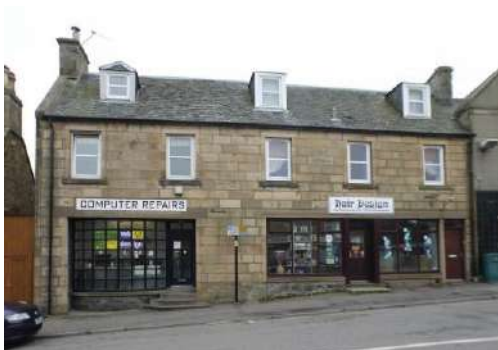
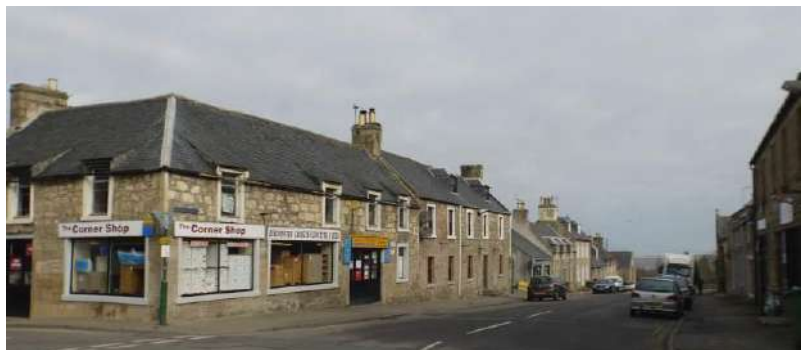
The top (south end) of the street has continuous frontages and with a few shops and the gable of quite a substantial elegantly designed corner building, fronting onto Stafford Street but with a splayed corner. Unfortunately the ground floor has been altered and tiled in black.

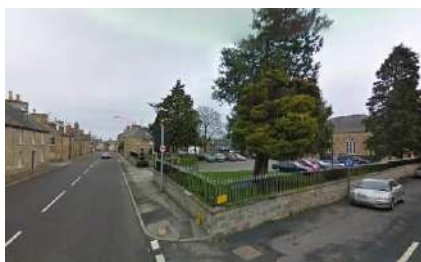
The next block is entirely taken up with the frontage of the former parish church, now the St Duthac's centre. Built in 1811-15 to a design by James Smith of Inverness (who also designed the Academy) it was intended to be seen, like the Academy, in the setting of extensive grounds. It is B-listed and described as "*Late Georgian Gothick ..... piended slate roof. Modern harled additions; modern Fife stone porch to Shandwick Street. Low coped rubble wall with cast-iron spearhead railings; quadrant walls and gates to Stafford Street*

The building and its grounds are important elements in defining the character of the south eastern suburb. They give status and gravitas in a way the smaller scale terraces of houses lack and, as noted, the presence of the church would have been a strong draw to those considering taking a feu in the area.

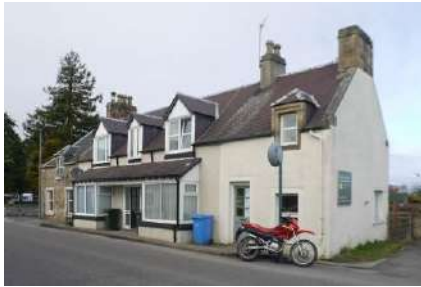
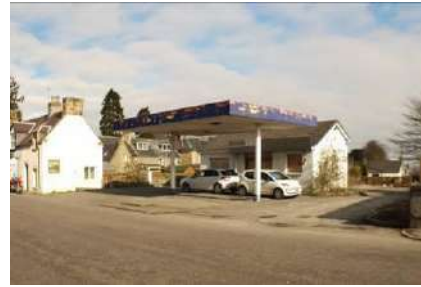
On the north side three cottages, one with more recent alterations terminate the conservation area. Unfortunately the bay window and link roof extension and the altered dormers are out of character with the building. The cottages are shown on the 1832 plan.
