## HIGHLAND COUNCIL

**Committee:** Easter Ross Committee

**Report Title:** *Draft Tain Conservation Area Appraisal and Conservation Area Management Plan*

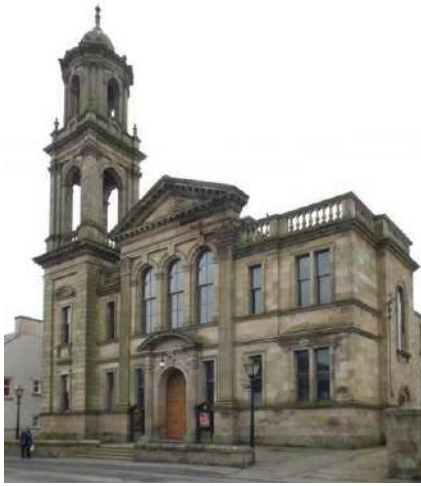
Built as Tain Free Church, now Church of Scotland, this B listed, Italianate building was designed by Andrew Maitland and Sons, and built in 1891/92. It is described as *"Ashlar frontage, dressed and coursed rubble*

*flanks and rear, polished ashlar dressings. Rectangular church with ornate pedimented 7 bay north frontage to Queen Street with tall open campanile at NE angle. 3 centre bays flanked by giant fluted pilasters supporting entablature and pediment. Wide centre entrance flanked by ionic columns supporting segmental pediment”.*

The building has the scale of one of the large urban churches in Edinburgh or Glasgow and was clearly built to have a striking presence in Tain. Perhaps it was anticipated that larger scale development might follow in the immediate area. The building at the top of King Street (thought also to be Andrew Maitland & Sons) suggests how this might have begun to take place. However, the buildings adjoining the church and lining the street opposite are small scale and quite undistinguished while the modern flats immediately adjacent to the east are particularly bland. Queen Street itself is narrow and the setting of the church suffers from a lack of public space in front. In fact the only sizeable open space is the car park diagonally across the road, shown on the 1878 Town Plan as garden. While allowing the church to be seen from a little distance, the space does not contribute to the setting of the church and somewhat takes away from any aspirations to urban development at this location.

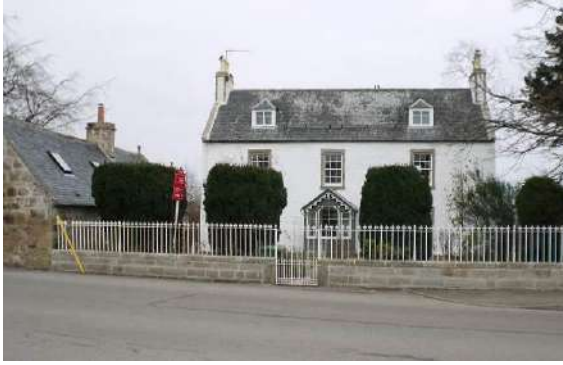
The most significant of these is the former manse, B-listed and described in some detail as: *“built by local tradesmen led by Alexander Stronach in 1719-20, repaired in 1820-22 and altered later in the 19th century, 2 storey and attic house 3 bays with middle bay slightly off-centre. Harled, ashlar margins; later 19th century bargeboarded porch screening door with lozenge glazed fanlight. 12-pane glazing; 2 piended dormers; ashlar margined end stacks; slate roof. Single storey stable block with gable to street; rubble; ridge stack; apex ball finials; slate roof. Low coped retaining wall with cast-iron spearhead railings and matching pedestrian gate. Later channelled gatepiers with moulded cornice and square caps; coped rubble garden walls”*. Manse House was studied as part of the Scotland’s Urban Past Project.

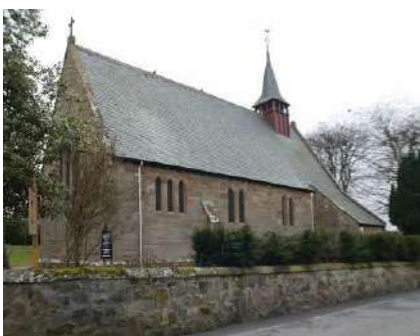
Across the street, the B-listed St Andrew’s Episcopal Church forms a fine termination to the view west along Manse Street. The first building was an iron church built in 1880-81, replaced in 1887 by St Andrew’s Episcopal Church designed by Ross & Macbeth.

The building forms a simple 4 bay rectangular church orientated east/west with lancet windows and good quality detailing, including a small timber louvred ridge bellcote with small faceted and bellcast spire and apex cross finials.

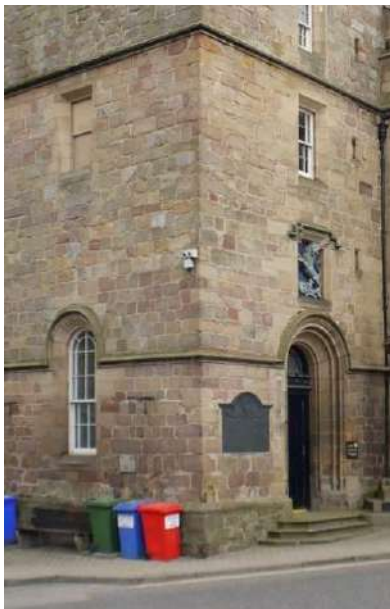
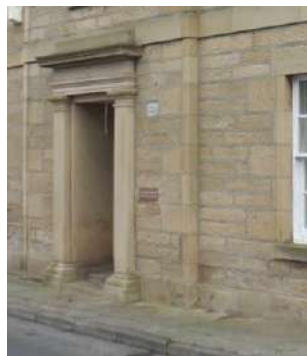
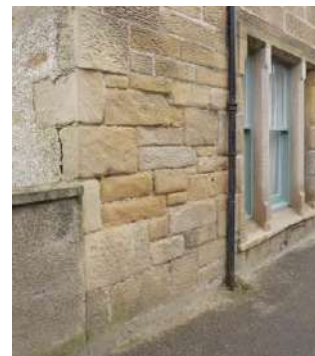
Tain was fortunate to have a local source of good quality stone, the sandstone from the local quarry proving durable and an attractive golden buff colour that has mellowed over time. Many buildings are well finished and finely dressed, with good carved detail, as these examples over 100 years apart illustrate.

Unfortunately the stone is not immune to erosion and some buildings show a degree of decay, those in range of the road salting vehicles suffering quite severely at ground level while leaking downpipes is another common cause of decay.

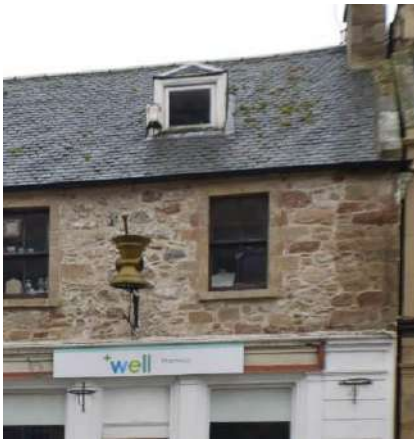
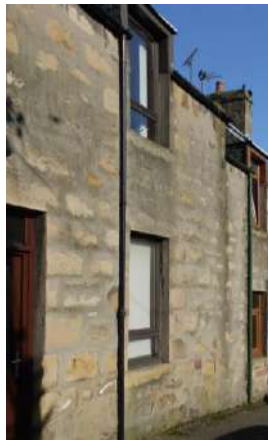
Dressed stone was expensive and the more modest earlier buildings often used rubble for general walling, saving dressed stone for architectural details such as window rybats. There is also a reference to the houses in the early expansion to the south east being built of stone and clay. These were probably originally 'slaister pointed,' ie. with lime mortar spread widely across joints. Recent techniques include unsatisfactory hard cement-based pointing, although there are several examples of well executed lime mortar pointing (far left).

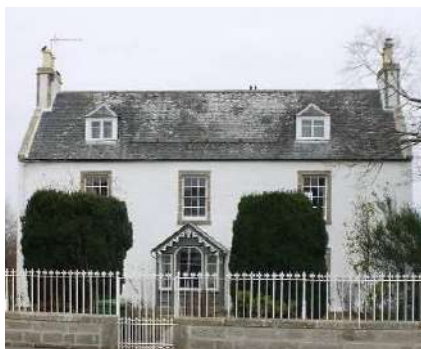
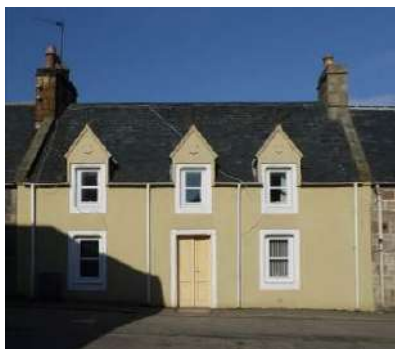
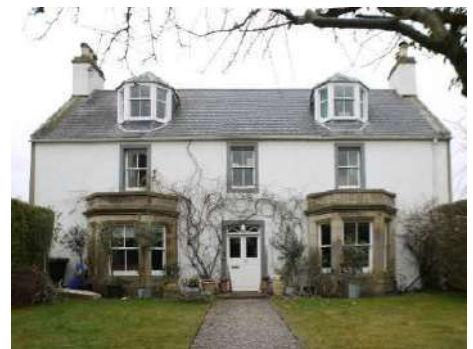
Although in the minority overall, there are many examples of harled (rough textured) or rendered (smoother finish) buildings in Tain. Lime render, by its nature tends to decay over time and coatings, in most cases are likely to have been replaced. Some buildings may have started life with rubble walls and then been harled or rendered. Harling was occasionally used as a solution to a poorly constructed wall that was deteriorating or might have been allowing damp to penetrate. 23-24 High Street is an example with a dressed ashlar frontage but modern harling to the gable and rear (and also alien hard cement ribbon pointing). Painted cement-based wet dash harling became the norm in the latter half of the 20<sup>th</sup> century and some quite old buildings have modern harling or render. Lime based traditional harls or renders have made a comeback over the last twenty years or so but require a knowledge of traditional building methods that relatively few contractors possess. To determine the authenticity requires a detailed examination of each building.

5 St Duthus Street (above, right) is an interesting example of a substantial villa (B-listed) from the early 19<sup>th</sup> century that is harled (with painted window margins) but the later 19<sup>th</sup> century alterations include imposing ashlar canted bay windows.

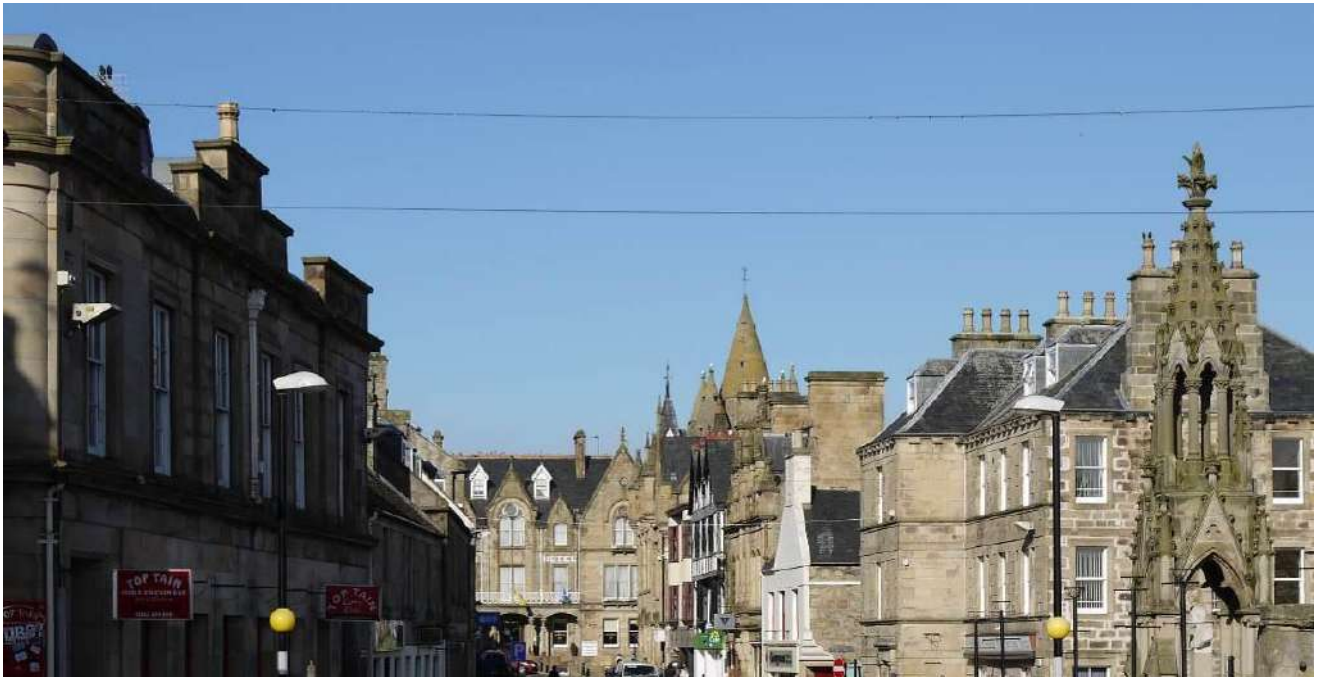
Chimneys are an important element of the skyline and townscape generally and fortunately the good quality stone seems to have meant that the majority have survived. Chimneys tend to follow the walling below ie. ashlar on ashlar buildings, harled on harled buildings, although with some variations, and are well illustrated in the preceding photographs. Most in Tain are end gable stacks but the larger buildings often have additional ridge stacks, as seen in the general view below.

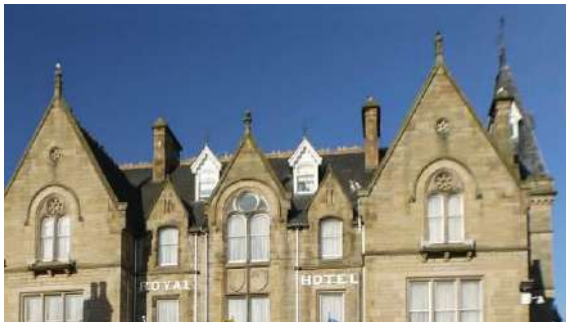
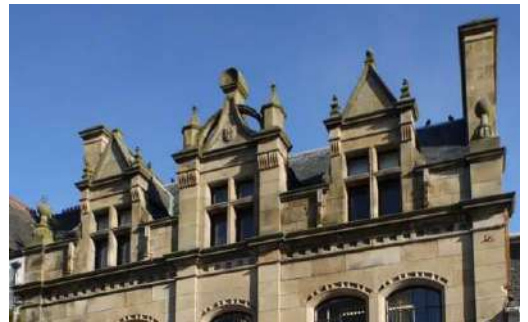
**Gables** (usually the end of a building or wing of a building) and **gablets** (usually over a single window or pair of windows) are an important feature in Tain. Many of the more modest houses are two-storey but with a coombed first floor and dormer windows rising through the eaves, sometimes with a piended slate roof (far left) but often with a bolder gablet, such as in Hartfield Street, left (sadly with a modern window). As the 19<sup>th</sup> century progressed details became more elaborate, for example to include finials, skewputs and chamfered window margins (below left), with some of the more commercial buildings having elaborate rooflines, perhaps taken to extremes with the examples below from Andrew Maitland's office.

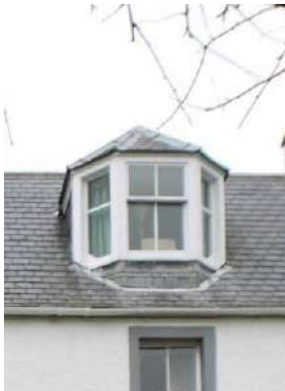
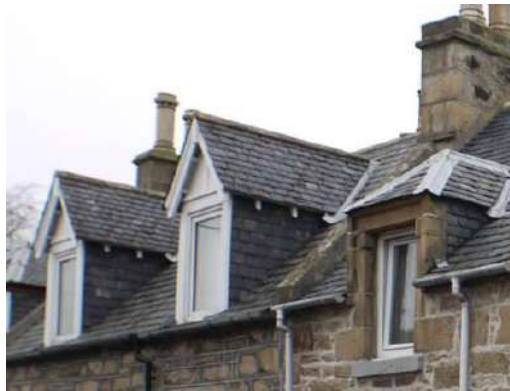
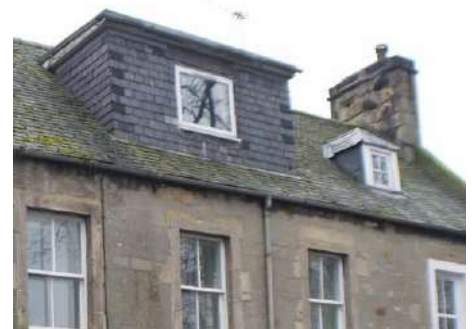
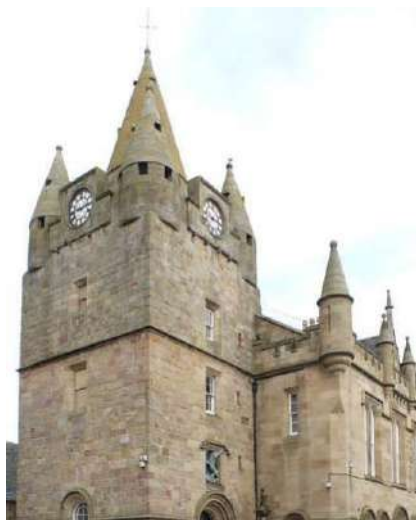
**Dormer windows** also tended to start at a modest scale in the earlier buildings, but by the mid-19<sup>th</sup> century larger, canted bay windows became popular (giving more space and light to the attic room), while gabled versions perhaps gave more expression to the building. Andrew Maitland's Royal Hotel has small roof dormers set behind the prominent gablets (such small dormers set into a roof pitch, often on spires or towers are referred to as lucarnes). Sadly, demand for space and lack of historical sensitivity in the 20<sup>th</sup> century, resulted in box dormers becoming a way to create space. These are quite unsympathetic in the context of historic buildings and in many cases spoil an otherwise good original building. The example from Academy Street (below, right) shows the leap from one end of the spectrum to the other on one roof.

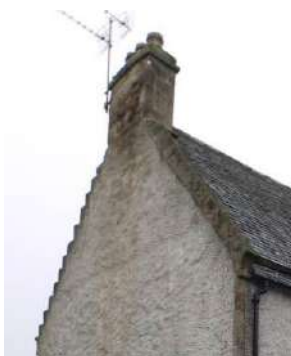
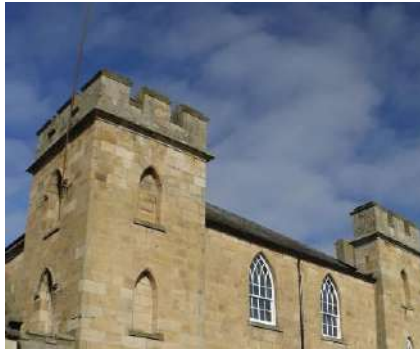
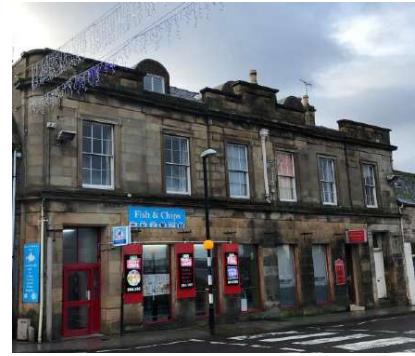
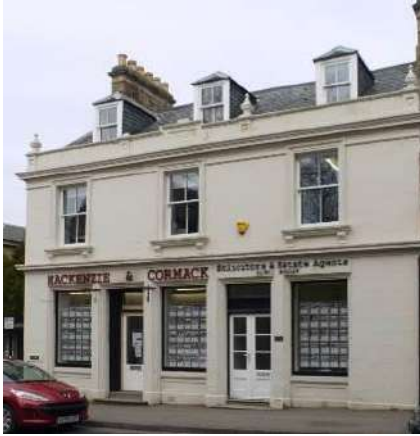
In terms of earlier details, there are few examples of crowstepped gables – this one in Tower Street (below, left) and the St Duthus Hotel opposite surviving from the earlier to mid-18<sup>th</sup> century.

In the early 19<sup>th</sup> century, architectural features were relatively restrained. The former parish church sports late Georgian 'Gothick' battlements to go with the Gothic windows below. 1-5 Lamington Street has raised square parapets, no doubt intended to give a more imposing presence.

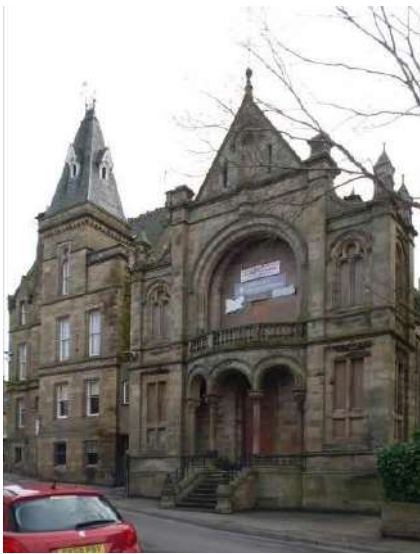
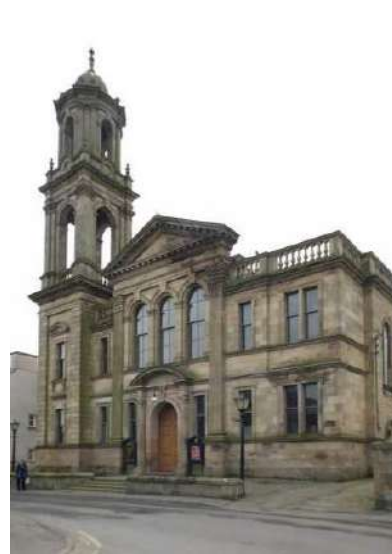
The 1860, B-listed, 16-18 Tower Street takes this a step further and perhaps marks the transition to a more decorative style with the parapet and finials topping a neatly designed façade. By the later 19<sup>th</sup> century increased prosperity and greater architectural ambition appears to have led Andrew Maitland & Sons to experiment with different historical styles. The tower and spire of the Royal Hotel (1872) is relatively plain while next door the 1874-76 former Town Hall takes off with an elaborate, very free, renaissance elevation with a wonderful mix of features. By 1891/92 Andrew Maitland & Sons designed the building that most altered the skyline and existing scale of Tain, the Italianate Queen Street Church. This has an imposing frontage and very tall tower, the tallest structure in Tain to this day and now a more significant landmark than the Tolbooth. The fleche/bellecote on the Ross & Macbeth Episcopal church seems excessively modest by comparison.

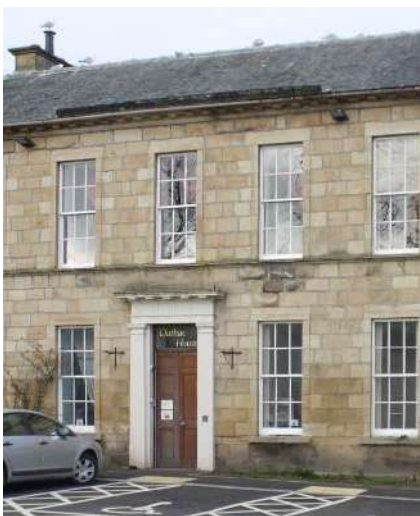
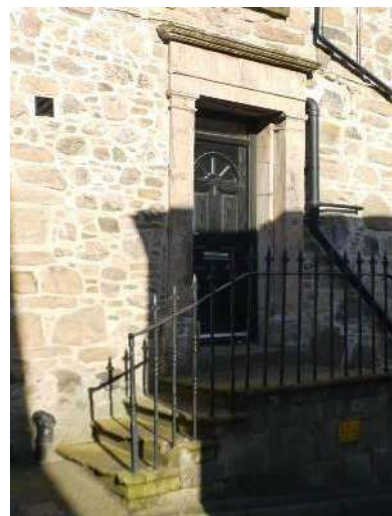
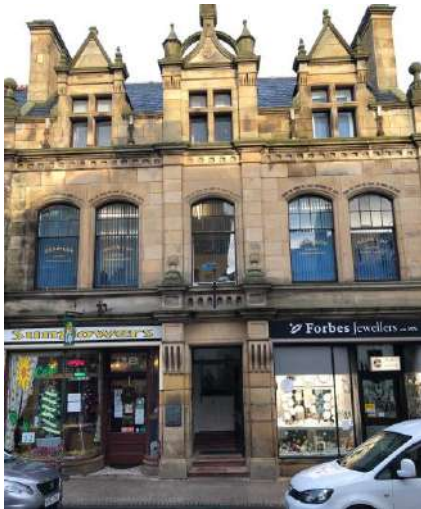
Late Georgian buildings showed restraint, owing more to regular composition and proportion than detail; however, elements such as door surrounds gave the opportunity for neat classical aedicules, as below.

The example near left, in Ross Street has a neatly designed forestair, one of a few in Tain. 16-18 Tower Street, illustrated above, shows the transition to a more elaborate type of detailing with projecting cills supported by corbels, prominent cornice and string course and moulded architraves to the windows. The shopfront openings and stallrisers are also carefully detailed. This kind of detail is seen in many of the earlier 19<sup>th</sup> century shopfronts (see below).

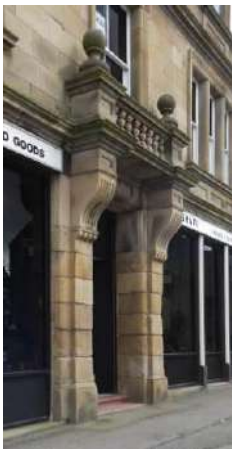
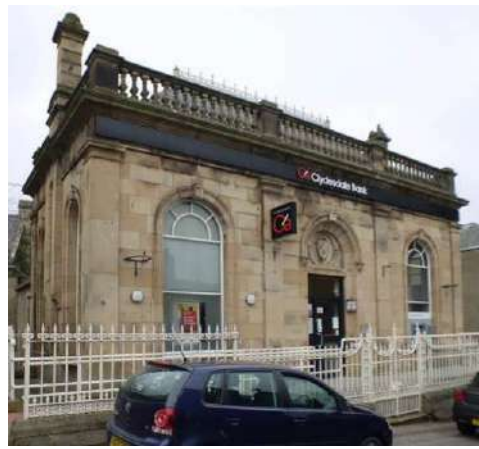
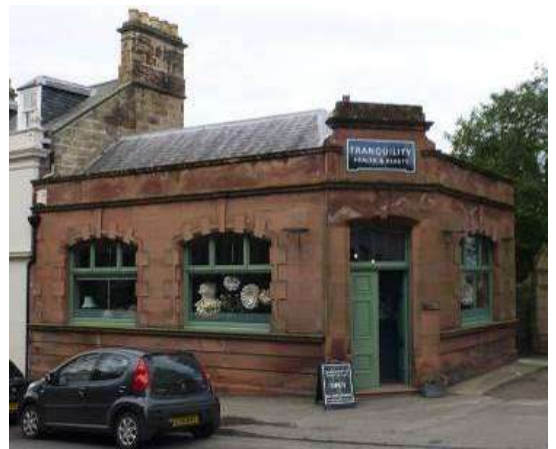
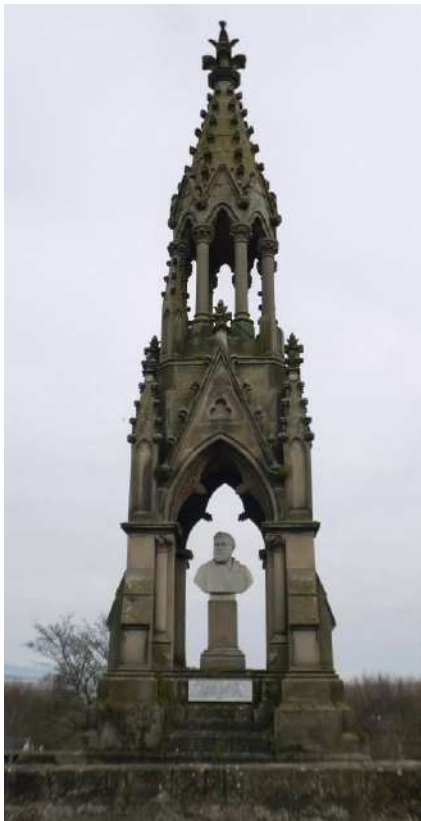
By the later 19<sup>th</sup> century, as noted above, flamboyance increased, perhaps typified by Andrew Maitland & Sons 1897 French Renaissance, B-listed, 18 High Street, designed in a 'free Renaissance' style, with architectural features expressed at every opportunity. The massive doorpiece is repeated (with modest changes) at the otherwise more restrained version of the building at the top of King Street (photograph below, left). The slightly earlier 1878 former North of Scotland Bank, also B-listed and by Andrew Maitland & Sons also has a great richness of architectural features including balustrade and cornice, pilasters and moulded arched and keystone window architraves, arched over-door with crest in roundel as well as good quality ironwork to the ridge crest and railings. The modest commercial building at 20 Tower Street is notable in being the only red sandstone building in the town centre and is neatly detailed with rusticated arches to the windows.

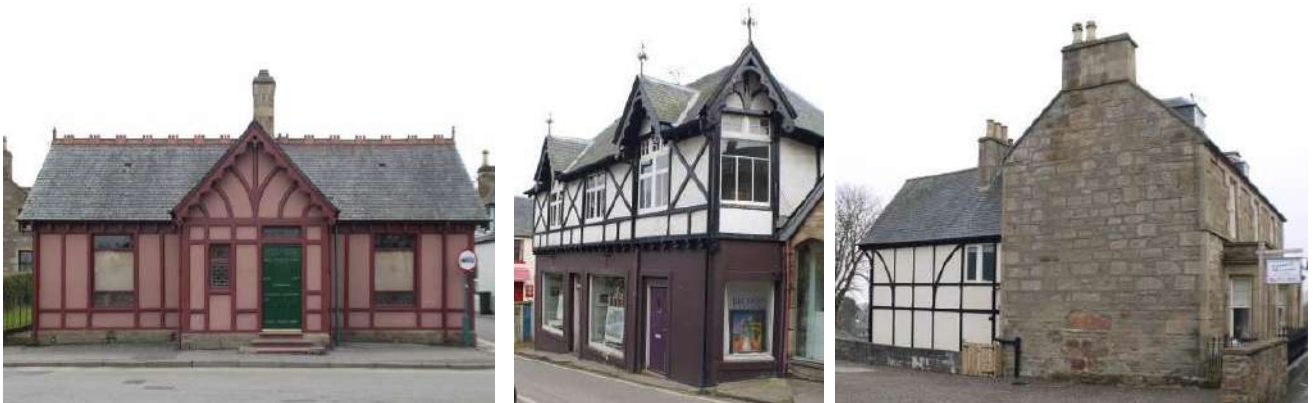
There are four examples of mock Tudor buildings in Tain including the former office of Andrew Maitland and Sons (below, left) built in 1893-94 and described in the list description as “cottage-sized building in Maitland's distinctive picturesque style, with decorative barge-boards and timber-framed, painted walls, slated roofs with deep eaves and red ridge-tiles”. It is assumed that the other buildings are from the same hand.

The Co-operative building contrasts significantly with all the other High Street buildings, despite their great variation in period and style. The Castle Brae building is a less assertive oddity while the extension to the mid-19<sup>th</sup> century Shandwick House, right, is a marked collision of styles. Perhaps this imported style can best be viewed as evidence that Tain looked well beyond the local when adding to its built environment.

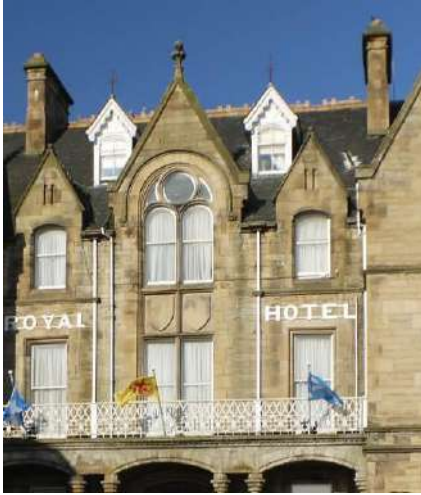
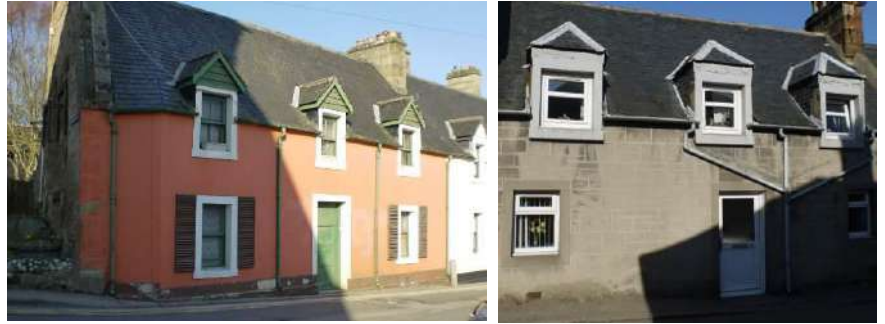
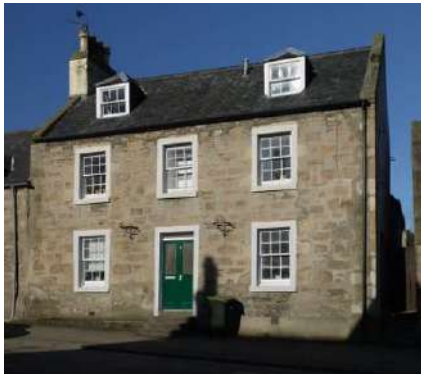
Ridges are often capped with stone (sometimes later replaced with plain fireclay ridge cappings) or lead (often replaced with zinc). A few buildings, usually later, have decorative clay ridge cappings and finials (eg the Carnegie Library and Royal Hotel) and the bank building in Market Street has decorative ironwork on its ridge. There are occasional wrought iron finials (as on the dormers to the Royal Hotel).

Valleys flashings and hip flashings are traditionally lead, although some

replacement with less durable zinc has taken place.

Rainwater goods are traditionally cast iron, usually simple half round beaded gutters and circular downpipes, but sometimes on later buildings more elaborate, with OG profile gutters and, as at the Royal Hotel, square downpipes worked into the architectural detailing. Unfortunately there are several examples of later PVC replacements.

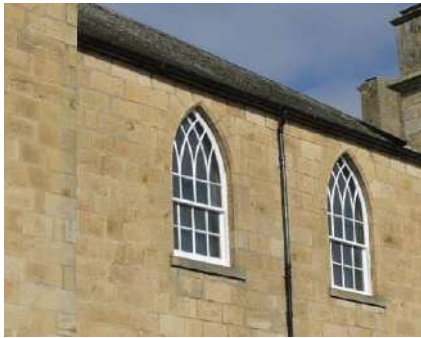
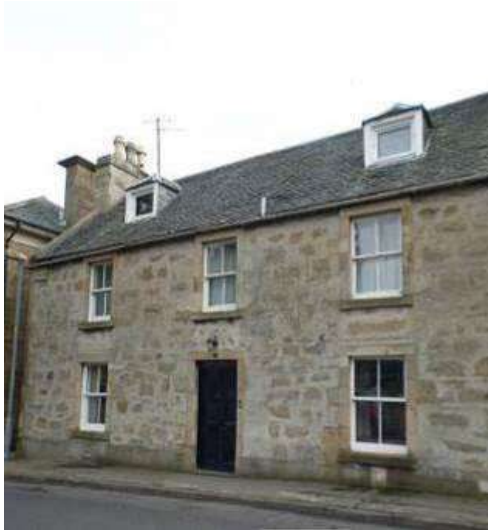
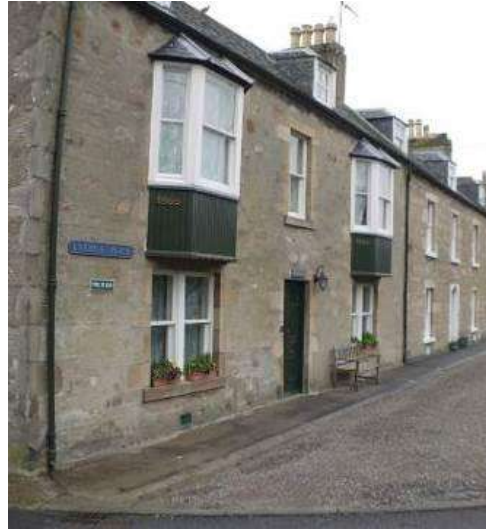
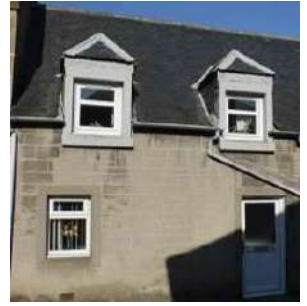
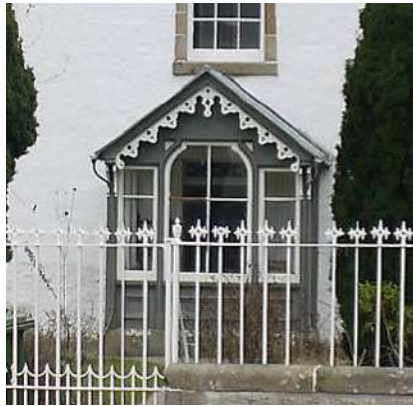
**Windows and doors** are clearly major elements in defining the character of individual buildings. Late Georgian buildings usually had astragalled windows, due mainly to limitations in glass size, as seen in the example, left, at 5 Geanies Street, as well as the Academy, former parish church and manse in Manse Street. Relatively few examples survive. By about 1840 plate glass became far more common as improved methods of manufacture made it less expensive and by the mid-century most sashes either had only a single, central glazing bar, or none at all. Some of the early 19<sup>th</sup> century houses, where small pane windows might be expected, have what appear to be later 4-pane windows. As building continued in the mid-19<sup>th</sup> century many houses will have original 4-pane, sash and case windows. Many houses had openings enlarged (presumably to admit more light) often destroying the original 3-bay proportions of the elevation, and the example of the 19<sup>th</sup> century addition of oriel windows and larger ground floor windows in the house in Esther Place contrast with the original composition seen next door. Sadly, the trend to replace windows in non-historical manner became prevalent from the late 20<sup>th</sup> century onwards and there are many crass examples of oddly proportioned windows, sometimes not even fitting original opening sizes (below, extreme right).

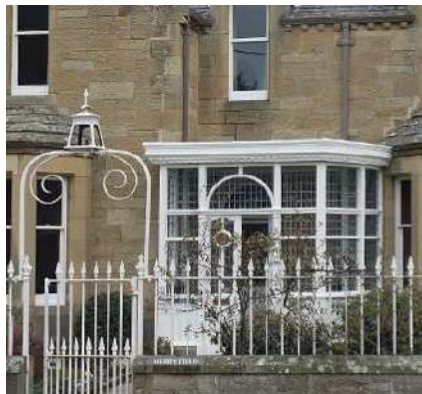
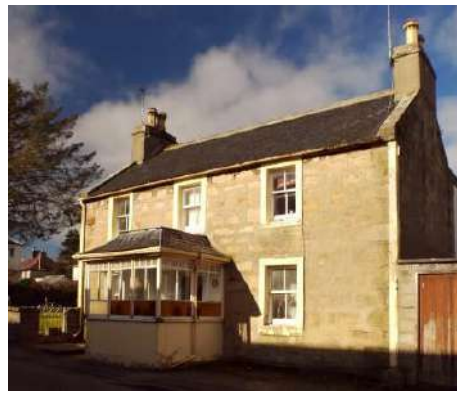
A relatively small number of buildings have porches, almost all of which appear to be later additions and built in the style of the period they were added, for example the late Georgian manse in Manse Street has a nicely detailed Victorian porch while 'Murrayfield' (also in Manse Street) appears to have an Edwardian porch that is well detailed but collides with the original architectural features (below left). Some are somewhat over-sized, such as the example below from Gower Place, which detracts from the simple Georgian proportions of the house. Other examples, such as in Shandwick Street and Stafford Street, bottom, quite change the appearance of the buildings.

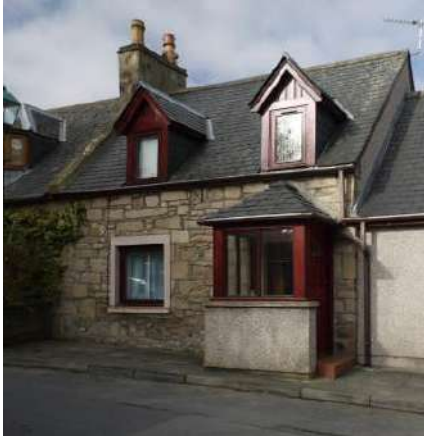
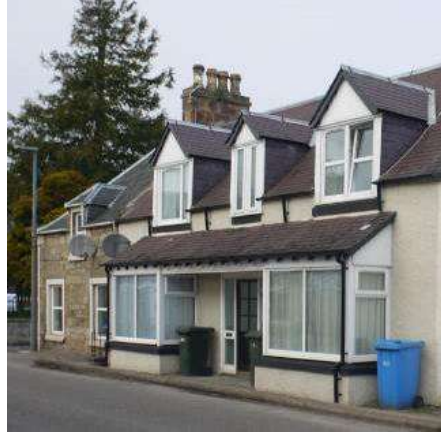
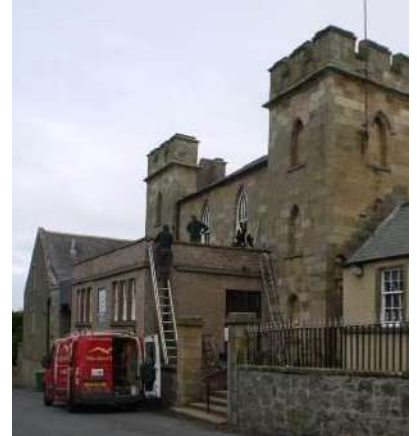
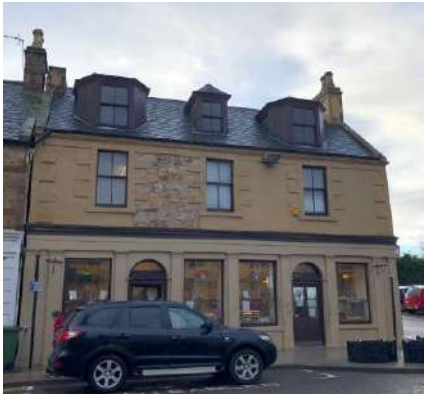
Perhaps one of the worst examples is the large porch/entrance built on the Shandwick Street side of the former parish church. It is of an alien Fyfestone construction and masks the original elevation.

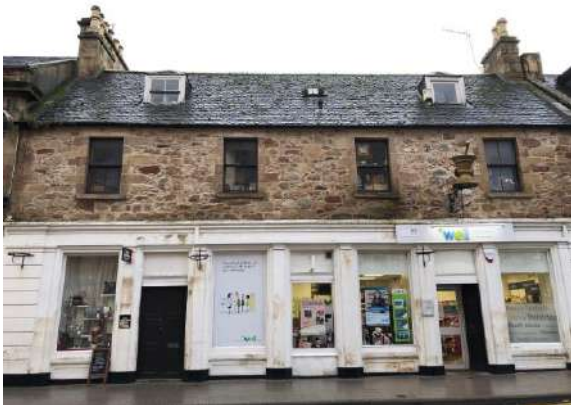
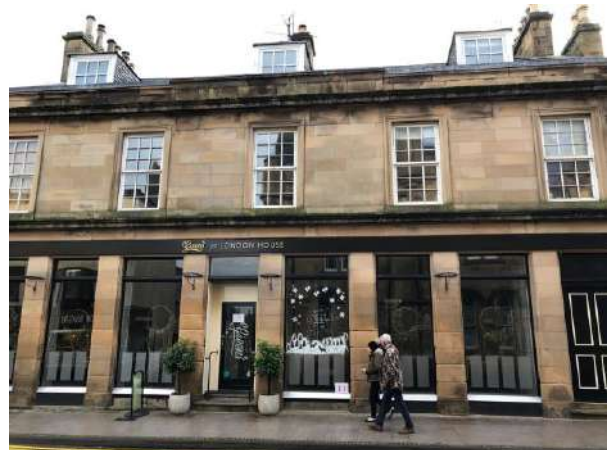
Tain has a better-preserved complement of traditional shopfronts than most other Scottish towns and is fortunate that so many survive in ways that are recognisably close to the original. Earlier shopfronts, such as those between 1 and 9 High Street appear to have been built as commercial enterprises with dwellings above and have fairly massive stone piers between modestly sized windows. 1-3 has arched door openings and pilasters between openings, doubled at each end while 5-9, though similar, has rusticated piers at each end and rectangular doorways. No doubt the original windows had some form of astragals and doors have also been changed. Signage is modest and overall the character of the original is evident. The late 1840s shop at 11-15 is also a good example of its period, retaining opening sizes and the neat signage fitting in well with the architectural composition.

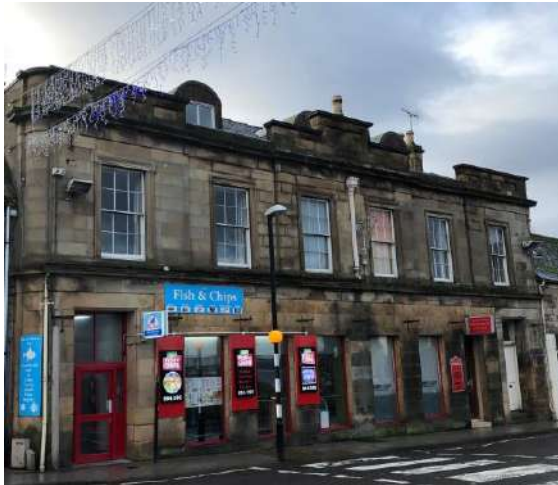
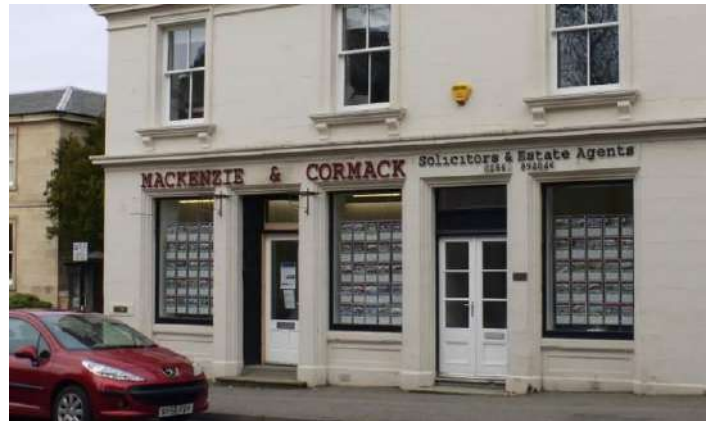
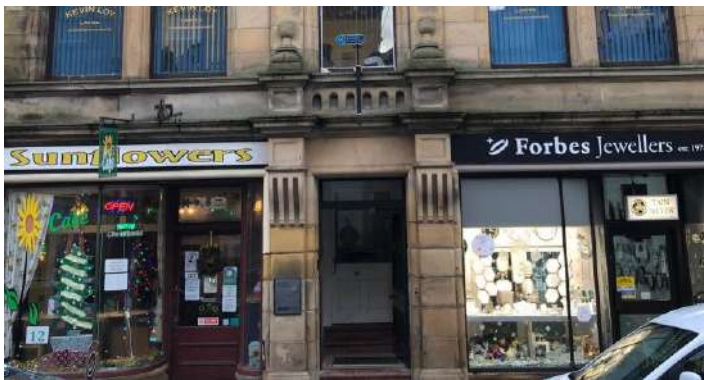
1-5 Lamington Street is in a similar vein while 16-18 Tower Street is also a good example of a mid-19<sup>th</sup> century shopfront.

Later designs took advantage of larger sizes of plate glass as at 18 High Street. Detailing was very much part of the architectural composition of the whole building with space allowed for signage. The frontage of each shop has thin iron glazing mullions, stone stall risers and recessed doorways and are good examples of their period.

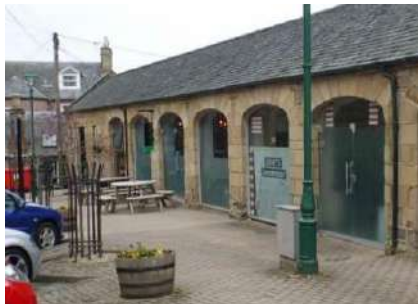
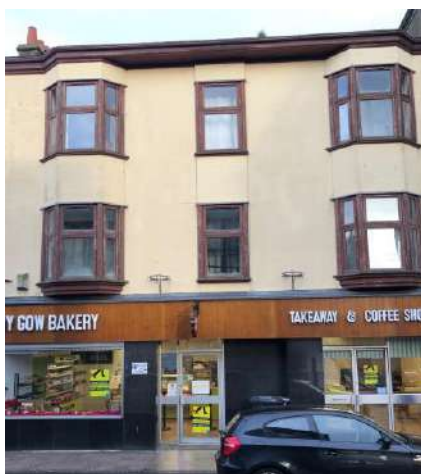
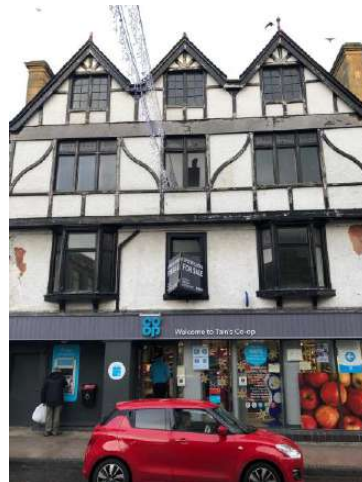
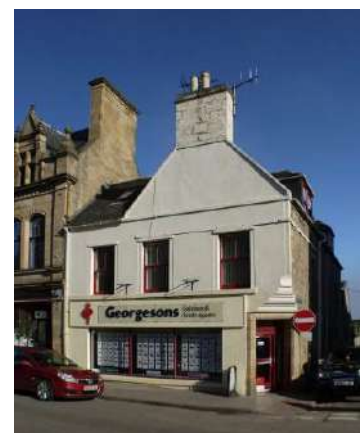
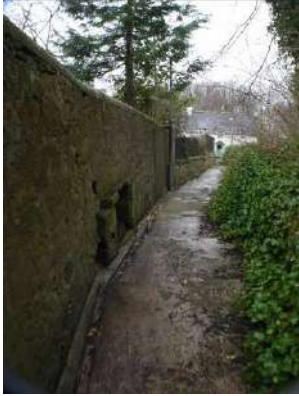
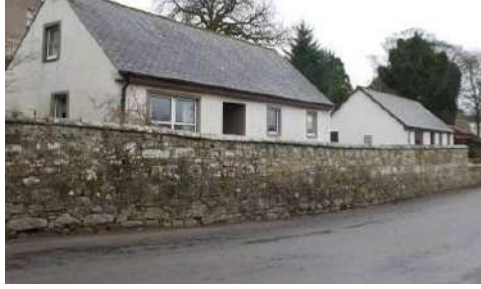
Some buildings have undergone recent upgrading to become contemporary commercial premises. Two good examples (in Market Street and Castle Brae) show that simple detailing that retains the architectural integrity of the historic structure can work well, allowing the original building to be 'read' as such. Where the original architecture is ignored and large openings created or large-scale signage sweeps across whole elevations, masking detail beneath, results are far from satisfactory, as the three examples below demonstrate.

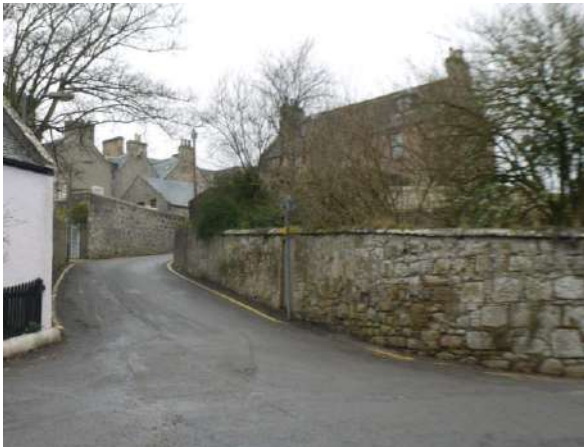
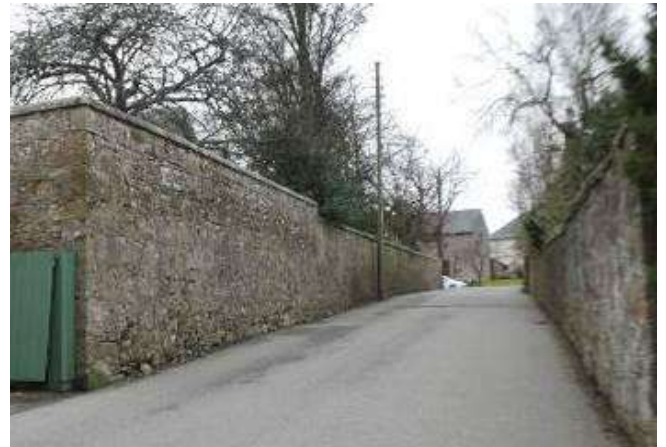
High sandstone boundary walls are characteristic of the secondary streets on the north escarpment. These are traditionally detailed – coursed rubble with inband and outband dressed blocks at the corner (example, left) and half-round dressed copes, many with an overhang, all flush pointed in lime mortar. These walls give a defined sense of enclosure and lend particular character to these streets.

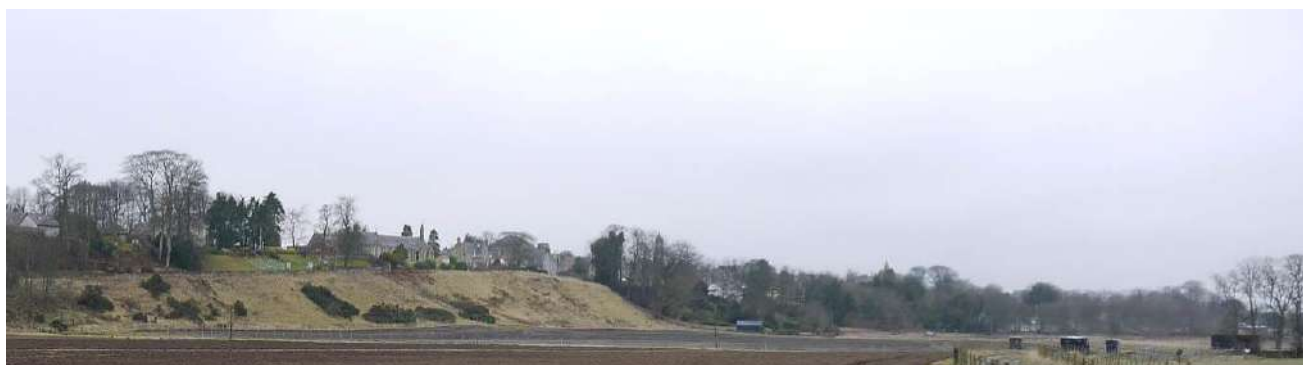
Those buildings near the escarpment relate to the steep slopes with what is now mature tree cover. Initially the principal site in Tain was that of the Parish and Collegiate Churches, while the early 19<sup>th</sup> century original Royal Academy occupies a similar position. This tree cover now runs for most of the length of the escarpment, from the bottom of Murray Street in the north west to the lane just to the south east of Knockbreck Street (the current boundary of the conservation area). Some of the trees are in private gardens. Those around The Grove (Lamington Street) are quite dense.

The wooded escarpment is an important element in relation to the setting and environment of Tain. However, many of the deciduous trees are covered by dense ivy and are possibly nearing the ends of their lifespans. Many seem to be of a similar age, so tree loss would be quite noticeable.

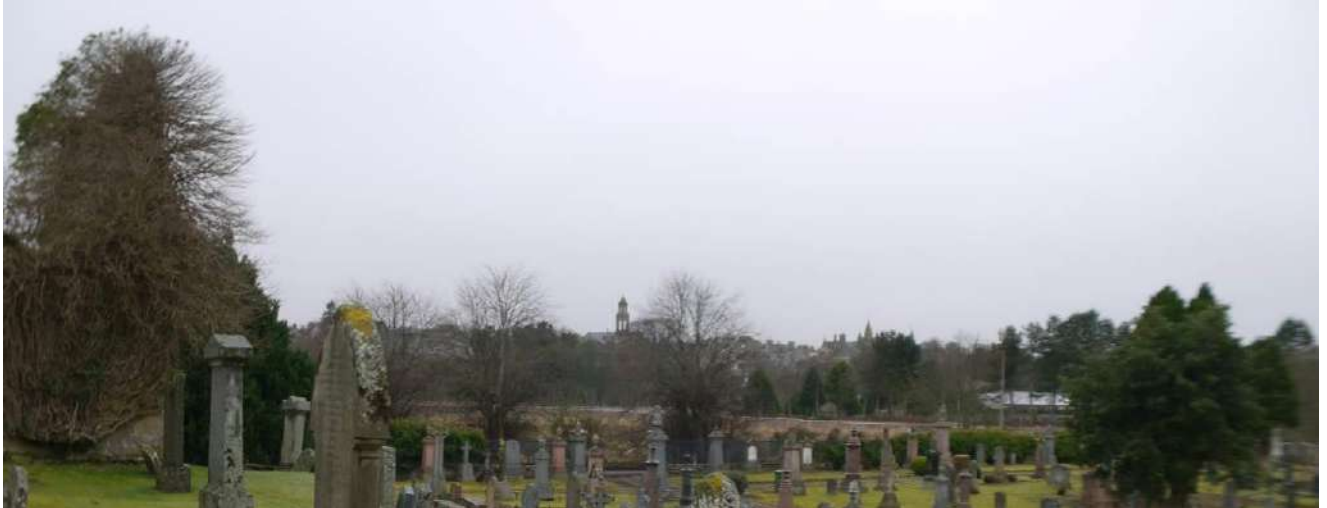
Trees are also an important element of views into Tain conservation area, especially from the St Duthac's Chapel (below). This was not always the case. Clark's engraving of 1828 shows some groups of trees but some stretches of the town have none, in particular, in front of the then new Parish Church and along as far as Lamington Street, a strip now quite densely covered. Many of the trees seen today are likely to be late 19<sup>th</sup> century planting with elements of natural regeneration.

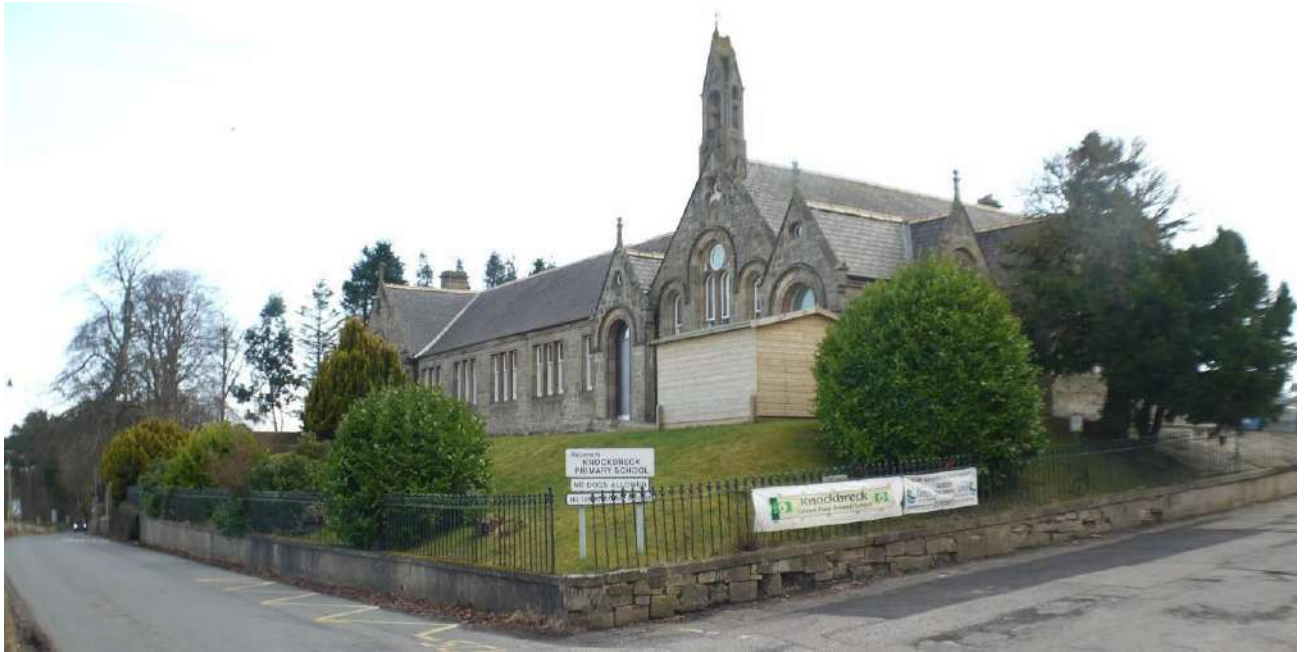
#### **Knockbreck Primary School**

The impact of vegetation, especially non-native evergreen trees and shrubs, on the appearance of Knockbreck Primary School should be carefully considered. The vegetation should be managed and inappropriate or overgrown species gradually replaced with native species at a suitable distance from the building.

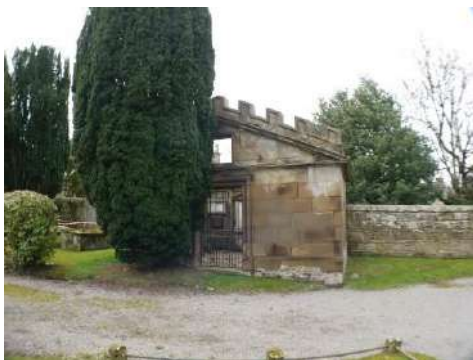
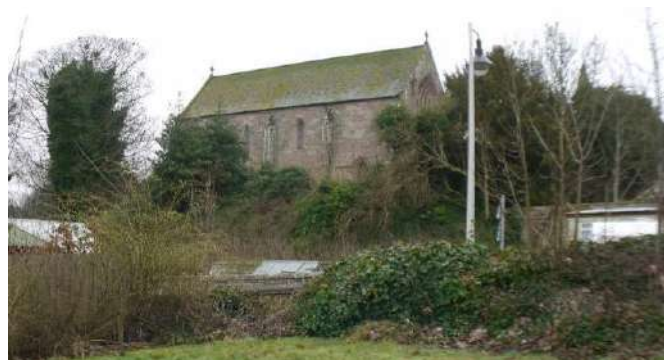
There is heavy tree cover and vegetation on the north slope behind the church and this affects the setting of the scheduled monument (see photo below). The balance between framing the building in a positive way and blocking it from view needs to be managed carefully. At the moment the area appears unmanaged.

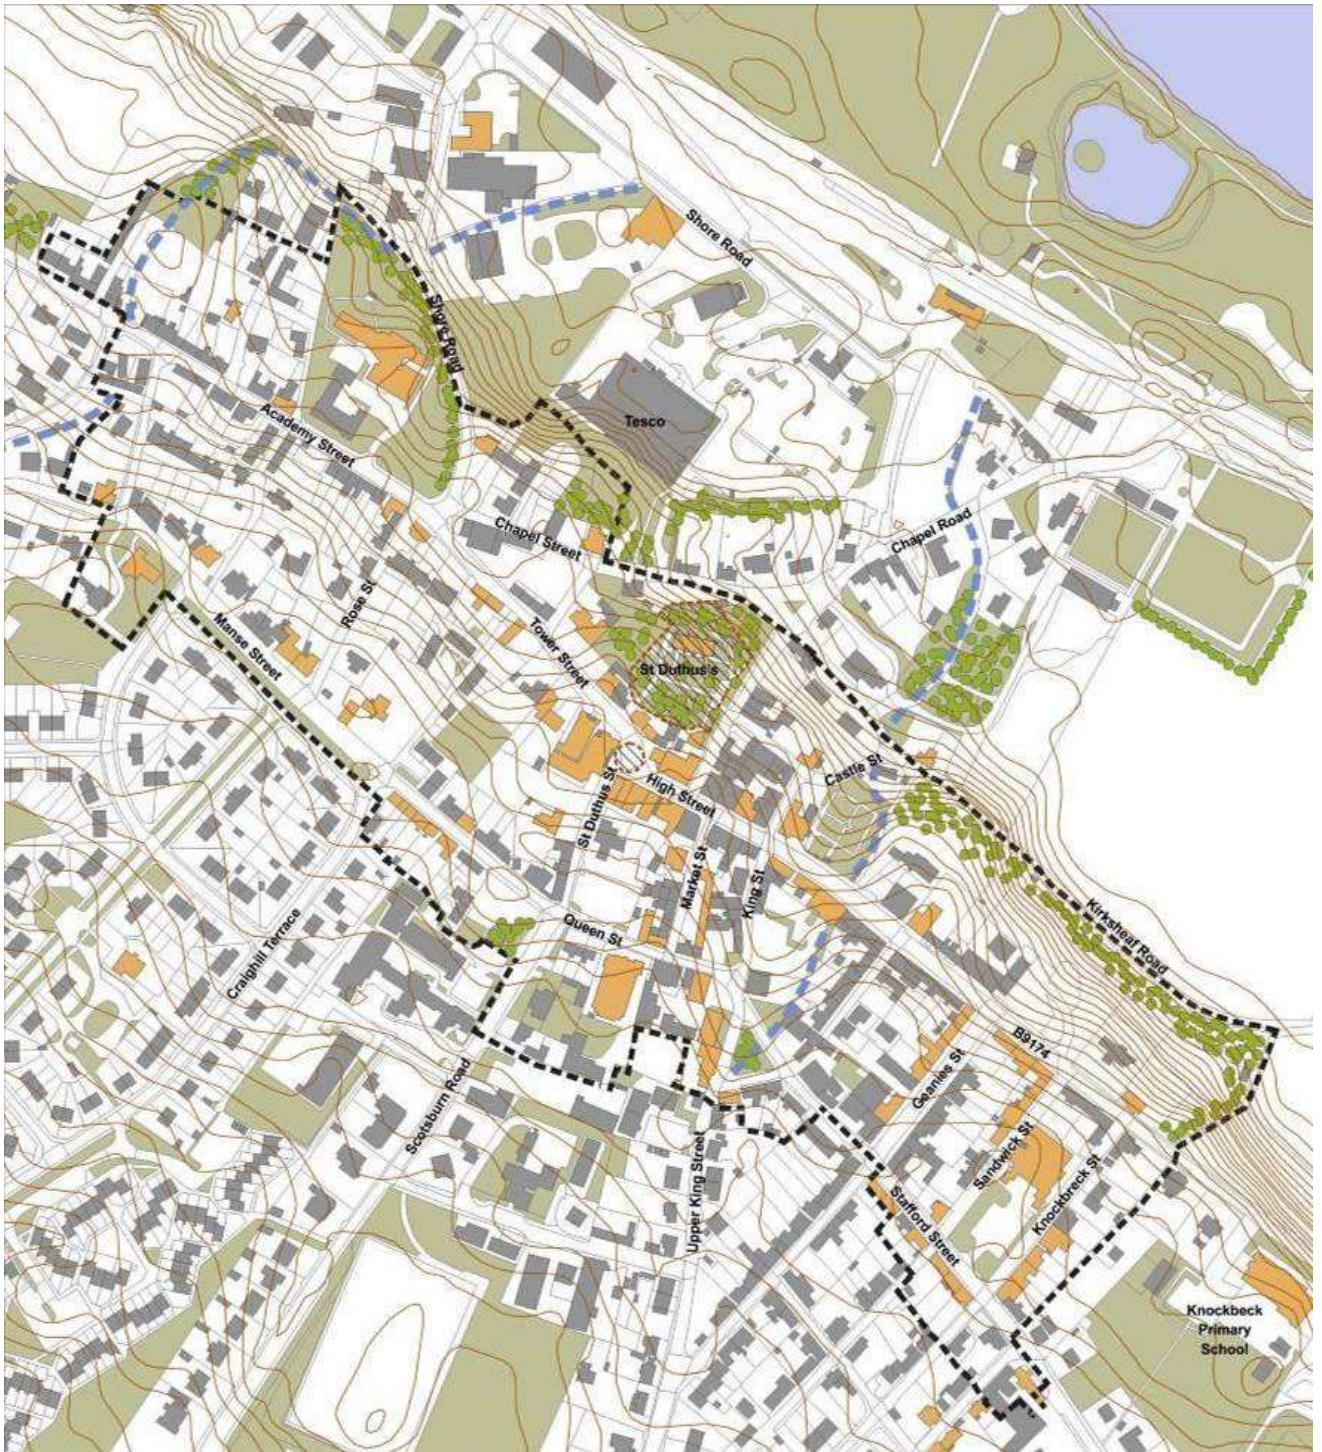
The map below shows significant trees in public spaces. Individual trees or tree groups in gardens are not shown.

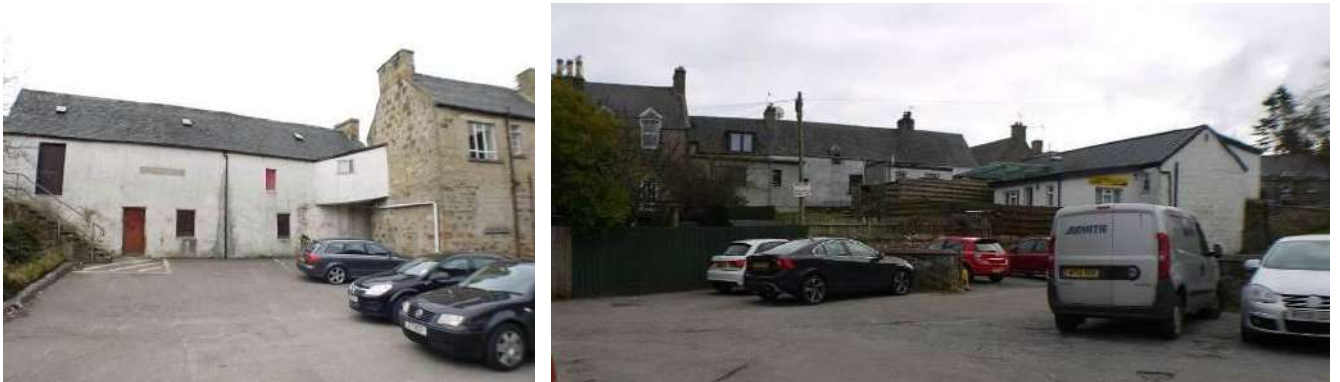
#### King Street

The 1904 plan shows King Street as a narrow street lined with buildings on both sides. Most of the east side has been lost, leaving the commercial building at the south end in incongruous isolation and exposing the rear elevations of Ross Street, Lamington Street and part of the High Street, various gardens and the rear of the modern shed-like building in Cadboll Place. The Polcalk Burn ran through this area, creating

The changes in level and bank of trees help break up the area; however, the King Street frontage is poor and most of the buildings were not designed to be seen from the rear. Efforts are needed to landscape the car park to a higher standard and deal with the untidy area left by the removal of the King Street buildings.
