## HIGHLAND COUNCIL

**Committee:** Easter Ross Committee

**Report Title:** *Draft Tain Conservation Area Appraisal and Conservation Area Management Plan*

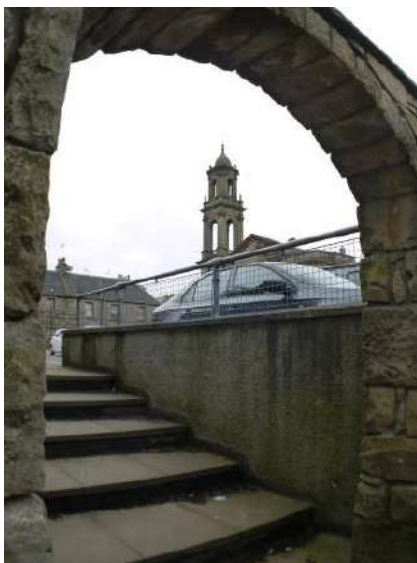
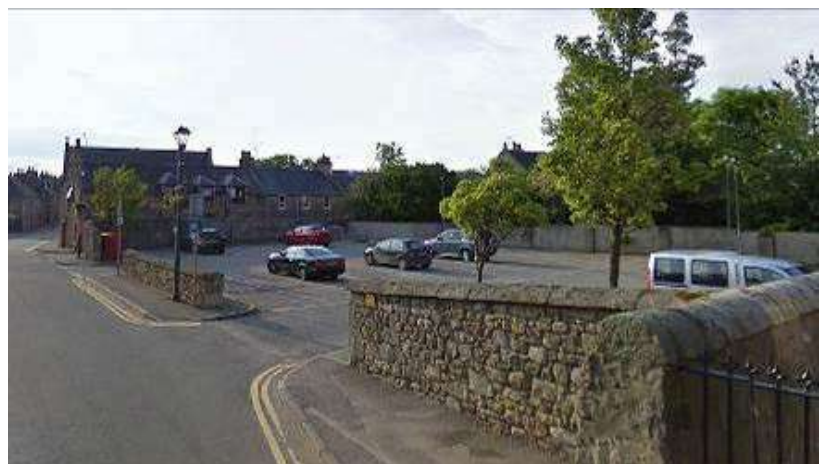
#### **Queen Street**

The 1878 Town Plan shows a large garden. Now a car park, at least some of the wall to Queen Street has been retained but the four trees at the south side (two at each corner) are all by way of landscaping. The situation is saved, to some extent, by the adjoining garden to the north, the trees of which give some definition to this side, and the arch and steps leading from St Duthus Street. Improved soft landscaping might help to restore some sense of the former garden.

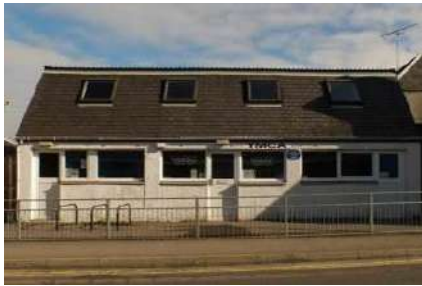
Cadboll Place – historically affected by the Polcalk burn running down through the gap now occupied by the modern shed-like building and by the realignment of Cadboll Place to bring the route from Stafford Street directly across to the junction with King Street/Queen Street, this area is shown with slightly randomly placed buildings on both the 1832 and 1878 maps. The situation could perhaps have been redeemed if the infill building had some architectural merit but the present building and, particularly, its front parking area detract from the urban grain of the street in this important area (which should, ideally, form a decent third side to the triangular open space).

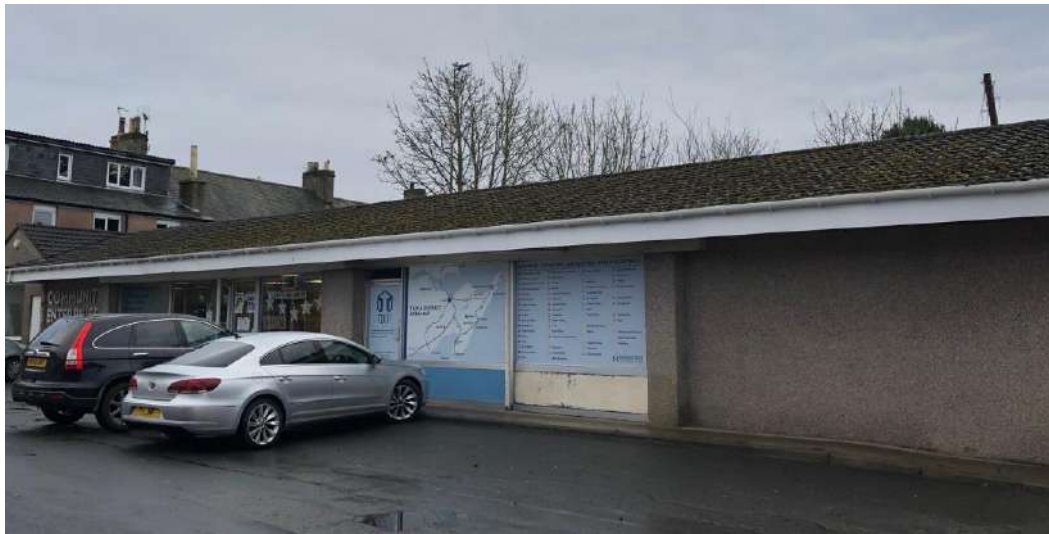
The first section of Stafford Street is shown lined with buildings on both sides in both the 1832 and 1878 plans. To the north a poor quality commercial building has been set back from the building line. A token slate roof to the front pitch barely conceals the corrugated metal rear roof. On the south side a modern building with a long low horizontal, concrete tiled roof and poor quality gable is set back from the building line and has frontage parking – all elements that are alien to the urban quality in the centre of the conservation area.

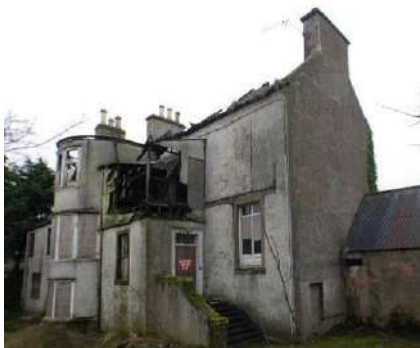
##### **The Grove, High Street (Unlisted)**

Tain Museum Website states *“The Grove is situated off Cunarder Lane (which links the High Street and Kirksheaf Road). This picture was taken before part of the grounds were used for the existing Post Office car park ... a former owner, .... Alex Macleod (“Dow”) was a photographer and used parts of the building as a shop and a studio”*. It appears in the 1832 town plan and the 1878 Town Plan shows the grounds set out as a garden, seen in the photograph below. It has the appearance of a late 18<sup>th</sup> or early 19<sup>th</sup> century substantial house, on a scale similar to the Manse in Manse Street. It is badly fire damaged and derelict.

The Buildings at Risk Register states: *“28 March 2019: Full Planning Permission and Conservation Area Consent for partial demolition and conversion of the building into flats with new build dwellings within the surrounding grounds (18/03191/FUL & 18/03192/CON) are being sought. Supporting documents with the applications note the property was last in*

use as a shop with flatted accommodation above, and that the property was fire damaged in 2014". Both planning applications were approved on 10 December 2020.

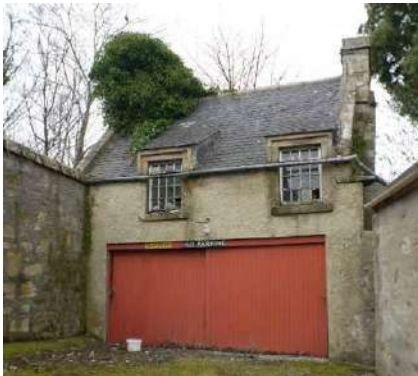
**Building to rear of 5 Market Street (Unlisted)**

The report notes: *"October 2013: External inspection finds the small building in generally fair condition but with heavy plant growths at roof level and very damp walls in places. Some damaged slates are evident with shrub growth at wallhead. Stone damage to North chimney, South stack obscured by ivy growth. Timber elements are in need of maintenance. The building may be in use as storage space"*.

*29 November 2018: External inspection finds deterioration since the previous visit - harling is cracking and has been lost to one section of masonry and ivy is now engulfing a gable. Condition moved to Poor.*

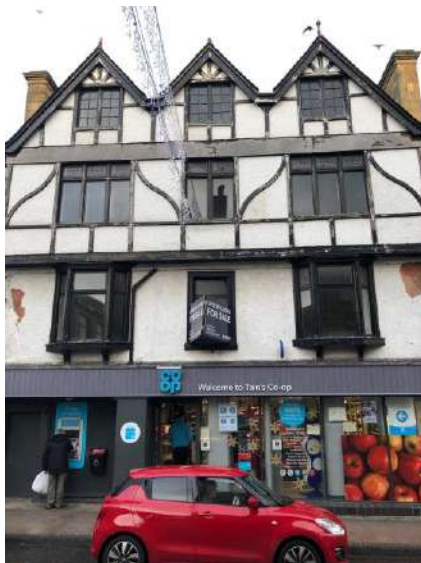
**Kingsway House, 10-14, High Street (Unlisted)**

The report notes: *"4 October 2013: External inspection finds the significant High Street building in generally fair condition but in need of maintenance, particularly to timber work and windows. There appear to be support struts to the 2nd floor windows suggesting there may be structural issues. The ground floor is in use as a mini-market, the first floor office space is currently being marketed for lease. It is unclear whether the two upper floors are in use"*.

*29 November 2018: External inspection finds the building remains in much the same condition as previous. A marketing board is affixed advertising the upper floors for sale through MJHJ Property.*

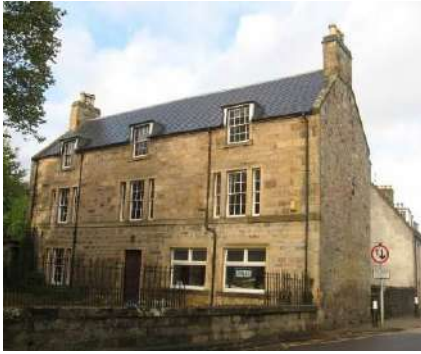
#### **Tower Gardens, 9, Tower Street (C listed)**

The report notes: *“4 October 2013: External inspection finds the building in overall fair condition but disused. The roof has been recently replaced. Pointing is poor in large areas and rising damp is evident. Railings have been broken in several places and building materials are lying within the garden area. Listed Building Consent for roof repairs with replacement slates and temporary removal of a section of boundary railings for the placement of skip (in retrospect) was conditionally granted Apr 2011 ref:11/00420/LBC. Full Planning Permission and Listed Building Consent for change of use from offices to residential use with alterations were conditionally granted May/ Apr 2011 ref: 11/00777/FUL & 11/00782/LBC. Papers within the 2011 applications note the property had been marketed for sale for some time since its use as a solicitor’s office had ceased”.*

*29 November 2018: External inspection finds the property remains in much the same condition as seen previously and remains disused.*

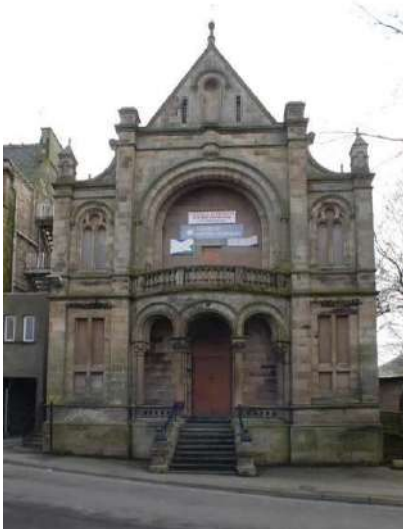
#### **Former Town Hall (B listed)**

The report notes: *“30 November 2018: External inspection finds the building disused and boarded up. Although previously understood to have been restored, it would appear the restoration scheme stalled sometime previously.*

*Overall the property is now in poor condition - damaged clay ridge tiles, slipped slates and vegetation growths to the roof, rainwater goods in need of maintenance, and areas of damp and erosion to the masonry walls. Moved back from Saved to At Risk.*

*April 2021: The owners, Tain Heritage Trust, in conjunction with the Tain & Easter Ross Civic Trust and the Tain & District Development Trust, are currently renovating the building with a view to re-opening it as a cultural centre.”*

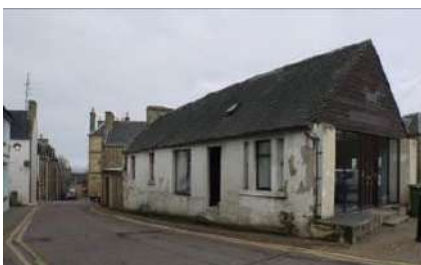
#### **4-6 King Street (Unlisted)**

The report notes: *29 November 2018: External inspection finds the property, latterly a retail unit, disused. General deterioration to the building fabric is evident - some slipped roof slates, cracked/ bossed render in places suggesting dampness to walls, rainwater goods are defective and missing in sections. One opening has been boarded up and the roof has recently sustained damage.*

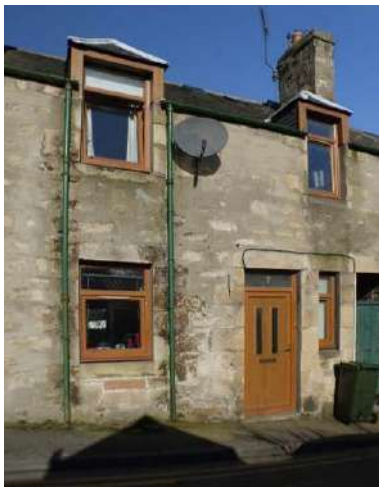
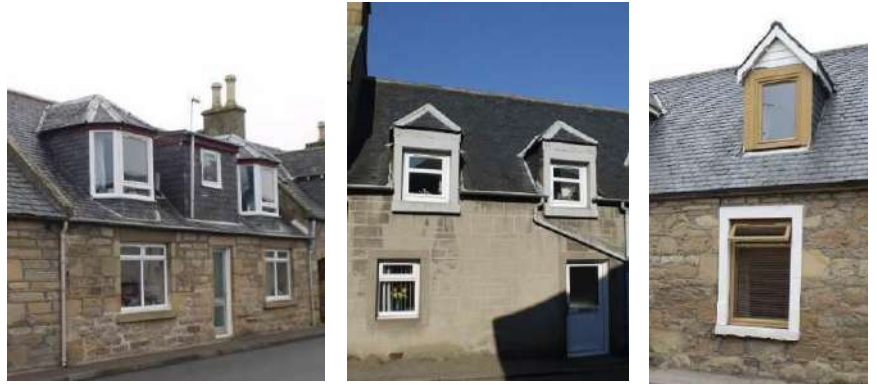
However, these examples, sadly, appear to be in a minority and many buildings have suffered from ill-proportioned replacements quite out of character with the age and style of the architecture. Some examples are shown left and below.

The impact on the building can result in a significant change of character when also coupled with enlargement of original openings.

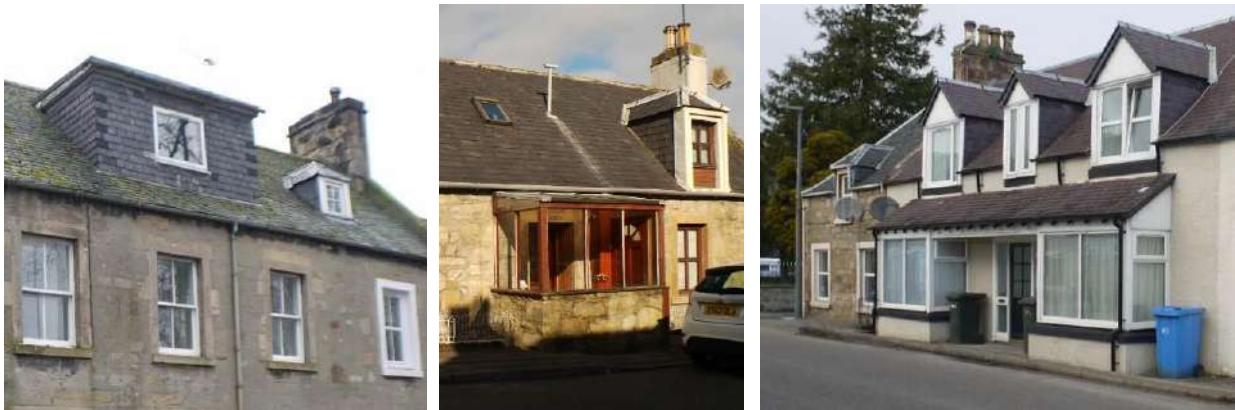
### Box dormers, porches and other accretions

Box dormers are relatively rare but have a significant adverse effect where present – particularly when almost engulfing a small early cottage, left, or seen in contrast to the original, bottom left. Some Victorian and Edwardian porches add character to some of the buildings but over-sized modern porches can detract. Below right, where the original appearance was probably similar to the building on the left, enlarged dormers and added bay windows with a linking open porch roof, built onto the pavement have made dramatic changes to the character.

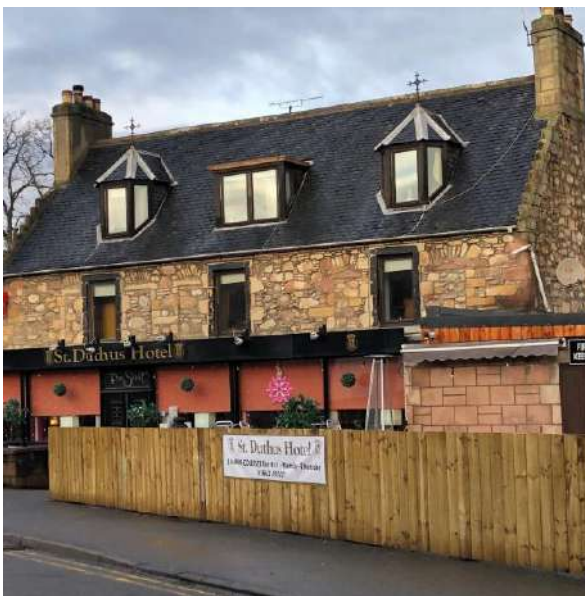
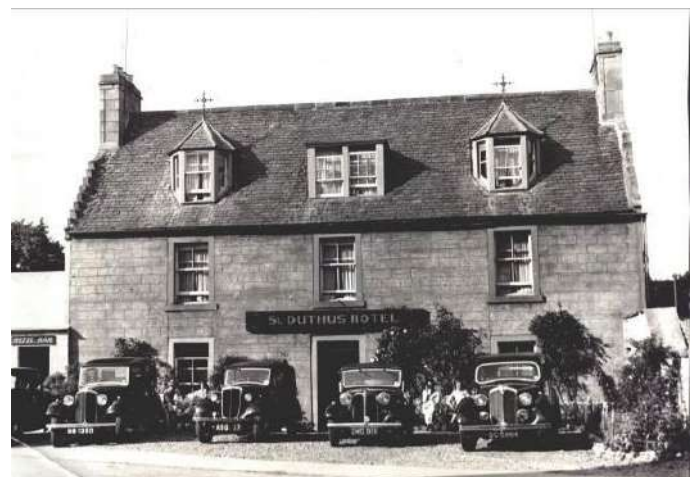
One building shows how changing tastes have brought dramatic changes of appearance over time. The St Duthus Hotel, one of the few crow-stepped buildings in Tain, is possibly one of the earliest remaining. The current 'picked and pointed' appearance shows an earlier pattern of smaller irregular window openings, now blocked up. The building might originally have been harled. The 1930s photographs shows a more regular 3-bay building, similar to many built in Tain in the earlier to mid-19<sup>th</sup> century, but with two canted Victorian dormers sporting iron finials. These suggest a later date while the off centre dormer may be later still. The smooth render appears to be lined out and may well be a cement based 20<sup>th</sup> century coating. The modern extensions obscure what has been a fine building and would perhaps have been better added to the side where there is a large car park.

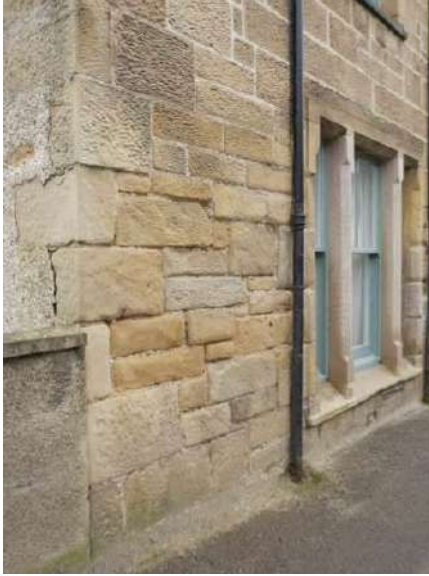
Tain is fortunate in that it had a source of good quality stone at the Hill of Tain quarry which furnished the ashlar blocks for the Tolbooth begun in 1706. It appears to have operated up until 1915. Correctly bedded and built in lime mortar that matches the stone in porosity many of the buildings have lasted well. Unfortunately damage can occur from a number of causes, for example, persistent dampness (such as from leaking rainwater goods or rising damp), incorrect repointing with hard cement based mortar and from exposure to road salt, the latter being a particular problem as so many houses are built right onto the street. The example, left, is typical of the type of erosion that occurs from road salt.

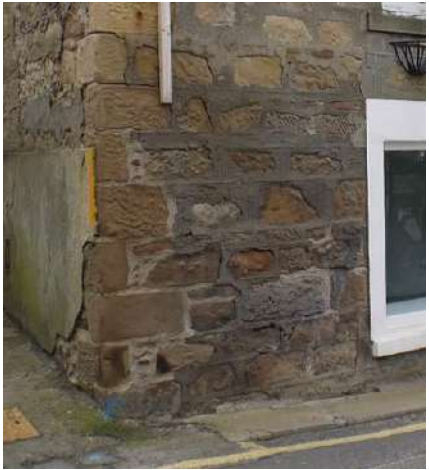
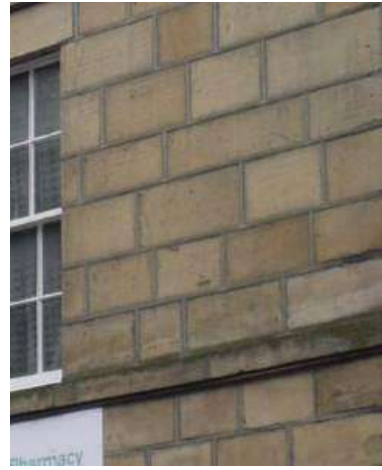
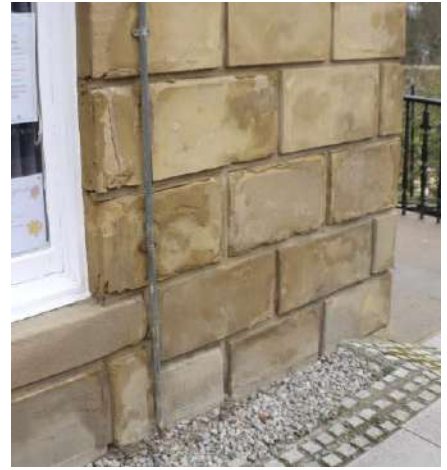
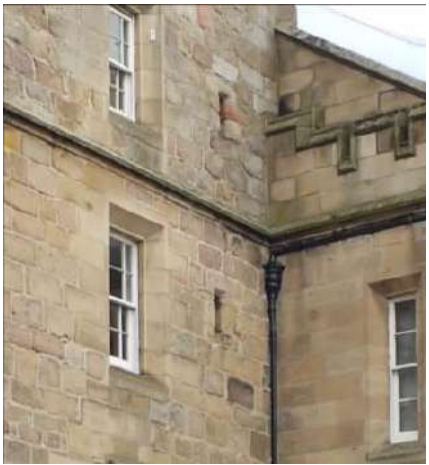
'Ribbon pointing' where a cement-based mortar joint is formed to stand proud of the stone is usually a modern introduction and is potentially harmful for the stone. There are good recent examples in Tain of buildings repointed using lime-based mortars for rubble walling in a traditional manner. Ashlar requires fine joints (approx. 3mm). If repointing is needed this should be done in finer lime-based mortar (the original courthouse pointing is a good original example).

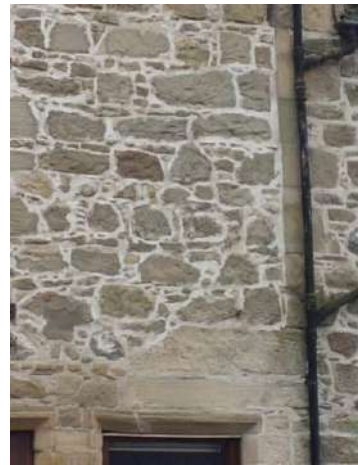
Hard cement mortar is less porous than the sandstone and when the wall is soaked by rain the moisture evaporates out through the stone, bringing salts and causing decay. Lime mortar pointing performs much as the stone and drying out is more even. In many instances the stone erodes back, leaving the cement mortar standing proud (and also able to trap more water), as in the example, below left.

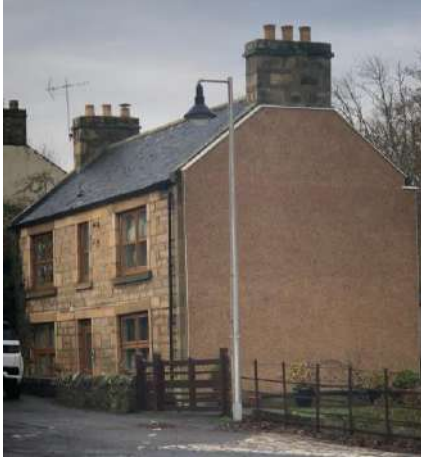
### **External Insulation**

External insulation is poorly detailed and results in a poor, sub-standard and non-traditional finish. It should not be considered for use in conservation areas. External insulation can obscure architectural detailing, original finishes and fabric, alter the profile of window and door openings and affect how rainwater goods and other fittings and fixtures are fixed to the building. External insulation does not only adversely affect the character and appearance of individual buildings, but it can have a detrimental impact on neighbouring buildings and on the wider streetscape. Planning permission is required to install external insulation on any building within a conservation area and as it is unlikely to preserve or enhance the character and appearance of the conservation area, such permission is unlikely to be granted. Internal insulation however is encouraged and should always be considered in the first instance.

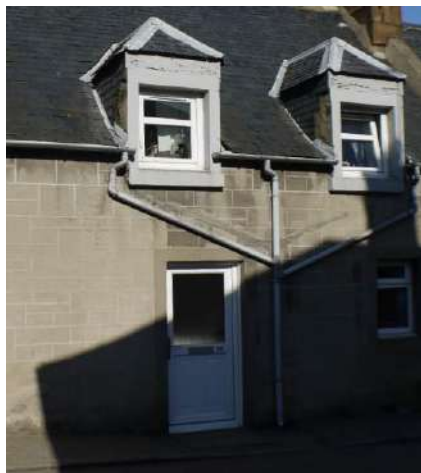
### **Rainwater Goods**

Traditional cast iron rainwater goods are part of the historic character. A good proportion remain in Tain and the civic/public buildings show a range from simple half-round gutters and circular downpipes to more elaborate details such as the rectangular sections on the Royal Hotel and the hoppers on the Tolbooth. The prevalence of buildings with dormers rising through the eaves line creates a multiplicity of gutters on buildings, traditionally dealt with in a simple way with vertical round cast iron downpipes to each section. PVC rainwater goods are less durable and have an unfortunate appearance when branched across elevations.

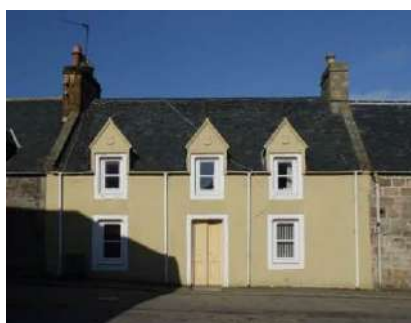
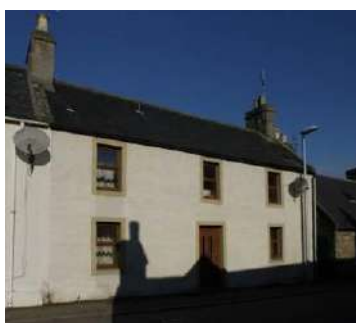
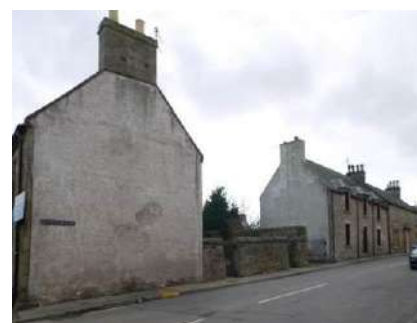
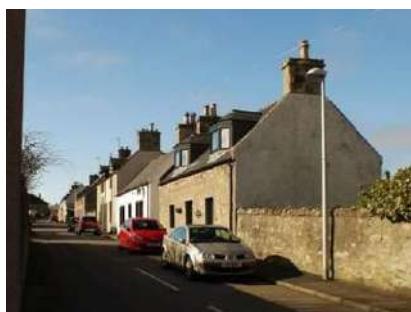
Hartfield Street is, in many ways a continuation of Geanies Street although narrower and comprising mainly the smaller scale dwellings. The west side is shown fully developed on the 1832 plan. There are some good examples of their period, some a full two storeys and several having the upper storey with gablets rising through the eaves. There are a couple of single storey cottages. The east side of the street is less consistent with the two gables of Sutherland Street and back gardens to these (one a car park) breaking up the building line.

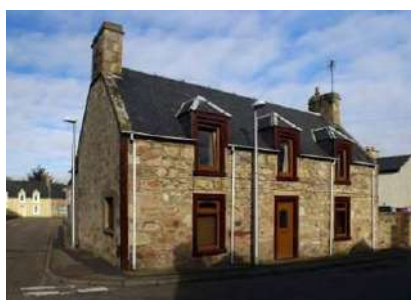
The buildings in these streets confirm to the types common in the area, although at the smaller end of the scale. The west side of the street is developed while the east side has only a couple of houses. Nos. 1 and 3 are single storey and attic cottages, both altered with changed openings, modern windows and later dormers (no. 1). No. 3 is harled and has a large rear extension.

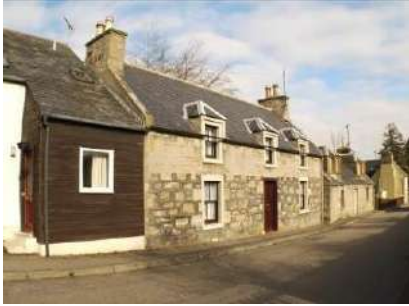
Further south the houses are two-storey with gabled dormers. The first a pair of semi-detached houses, now harled. No. 7 is more original, although with modern windows and door and the stonework 'picked and pointed' with cement based, recessed mortar. The last pair, in the south section of Petley Street are similar, although the first is harled and both have modern windows and doors and both have unattractive side extensions. The two houses on the east side are a two-storey house with gabled dormers and a single storey cottage. These two are on the corners with Sutherland Street.

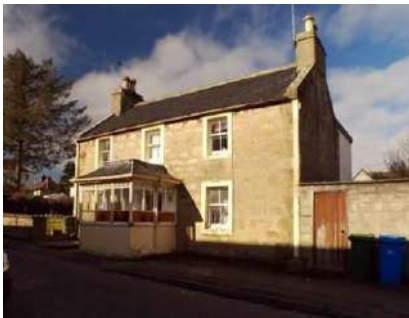
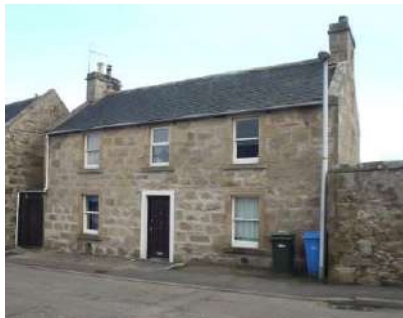
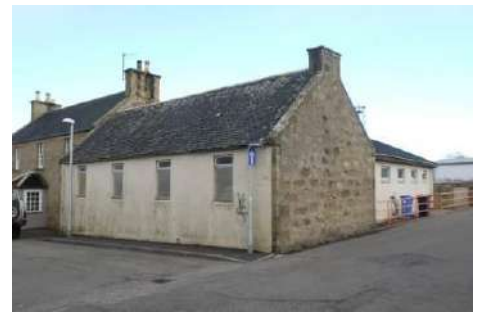
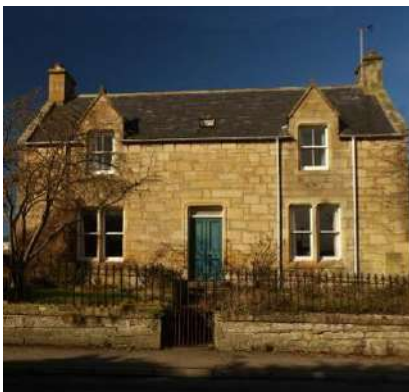
Gower Place, in addition to the interesting group at the corner with Knockbreck Road (within the conservation area) has a pair of good quality substantial houses, opposite each other nearer the south end of the street and a third similar house in the middle of the east side. No.3, left, is B-listed while the other two are C listed. There is also a single storey cottage.

A single storey 19<sup>th</sup> century building sits on the corner of Sutherland Street but has been much altered and extended. It appears to be listed C but the description does not match the current configuration.

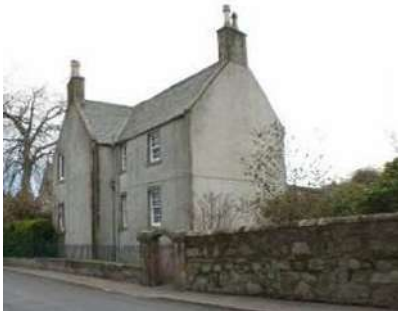
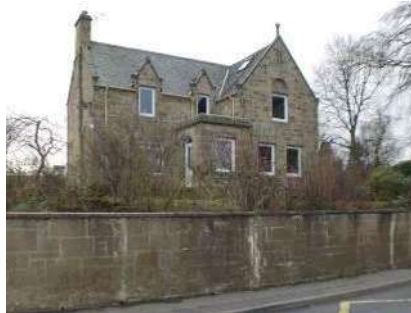
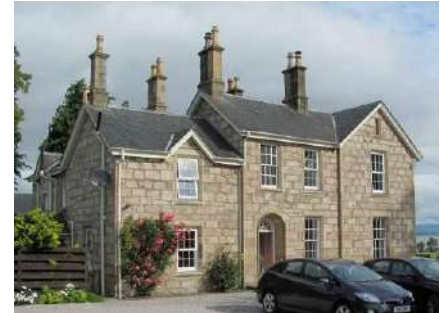
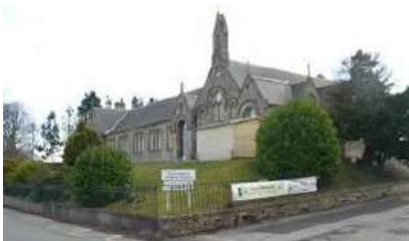
The two houses just beyond the boundary, Knockbreck Primary School and the Golf View Hotel are described in section 3.07. These buildings represent the quality of the construction during the mid – late 19<sup>th</sup> century. Although not of the same character as the planned expansion, they are largely a result of the extension of Ankerville Street.

The building group is similar in character to the west end of Manse Street, and the position on top of the escarpment continues the pattern established by the siting of early Tain. The fine detailing of the Primary School brings elements of townscape (eg. the high bellcote) almost into the countryside. Extending the boundary to include this group and the former playing fields beyond would enhance the conservation area.

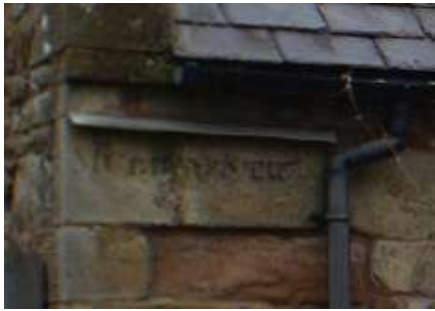
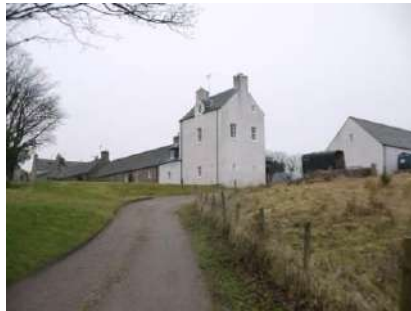
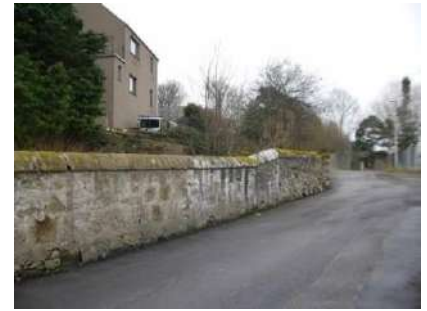
Where the route follows the contour along the line of the Matach Gully the edge is well defined by a traditional sandstone rubble wall with half round stone copes. The boundary of the conservation area should be adjusted to include this path/road and the wall.

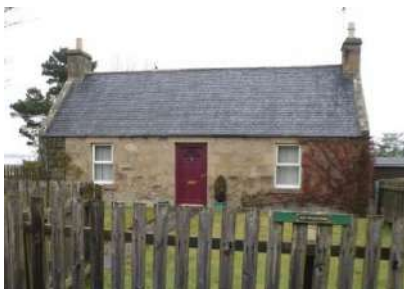
The proposed extension would result in the inclusion of an attractive late 19<sup>th</sup> century stone cottage (left) and the two-storey stone blocks at the north end of Dunrobin Street. These are a well-built response to the context. (Refer to section 3.05.)

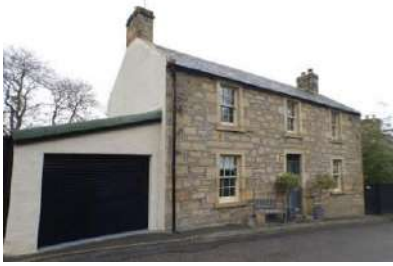
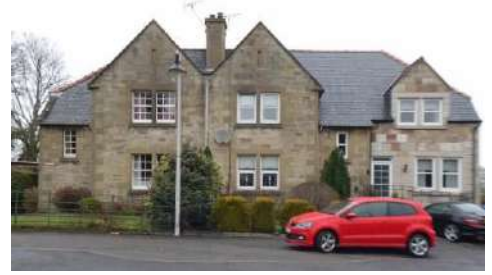
The first two are late 19<sup>th</sup> century two-storey houses of 3 bays, coursed squared rubble with dressed margins, though much altered. The next, a bungalow with dormers, possibly 1920/30s, then a two-storey block of similar date, with characteristic gables and swept roof detail (though the

symmetry has been disrupted by a recent extension on the east side). These houses retain their original 'estate' railings.
