## HIGHLAND COUNCIL

**Committee:** Caithness Committee

**Date:** 12 August 2021

**Report Title:** Draft Wick Pulteneytown Conservation Area Appraisal and Conservation Area Management Plan

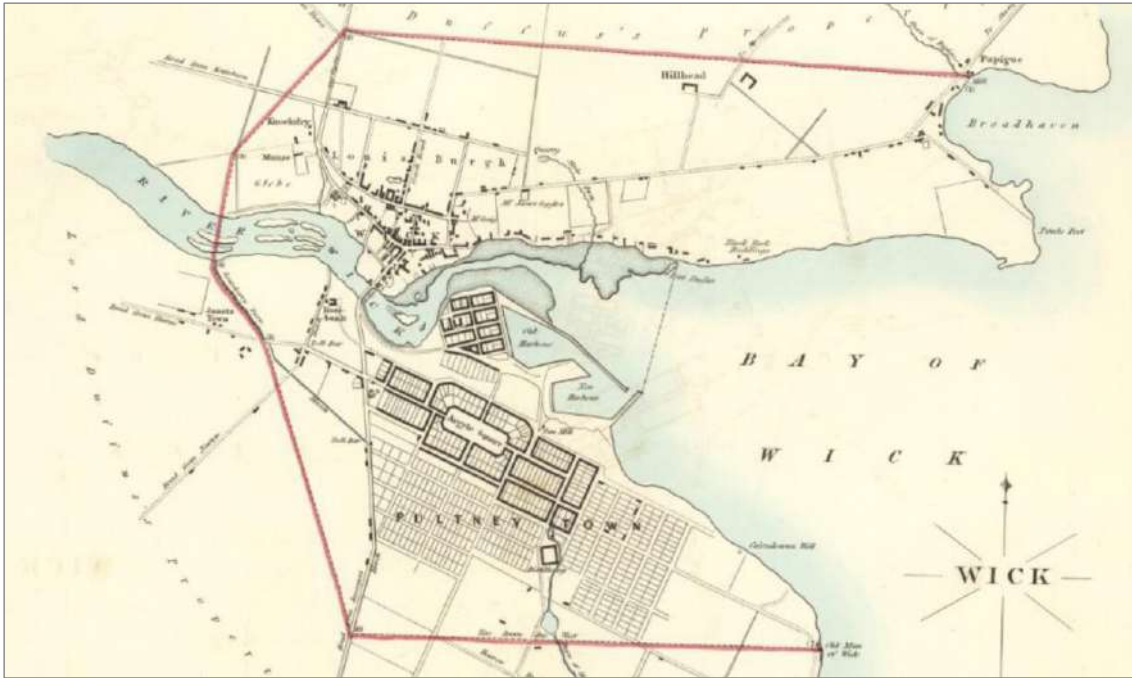
Figure 4A: *Reform Act Plan, 1832*: the earliest map representation of Pulteneytown. Whilst broadly reflecting the new town’s development, the extent and accuracy of specific buildings cannot be relied upon. ©NLS

With the original feus of the new town plan let, it appears additional lots were created including: the western end of Sinclair Terrace; on the originally open ground on the north side of Breadalbane Terrace; Harbour Terrace; and on reclaimed land in the western section of Lower Pulteneytown forming Union Street and River Street (compare figs 4 & 5; map 6.1).

By comparing historic maps (figs 3B, 4 & 7), the two blocks north of Martha Terrace were not part of the original lots, and in the 1870s this area, just above the high water mark, was the site of a number of more temporary buildings and the original lifeboat house (1848). Shortly after the 1<sup>st</sup> Ed. Ordnance Survey (1872), a new bridge was constructed (whilst Telford’s original Bridge of Wick was replaced) and a route formed from Williamson Street to the north bank of the river at the end of the High Street. The 2<sup>nd</sup> Ed. Ordnance Survey (fig 6) shows development on the western plot (currently the medical centre, built 1995) but no development on the eastern part (currently the fire station site).

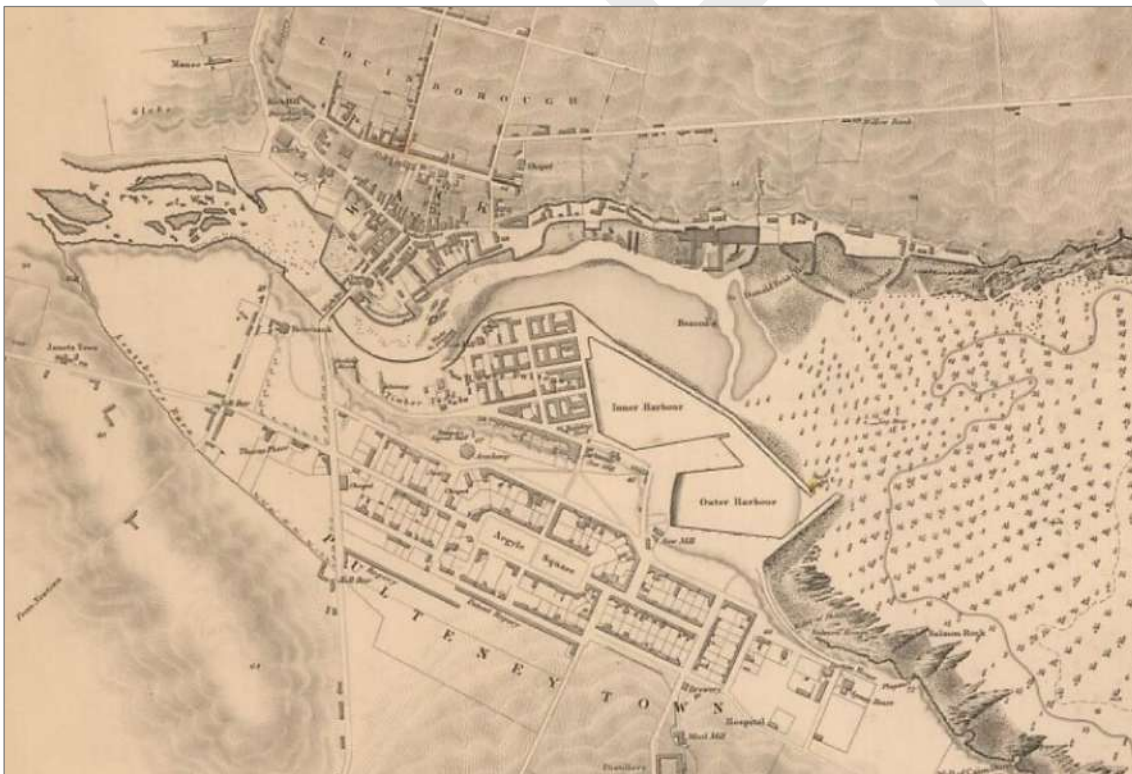
Figure 4B: *Admiralty Charts of Scotland: The Port and Vicinity of Wick* (surveyed 1839; additions 1857) provides the most detailed plan before the Ordnance Survey in 1872. Whilst additions are said to have been made to the map in 1857, the omission of a number of key buildings constructed in the 1840/50s suggests no update was made to the town plan, probably only the marine map in 1857. The plan captures Telford’s design before it extended in the second half of the 19<sup>th</sup> century to the west in Lower Pulteneytown and on the land between the lower and upper towns. Paths are indicated across this open area, which presents a level of formal grandeur to in particular Breadalbane Terrace. Development of the upper town to the east (Huddart and Vansittart Streets) and to the south (Moray Street, Brown Place and Kinnaird Street) is clear with the ‘Ropery’ south of Brown Street clearly marked. In the lower town the map states that works are progressing on River Street. ©NLS

On Bank Row, the property lots extended back into the steep former river embankment. As discussed above (section 3.5), this slope was not initially intended for development, and the Port of Wick plan (1839/57; fig 4) captures its early form with paths across this area and converging on the Black Stairs. This plan presented a level of formal grandeur to in particular Breadalbane Terrace, the character of which is now very different. Subsequent development has covered a large part of this area, however there remain significant pockets of green space, with large trees particularly west of the Wick Heritage Museum garden. This important open space assists in defining and separating the upper and lower towns. Further open space lies behind the Round House and Harbour Place to the rear of the Breadalbane Crescent terraces. This land includes gardens and a number of mature trees which contribute to views of Upper Pulteneytown from the harbour (fig 27). Also on Bank Row, part of the area damaged by bombing in 1940 has been made into a community memorial garden in memory of the 18 civilians killed during two raids on Wick; 15 of which at the Bank Row site. The Memorial Garden is an important public open space, and the only 'public' garden within the conservation area.

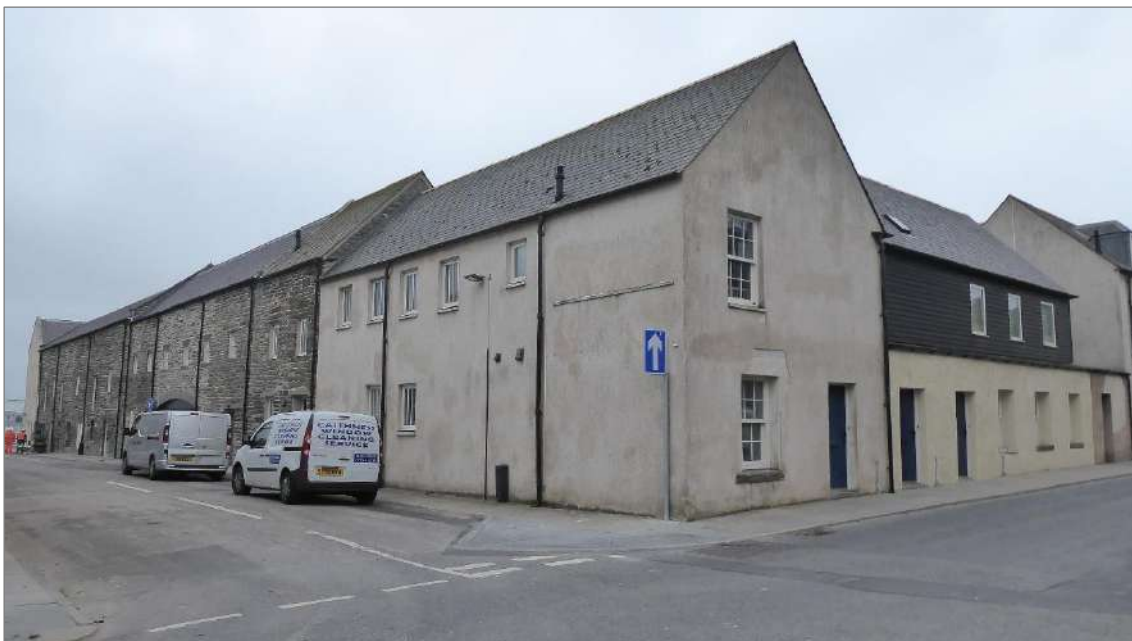
Figure 9: the typical hard urban grain of the original Lower Pulteneytown lots with buildings constructed on the street line.

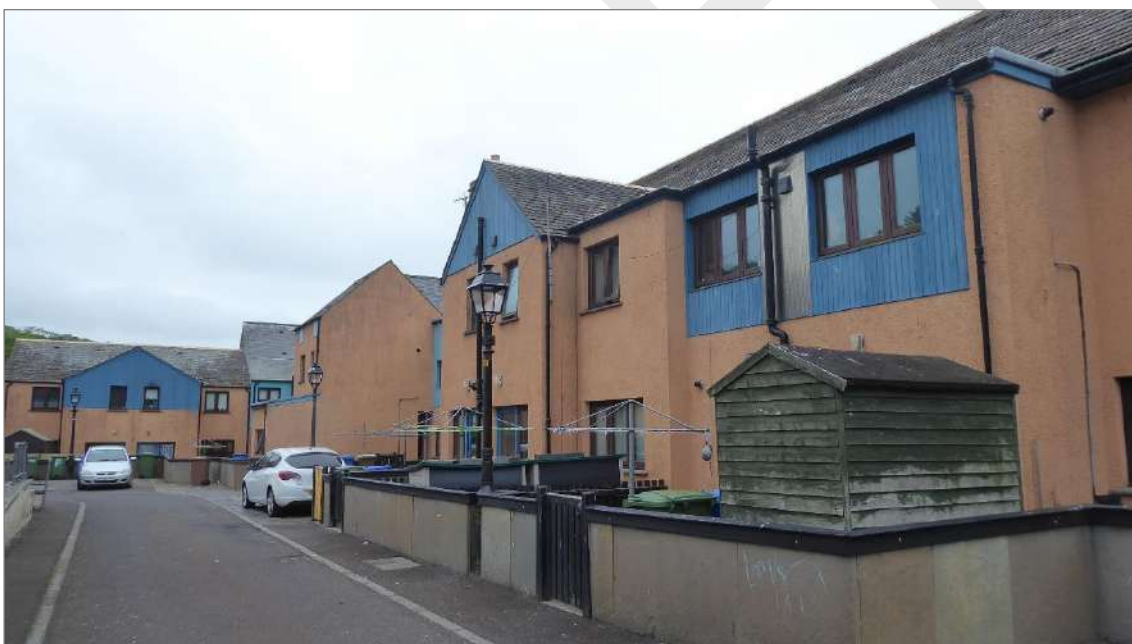
Figure 10: recent redevelopment on Saltoun Street has reduced the hard frontage of the block and set housing back from the street line with small front yards and parking.

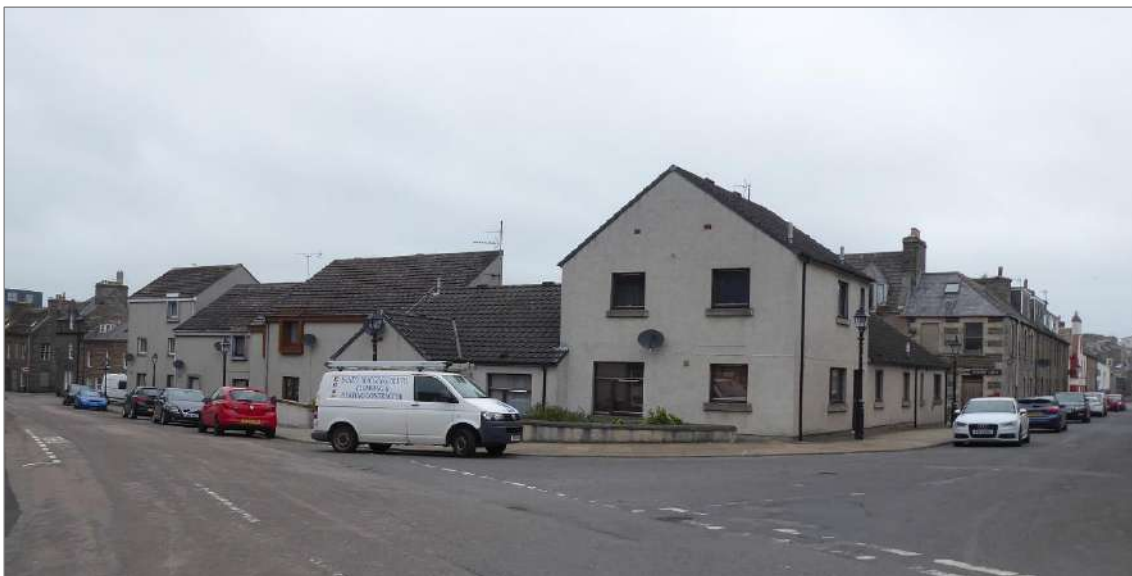
Figure 11: later 20<sup>th</sup> century redevelopment of the triangular block on Bank Row. The houses have been set at an oblique angle to the street line; the considerable variation in building height is also not in keeping with the original 2-3 storey buildings.

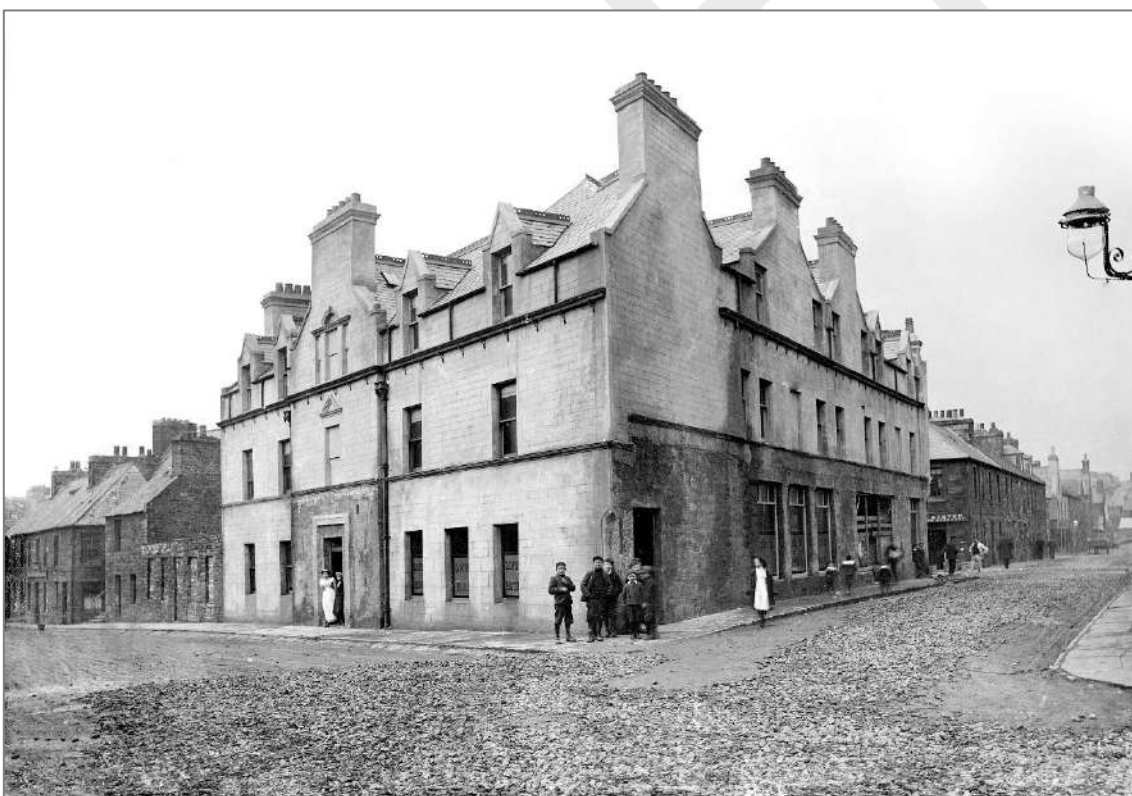
Figure 12: the Lorne Hotel occupied the corner of Bank Row and Williamson Street, pictured here in 1900. In comparison to the redevelopment above, the form and scale of the hotel provided a strong corner and reaffirmation of the urban structure of the industrial area. Note the road surface made up in sea gravel and Caithness stone pavements. © The Wick Society - The Johnston Photographic Collection

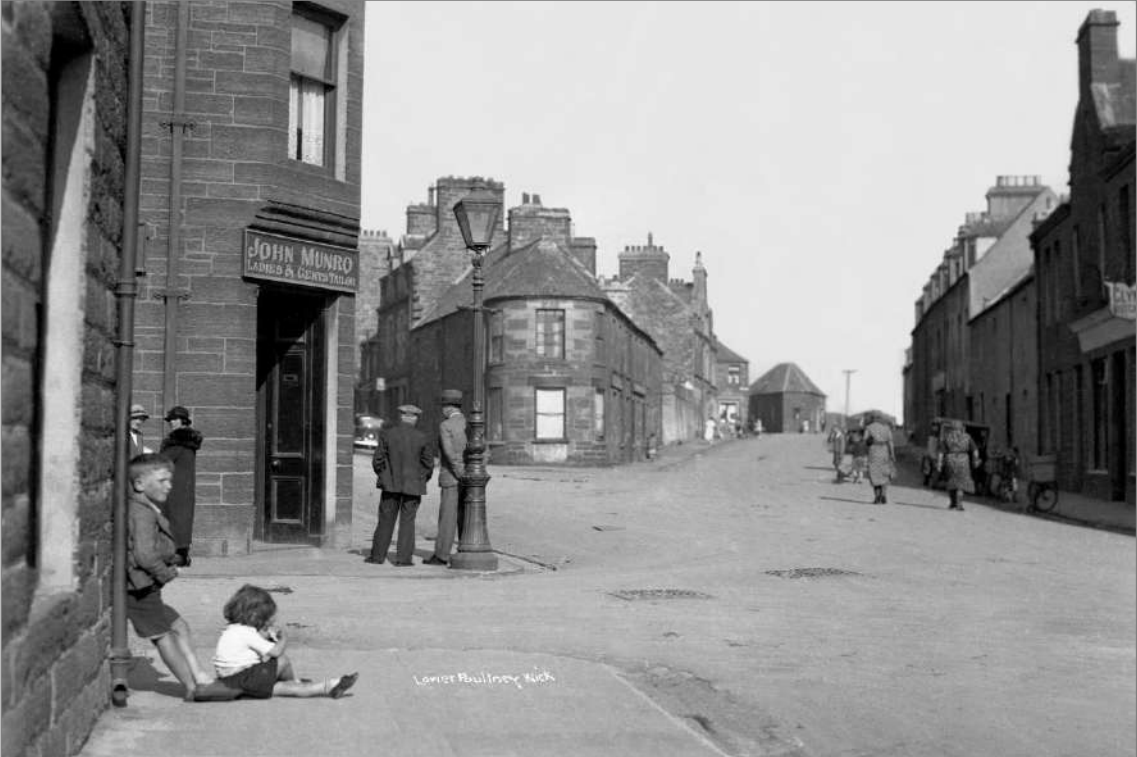
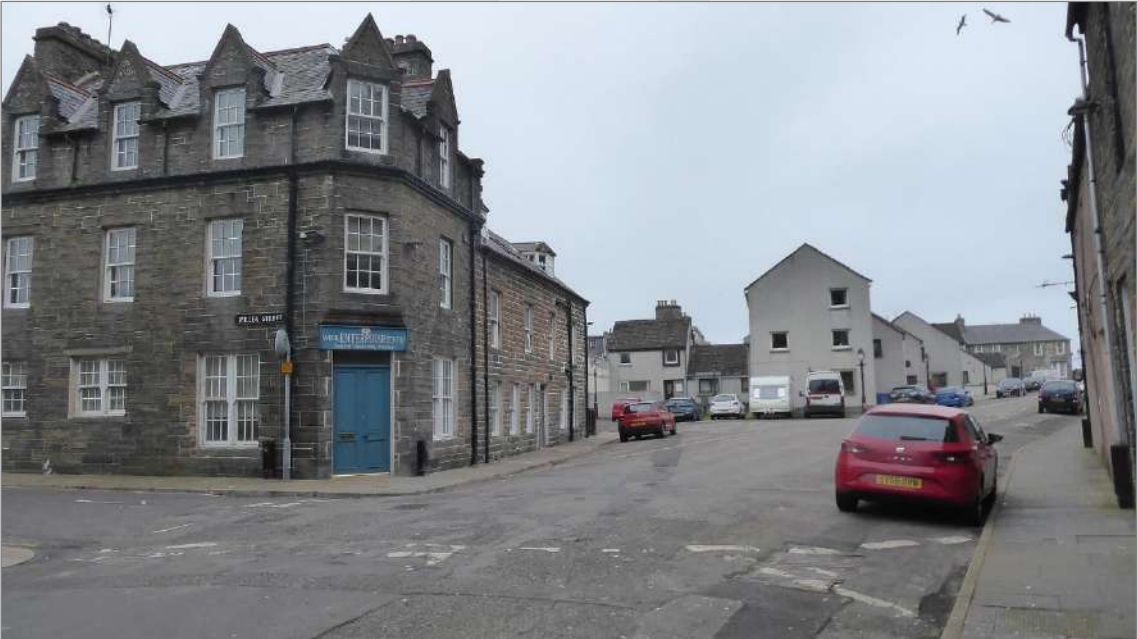
Figure 13: (top) looking east on Bank Row in the 1930s, with the triangular block on Saltoun Street on the left and the former police station buildings at the end of the boat yard site in the distance (now demolished) © The Wick Society - The Johnston Photographic Collection; (below) similar view in 2019, the Saltoun Street block has been redeveloped with later 20<sup>th</sup> century housing.

World War bombing resulted in the loss of several buildings at the eastern end of Bank Row including the Crown Hotel on the corner of Bank Row and the Black Steps. This creates a void in the urban structure where the buildings have not been replaced, and there are views to the rear of the large properties on Breadalbane Crescent. The wedge of space between Bank Row and Rose Street was once the site of a boat yard and the town's police station and jail (fig 13). It is currently undeveloped but defined by low masonry walls.

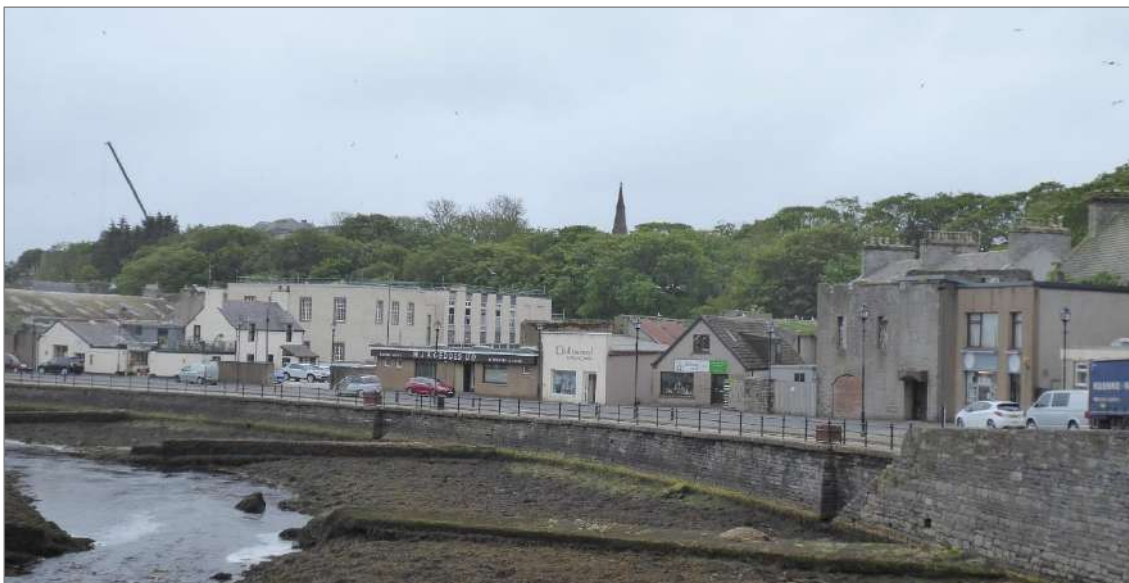
Figure 14: view of the River Street frontage from the Bridge of Wick. Note the irregularity of the street frontage which developed on the ends of the lots extending through from Union Street. There are gaps where buildings or high walls have been lost and the form and height of the 20<sup>th</sup> century Telecoms building is inconsistent with the traditional industrial buildings.

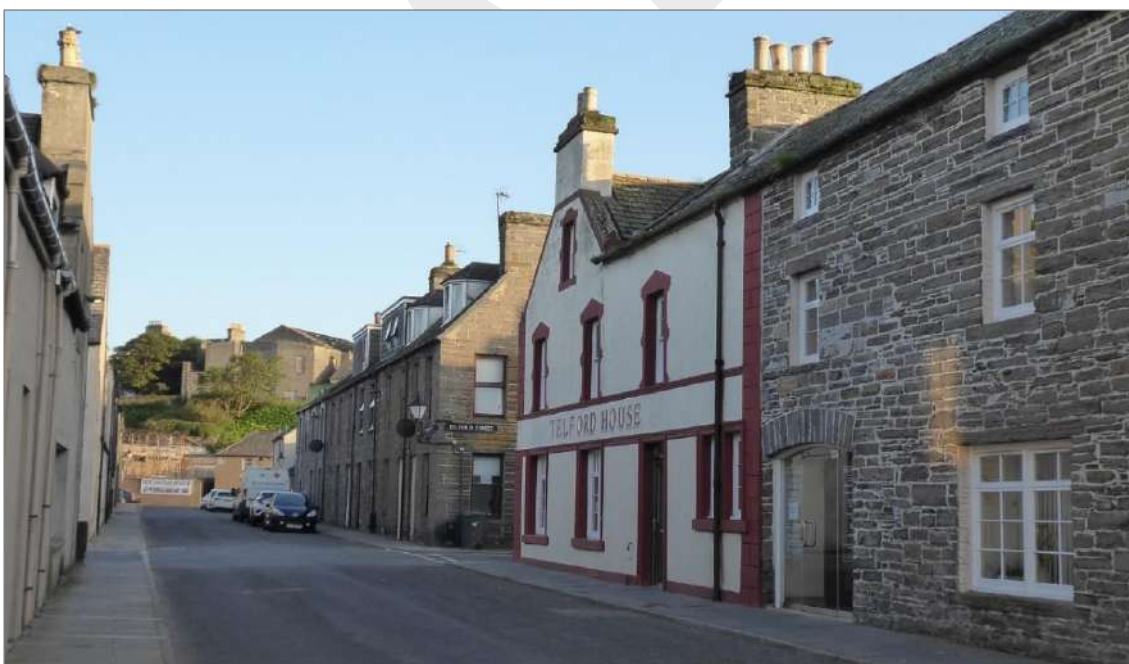
Figure 15: the consistent eaves line on Williamson Street (west side). Note how the 3-storey warehouse on the right maintains the eaves line of the neighbouring 2-storey Telford House.

Telford had defined the scale of buildings in Lower Pulteneytown by stipulating in particular that the height of buildings be a minimum of 18 feet to the eaves whether a street fronting (or rear facing) herring house, or a street fronting domestic building (GD9/337) with the aim to create a constant scale. The herring houses were also to have a minimum 18 feet internal width. However, in reality Lower Pulteneytown comprises of range of building heights from 3-storey warehousing to 2-storey office and residential buildings, and a small number of single or 1½ storey support buildings. The height of street elevations vary with some more consistent than others. The west side of Williamson Street has a strong and consistent eaves line, which accommodates a 3-storey warehouse and 2-storey housing (with dormers set back), as well as the elevated Telford House façade, only the latter's unusual gable end breaks the eaves line to the street (fig 15).

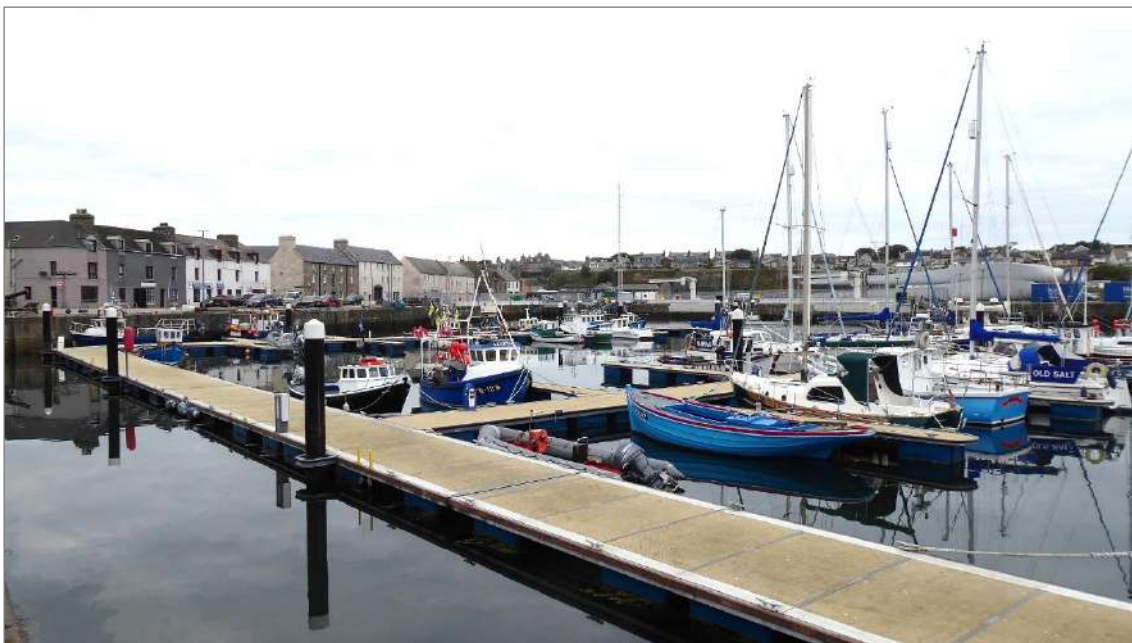
Figure 16: view of the Harbour Quay street frontage where the warehouses and support buildings are 2 to 3-storey in height with the tallest warehouses at the centre providing a balanced and attractive backdrop to the harbour.

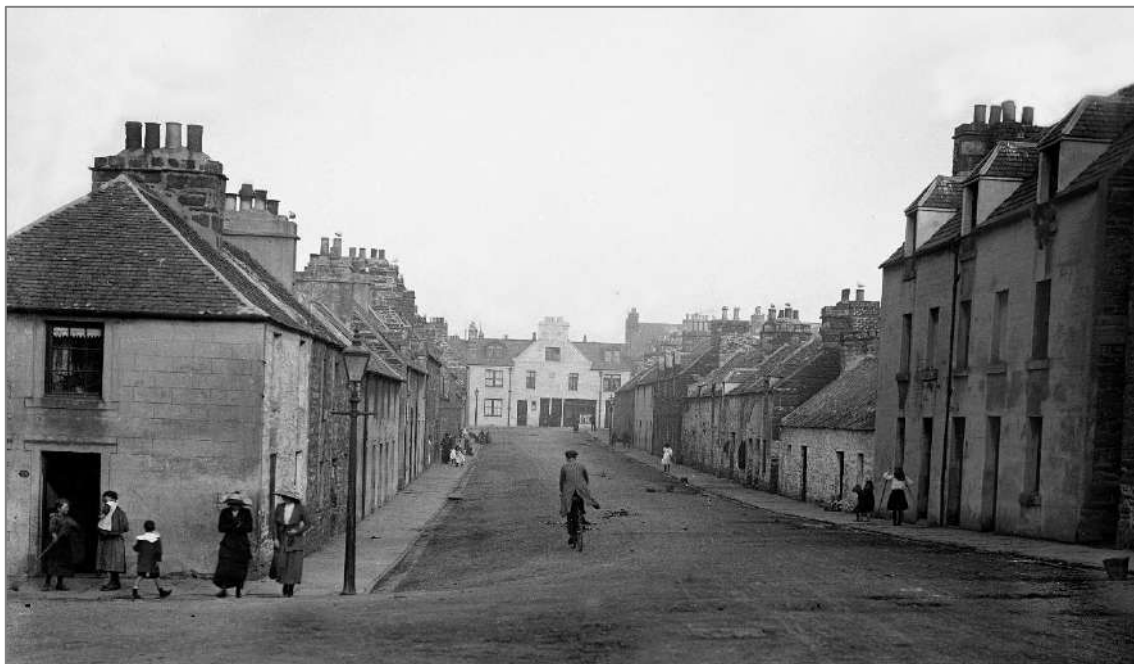
Figure 19: Grant Street in the early 20<sup>th</sup> century, the right hand side of the street is now demolished but note the contrast of the single storey cottage and the neighbouring buildings. There was a noticeable variation in building heights here. © The Wick Society - The Johnston Photographic Collection

Telford supplied standard house designs for both single and 2-storey models. He suggested that the Feu Charter determine where houses were to be 2-storey and in which streets single storey houses would be an option (GD9/289/51). The 2-storey house was to be a minimum of 17 feet to the eaves (a foot lower than in the industrial area) with a door 6 x 3 feet and windows 5 x 3 feet. Single storey houses were to be at least 8 feet at the eaves with the same door size but slightly smaller window openings at 4 x 3 feet. In construction, 2-storey houses predominated, with single storey buildings being extremely rare in the conservation area on the street elevations, although a few survive in the adjoining streets (e.g. Brown Place) and are evident in historic photographs (fig 19, Grant Street).

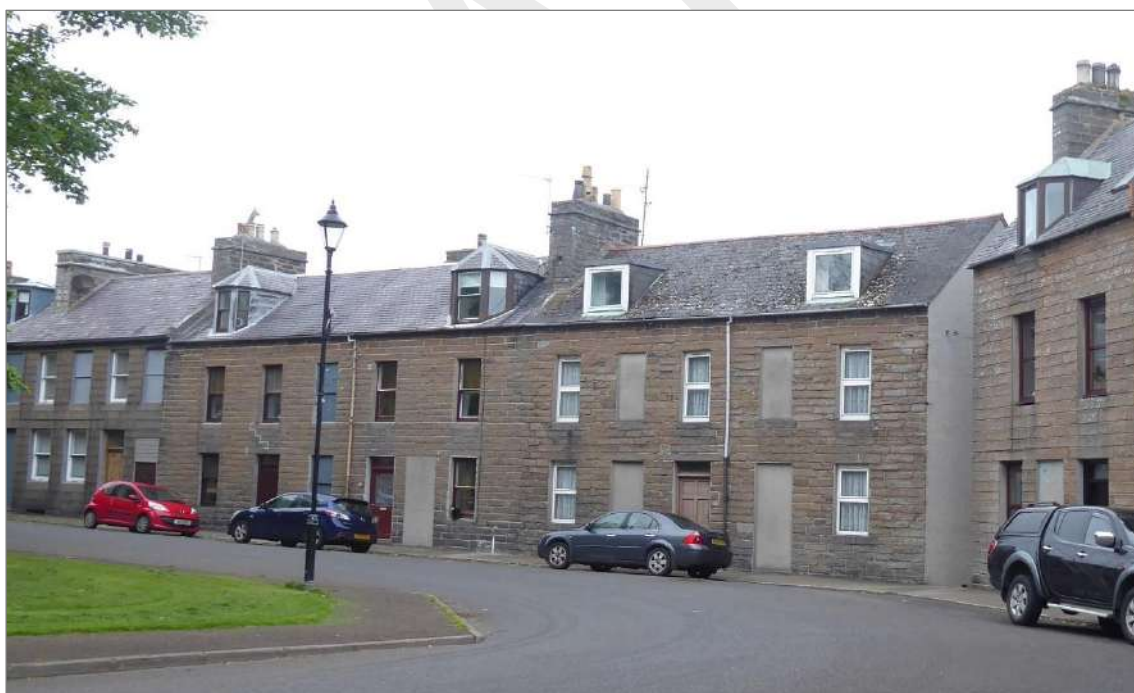
Figure 20: Argyle Square: note the variation on the height of the windows to the eaves, and also the height of the eaves line, which is slightly different between lots.

Admittedly there is some variation in the height of these 2-storey buildings, nevertheless there is an overall consistency. However as can be seen on Argyle Square, independent builders produced design variations which may also have been influenced by the date of construction. For example the relationship of the upper window position to the eaves can vary, and whether there was an attic storey with dormers (fig 20).

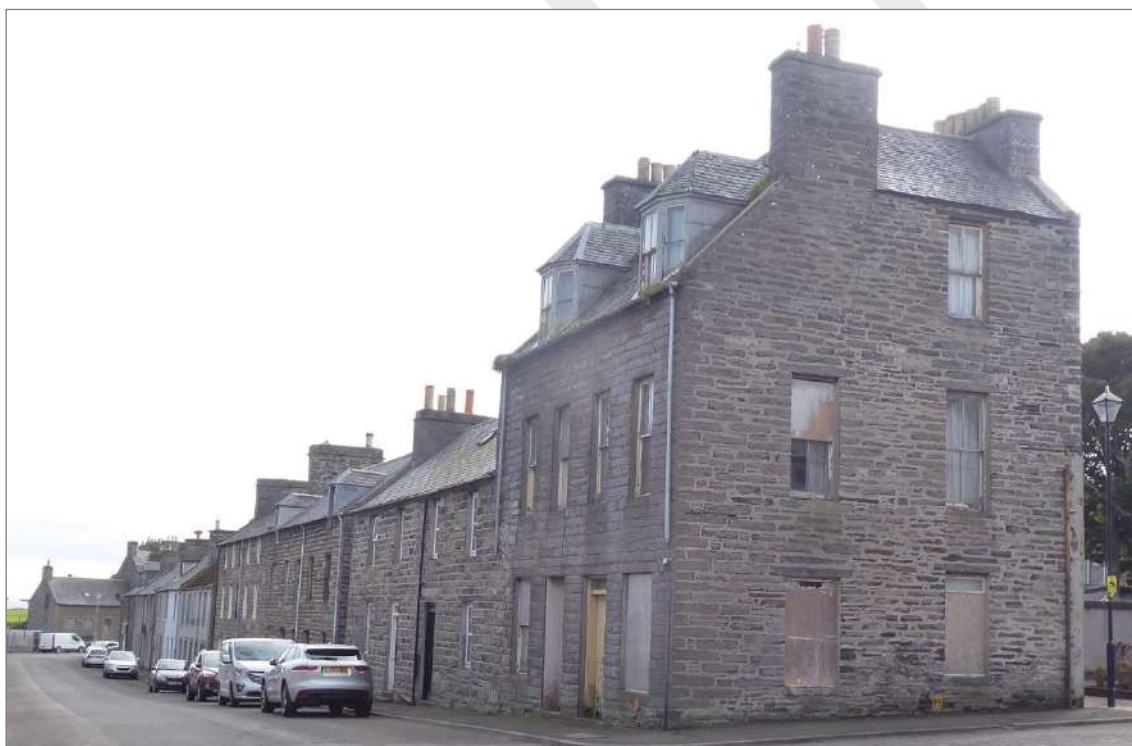
Figure 21: the Draft Feu Plan for the east side of Breadalbane Terrace and below the development on those lots. Note the larger scale of the corner building in comparison to its neighbour, shaded on the plan (lot 9) and one of the earliest buildings on the terrace constructed by 1813. The incline of the site has allowed progressively taller buildings to the east ending in the 3-storey at Nos 22-23. © SRO/GD9/337/1

Upper Pulteneytown streets are wider than in the lower town, with the Draft Feu Charter indicating 44 feet from the front of each house which would have accommodated Telford’s specifications for roads to be 30 feet wide with 6 feet wide pavements and kerbs each side; the only street which appears to be wider is Macarthur Street (SRO/GD9/337). Generally lots were to be 50 feet to the street frontage and 100 feet deep although this did vary for example at corner lots (figs 17 & 21). This produced a consistent

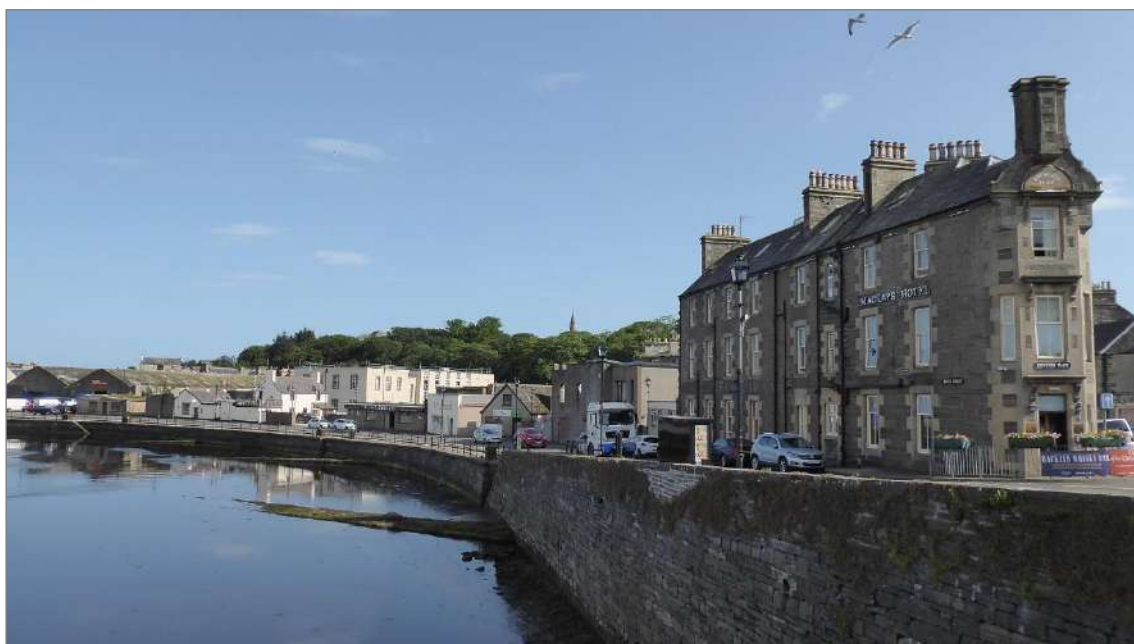
Figure 26: view of Lower Pulteneytown (River Street) from the Bridge of Wick. The majority of the street frontage has an inconsistent form and scale; however the street is anchored by the prominent Mackays Hotel cleverly fitted onto the narrow triangular site where River and Union Streets meet.

Set out on and above the river estuary and harbour, views on approach to the conservation area are very significant from Wick town centre, the harbours and the seaward approach. Therefore of the sea frontage on Harbour Quay, Harbour Terrace and Smith Terrace is very important in the presentation of Wick to in particular those using the harbour, and visiting the marina. The traditional warehouses and buildings on Harbour Quay provide scale and continuity to this frontage (fig 28), enhanced by recent restoration and adaptation on two full blocks. By contrast River Street presents a more confused urban frontage which is not continuous and has a mixture of building form and scale (fig 26).

The nature of the design of Lower Pulteneytown means there are very few landmark buildings which distinguish themselves from their surroundings. Two exceptions are The Round House (1807; section 4.2.2), an elegant Regency house on the elevated Harbour Place; and Mackays Hotel (1883; fig 26) with its striking narrow frontage and later Victorian detailing. Both contrast dramatically in their design and both are not typical of the buildings in the conservation area in terms of design. Within the former industrial area, Telford House on its corner plot forms a minor landmark with more elaborate Georgian detailing and current painted frontage (fig 27). The river front and harbour both form significant natural landmarks.

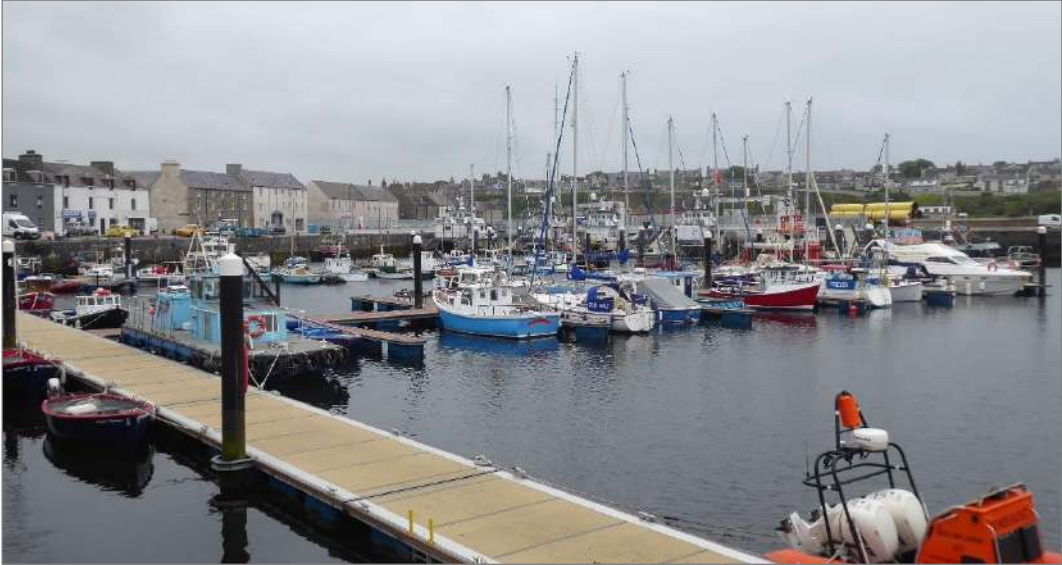
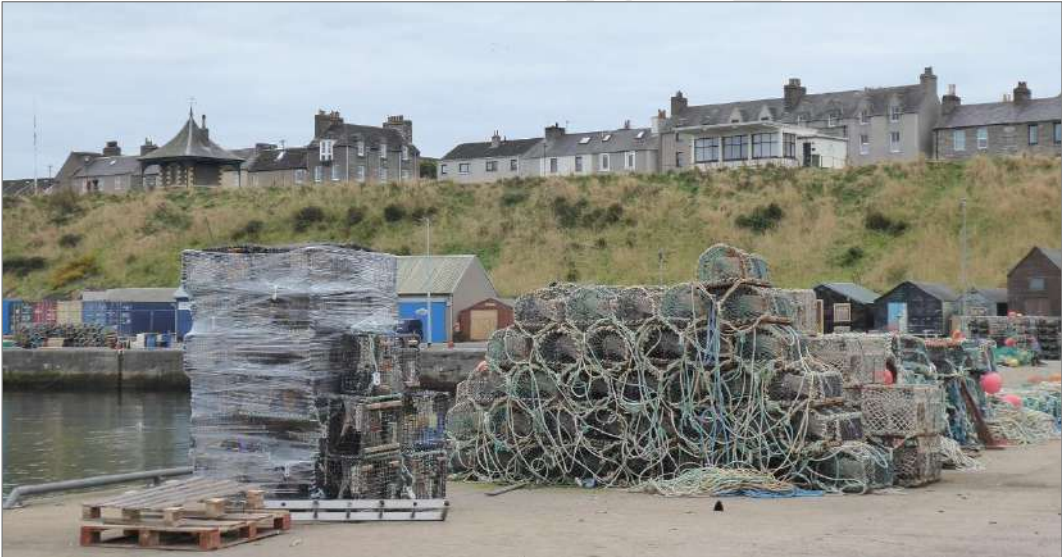
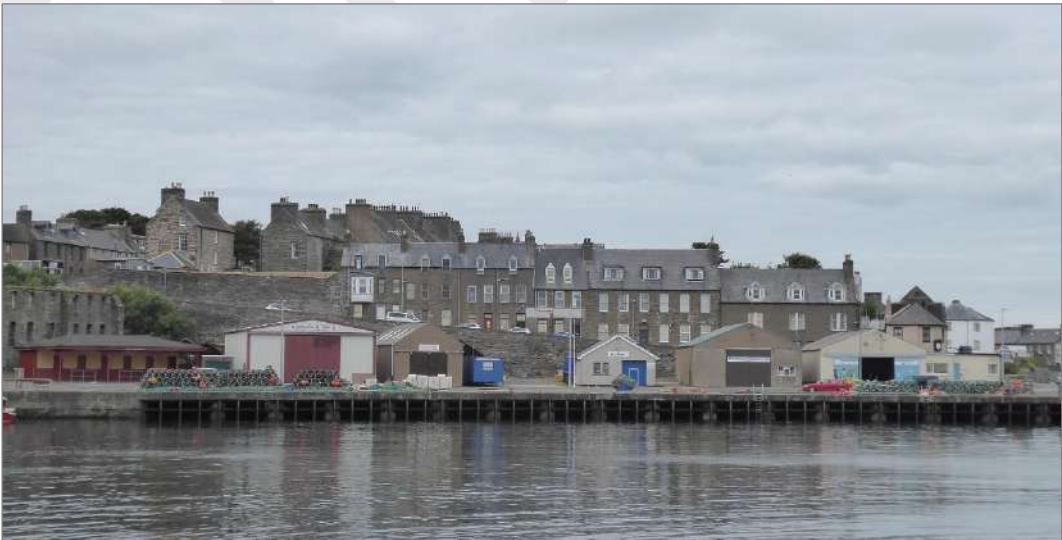
Figure 28: harbour approaches present views of Harbour Quay (top); Smith Terrace (centre); and Harbour Terrace (below); making the condition and integrity of design and materials on these properties particularly important to the overall impression of Wick Harbour.

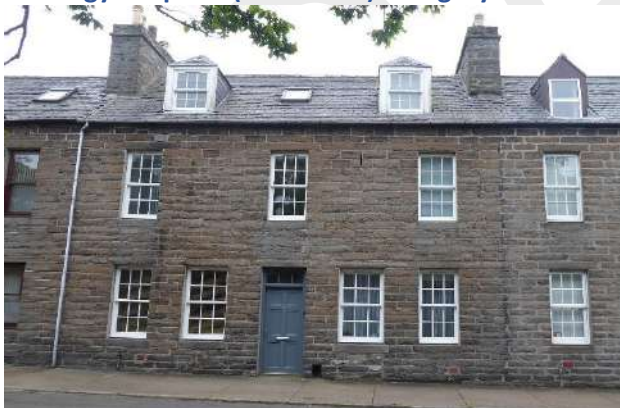
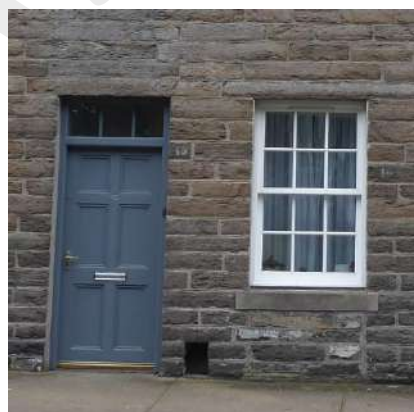
### No. 15 Argyle Square (south side) Category B listed

This house is part of one listed building record for Nos. 11-18 Argyle Square:

*“Thomas Telford, circa 1840. Terrace of, 2-storey, predominantly 2-bay, symmetrical, rectangular-plan, gabled town houses....Squared and tooled, long coursed Caithness stone slabs, some harled. Regular fenestration, irregular to rear.”* (HES, LB report 42269).

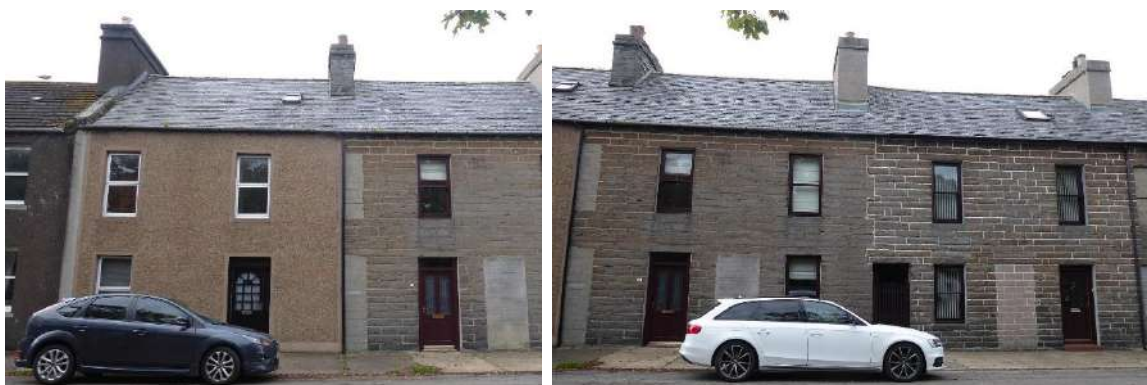
### No. 12 Argyle Square (south side) Category B listed

This house is part of one listed building record for Nos. 11-18 Argyle Square. In comparison to No. 15, the house at No. 12 has a smaller frontage with no dormers or rooflights. (No. 13 next door was repointed with roof and chimney repairs with grant assistance during the CARS). Similar to a number of properties on Argyle Square, it is presumed there has been reconfiguration of the properties internally, as can be seen by the infilled doorways. No.12 was originally part of the lot with No. 11 (harled to the left) and the principal boundary can be defined by the slightly larger chimney stacks at the boundaries. Note the pend on the right to No. 13 visible on the Town Plan.

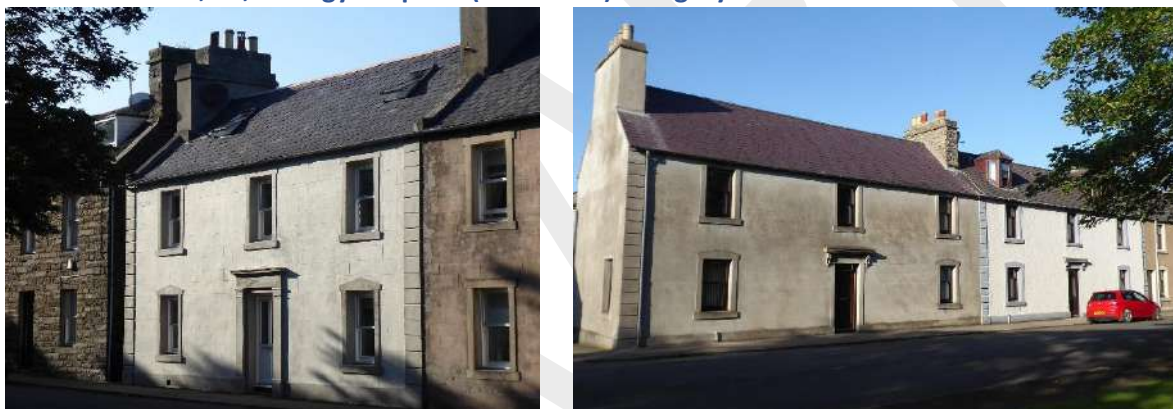
### Nos. 48-49 & 51, 52, 53 Argyle Square (north side) Category B listed

Nos. 48 & 49 are part of one listed building record for Nos. 35-49 Argyle Square.

There are later alterations evident: No. 49 has adaptations to form a commercial shopfronts; No. 52 has canted dormers and a small central rooflight; No.53 has larger rooflights. All timber entrance doors appear to have been replaced (although the possible original feature of a rectangular fanlight has been retained), as have the original timber sash & case windows. The material for the render appears to be cementitious and finished in modern paint or dry dash (No. 53). At No. 48, the west side is enclosed by a blind gable end forming a narrow passage with its neighbour, as was required by the British Fisheries Society's building regulations.

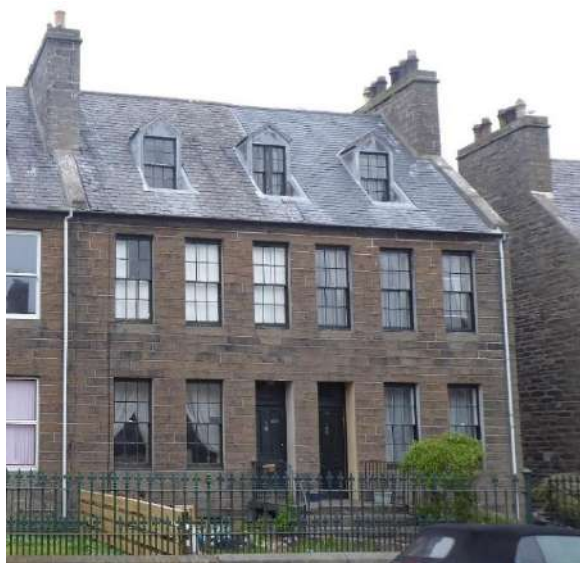
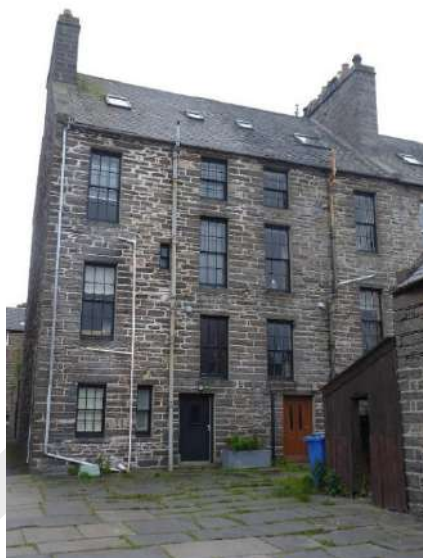
**Nos. 10-13 Breadalbane Crescent Category B listed**

Built circa 1860-1865 and considered to be the “homes and workplaces of the herring fishing entrepreneurs” and wealthier merchants (Beaton, 1996, 41).

Symmetrical block of 4 terraced 3-bay townhouses of 2-storey with basement and attic, gable ended constructed of coursed Caithness stone. 4-panelled entrance doors with 3 pane rectangular fanlights above. Nos. 10 & 11 appear to retain original 6 over 6 timber sash & case windows, and small gabled dormers, the central dormer at No. 10 expressing the division between the two houses. Grey slates, with flat copes and raised skewputt, gable chimney stacks with simple tabling course below the copes. Rear yards are paved in Caithness flagstones and contain cooperages, long single storey former industrial buildings (refer below). Low stone boundary walls enclose front gardens with original decorative cast iron railings. Walls have saddle-backed copes and are terminating with tall stone piers with pyramidal caps at the entrance lanes to the cooperages.

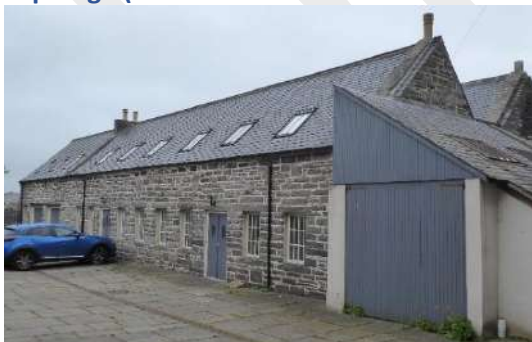
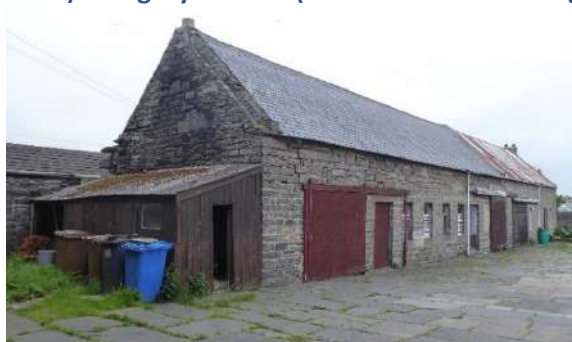
**Coopage (to rear of Nos. 10-13 Breadalbane Crescent) Category B listed (with townhouse listing)**

Coopage behind No. 9 restored using CARS funding to form 2 houses (left).

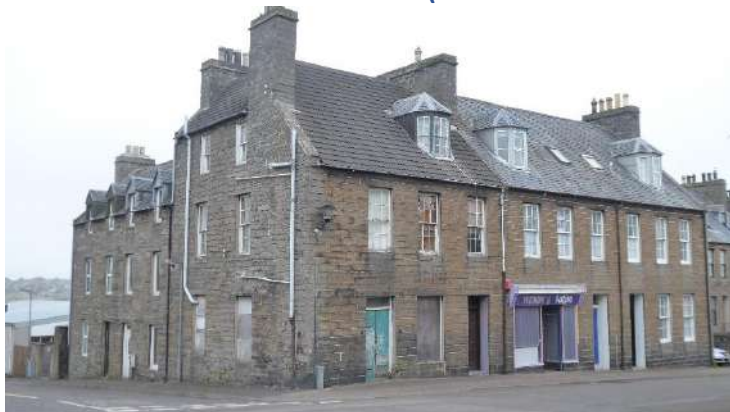
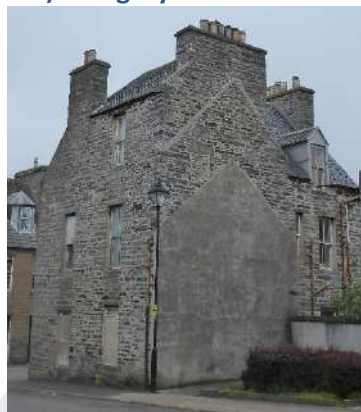
**Nos. 14-18 Breadalbane Crescent (corner of Lower Dunbar Street) Category B listed**  
**Nos. 28 & 29 Breadalbane Terrace (corner of Lower Dunbar Street) Category C listed**

Nos. 14-18 (c.1860 in HES, LB report 42291) are a terrace of 2-storey and attic, 3-bay, symmetrical, gable ended houses constructed in coursed Caithness stone. Nos. 14, 15 & 17 retain original 4-panelled entrance doors with rectangular fanlights above. Traditional 6 over 6 timber sash & case windows, and canted dormers (No. 17 retains its possibly original 4 over 4 windows). Grey slates, with flat copes and raised skewputt at each end of the terrace; 3 (possibly originally 4) gable chimney stacks with simple tabling course below the copes. Some adaptation including small plate glass shop front with recessed entrance door at No. 16. Concrete roof tiles to Nos. 17-18. No. 17 & 18 appear vacant.

The building forming Nos. 28-29 Breadalbane Terrace, directly opposite Nos. 17 & 18 Breadalbane Crescent is almost a mirror image; although with a loftier façade and (possibly later) 2 over 2 traditional timber sash & case windows. As well as retaining these windows it also has an unusual arched panelled door (fig 34c) thought to be a local design. HES, considers this to be of an earlier date than the opposite terrace, c. 1820 (HES, LB report 42295) and a house is recorded on this lot in 1818 (SRO/GD9/376/1). Nos. 28-29 vacant.

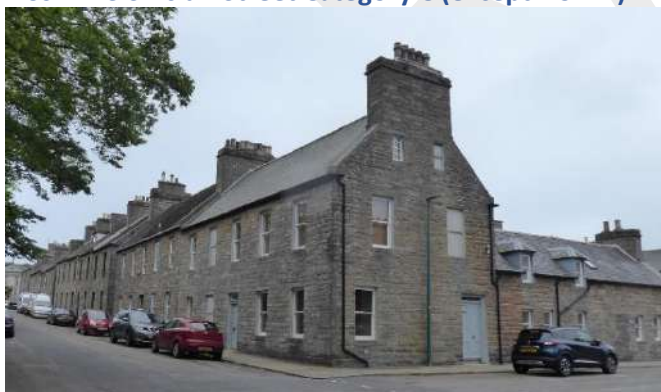
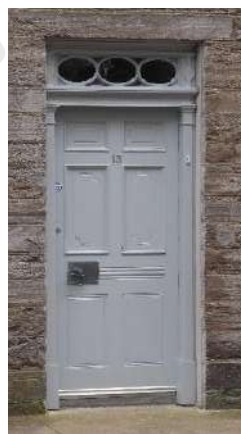
**Nos. 1-13 Sinclair Street Category C (except No. 12)**

A very consistent terrace of 5 and 2-bay houses in four blocks separated by narrow lanes. All original main doors survive except at Nos. 5, 6 & 9, several of unusual design thought to have been made by local joiners and several with original fanlights. Of particular note are Nos. 7, 8 & 10 which have central roundels, and Nos. 12 & 13 with a delicate 6-panel doors with pilasters supporting a 3 oval fanlights above (Nos. 3 & 4 without fanlight detail). A number of doors also retain original heavy bronze door ironmongery. No. 13 ends the terrace, with an adjoining single storey block extending along MacLeay Street. A traditional garret window survives at the attic level.

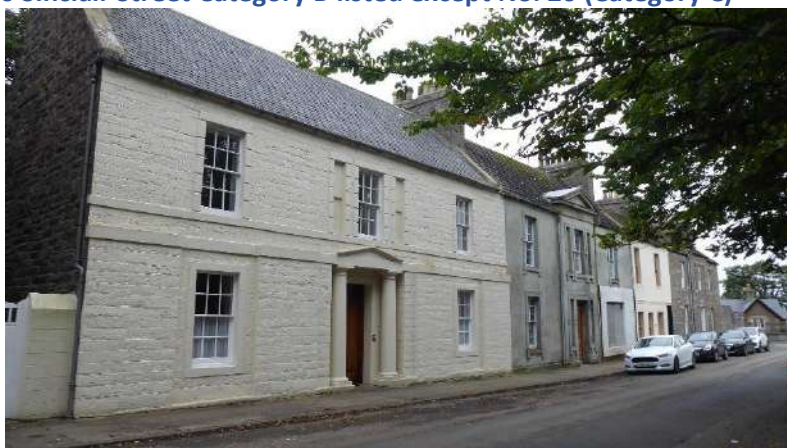
**Nos. 17, 18 & 20 Sinclair Street Category B listed except No. 20 (Category C)**

A distinctive group of three 2-storey, 3-bay, symmetrical, gable ended houses with refined architectural design and detail to their frontages. No. 19 (unlisted) forms a short 2-bay elevation. No. 17 has a slightly recessed door entrance with Doric columns and pediment forming a portico. Unusual tripartite paneled door to centre, with very decorative fanlight above (below). Slightly recessed window bays at ground floor. Raised, broached and droved ashlar margins to upper storey openings; centre tripartite window, centre flanked by narrow blind windows; dividing band between floors, and 1st floor cill course. 6 over 6 timber sash & case windows.

No. 18 has a similar tripartite upper window, the style of which is repeated to the entrance door below, both sit within a pedimented central bay which breaks through the eaves line. Raised, blocked margins to openings. Original 4-panel door with fanlight above.

There has been some adaptation to No. 18 with a commercial premises to part of the ground floor with a large plate glass window disrupting the regular design. Next door, No. 19 is not listed and is a 2-bay property. No. 18 and 19 received grants for windows works during the CARS project.

The façade treatments vary across the buildings which diminishes its group impact. No. 17 has painted coursed Caithness stone; No. 18 is smooth rendered (and ruled out) and No. 20 has exposed Caithness stone with later ribbon cement pointing. HES dates these buildings to c.1830 (HES, LB reports 42331, 42332, 42333) however not part of the 1813 Draft Feu Plan and likely after 1840.
