## HIGHLAND COUNCIL

**Committee:** Caithness Committee

**Date:** 12 August 2021

**Report Title:** Draft Wick Pulteneytown Conservation Area Appraisal and Conservation Area Management Plan

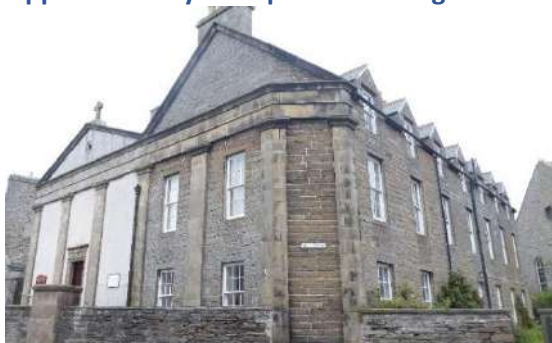
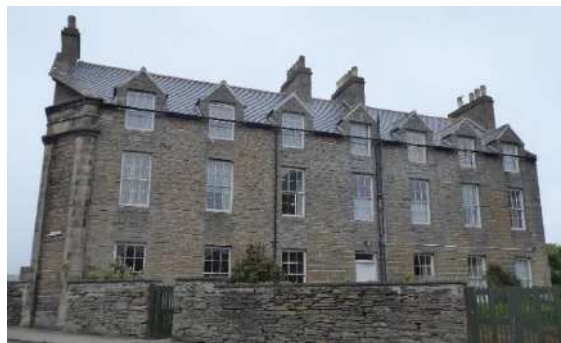
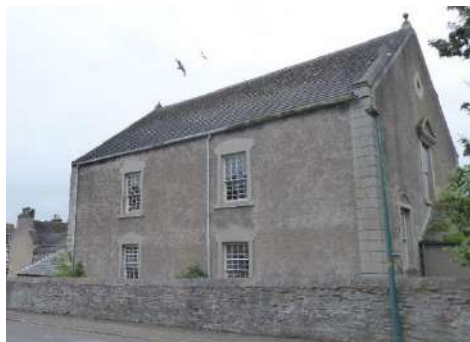
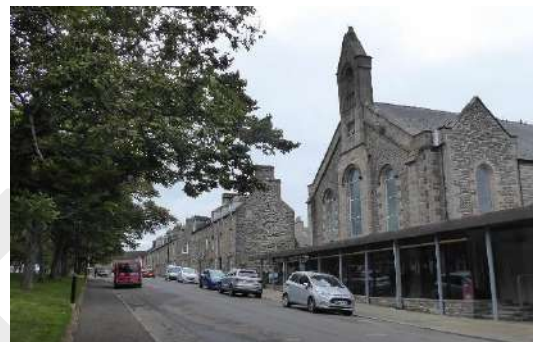
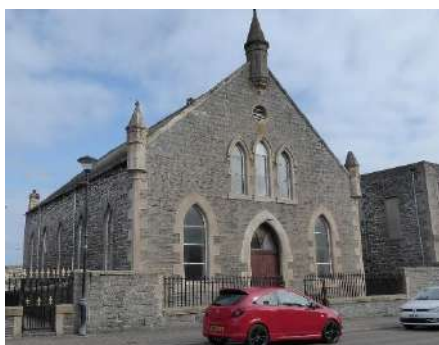
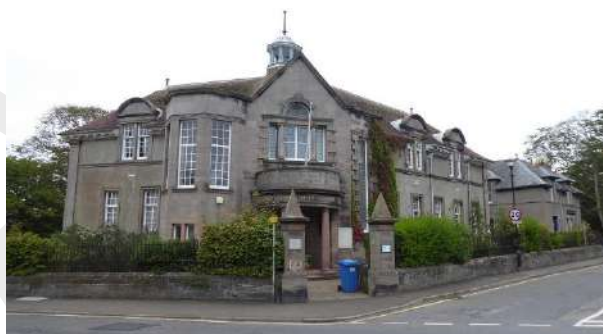
### Upper Pulteneytown public buildings

There are five churches in Upper Pulteneytown. St Joachim's RC Church (top left; 1833-34 William Robertson Architect Elgin; Category B) was the first to be constructed, on land gifted to the church after the contribution of Father Lovi during the cholera epidemic of 1832. The imposing pedimented and pilastered frontage closes views along Sinclair Terrace, the rich brown sandstone came from Moray. It was originally a seasonal church for catholic itinerate workers. The adjoining building (top right; Category C listed) was built in 1869 and designed as a school but eventually used as a convent and nursery (now converted to residential flats).

Standing opposite St Joachim's is the Wick Martyr's Free Church (centre left; Category B listed) dated 1839 on its finial; originally the Reformed Presbyterian Church, and after several changes was last the Wick & Keiss Free Church (not in use as such). Unusually the rear of the lot was not developed and remains a gap on the corner at Dempster Street. Three further churches were built in the upper town: Pulteneytown Parish Church, Argyle Square (centre right; 1842; Category C); former Pulteneytown Free Church, Dempster Street (fig 25; 1853; Category B; now Wick Baptist Church; not in the conservation area), and former Free Presbyterian Church, Breadalbane Crescent (bottom left; 1905; no longer Place of Worship).

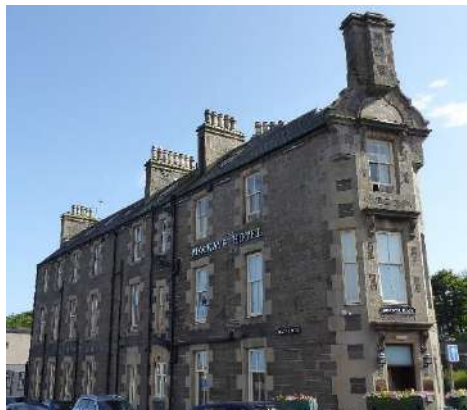
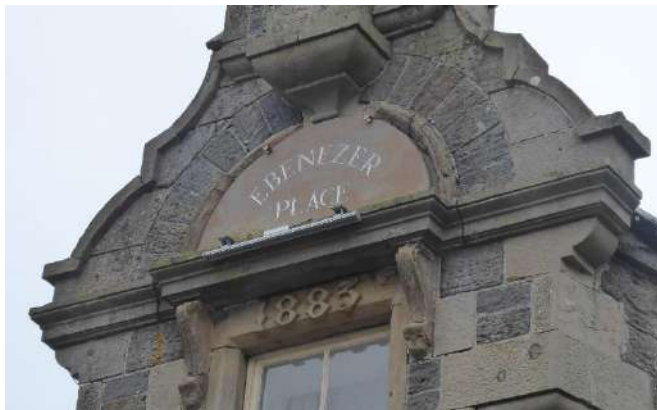
### Mackays Hotel, Ebenezer Place/ Union Street / River Street, not listed

Built in 1883 by Alexander Sinclair as a Temperance Hotel, it is described by Beaton (1996, 37) as “filling a narrow triangular plot as regally as a ship’s prow...” with apex chimney stack and date stone below the incised Ebenezer Place. Ebenezer Place is in the Guinness Book of Records as the smallest street in the world at 6’9” (2.05m) across. Later 20<sup>th</sup> century function room extension next to the former Baptist Church (1868; currently owned by hotel but not in use).

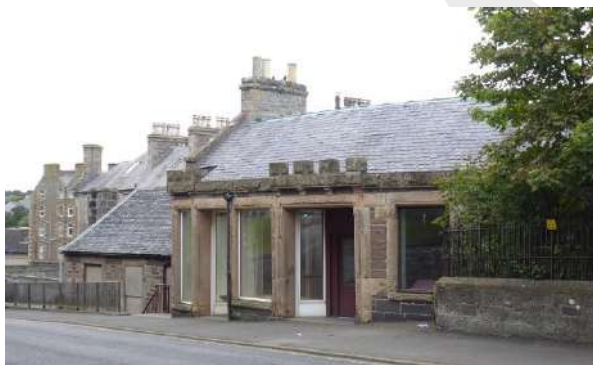
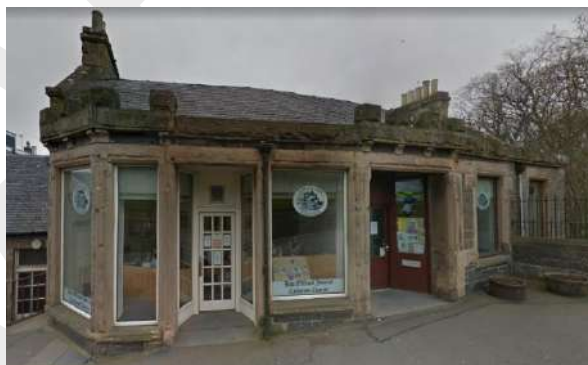
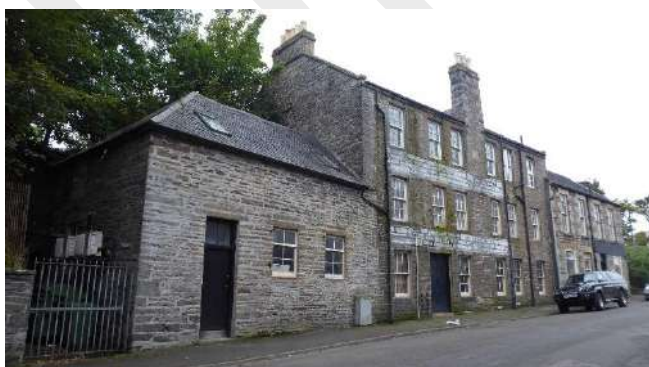
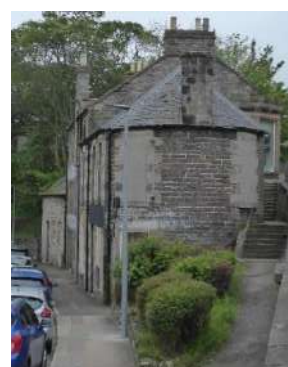
### No. 42 Union St / Cliff Road, The North of Scotland Newspapers Category B listed

Terrace of 3 linked buildings of varying height spanning the site at the western tail of the steep bank that separates Lower and Upper Pulteneytown, with external steps connecting Union Street and Cliff Road. The building appears as a single storey cottage on Cliff Road, with 2 and 3-storey works and offices to the rear (Union Street). Until 2020, the home of the John O’Groats Journal and Caithness Courier. Key features include the typically Georgian elegant bow end in coursed Caithness stone with sandstone window margins. The plate glass and rubble face stonework to the shop front on Cliff Road is a later adaptation.

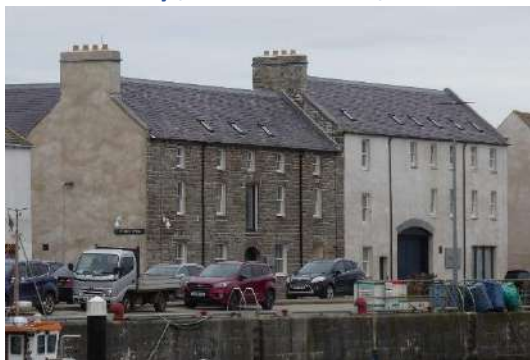
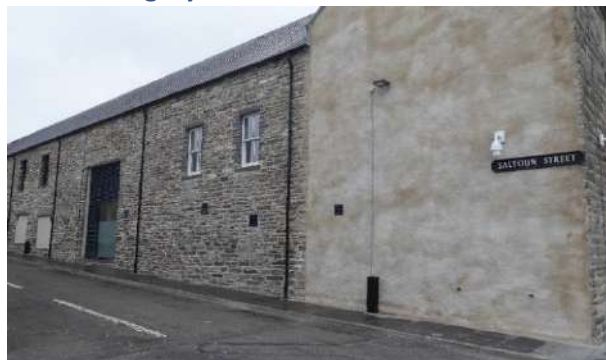
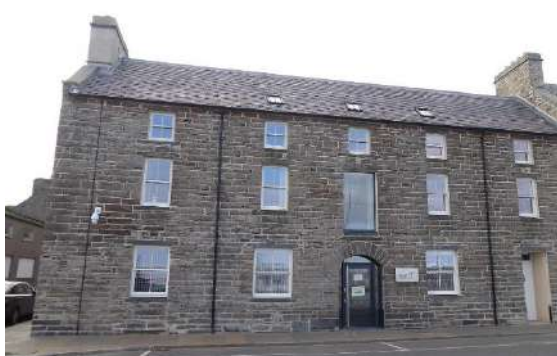
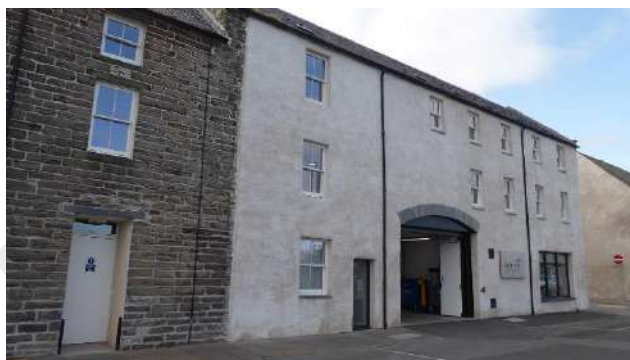
**Harbour Quay / Saltoun Street / Telford Street block. Category C listed**

Street block comprising two 3-storey, 5-bay, gable-ended storehouses constructed in coursed Caithness stone; partly lime harled during recent adaptation and restoration. Building on the corner with Saltoun Street has regular fenestration with a segmental-arch (originally a pend) at the centre at street level and above a former doorway at 1<sup>st</sup> floor above (now glazed); smaller windows to 3rd storey. Blind gable with stout chimney stacks, simple tabling course below the cope. Building on the corner of Telford Street, harled; previous large vehicle entrances slapped to centre and right. 2-storey walls ran the length of the plot on the side roads to enclose a herring curing yard; blocked windows were reinstated during restoration. The building recently adapted and brought back into use with SSE funding for use by the Beatrice Offshore Windfarm.

In 2002, HES stated that: “... this storehouse displays the best-preserved elevation of a typical Pulteneytown storehouse/curing yard although the interior curing yard had been covered over. The building materials of stone and slate, and the overall dimensions, height and length, for the storehouses that form the Lower Pulteneytown grid were drawn up by Telford as part of his overall town plan and were laid down in the BFS's Building Regulations. However, the central segmental arched pend that forms the central feature of the storehouses, where remaining, was not specified by Telford but appears to be a practical design that was widely adopted, thereby forming a local design type. The buildings are in effect complete fish processing factories rather than simply storehouses. The original layout, repeated throughout, was of a large gabled storehouse and offices building facing the main street and running the entire length of the feu, i.e. a whole or half block. The central archway led through a pend to a large open air flagstoned curing yard behind. The curing yard was surrounded on the remaining three sides by ancillary stores and workshops such as the salt stores, cooperage and smokeries. From the outside the continuous high walls of the yards, running round the entire block, hid the industry within.” (HES, LB report 48404).

Comprising 2 of the original lots auctioned in 1808 (lot 3 & 4 on the Draft Feu Charter 1813; fig 8), a building on Saltoun Street was recorded in 1813, the lot described as “...enclosed by a wall 9 feet high. Salt cellars and a cooperage in the yard are the only houses yet erected” (SRO/GD9/376/1, 1, 1818). The storehouse therefore built sometime after March 1818.

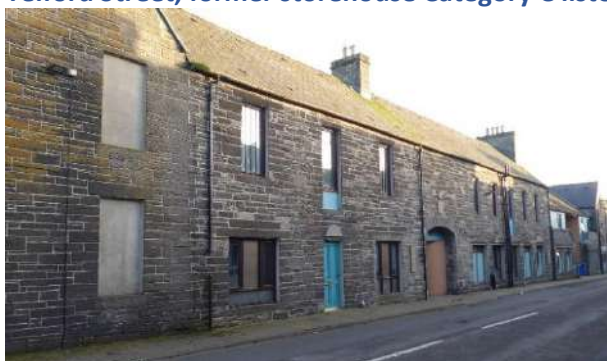
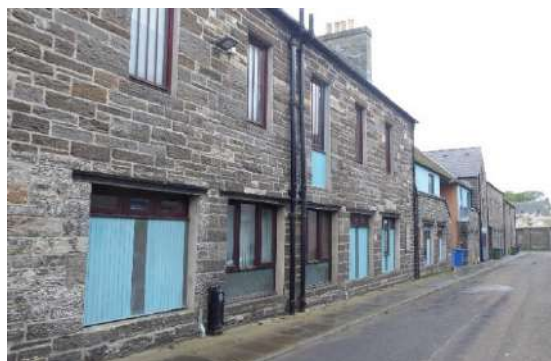
**Telford Street, former storehouse Category C listed**

Formerly disused 2-storey, 9-bay storehouse with central pend constructed in coursed Caithness stone slabs. Feued in 1814, but possibly built c. 1830 (HES, LB report 48410). Earlier alterations such as the large square windows to the ground level were present before more recent adaptation to housing funded by the Heritage Lottery Fund. This listed building abutting the Williamson Street terrace housing to the east now forms part of a larger housing development with other unlisted buildings on this section of Telford Street.

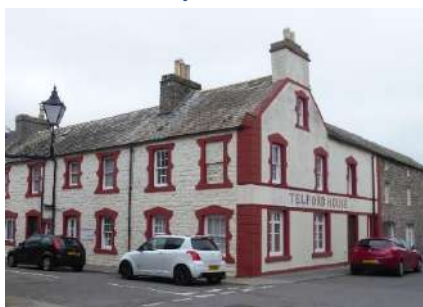
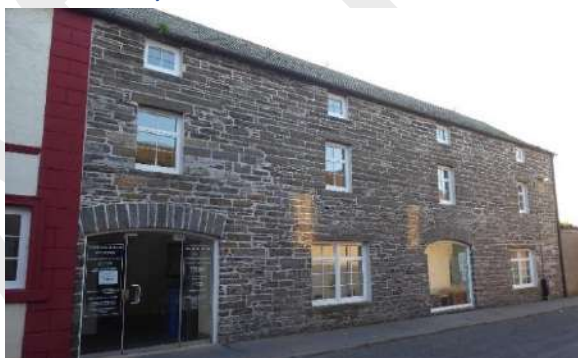
**Telford House / offices on Telford and Williamson Streets, not listed**

A wide 4-bay storehouse on Williamson Street with two pend entrances has been converted to office space and sits alongside the contrasting style of Telford House, possibly built as offices / housing. It has details typical of the more refined Upper Pulteneytown houses with unusual raised margins to the openings and moulded string courses to the ground floor lintols and 1<sup>st</sup> floor cills; unusually the gable end is not blank, as was common in the warehouses, and is pronounced by channelled quoins and banded cope and decorative skewputt; it also features a central garret window. This level of detail contrasts with the typically plain stone façades of the other lower town housing for example the block south of this on Williamson Street (fig 15).

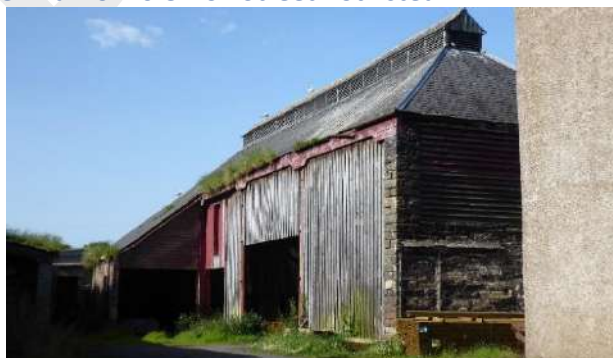
**Former kipping kiln behind No. 16 Union Street not listed**

Thought to be an original kipping kiln later adapted for timber storage, at the rear of a Union Street lot in a former curing yard (1<sup>st</sup> Ed. OS Town Plan; Canmore ID 100253). The long ridge ventilator and the open slatted gable are typical features.

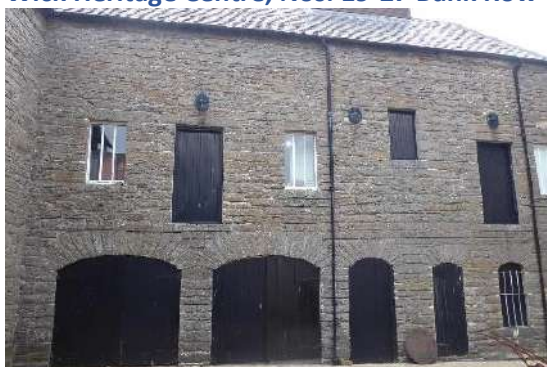
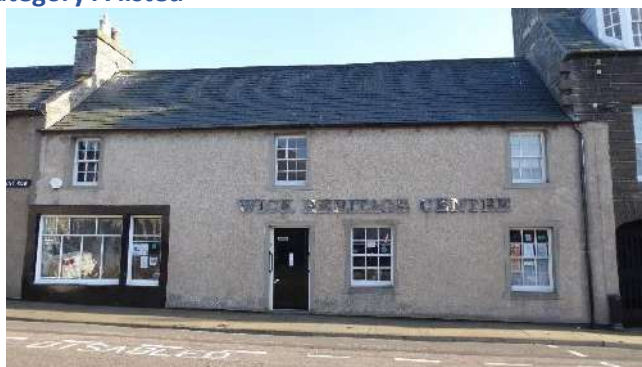
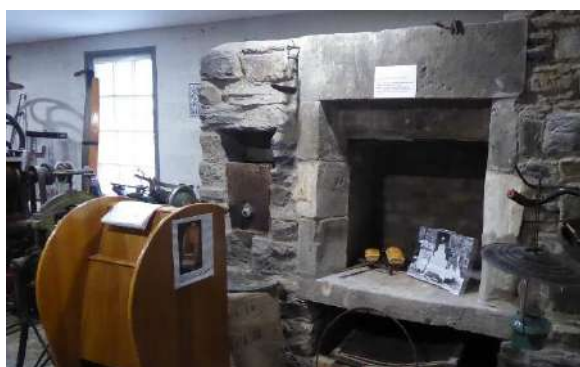
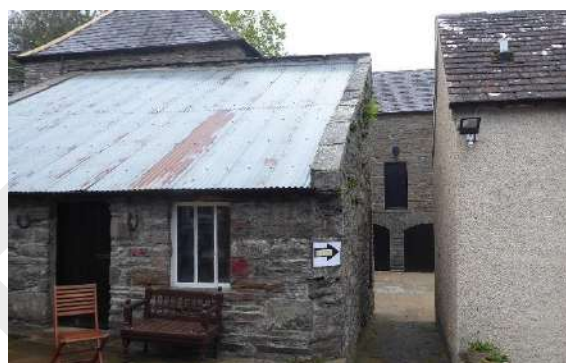
**Wick Heritage Centre, Nos. 19-27 Bank Row Category A listed**

The Heritage Centre comprises a complex of buildings including dwelling houses on the street frontage, curing yard, cooperage, kippering house/kiln, and blacksmith's. It forms part of the terrace backing onto the steep slopes below Upper Pulteneytown. Segmental arched pend leading to the yard enclosed by buildings some with very fine masonry detailing (fig 29). Buildings gifted to, and opened in 1981 by The Wick Society. CARS grant for comprehensive repair of roofs, and joinery including the shop front. HES (LB report 42286) states that the Wick Heritage Centre is listed Category A as the last surviving example of a traditional herring curing house in what was, from 1820 to 1914, the busiest herring port in Britain and northern Europe. Interiors of particular interest include the herring drying and smoking racks and the cooperage.

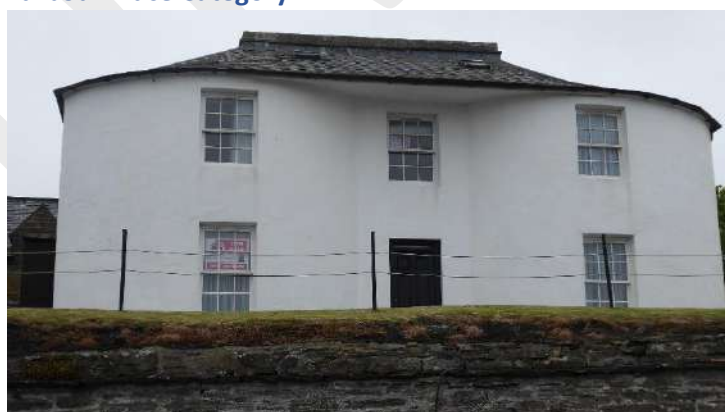
The Round House was designed by Thomas Telford and built by George Burn in 1807, who was responsible for constructing Telford's original Wick bridge and the Inner Harbour. Later occupied by James Bremner who built the Outer Harbour. Occupying a commanding position overlooking the harbour, the house has a striking and elegant double bow front with over hanging eaves, the elegant design emphasised by the smooth rendered finish and shallow piend roof; the original long row of chimney stacks have sadly been reduced to a flat coping (refer Beaton, 1996, 44). CARS grant for reinstatement of windows and doors, and repair of the original 'Roman cement' render finish.

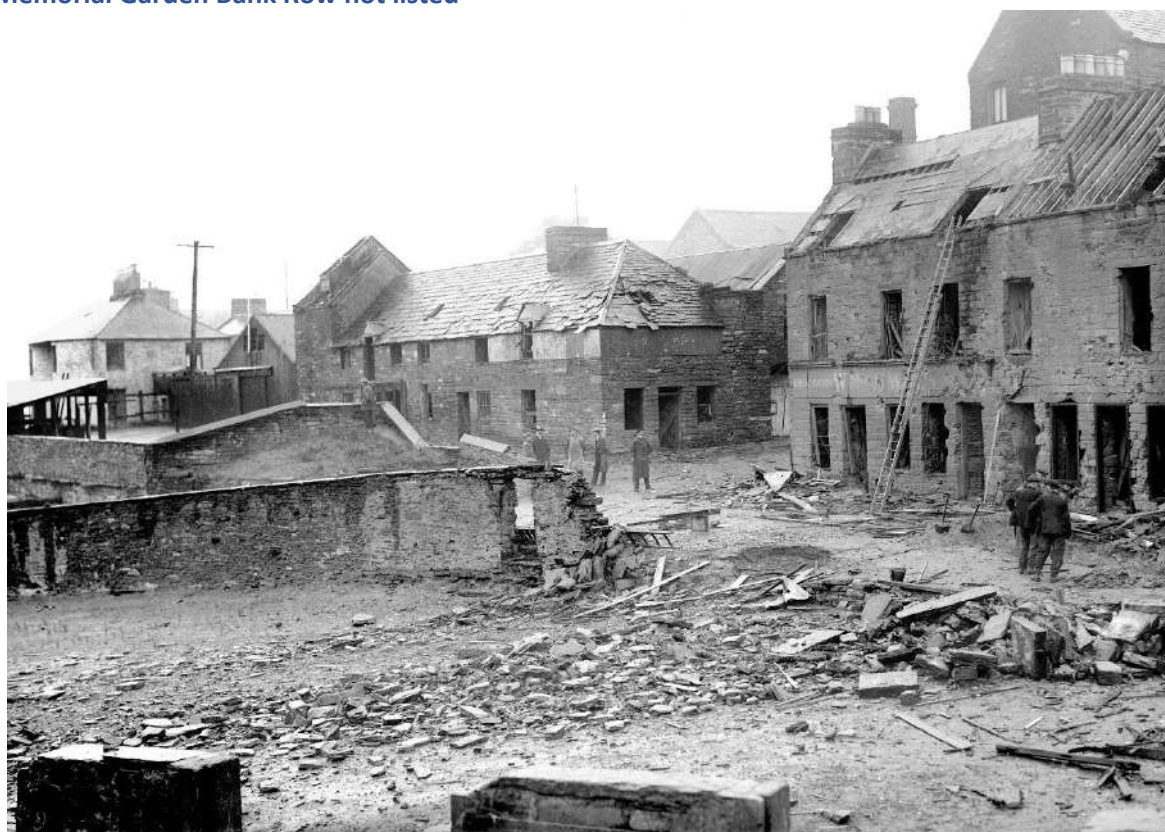
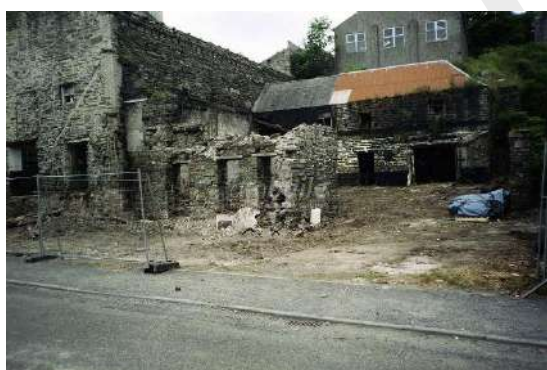
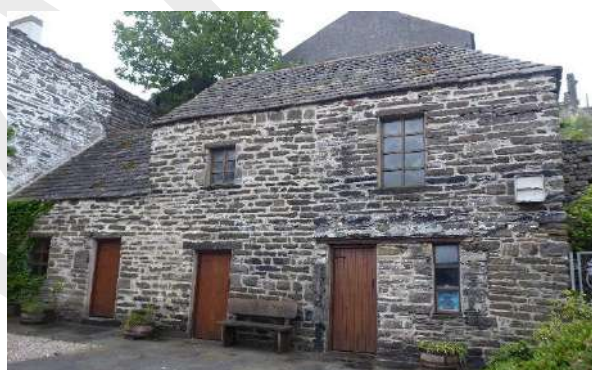
**Memorial Garden Bank Row not listed**

Surviving traditional building at the rear of one of the lots bombed during the Second World War and where the street fronting buildings were damaged and subsequently demolished. The top image illustrates the bomb damage adjacent to the garden on the corner at the Black Stairs © The Wick Society - The Johnston Photographic Collection.

Having laid derelict for many years, the area is now a Memorial Garden to those killed in the Wick bombings and the building has been restored with a Caithness slab roof. (left image prior to restoration © Am Baile).

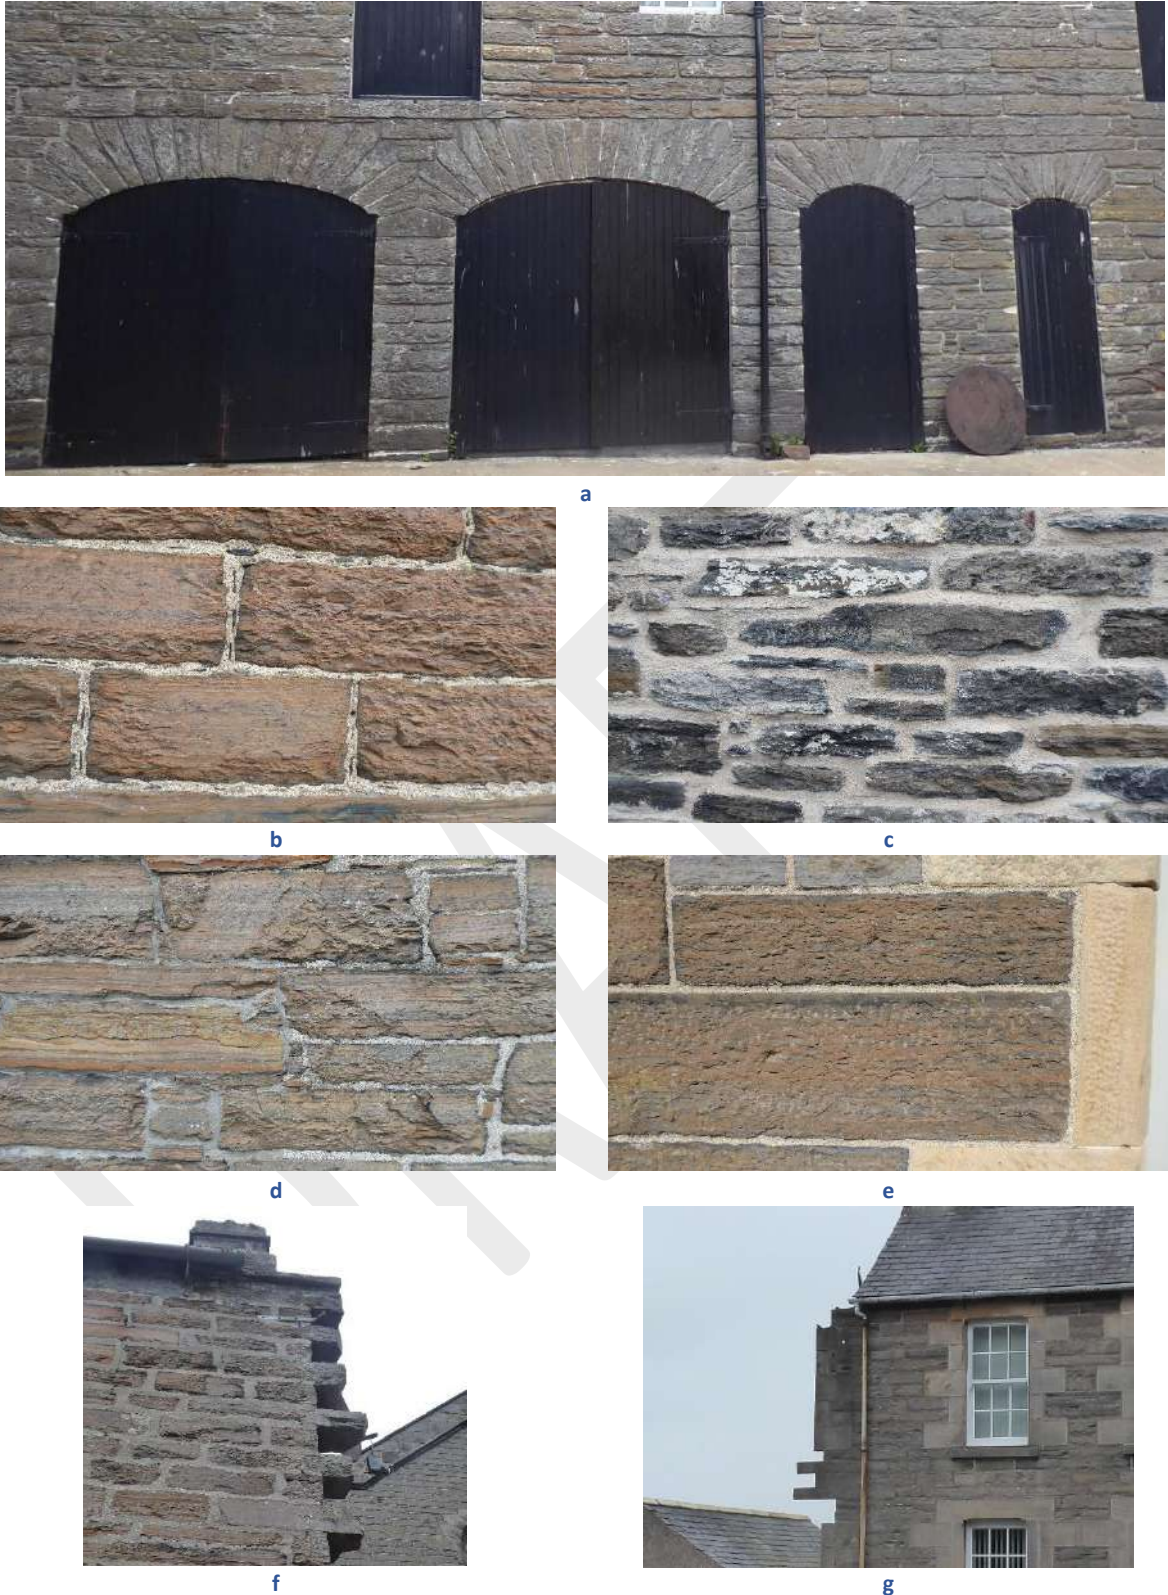
Figure 29: Masonry details: a: very fine examples of the segmental arches used in Pulteneytown particularly in the industrial buildings and to access internal yards, here at the Wick Heritage Centre; b: squared blocks of a warm brown Caithness stone with lime mortar and slate pinnings; c: walling recently repointed in lime on Saltoun Street warehouse, note the stones are more irregular in shape and darker grey in colour; d: a similar wall on a domestic property with irregular stones and courses, the gaps made up in smaller stacked stones; e: shaped Caithness stones on a Victorian building, cut to size, and used with sandstone dressings for openings; f and g: examples of masonry with projecting stones, known as ‘tusking stones’ or ‘tuskers’; left for bonding into the adjoining façade; image g showing the dressed window stones for the next property.

In Lower Pulteneytown the building function varied from residential and office buildings, which were of modest design like the upper town, to larger warehouses. The character of the warehouses is stark, with simple window and door openings within a plain stone façade running sometimes 60 feet continuously to meet the original design regulations. There are fewer breaks in the facades, unlike the passageways in the residential town, but there are more frequent arched entranceways, a detail characteristic of the construction of Pulteneytown referred to locally as the 'Telford arch' (section 4.2.3; fig 29).

The flagstone character of the Caithness stone created masonry walling with narrow courses and typically long stone lintols over openings. Where larger openings were required a stone arch was formed and this attractive structural detail is a strong characteristic on Pulteneytown found in both the upper and lower towns. The origin of the arch design is not clear, for as HES state (section 4.2.2) this was not specified by Telford, however it is referred to locally as the ‘Telford arch’ or the ‘basket / basket store arch’. Some buildings, such as the curing yard of the Wick Heritage Centre, exhibit very fine masonry detailing (fig 29). In some places small pinning stones are common, making up the gaps in the longer flagstones. The colour of the stone can vary quite considerably from a warm golden colour to a blue grey as described in the Account, often within the same stone. This gives an overall subdued light to mid brown appearance from a distance.

Another common feature within Pulteneytown is what appears to be the remnants of the masonry technique whereby individual stones are not cut off, but left to project into the adjoining building lot to allow bonding of each façade to the next. This technique is known as ‘tusking’. These stones can be seen in several locations where adjacent lots were not developed (figs 29 & 30).

Window and door openings in the earliest houses were simply formed using a flagstone lintel and squared stones forming the opening (fig 30a). Some margins are emphasised with raised banding sometimes with incised detail such as at Nos. 50-53 Argyle Square (fig 34). Dressed sandstone margins are less common but examples can be found such as Nos. 48 and 49 Breadalbane Terrace which has a refined Georgian façade complete with decorative ironwork balcony to the first floor windows (fig 30b).

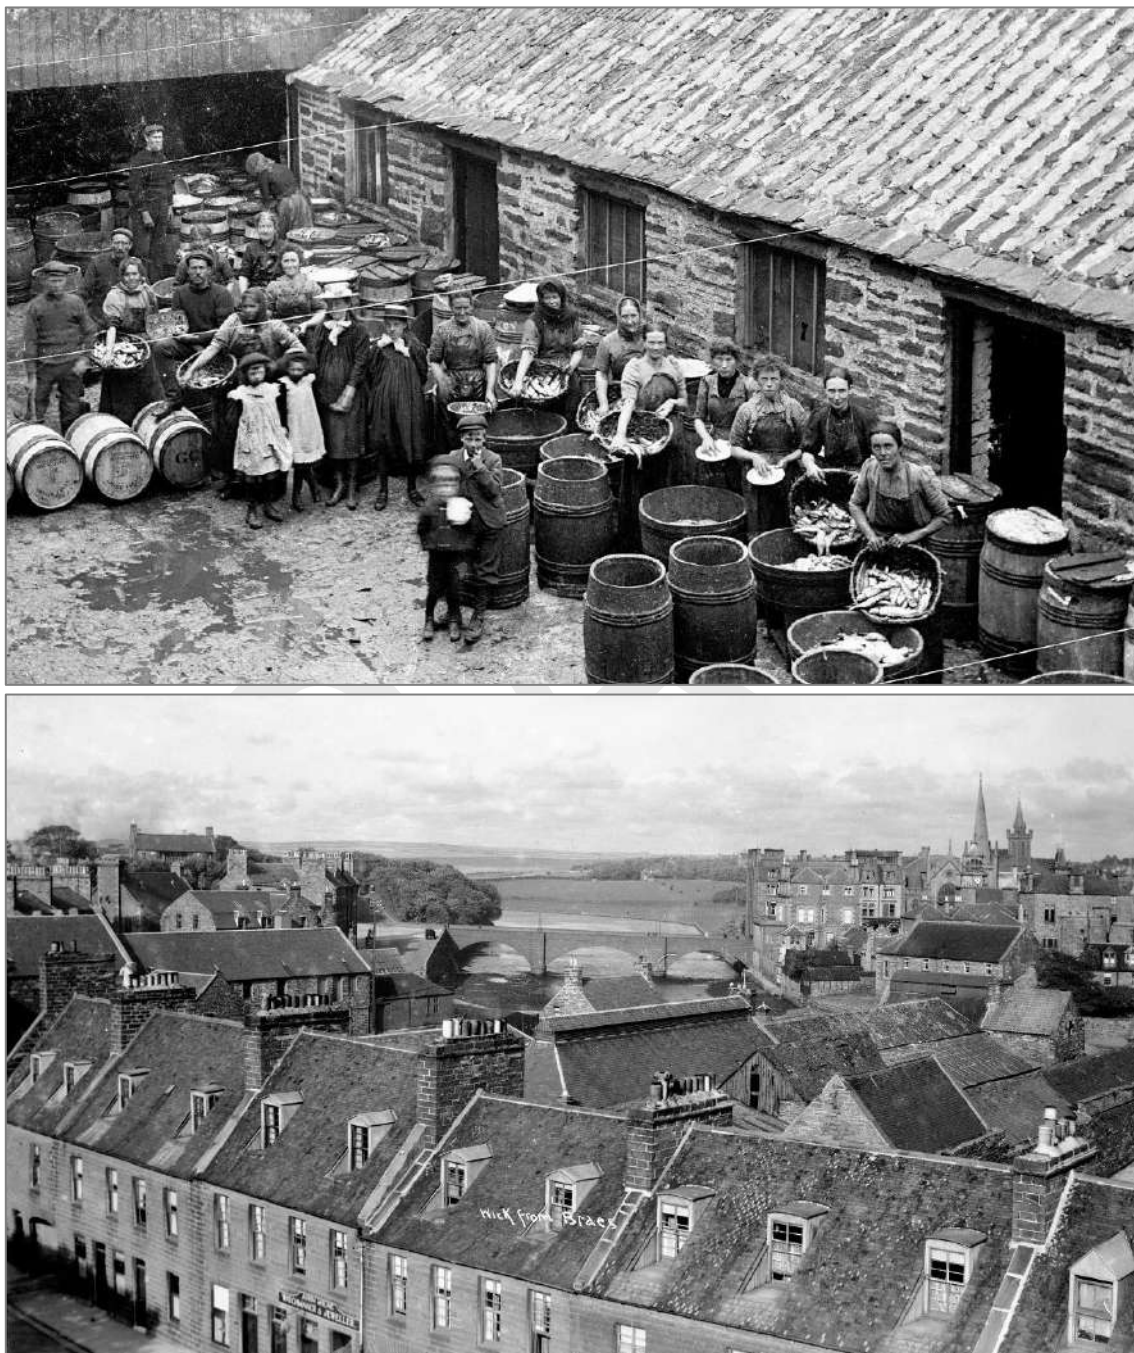
Figure 31: (top) George Cormack’s yard in Lower Pulteneytown in 1900s with pantiles on the roof of the single storey building and what looks to be a Caithness slate easing course at the eaves; a rough cobble stone finish to the yard; (below) Historic view over the roofs in Union Street illustrating the predominance of slate roofing but with other finishes including pantile on some industrial buildings. © The Wick Society - The Johnston Photographic Collection

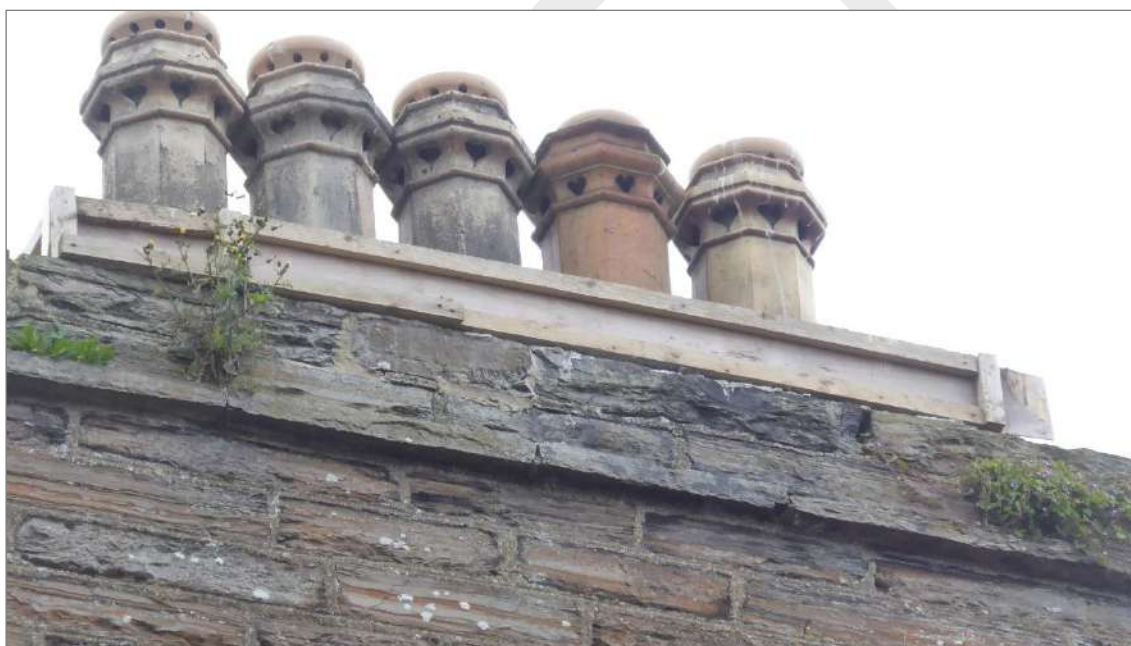
Figure 33: a typical Pulteneytown chimney with a thin flagstone slab forming a projecting tabling course detail before a further one or two courses of stone form the cope. Here with more elaborate hexagonal buff coloured chimney pots.

Chimney pots are still common, although a significant number have been lost or removed. The most common are cylindrical buff terracotta pots, but there are more decorative hexagonal pots (fig 33).

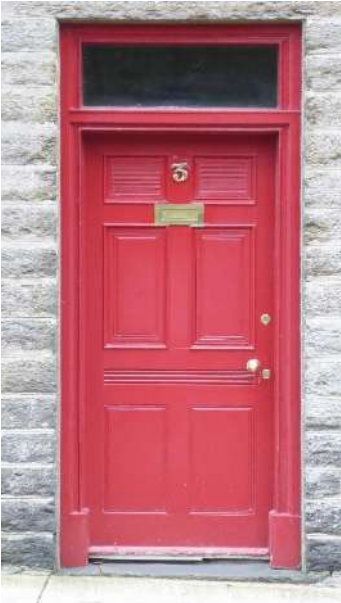
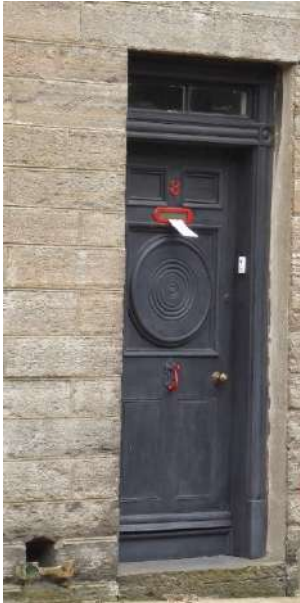
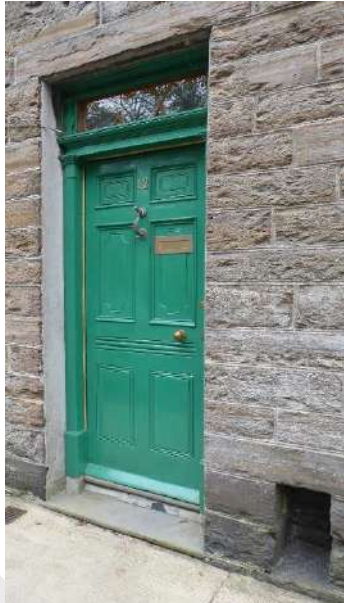
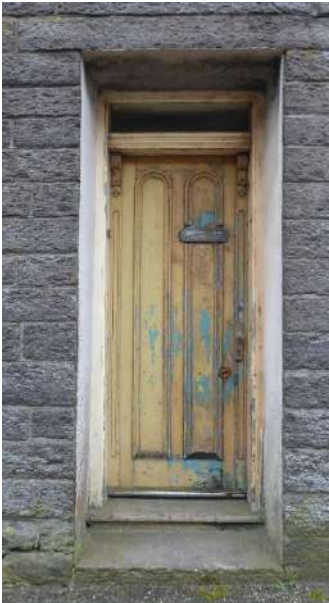
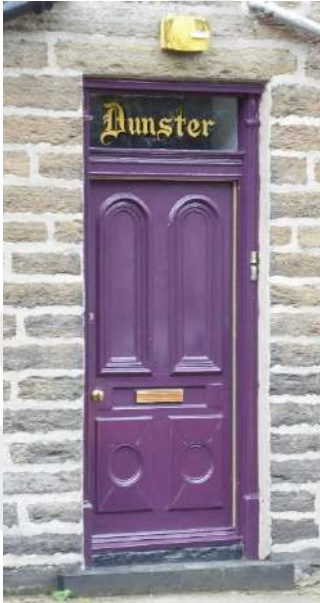
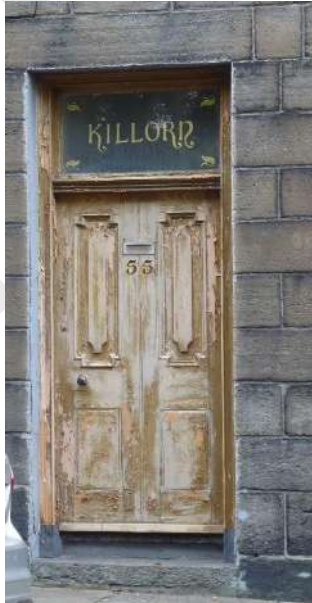
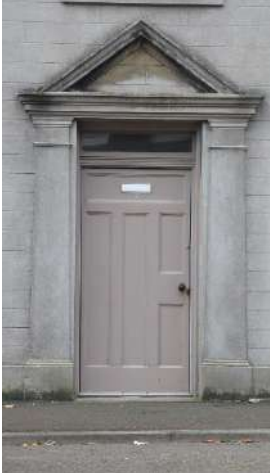
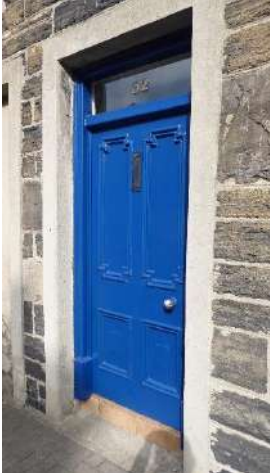
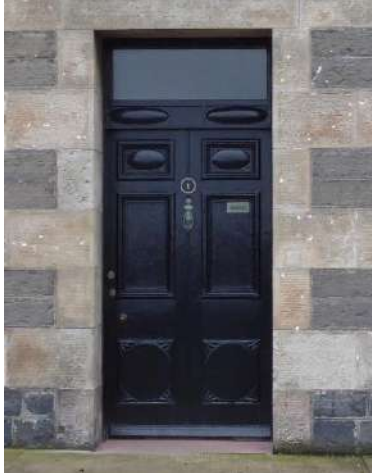
Figure 34: Windows and doors: the variety, distinctive detail and carpentry skill evident in surviving original doors.

There are a good number of surviving traditional entrance doors (fig 34 a-i), and as Beaton (1996) describes some are very attractive and distinctive, including a significant number of original doors on Sinclair Terrace (section 4.2.2), Breadalbane Terrace, Argyle Square, Union Street and Dempster Street (out with the conservation area). Most have rectangular fanlights above, often with decorative timber work dividing the glass in a number of designs including circles (No. 49 Breadalbane Terrace; fig 30b), ovals (No. 13 Sinclair Terrace, section 4.2.2 and No. 12 Sinclair Street fig 34c), and more elaborate shapes (No. 17 Sinclair Terrace; section 4.2.2). These small but refined details are important in defining the character of the properties, and conserving surviving joinery is an important consideration.

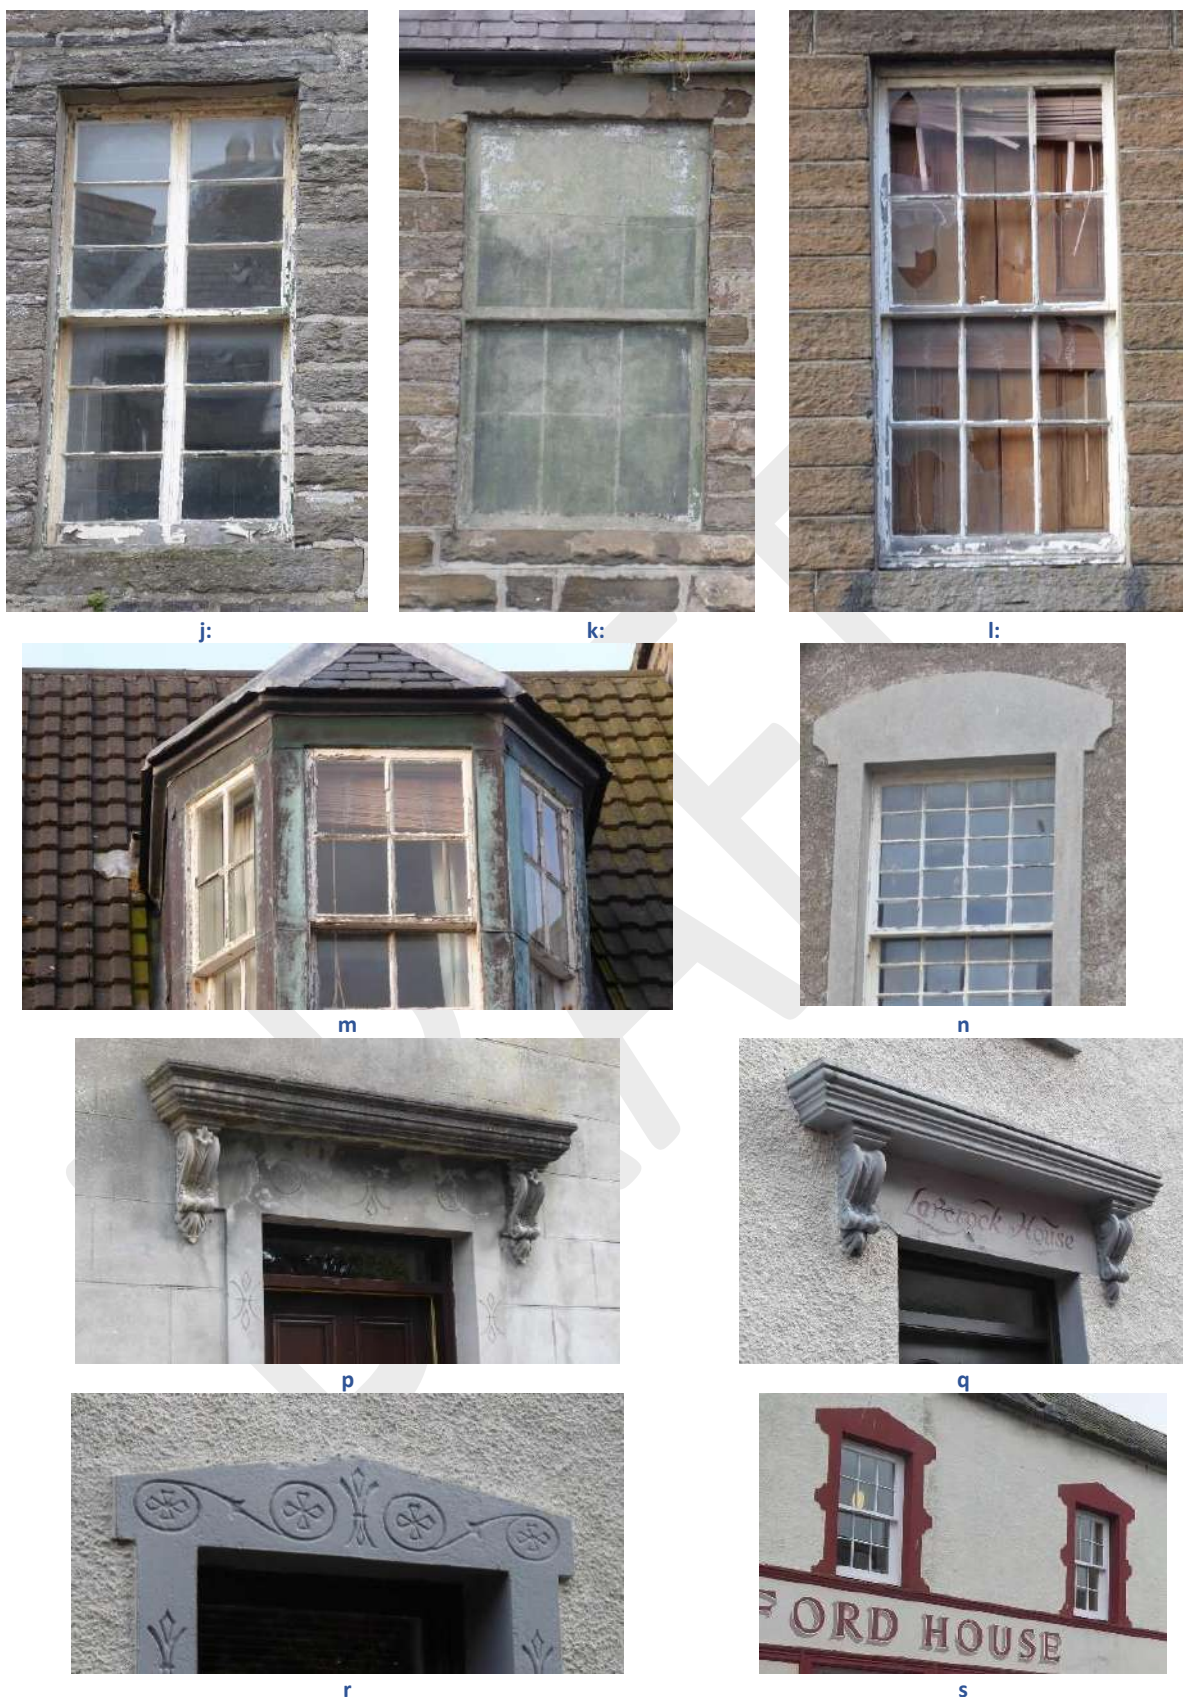
Figure 34: Window and doors: j: original lying pane windows at 2 Union Street; k: blind window on Smith Terrace; l & m: typical 6 over 6 Georgian window with internal shutters at 17 Breadalbane Crescent, with 4 over 4 pane dormer window to attic; n: distinctive multiple pane window on former Wick Free Church on Malcolm Street; p-r: examples of incised detail on door surrounds, console brackets and moulded lintels in Argyle Square; s: unusual window margins to Telford House in Lower Pulteneytown.

several properties had this design, with original windows surviving on No. 2 Union Street, which also displays the Georgian 'blind window', a blank window used to maintain the symmetry of the elevation (fig 34). Other fenestration patterns include 2 over 2 (as original or mid-Victorian replacements) and which can be seen for example of No. 29 Breadalbane Terrace (fig 21). More unusual window patterns are reserved for public buildings such as churches with both St Joachim's and the Martyrs' Free Church having multiple pane windows. Examples of original windows or traditional windows of some age are fairly rare notwithstanding the examples above, although other examples may survive to rear elevations.

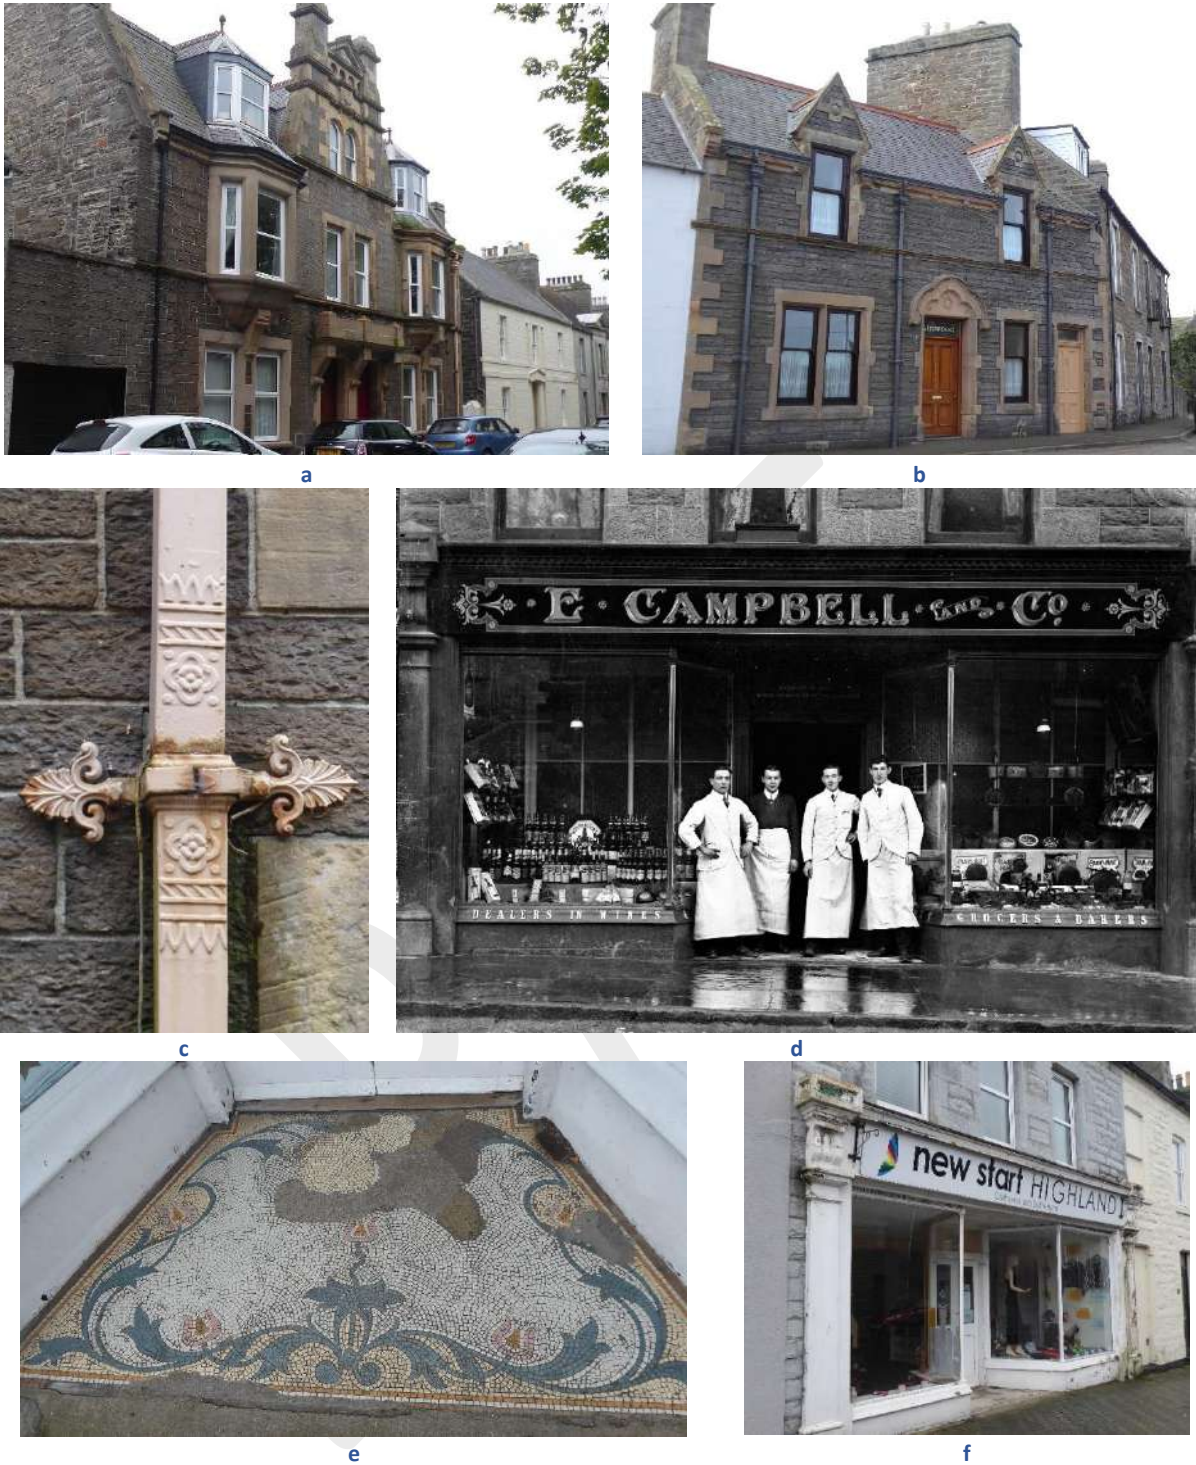
Figure 35: Victorian buildings: a: Nos. 15 and 16 Sinclair Street are elaborate Victorian style houses which dwarf their Georgian neighbours and exhibit much of the change in design and material use by the end of the 19<sup>th</sup> century; b: a more modest Edwardian house on Breadalbane Terrace built in 1911 with again more intricate stonework and decorative cast iron rainwater goods; c: decorative square downpipes and acanthus holding brackets at 15 and 16 Sinclair Street; d-f: just out with the conservation area, a late Victorian shopfront survives with a traditional terracotta mosaic entrance platt, originally E. Campbell & Co. Grocers. (Historic image © The Wick Society - The Johnston Photographic Collection).

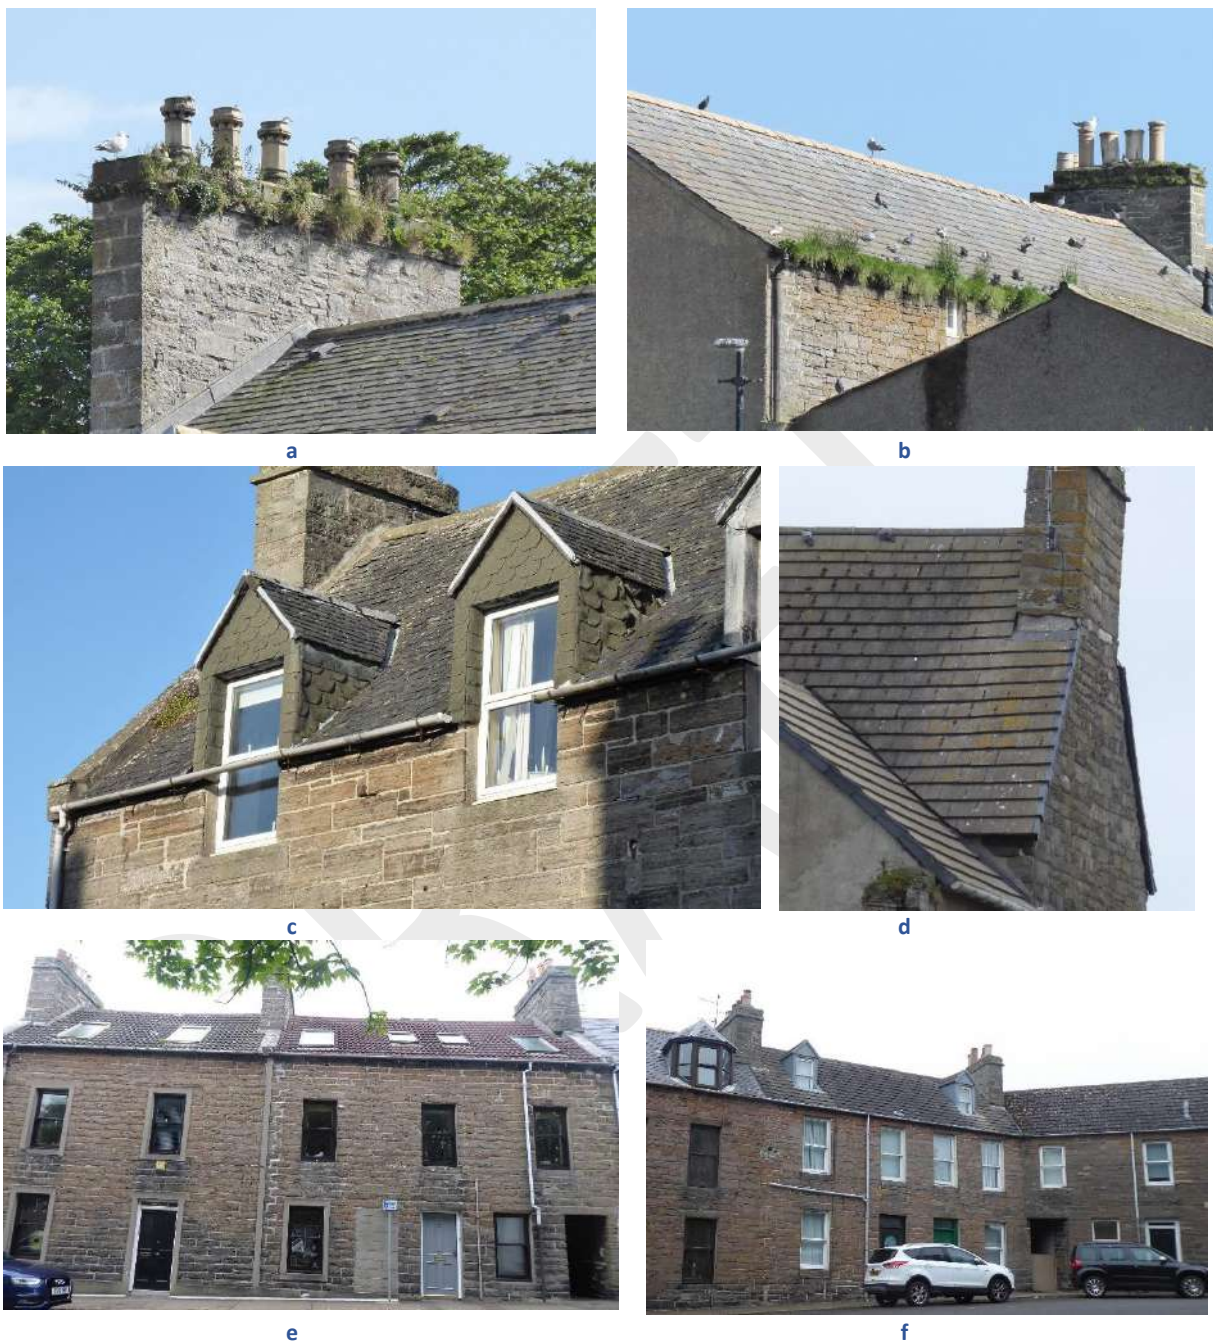
Figure 36: two common examples of vegetation growth leading to different defects and courses of action: a: plants taken root in open mortar joints in the masonry chimney. This is significant and roots unattended will continue to grow into the masonry and expand, over time destabilising the chimney stack; b: grass growing in a presumably blocked gutter with debris forming a soil for the vegetation. Here the blockage will lead to dysfunction of the rainwater system and overflowing of rainwater over the masonry walls and potentially backing up under the roof slate into the interior of the building; c: inappropriate materials, felt tiles, applied to two traditional gabled dormers; d: concrete tile replacement roof with possible removal of stone copes at the gable wall head, replaced by a plastic edge trim; e & f: inappropriate tile roof replacements on the terraced rows in Argyle Square; e: two different tiles, one red in colour both with large replacement rooflights; f: again two different tile finishes with a new slate finish on the left and a later large canted bay dormer.
