## HIGHLAND COUNCIL

**Committee:** Caithness Committee

**Date:** 12 August 2021

**Report Title:** Draft Wick Pulteneytown Conservation Area Appraisal and Conservation Area Management Plan

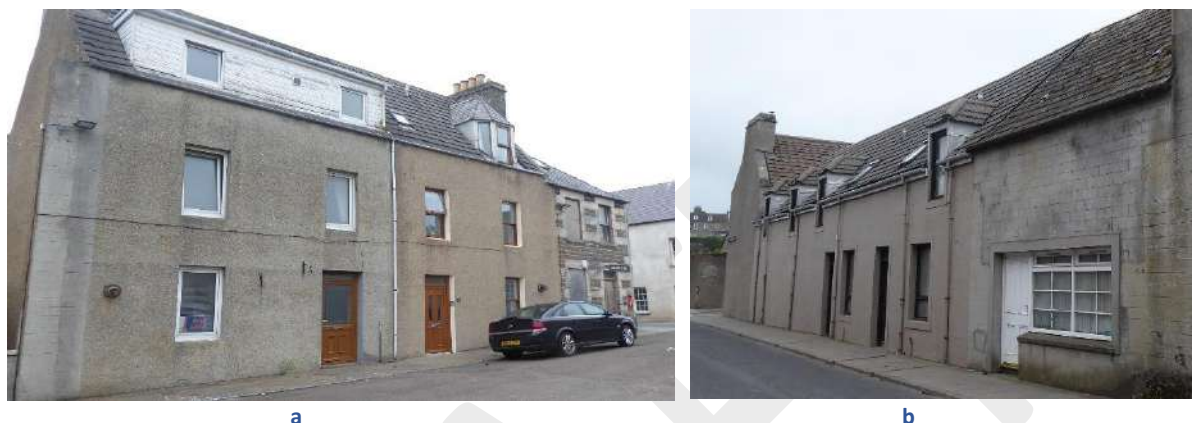
Figure 37: modern cement finishes applied to traditional buildings; also note on a: the large box dormer which has a negative impact on the building frontage and roofscape; and b: again shows the presence of concrete tiles, here next to a restored traditional Caithness slate on the roof to the right.

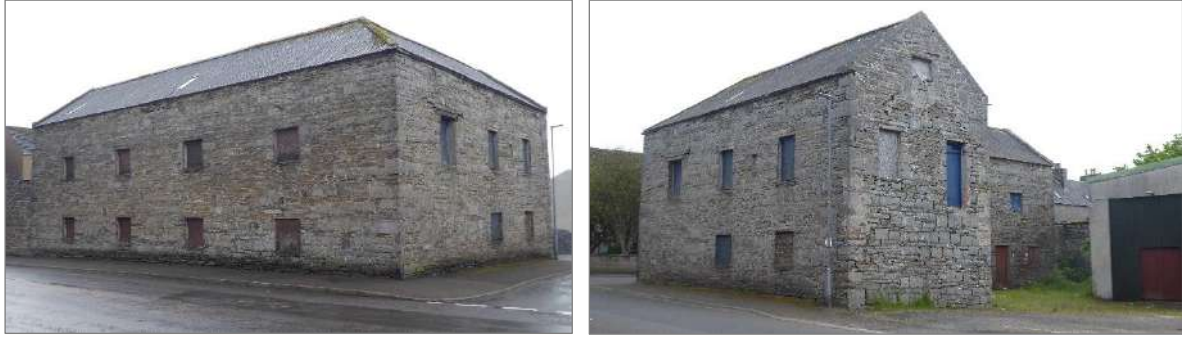
Figure 43: industrial building which formed part of the rope works on Brown Place at Macrae Street corner.

Pulteneytown and in views to and from Argyle Square (fig 25). Similarly Brown Place (fig 44) forms the stop end or back to the Argyle Square lots and has a strong traditional character. The remaining warehouse, and walls of the contemporary rope works, should also be considered for inclusion in the conservation area, and /or as an independent listed building (fig 43).

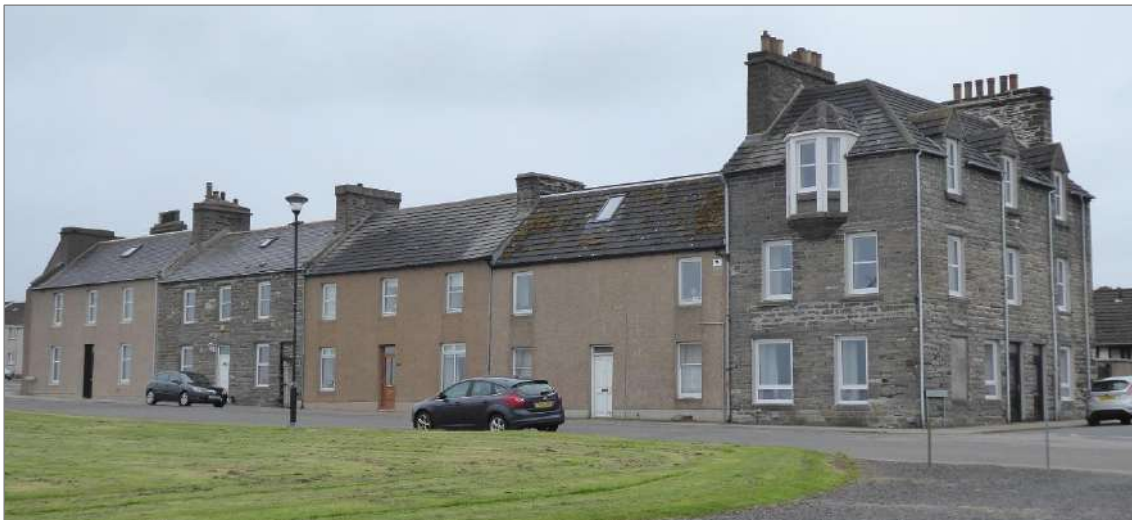
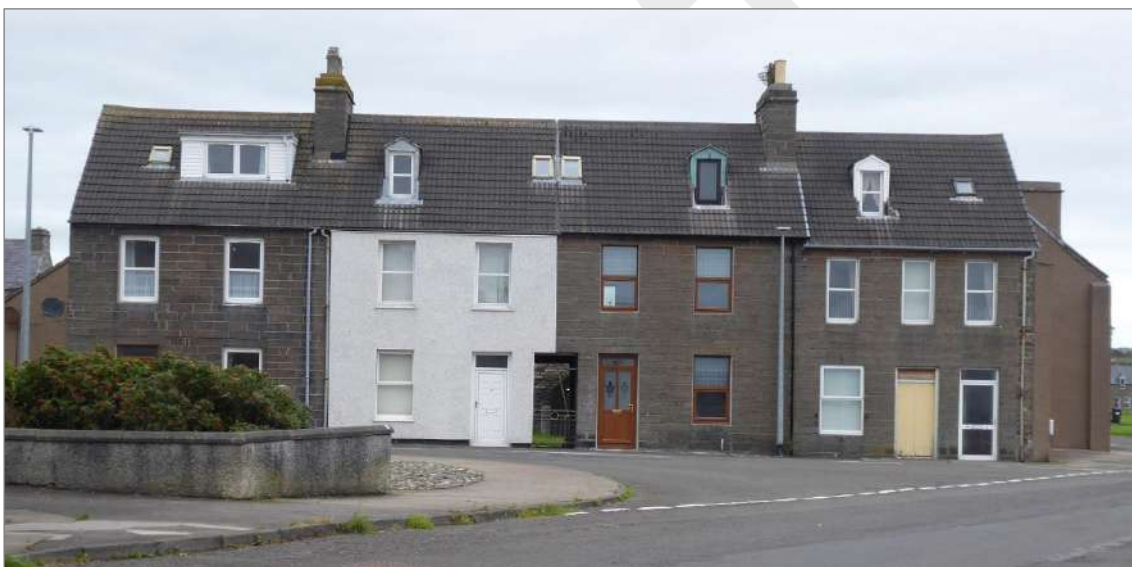
Figure 45: (top) pre-1839 properties forming the eastern row of Smith Terrace and similar original houses on Vansittart Street (below) all part of Telford’s plan and having been feued by George Burn; part of Lot 1 on Vansittart Street was constructed by 1813, thought to be Nos. 5 & 6 on the left of the pend. Both rows out with the conservation area.

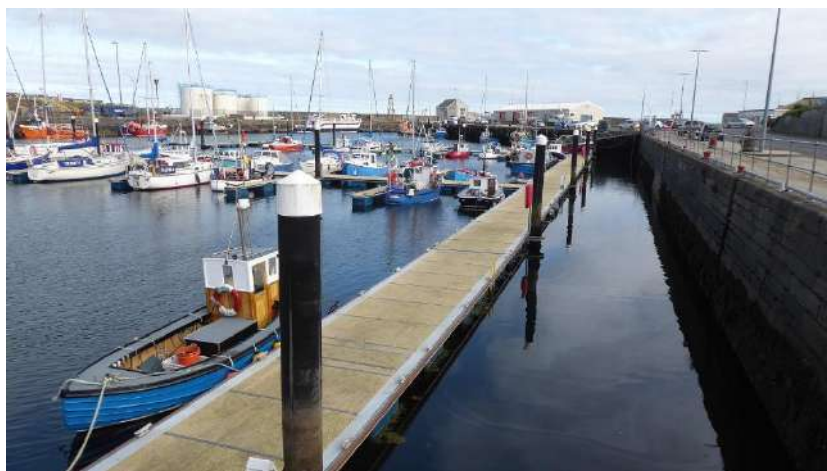
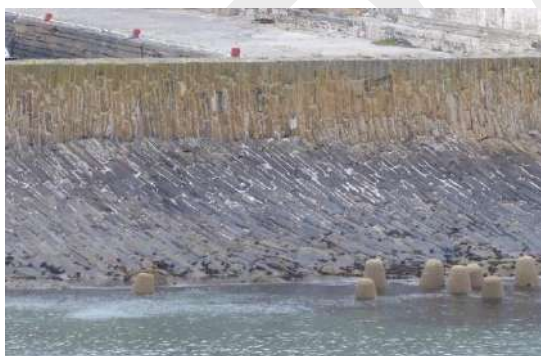
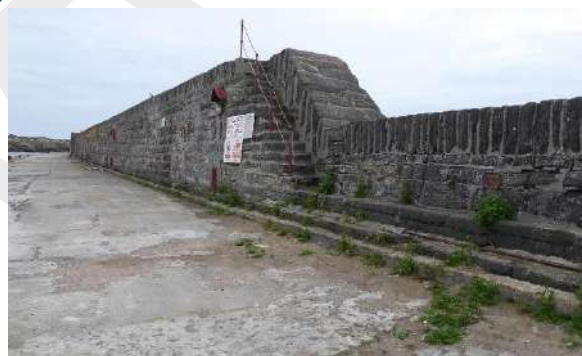
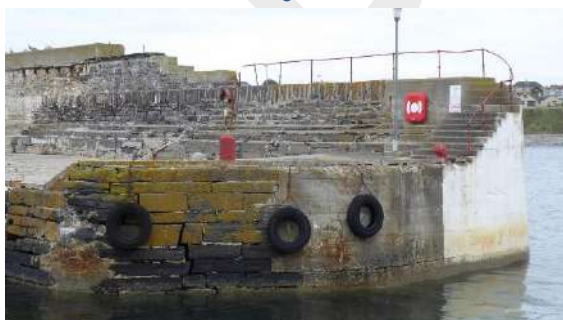
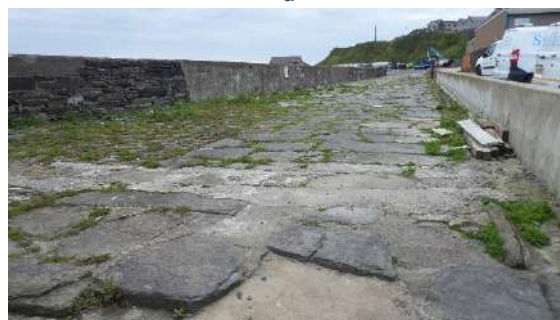
Figure 46: a: Inner Harbour, original stone walling on the right; b: Outer Harbour general view with both lighthouses; c-d: traditional stonework forming the outer harbour's south pier; e: eastern end of the north pier; f: flagstone quay at eastern end of the South Quay.

A fundamental part of the design of Pulteneytown is the infrastructure which forms its harbour (figs 46 & 47). The Inner and Outer Harbours provide the wider setting of the modern day town and have a significant influence on the character and appearance of Pulteneytown and activity within the area. Buildings and structures in this area have a direct impact on the town beyond and on the appearance of the town on seaward approaches. Several industrial buildings have a positive impact such as the small wooden fishing gear sheds (Beaton, 1996, 43; fig 47) on South Quay.

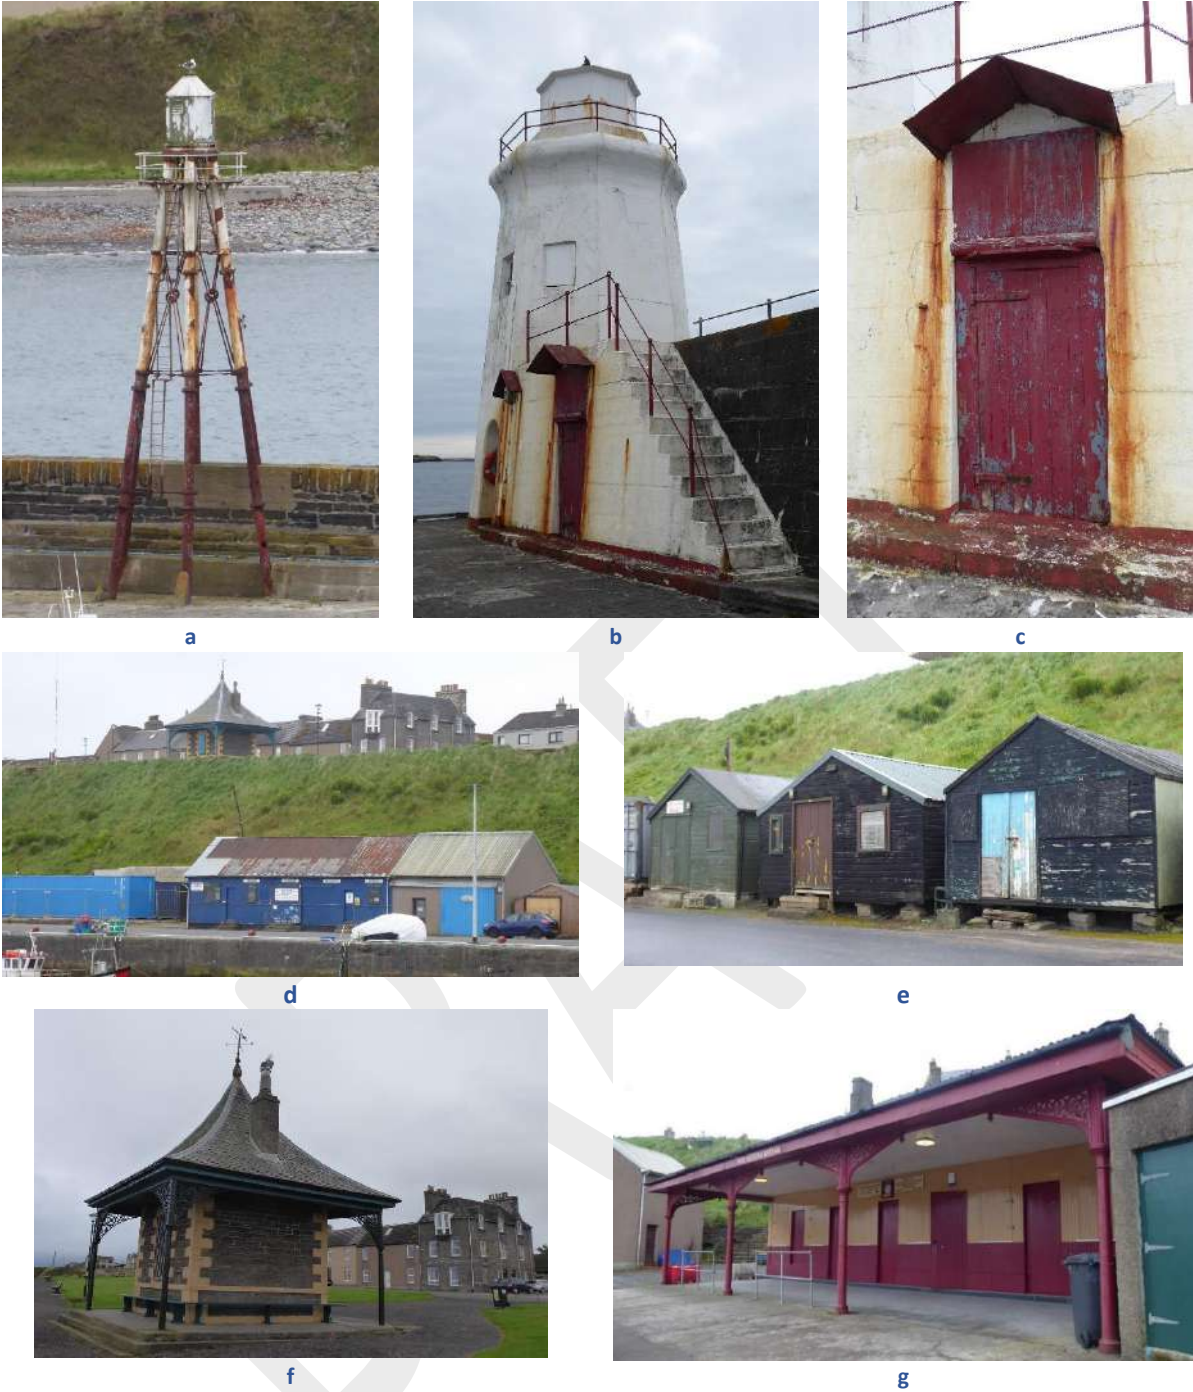
Figure 47: a: north pier lighthouse; b -c: south pier lighthouse; d-e: small traditional style timber fishing sheds on South Quay, d: with Braehead behind, note the small structure of the Pilot's House and beyond the traditional houses on Smith Terrace, all currently out with the conservation area; f: the Pilot's House; g: the historic Fishing Mart on the South Quay.

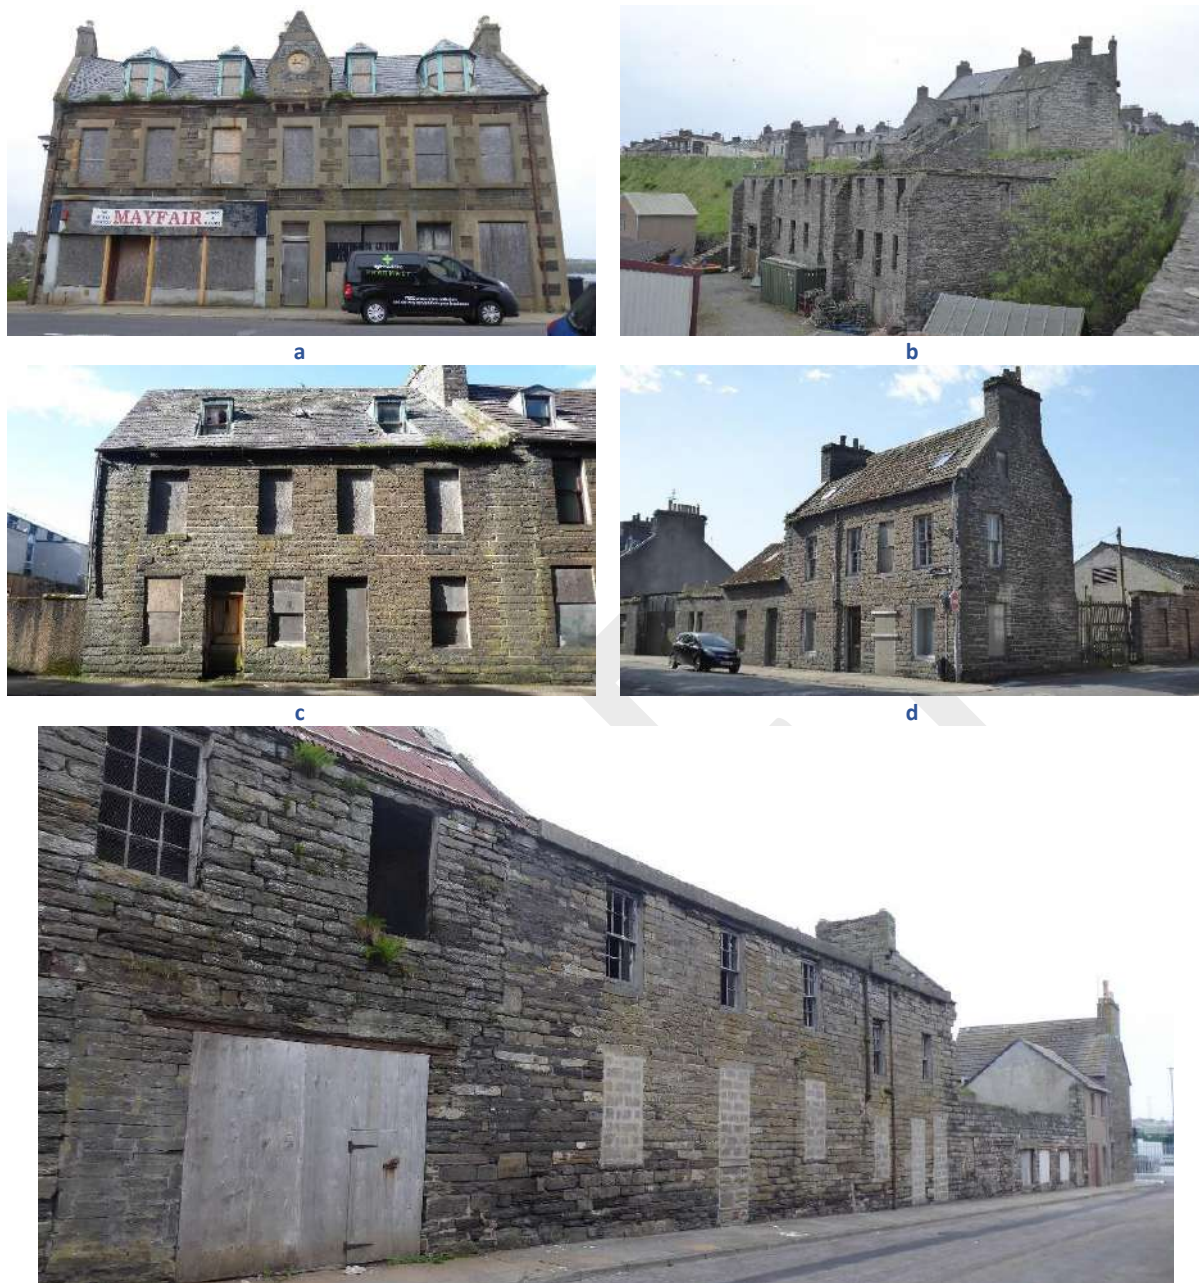
Fig 49 a: former Cooperative store at Nos. 1-4 Macarthur Place (not in CA); b: former Cooperative bakery, South Quay (not in CA); c: Nos. 15 & 16 Union Street; d: No. 2 Union Street; e: partially roofed buildings on Burn Street.

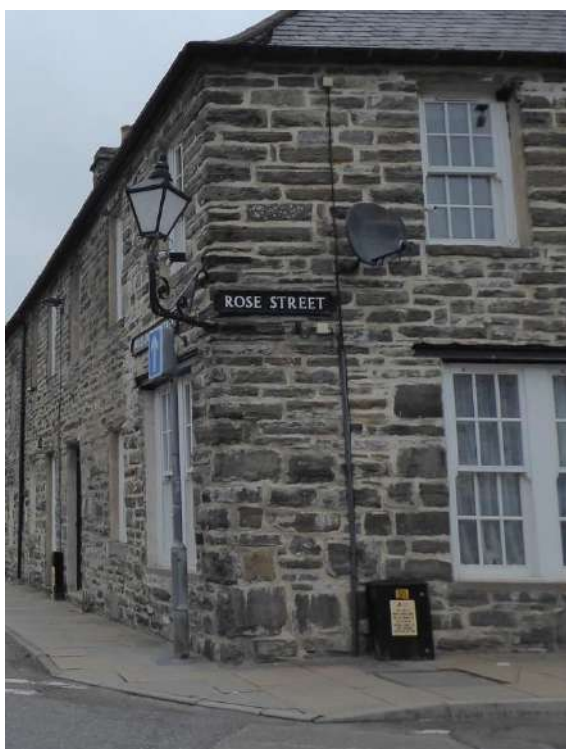
Mixed and cluttered street furniture: enhancement gained by using a traditional lantern and street sign is offset by cabling, satellite dish position and standard one-way road sign. Note the dropped kerb using Caithness flagstone.

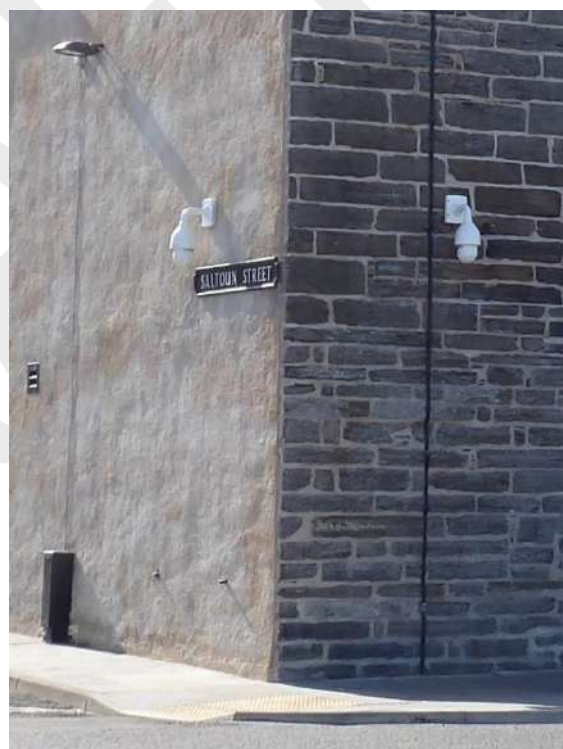
Reinstated lime harling on prominent gable with traditional street sign alongside a standard flood light and two modern white lamps showing a lack of appropriate and coordinated design. Note dropped kerb constructed using textured concrete paving which is not in keeping with the Caithness flagstone.

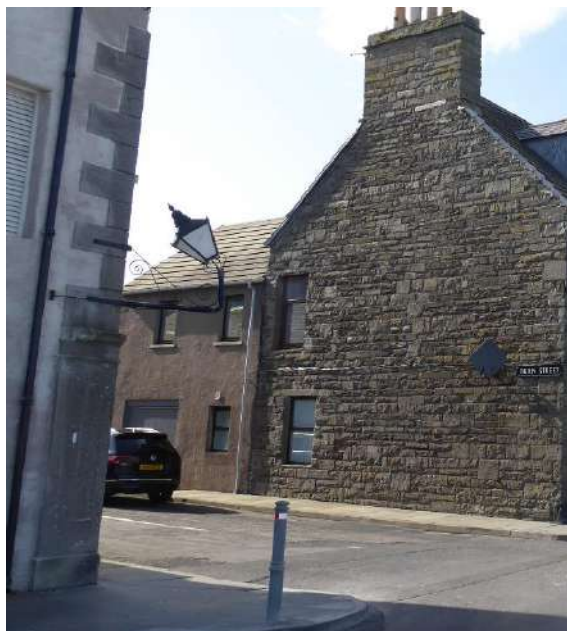
Mixed and cluttered street furniture: enhancement gained by using a traditional lantern and street sign is offset by a grey standard relective bollard and poorly positioned satellite dish. The lantern has suffered impact damage.

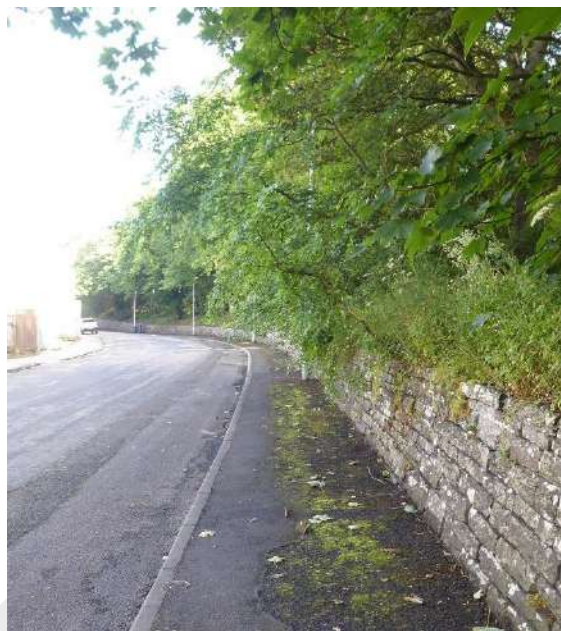
Union Street was not part of the enhancement area for the the previous THI programme. The tarmac pavements are in poor repair and the managment of the green space has been highlighted. Both offer opportunity for enhancement.

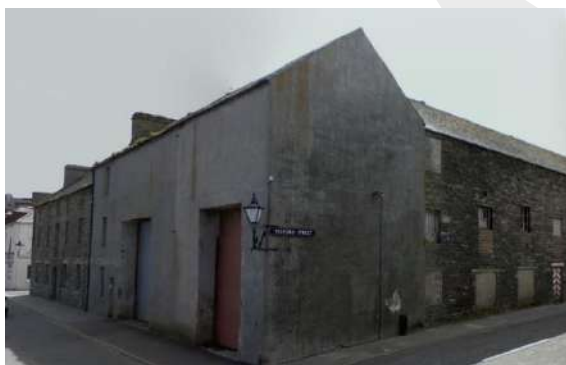
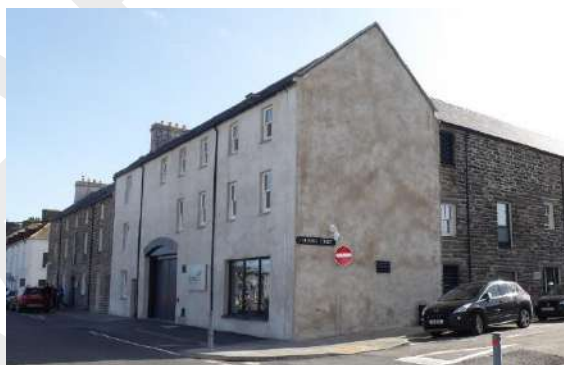
Before and after of Telford/Saltoun Street east block adapted for Beatrice Offshore Windfarm Ltd, opened in 2019; SSE funded (left) © Google Maps 2008

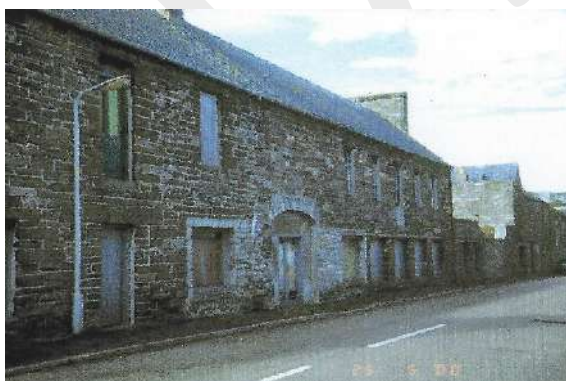
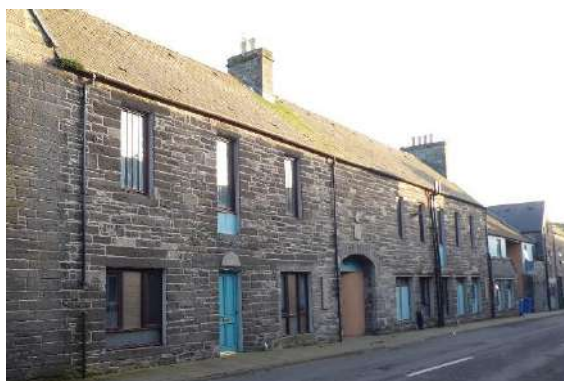
Before and after of Telford/Saltoun Street west block adapted to provide 16 dwellings for Pentland Housing Association, opened in 2004; part of THI (left) © Google Maps 2008

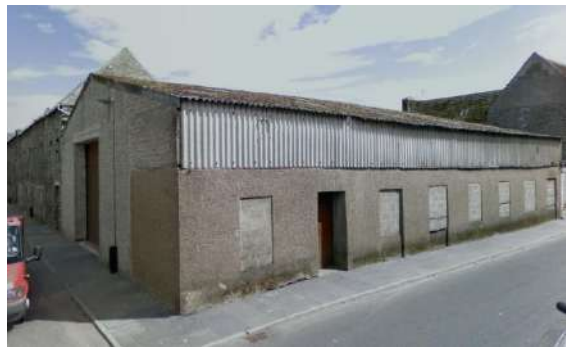
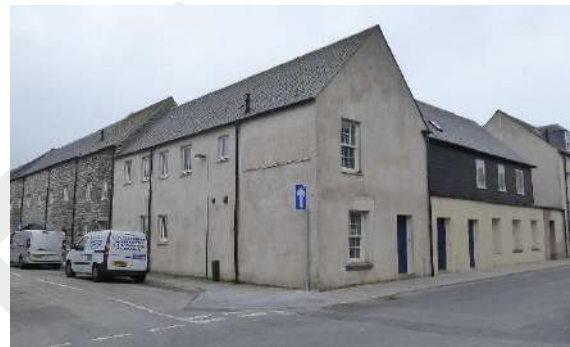
Before and after of Telford/Saltoun Street east block at Williamson Street with adaptation and reconstruction of traditional buildings to provide 11 new dwellings; part of CARS (left) © Google Maps 2008

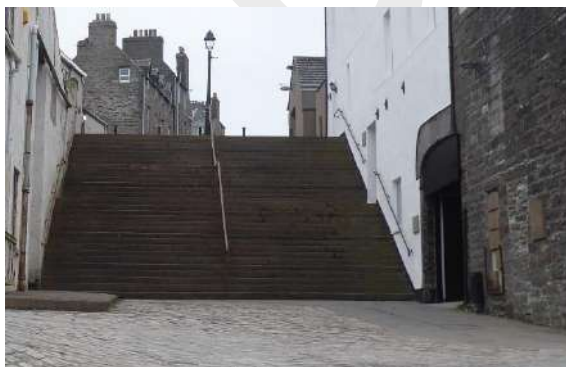
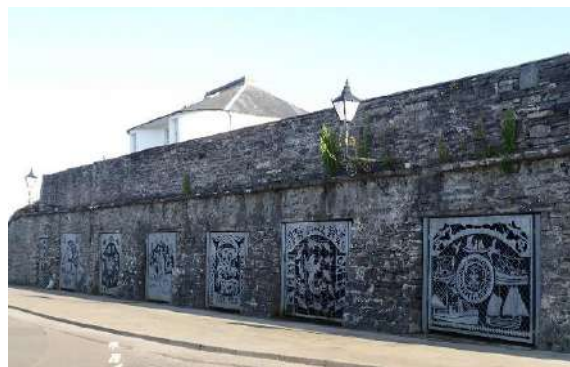
Repair of Black Stairs and streetscape enhancement using Caithness flagstones; part of THI 2008

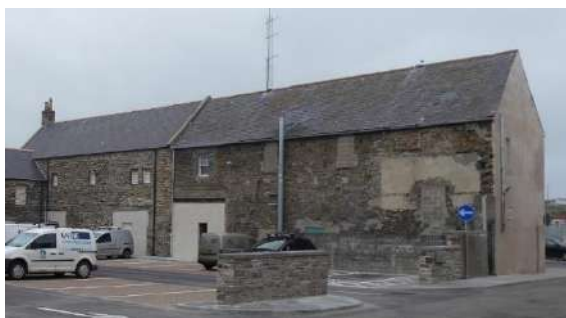
Telford/Burn St east block made wind & water tight during Beatrice development and CARS c.2012.

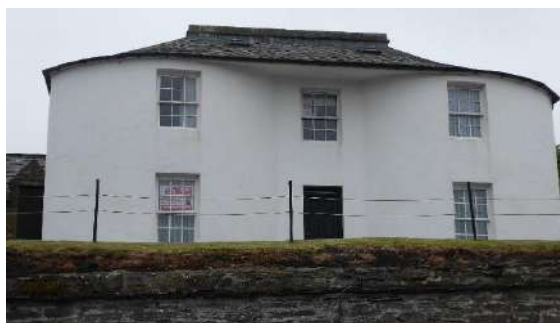
The Round House designed by Telford, repaired under the CARS.

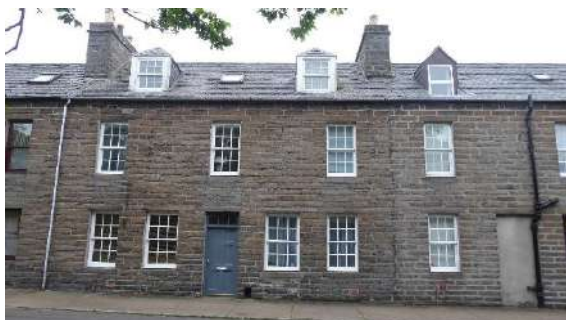
Example of several smaller projects for traditional repairs and window reinstatement under the CARS

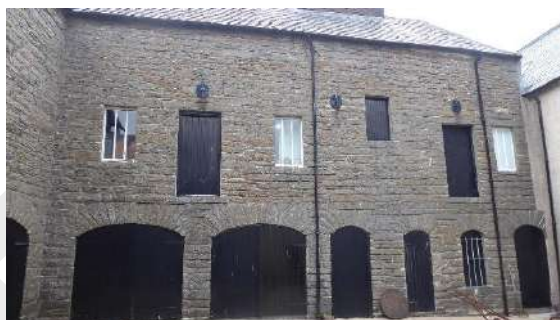
Courtyard of Wick Heritage Museum repaired under the CARS.

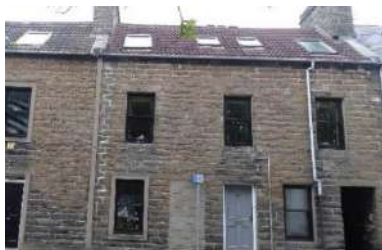
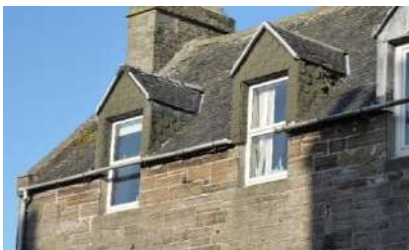
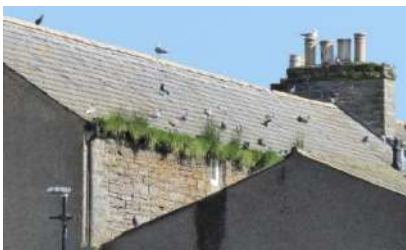
<b>THREAT 1: LOSS OF AUTHENTICITY</b>		
<b>A: Loss of historic fabric</b>		
<b>DESCRIPTION</b>		
Unnecessary repair or replacement of materials, elements of a building, the building itself, and other parts of the historic environment such as boundary walls, railings, traditional streetscape etc.		
<b>B: Inappropriate repair</b>		
<b>DESCRIPTION</b>		
The repair or replacement of traditional components made inappropriately in terms of materials, methods and /or design.		
<b>C: Lack of preventative maintenance and timely repair</b>		
<b>DESCRIPTION</b>		
Maintenance and repair requirements have been identified for both properties and the historic built environment. A lack of preventative maintenance and timely repair will lead to the unnecessary loss of fabric.		
<b>PROBABLE CAUSES</b>		
<p><b>POLICY &amp; MANAGEMENT</b>                  Lack of statutory protection over much of conservation area until re-designation in 2000; and Article 4 Direction in 2002;                  Lack of awareness / adherence to policy by listed building property owners, and unlisted building property owners after 2002;                  Possible interpretation of policy;                  Lack of enforcement by THC;                  The Town and Country Planning (General Permitted Development) (Scotland) Amendment Order 2011 – which removed householder permitted development rights in a conservation area.</p> <p><b>GUIDANCE &amp; PRACTICALIITES</b>                  Lack of understanding of significance and value of the historic environment;                  Lack of awareness of traditional materials and skills;                  Lack of awareness of supplementary guidance;                  Lack of availability of suitable materials;                  Lack of availability of skilled contractors;                  Lack of (and cost of) safe access;                  Lack of investment in building maintenance and small repairs over time;                  Low property values v cost of appropriate repair;                  Environmental and economic concerns (e.g. double glazing);                  Ownership issues, co-owners, absent owners etc.</p>

Loss of historic fabric	Inappropriate repair	Lack of preventative maintenance

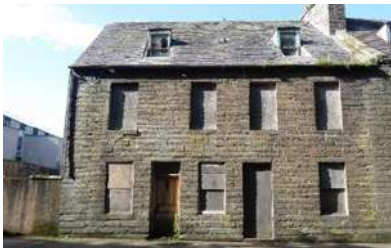
Buildings at Risk Union Street	Vacancy & gap site Burn Street	Vacant building Breadalbane Terrace

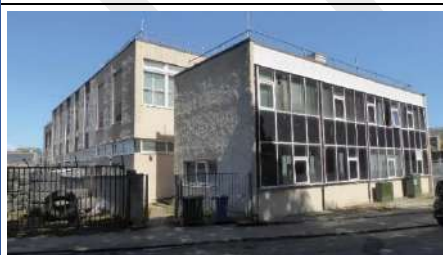
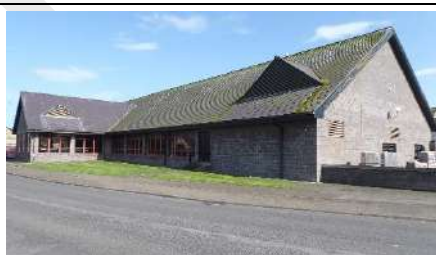
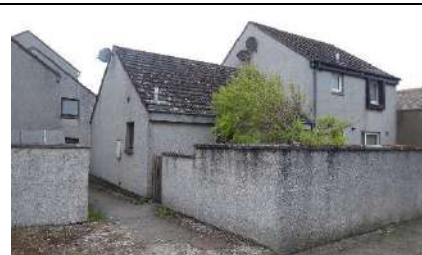
Inappropriate development

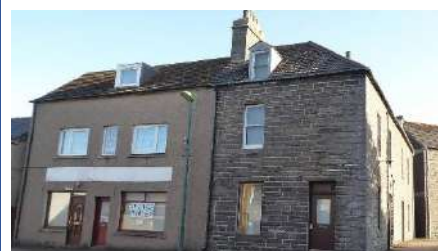
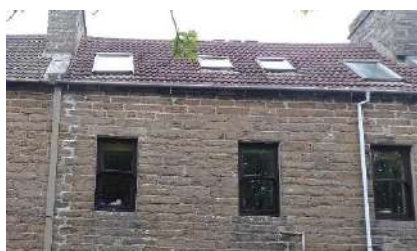
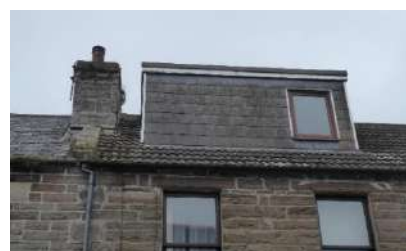
Unsympathetic alterations

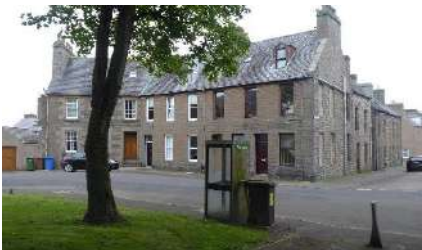
<p>Public realm Argyle Square</p> </div> <div style="text-align: center;">

For example, Argyle Square is a significant feature and community asset; however, some elements of street furniture are of standard or poor design quality, such as the use of ‘wheelie’ bins for litter on the central path, and generally there is a lack of continuity in the design and materials used for information boards, seating and street furniture. A coordination of approach and an overall vision of the streetscape is required. This could start with a public realm / streetscape audit to fully record the existing fabric and plan accordingly for future management, change and enhancement opportunities. This audit may be undertaken by a local community group with appropriate support and guidance from THC; this would also allow for feedback on the streetscape through community representation. A regular monitoring programme should be put in place.

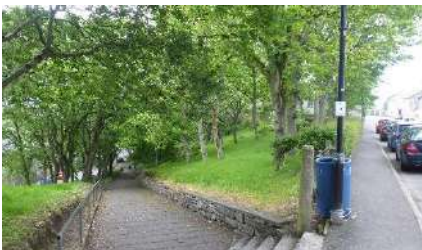
<p>Green space / paths Academy Braes</p> </div> <div style="text-align: center;">

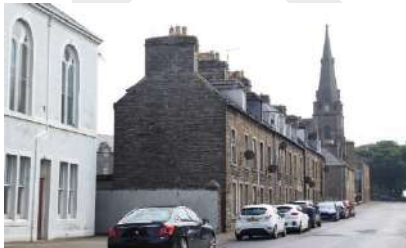
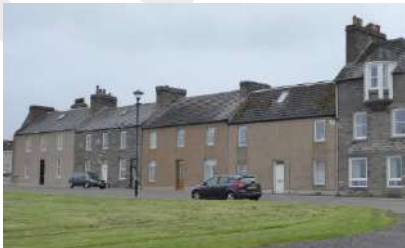
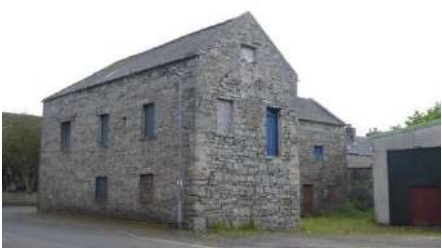
Some of the rows on Dempster Street, not in the conservation area or listed.	Pre 1857 houses on Smith Terrace, not in conservation area or listed.	Industrial building from rope works, not in conservation area or listed.

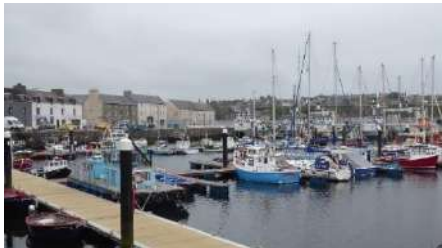
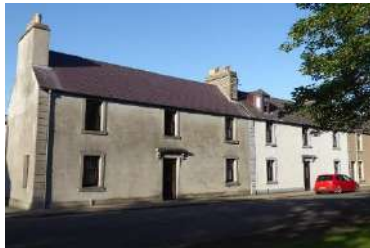
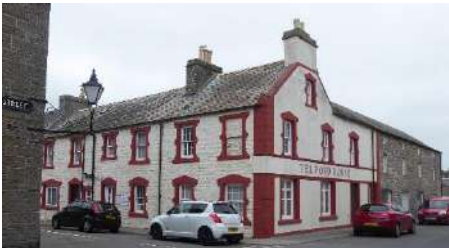
Wick harbour plays a fundamental role, but is not within the conservation area.	Contemporary buildings, left on Argyle Square are listed; on right Telford House is not.

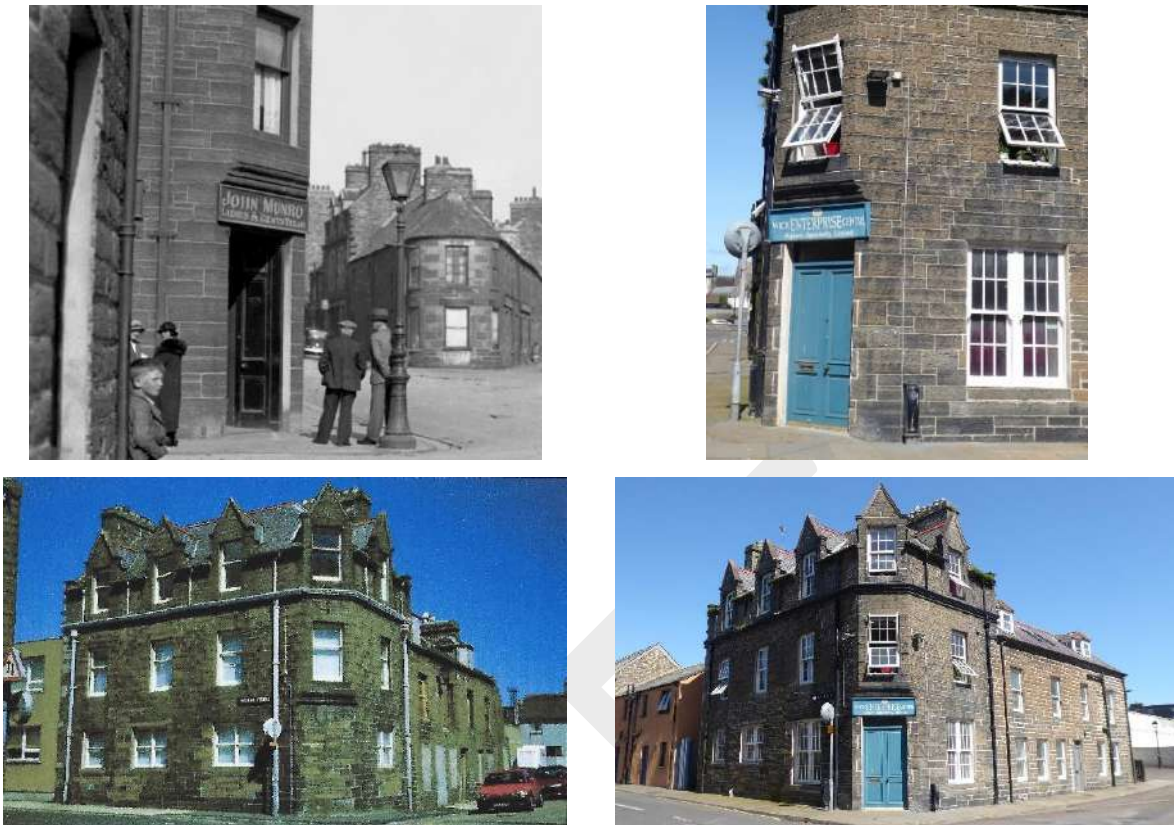
Figure 5: illustrating the importance of following window guidance fully. On the left an image from the 1930s showing likely original window and door design with below the building in 2000 with the same window pattern (door built up). The building in 2019 (right) has new replacement windows which have not replicated historic evidence and the opening form does not comply with current guidance that window opening methods should not disrupt the elevation. 6 over 6 pane windows may be the correct pattern for some earlier buildings in the conservation area, but the date of this property in the late 19<sup>th</sup> century would suggest it is less likely and such windows would rarely combine ‘horns’ in the original design. The reinstatement of the door is however a positive enhancement.

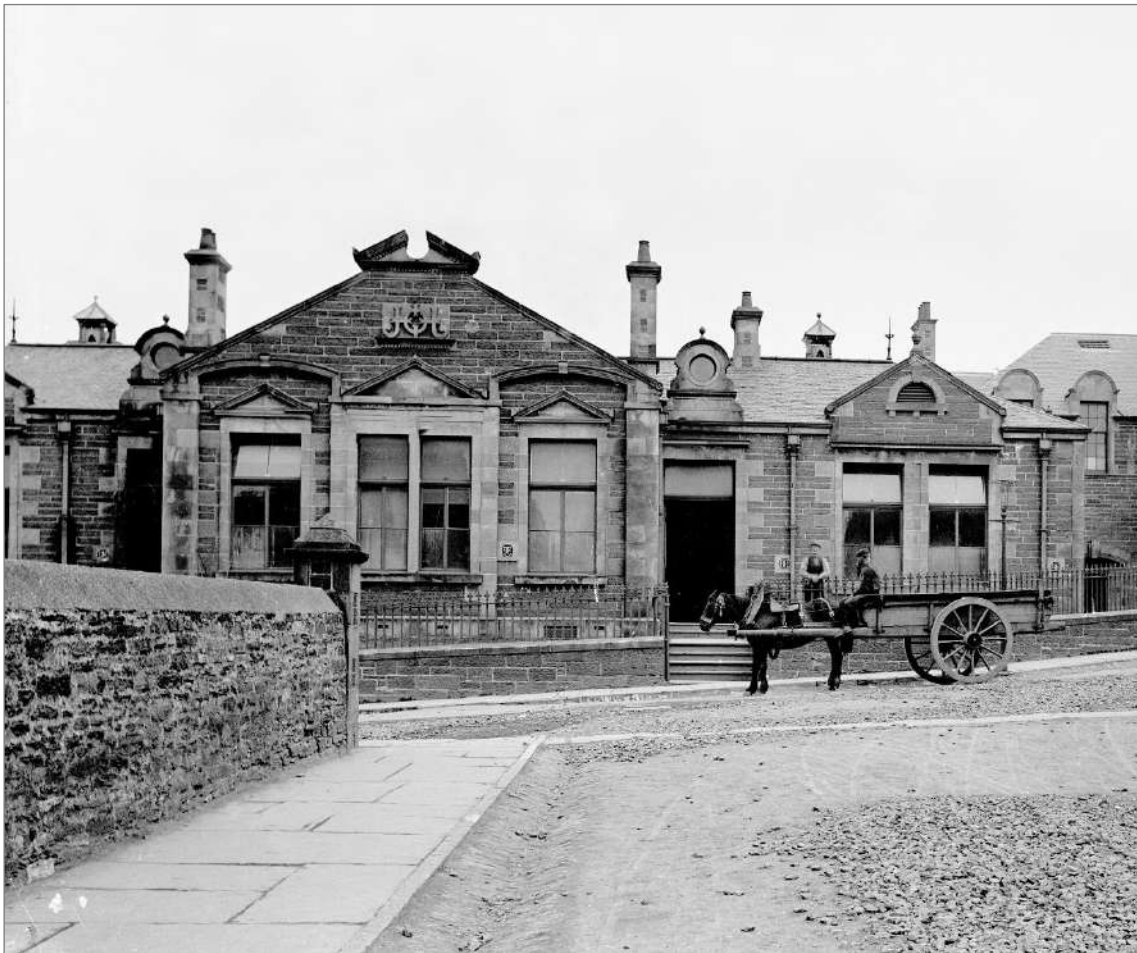
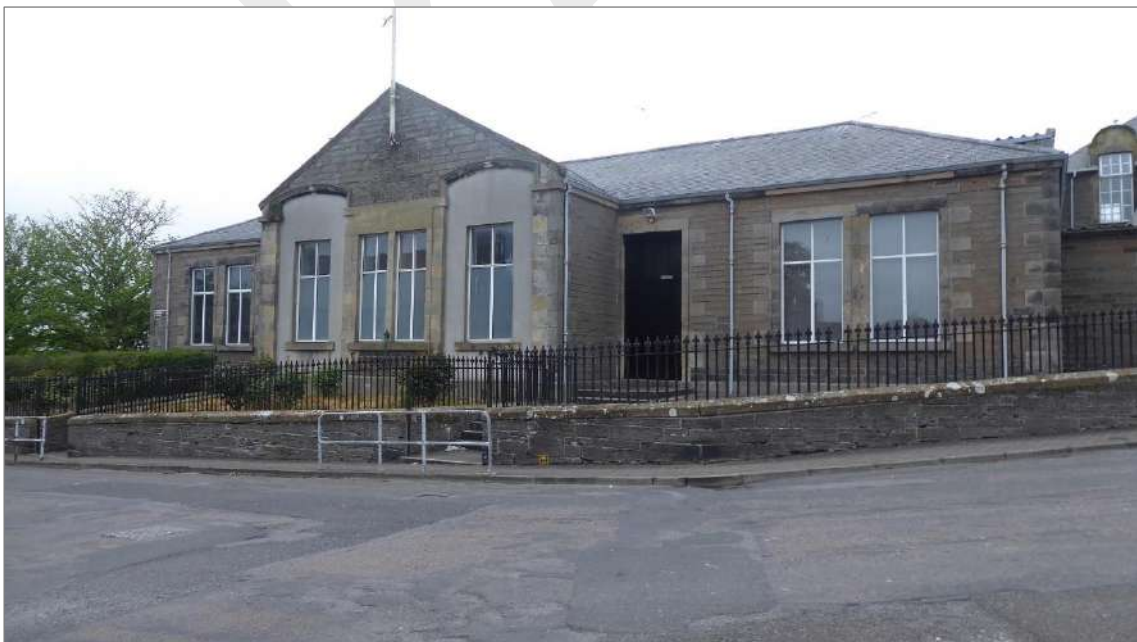
Figure 9: Inappropriate alterations: the importance of retaining architectural detail can be illustrated by comparison of the historic image of Assembly Rooms on Sinclair Terrace and its form in 2019. Constructed as the Pulteneytown Academy in 1838, stripping the building of its architectural features has removed much of the building's original character. Note historic image shows original 'sea gravel' on road and Caithness stone pavement and kerb. © The Wick Society - The Johnston Photographic Collection.

1. Traditional buildings of value which have been altered to such a degree that their current appearance has a negative impact on the building, its neighbours and the conservation area (figs 9 & 10). This is not to say they have no value or significance in respect of the authenticity of the site, however it means that opportunities to enhance such buildings and restore traditional appearance and character should be sought when either individual opportunities arise, or as part of a broad site approach.
2. Any building where its form, scale, materials, colour and/or quality detracts from the character and appearance of the conservation area (fig 11).

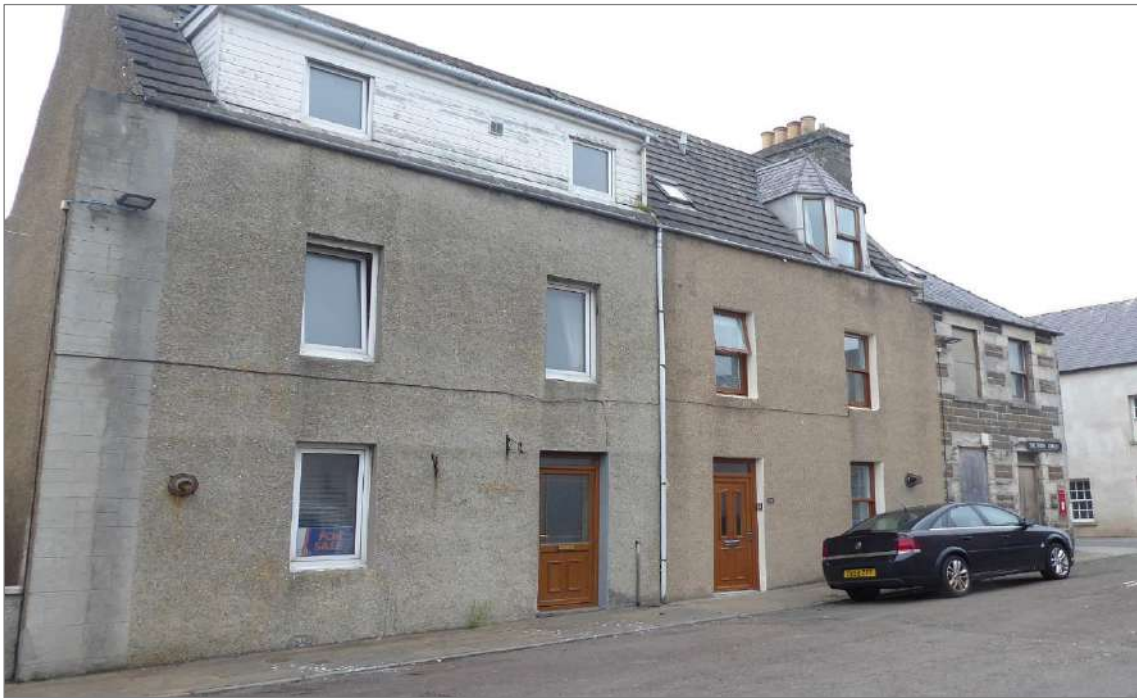
Figure 10: Inappropriate alterations: an example of past unsuitable change to a traditional building of heritage value which results in a negative impact. The original Caithness stone has been covered by a modern cement finish, the original windows and doors have been replaced; the window design and opening method has been altered; a large box dormer has been constructed which changes the form of the roof and obscures the original pitched slope; the original slate finish has been replaced in concrete tile. Buildings such as this can be enhanced and restored when opportunities arise through planning management.

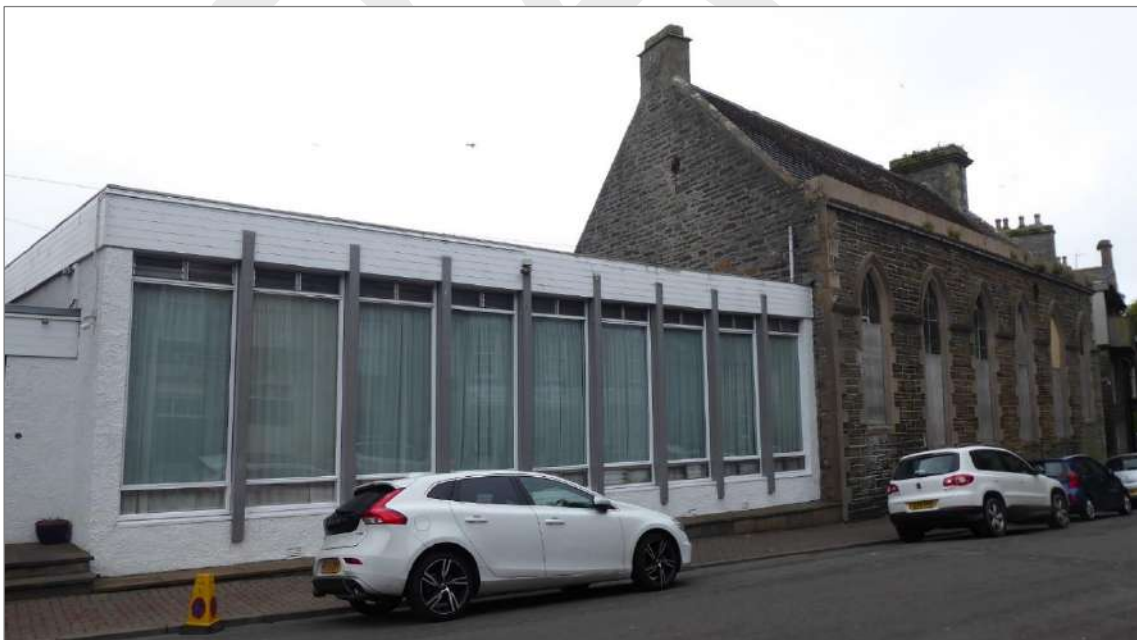
Figure 11: Inappropriate design: an example of a later 20<sup>th</sup> century building design which is inappropriate to the character and appearance of the conservation area in terms of form (low horizontal emphasis and flat roof), materials and colour, the bright white is in stark contrast to the adjacent stonework and draws further attention to the building. Buildings such as this may offer opportunities for redevelopment or enhancement through planning management.

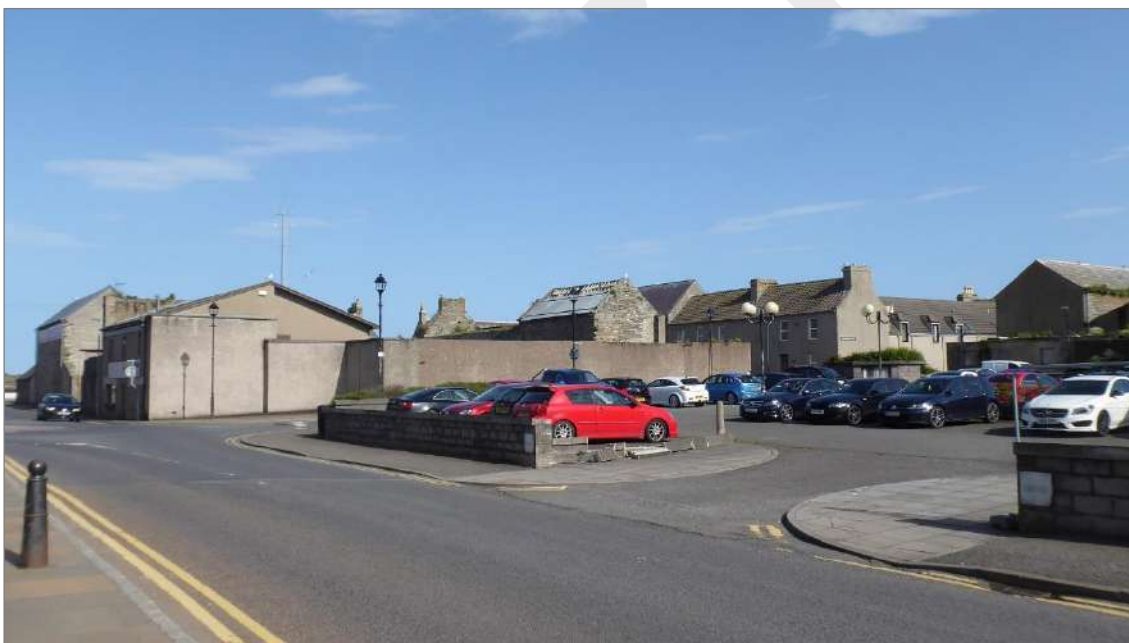
Figure 12: view towards Williamson Street with the expanse of the former swimming pool car park in the foreground having a negative impact on the conservation area. The original buildings on this block and the corner buildings to the east on Burn Street have been removed effected in part by the introduction of a roundabout (on left). Reinstatement of street fronting buildings or a suitable high quality finish to the car parking area would be beneficial to the conservation area.

The audit recommends examining the feasibility of removing this roundabout if harbour traffic permits. This could offer an opportunity for enhancement in the conservation area. This form of road movement and design is alien to the historic street pattern and is an issue in many conservation areas. The relationship of the historic built environment to modern vehicular traffic requirements can be challenging, with standard engineering solutions often at odds with the principle to protect and enhance the conservation area. This roundabout is an example of that, its construction effectively required the removal of the corner buildings from each urban block (fig 12).

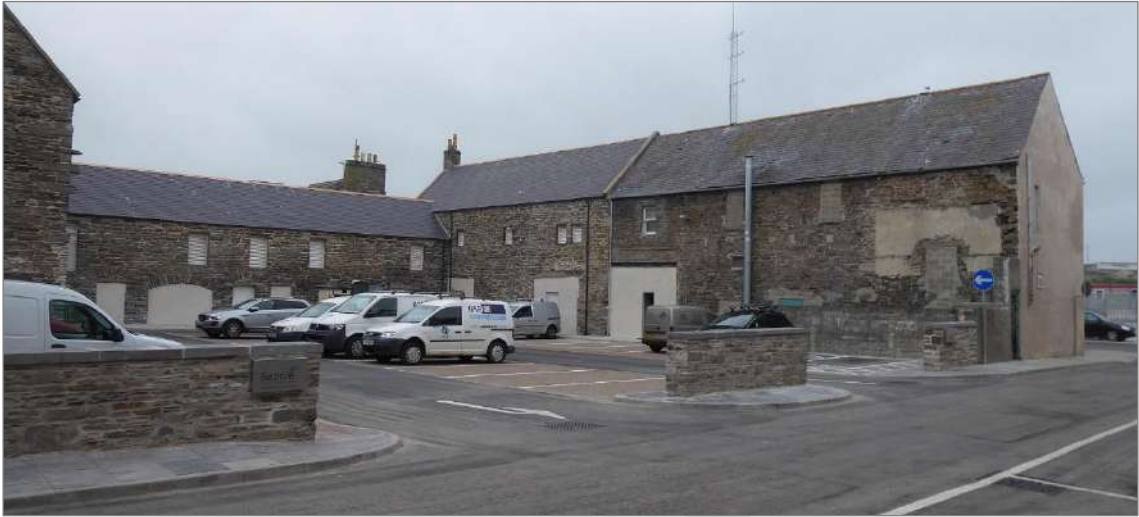
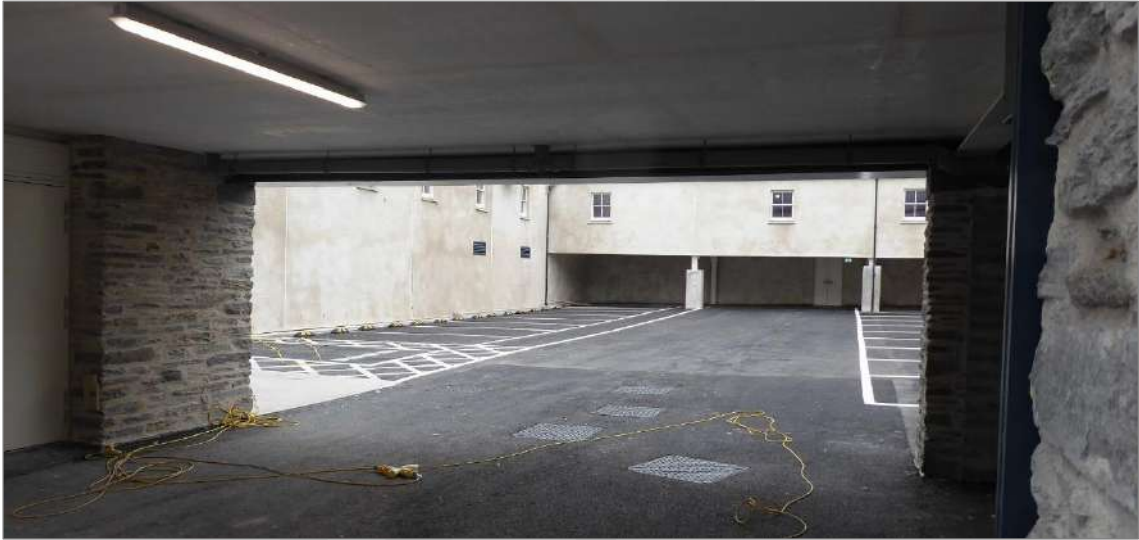
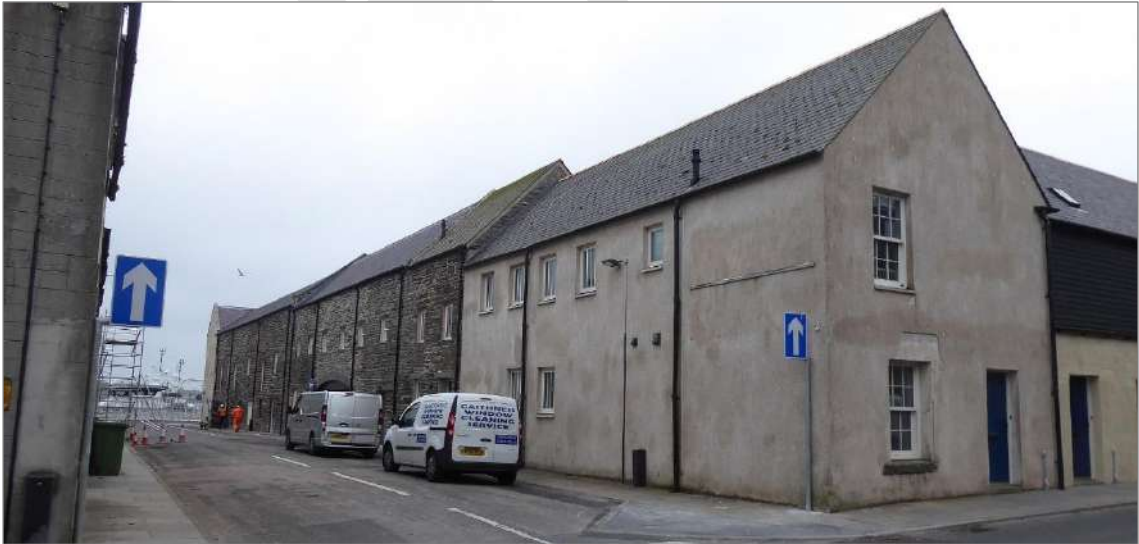
Figure 13: Parking and changes to traffic movement introduced as part of the regeneration of the eastern urban blocks either side of Telford Street: (top) open parking area created from former curing yards after loss of internal and street fronting buildings; parking area is highly visible; (centre) partly obscured parking within the block is a more sensitive approach although the finishes are still standardised they are less visible from the public realm; (below) to facilitate new uses Telford Street has been made one way with the standard blue signage standing out against the traditional finishes.

In Lower Pulteneytown there is parking on-street and at larger premises such as the medical centre, former swimming pool and recently for the Beatrice facilities on Telford Street (fig 13). Each of these car parks create large expanses of tarmac often having a negative visual impact emphasised by boldly coloured traffic signage. Whilst safe movement for parking is essential there are likely to be more sensitive means to provide this such as the use of alternating surface textures and suitable colour changes.
