## HIGHLAND COUNCIL

**Committee:** Caithness Committee

**Date:** 12 August 2021

**Report Title:** Draft Wick Pulteneytown Conservation Area Appraisal and Conservation Area Management Plan

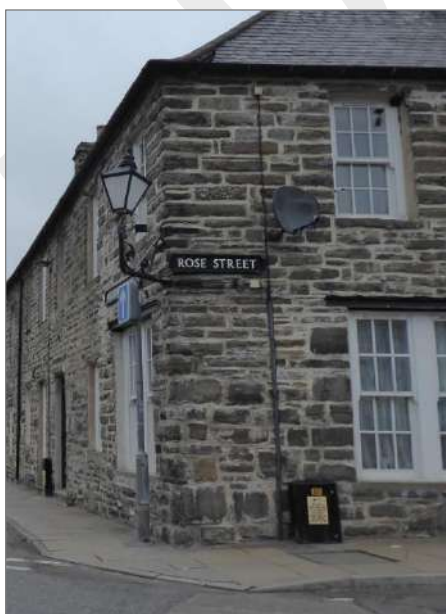
Mixed and cluttered street furniture: enhancement gained by using a traditional lantern and street sign is offset by cabling, satellite dish position and standard one-way road sign. Note the dropped kerb using Caithness flagstone.

Figure 14: inappropriate street furniture and unattractive streetscape.

This priority also recommends that changes are made to assist DDA compliance. Whilst this is a desirable functional change to improve access and movement for all, the method and materials for this intervention need to be carefully considered and sensitively designed to the historic environment and not be standard coloured concrete paving blocks (fig 14).

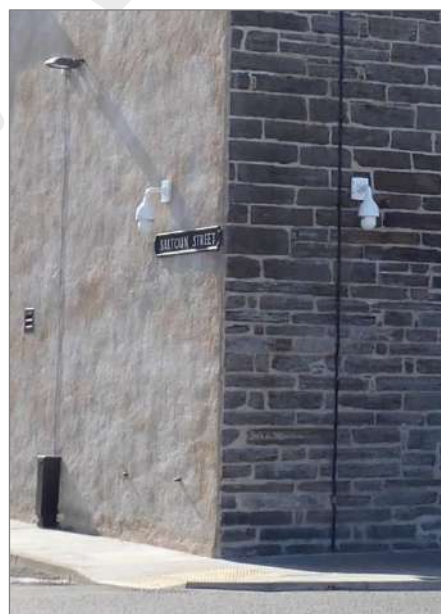
Reinstated lime harling on prominent gable with traditional street sign alongside a standard flood light and modern white lamps lacking appropriate and coordinated design. Note dropped kerb constructed using textured concrete paving which is not in keeping with the Caithness flagstone.

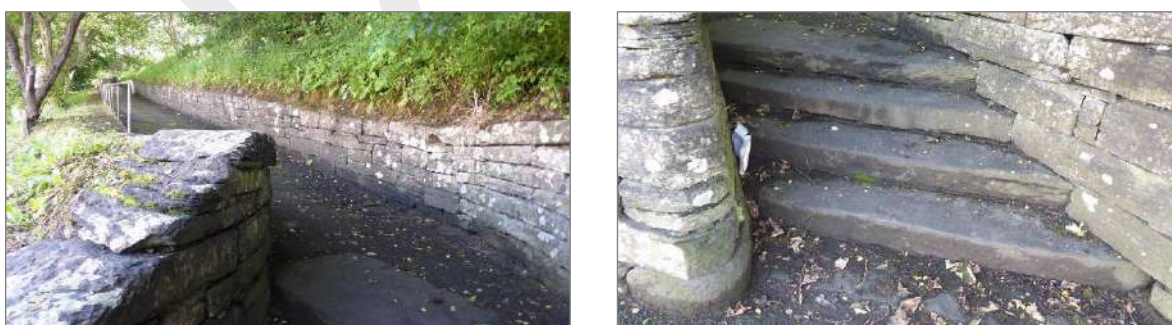
Fig 15: the well-established route across Academy Braes, leading to the upper town, and originally Pulteneytown Academy (now the Assembly Rooms); the original Caithness stone walling and steps remain although the former rough shingle path has been tarmacked with a standard modern metal handrail fitted. A management plan for this green space should include architectural features such as the walling and steps and plans for their retention, maintenance and future repair using appropriate materials and methods. Whilst the green space is semi-natural (rather than a formal landscape) it is very overgrown.

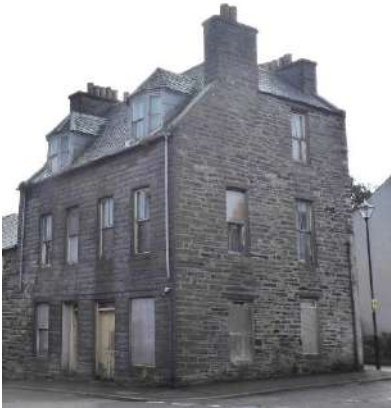
2020	At Risk Condition: Fair 09/2013	Building remains vacant and at risk. No apparent action, condition slightly deteriorated since 2013. Original doors and windows still in place.  Listed Building. Good example of earlier housing on prominent corner block with surviving traditional external joinery and dormers.  Included in CAMP Appendix 5-2.
<b>17 and 18 Breadalbane Crescent</b> (refer CAA section 4.2.2)

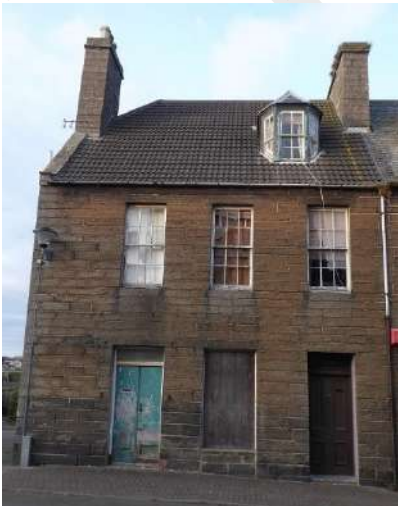
2020	At Risk Condition: Fair 09/2013	Building remains vacant and at risk; No apparent action, condition slightly deteriorated since 2013. Original door, windows, shutters and dormer still in place.  Listed building. End house of prominent corner terrace with surviving original external joinery and dormer.  Included in CAMP Appendix 5-2.

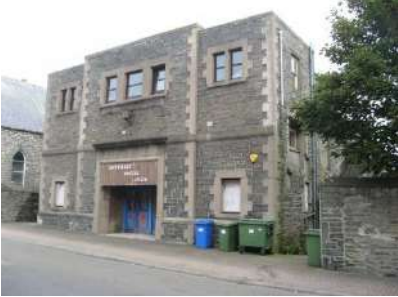
<b>Former Dounreay Social Club</b> 38 Breadalbane Crescent	At Risk Condition: Fair 09/2013	Building remains vacant and at risk. Condition had deteriorated with roof becoming dangerous. Roof cover removed in 2019 under Dangerous Building Notice. Structure now open to the elements, not clear if wallhead have been stabilised / capped.

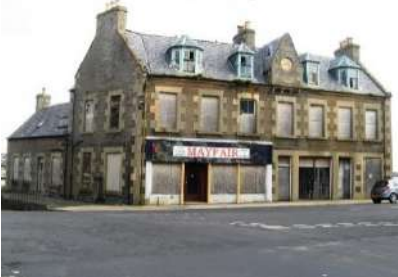
<p>2020</p>	<p>At Risk Condition: Fair 09/2013</p>	<p><b>Property in proposed CA boundary extension</b></p> <p>Building remains vacant and at risk. No apparent action, condition deteriorated since 2013.</p> <p>Positive building. Very prominent focal point and highly visible in views from the town, river and harbour.</p> <p>Note this site is in CaSPlan WK22 site allocation as industrial use. Wick Charrette suggested reuse as residential.</p>
<p><b>Former Cooperative Bakery,</b> South Quay (CAA fig 49)</p>

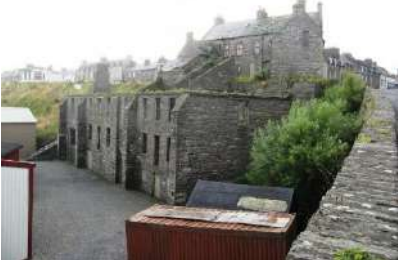
<p>©HES 2013</p>	<p>At Risk Condition: ruinous 11/2017</p>	<p><b>Property in proposed CA boundary extension</b></p> <p>Building remains ruinous and at risk. No apparent action, condition deteriorated since 2013, notably condition of wallhead cappings and vegetation growth to chimney.</p> <p>With former Coop, a very prominent focal point and highly visible in views from the town, river and harbour.</p> <p>Note this site is in CaSPlan WK22 site allocation as industrial use. Wick Charrette suggested reuse as residential.</p>

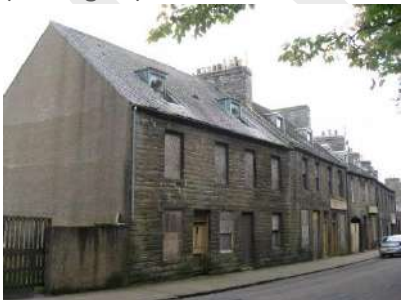
<p>© HES 2013</p>   <p>2019</p>	<p>At Risk Condition: Fair 09/2013</p>	<p>Building remains vacant and at risk. No apparent action, condition deteriorated particularly roof and guttering since 2013. Original door and dormers still visible in 2020.</p> <p>Positive building. End house of coherent terraced row forming the frontage of original curing &amp; timber yards. <i>Note block original extended to the west with an adjoining pend to yard.</i></p> <p>Ground, rot and structural reports undertaken during CARS and provided to all owners (reports not found); concluded subsidence is <b>not</b> an issue.</p> <p>Included in CAMP Appendix 5-1.</p>

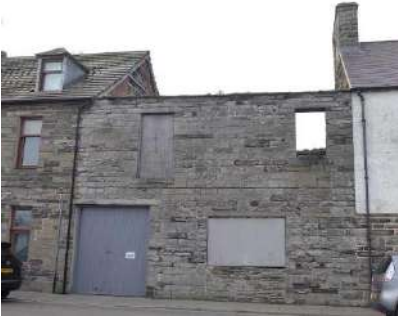
<p>No. 4 Harbour Quay</p>	<p>Not on BARR</p>	<p>Façade only appears to remain (site not accessed).</p>

<p>2020</p>		<p>Important part of the Harbour Quay frontage.</p> <p>Mentioned in early CARS report; possible conversion as commercial unit and maisonette above.</p> <p>Included in CAMP Appendix 5-3</p>
<p>SW corner building on Williamson Street and Burn Street</p>

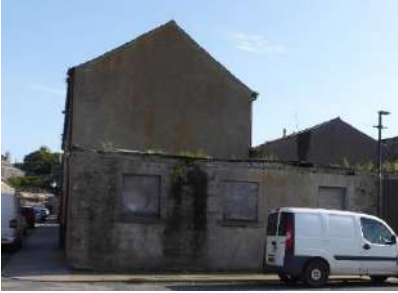
<p>2019</p>	<p>Not of BARR</p>	<p>Single storey building next to Caithness Voluntary Group building on Williamson Street. In poor condition.</p> <p>Included in CAMP Appendix 5-3</p>
<p>Buildings behind 5-6 Union Street</p>

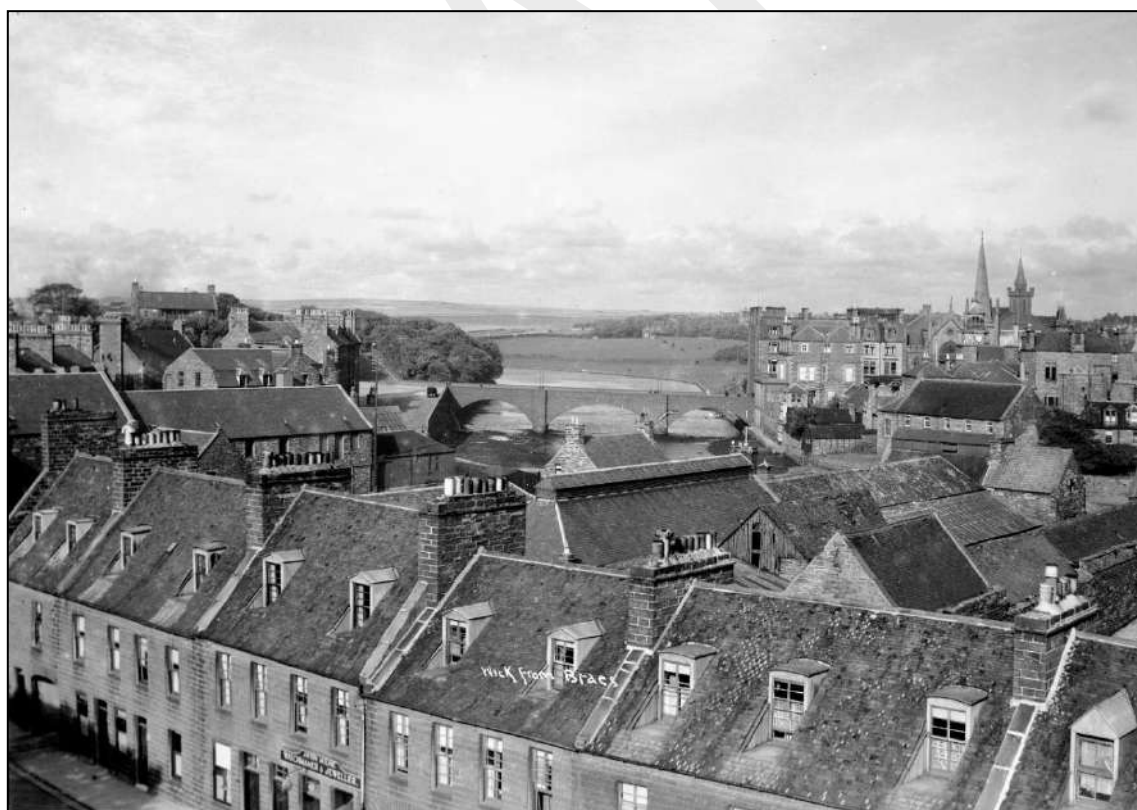
Figure 7: Historic view over the roofs in Union Street illustrating the predominance of slate roofing and also the original building forms with long double pitched roofs extending at right angles to the Union Street frontage. © The Wick Society - The Johnston Photographic Collection. Note kippering kiln with its distinctive ventilator.

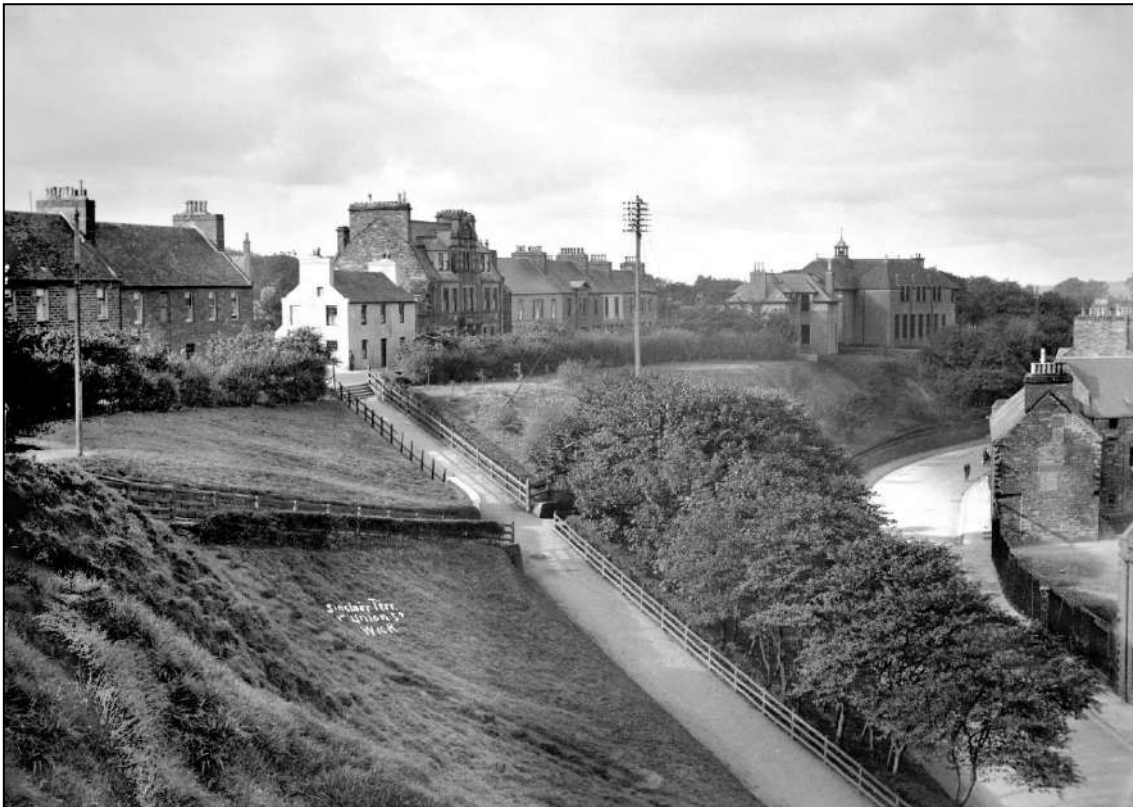
Figure 8: one of several historic images of Academy Braes which also captures part of Union Street (1920s). A gap site or yard (now the Telecom building) is visible on the right with the gable wall of what is thought to be the former Wick Steam Mills beyond (now largely demolished although external walls may survive). © The Wick Society - The Johnston Photographic Collection.

Part of the W&A Geddes site (west of the Telecom building) looks to retain high (2- 2½ storey) masonry walls from the former Wick Steam Mills (corn and saw mills) on this site (refer OS Town Plan & Johnston images). The Union Street elevation (or part thereof) of the mill building is still standing with its central arched pend opening (fig 9). This building is thought to have been 2-storey and visible in historic images (fig 8).

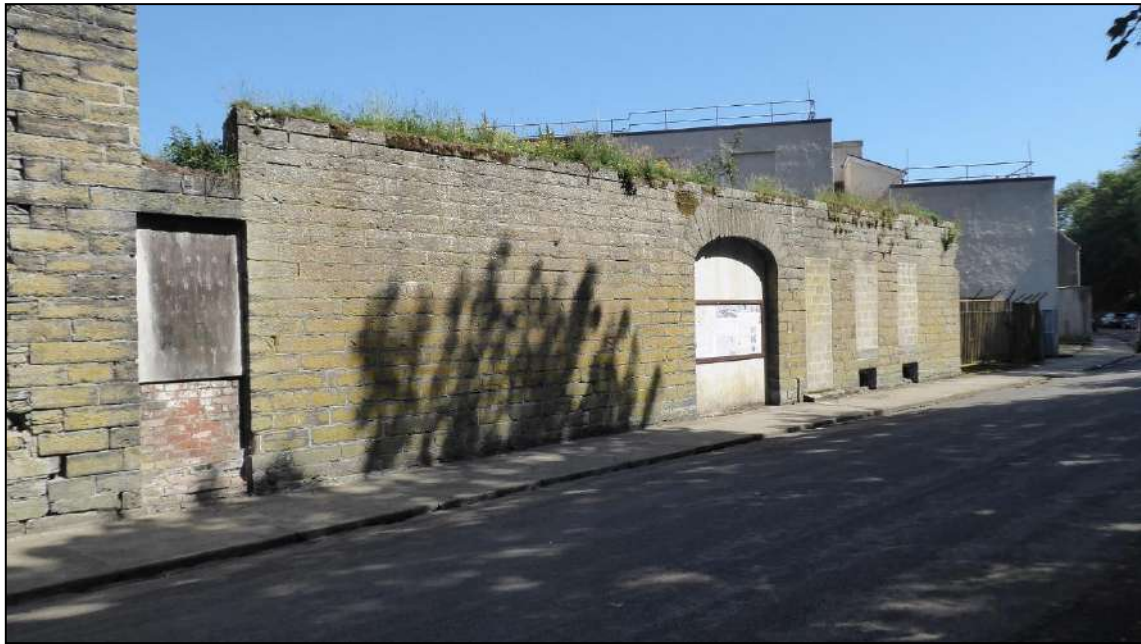
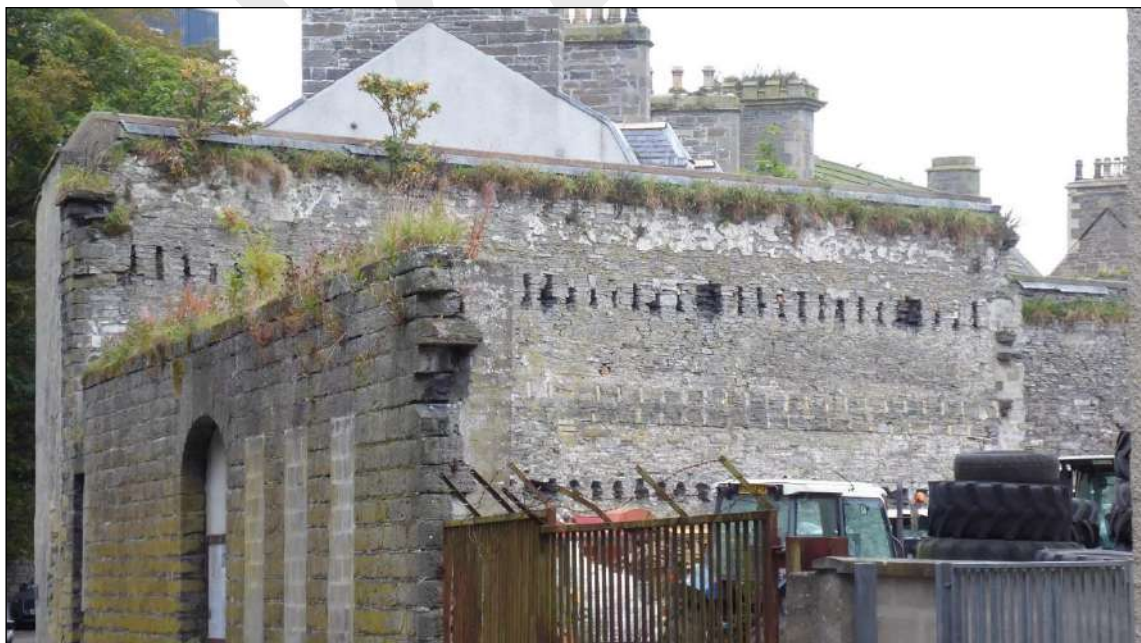
Figure 9: (top) part of the surviving elevation of the former Wick Steam Mills on Union Street with arched opening; (below) masonry side elevation also remaining.

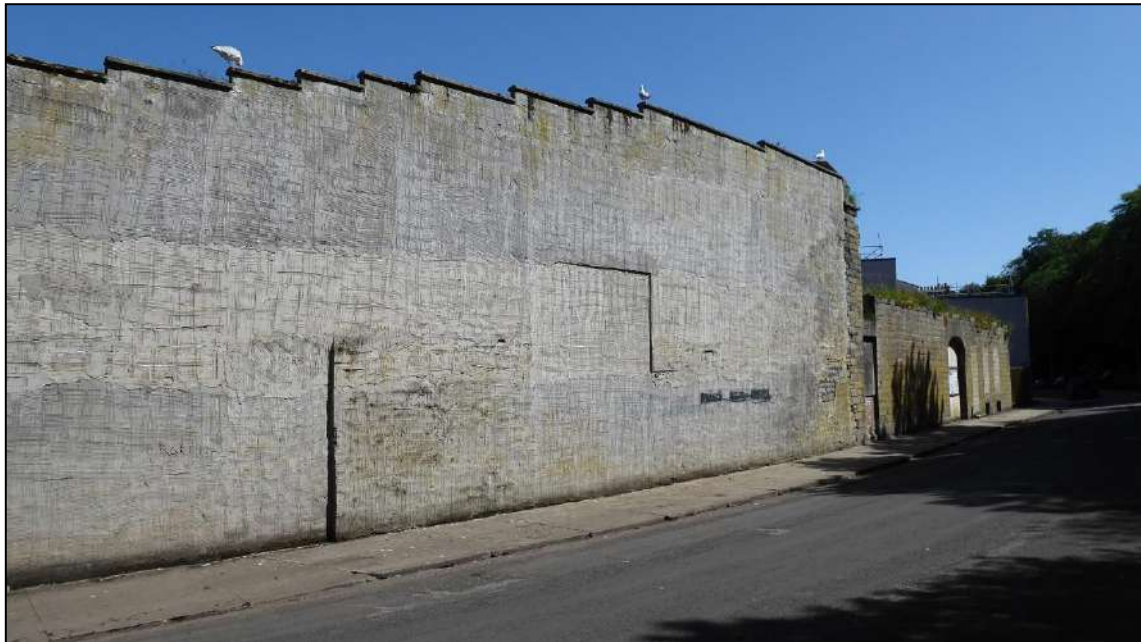
Figure 10: high masonry wall enclosing a plot on Union Street has a negative impact in terms of scale, materials, quality and monolithic style. It is unclear if original masonry fabric may survive below the rendered finish; earlier buildings on this site can be seen in historic images (e.g. fig 8)

- British Telecom building (monolithic scale, form and articulation of the building, materials used, position on plot).
- Later 20<sup>th</sup> century buildings particularly low single storey and flat roofed structures such as the MacKays Hotel extension and nearby business premises fronting River Street; as mentioned the inconsistency of the form and scale of the River Street buildings has a negative impact on the river frontage and views from Wick Town Centre.
- Union Street the large cement rendered wall enclosing a full plot width (fig 10).
- The loss of the traditional roof form at 45 Miller Street creates a negative impact.

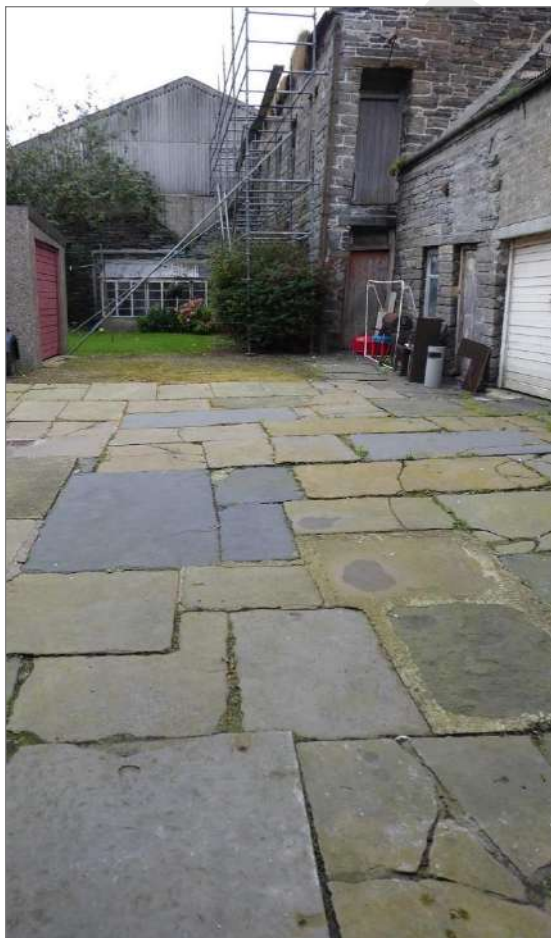
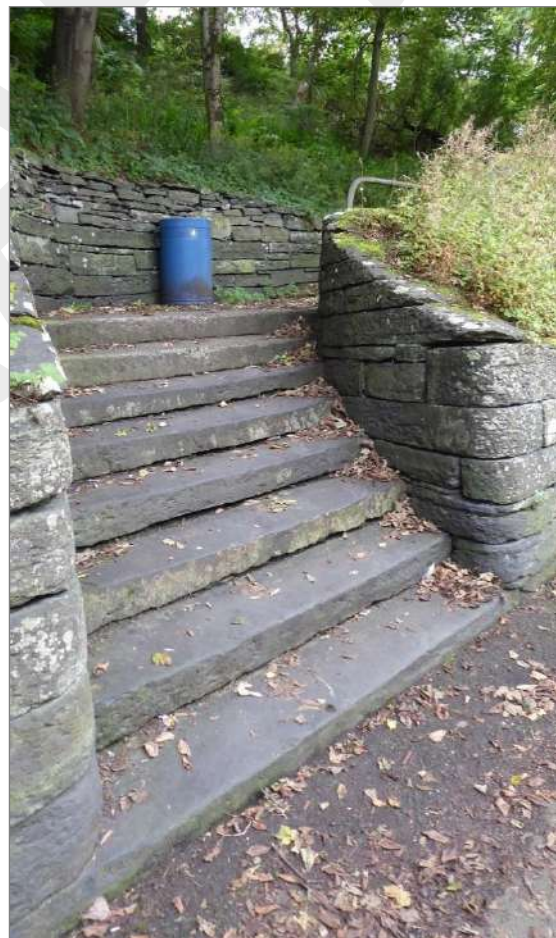
Figure 11: (left): flagstone pavement to yard behind 5 & 6 Union Street; (right) high quality masonry walling and stone steps at the entry points to Academy Braes.

On the south side on Union Street, there are low stone retaining walls to the Academy Braes, original stone steps and high quality stone walling details (fig 11).

Original paving survives in the yard and pend behind 5 & 6 Union Street and provides considerable character (fig 11). Further traditional finishes may remain within these lots.

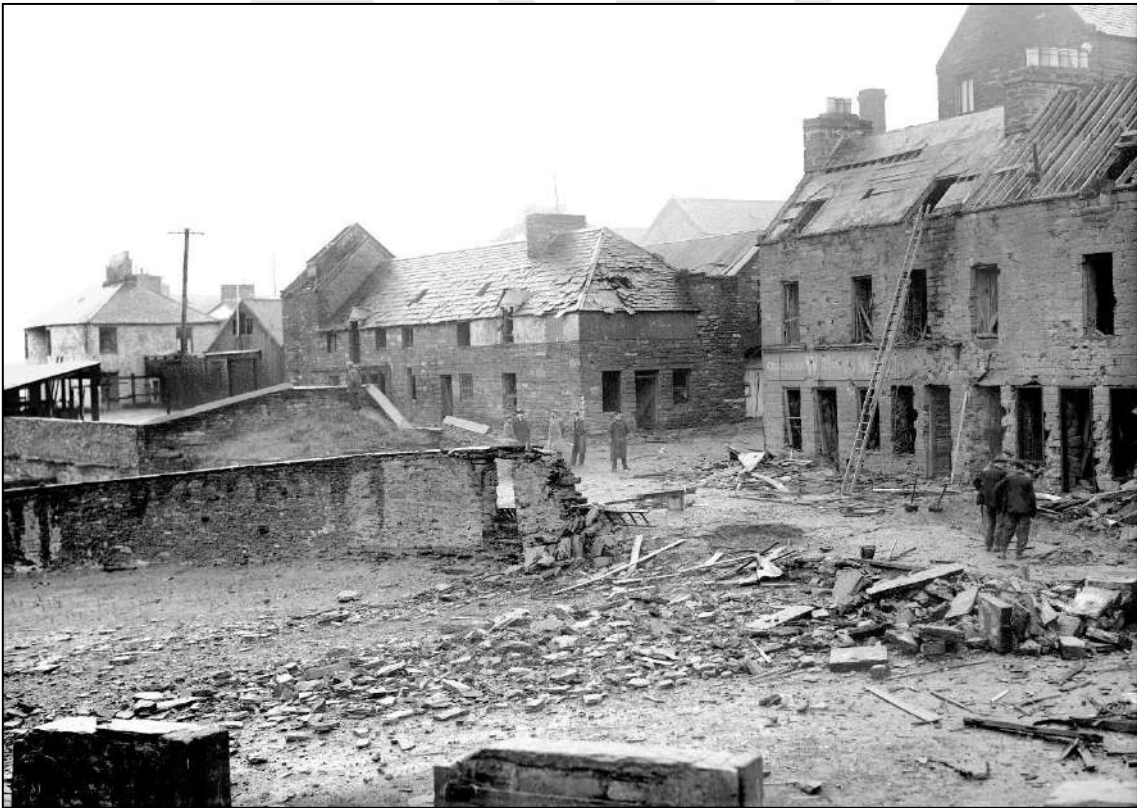
Figure 6: bomb damage in 1940 with the boat yard site in the foreground showing damage to the boundary walls, and looking at the end of Bank Row (right; now demolished) and the buildings at the foot of the Black Stairs. © The Wick Society - The Johnston Photographic Collection ref JN21143B011

The building plots to the south on Bank Row still show the impact of the bomb damage and subsequent demolition of the street fronting buildings. There is a gap in the street frontage running from the foot of the Black Stairs to 19 Bank Row opposite Williamson Street. Surviving walls have been consolidated and a small traditional building at the rear of one of the lots was restored in 2008, having laid derelict for many years, as part of a Memorial Garden to those killed in the Wick bombings (CAA, section 4.2.2). The adjoining lot to the west is owned by The Wick Society and the modern building on this site was under redevelopment as a storage facility during 2019.

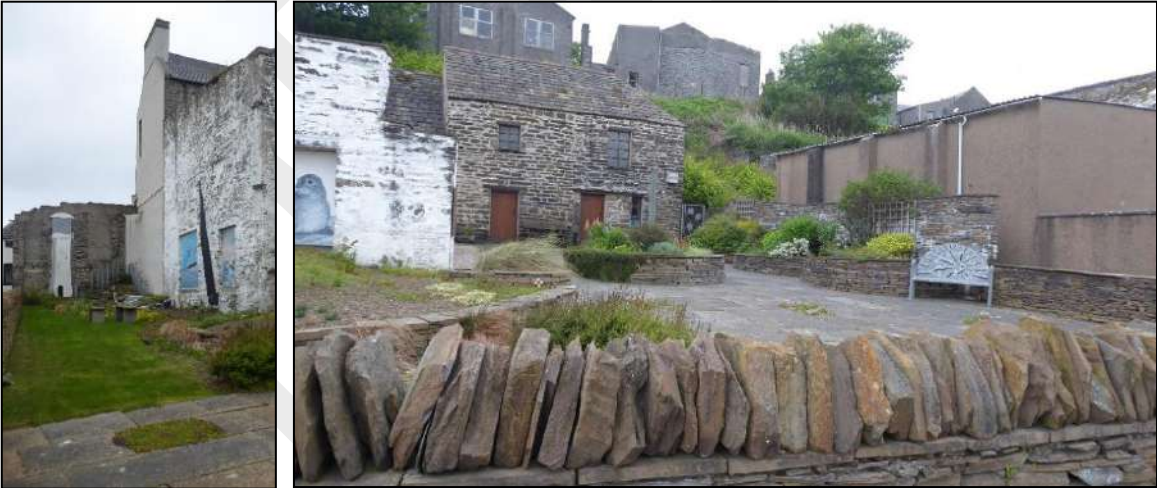
Figure 8: the Memorial Garden opposite the former boat yard site; on the left 3-storey walls of a former building have been consolidated and painted white, paint finish is failing.

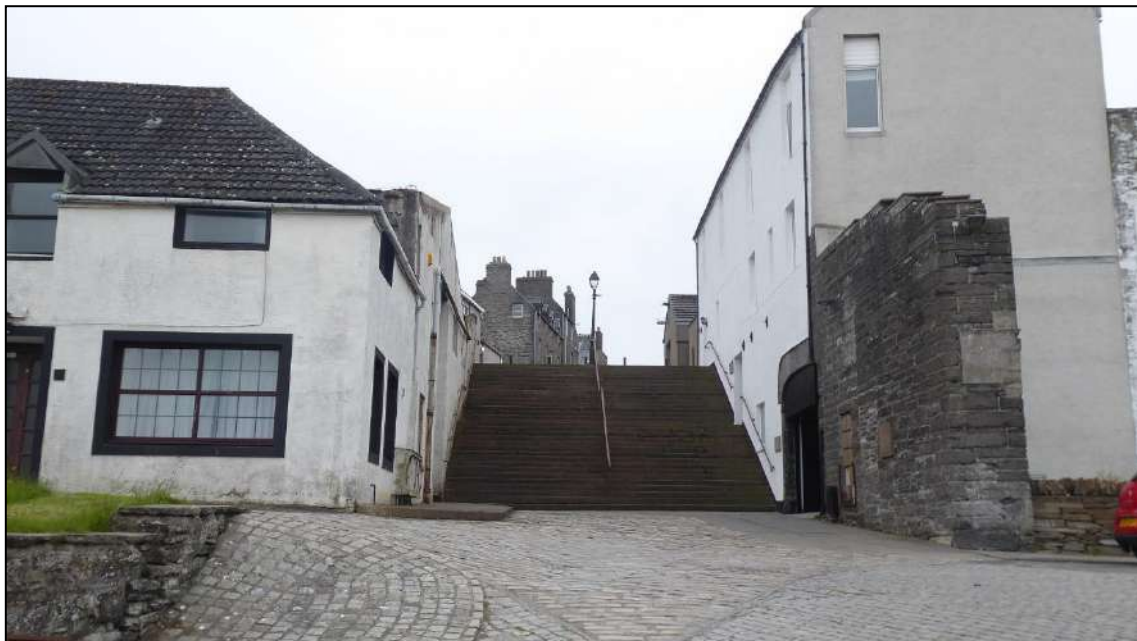
Figure 9: the foot of the Black Stairs, note previous inappropriate alterations to the traditional building on the left (horizontal windows, painted masonry, concrete tile roof); enhancement works as part of previous investment has reintroduced traditional street finishes.

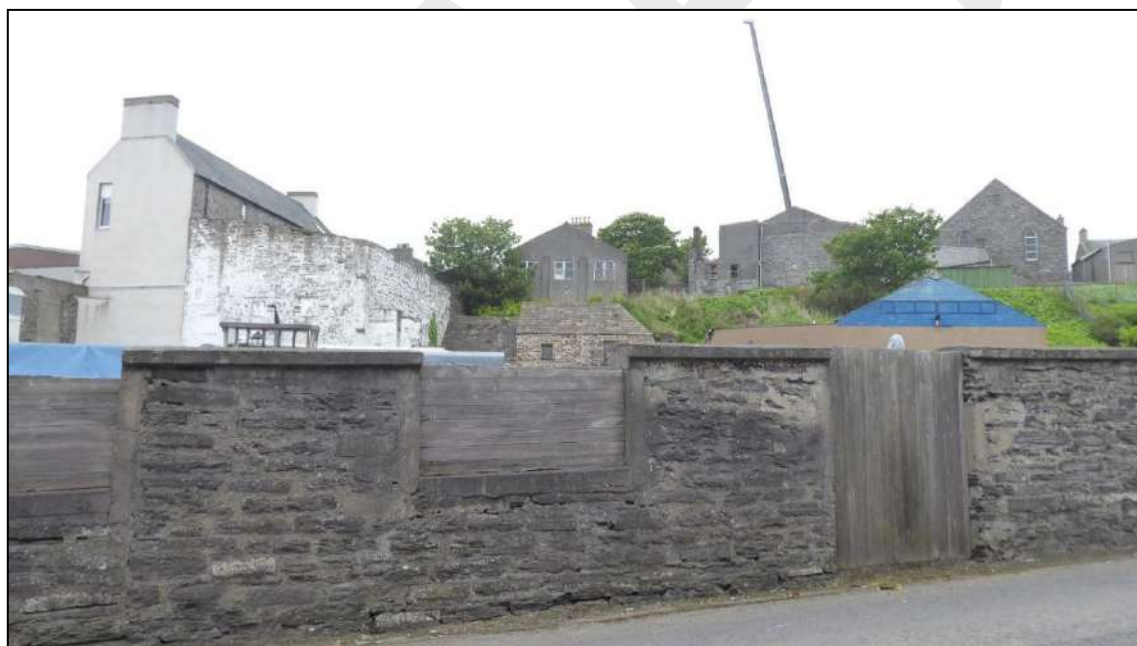
Figure 10: view with the stone boundary wall of the former Boat Yard in the foreground, and the rear of properties on the higher ground on Breadalbane Crescent beyond. Note the prominence and impact that the rear of the properties on Breadalbane Crescent have on the site.

*Views:* the site has an open view to the harbour and marina to the east on the Harbour Quay frontage. The north elevation faces onto the buildings on Rose Street and any building on this street line would impact on the light and amenity of those existing buildings. To the south and south-west, the site addresses the gap frontages on Bank Row and the industrial uses set back at the foot of the Black Stairs. The nature of the frontage on Bank Row means that there are open views to the rear of buildings at higher level on Breadalbane Crescent (fig 10).

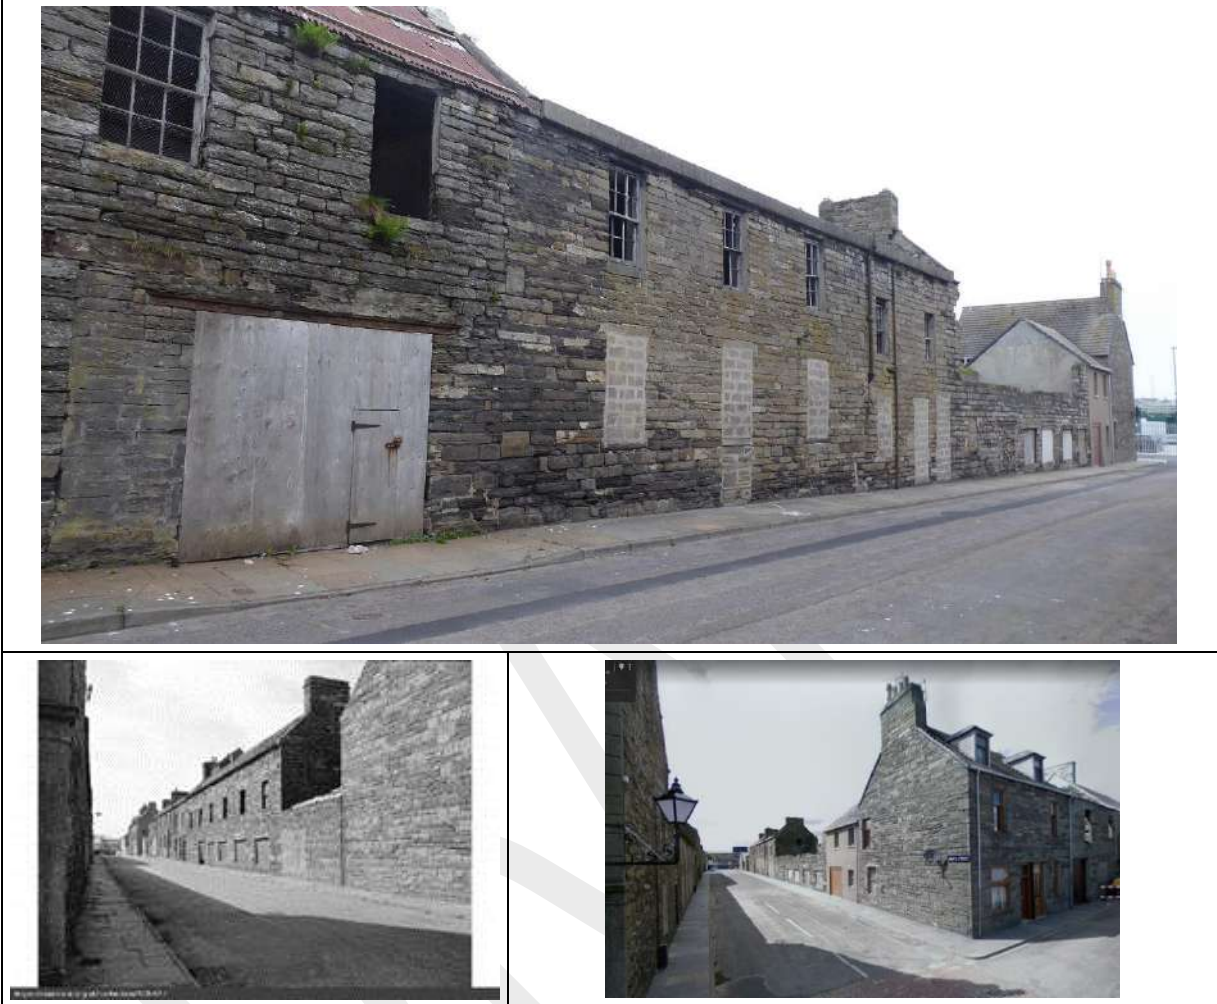
Figure 8: (top) Buildings at Risk on the north side of Burn Street looking east to Harbour Quay, 2019; the buildings span three separate lots; two street fronting buildings remain largely intact, the third has been reduced to a single storey. The 2-storey building in the distance is a later infill incorporating an original single storey yard entrance, it appears somewhat small in scale in comparison to the traditional buildings and the modern render finish is out of character.

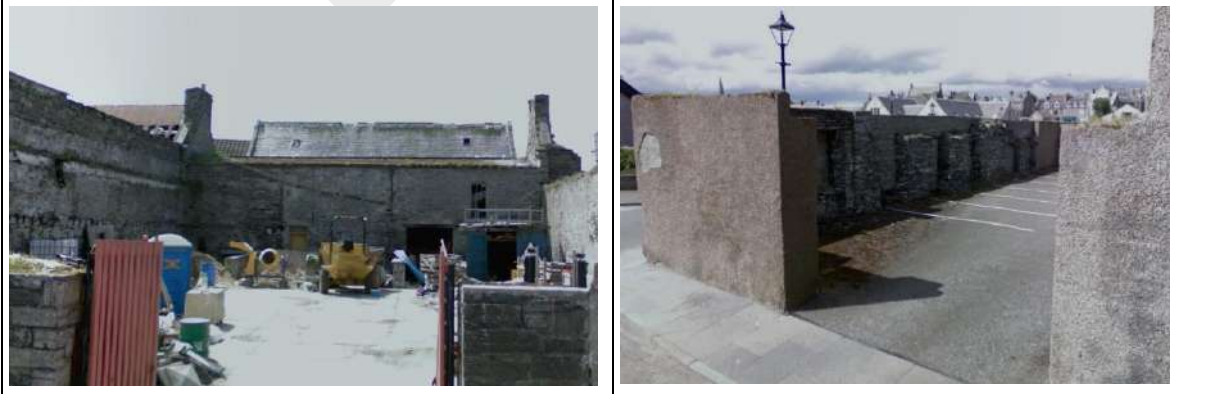
(Above left): potential gap sites include the yard next to GMR Henderson retaining high stone walls defining the original lot; the rear elevation of the de-roofed building on Burn Street is visible at the rear (image 1974 © HES); (right) remains of original Caithness stone walling on the internal face of the boundary wall on Williamson Street (betw. Burn Street and Martha Terrace).

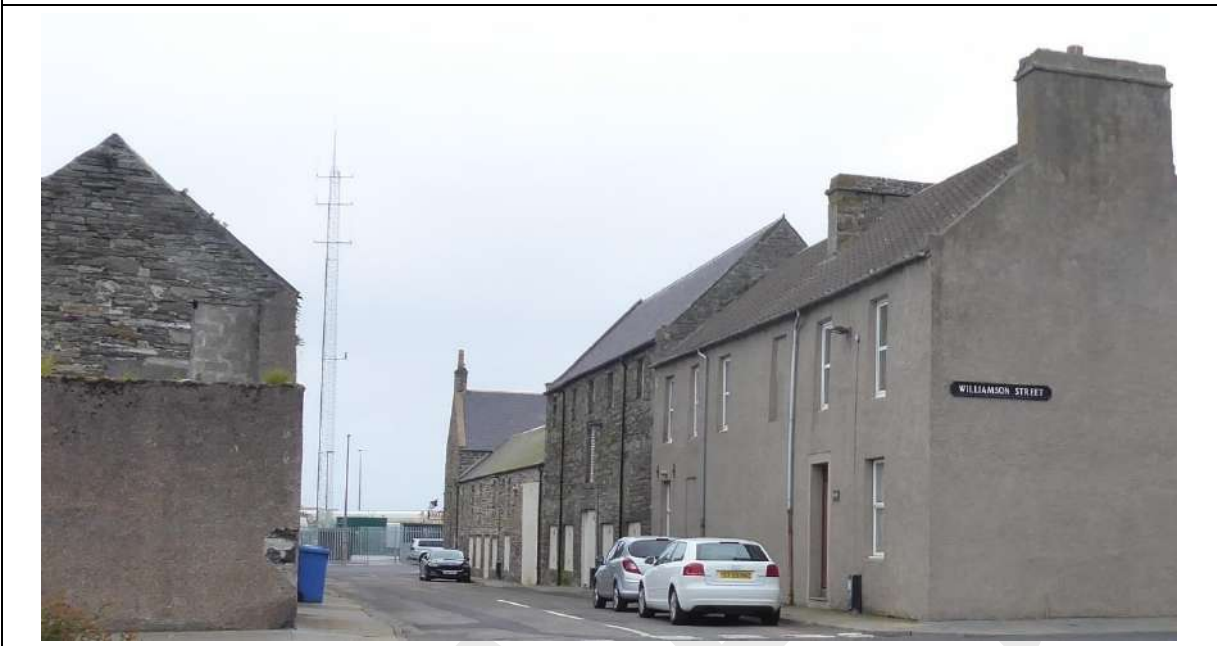
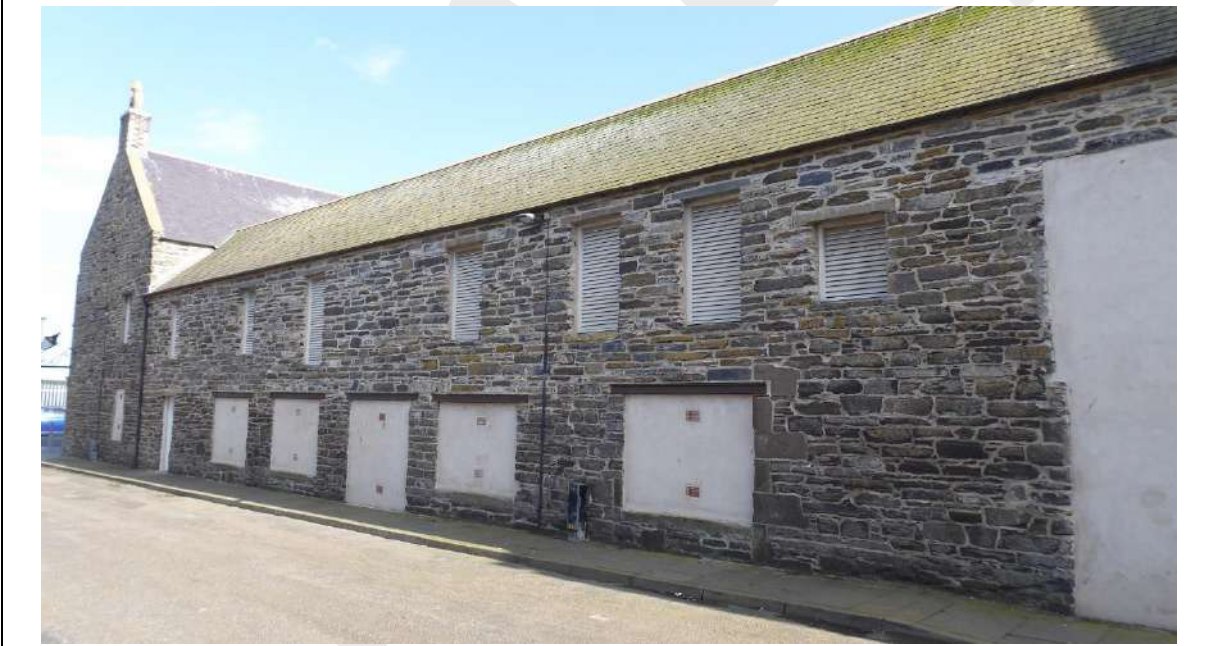
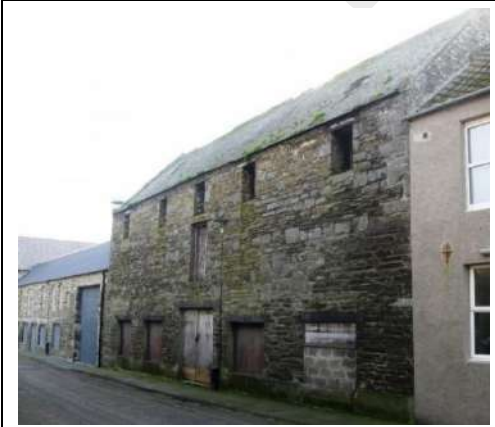
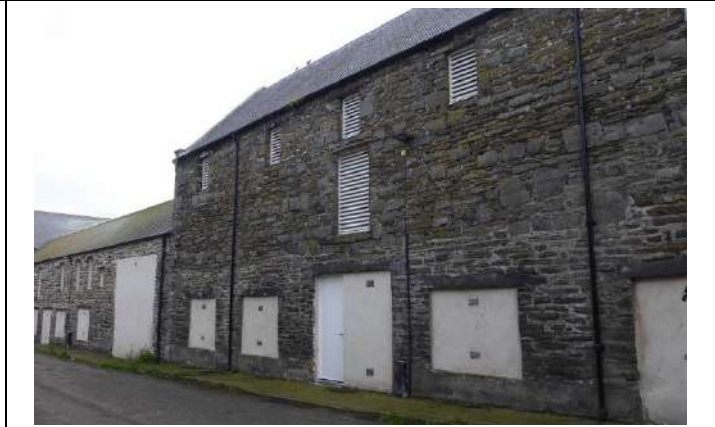
Figure 9: (top) south side of Burn Street looking east to Harbour Quay, 2019; the eastern lots of former curing yard warehouses were repaired in 2012, but still awaiting a new use; (bottom left: BARR 2013 © HES) an early herring house partly repaired sometime after 2013, also vacant.

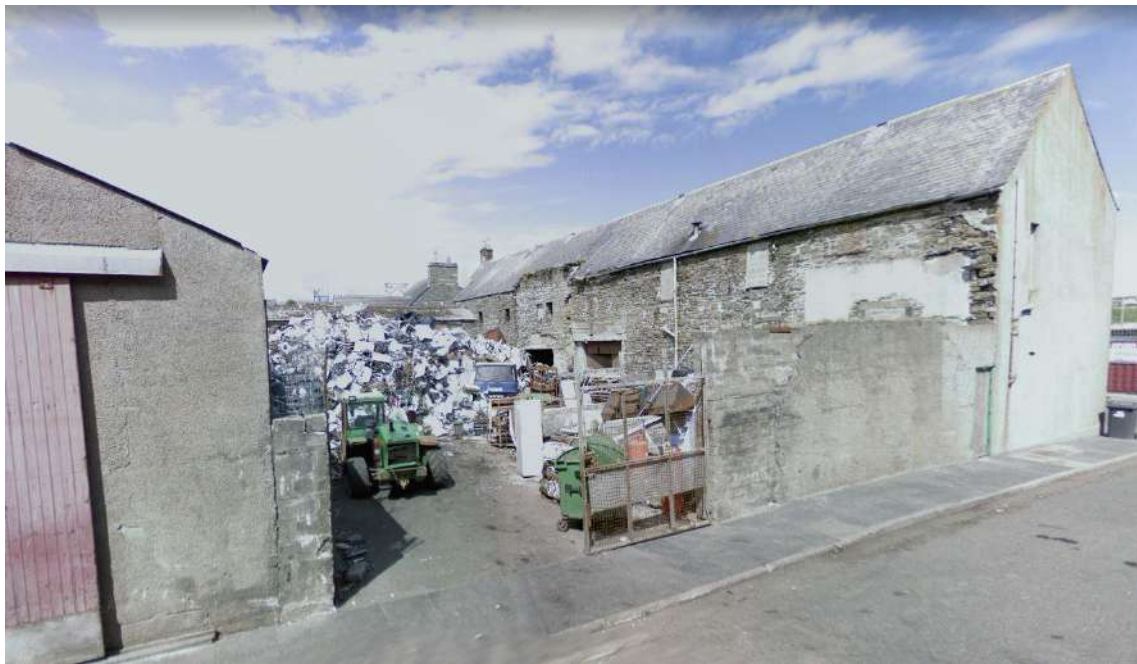
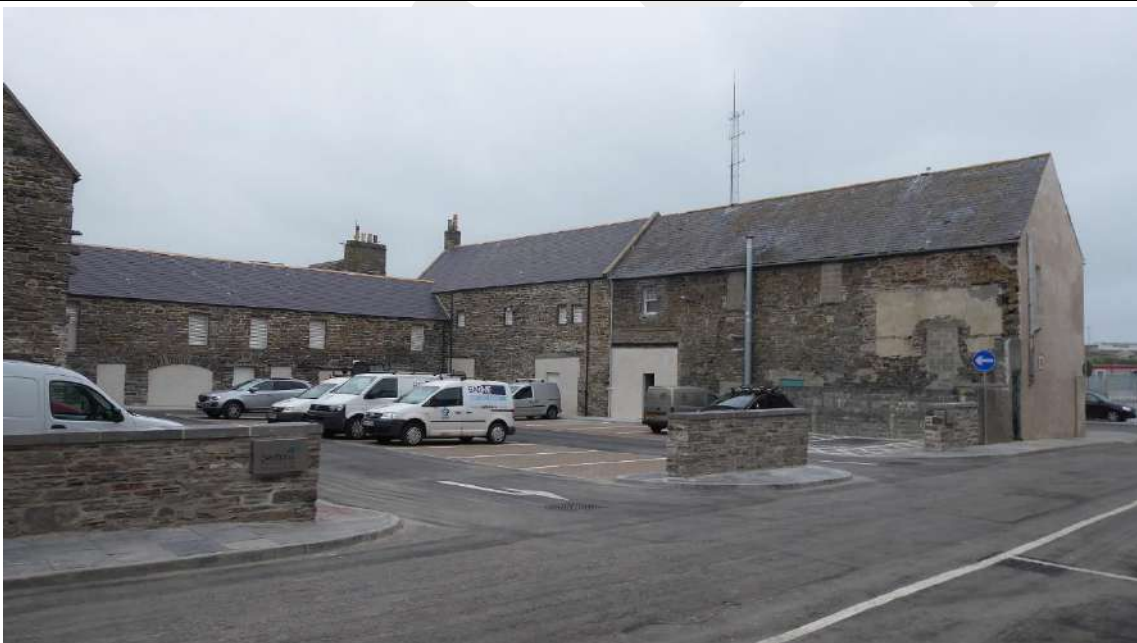
Figure 10: Two lots on north side of Telford Street which address Harbour Quay were repaired c.2012 as part of the Beatrice Offshore grant / investment. The buildings are still awaiting a new use. The former herring curing yard was a scrap metal yard in 2008 (top, © Google Maps); the Telford Street fronting buildings appear to have been demolished sometime before the repair work, which consolidated existing buildings (below 2019). No structures remain from the original buildings which divided the two lots. The site offers further potential for street frontage infill which would also obscure the open car parking site from view.

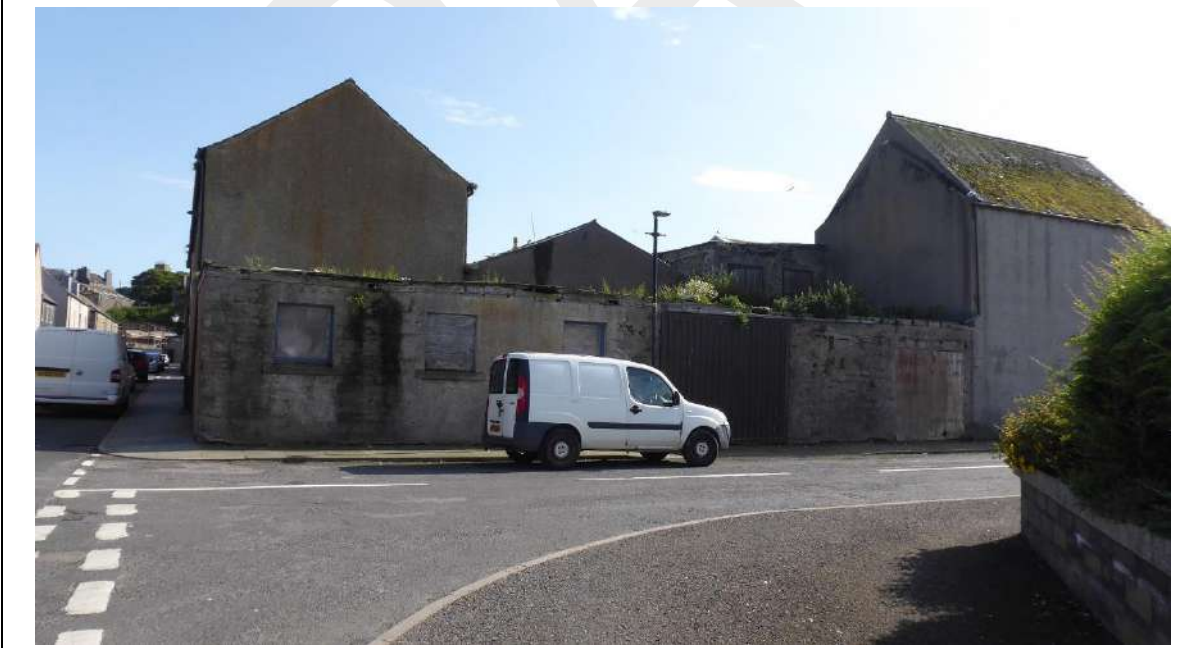
Figure 12: single storey structure on the SW corner of Burn Street and Williamson Street

- two derelict buildings on the south side of Burn Street and adjoining surviving single storey partial building (fig 8);
- former herring house, curing yard and buildings on the south side of Burn Street, part of block with Harbour Quay and Telford Street north side (fig 9);
- Gap site/partial building (façade only?) on Harbour Quay (fig 11);
- Yard next to GMR Henderson on Martha Terrace (fig 8);
- Single storey flat roofed structure at the south-west corner of Williamson Street / Burn Street next to Caithness Voluntary Group building (fig 12).

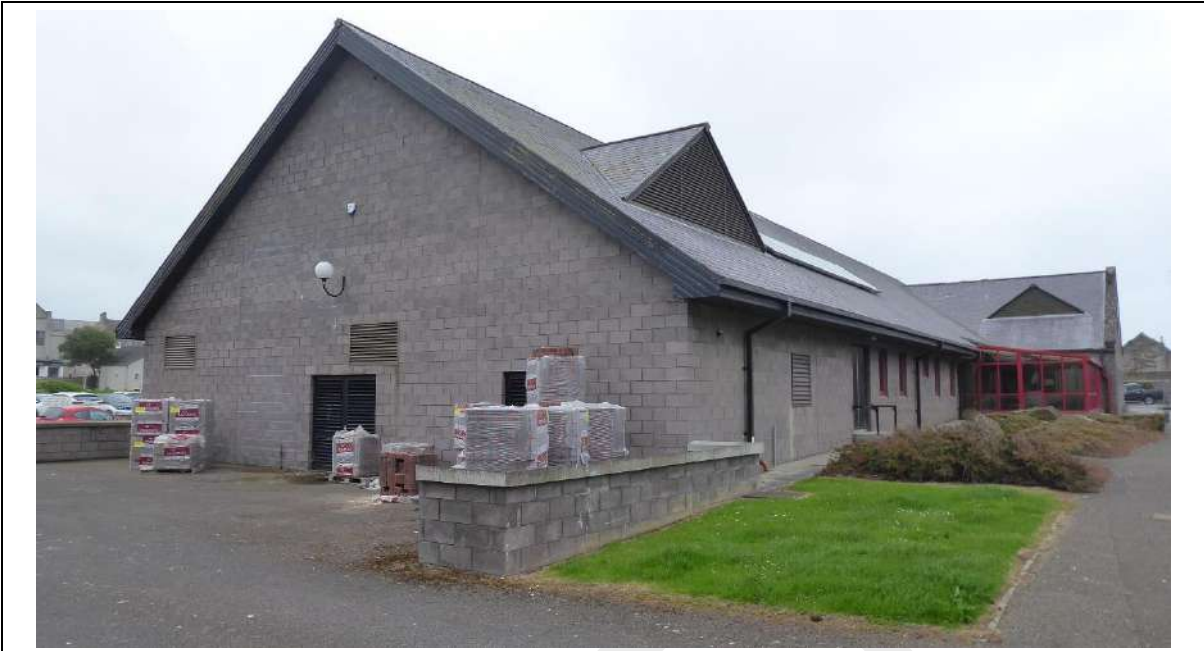
Figure 13: former swimming pool now redundant

- the redundant swimming pool (fig 13; scale of the building, position on plot, lack of street frontage on block, wall materials, standard hard surface finishes);
- Building on the south-east corner of Williamson Street / Martha Terrace and rendered boundary wall treatments (possibly covering original masonry walls; figs 8 & 14);
