The Highland Council

Agenda Item	9.
Report No	CCC/17/24

Report Title: Net Zero Audit & Survey Programme Update

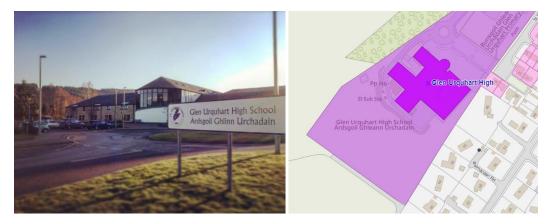
Figure 1: Glen Urquhart High School & Site Details

Glen Urquhart High School was built to the Scottish Building Regulations applicable at the time and opened in August 2002. The school is situated in the rural village of Drumnadrochit, Inverness-shire on the banks of Loch Ness. The school serves approximately 200+ pupils from a wide catchment area ranging from Tomich and Cannich in the West to Invermoriston in the South-West.

Encompassing a total conditioned floor area of approximately 5,200 m², the building serves as a multi-functional facility. Inside, the building offers the expected amenities for a modern learning environment: a full range of teaching spaces, toilets and changing areas, a kitchen and canteen, sports hall, an all-weather sports pitch, administrative offices and storage facilities. Beyond its primary function as a secondary school, it also incorporates a nursery, community library and a sports hall, and is used out of core school hours by the community.

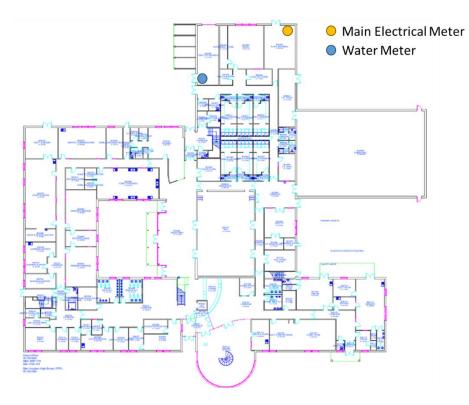
Figure 2: Electrical & Water Meter locations

As shown in Figure 2, the main electrical meter is located within the electrical plant room, while the water meter is within the tractor store. The site has no electrical sub-metering present.

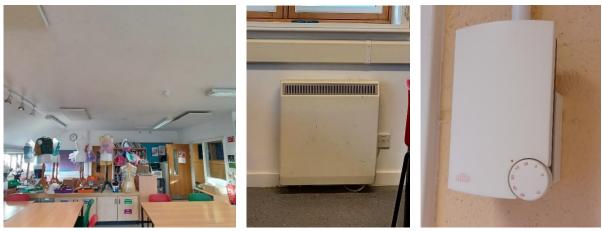
Space	Heating Strategy	
Typical classrooms /	Electric radiant panel heaters with black bulb thermostats and storage	
Nursery/ Changing rooms	heaters (Figure 4)	
Games Hall	Electric radiant panel heaters with black bulb thermostats (Figure 5)	
Main Hall	Variable Air Volume (VAV) supply air-handling unit with electric heater	
	batteries.	
Office spaces and smaller	Electric Storage heaters (Figure 6)	
classrooms		
Corridors	Overdoor Air Heaters (Figure 6)	
Music room	Originally designed with only storage heaters, it was found to be	
	challenging to maintain comfort and infra-red panels with localised	
	manual control were subsequently added. However, the site	
	confirmed that only half of installed infra-red panel heaters are	
	required to achieve a comfortable temperature.

Figure 4: Typical Classroom Heating – ceiling-mounted electric radiant panel heater (left); electric storage heaters (middle); controls for panel heaters (right)

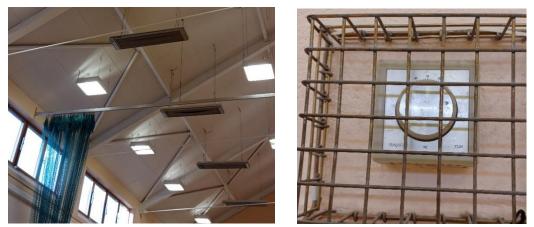
Figure 5: Games Hall Heating – heating units (left); thermostat control (right)

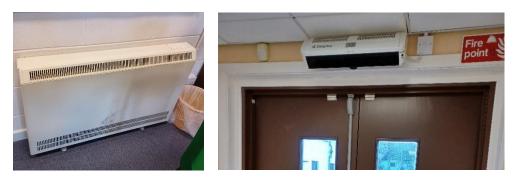
Figure 6: Small Classroom Heating (left); Corridor Over Door Heater (right)

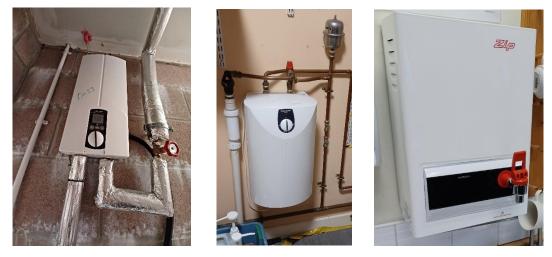
For most areas, including classrooms, toilets and changing rooms, DHW requirements are provided by localised 10-15 litre point-of-use water heaters. For the kitchen a dedicated 200-litre calorifier with electric immersion coil, located in the attic plant room, provides all DHW requirements (Figure 7).

Figure 8: Point of Use Water Heaters (left and middle) & Instant Hot Water ZIP unit (right)

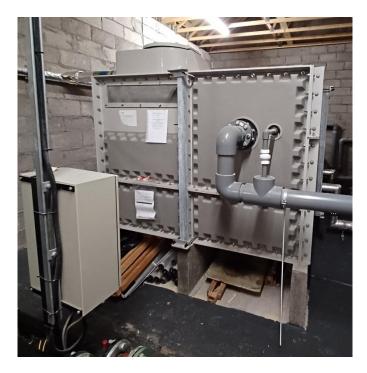
A 9m³ cold water storage tank located in the roof plant space above the tractor store serves the entire building. Onsite staff reported no issues with elevated (>20oC) temperatures of stored water.

Figure 9: Cold Water Storage Tank

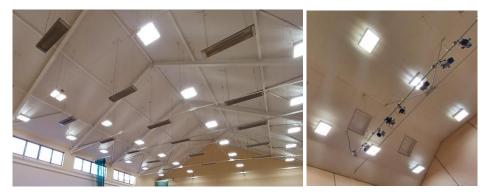
Most of the school's internal lighting comprises T8 fluorescent and CFL fixtures. However, a transition to LED technology is underway in the transitional areas and toilets, with approximately 25% of the fixtures replaced. External lighting and Multi-Use Games Area (MUGA) pitch have been recently upgraded to LED lighting.

Figure 13: Games Hall (left) and Main Hall (right) Lighting

• **Lighting:** Approximately 75% of light fittings across the school are T8 fluorescents. Replacement with LED equivalents would not only reduce energy consumption in a cost-effective manner but also reduce associated maintenance requirements.

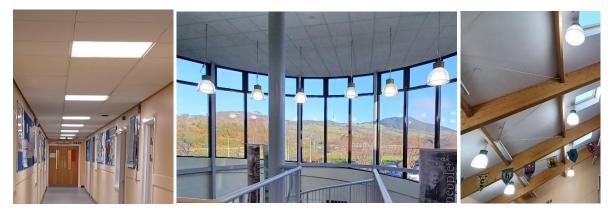
Figure 14: LED Lighting in Corridor (left), Library (middle) and Dining Hall (right)

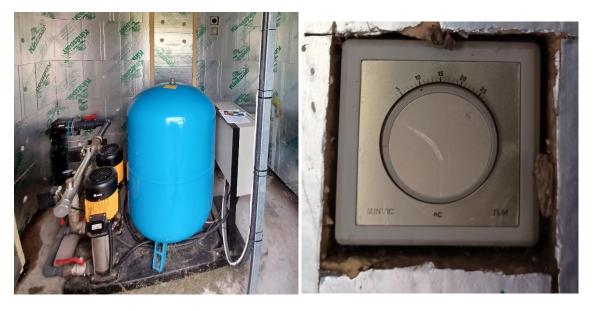
• Excessive Pumphouse Forst Protection: During the inspection, the pumphouse was found to be excessively warm with the space thermostat for frost protection set at 26°C. It was highlighted by the FM team that issues with frozen pipes had occurred previously, leading to a cautious approach.

Figure 23: Inside Pump House (left) Pump House Thermostat 26°C (right)

• **Pump House:** Recommend adjusting the thermostat and heater settings to a lower level that maintains adequate frost protection, whilst minimising energy consumption.

- Excessive Pump House Heating: During the inspection, the pump house was found to be excessively warm. Recommend adjusting the thermostat and heater settings to a lower level that maintains adequate frost protection while minimising energy consumption.

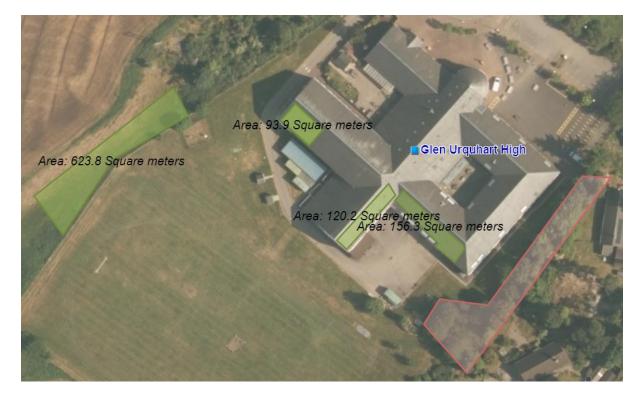
Figure 24: Possible PV Locations

• As a minimum it is recommended that 50kW of PV should be installed at the site to reduce annual bills and improve on site emissions.

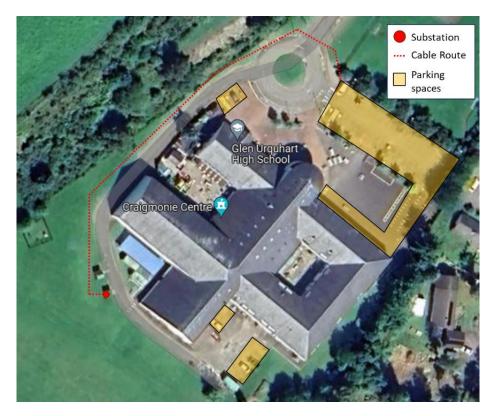
Ideally these would be located in the main car park at the front of the school, with the proposed cable routing visualised in Figure 26. The route minimises disruption and costs by digging primarily across soft ground.

Figure 26: Proposed EV Charger Location

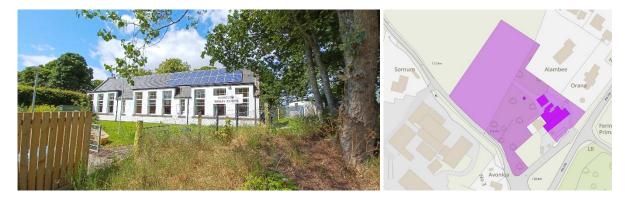
Figure 1: Ferintosh Primary School & Site Details

Ferintosh Primary School (Figure 1) is situated in the rural village of Easter Kinkell and is in the wider Associated School Group (ASG) of Dingwall. The school has a capacity for 50 pupils with a recorded school roll of 13 during the school year 2023-24. It has six permanent staff (mix of part and full time).

The gross internal floor area is approximately $365m^2$ and includes teaching spaces, toilets and changing areas, a canteen with some catering facilities, library area, office areas, staffroom and storage facilities. There are 3 main elements to the building – the main area being built in 1900s, an extension including the WCs in 1955, and a further separate demountable building was installed to provide canteen facilities in 1990.

The building is single-storey throughout, with the original building incorporating storey-anda-half spaces. The site is not listed nor located in any Protected Areas.

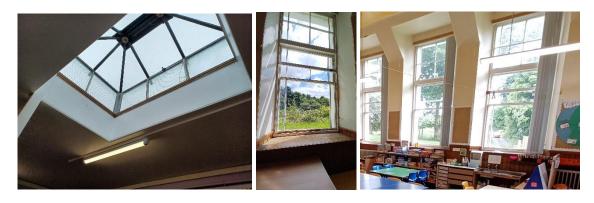
- Condition of existing single glazed units, draughtproofing and frames (including rooflight in Library area) considered poor, potentially indicating need for replacement within short to medium term.
- Double glazed units appear in good condition with tricklevents present.
- No curtains or blinds on large south-facing windows (good for solar gain in summer but will increase heat loss during winter months).

Figure 2: Single glazed rooflight with cracked panes (left); single glazed windows with rotten/flaky paint frames (centre); blinds removed from south-facing double height windows (right)

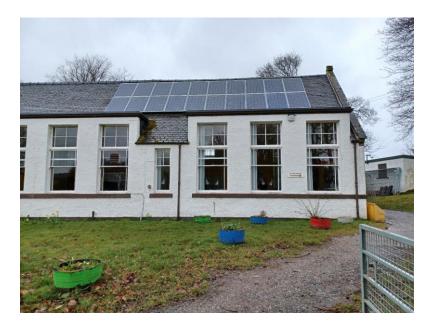
Figure 6: Existing 4kW solar PV system

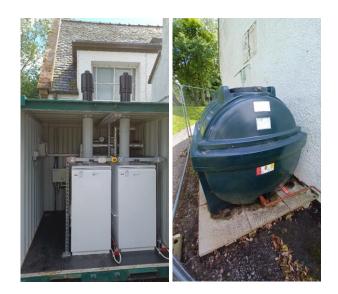
Figure 8: Two temporary oil boilers (left); 2,500l oil tank (right)

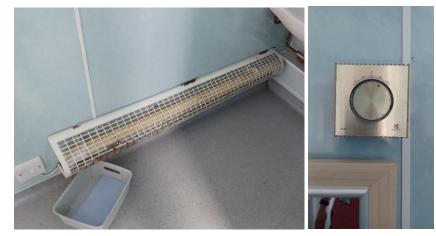
Figure 11: Electric tube heaters in WCs (left); thermostat controls in WCs (right)

- Girl's WC: Thermostat for tube heaters was set to 24°C; felt overly warm when entering.
- **Portable electric heaters:** Three stored in the old Boiler Room and one in the Staffroom (Figure 13).

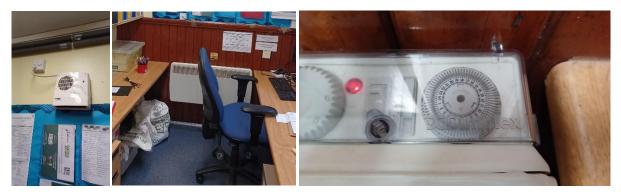
Figure 12: Office wall mounted element fan heater (left); convection heater (centre); convection heater controls (right)

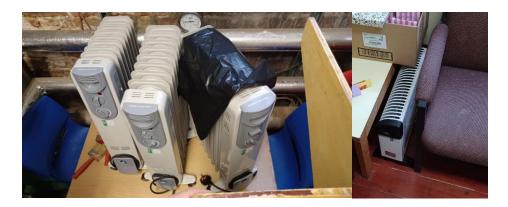
Figure 13: Portable heaters stored in Boiler Room

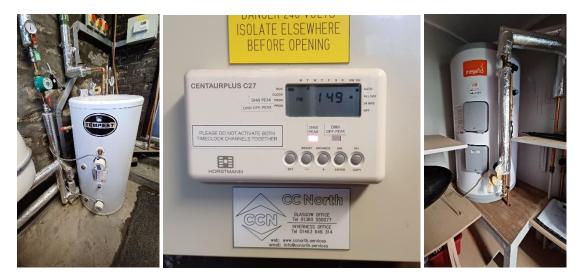
The main DHW system is controlled by a wall mounted programmer, whilst the Canteen system is via on/off switch in Kitchen area and temperature setting on the tank itself.

Figure 14: Main building hot water calorifier (left) and programmer control (centre); Canteen hot water calorifier (right)

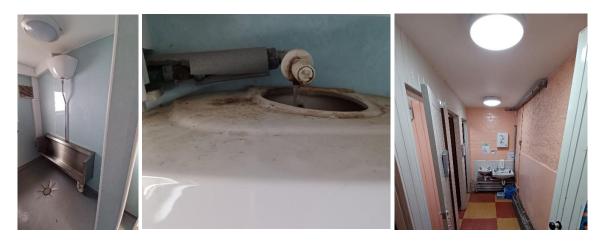
• Appear in acceptable condition, except one cold water tap in the Girls WC (Figure 15) which had a constant drip during the survey.

Figure 15: Urinal (left) and controls (centre); Dripping tap in Girls WC (right)

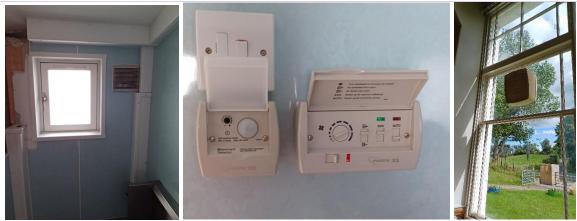
Ventilation Strategy	
Naturally ventilated. Tricklevents within double-glazed units	
(Figure 17). One extract fan in Classroom (Figure 16).	
Localised extract units wall mounted. Controlled via PIR and	
control panel (Figure 16).

Figure 16: Wall mounted extract fans in WCs (centre left); Extract fan controls in boys WC (centre right); Extract in Classroom (right)

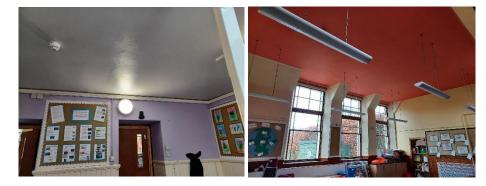
Table 8 outlines the lighting strategy for the school. All internal lighting within the school is LEDs (Figure 18) except for two ceiling mounted T8 fluorescent tubes with manual control in the old Boiler Room (Figure 19). External lighting is assumed fluorescent wall mounted security lights controlled by solar dial time switch in Reception (Figure 20).

Figure 18: Typical LED lighting in school

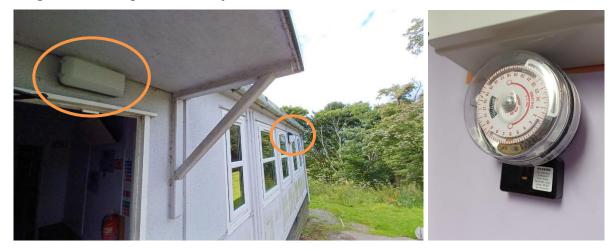
Figure 20: External security lighting (left); solar dial time switch control (right)

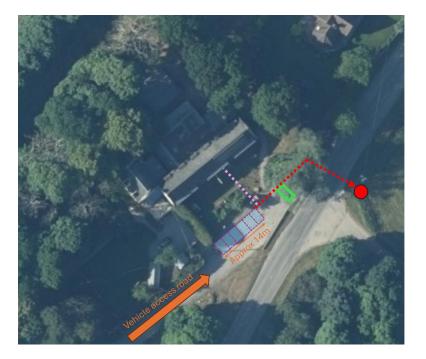
Figure 26: Proposed EV charger location

The school has no parking within the site boundary. However, there is an informal space for 5-6 cars which is used by staff and visitors. There are no formal parking bays outlined. Scottish Government guidance suggests 10% of car parking spaces should be designated for electric vehicle charge points (EVCPs).

Ideally therefore, one EVCP would be situated close to the school, with the proposed approximate cable routing outlined in Figure 26. Further investigation is necessary to determine whether the EVCPs could be directly connected from the local substation (red line) or utilise the school's spare electricity capacity (purple line). Currently, the substation adjacent to the school has a capacity allowance of 100kVA (Figure 27), with a maximum demand of 29.62kVA, leaving 70.38kVA potentially available for EVCPs. The recommended EVCP setup would consist of a 7kW (14kVA) fast charging point, which could be currently accommodated. Please note, the impact on available capacity of the school and substation due to the proposed change from oil to electric heating (heat pump) must be considered prior to any EVCP proposals.

- Estimated location of parking bays (unmarked)

- Waste and recycling area (access required by recycling truck)
- Cable route to substation (approx.)
- Substation (location approx.)
- Cable route from school (approx.)

The nearest secondary substation appears to be pole mounted, directly opposite the school.. If EV chargers are under consideration for future installation, a connection request to SSEN would need to be submitted to confirm the availability of this capacity.

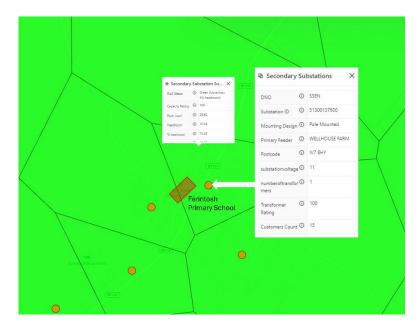
Figure 27: Substation Location and Capacity (via SSEN LENZA Tool)
