# The Highland Council

Agenda Item	9.
Report No	CCC/8/25

**Report Title:** Net Zero Audit Surveys Update

# Deshar Primary School Net Zero Audit Report

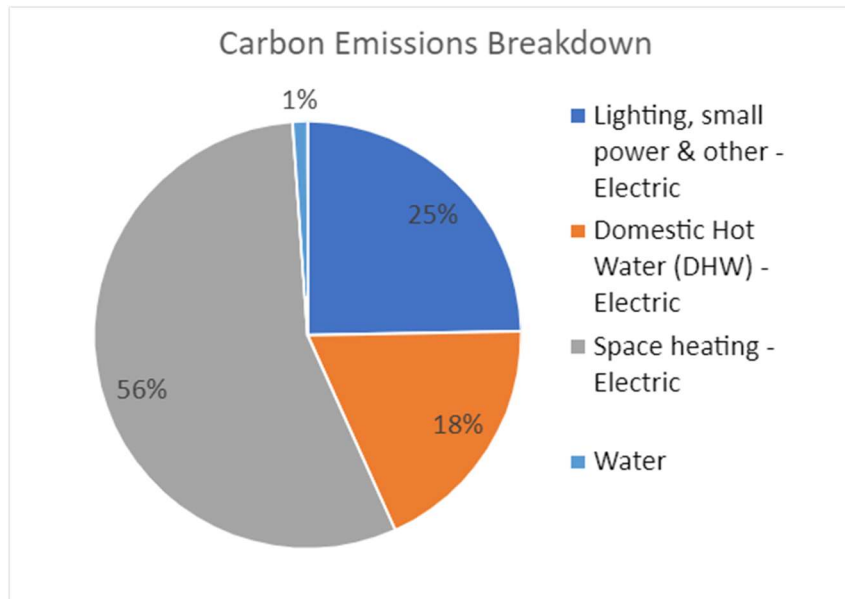
Figure 3: Carbon Emissions Breakdown

Figure 3 outlines the estimated carbon emissions of different energy end-uses in the school. Note, this does not include travel or waste related emissions. The main area of carbon emissions is space heating (electric).

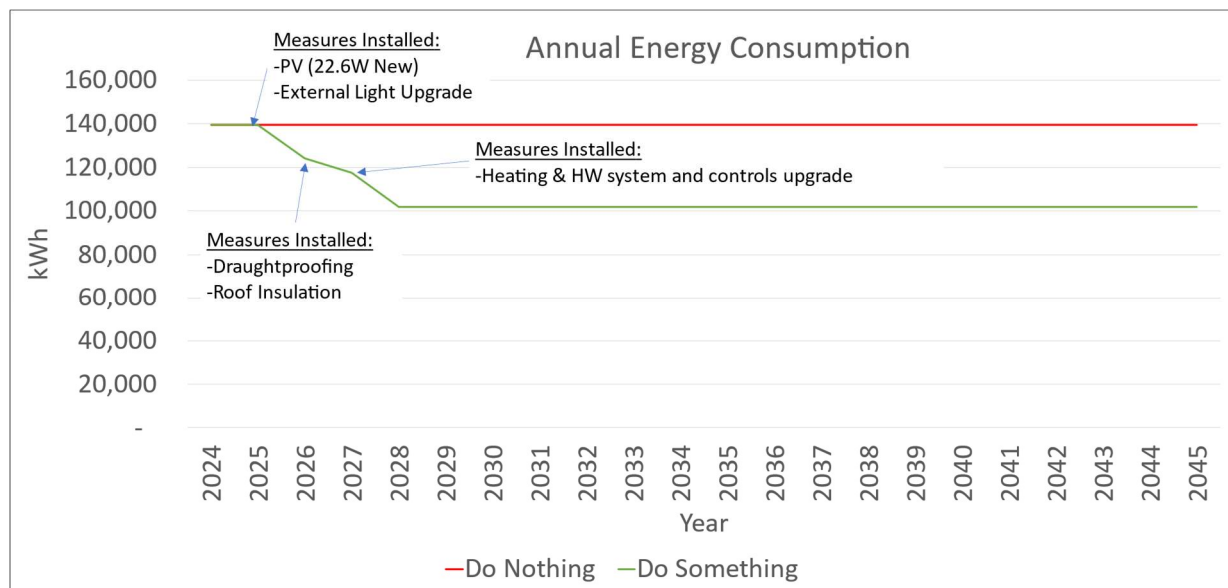
Figure 8: Annual Energy Consumption Forecast

Figure 8 and Figure 9 highlight the changes in annual energy consumption and energy costs from implementation of the recommended measures (max 20-yr payback), with doing nothing (red) vs doing something (green). Profile is based upon the measures being progressed over the period 2025-27.

Between 2024 and 2045 the cumulative cost savings and energy reduction are estimated to be £135,685 and 710,815kWh respectively.

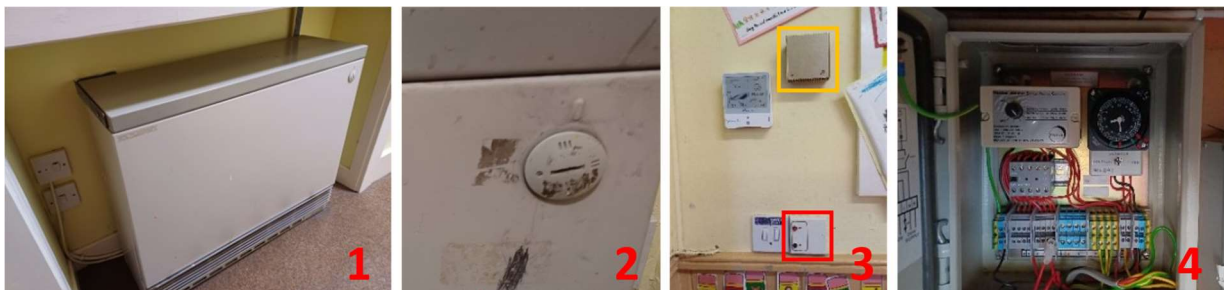
All heating is electrically based. A breakdown of the heating strategy is presented in Table 12. Storage heaters (SHs) are the main source of heating throughout the Main Building, and the Horsa Hut (Figure 13). The Nursery is heated via a 14kW Air Source Heat Pump (ASHP).

In total, there are approximately 27 SHs (Main Building: 23, Horsa Hut: 4). It was not possible to determine exact specifications for all units, however based upon size, age and type, it is expected they vary between 2-4kW each.

Figure 13: Storage heater [1]; Dial Controls [2]; Room Thermostat (yellow box) and Boost Control (red box) [3]; Weather Watcher Control [4]

Heating & Hot Water	Heating Infrastructure	Older storage heaters present. Upgrade electric heating and controls in Main Building and Horsa Hut from SHs to electric radiators or panel heaters with localised smart controls.	Y
	Heating Controls	Controls old and lack customisable options for occupancy patterns (eg. Not able to set different weekday vs weekend timings). Involve upgrade to appropriate localised smart controls.	Y
	Hybrid / Bivalent Heating	As the school is electrically heated this would require a full heating replacement which is not advised in this scenario.	N
	HW Ancillaries	Some HW pipework requiring insulation. Some older water heater models – advise upgrading to increase efficiency.	Y
	HW Controls	HW controls are basic, but occupants using them efficiently.	N
Ventilation	Heat Recovery	Lack of physical space for HR system to be installed; natural ventilation strategy deemed appropriate for building.	N

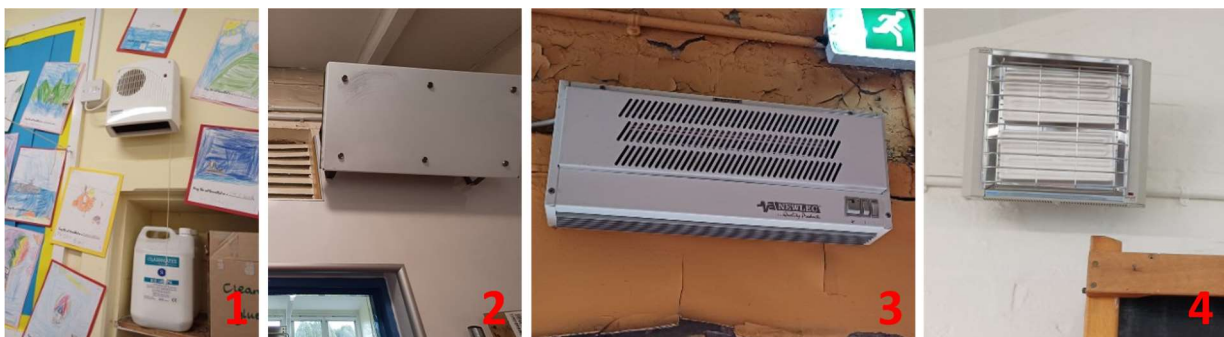
Figure 14: Wall Fan Heater (Classroom) [1]; Radiant Panel Heater (Kitchen Store & Cleaner's Cupbd) [2]; Overhead Air Heater (Horsa Hut) [3]; Infrared Heater (Horsa Hut) [4]

Space	Heat Emitters	Controls
Main Building and WCs	Electric SHs plus portable heaters and Dimplex wall fan heaters (Figure 14).	Overnight storage through centralised Weather Watcher SH controller w'localised dial control (o-III), room thermostat and override boost control.
Horsa Hut	SHs, overdoor air heaters, infrared heaters and overhead radiant panel heaters (Figure 14). Additional overhead heater in vestibule.	Timer switches at rear of canteen, controlling infrared heaters. Programmer & timer controlling SHs and overhead heaters.
Nursery	Underfloor heating.	Programmer & Timer with room thermostats.

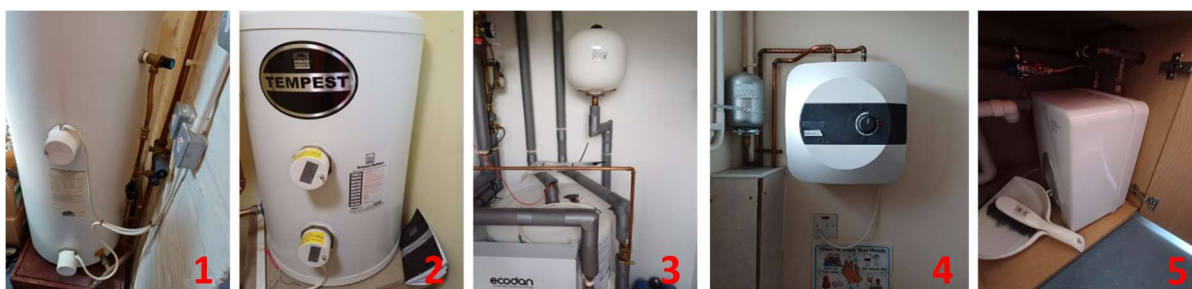
- 90litre calorifier (South Block WCs wash hand basins (WHBs))
- 210litre calorifier (Kitchen and Canteen sinks)
- 150litre calorifier (Nursery sinks and WHBs)

Seven 5-10litre point-of-use 2kW water heaters (Cloak, North Block WCs, Staff and Food Prep areas) provide hot water for sinks and WHBs.

Figure 15: Electric Immersion Calorifier (Horsa Hut) [1]; Electric Immersion Calorifier (South Block WCs) [2]; Hot Water Calorifier (Nursery) [3]; Point-of-Use Water Heater (North Block WCs) [4]; Under sink Point-of-Use Water Heater (Cloak/Craft Area) [5]

- Generally appear to be in good condition, some PoU WH older models.
- All three calorifiers monitored by the Energy Team's IoT sensors. Readings correspond with findings on site.
- HW programme and timers installed for the Kitchen and Nursery calorifiers: Nursery on timed settings and not touched by occupants, Kitchen programmer set to 'off' and 1 hour boost override is being used by occupants as required.

- Lack of insulation around HW pipework throughout Main Building & Horsa Hut.
- HW tap in Cleaner's Cupboard in Nursery was found to be dripping.

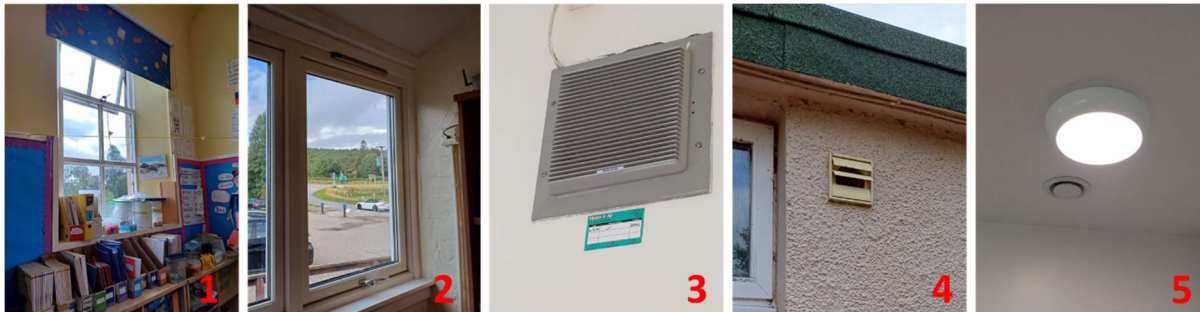
Kitchen	NV: operable windows; some w'tricklevents. Wall mounted extract fan mounted within window (on/off control).
Staff Toilets	Localised extract unit controlled via light switch.
Boys & Girls WC (North)	NV: operable windows, no tricklevents. Extract vent (constantly open) with no controls apparent.
Boys & Girls WC (South)	NV: operable windows, no tricklevents. Gap between threshold and bottom of door leaf.
Nursery	Mechanical Ventilation (MV) system w'ceiling vents and DG windows w'tricklevents.

Figure 16: Openable DG windows (no tricklevents) [1]; Openable DG windows (tricklevents) [2]; Extract in Kitchen [3]; Vent (North Block WCs) [4]; MV System Outlet (Nursery) [5]

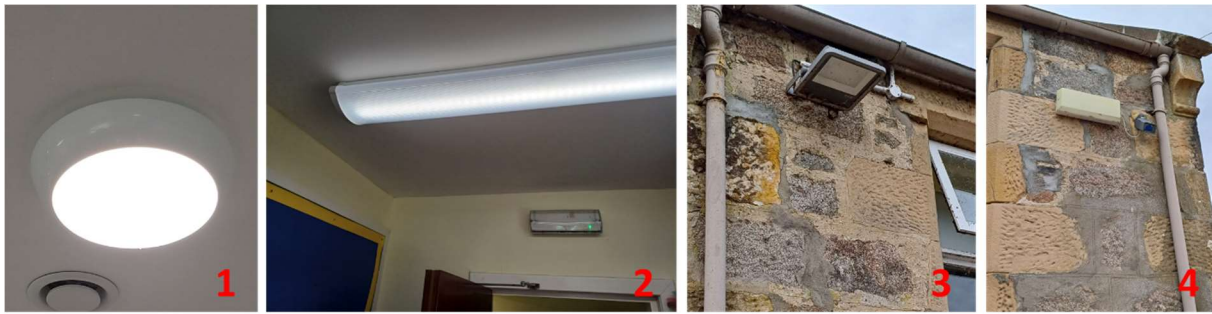
Space	Lighting Strategy
All indoor areas	Ceiling mounted LEDs with manual control (dimmer switch only in Office) (Figure 17).
External (Horsa Hut and Main Building)	Four out of six wall mounted security lights fluorescent (Figure 17), controlled via Sangamo time switch and external photocell.
External (Nursery)	Under-roof and wall mounted LED security lights, controlled via timer in Nursery Plant Room.

Figure 17: Typical Internal LED Lighting [1]; Typical Internal LED Strip Lighting [2]; External LED Lighting [3]; External Fluorescent Lighting [4]

- All new fittings appear in good condition.
- One ceiling mounted light in understairs cupboard appeared to be fluorescent.
- External lighting solar time switch clock out by one hour. Does not allow daily or weekly time settings to reduce use during holidays/summer.
- Facilities Officer confirmed fluorescent lights (internal and external) replaced at end-of-life with LEDs.

Lighting	Lighting (LED Upgrade)	Recommend replacement of all external light fittings to energy efficient LED.	Y
	Lighting Controls	Manual switches only present; deemed acceptable for size and use of building.	N
Cooling	Cooling Replacement	Minimal cooling equipment present, and minimal savings would be achieved in replacement.	N
	Cooling Control	As above.	N

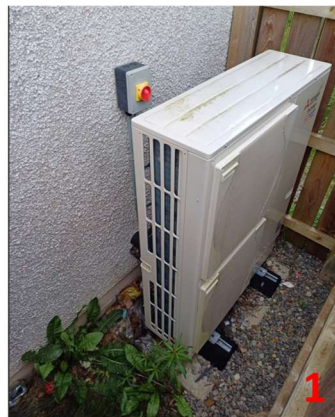
A 14kW air to water heat pump provides space heating (underfloor) and hot water for the Nursery (Figure 18). It is controlled by a programmer and room thermostats.

Figure 18: Air Source Heat Pump System (External Unit [1]; Room Thermostat [2]; Programmer [3])

- All aspects of ASHP appear in good condition.
- Programmer out by one hour.
- Staff noted that they did not know how to change programme settings.
- Room thermostats reading 19-21°C (acceptable thermal conditions).
