Job Title
Highland School RAAC Survey –
Nairn Academy

Prepared for
Highland Council and Watts Property
Service

Report Type
RAAC Survey Final Report

Date
21 August 2023

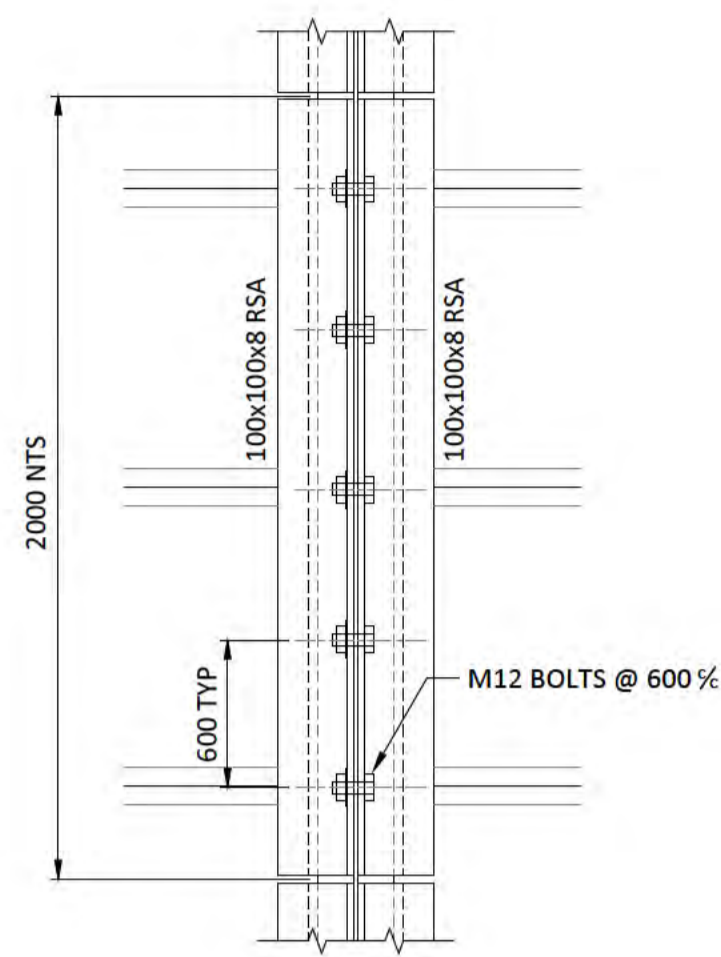
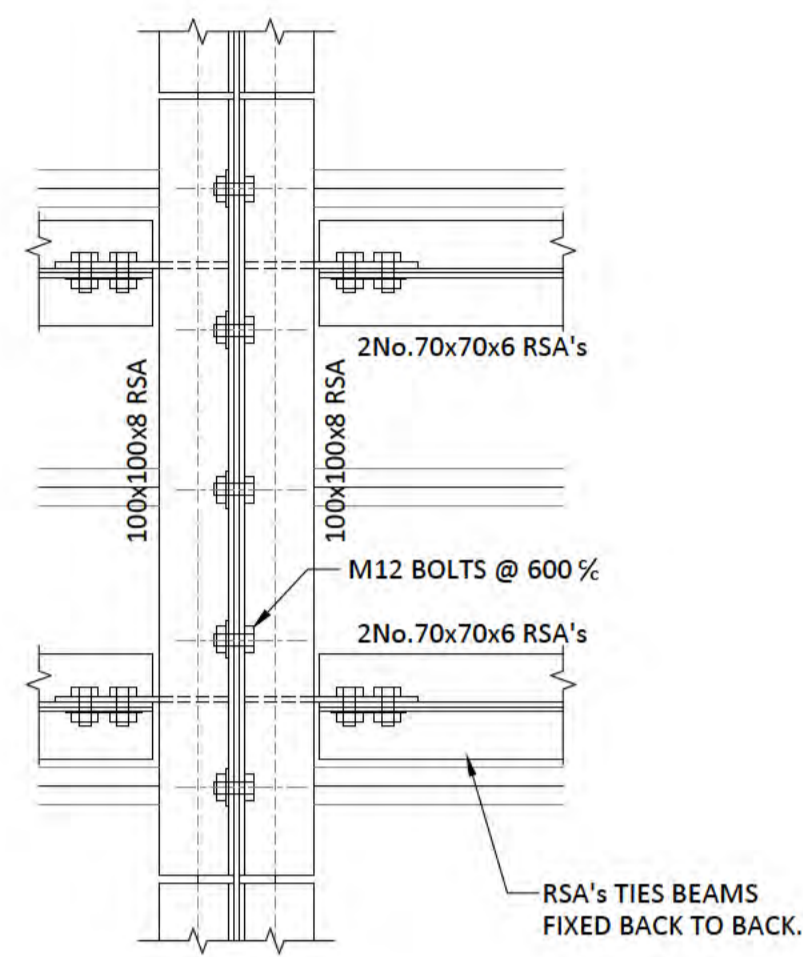
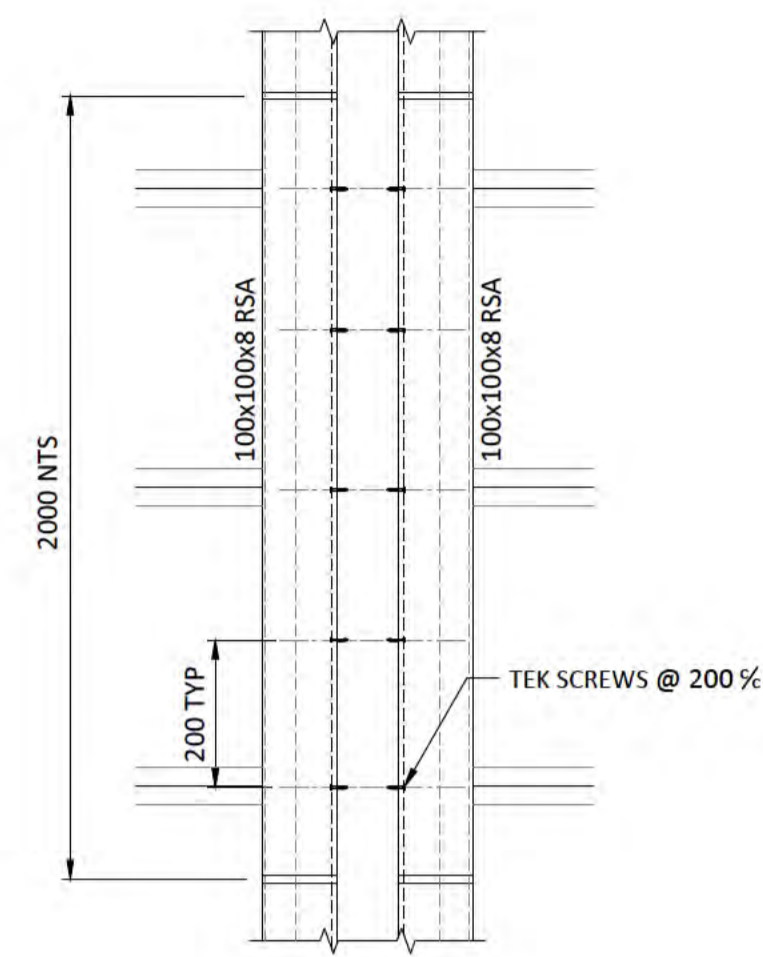
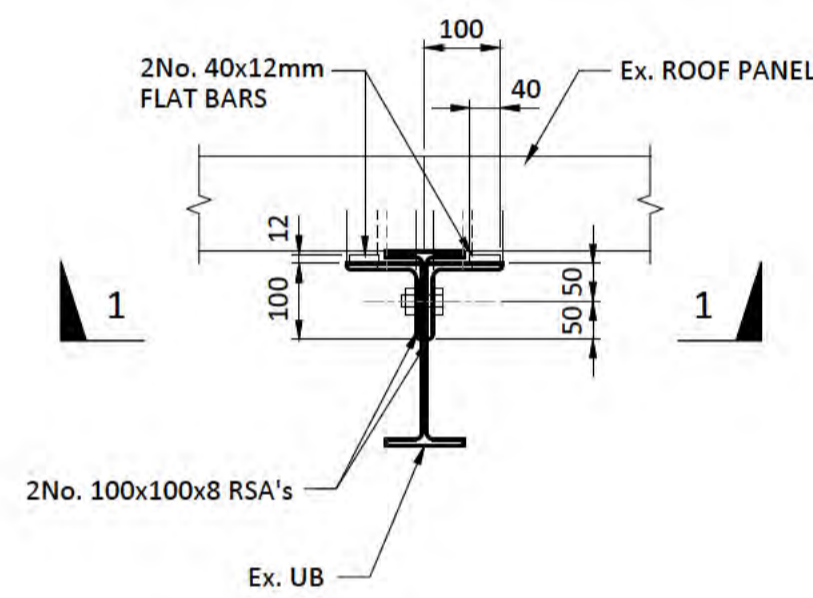
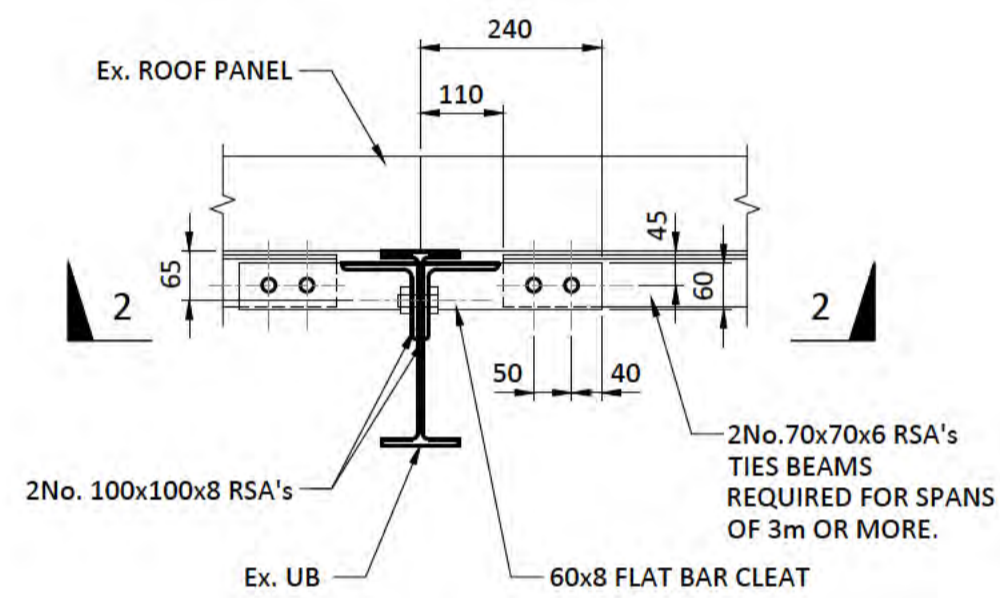
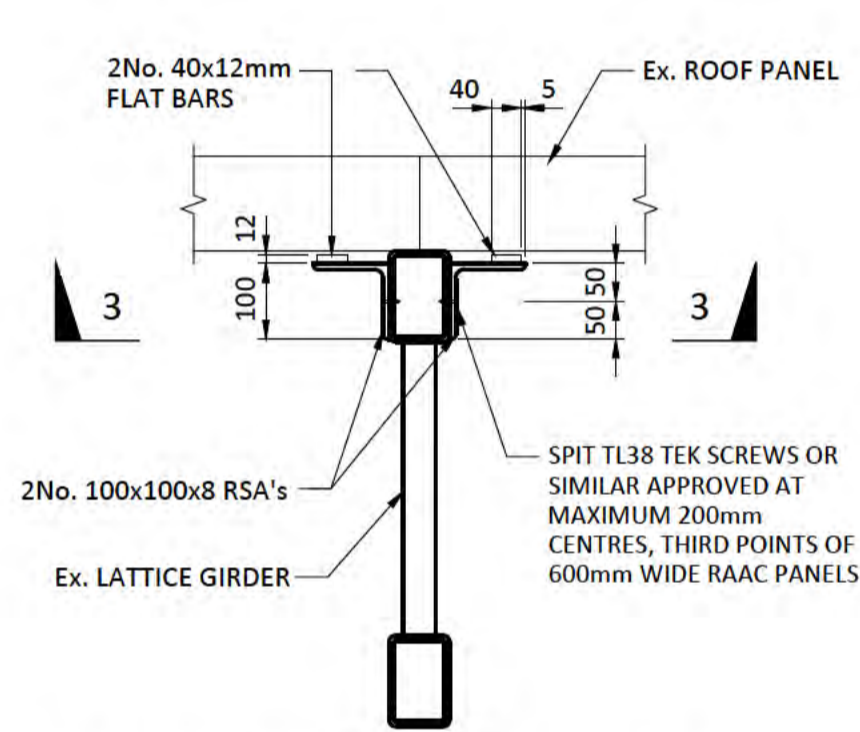
Civic Engineers provided design intent details for remedial works to ensure panels achieved minimum requirement of 75mm bearing and that additional support at intermediate points of panels was provided where panels were noted to show signs of water ingress.

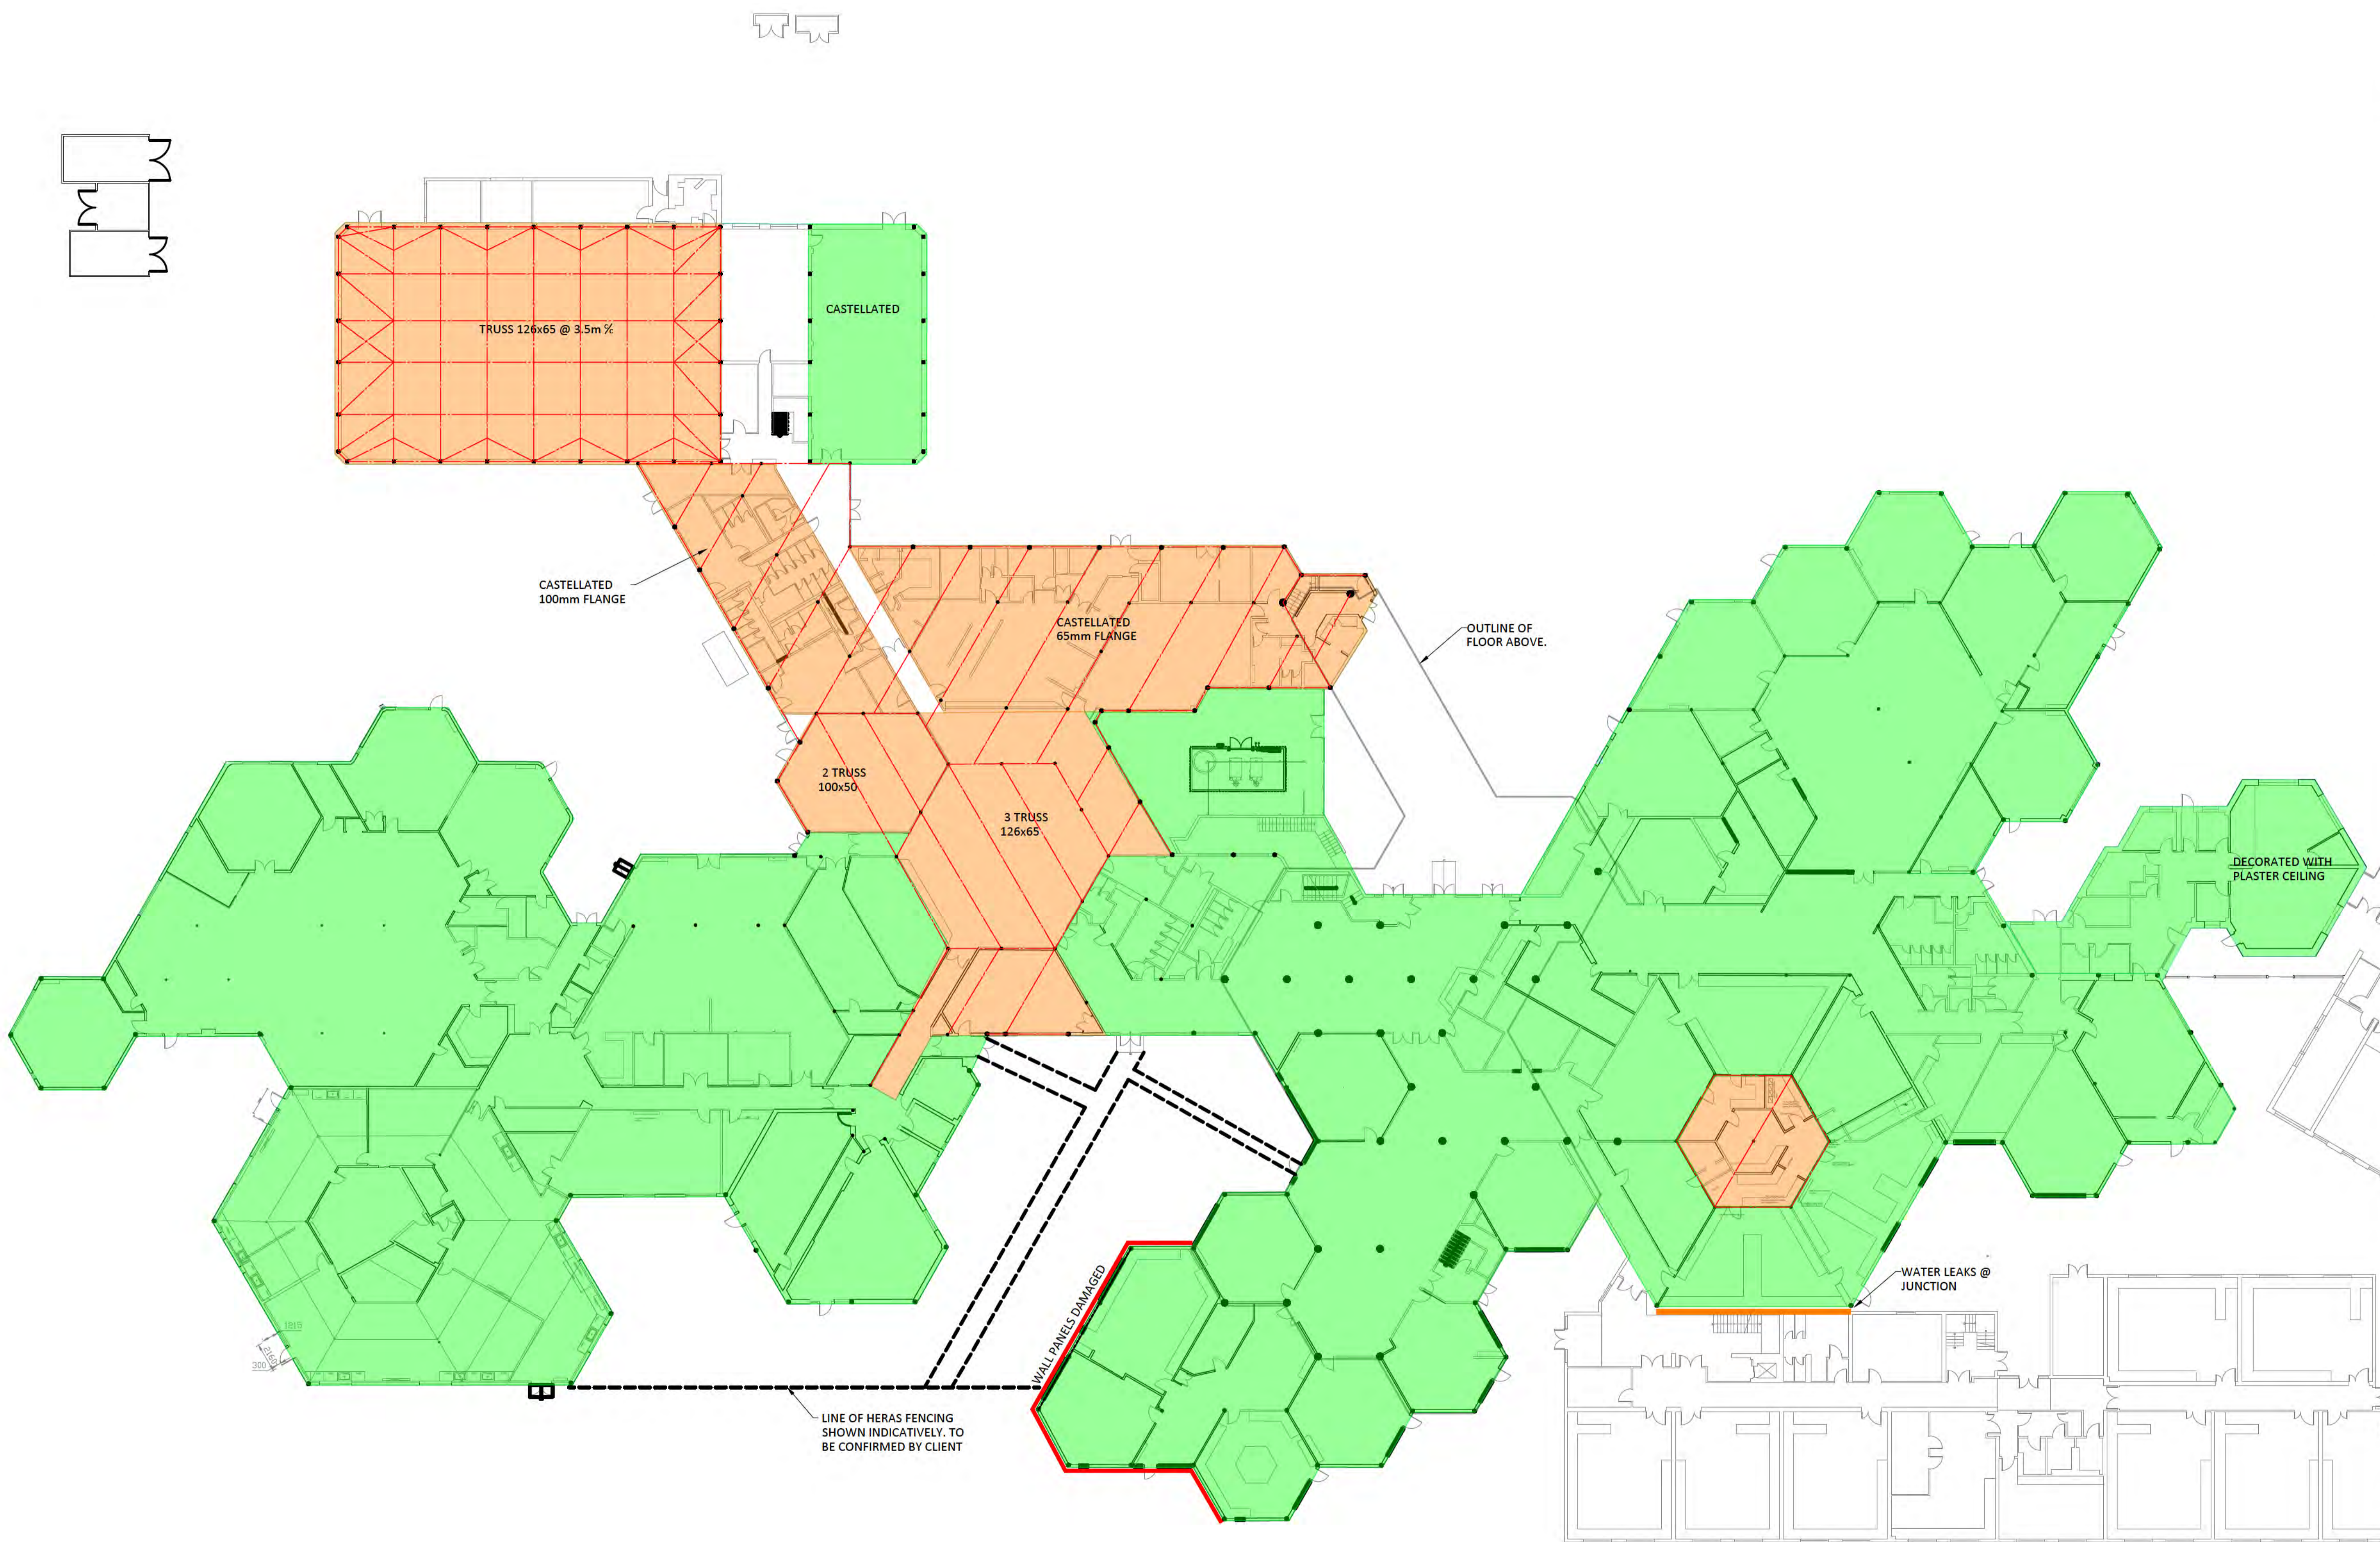
PLAN ON EXISTING GROUND FLOOR
Scale 1:250

Drawings of each floor with risk category annotated are included within Appendix B. Location of existing structure and anticipated span directions is also noted on plans. Should any structure encountered on site vary from that noted on drawings, Civic Engineers should be notified for review.
