Job Title
Highland School RAAC Survey –
Charleston Academy

Prepared for
Highland Council

Report Type
RAAC Survey Interim Report

Date
20 February 2024

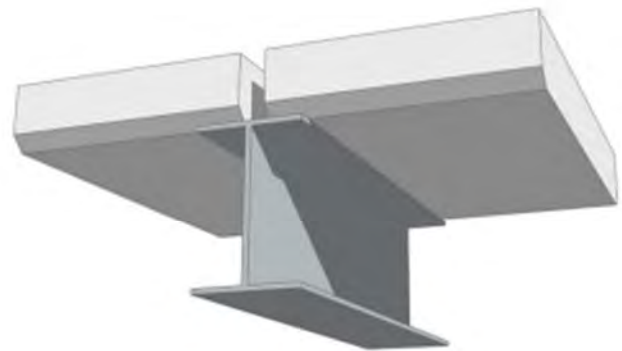
Figure 3 – End bearing condition

Narrow or short bearing lengths may be identified through visual inspection; for example, where panels span from either direction onto a narrow steel beam or masonry wall less than 100mm. These shared bearings on narrow beams or supports can therefore present risks of inadequate bearing length.

Sub-standard bearing on 100mm beam

For this reason, a minimum as built bearing length 75mm is now considered to be necessary. Any bearing less than 75mm would be considered substandard and present an unacceptable risk to panels from shear failure or slippage and remedial actions are recommended.

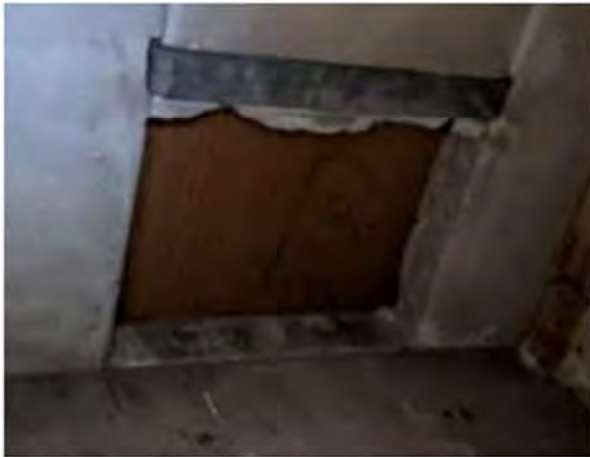
Figure 4 – Photo of hangers

Original construction techniques used narrow steel trimmers or hangers supported by adjacent panels to form openings in roofs. These steel hangers often have narrow bearing support and have been installed some distance from transverse reinforcement. Therefore, cut panels supporting on hangers present inadequate bearing conditions and poorly anchored longitudinal reinforcement.

Depending on the span of the panel being supported these conditions may present high risk of panel failure.

Cut panels should be identified in all instances. The length of the cut panel, support conditions and defects should be noted.
