Job Title
Highland School RAAC Survey –
Nairn Academy

Prepared for
Highland Council

Report Type
RAAC Survey Interim Report

Date
7 March 2024

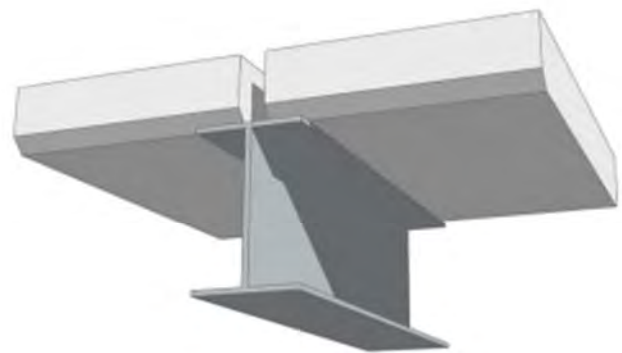
Figure 3 – End bearing condition

Narrow or short bearing lengths may be identified through visual inspection; for example, where panels span from either direction onto a narrow steel beam or masonry wall less than 100mm. These shared bearings on narrow beams or supports can therefore present risks of inadequate bearing length.

Sub-standard bearing on 100mm beam

For this reason, a minimum as built bearing length 75mm is now considered to be necessary. Any bearing less than 75mm would be considered substandard and present an unacceptable risk to panels from shear failure or slippage and remedial actions are recommended.

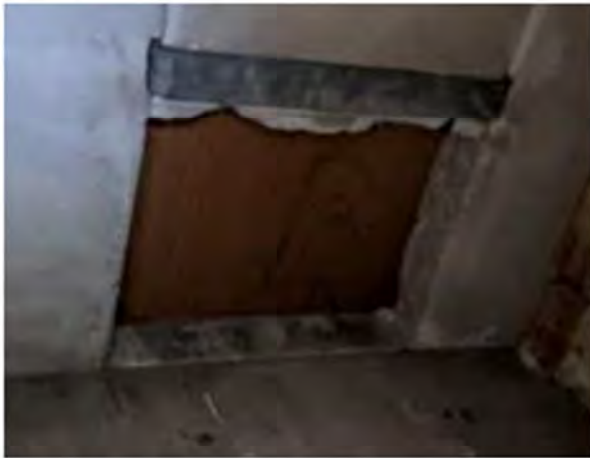
Figure 4 – Photo of hangers

Original construction techniques used narrow steel trimmers or hangers supported by adjacent panels to form openings in roofs. These steel hangers often have narrow bearing support and have been installed some distance from transverse reinforcement. Therefore, cut panels supporting on hangers present inadequate bearing conditions and poorly anchored longitudinal reinforcement.

Depending on the span of the panel being supported these conditions may present high risk of panel failure.
