A890 Stromeferry Bypass

Annual Slope Inspection 2024

The Highland Council

Project number: 60685712
AECOM Report Ref: GLRP0008

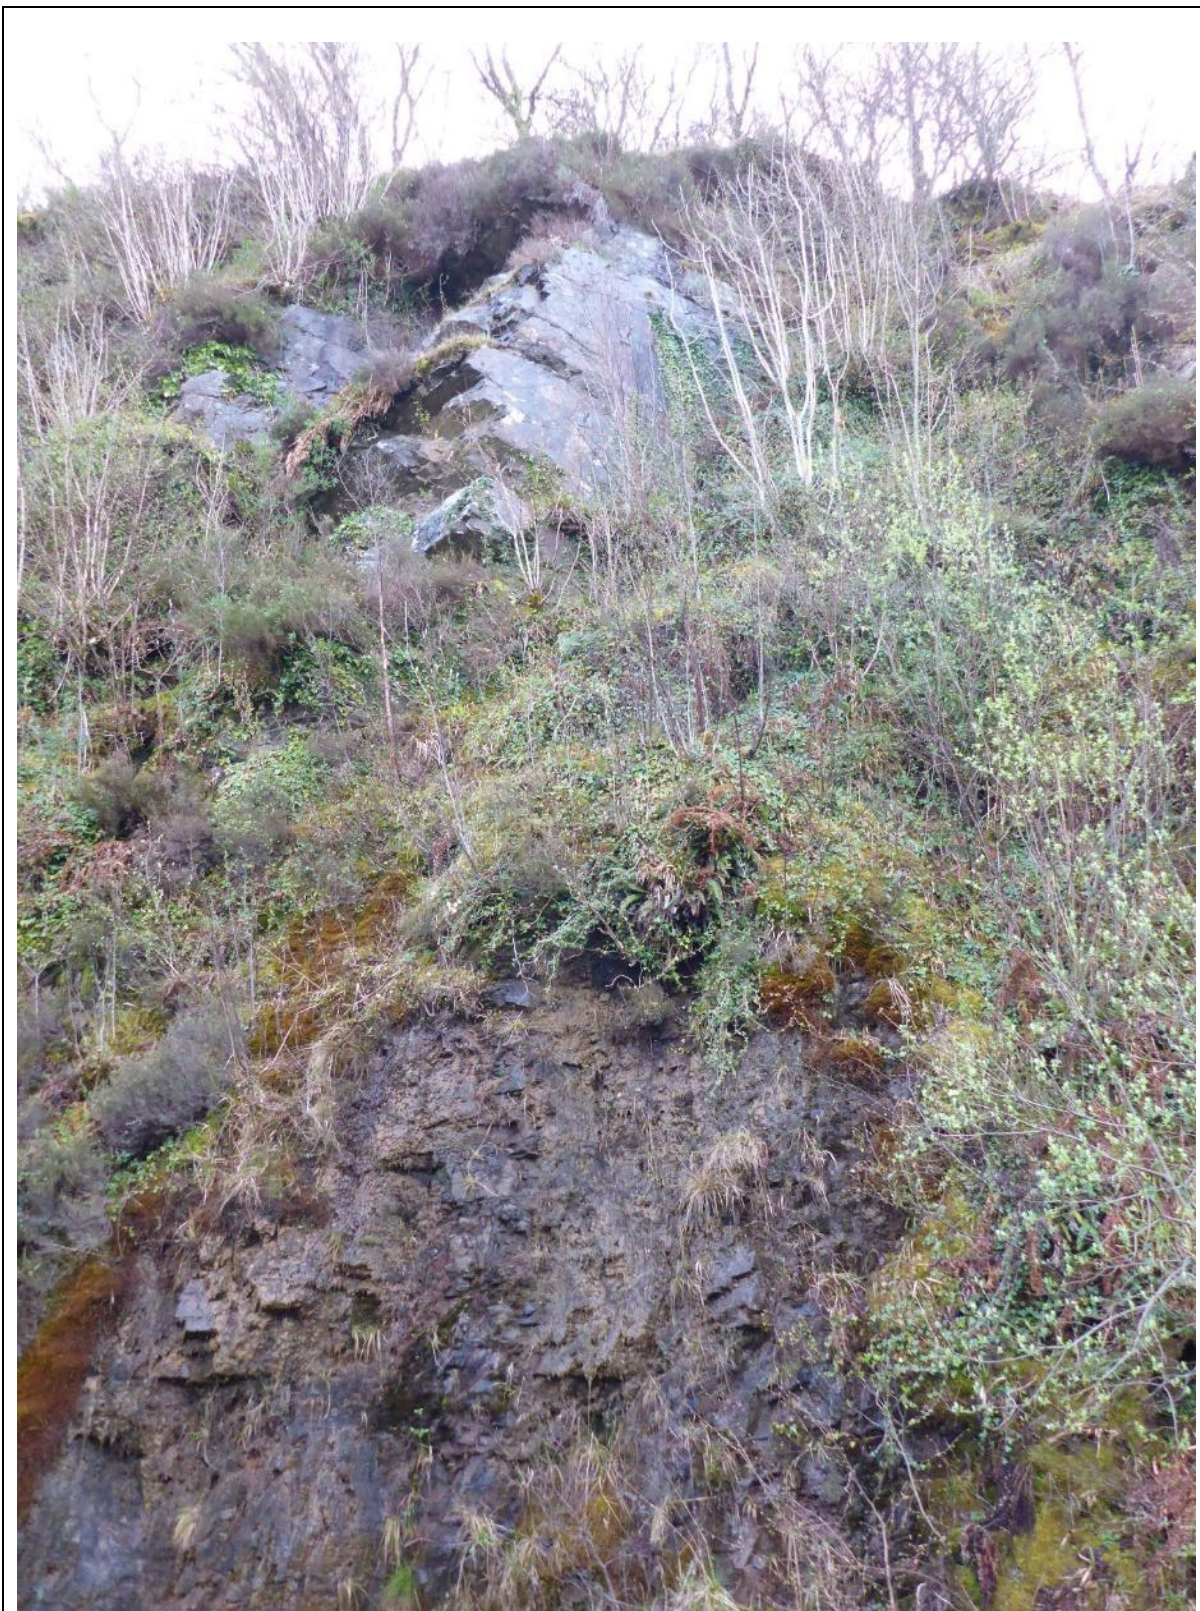
Photograph: AA4-2

Ch. 766 – Location of 2021 rock fall. Rope access inspection found the source ca. 4 to 6m below crest of slope.

Year observation first noted: 2021

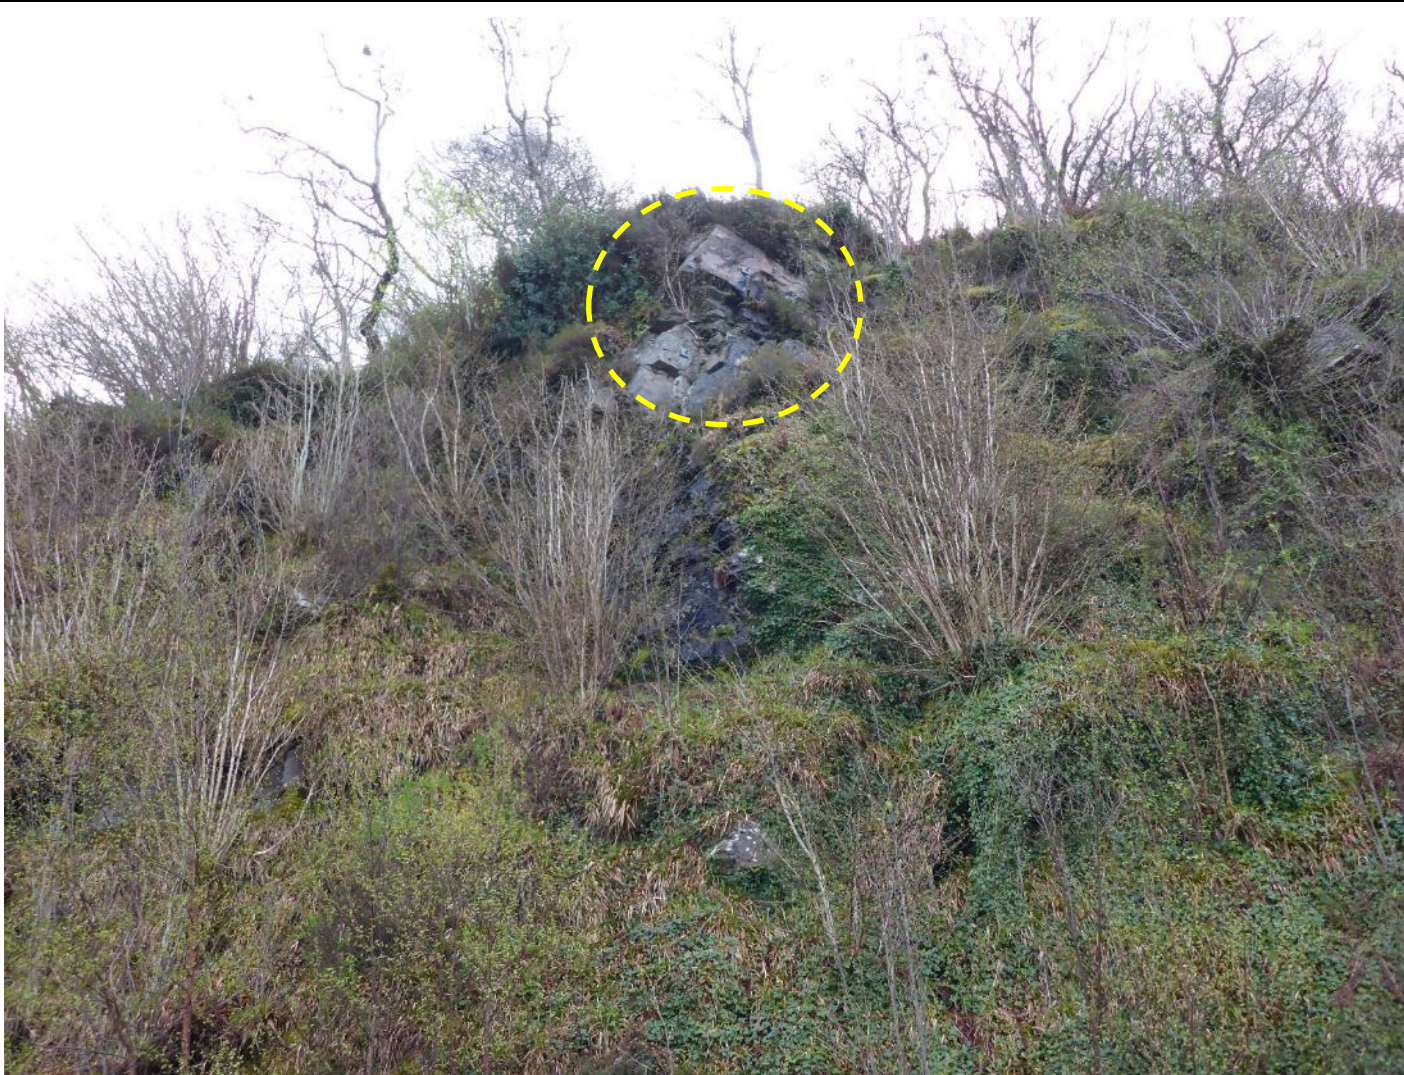
Photograph: AA4-3

Ch. 788 – Overhanging block at crest of slope.

Year observation first noted: 2016

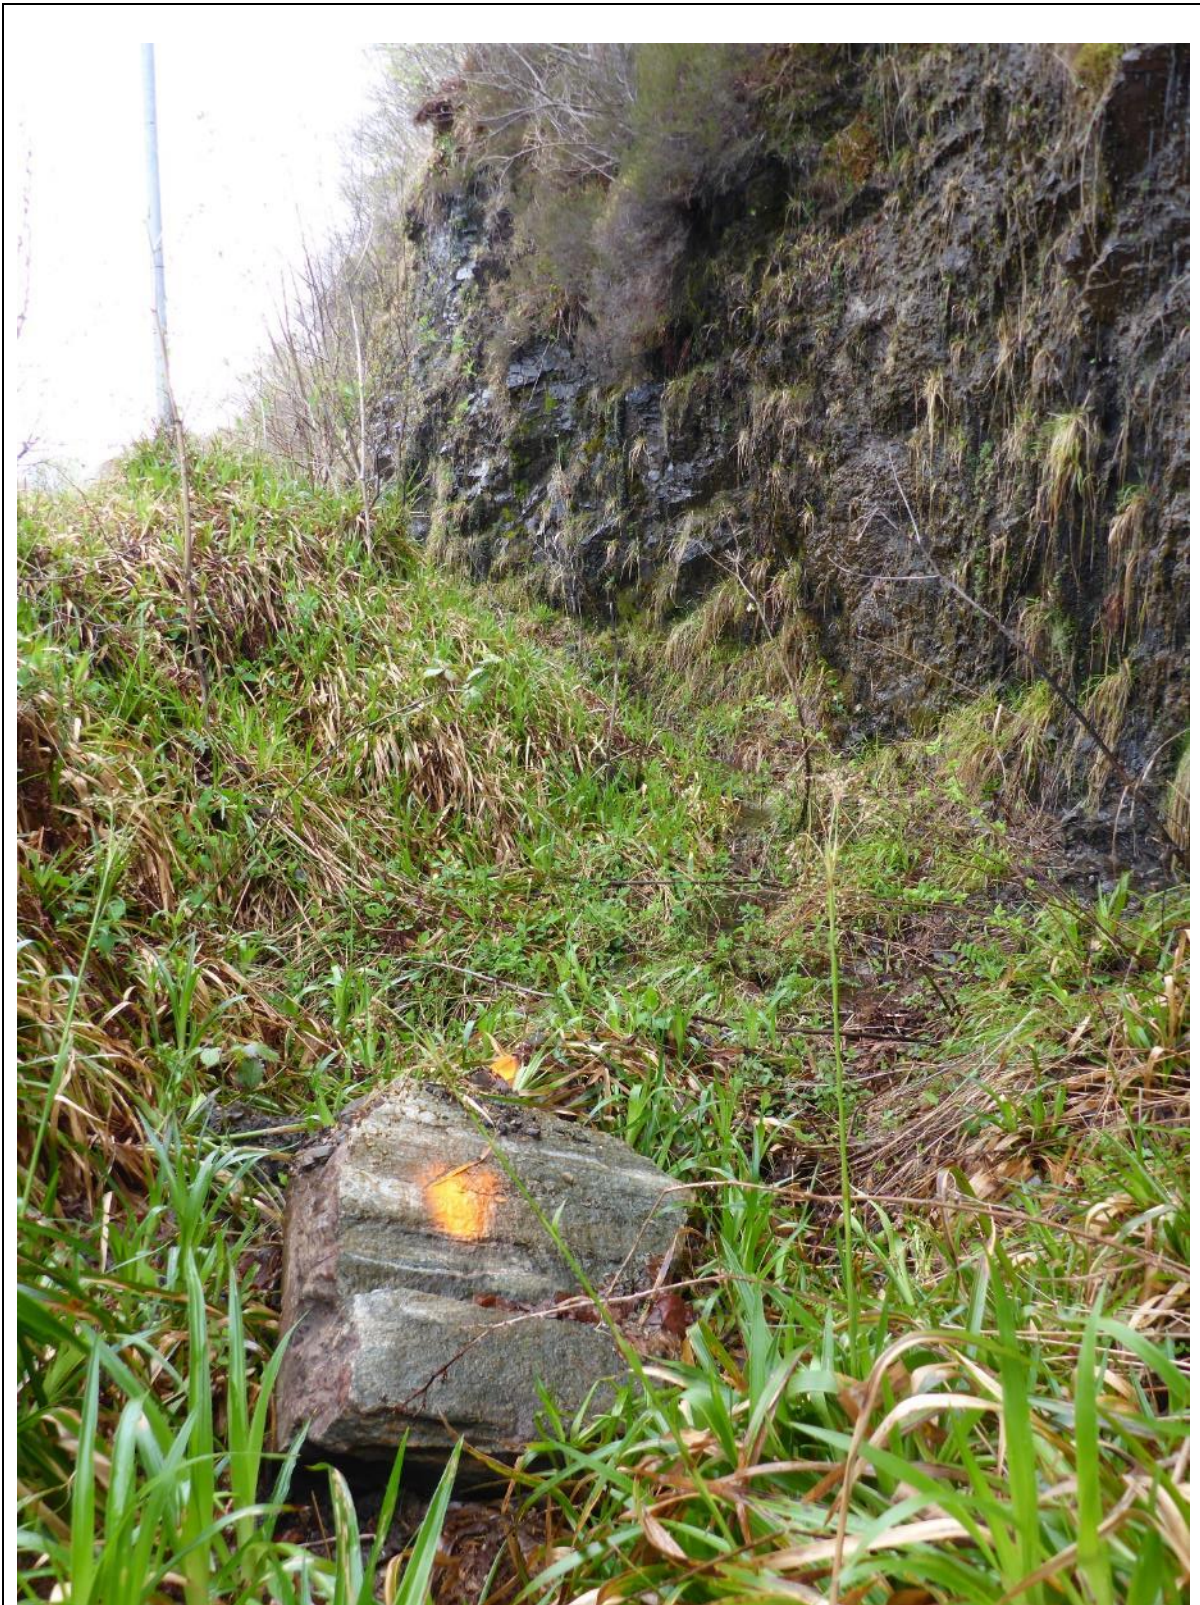
Photograph: AA4-4

Ch. 817 – Large block in ditch. Source location not obvious.
Possibly not native to location.

Year observation first
noted: 2024

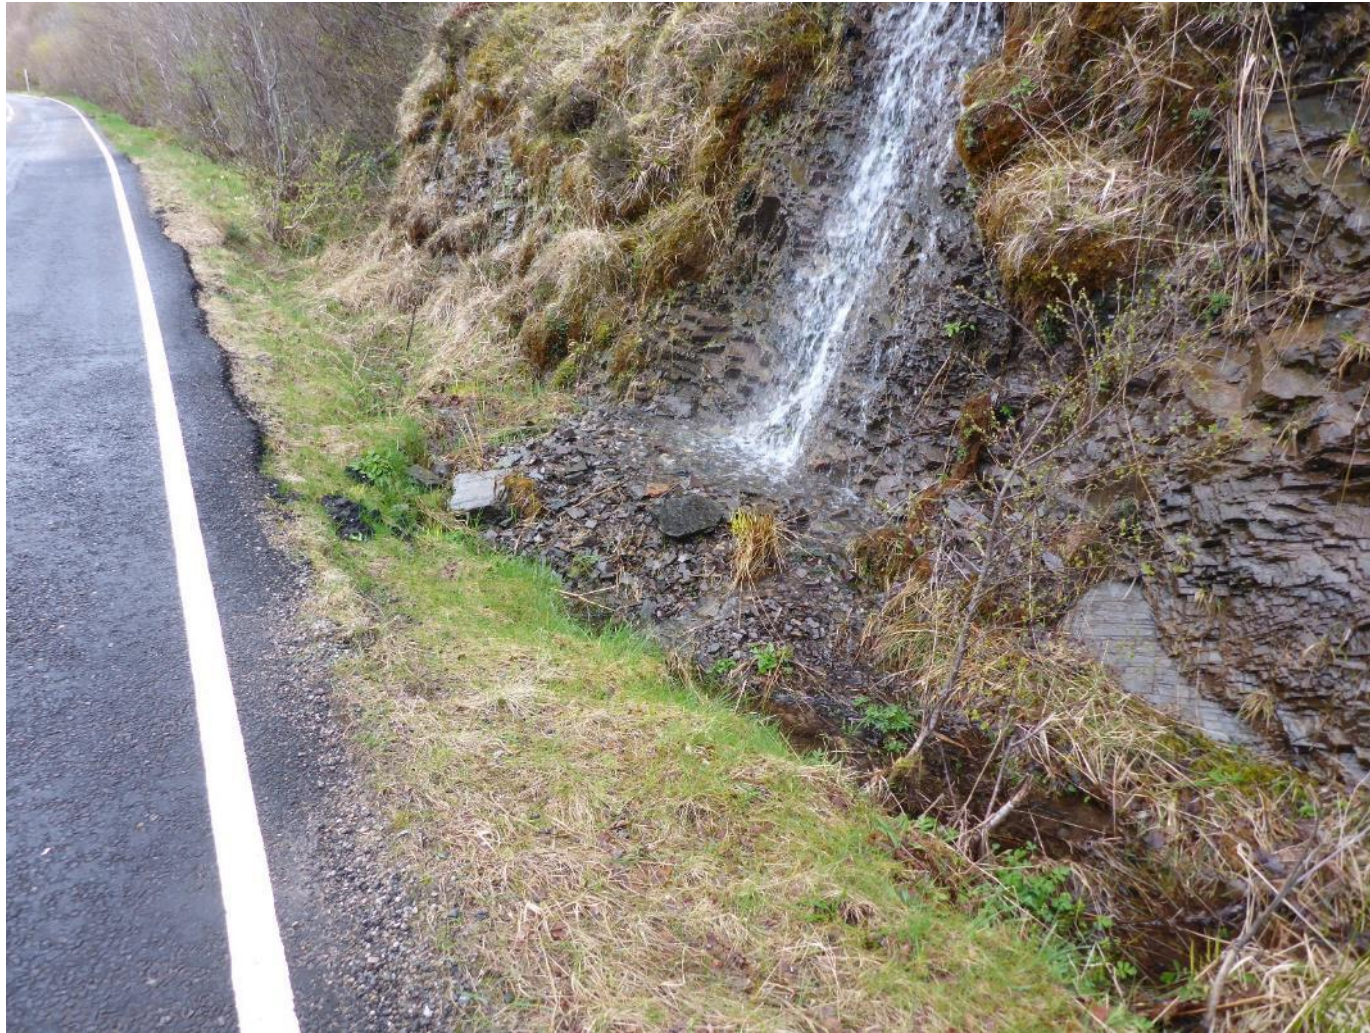
Photograph: AA4-5

Ch. 842 – Ditch full of debris at base of watercourse. Recommended to be cleared.

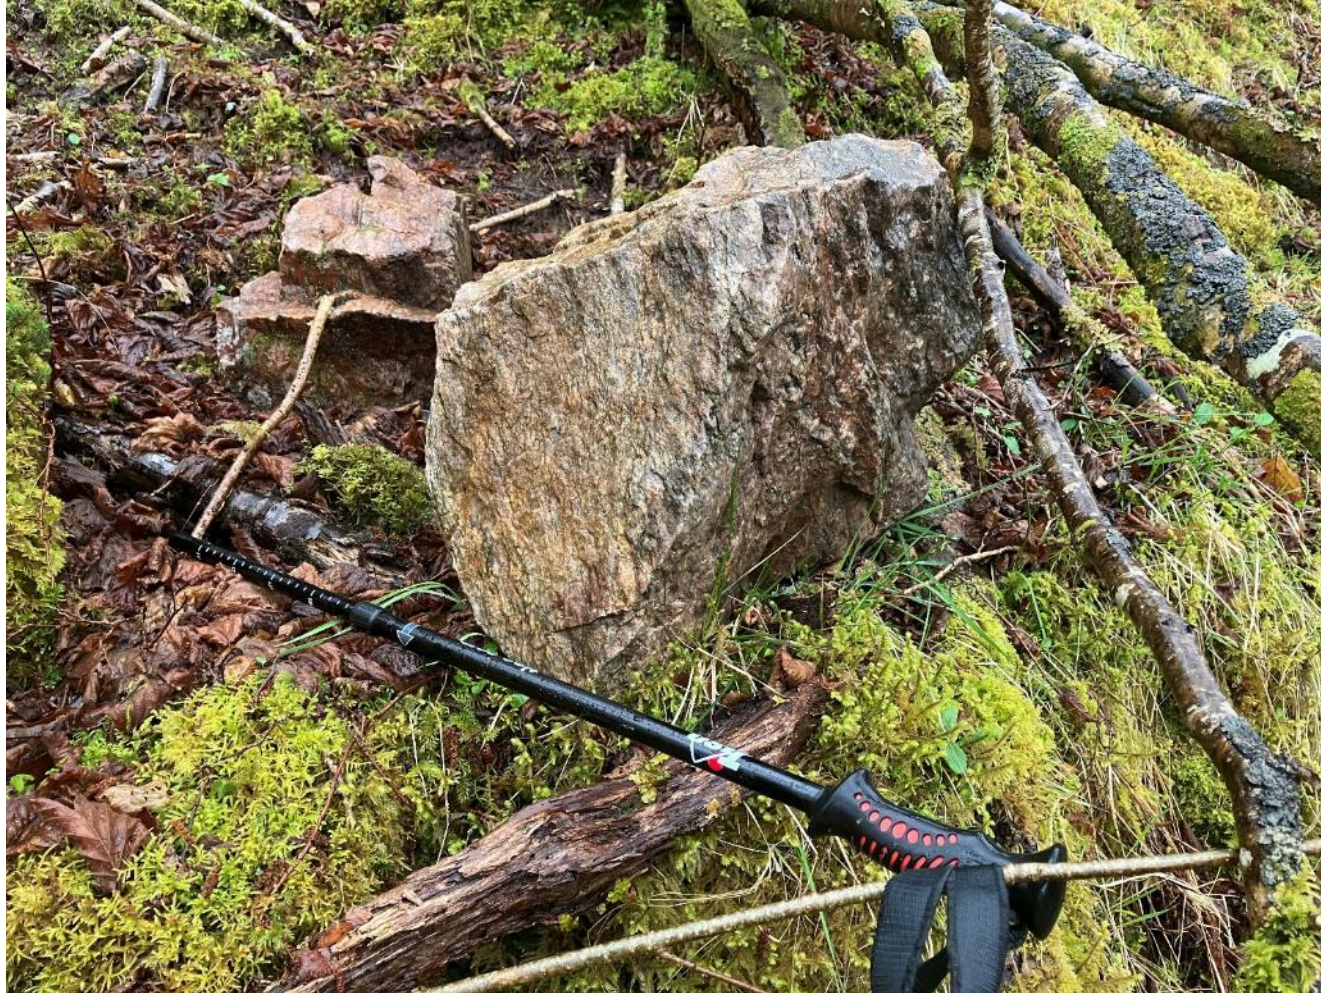
Photograph: AA4U-1

NG 89616 36364 – an example of recent boulder movement on slope.

Year observation first noted: 2024

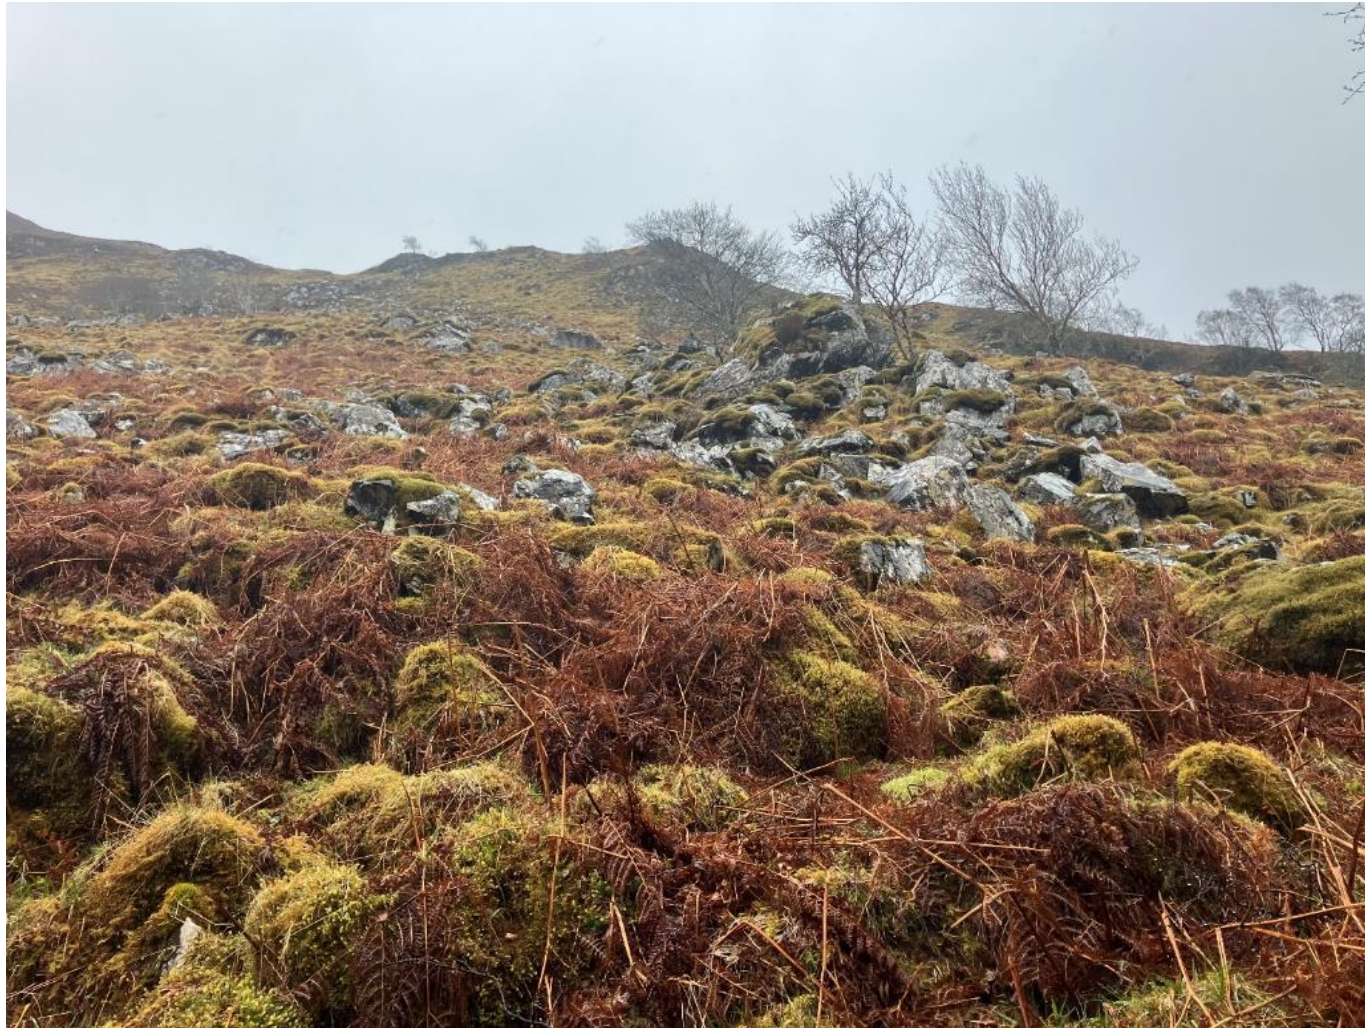
Photograph: AA4U-2

Boulder field above tree line.

Year observation first noted: 2018

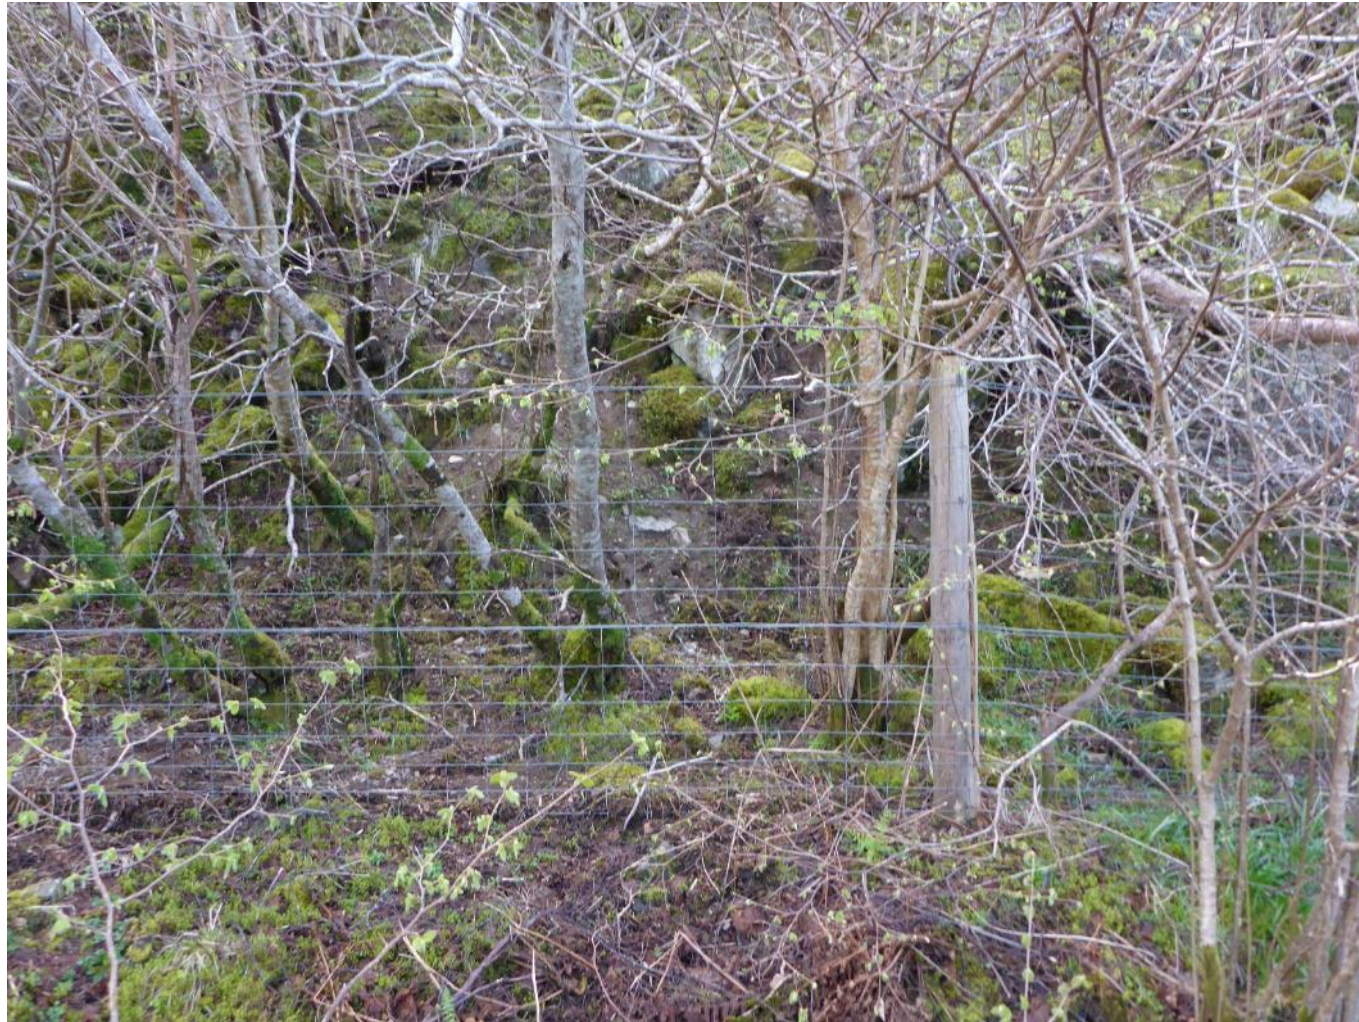
Photograph: AA4U-3

Ch. 930 – Evidence of water flow over slope surface.

Year observation first noted: 2024

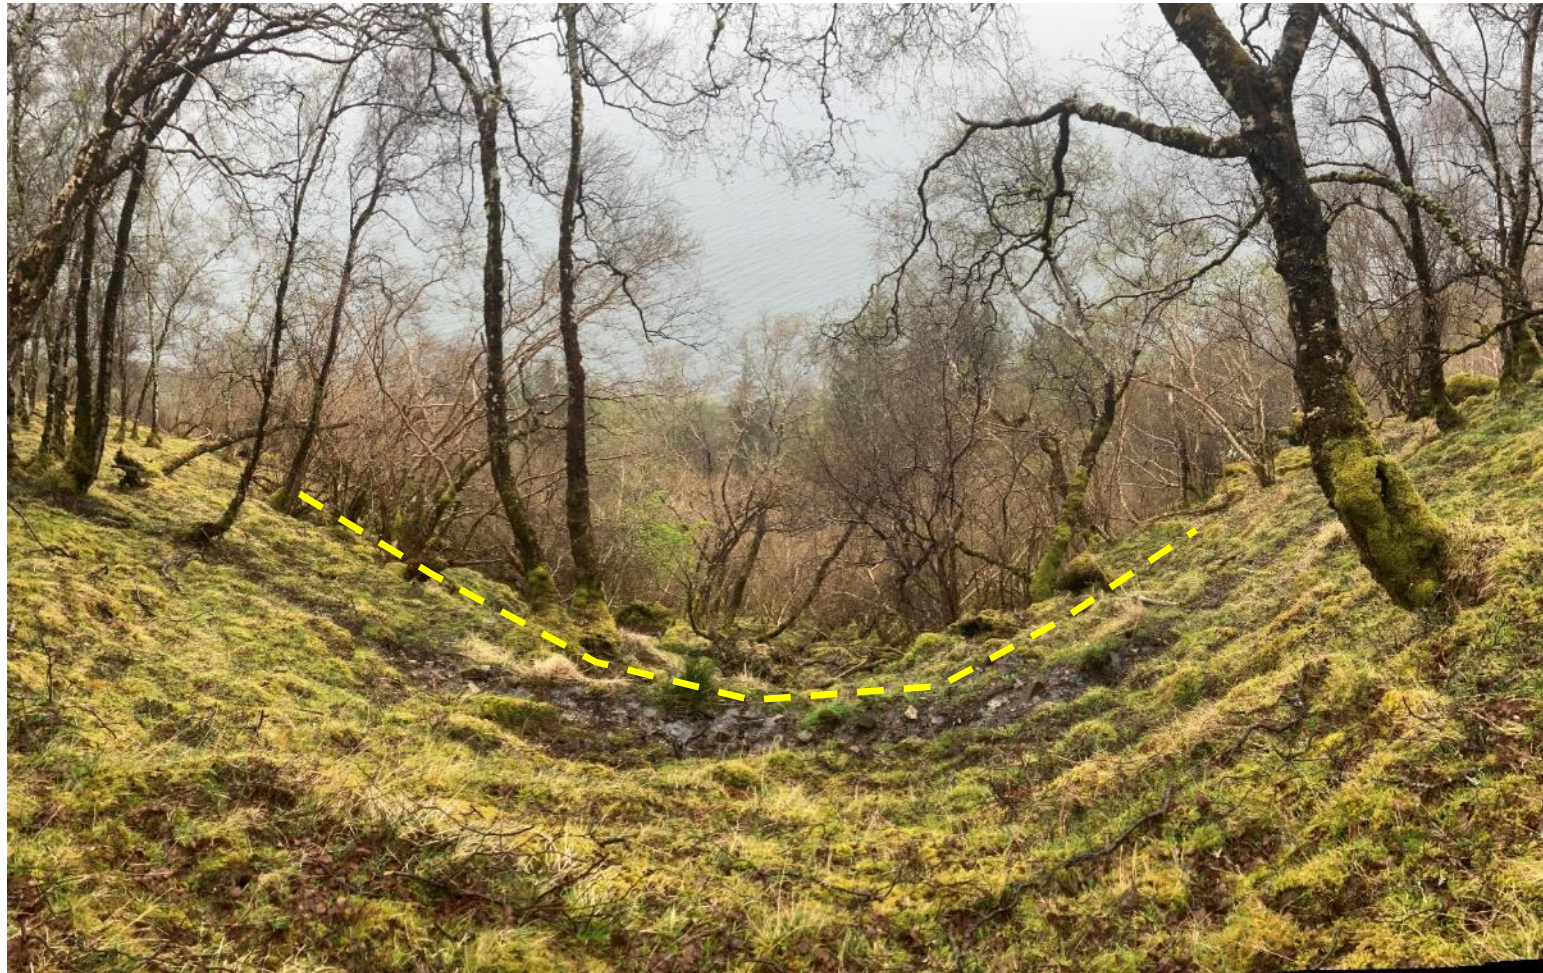
Photograph: AA4U-4

NG 89535 36201 - Crest of semicircular historic landslide shown by dashed line. Looking downslope towards road.

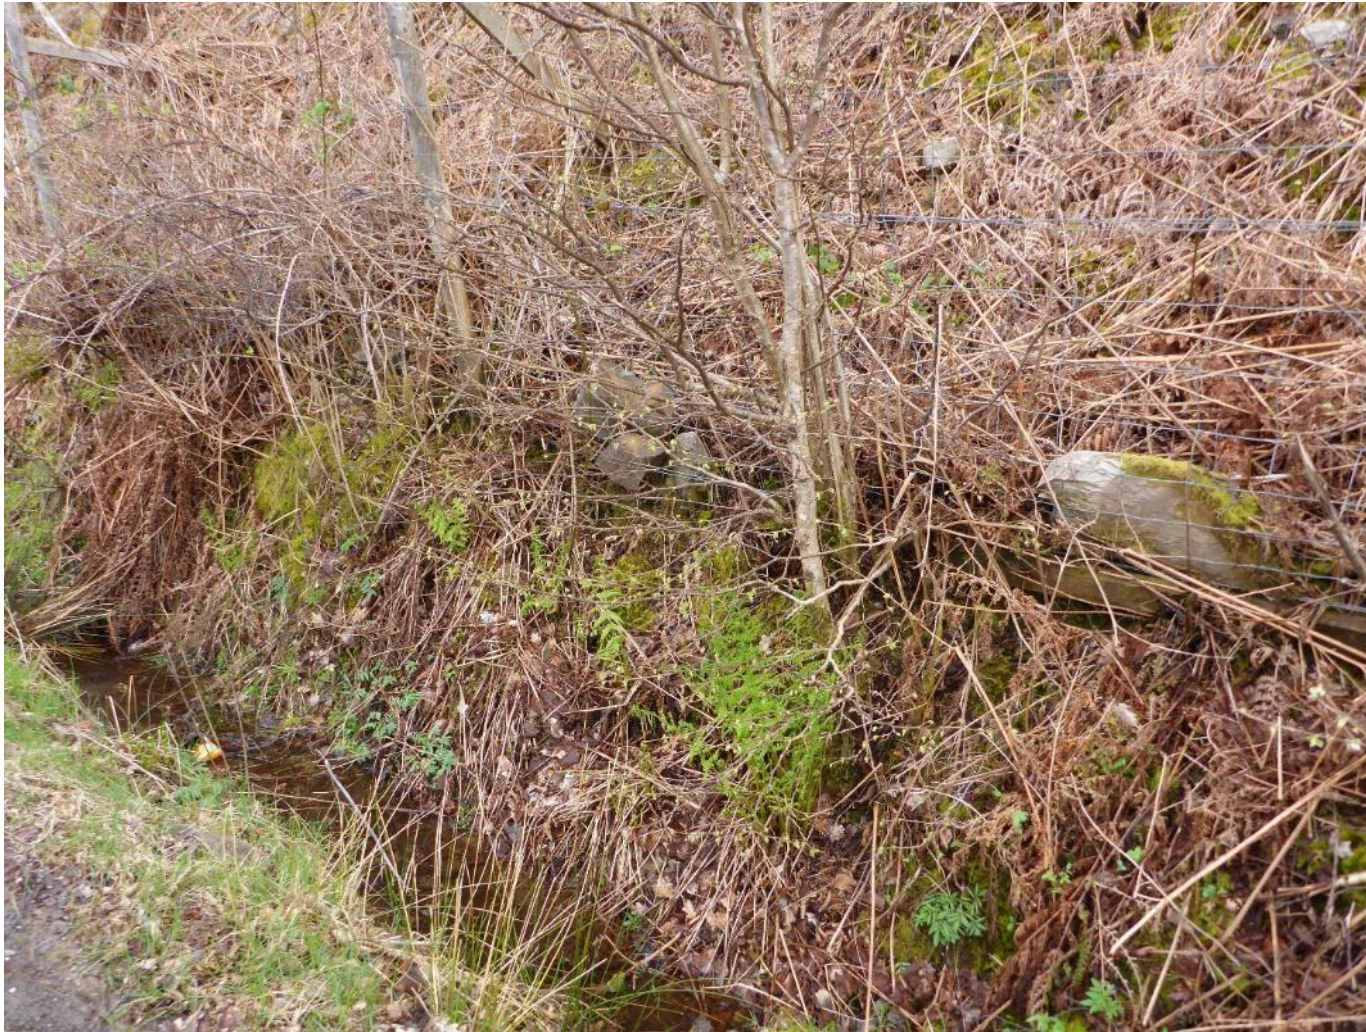
Photograph: AA5-1

Ch. 1323 – Several small rocks accumulated at deer fence or burst through and landed in ditch.

Year observation first noted: 2018

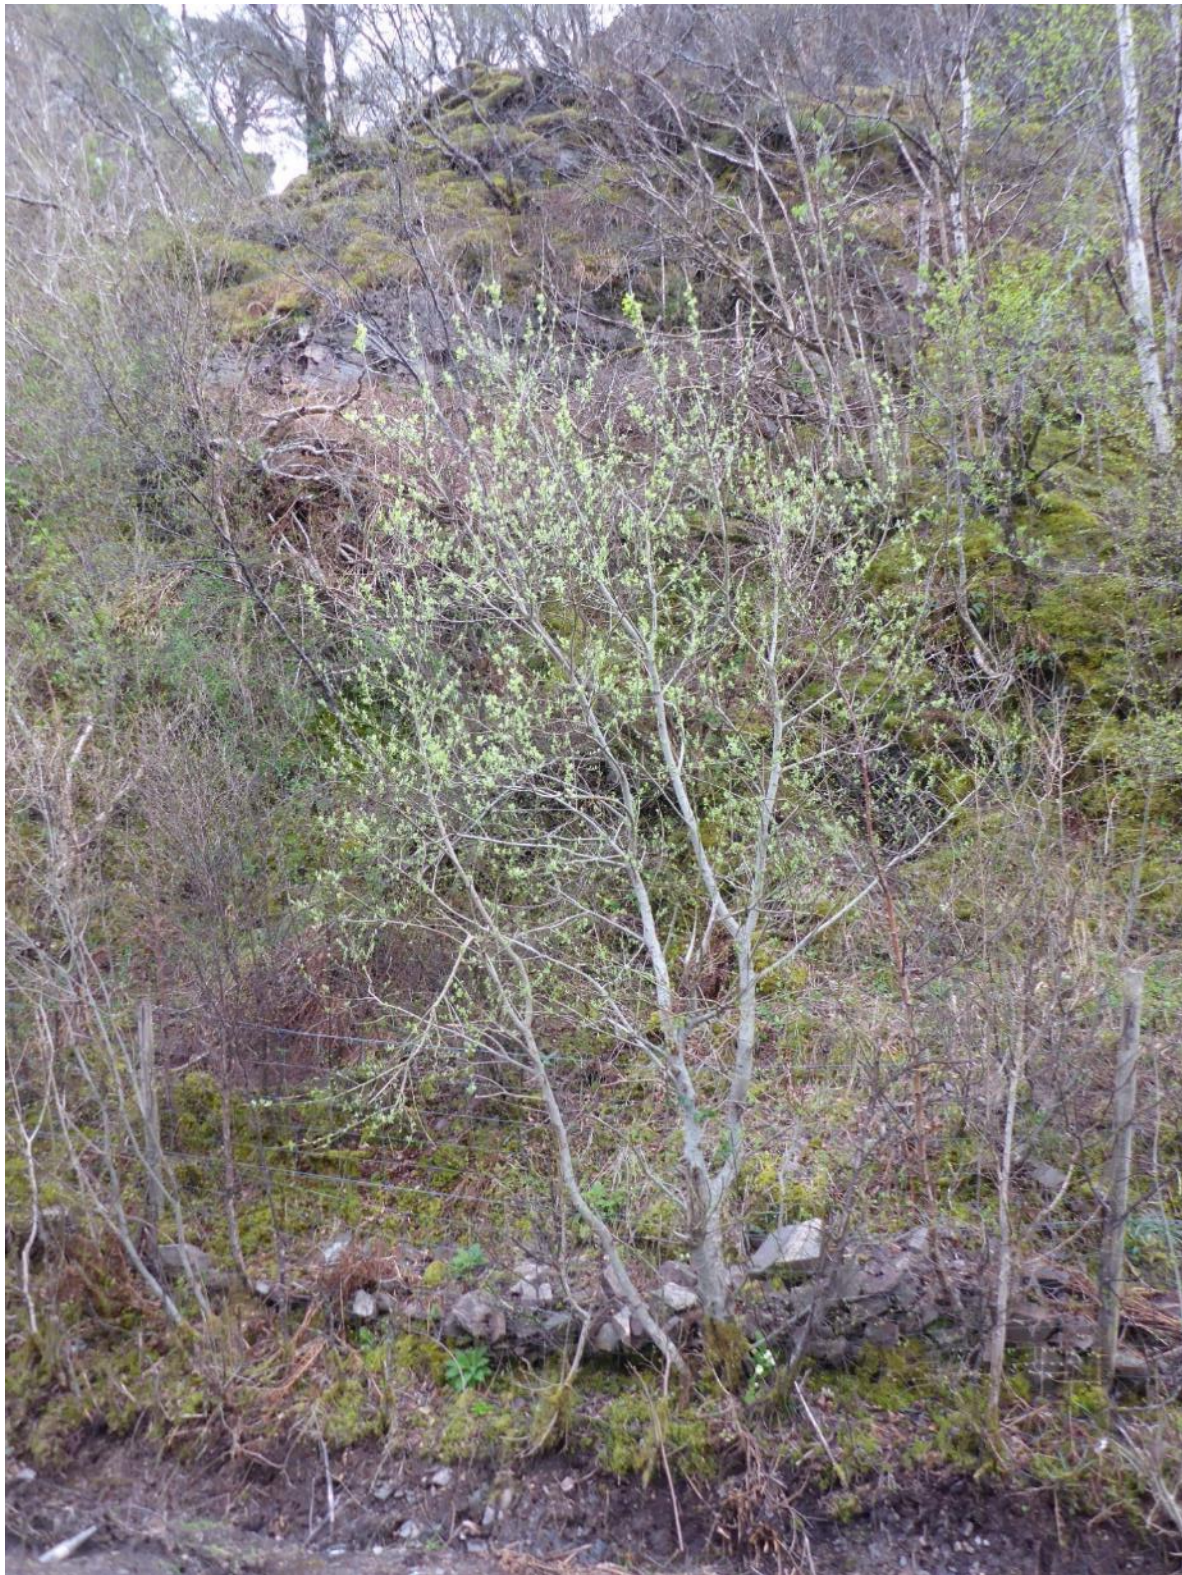
Photograph: AA5-2

Ch. 1360 - small accumulation of blocks behind deer fence.

Year observation first noted: 2017

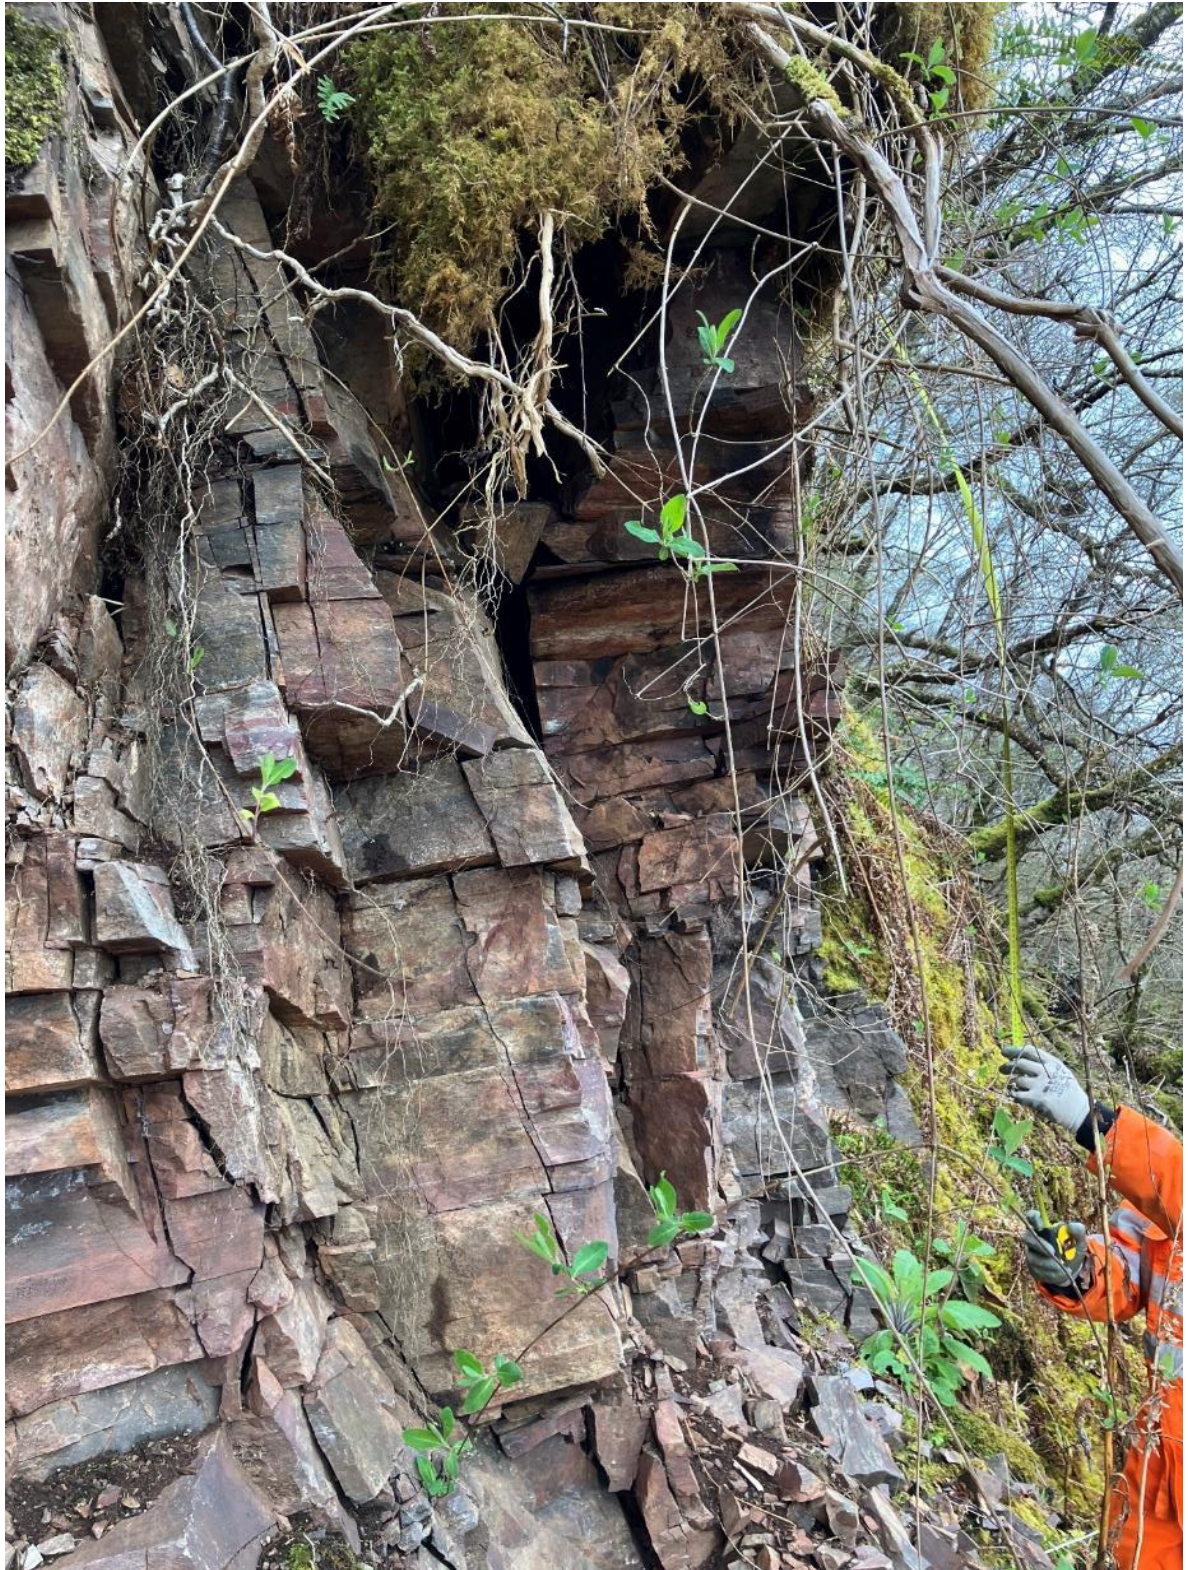
Photograph: AA5-3

Ch. 1360 – Area of fractured rock mass upslope of road.

Recommended Remedial Works / Actions		
Large Scale Rock Fall Protection Works (Category 3)	Localised Targeted Rock Fall Protection Works (Category 2)	Ongoing Maintenance (Category 1)
<ul style="list-style-type: none"> - Install rock fall catch fence along toe of slope. 	<ul style="list-style-type: none"> - Light scale outcrops at NG 89808 36661 and NG 89828 36663. (Only required if catch fence not installed.) - Scaling of fractured outcrop at NG 89856 36771 (10-15m above Ch. 1360). 	N/A

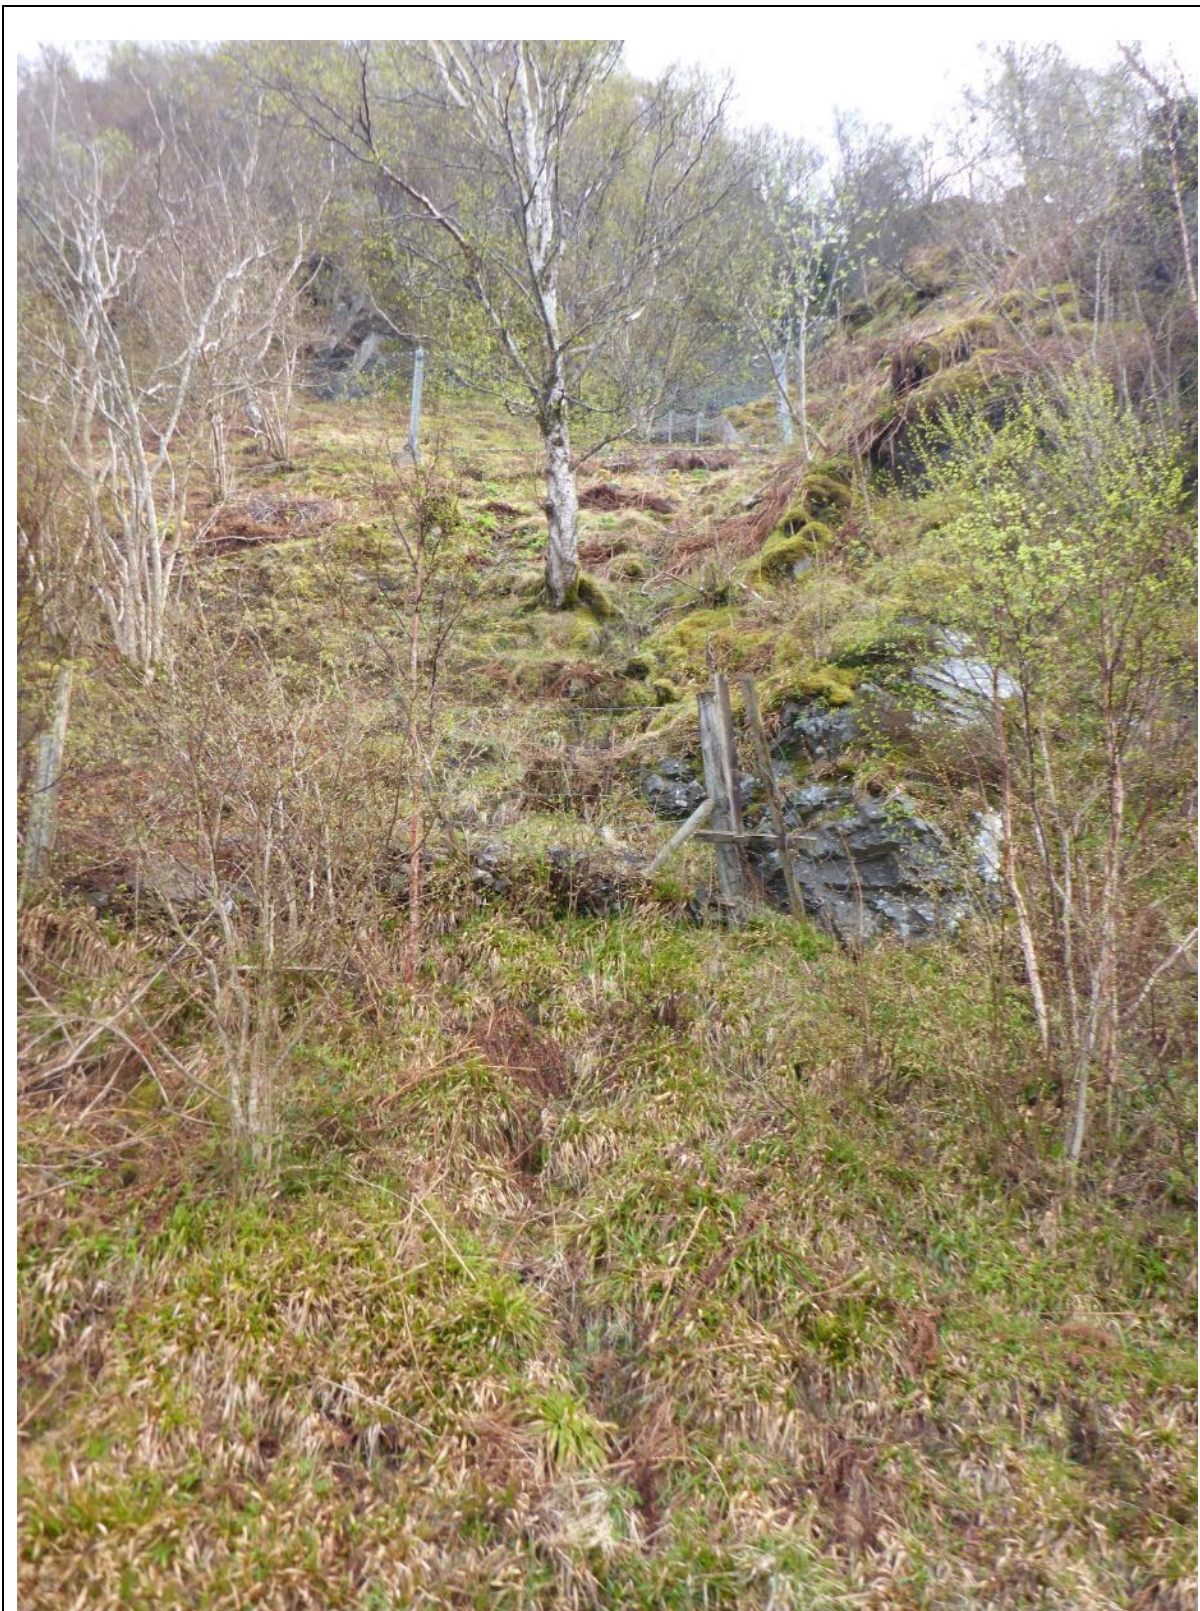
Photograph: AA6A-1

Ch. 1505 - Small accumulation of blocks at roadside deer fence.

Recommended Remedial Works / Actions		
Large Scale Rock Fall Protection Works (Category 3)	Localised Targeted Rock Fall Protection Works (Category 2)	Ongoing Maintenance (Category 1)
- Install roadside rock fall catch fence.	N/A	- Clearance of blocks retained behind deer fence (Ch.1505).

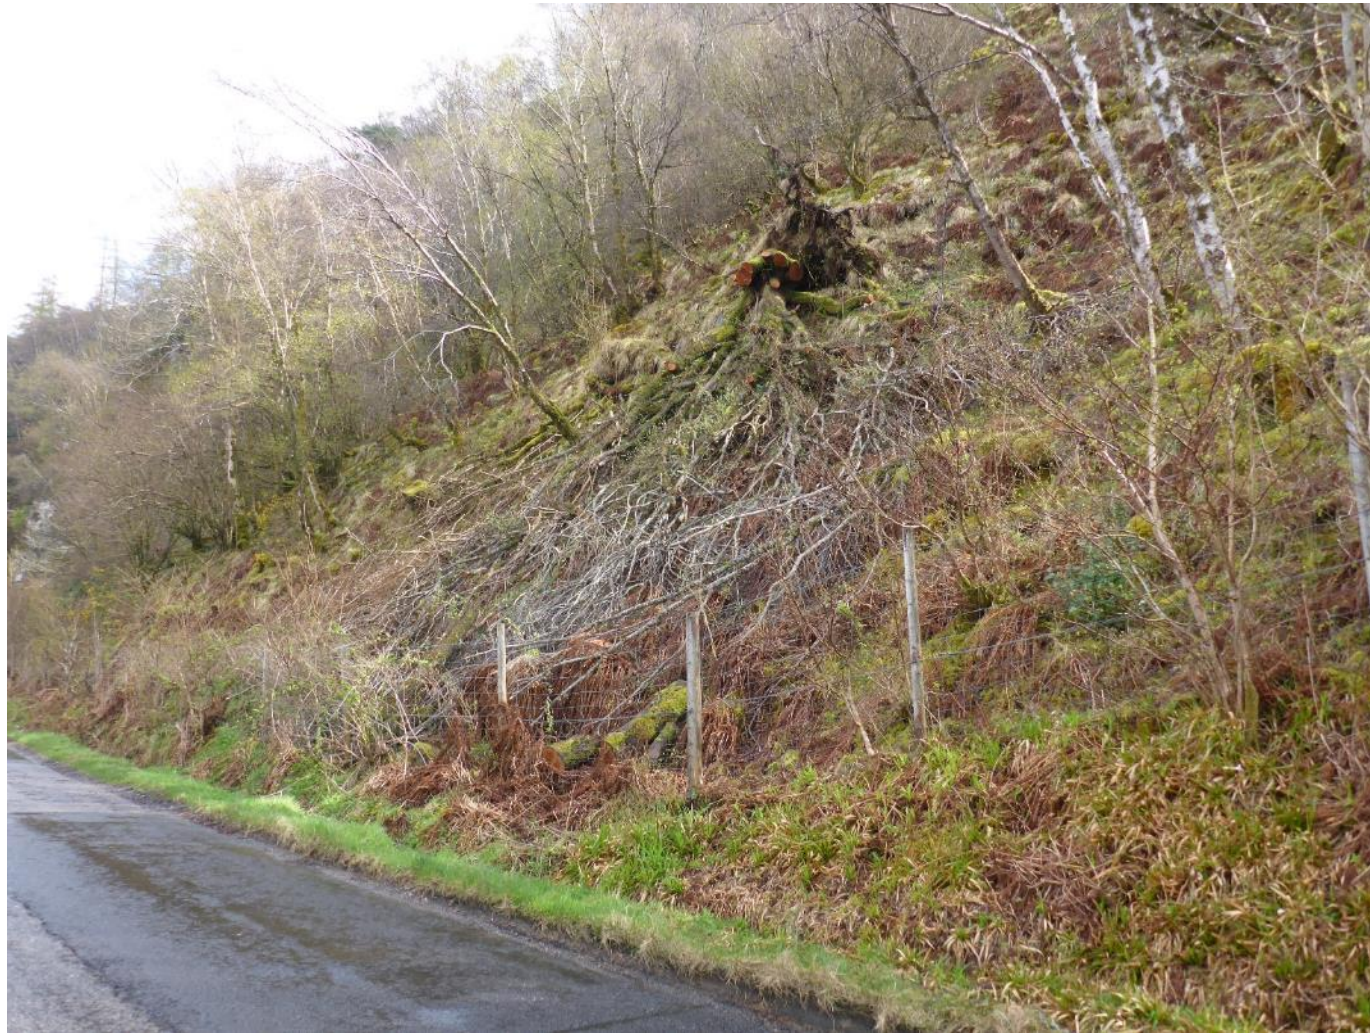
Photograph: AA6B-1

Ch. 1708 – Fallen trees were noted in 2020. Trees have now been cut back.

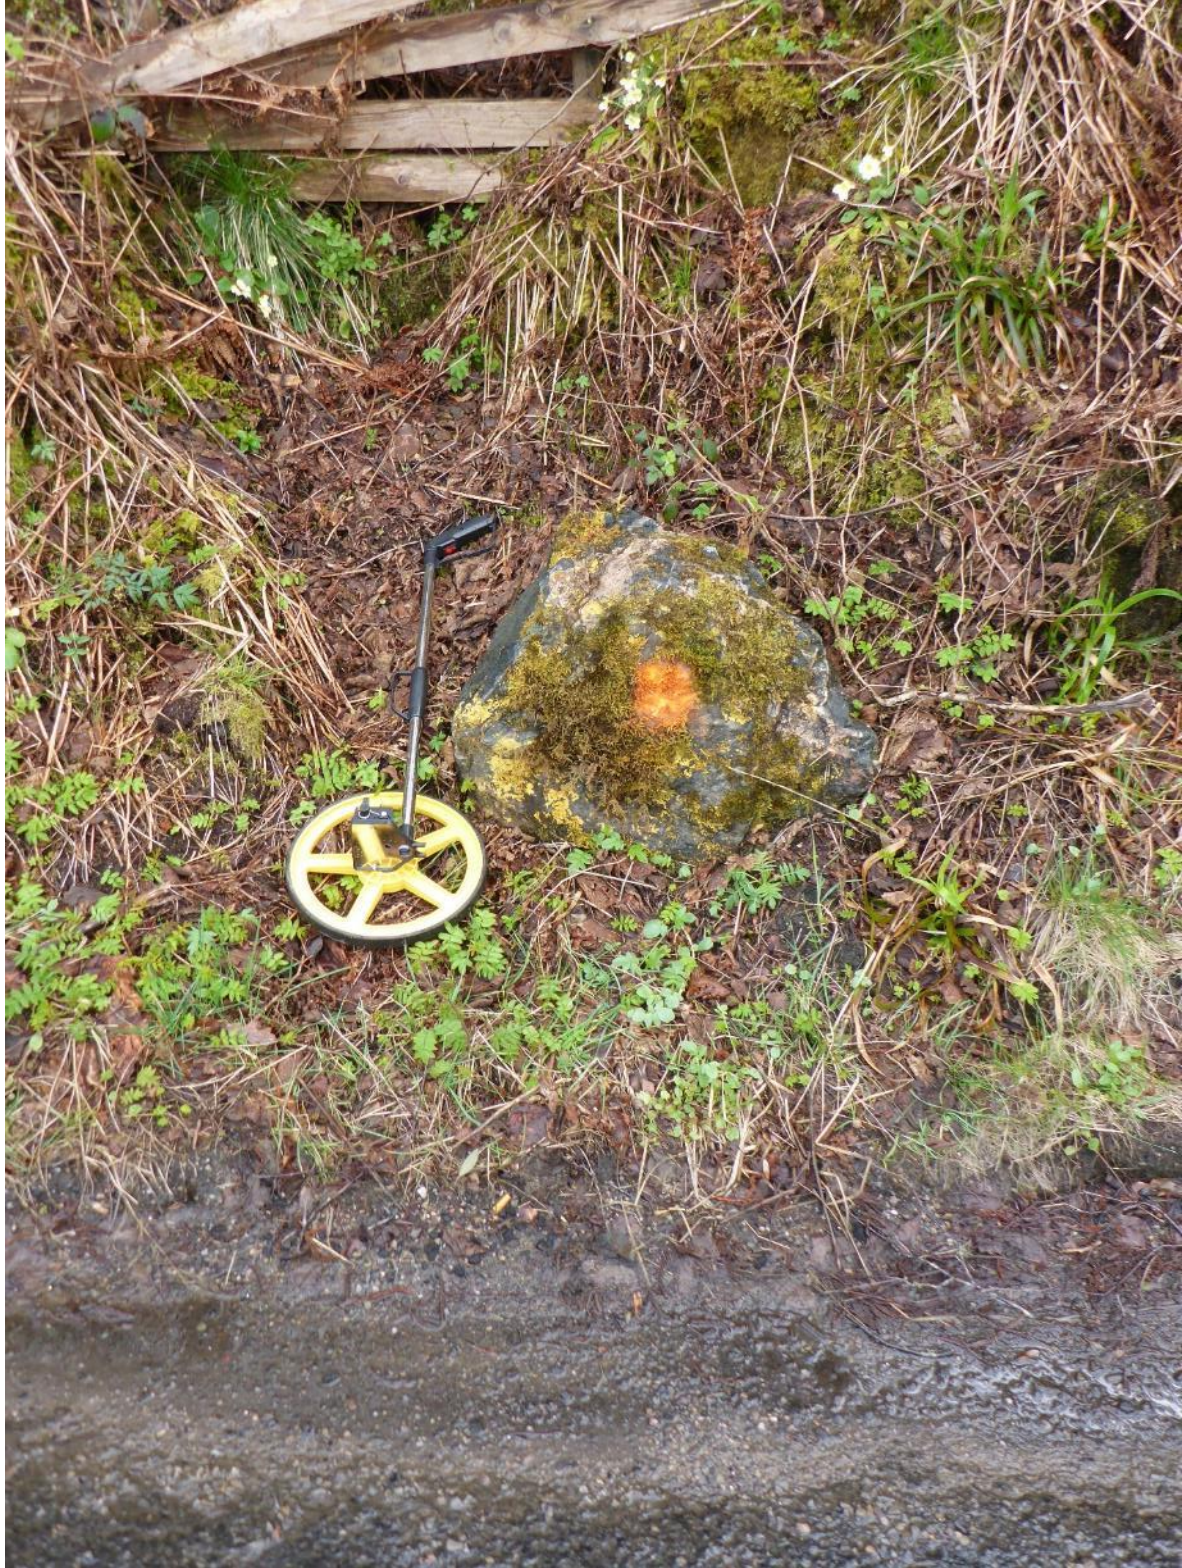
Photograph: AA7-1

Ch. 1770 – block present in verge. Reported by THC monthly inspections in January 2024.

Year observation first noted: 2024
