A890 Stromeferry Bypass

Annual Slope Inspection 2024

The Highland Council

Project number: 60685712
AECOM Report Ref: GLRP0008

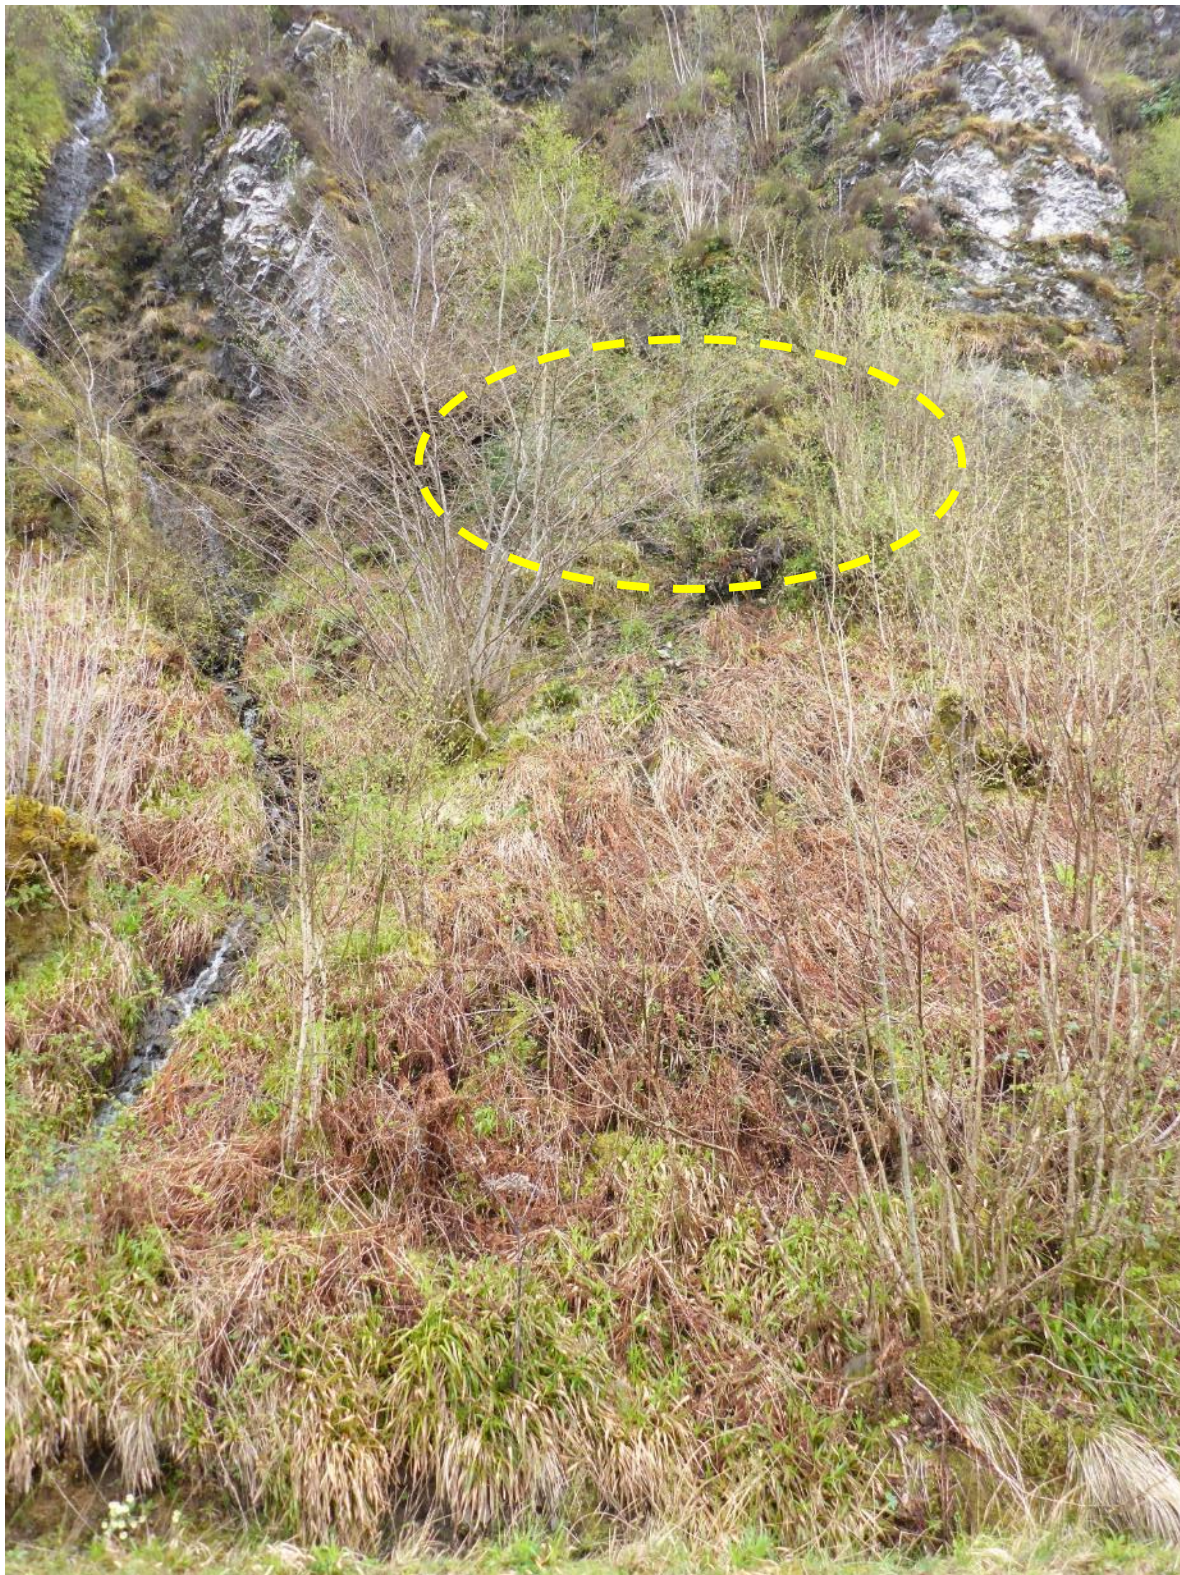
Photograph: AA7-2

Ch. 1820- 1826 – washout of soil and debris from gully. Accumulation of debris on slope 10m above road level (circled on image).

Recommended Remedial Works / Actions		
Large Scale Rock Fall Protection Works (Category 3)	Localised Targeted Rock Fall Protection Works (Category 2)	Ongoing Maintenance (Category 1)
N/A	- Scaling of rock mass ca. 18m above road level at Ch. 1820-1826.	<ul style="list-style-type: none"> - Recommend for debris resting on slope between chainage Ch. 1820 to 1826 to be cleared. - At Ch. 1825 and 1832 drainage gullies are recommended to be cleared.

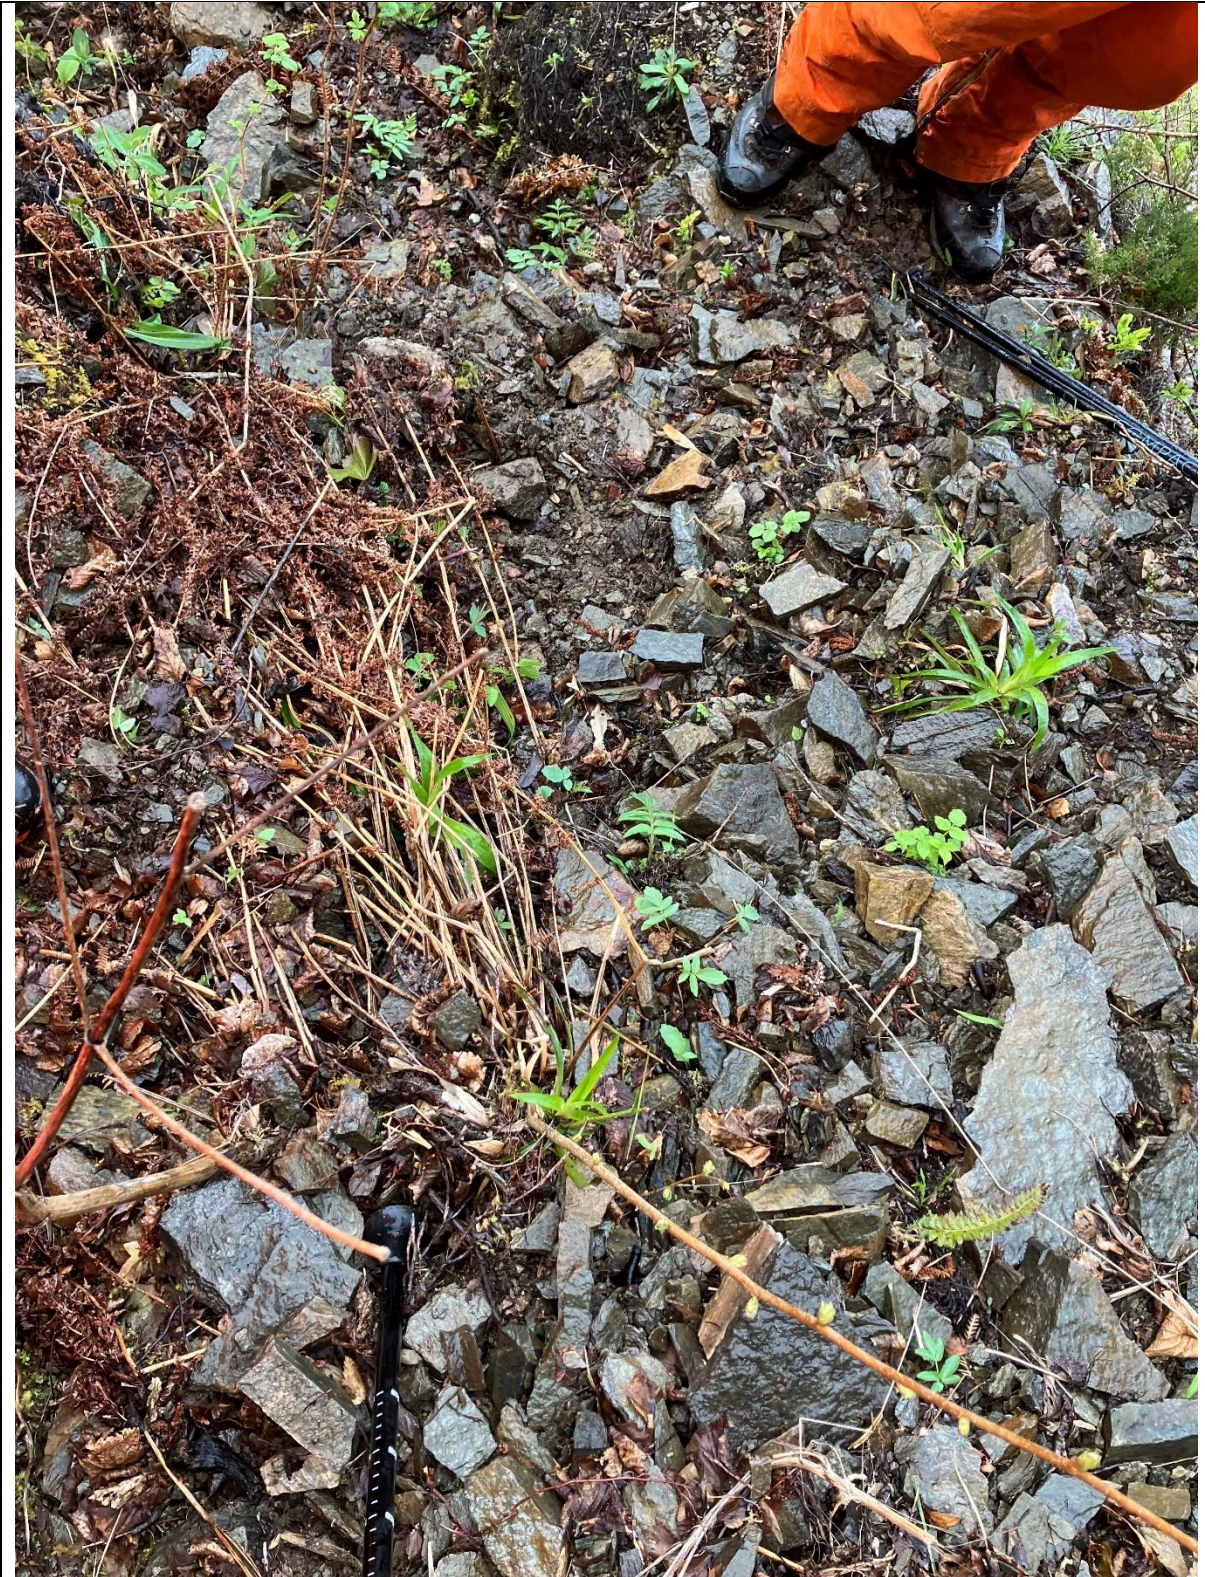
Photograph: AA7-4

Ch. 1820 - 1826 – accumulation of debris on slope from gully washout.

Year observation first noted: 2018

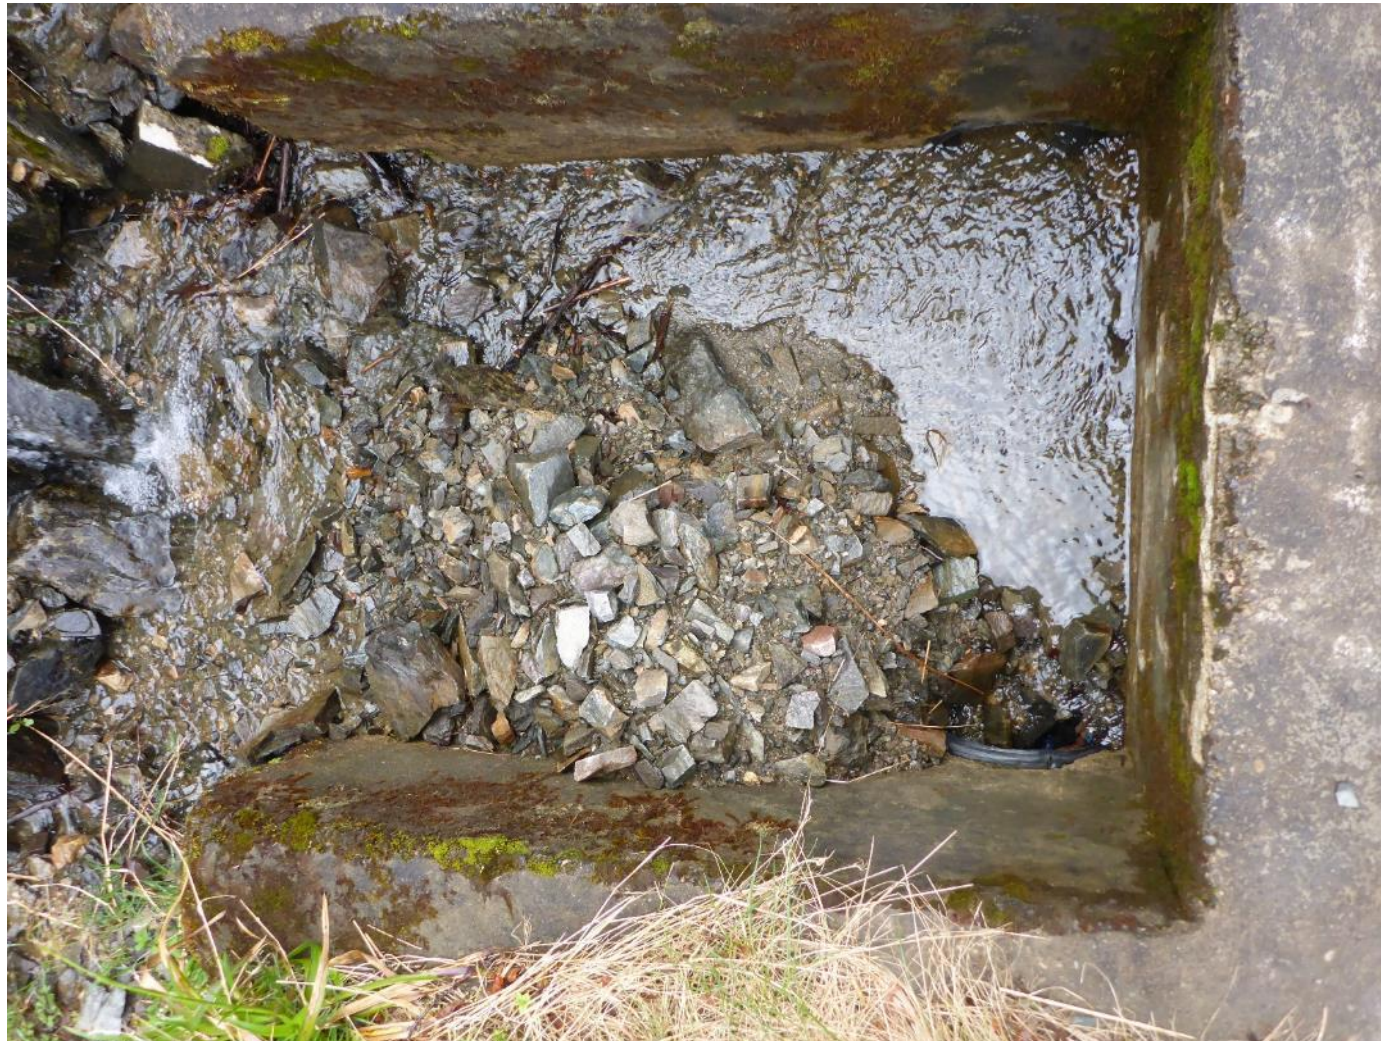
Photograph: AA7-5

Ch. 1825 – Debris in drainage gully nearly at gully capacity.

Year observation first noted: 2024

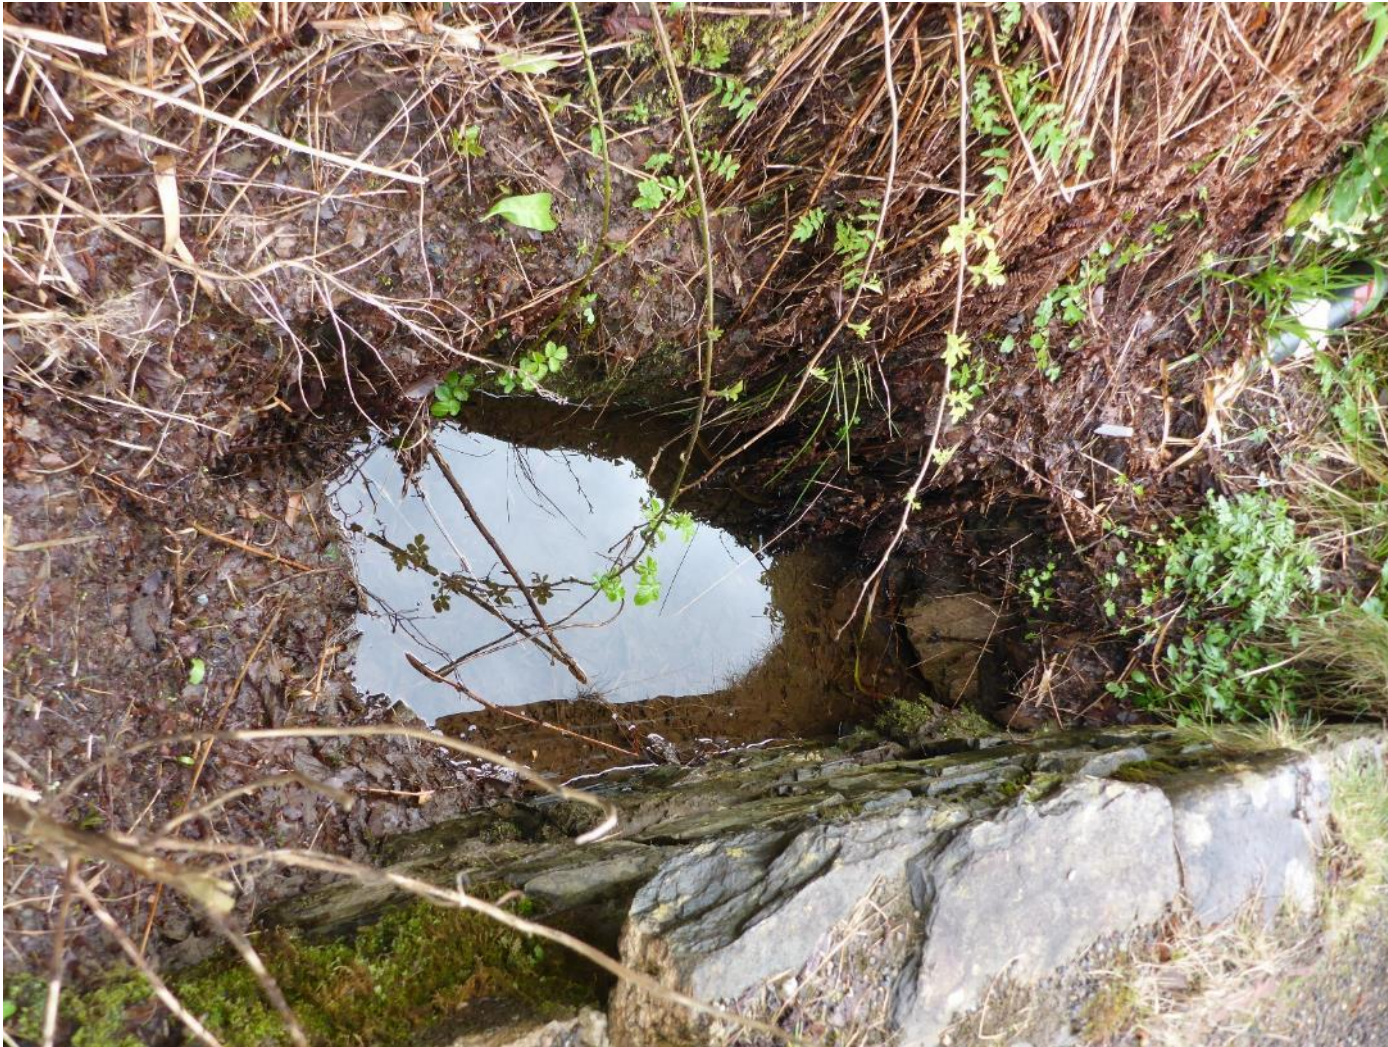
Photograph: AA7-6

Ch. 1832 – Drainage gully blocked.
