Agenda Item	10
Report No	SR/6/25

Report Title: Portree Harbour Update

PORTREE HARBOUR REPAIRS

FEASIBILITY STUDY

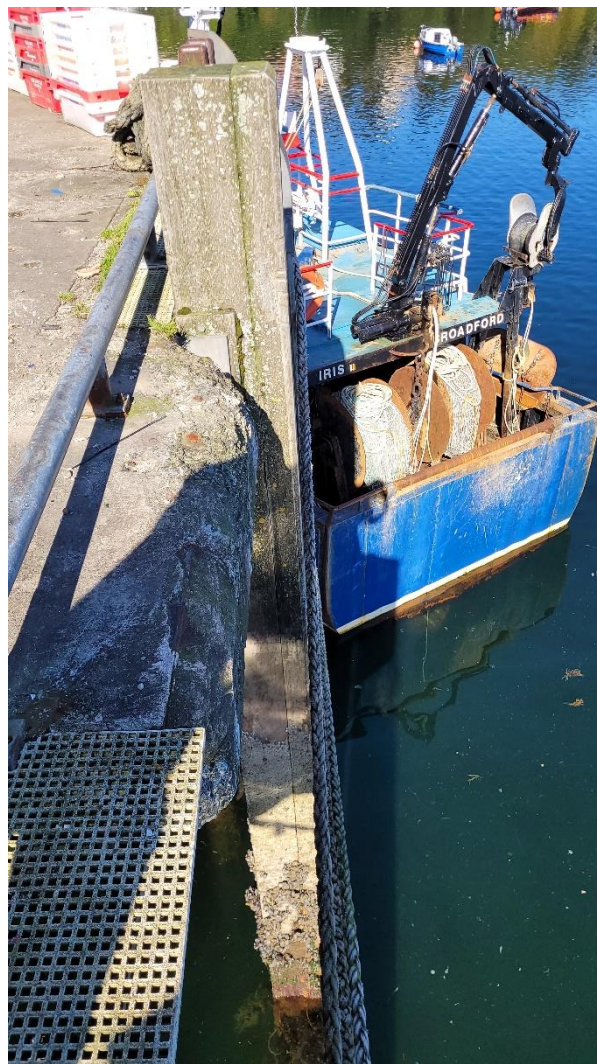
Photo 12: Rendhex Piles

The timber fenders are taking a lot of vessel impact, are in a poor condition and are even missing at the inner end next to the ladder.

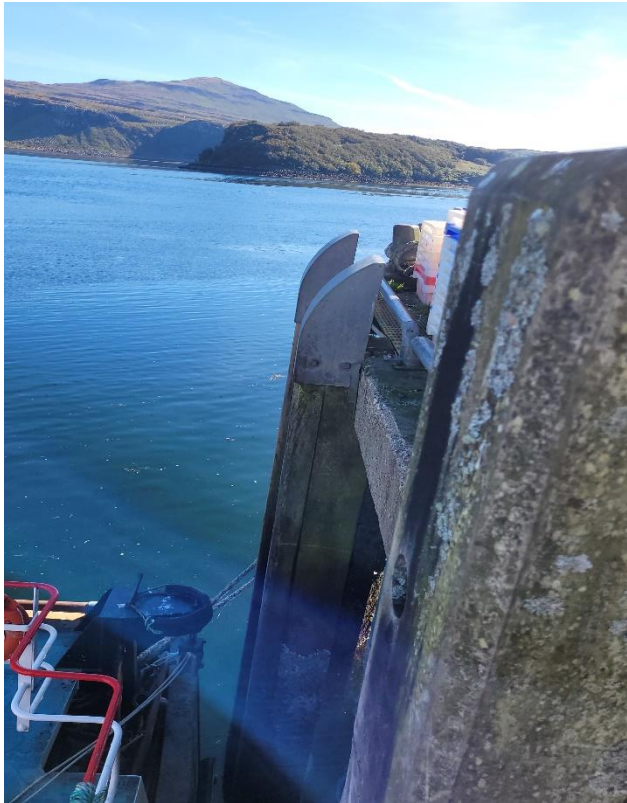
Photo 13: Pier Fenders

The timber fenders around the outer pier have recently been replaced and steel caps added for protection from fishing vessels during high tides.

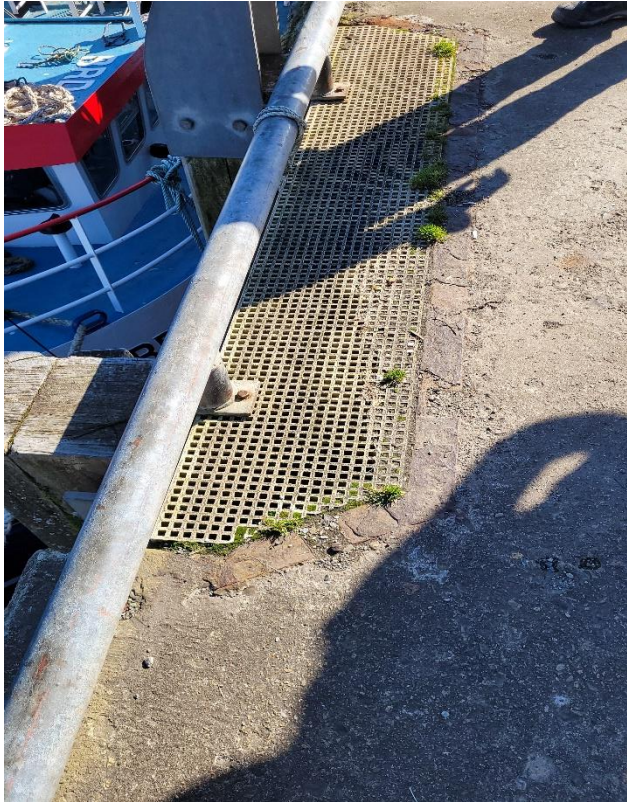
Photo 14: Pier Fenders with Steel Caps

- Holes in the sheet piles and rendhex piles.
- Lack of a CP system to prevent further corrosion of sheet piles and rendhex piles.
- Pier deck surface has frost damage and impact damage that presents a trip hazard.
- Unused recesses in the slab with open mesh flooring presents a maintenance issue and trip hazard.
- Unused pipework under the deck to be removed and redundant chamber to be infilled to eliminate a trip hazard.
