PROPOSED WORKS TO THE SOUTH TOWER (EAST ELEVATION)

PROPOSED WORKS TO THE SOUTH TOWER (SOUTH ELEVATION)

PROPOSED WORKS TO THE NORTH TOWER (WEST ELEVATION)

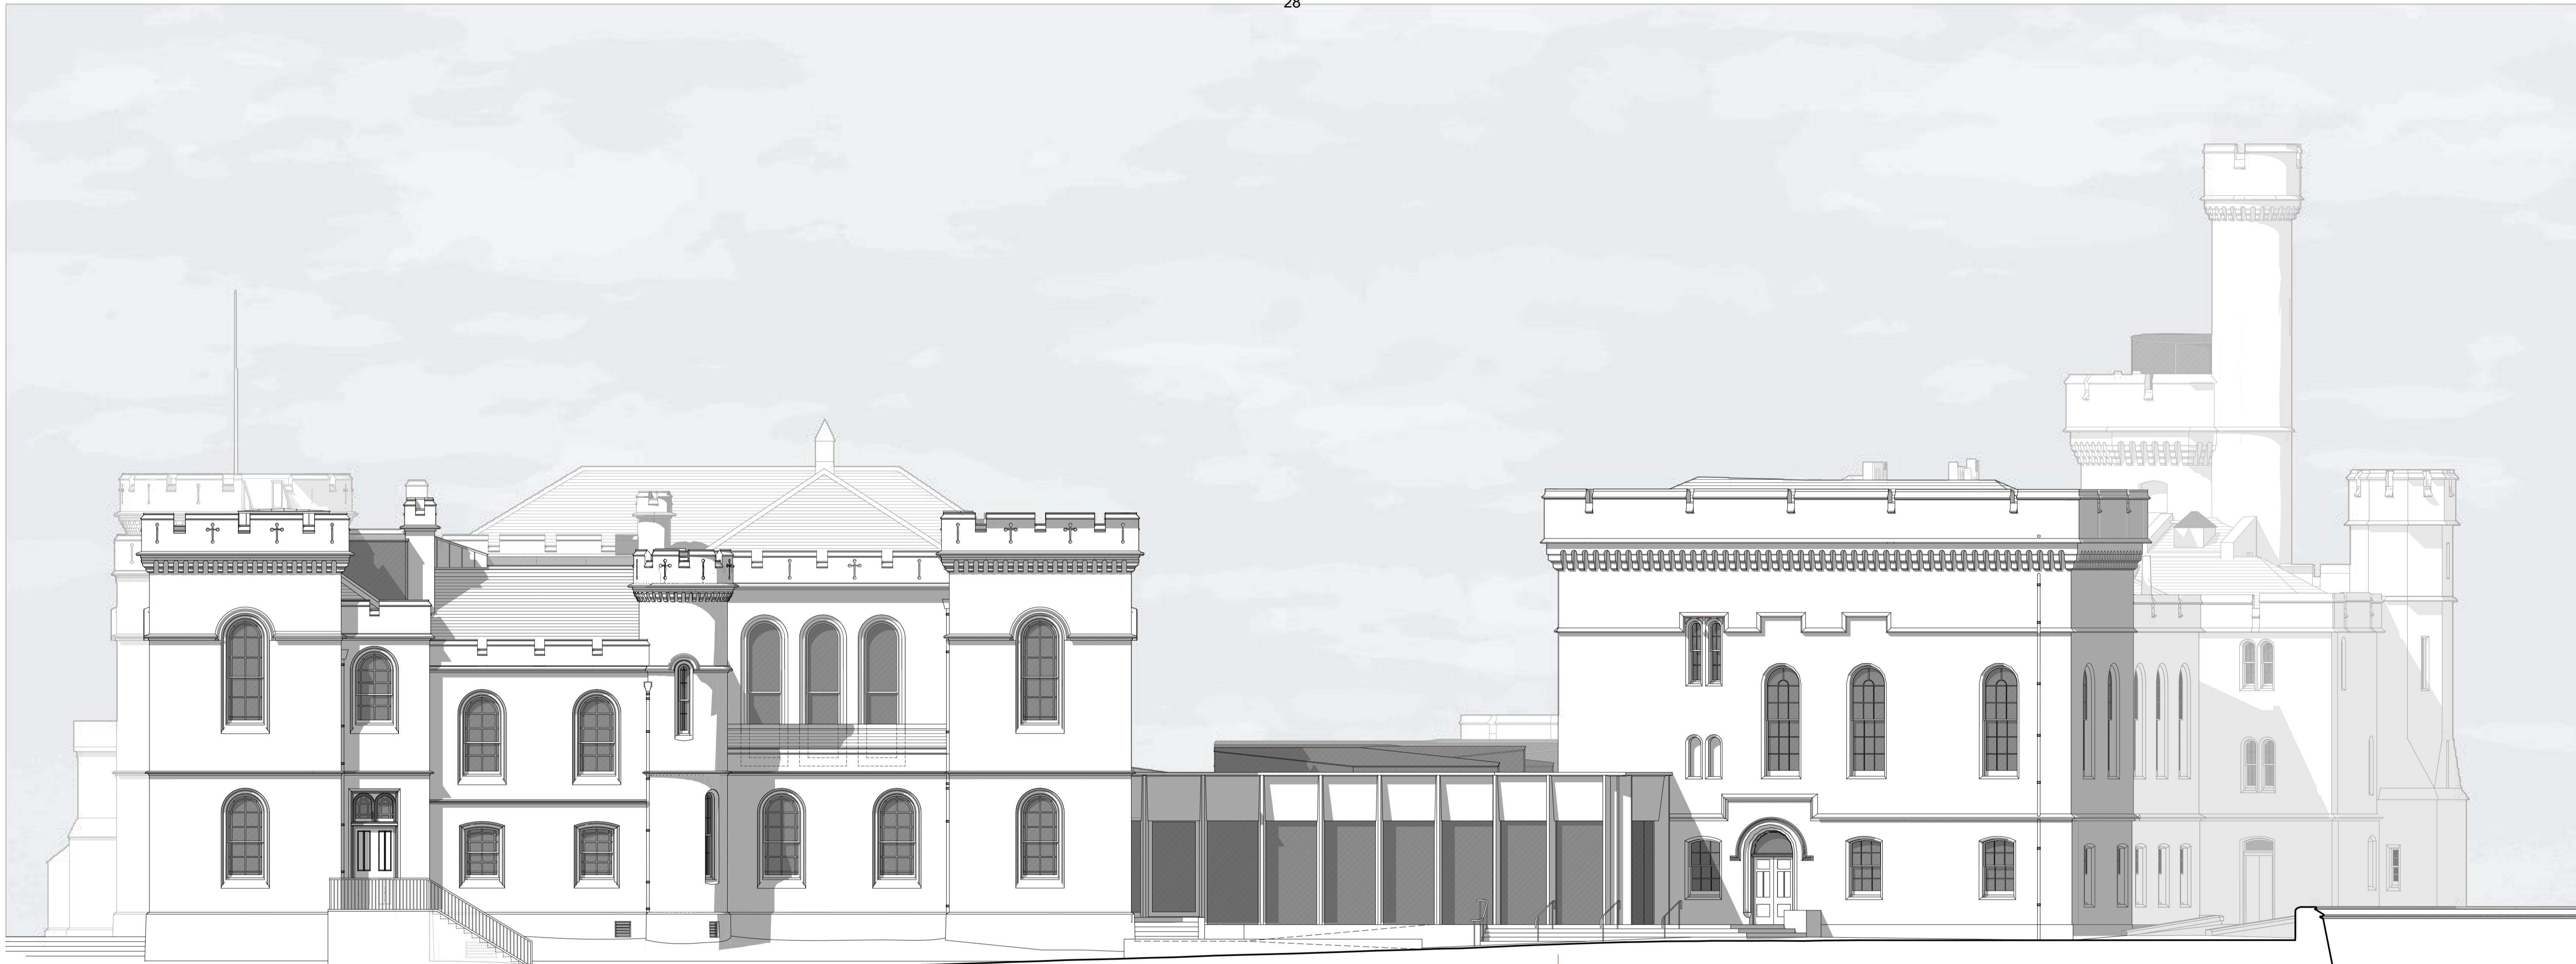
- Overhaul existing slate roofs comprising large format slates in even courses typical of a William Burn roof. Provide additional discrete ventilation to pitches.

- Overhaul existing LSA compliant leadwork including timber cored ridge rolls, lead valleys, lead flat roofs within turrets and parapet gutters.
- Provide additional maintenance access to parapet gutters via conservation type rooflights set behind parapets to replace present route.

- See detailed axonometric of roof level intervention comprising the extension of the service stair to roof level to access the new roof terrace.
- The majority of the existing chimneys are incorporated into the parapet walls and currently capped flush with paving slabs. Existing flues to be ventilated by marginally spacing new stone slabs off chimney flues.

- Check compliance of existing Lightning Protection System.
- Virtually all the wall heads are crenelated parapets. The towers and the main blocks are articulated by having raised and machicolated crenelated parapets. These parapets above the machicolation or stringcourses are in matching coursed ashlar incised with crosslets and capped with an articulated coping. The copes all appear to have been bedded on a red mortar so that there is an obvious continuous red line around the walls at high level. This is assumed to be a proprietary product. Repoint all parapets where mortar is friable

- The building is predominantly in coursed ashlar. The general surface was originally lightly tooled with polished detail and mouldings. It is comparatively finely jointed. Window and door margins are chamfered. Stringcourses are generally quite simple with angled top surfaces and well undercut, providing good run off. How much of this surface finish survives appears to depend on the specific characteristics of the original stone block and its exposure/location.

- The original masonry is a local pink hued Black Isle conglomerate. Depending on its exposure to weather, it has lost its surface and exhibits crumbling, flaking, granular disintegration due to salts, binder dissolution and exfoliation along grain boundaries. We also see some cuboidal cracking due to clay expansion. The building underwent at least two phases of stone replacement in the 1990s when under the control of the Scottish Courts Service. Two different stones were used; one potentially St Bees, the other more orange. It is noted that while the earlier work in the deeper red stone appears to exclusively involve whole stone indents, the later work in the orange stone often involves partial indents, particularly at window surrounds that stand out even more clearly because of the mismatch in colour. The pointing is a gritty cement based mortar throughout.

- The proposal is to undertake a repair scheme across the whole building including repointing the masonry and using a suitable source of matching stone subject to the results of a stone and mortar analysis report to be commissioned as part of the detailed design work. See Fabric report for extent of intervention.

- On the East elevation the extent of replacement of the decayed rybats etc is detailed in the accompanying fabric report.
- In order to comply with the Technical Standards for escape it is necessary to provide a larger external plat at the present entrance door and this new set of steps is to be detailed in matching red sandstone with a new wrought iron handrail set into the steps with lead.

- Existing double glazed windows dating from the 1980s to be overhauled. See detailed condition report.
- Existing original external door to be overhauled.
- Window and door colours to be the subject of historic paint investigation but windows provisionally to be painted a darker colour rather than white as at present, subject to agreement of sample for new overall decorative scheme for woodwork and cast iron.

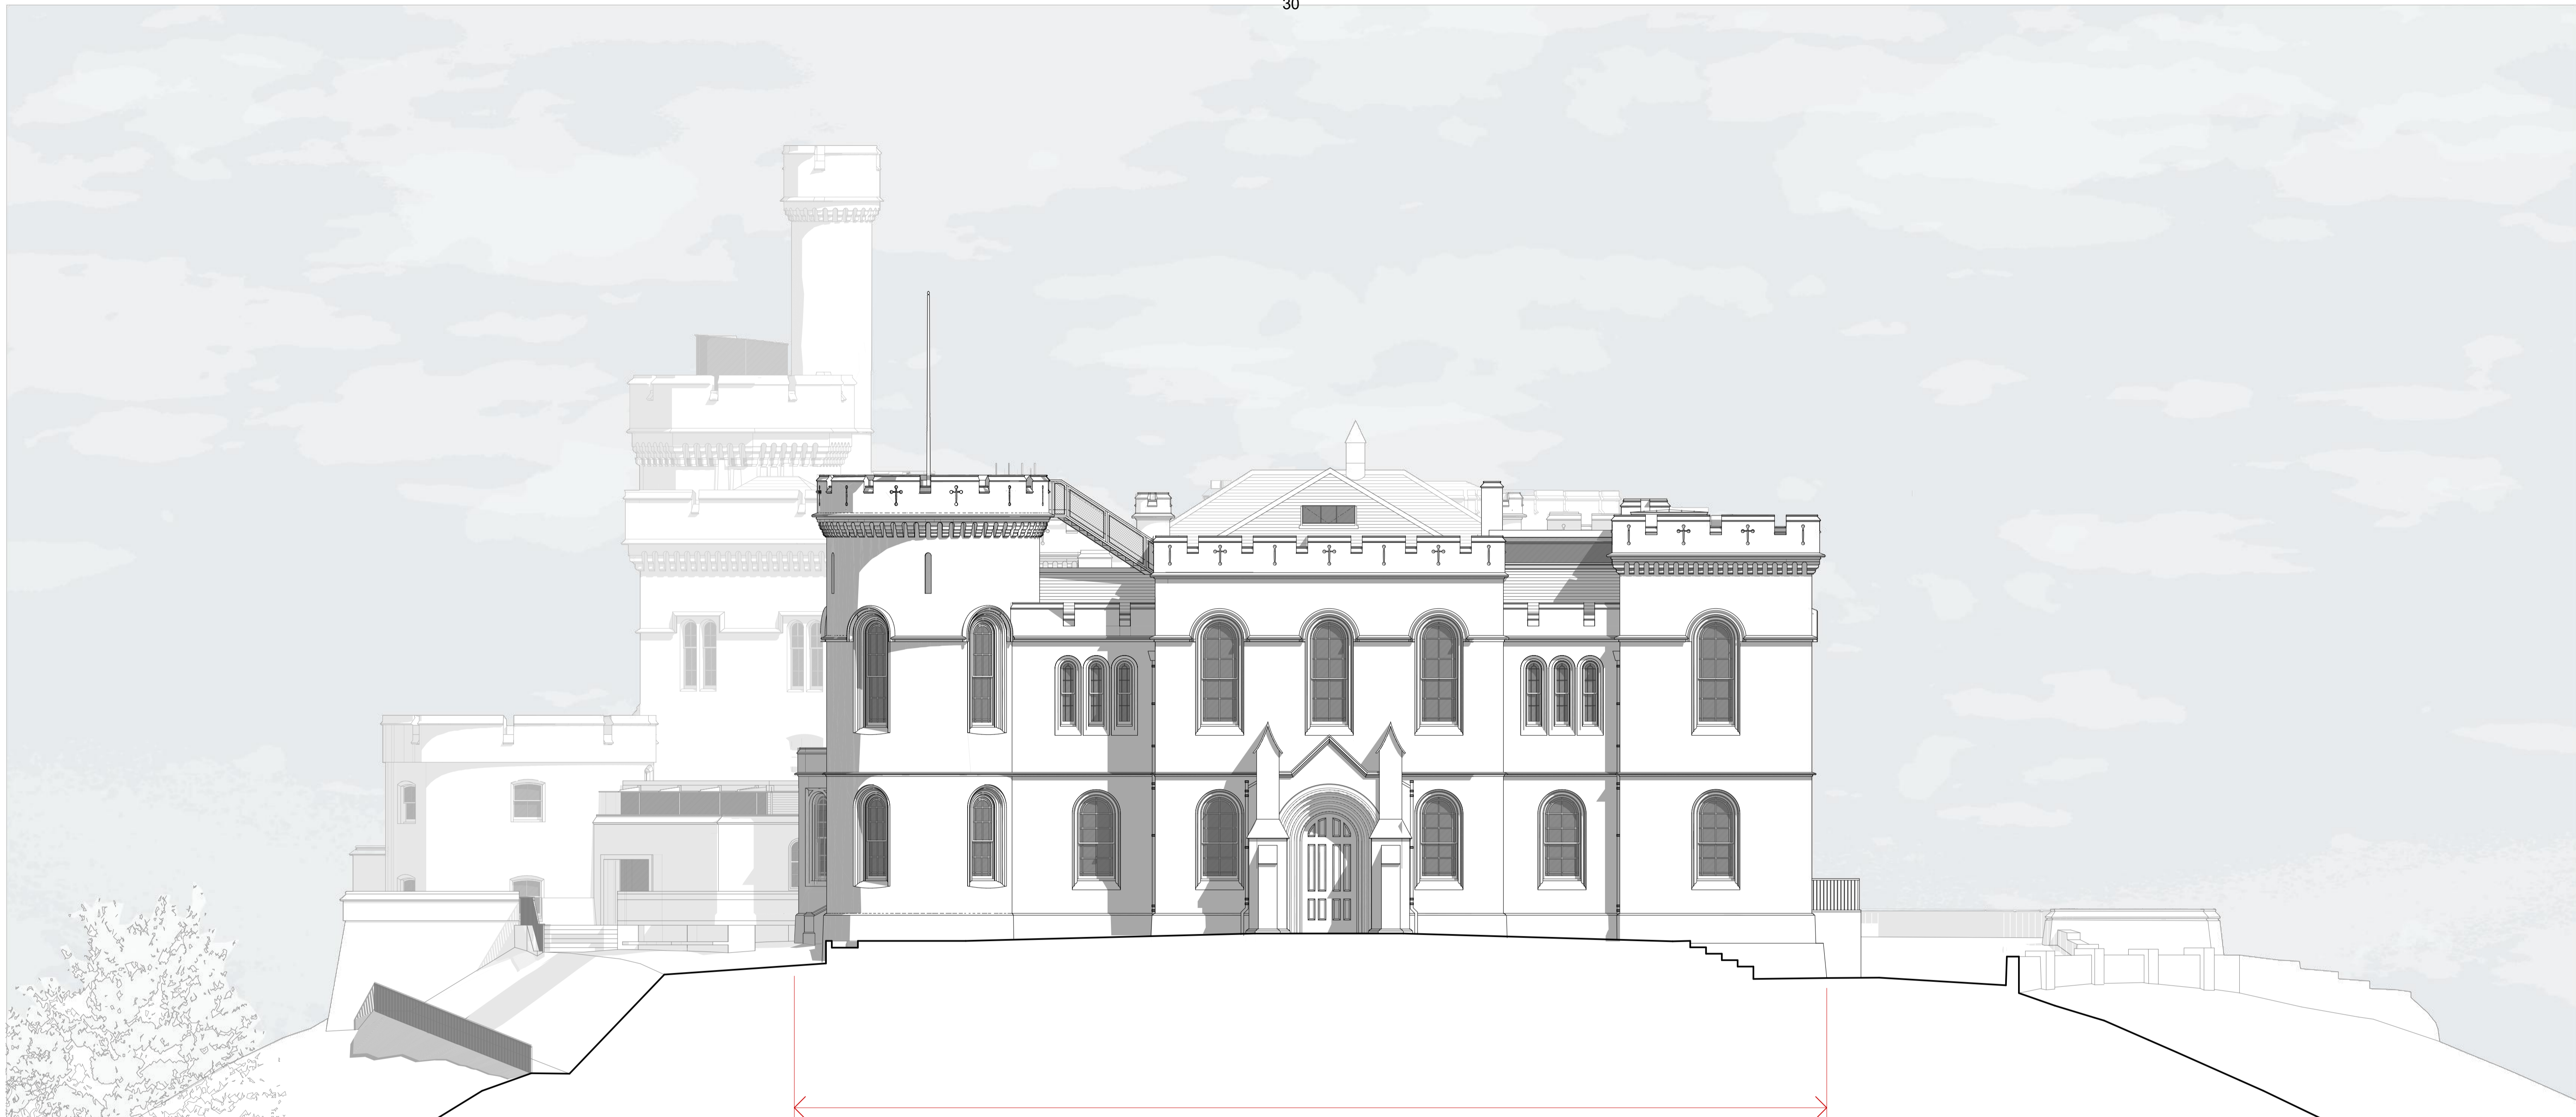
- Overhaul existing slate roofs comprising large format slates in even courses typical of a William Burn roof. Provide additional discrete ventilation to pitches.

- Overhaul existing LSA compliant leadwork including timber cored ridge rolls, lead valleys, lead flat roofs within turrets and parapet gutters.
- See detailed axonometric of roof level intervention comprising the extension of the service stair to roof level to access the new roof terrace. This includes the complete removal of one pavilion roof comprising timber trusses, purlins and rafters thus providing spare large format slates for repairs elsewhere.

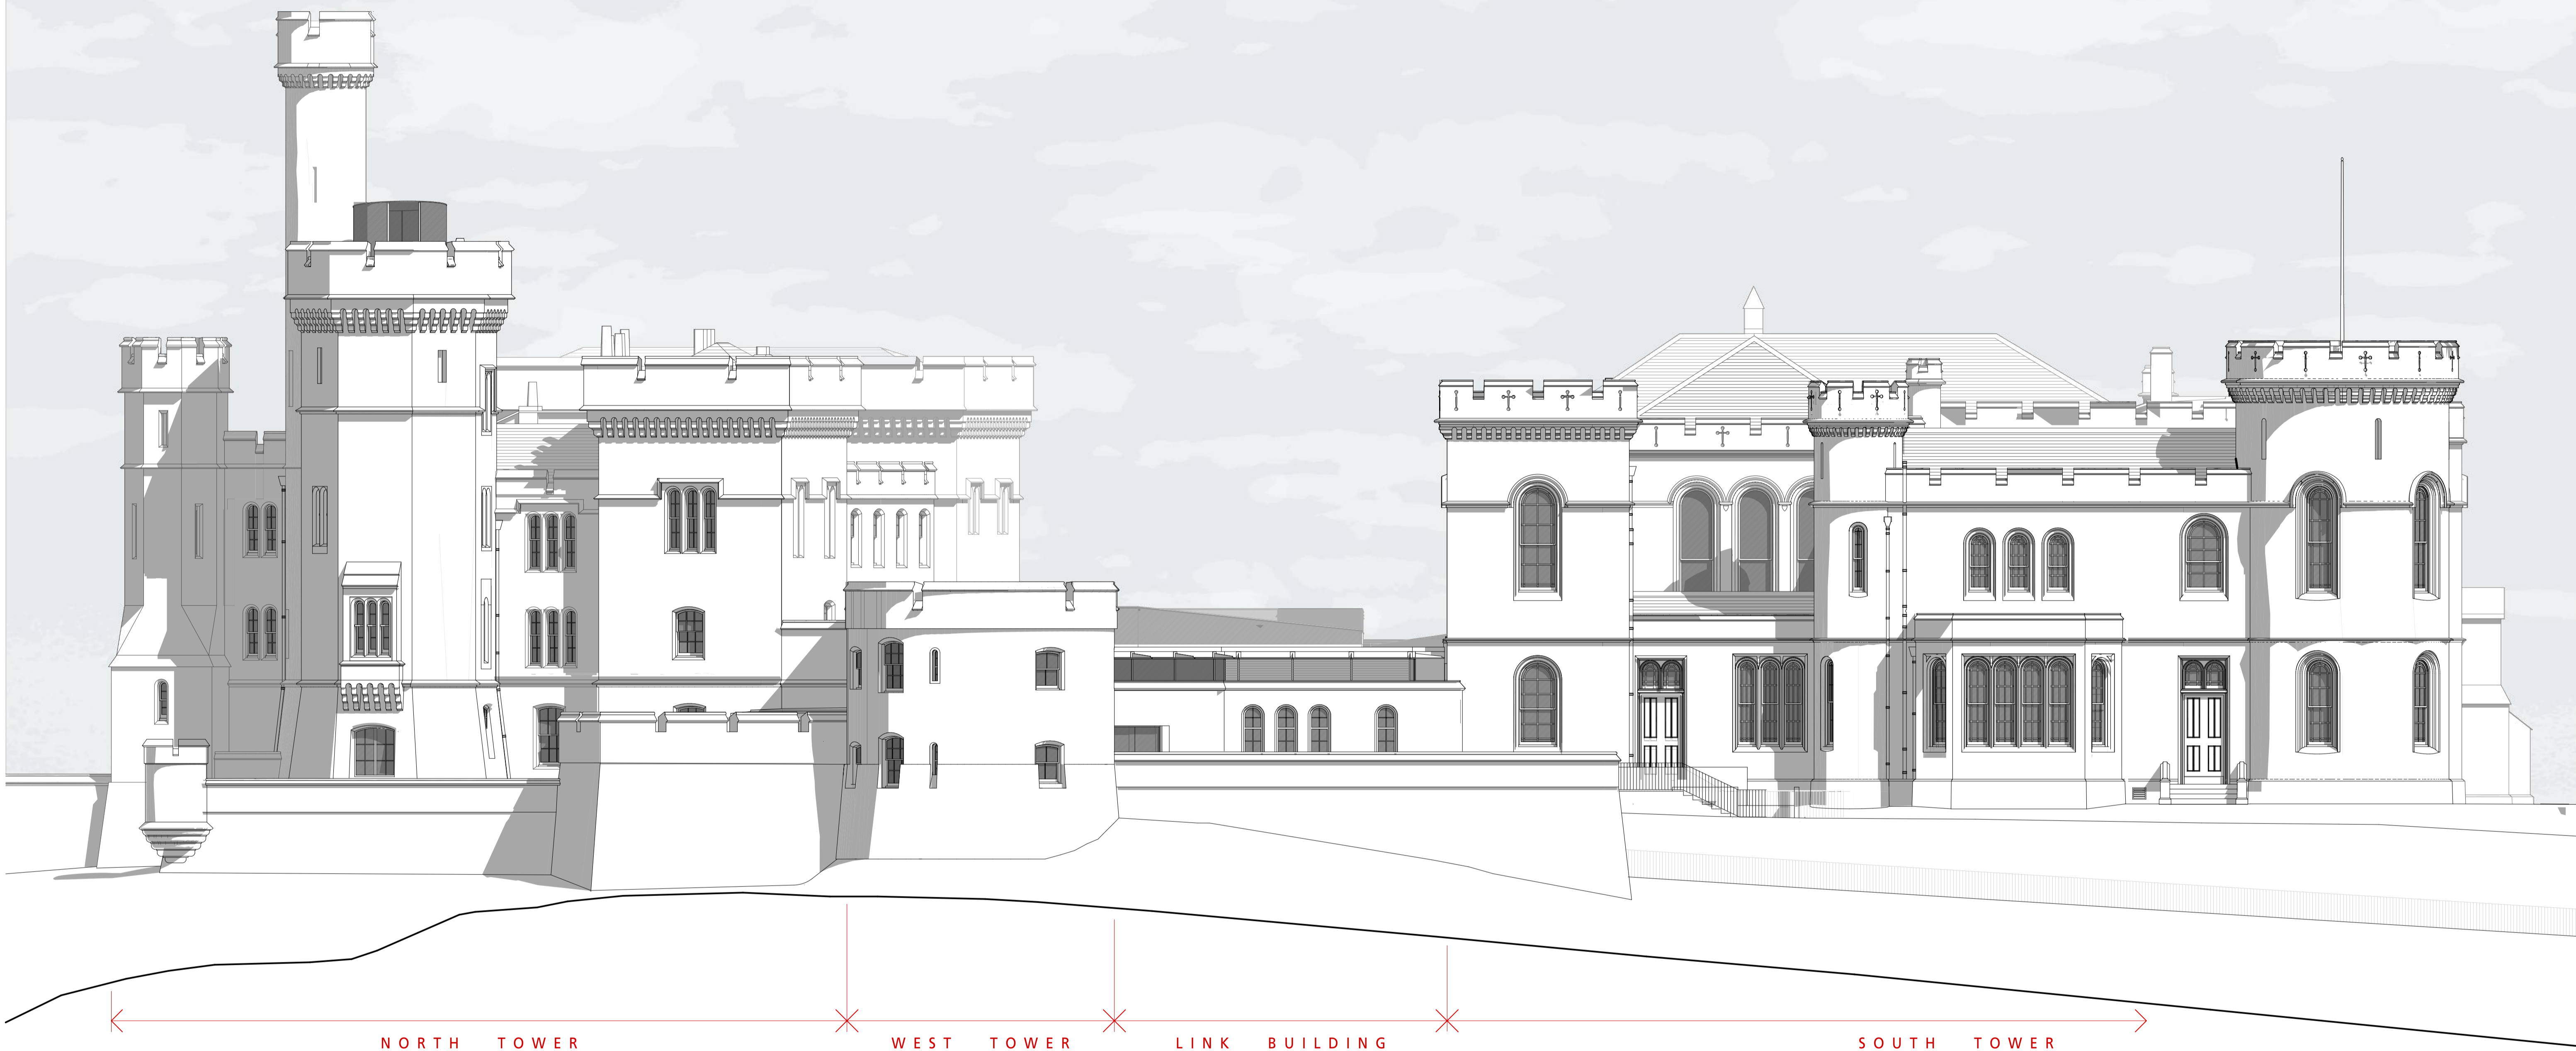
- It is proposed to use this door as an emergency exit.
 - Through consultation with The Highland Council Building Standards Officers, the existing step arrangement is to be replaced with new steps, providing:

- Compliant stepped access/egress,
 - Larger landing with sufficient space for temporary wheelchair waiting in the event of emergency,
 - Level threshold at the door to provide a more compliant access/egress point.

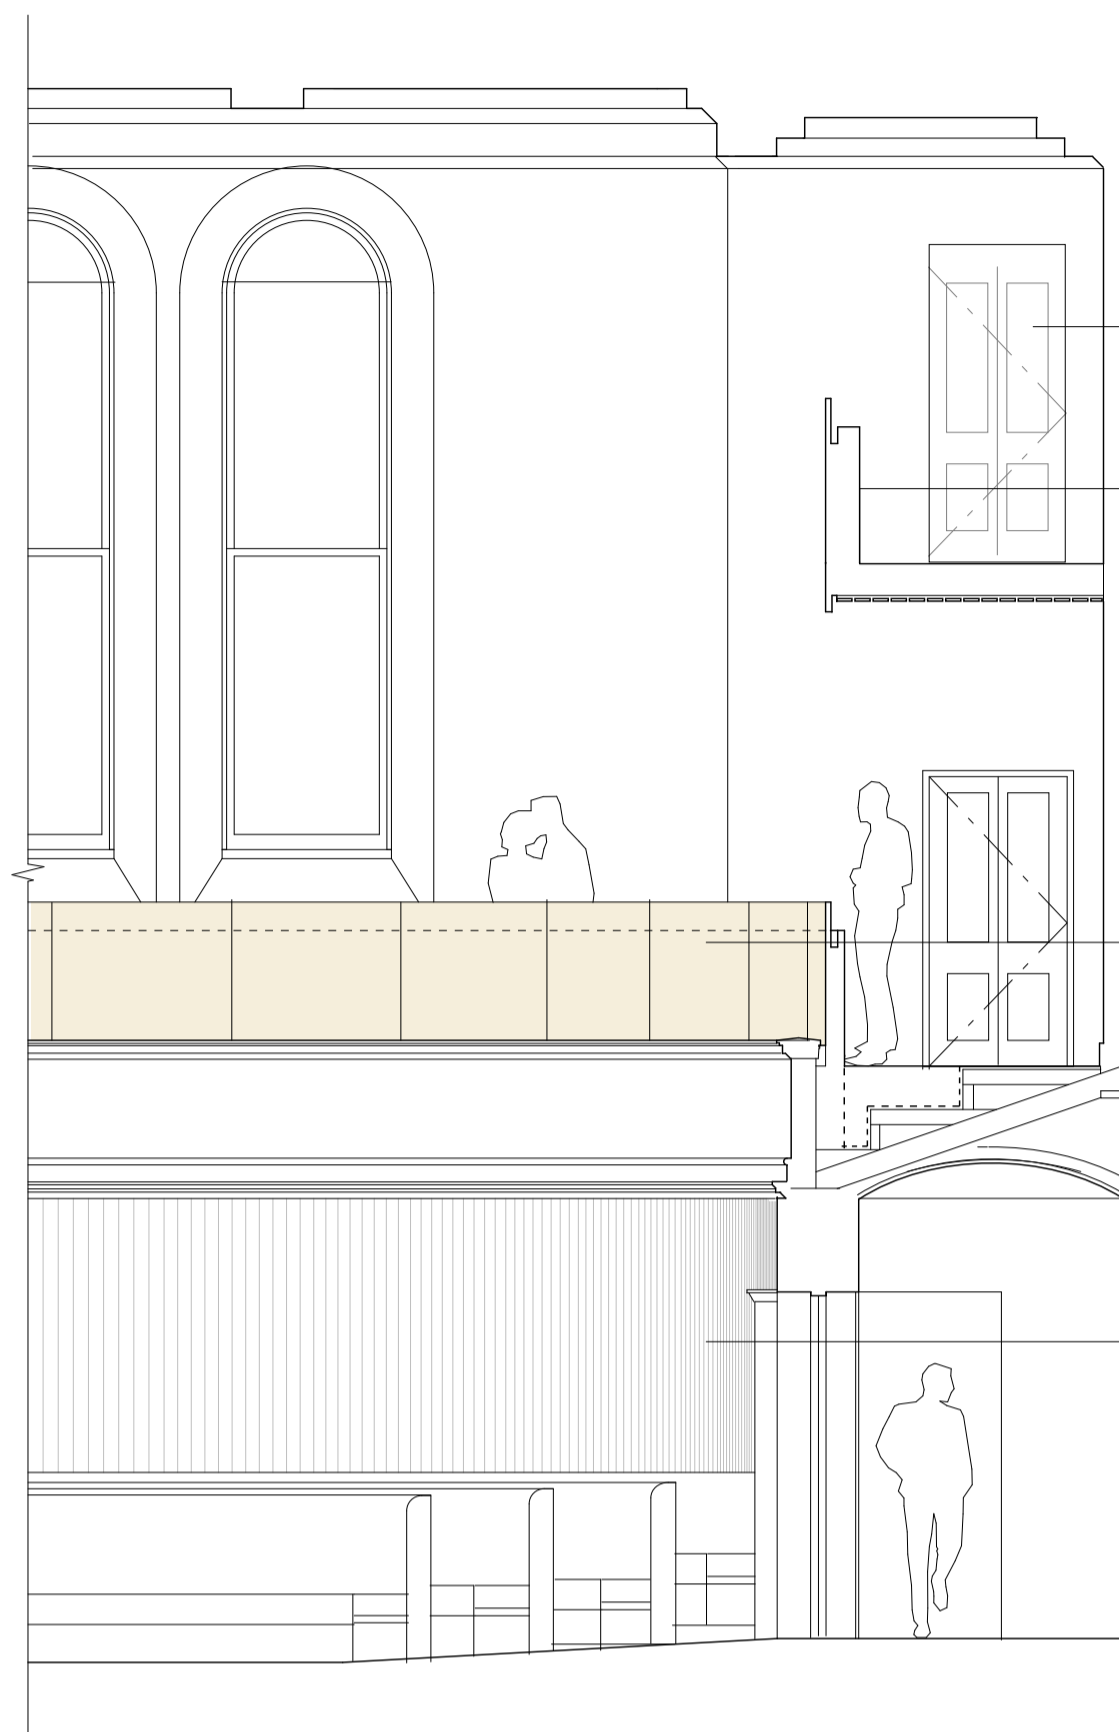
PART LONG SECTION THROUGH COURT ROOM AS PROPOSED scale 1:50

New slappings through to landing accessed from Service Stair

New balcony structure comprising girder truss in handrail spanning between masonry walls, supporting steel and timber floor structure.

Existing honey coloured strip timber boarding taken as palette for new veneered panelling. barrier to gallery follows curve of existing horseshoe and comprise steam bent veneered panels.

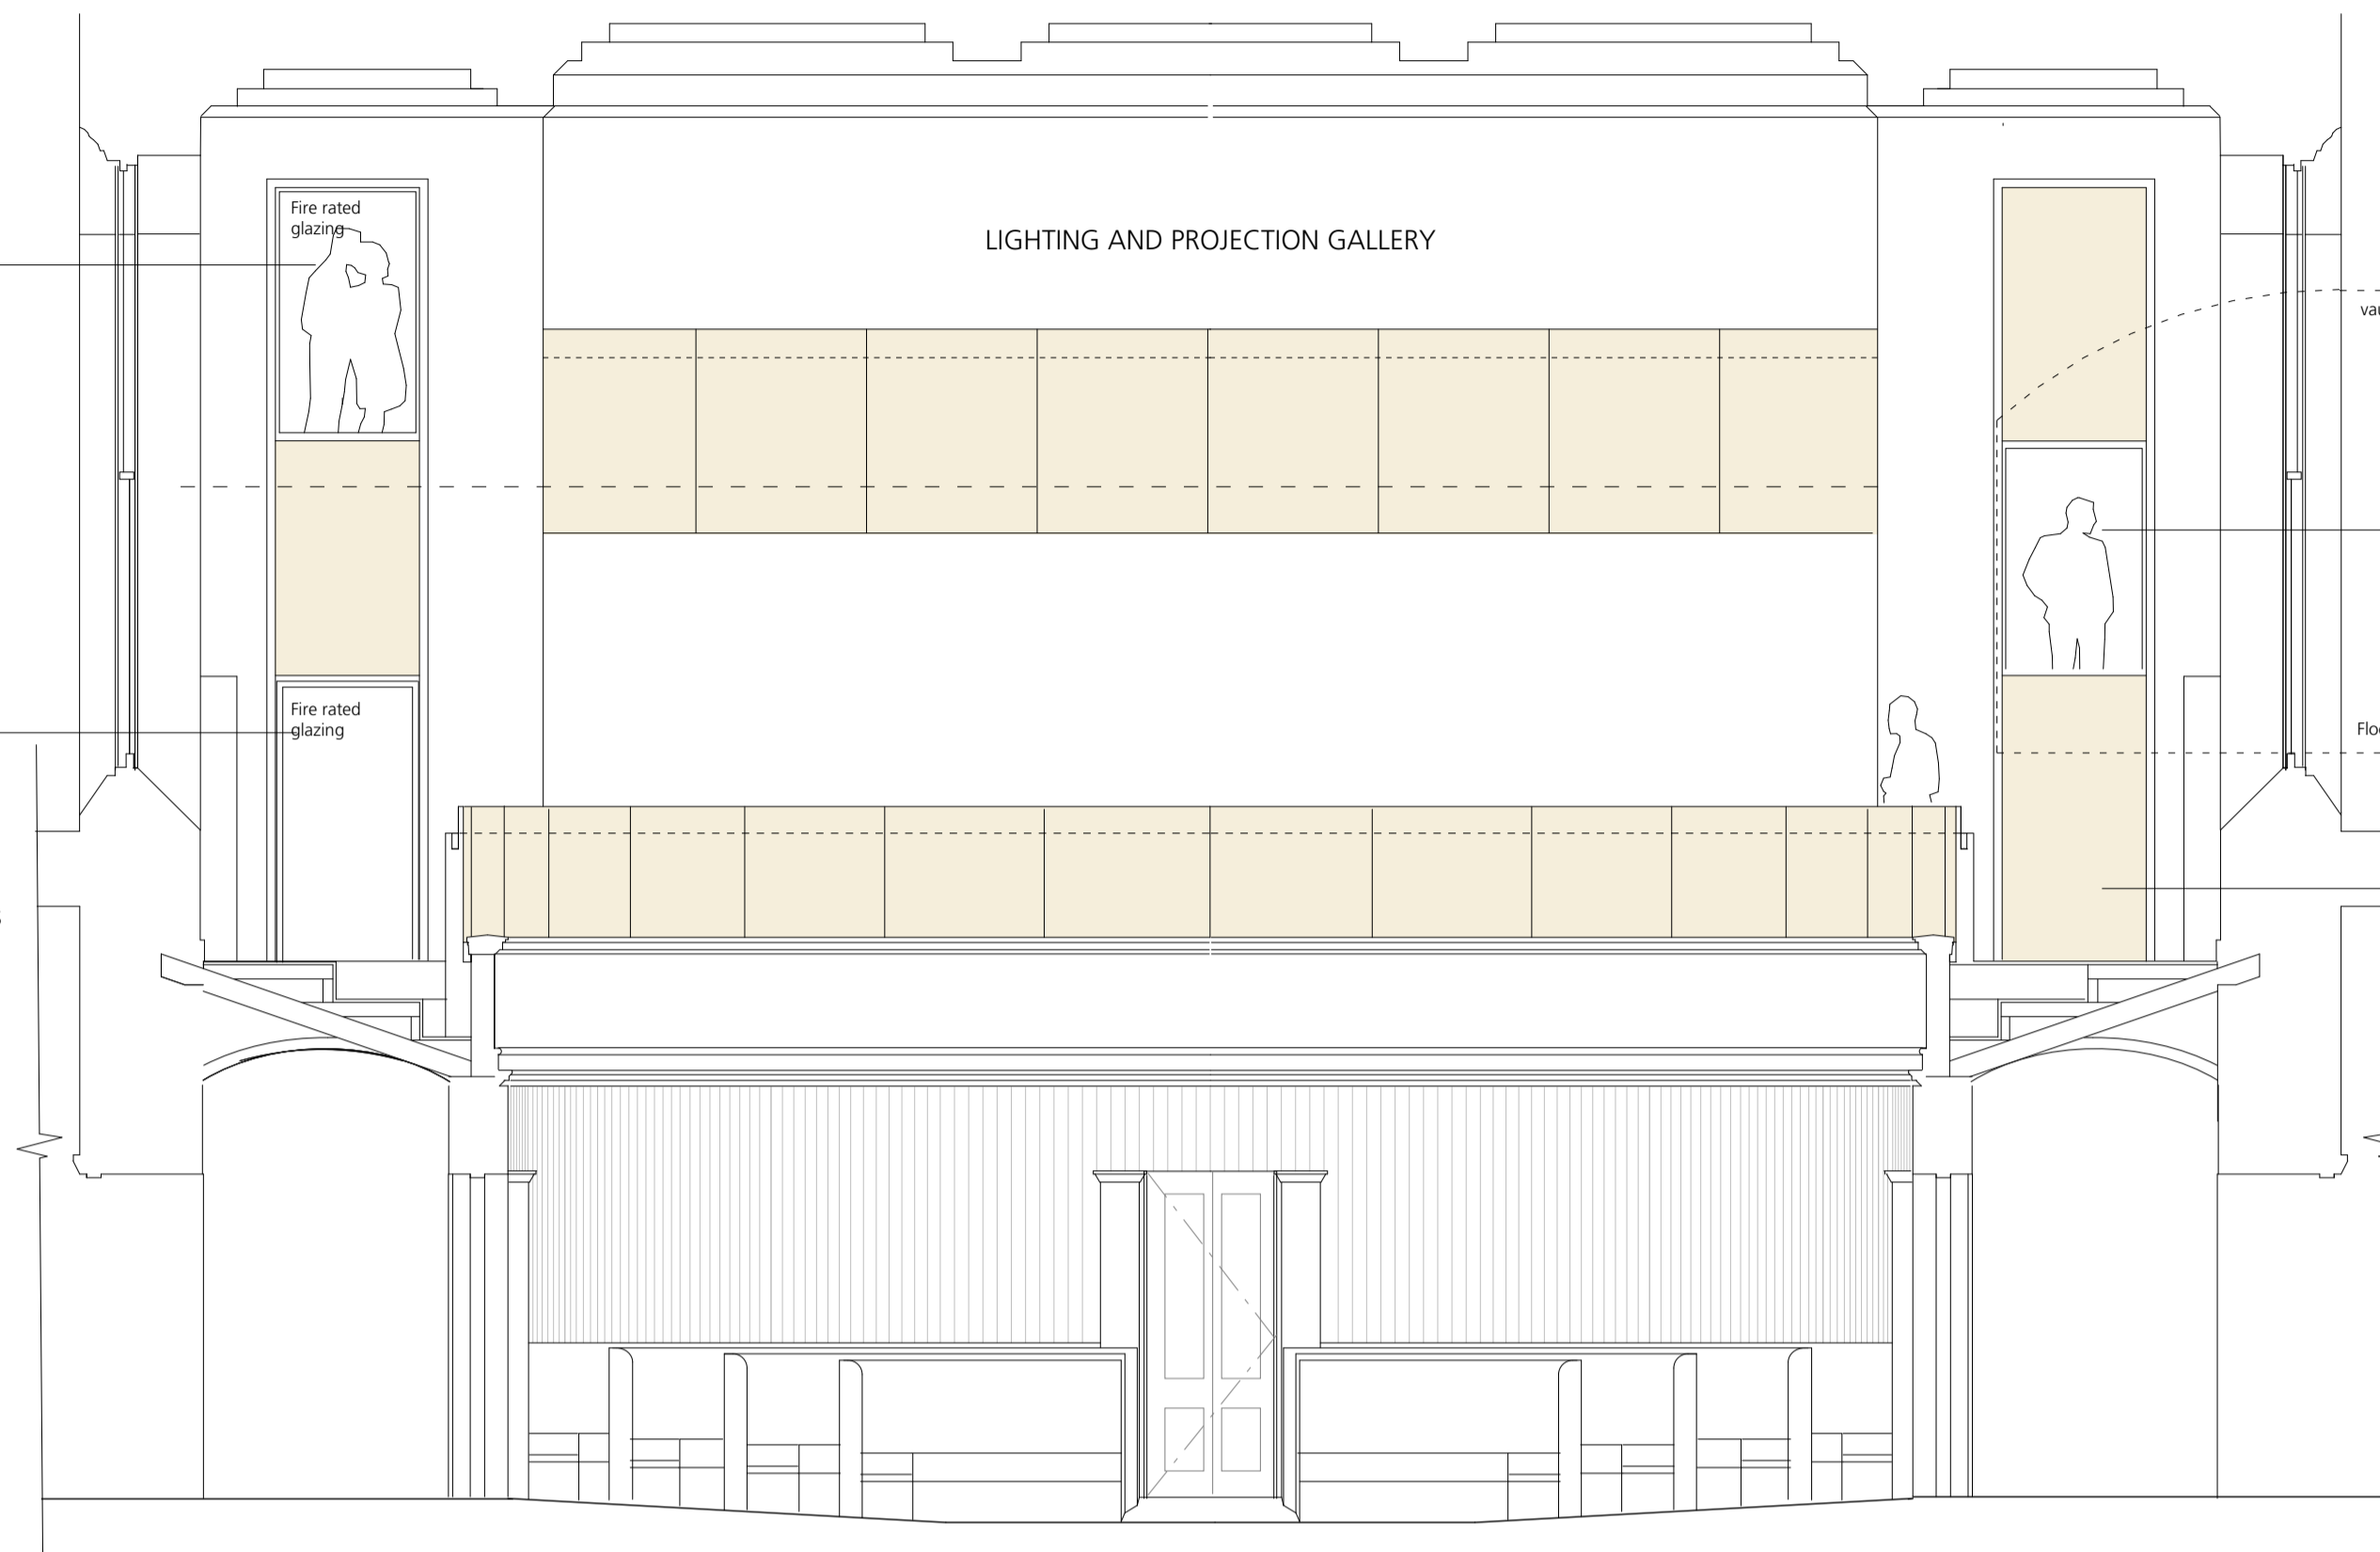
CROSS SECTION THROUGH COURT ROOM AS PROPOSED scale 1:50

Fire rated glazing

Openings on either side of gallery unified within an applied timber frame with veneered cladding panels set between fire glazing.

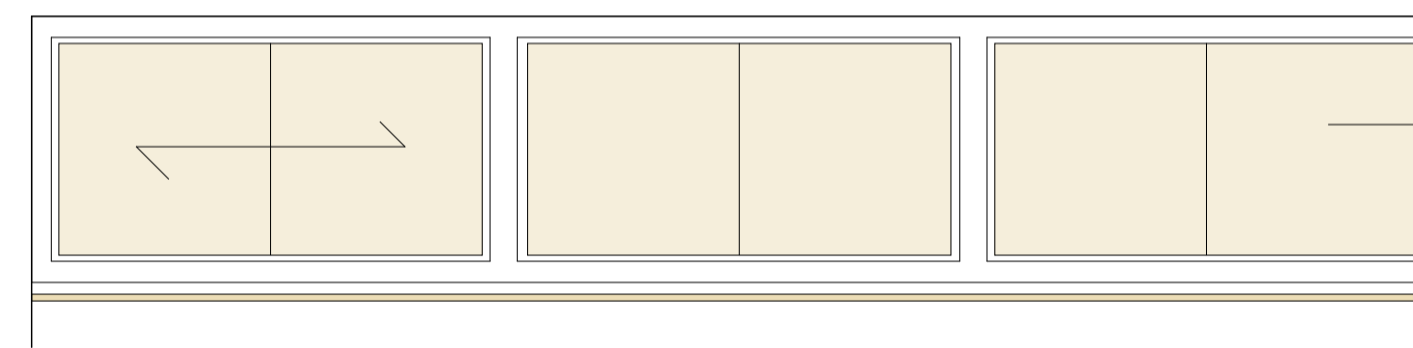
DETAIL THROUGH BALCONY SOFFIT scale 1:50

Expressed steel floor structure with coffering expressed as veneered panels
