**5.2.36 Slope Ref. AA22A**

GEOTECHNICAL ASSESSMENT SHEET											
<b>Site:</b>	A890 Stromeferry Bypass	<b>Slope Ref:</b>	AA22A	<b>Chainage:</b>	3386- 3415	<b>Start Grid Ref:</b>	NG 91451 37842	<b>End Grid Ref:</b>	NG 91483 37882	<b>Elevation:</b>	17m AOD

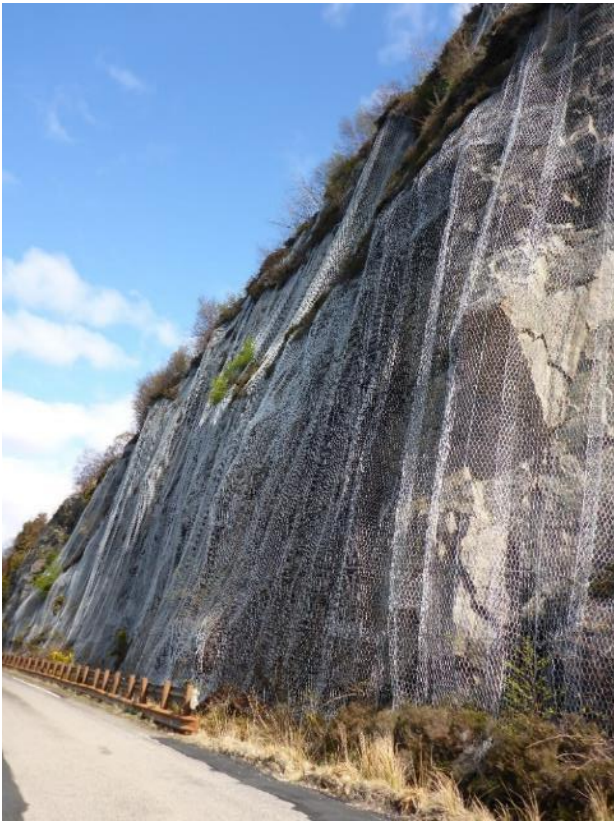
Photo at Start Chainage (looking east)	Photo at End Chainage (looking west)
